# DRAINAGE WORKS AT ST TYBIE'S CHURCH, LLANDYBIE, CARMARTHENSHIRE ARCHAEOLOGICAL WATCHING BRIEF (SN6182315550)

#### RHIF YR ADRODDIAD / REPORT NO. 2017/09 RHIF Y DIGWYLLIAD / EVENT RECORD NO.110315

Chwefror 2017 February 2017

#### Menna Bell

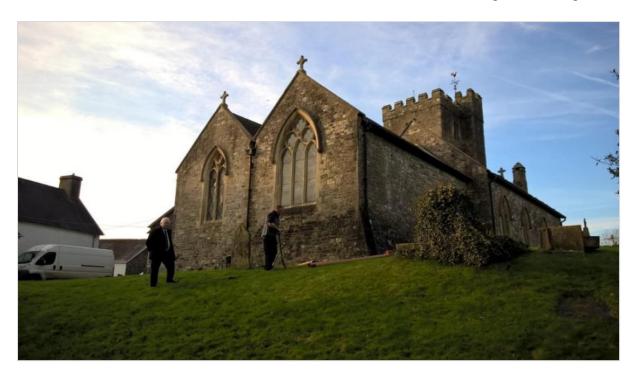
**Photo 1:** The eastern end of the double nave from which the rainwater will be diverted. Church Warden Brian Hopkins is pictured in the foreground whilst the contractor begins the hand digging of the drainage trenches (DAT Photo 110315-0001)

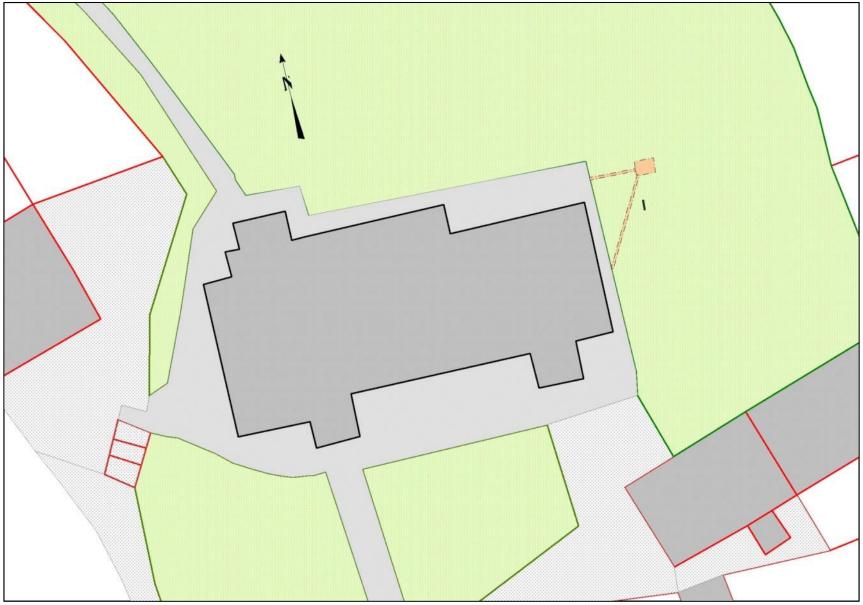
**Figure 6:** Plan showing St Tybie's Church and the location of the drainage trenches (coloured orange) monitored during this watching brief.

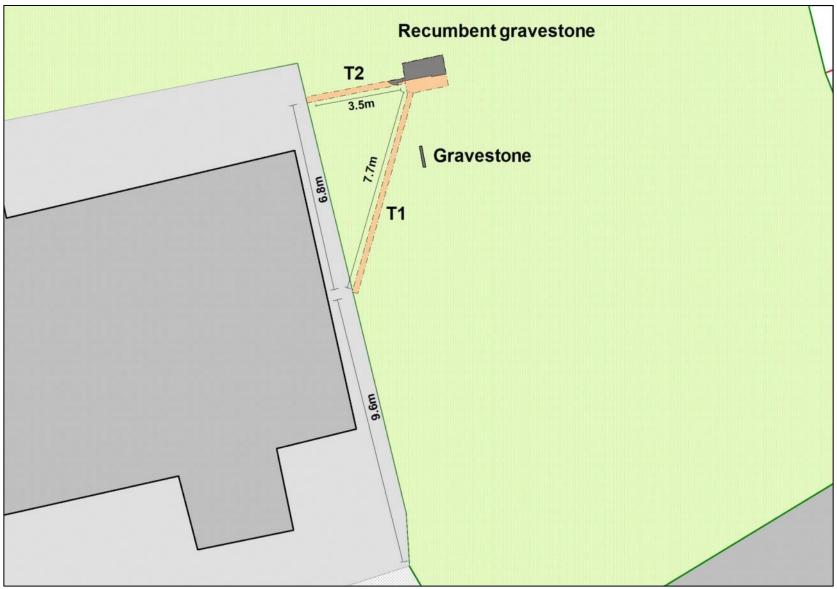
**Figure 7:** Annotated plan showing the two drainage trenches and the recumbent gravestone uncovered in the junction box for the water outlet. Also shown is the location of the upright gravestone situated east of the nave (drawing not to scale).

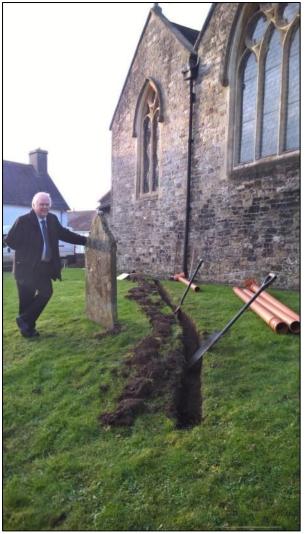
**Photo 3:** Drainage Trench T1 (DAT Photo 110315-0002)

- 5.3 T1 measured 20cm wide, 7.7m in length and only 22cm deep and therefore, did not exceed the medium brown, silty-clay, friable topsoil (101) which contained frequent mixed stone rubble, pieces of lime mortar and the occasional fragment of human bone. T2 was of equal width and depth to T1 but only 3.5m long, joining a junction box measuring approximately 1.45 wide and just over 1m in length.

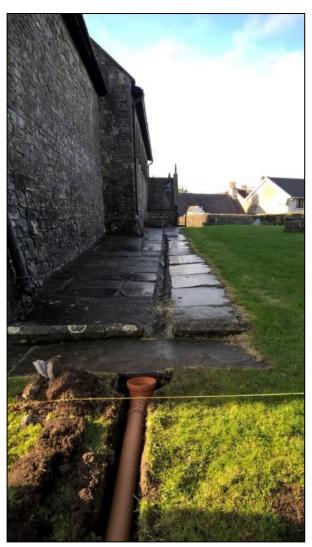
Photo 4: Drainage Trench T2 (DAT Photo 110315-0013)

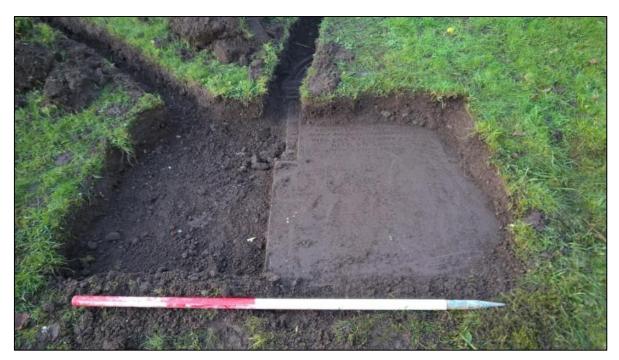
- 5.4 A recumbent, modern gravestone (102) was partially revealed beneath 14cm of topsoil (101) in the northern side of the junction box (Photo 5). The remainder of the junction box was excavated to a depth of 20cm. The gravestone appeared to be comprised of limestone, conventional in style with engraved detail and arched at the top although its full height was not revealed. The gravestone measured 80cm wide, 8cm in thickness and a length in excess of 1.7m. The mason's mark was Thomas of Llandybie. The dedication was inscribed in block lettering and it was possible to transcribe the following (Photo 6):

Photo 5: The partially revealed modern, recumbent gravestone in the junction box into which drainage trenches T1 and T2 terminate east of the church nave.
1m scale (DAT Photo 110315-0011)

5.5 The gravestone was not removed as it did not obstruct the work in any way. No other features or deposits were revealed during this scheme of works and the rare fragments of human bone unearth were reinterred in the trenches. The drain pipes were laid and the turves reinstated at the end of the day although the junction box remained open, awaiting the installation of the water outlet. Further to this work, the modern concrete drain running along the northern side of the church was scheduled to be demolished and replaced by a new drain (Photo 7). It was not considered necessary to watch this phase of work.

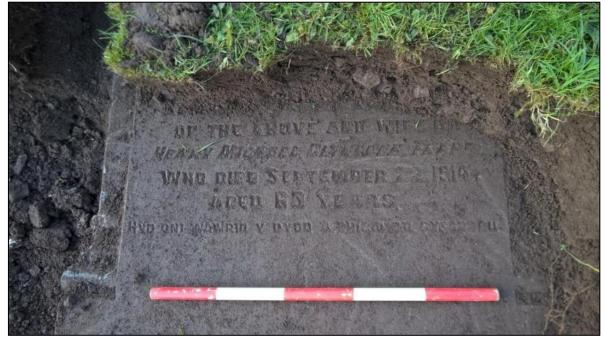
"OF THE ABOVE AND WIFE OF HENRY MICHAEL, GLYNCOCH TRAP WHO DIED SEPTEMBER 22 1914 AGED 68 YEARS HYD ON I WAWRIO Y DYDD ACHILIO O CYSGODAU"

**Photo 6:** The partially revealed inscription on the recumbent gravestone (DAT Photo 110315-008)

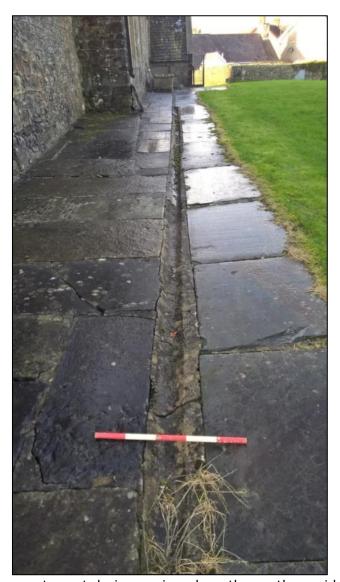
Photo 7: The concrete cast drain running along the northern side of the church. This is due to be demolished and replaced with a new concrete drain.
