## **Amroth Castle Farm Medieval Building – PRN 107832**

### **Site visits by Dyfed Archaeological Trust in 2015 & 2016**

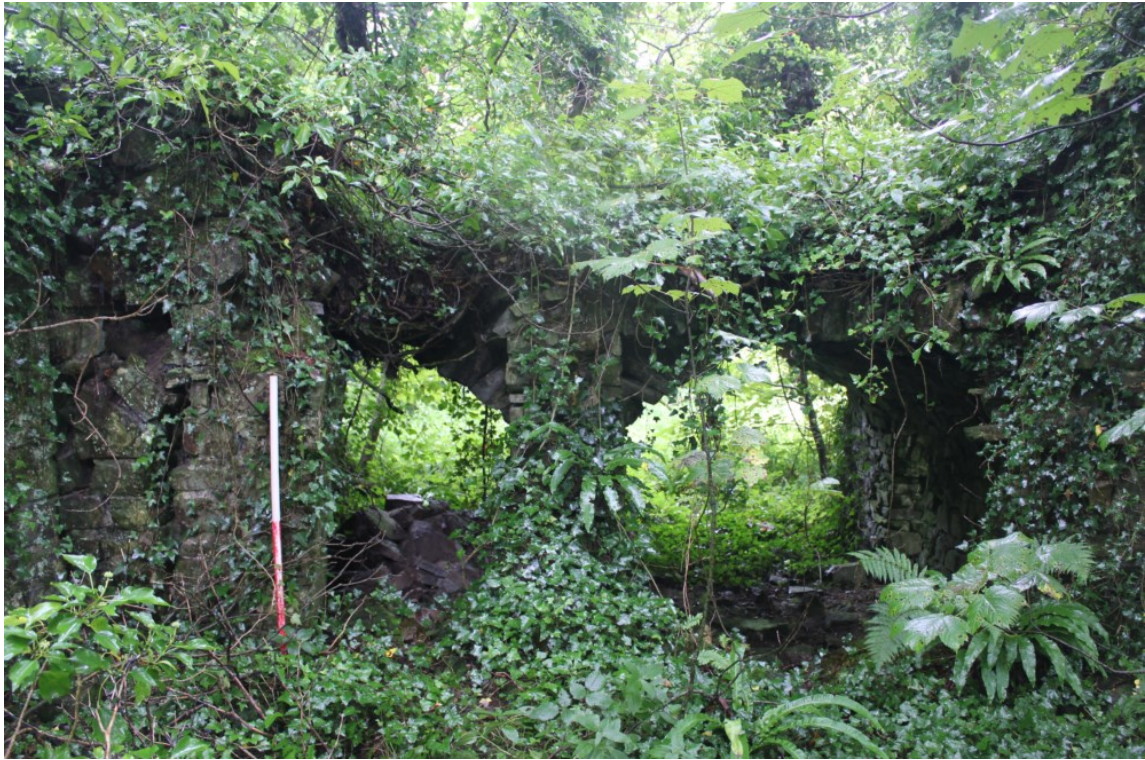
The masonry remains of a building which consists of two parallel barrel vaulted structures at the southern end of a rectangular building. The building is very ruinous with only one standing wall remaining on the east longitudinal side, which contains evidence of one narrow splayed window and the possible sill of at least one, possibly two more. Further structures lie to the north of the building, containing a curved corner. Other structures to the east of the building appear to be butted up to the main structure.

**Photo 1:** Looking south towards the vaults in 2015. 1m scale

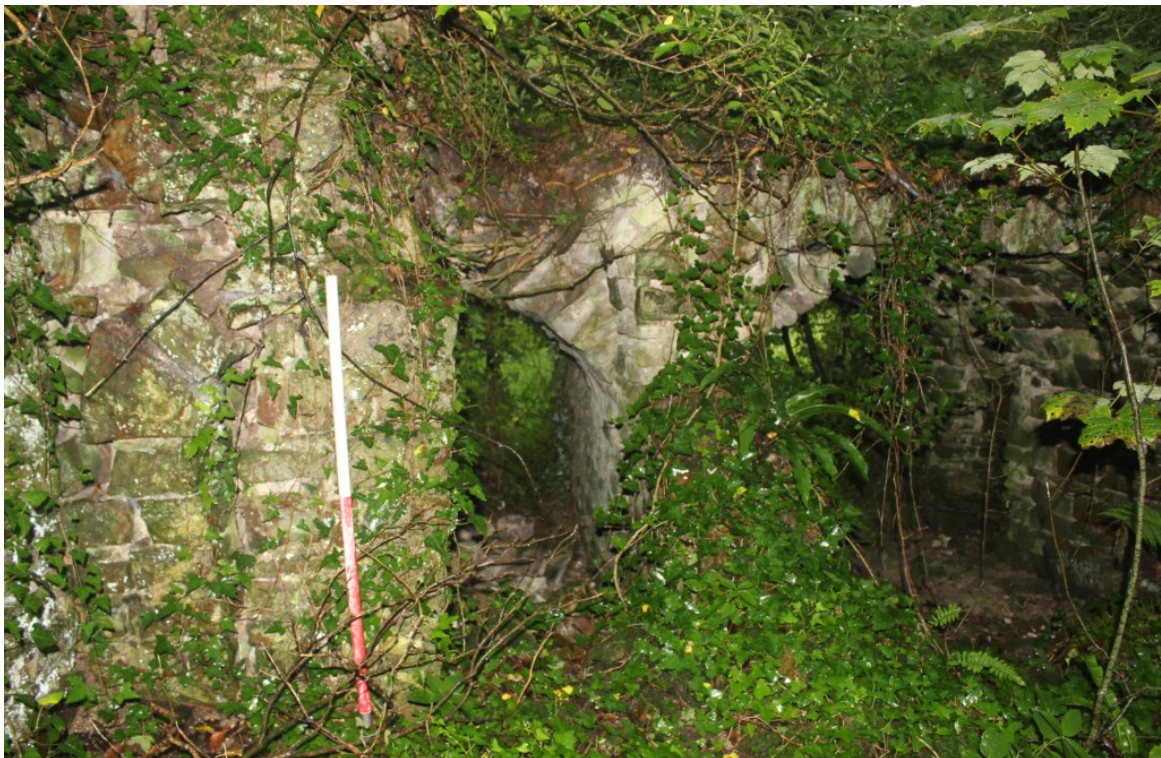
**Photo 2:** Looking towards the vaults from the north showing arch in stonework to left of ranging pole; visible in 2015. 1m scale

During 2016 a large tree growing within the east side of the vaulted structure collapsed across the structure approximately from east to west and ended up lying across the top of the 2 vaults. This caused extensive damage to the eastern vault (Photo 2) including the destruction of a possible window within the east wall recorded in 2015 (Photo 8). Fortunately the western vault remained intact although its roof showed signs of weakening. The collapsed tree was removed in sections by tree surgeons on 15th December 2016. As part of this process the saplings growing within and around the ruin were cut down to ground level, as was all other vegetation. This revealed the ruin more clearly (Photos 5-7). It appeared that the ruin had been built on an area of raised ground, to the south and west of which the ground dropped away to become very wet and boggy. A number of walls and possible structures associated with the ruin (Figure 3) were sketched in plan; some of which obviously postdate the vaulted structure. Not recorded in Figure 3 are the walls that form an arrangement of sub-rounded enclosures or small fields to the southeast of the vaulted structure, as it was not possible to record their full extent in the time available. They are unusual in size and form, and together with the other walls recorded in closer vicinity to the vaulted structure, suggest that the site could have undergone a number of changes of use over its lifetime.

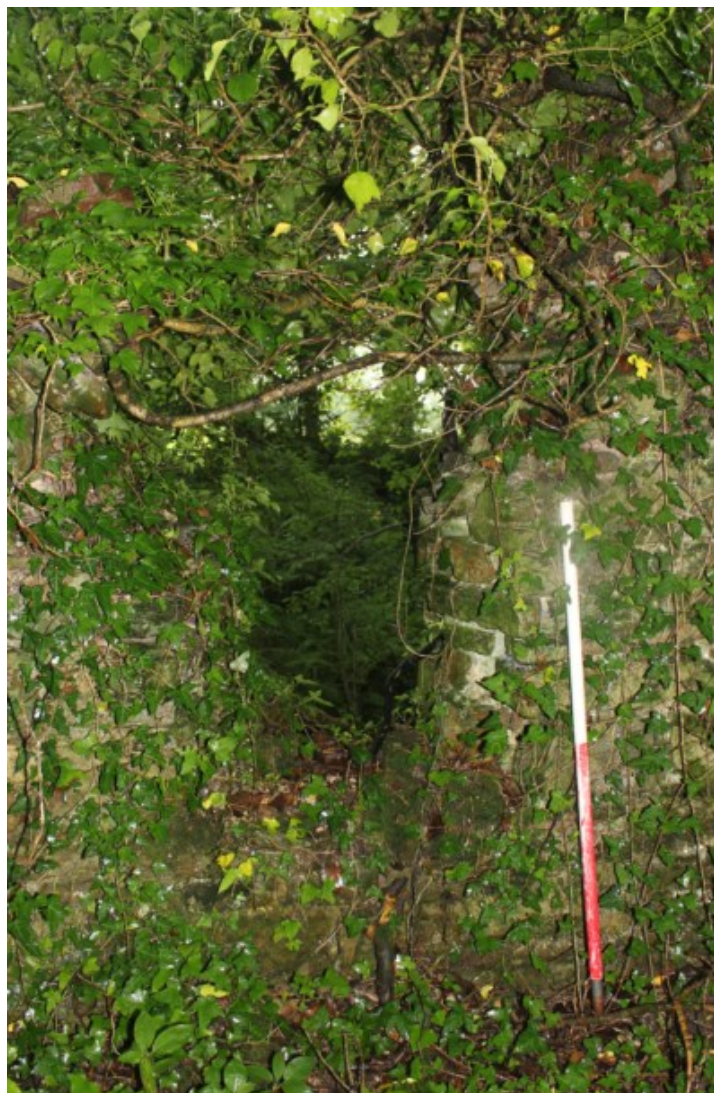
**Photo 3:** Splayed window in the east wall, from the interior, visible in 2015. 1m scale

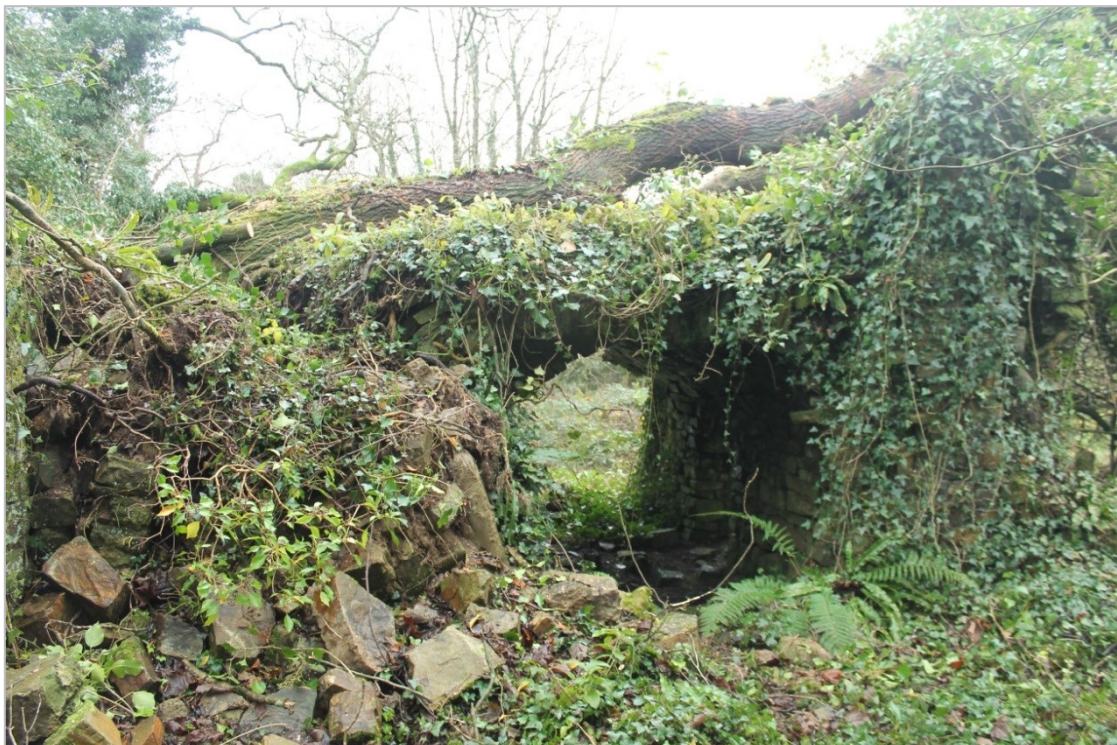
**Photo 4:** Looking roughly south towards the vaults in 2016 showing the damage caused to the eastern vault by the collapsed tree that can be seen lying across the top of the structure.

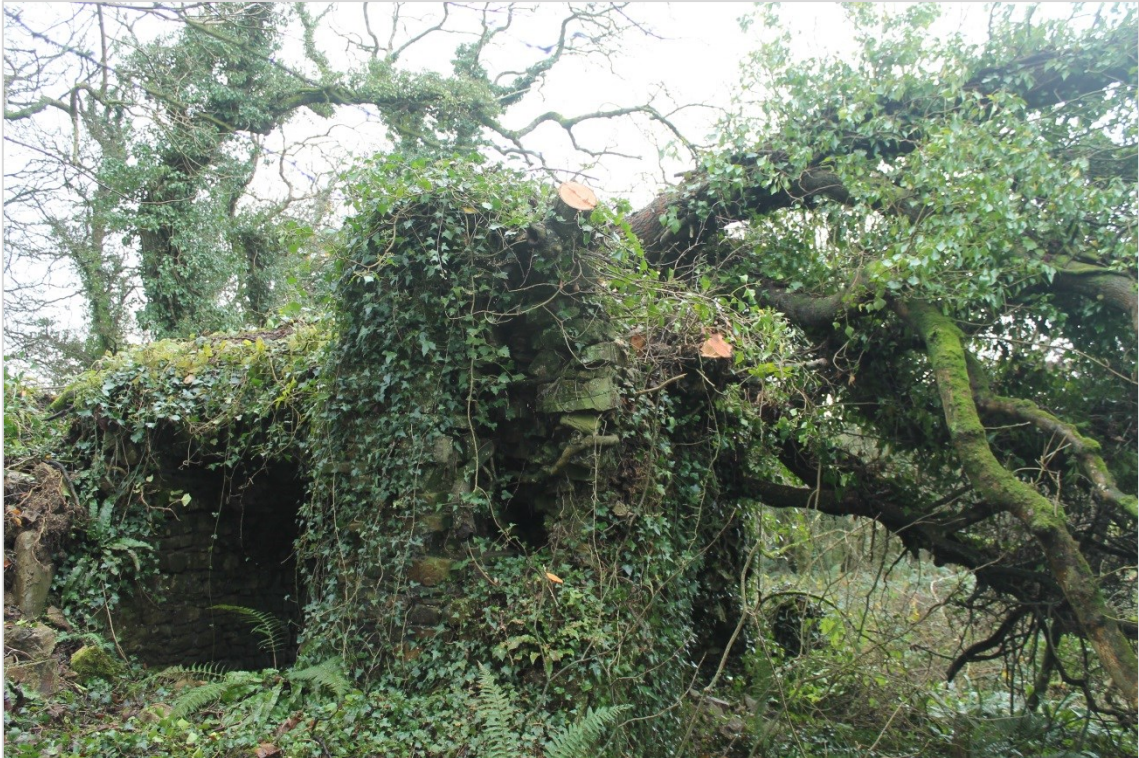
**Photo 5:** Looking approximately SE in 2016 towards the west wall of the western vault showing the branches of the fallen tree overhanging the ruin.

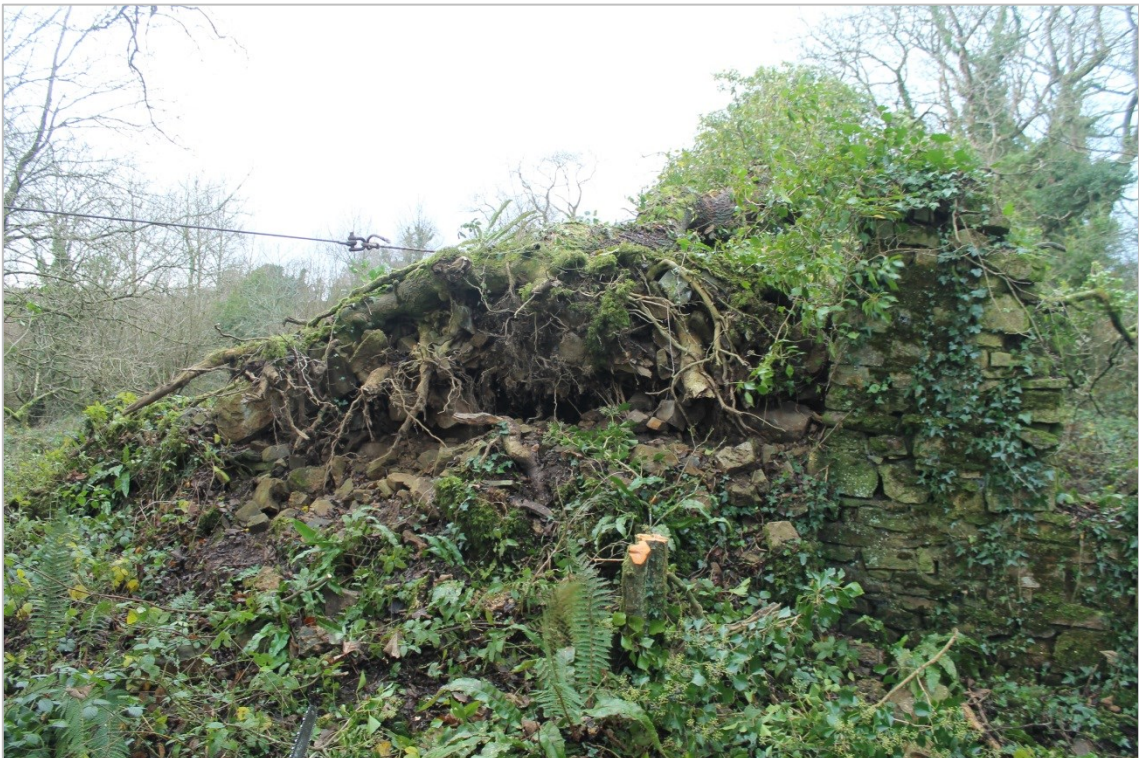
**Photo 6:** Looking approximately west in 2016 showing the roots of the collapsed tree that grew within the east wall of the ruin.

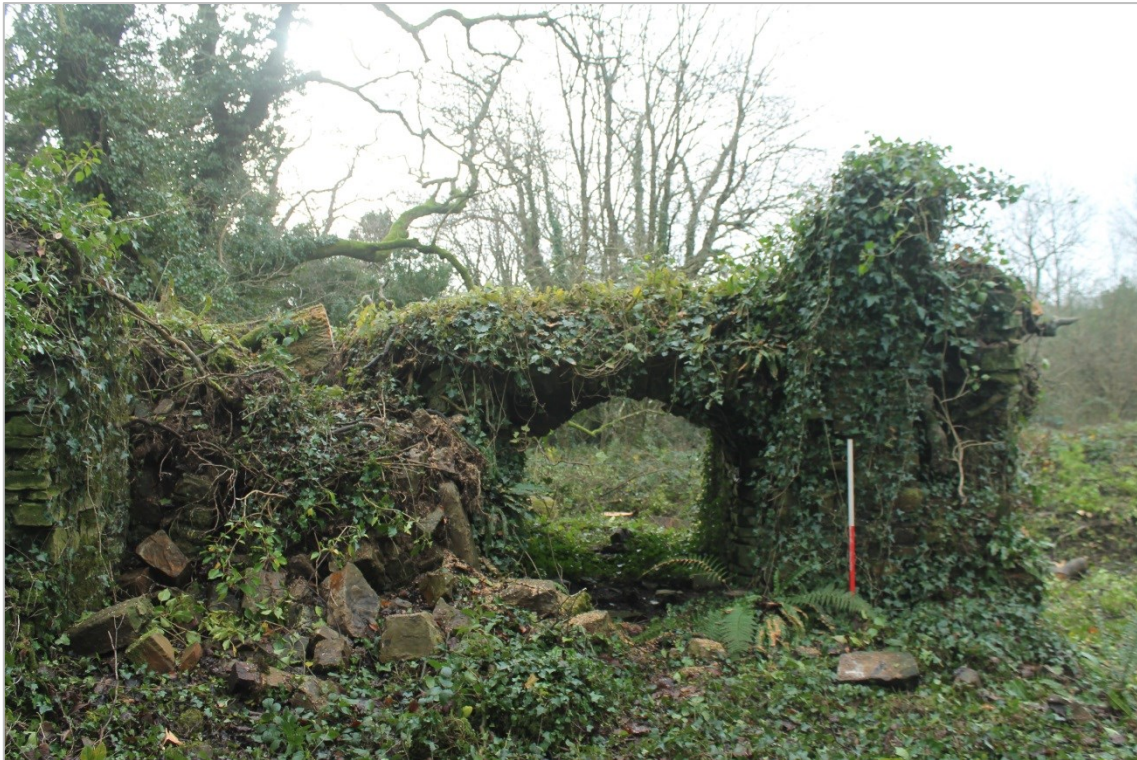
**Photo 7:** Looking south in 2016 towards the vaulted structure after the removal of the collapsed tree and clearance of the surrounding vegetation. 1m scale

The vegetation clearance within the vicinity of the ruin could allow for a unique opportunity to record in detail the ruin and its relationship with the surrounding enclosures before it becomes obscured by vegetation again.

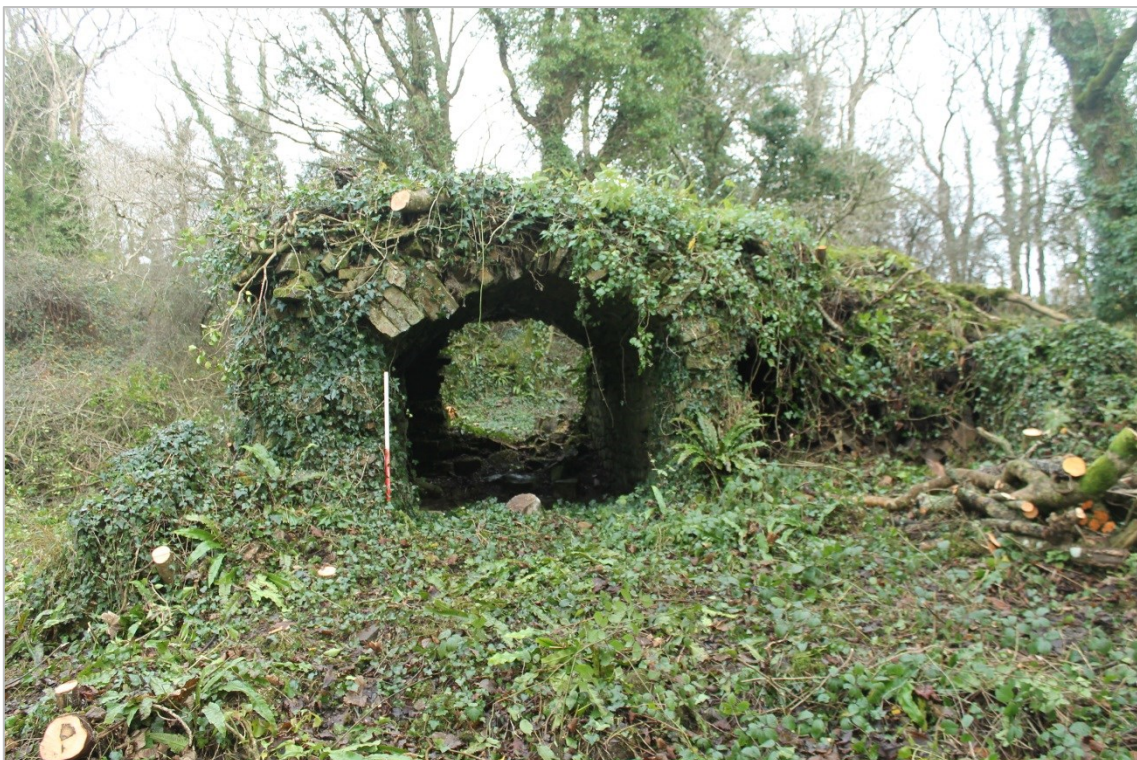
**Photo 8:** Looking north in 2016 at the vaulted structure showing the extant western vault after the removal of the collapsed tree and clearance of the surrounding vegetation. 1m scale

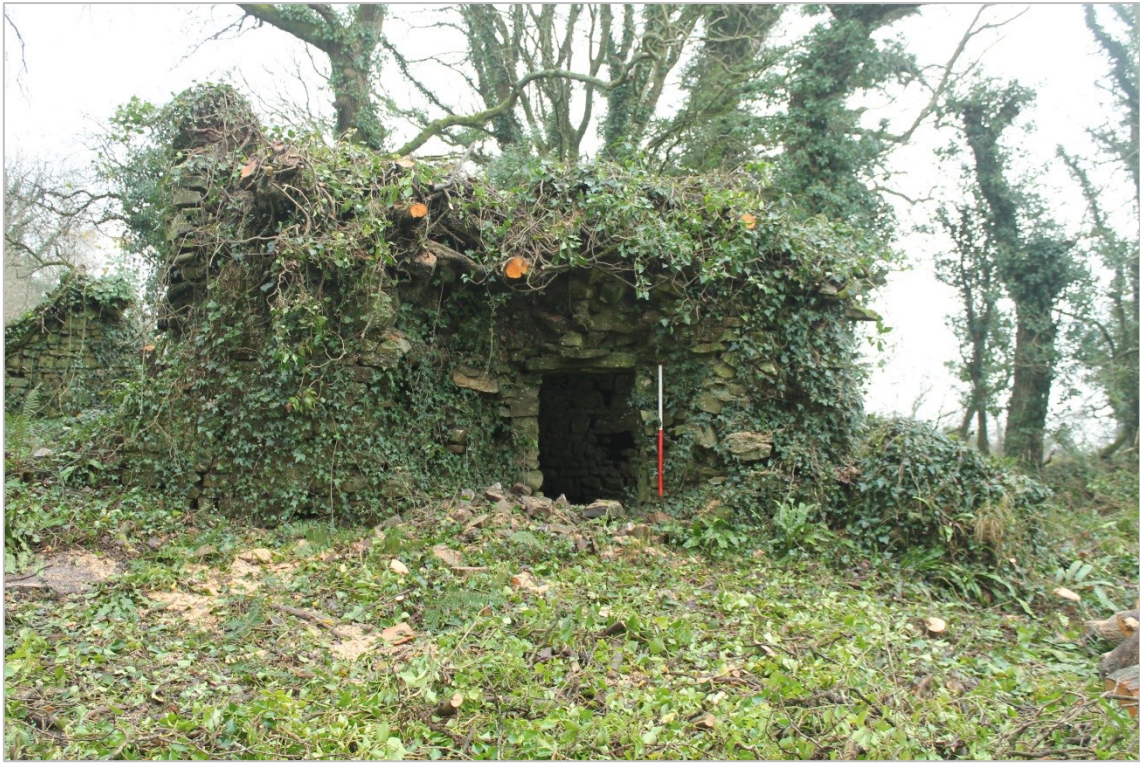
**Photo 9:** Looking east in 2016 showing the doorway into the western vault after the removal of the collapsed tree and clearance of the surrounding vegetation. 1m scale
