# **THE TYWI GATEWAY PROJECT – BISHOP’S PARK, ABERGWILI THE WALLED GARDEN: ARCHAEOLOGICAL INVESTIGATION 2017**

RHIF YR ADRODDIAD / REPORT NO. 2017/2  
RHIF Y PROSIECT / PROJECT RECORD NO. 110318

Chwefror 2018  
February 2018

Fran Murphy and Hubert Wilson

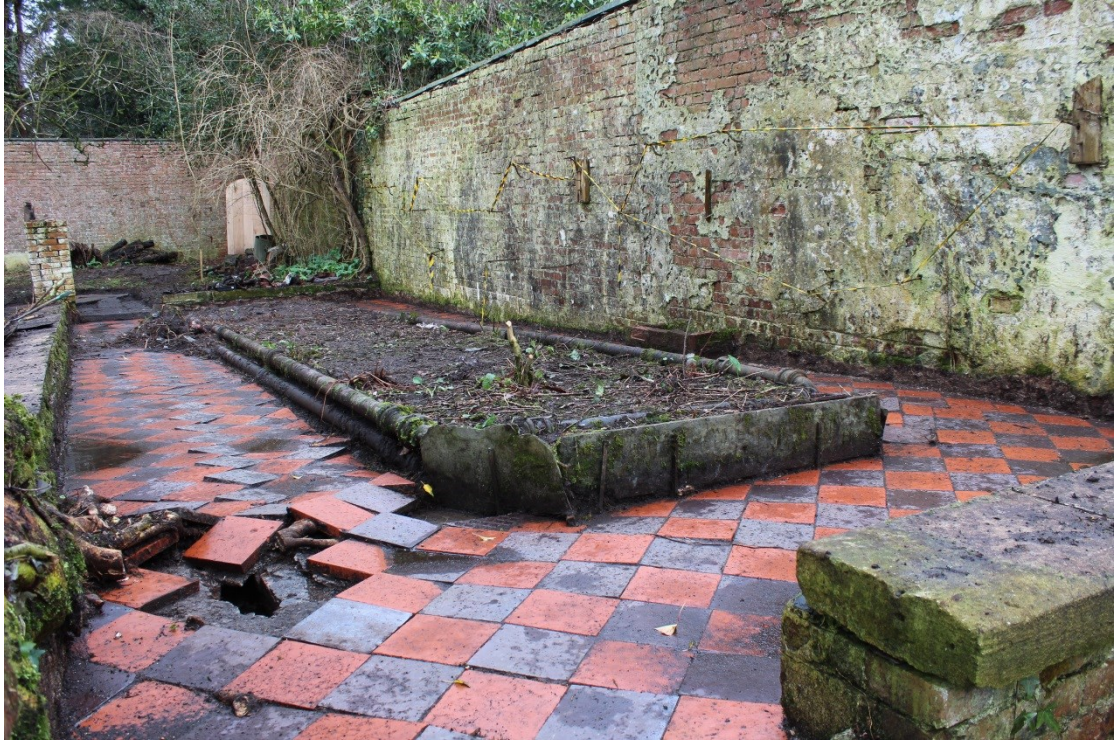
- 4.2.5 The roots of a tree at the south-western corner of the glasshouse had heavily disturbed the area and caused the collapse of the brick pillar at this corner (Photo 13).

**Photo 13:** Photo showing the area disturbed by tree roots in the southwest corner of the glasshouse. Looking roughly north

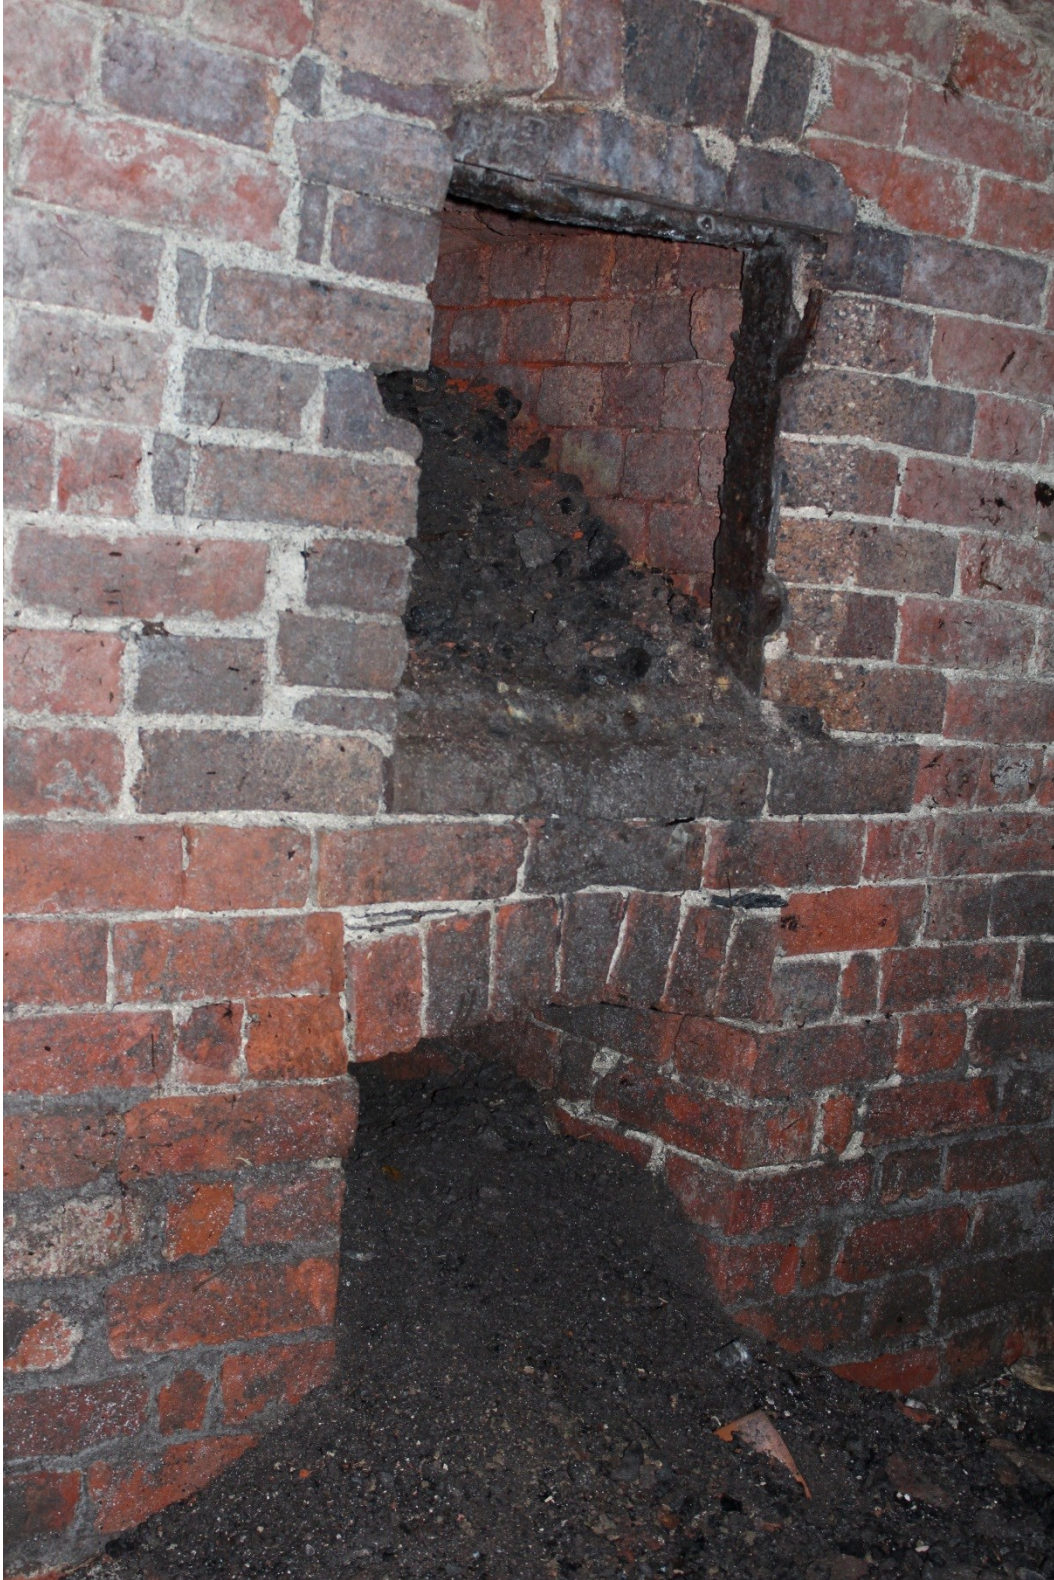
**Photo 23:** The west wall of the boiler house showing two bricked arched recesses. The upper one would appear to have been a firebox and the lower (at floor level) was probably for ash clean out.

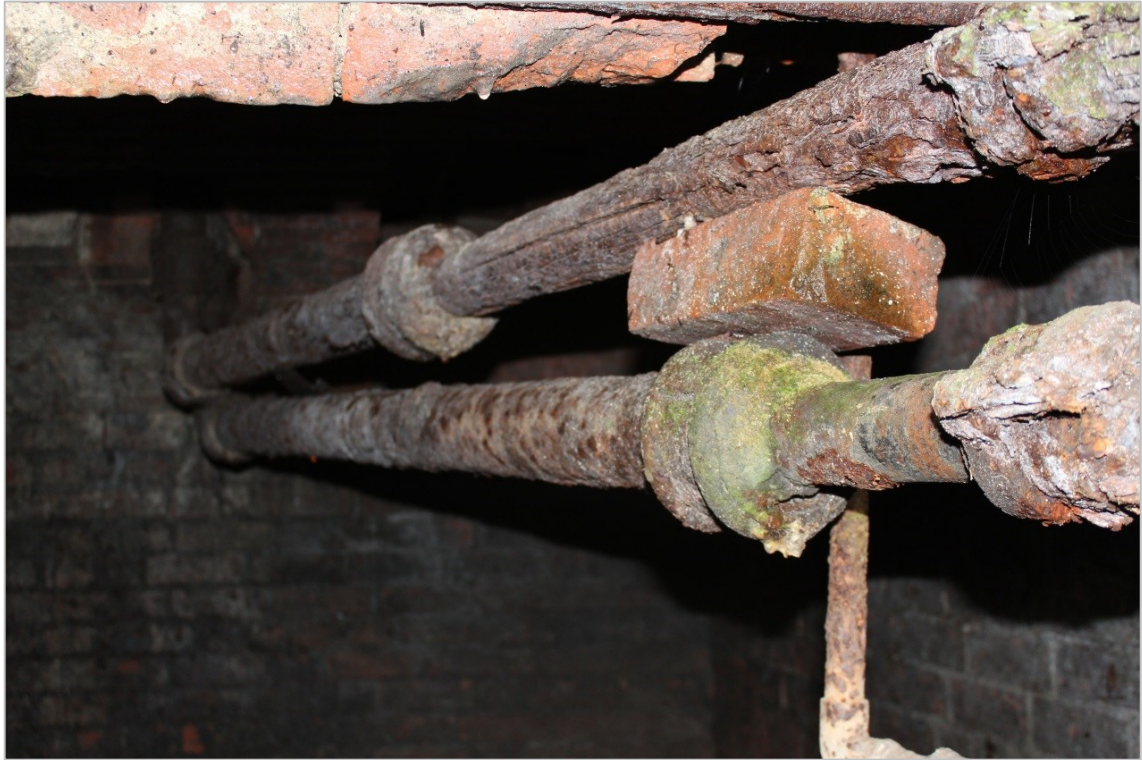
**Photo 24:** The two cast iron pipes that run northwards from the boiler. Bricks and pieces of wood have been used to separate the pipes. The narrower pipe in the background is from the header tank shown in Figure 10.

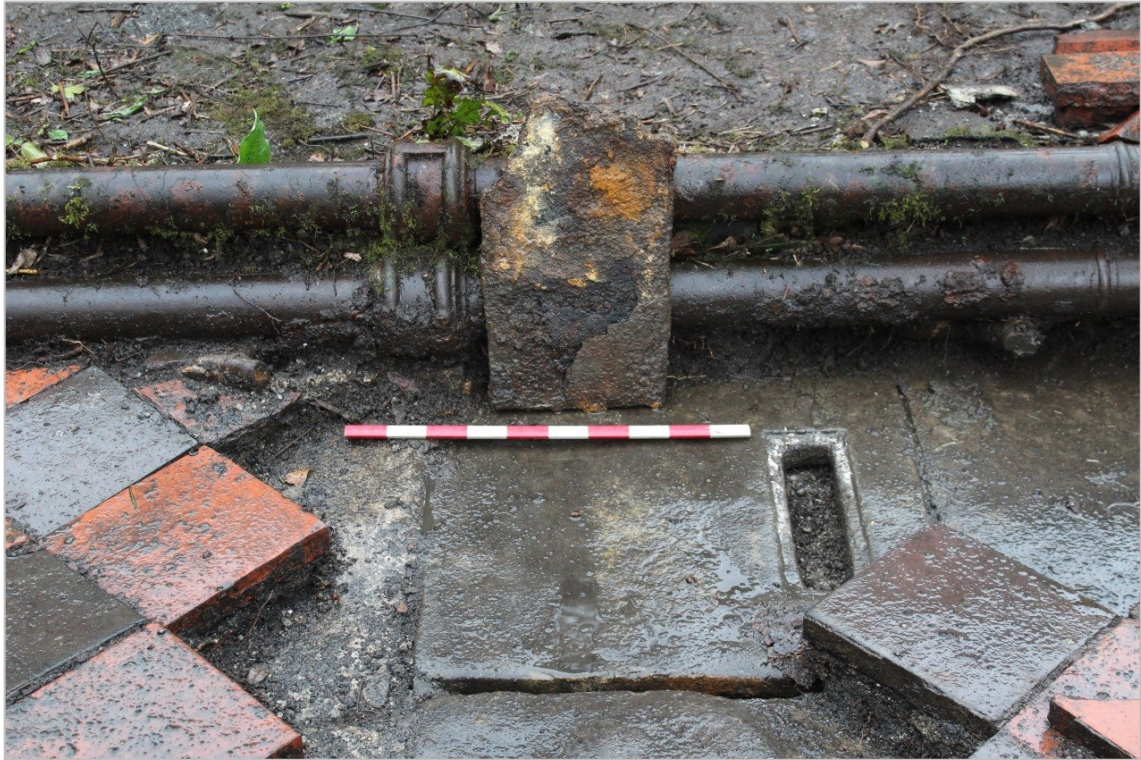
- 4.2.12 These findings suggest that there were at least two different phases of heating system (apart from the hot wall) for Glasshouse 1. The first comprised the heating, via the underground stove, of air within the cavity under the stone floor. Opposite the presumed siting of one vent within the stone floor was a wide slot within which was found the remains of a metal sheet that may have been used to control the flow of hot air through the vent (Photo 26).

**Photo 26:** Photo showing the corroded cast iron sheet found within the narrow slot to the west of the possible vent set into the stone floor on the west side of the central cultivation bed. 0.5m scale

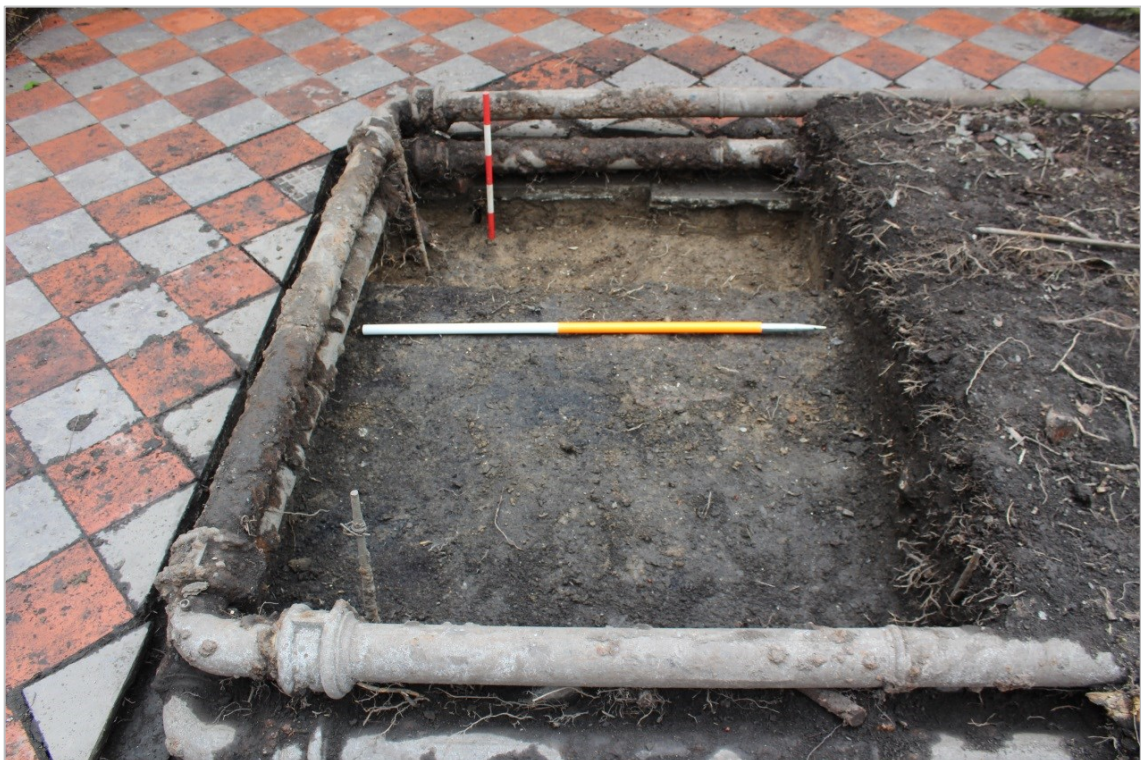
- 4.2.15 At the northern end of the central cultivation bed a section or sondage was excavated (Photo 27). Below the dark cultivation soil that filled the cultivation bed, lighter compact clay subsoil was revealed. After excavating 0.20m of the subsoil and thus being below the level of the stone floor, it seemed clear that there was no void beneath the cultivation bed.

**Photo 27:** The sondage excavated at the north end of the central cultivation trench; showing the lighter coloured subsoil below the dark cultivation soil. Looking east. 0.5m & 1m scale.

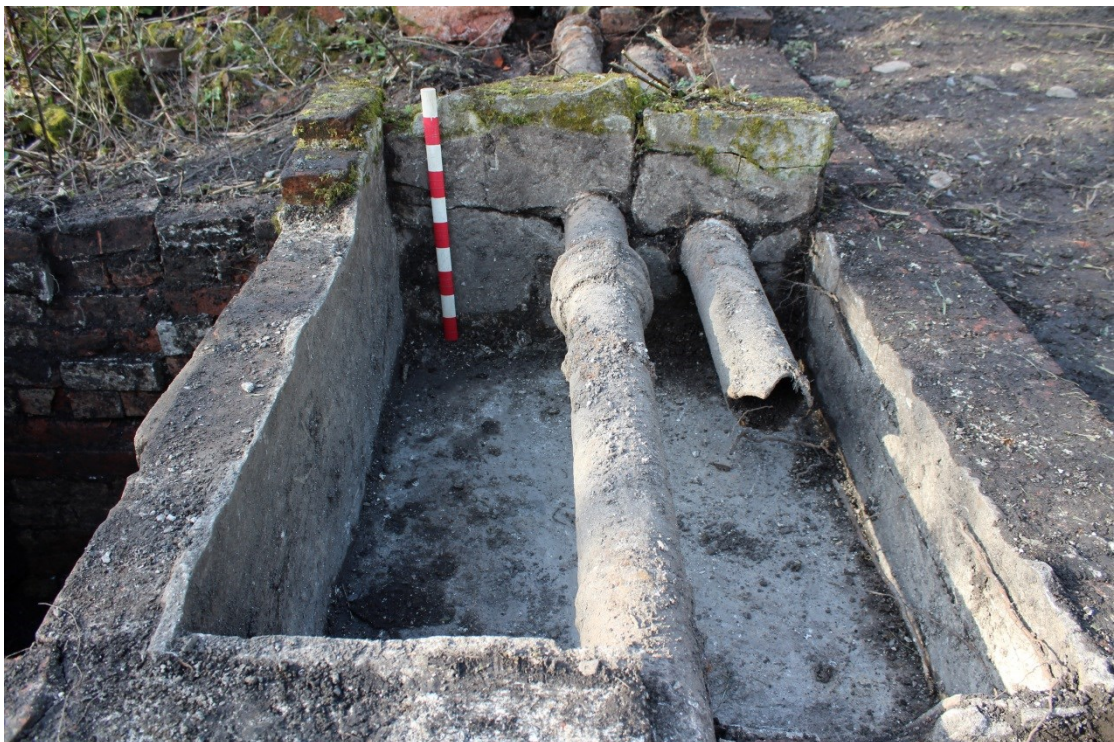
- 4.3.10 At the end of Glasshouse 3 the two main heating pipes passed through what was probably an evaporating trough (Photo 41, Figure 11). The hot pipes would have passed through this water filled tank thereby increasing the level of moisture within the glasshouse. At the western end of

**Photo 41:** The evaporating tank at the east end of Glasshouse 3 through which the heating pipes passed. Looking roughly northwest. 0.5m scale

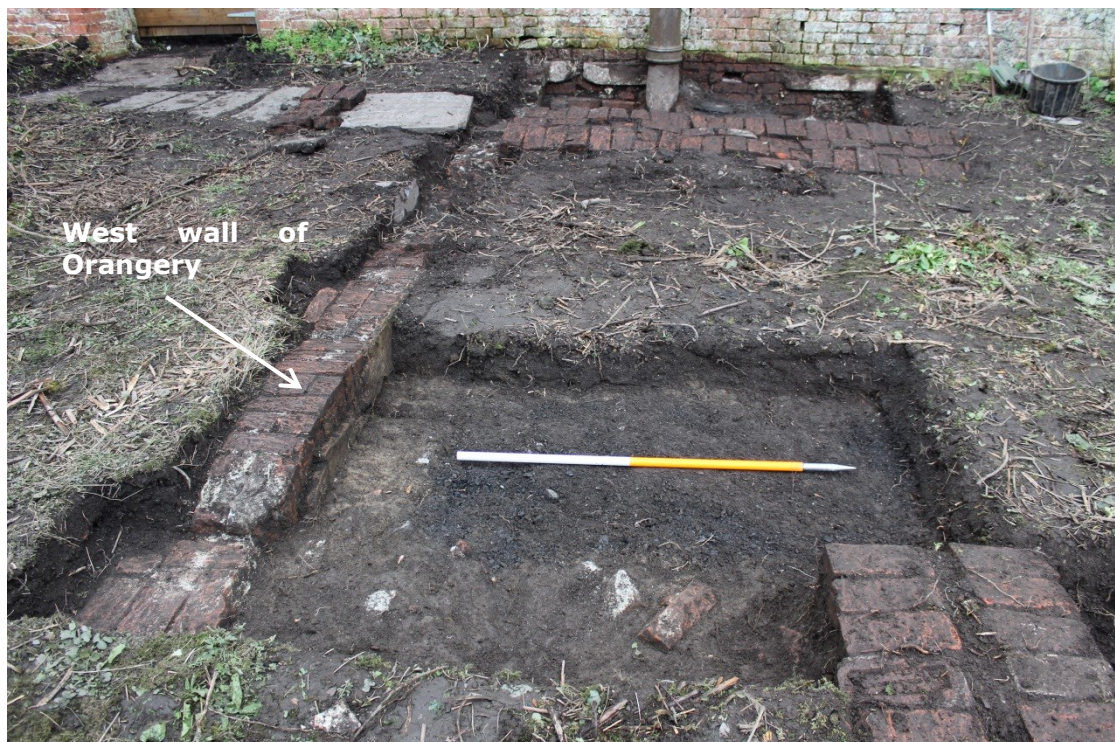
- 4.4.2 The 2017 investigations exposed a 5.40m length of brick wall that is believed to be the part of the west wall of the Orangery (Photo 47, Figures 11 & 13). There appeared to be evidence for the square foundations of a possible pillar at the southern end of this wall.

**Photo 47:** The remains of the west wall of the Orangery. 1m scale

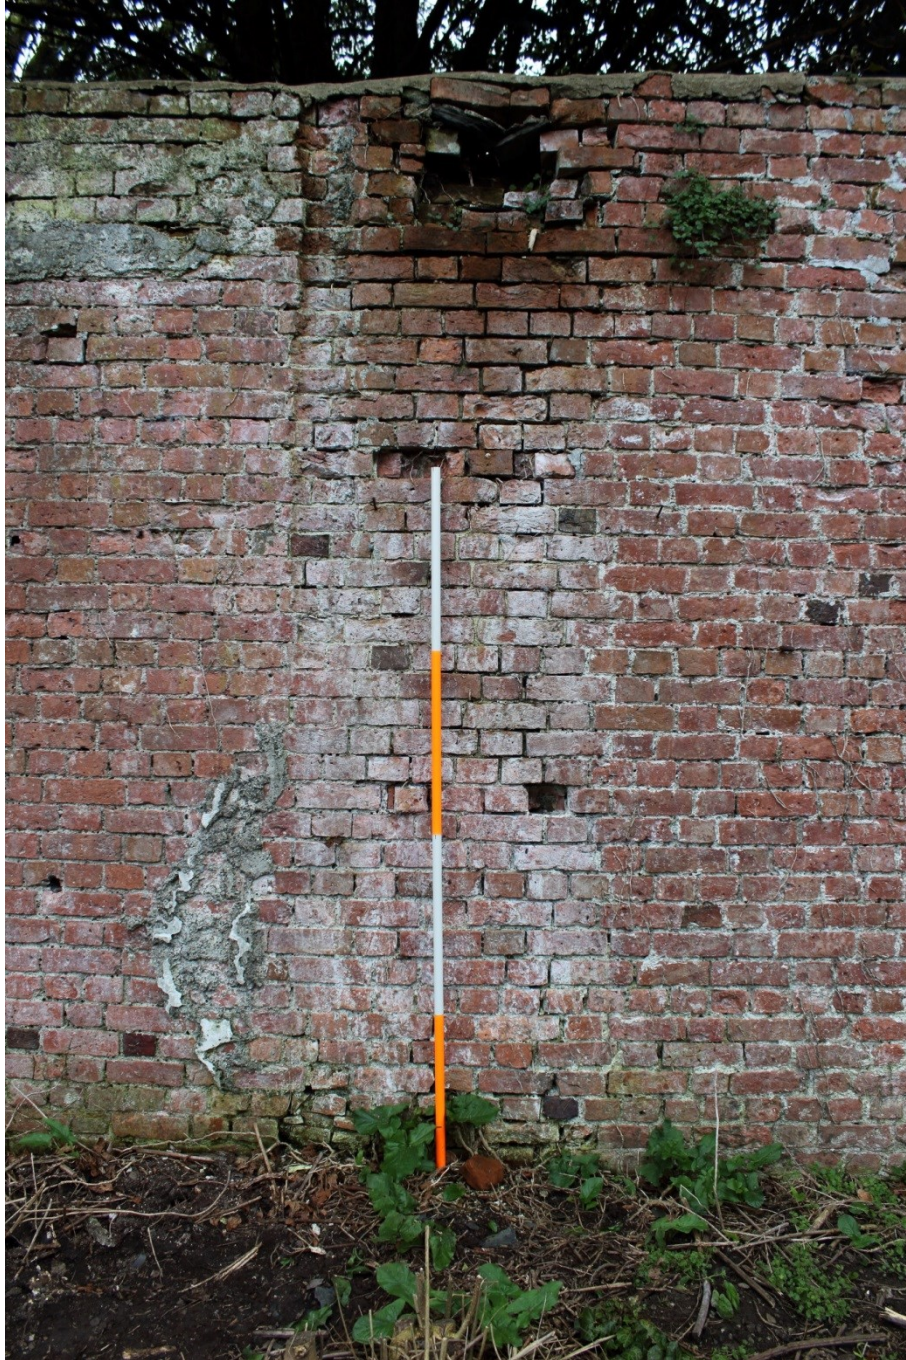
**Photo 48:** Close up of the brick flue within the north wall that possibly marks the east end of the extended Orangery. 2m scale

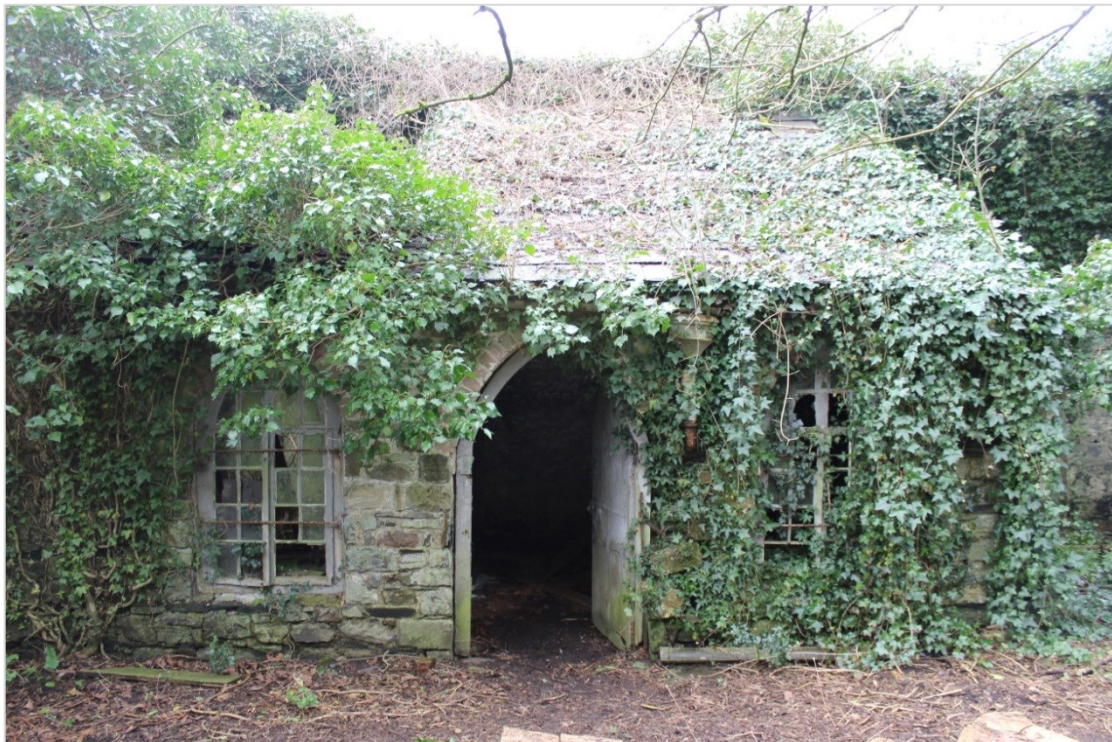
- 4.8.2 A photographic survey of the Bothy was undertaken after the ivy covering the building was removed (Photo 1). The building was in poor condition and the roof had failed in places.

**Survey Photo 1:** Arched door and windows  
before vegetation clearance - exterior
