**CRUNDALE MILL, CRUNDALE,
PEMBROKESHIRE
ARCHAEOLOGICAL WATCHING BRIEF
AND BUILDING RECORDING
(SM98112 17827)**

**RHIF YR ADRODDIAD / REPORT NO. 2017/12
RHIF Y DIGWYLLIAD / EVENT RECORD NOS. 108836 & 110325**

**CRUNDALE MILL, CRUNDALE, PEMBROKESHIRE
ARCHAEOLOGICAL WATCHING BRIEF
(ERN 108836)
AND BUILDING RECORDING
(ERN 110325)
(SM898112 17827)**

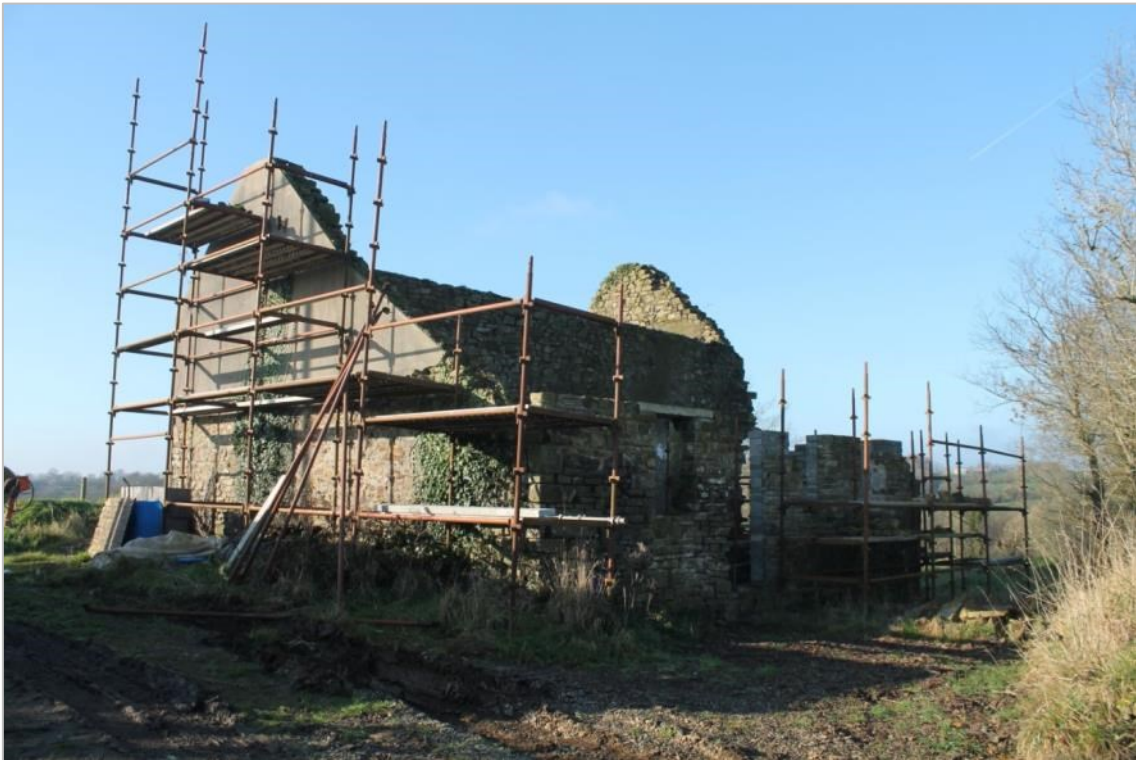
- 2.3 The site comprises the remains of the house and an adjoining rectangular parcel of arable land situated to the north-west of the house; separated by post and wire fencing. The majority of the external and internal elevations were supported by scaffolding and the building was roofless.

Photo 1: The building remains of Crundale Mill farm (PRN 17768) at the start of the watching brief and building recording. View facing west (DAT Photo 110325_0044)

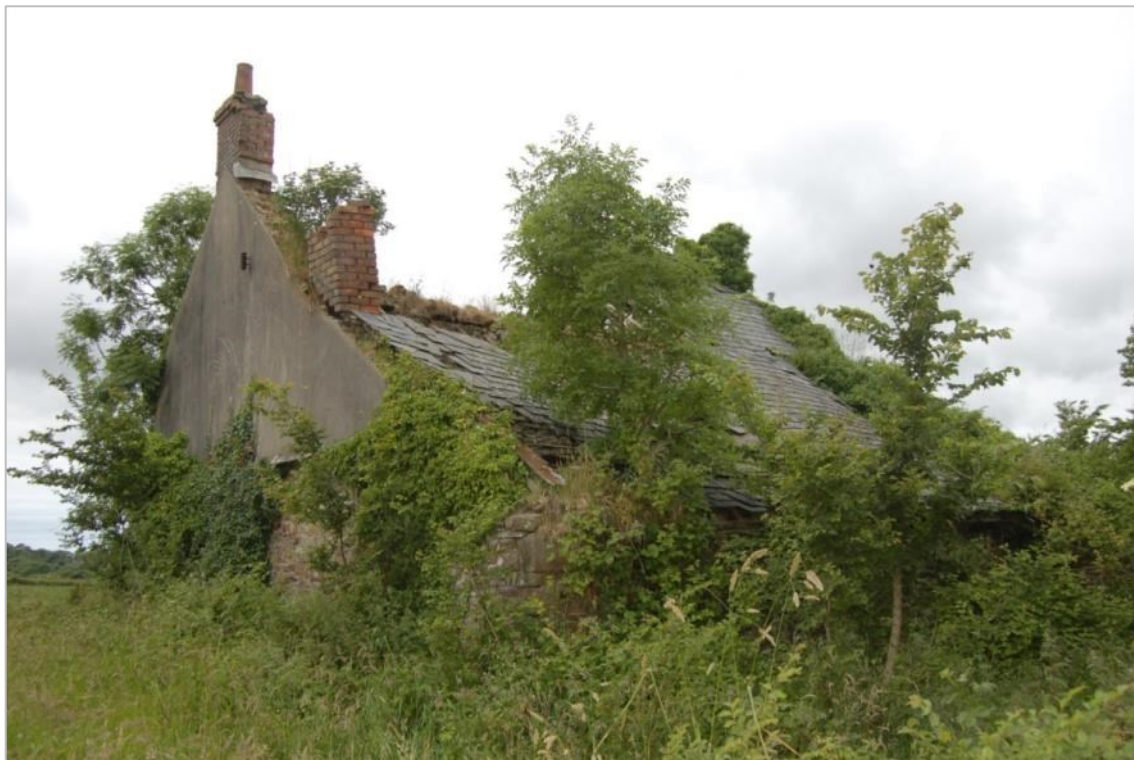
Photo 2: The rear of Crundale Mill prior to the start of restoration work in 2013
(DAT Photo DAT2014-5.193)

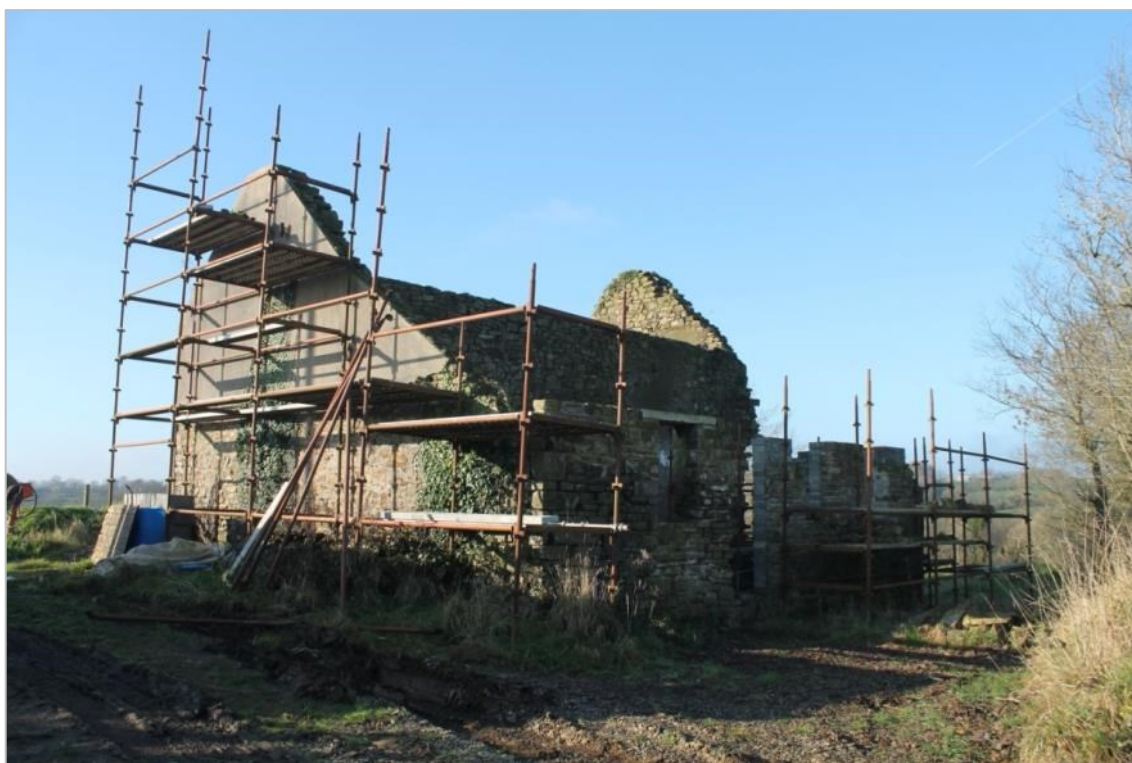
Photo 3: The rear of Crundale Mill during the building recording in 2017
(DAT Photo 110325-0044)

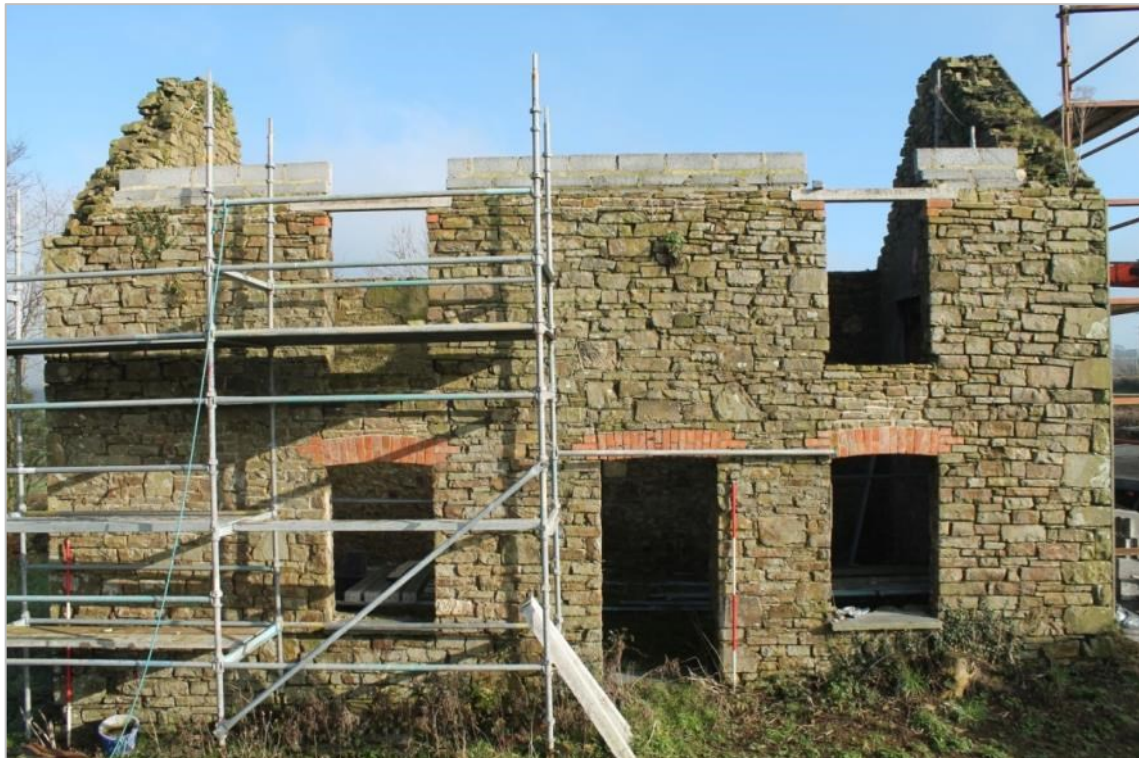
- 4.3.1 The front, south-west facing elevation comprised a central ground floor doorway flanked by mirroring single ground and first floor windows. The façade was not entirely symmetrical for the openings were slightly offset with the margin between the northern gable end and windows being the greatest (Photo 5). The wall fabric here was in good condition with only isolated instances of vegetation invasion. The red brick voussoirs of the door way and ground floor windows were intact and what appears to be the original, worn slate threshold remained in the doorway. The ground floor windows sills had been replaced with concrete sills. Elsewhere, the sills of the first floor windows were absent and concrete lintels had been installed.

Photo 5: The front external, south-west facing elevation of Crundale Mill
(DAT Photo 110325_0001)

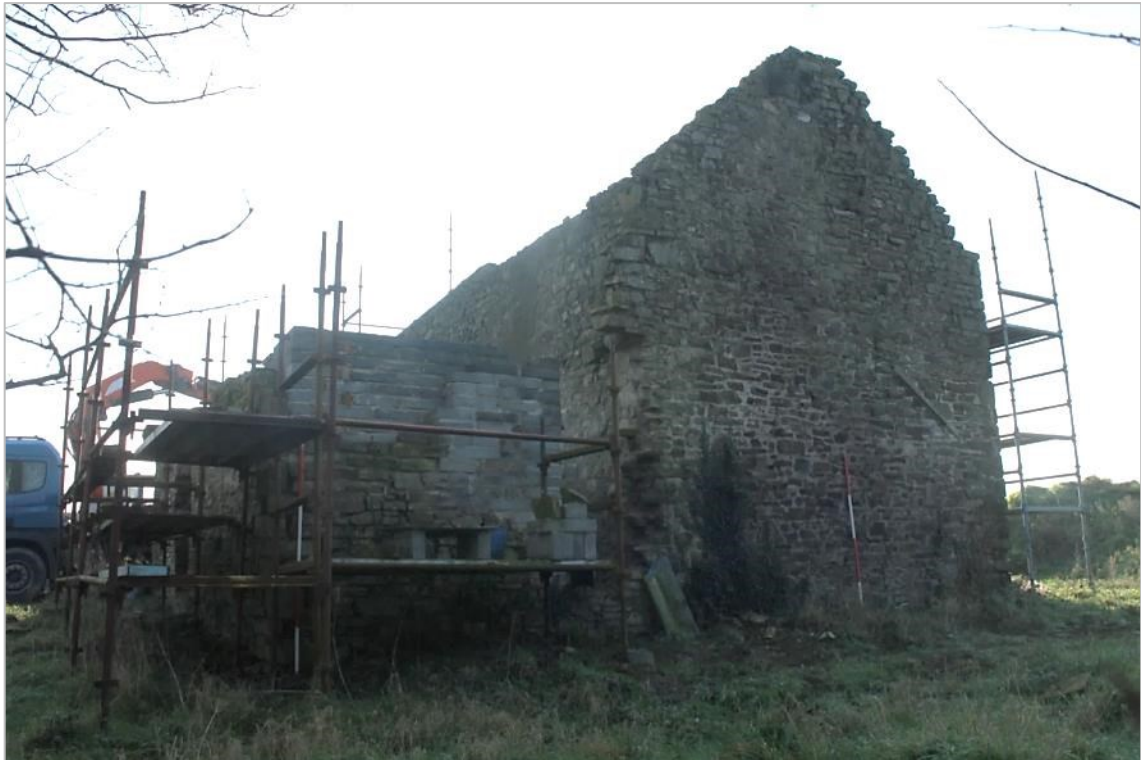
- 4.3.2 The north facing gable end survived to full height, was in reasonably good condition and largely free from ivy. The rear wall elevation had all but collapsed and was in the process of being rebuilt (Photo 6). From the surviving masonry it was possible to infer that there was no join between the east and western cells of the building indicating that they are contemporaneous in construction. The lower half of the gable end had been repointed almost in a "slobbered" technique, using cement. A portion of a cement ridge line around half way up the gable indicated the former presence of a structure/building adjoining this wall, which may be the building shown on the 2nd edition Ordnance Survey map of 1907 (Figure 6). The extent of the repointing corresponded to the height of this ridge line. The cement ridge line suggests that the adjoining building was single storied.

Photo 6: The external elevation of the north facing gable end wall
(DAT Photo 110325_0003)

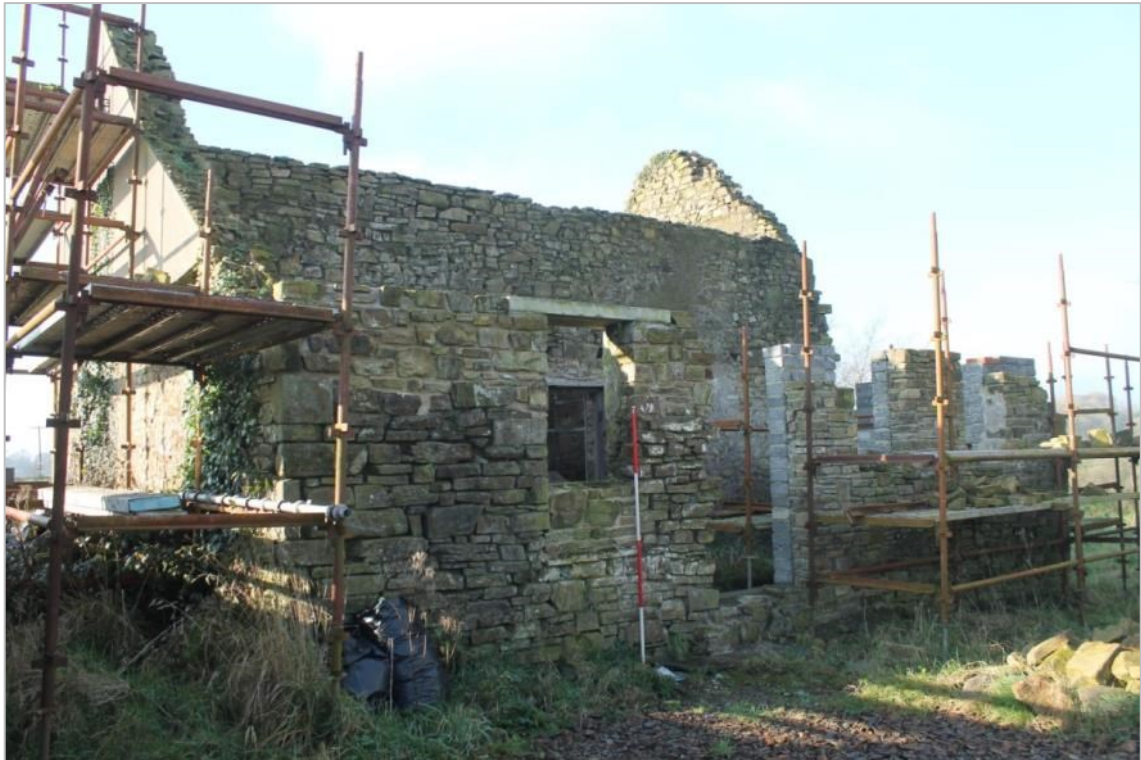
- 4.3.3 The east facing external elevation had been rebuilt to the window lintel level in a manner which was sympathetic with the original building fabric (Photo 7). The course work was random but appeared to be pointed with cement and a single, vertical course of breezeblocks replaced the internal face of the wall. This elevation now included a number of openings comprising a near central single door flanked by a single window at the southern end of the building and two single windows at the northern end. The southern single window opening is an original opening although this had been partially infilled during the restoration works (Photo 8). It is not known whether the two windows at the northern end of the wall are where original openings existed.

Photo 7: The east facing (and partially rebuilt) external elevation of Crundale Mill (DAT Photo 110325_0005)

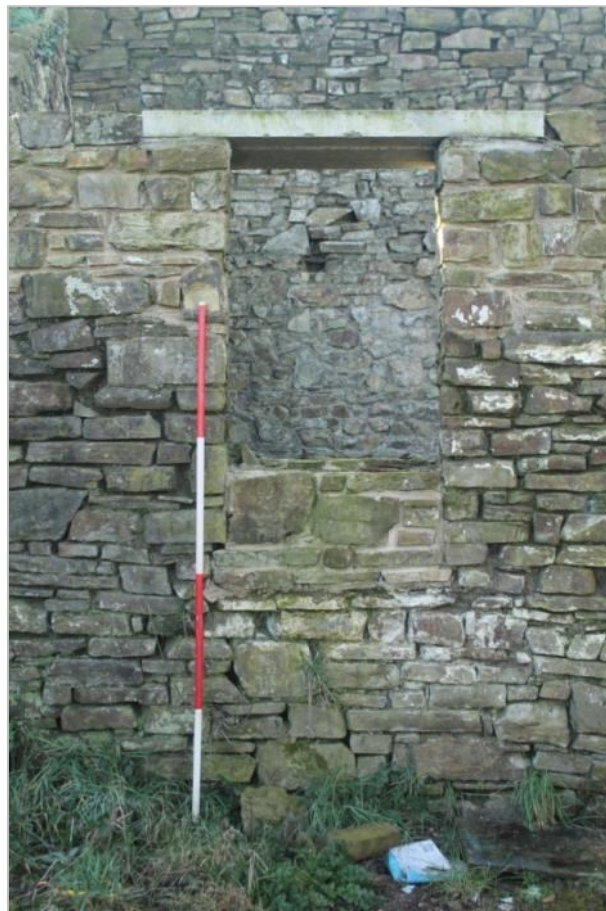
Photo 8: The infilled and partially rebuilt single window at the south-eastern end of the east facing elevation of Crundale Mill (DAT Photo 110325_0006).

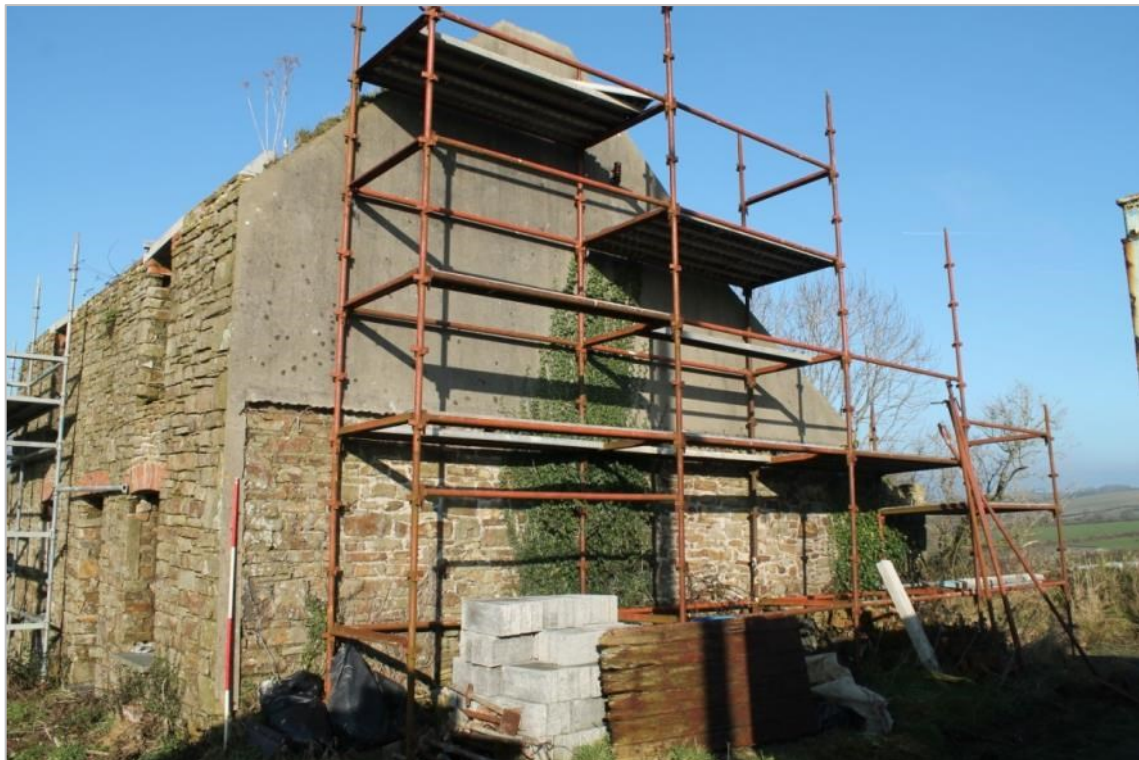
- 4.3.4 The south facing external elevation was intact but it was largely obscured by scaffolding and construction materials (Photo 9). The upper half of the elevation was rendered in thick cement, at the bottom of which was a cast ridgeline of a now absent corrugated lean-to roof. The wall below this ridge line was un-rendered but had been mostly repointed. It was not possible to closely inspect the wall to identify the mortar. This wall looked to be in good condition save for ivy growing up the centre and south-eastern corner of the wall.

Photo 9: The south facing external gable end of Crundale Mill
(DAT Photo 110325_0043).

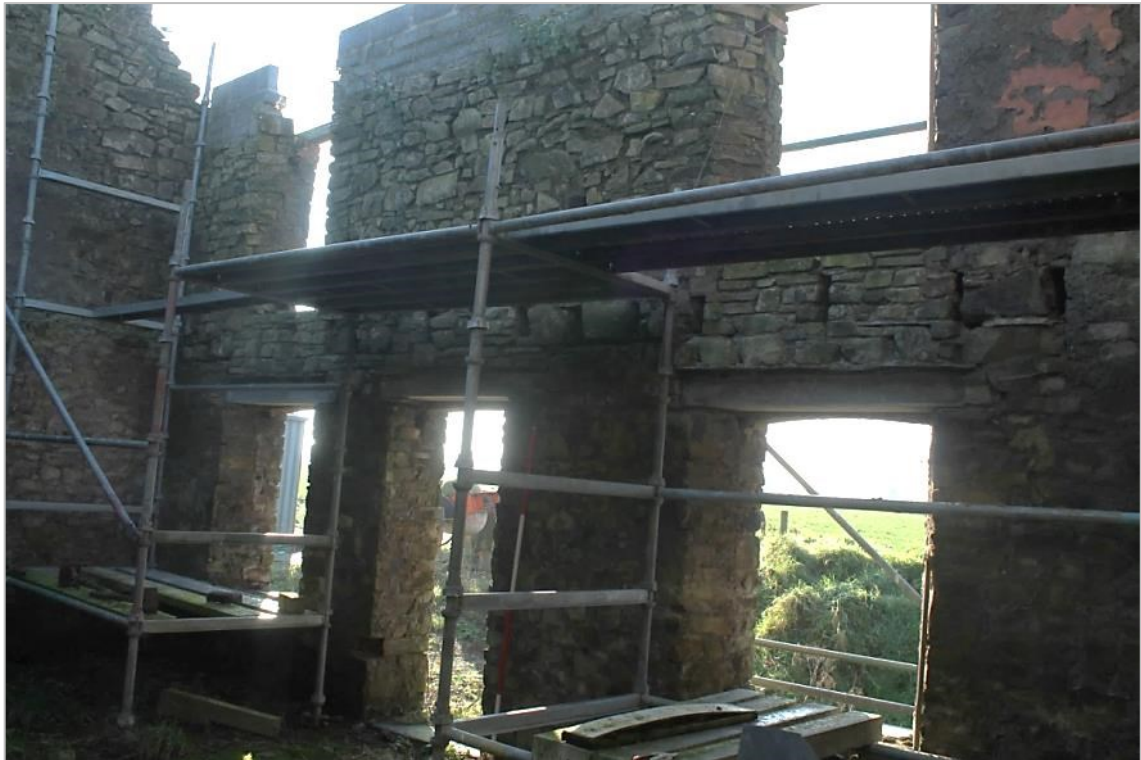
- 4.4.2 The east facing internal elevation (i.e. the front of the house) revealed that the window openings were splayed and that the original lintels had been replaced by steel ones (Photo 10). First floor beam slots were visible above the window lintels and the walls were un-rendered bare stonework save for a small patch of render and painted plaster at the northern end of the first floor. It is likely that the internal walls were rendered or lime washed.

Photo 10: The east facing internal elevation of Crundale Mill
(DAT Photo 110325_0030)

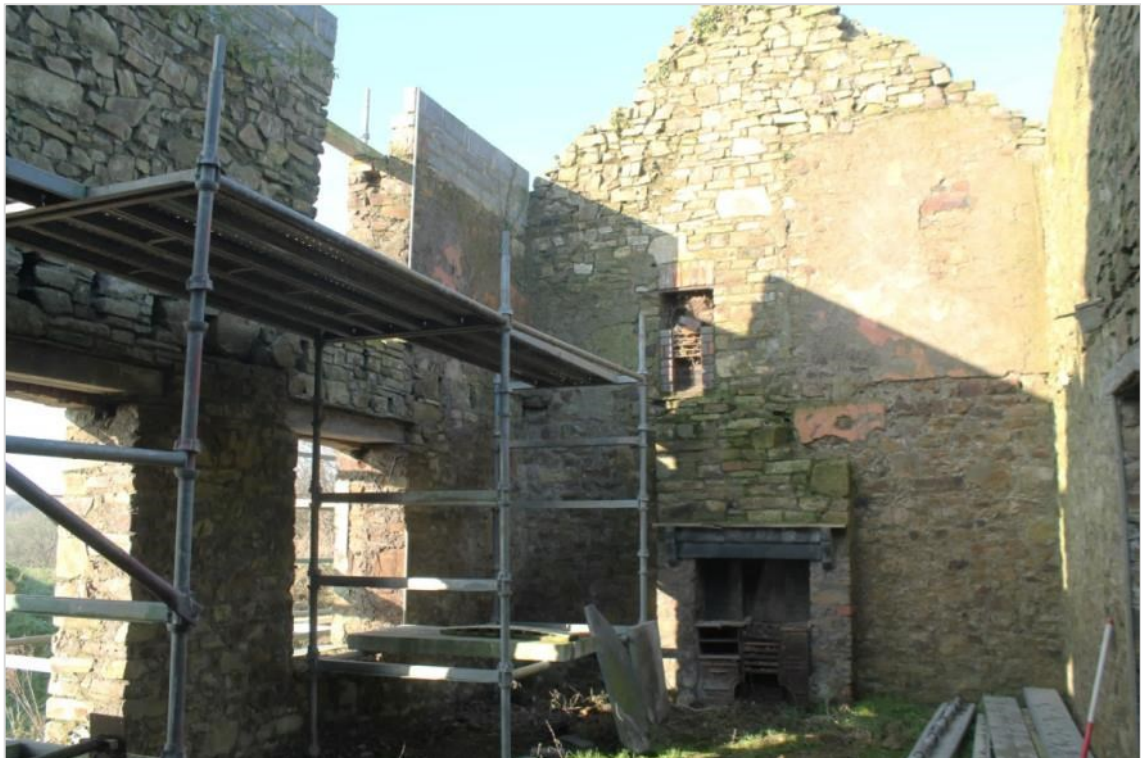
- 4.4.3 The northern gable end retained its original ground and first floor fireplaces. Large areas of internal rendering and painted plaster work on both the ground and first floor levels survived (Photo 11). At the northern end the ground floor fireplace consisted of a cast iron range set within a flat faced, square sided stone chimney breast which extended up to the first floor level. The eastern side of the top of the chimney breast appeared to be corbeled and the flue was lined with firebricks (Photo 12). The mantelpiece was made from carved wood which was nailed to the chimney breast.

Photo 11: The internal face of the northern gable end with its *in situ* fireplaces
(DAT Photo 110325_0035)

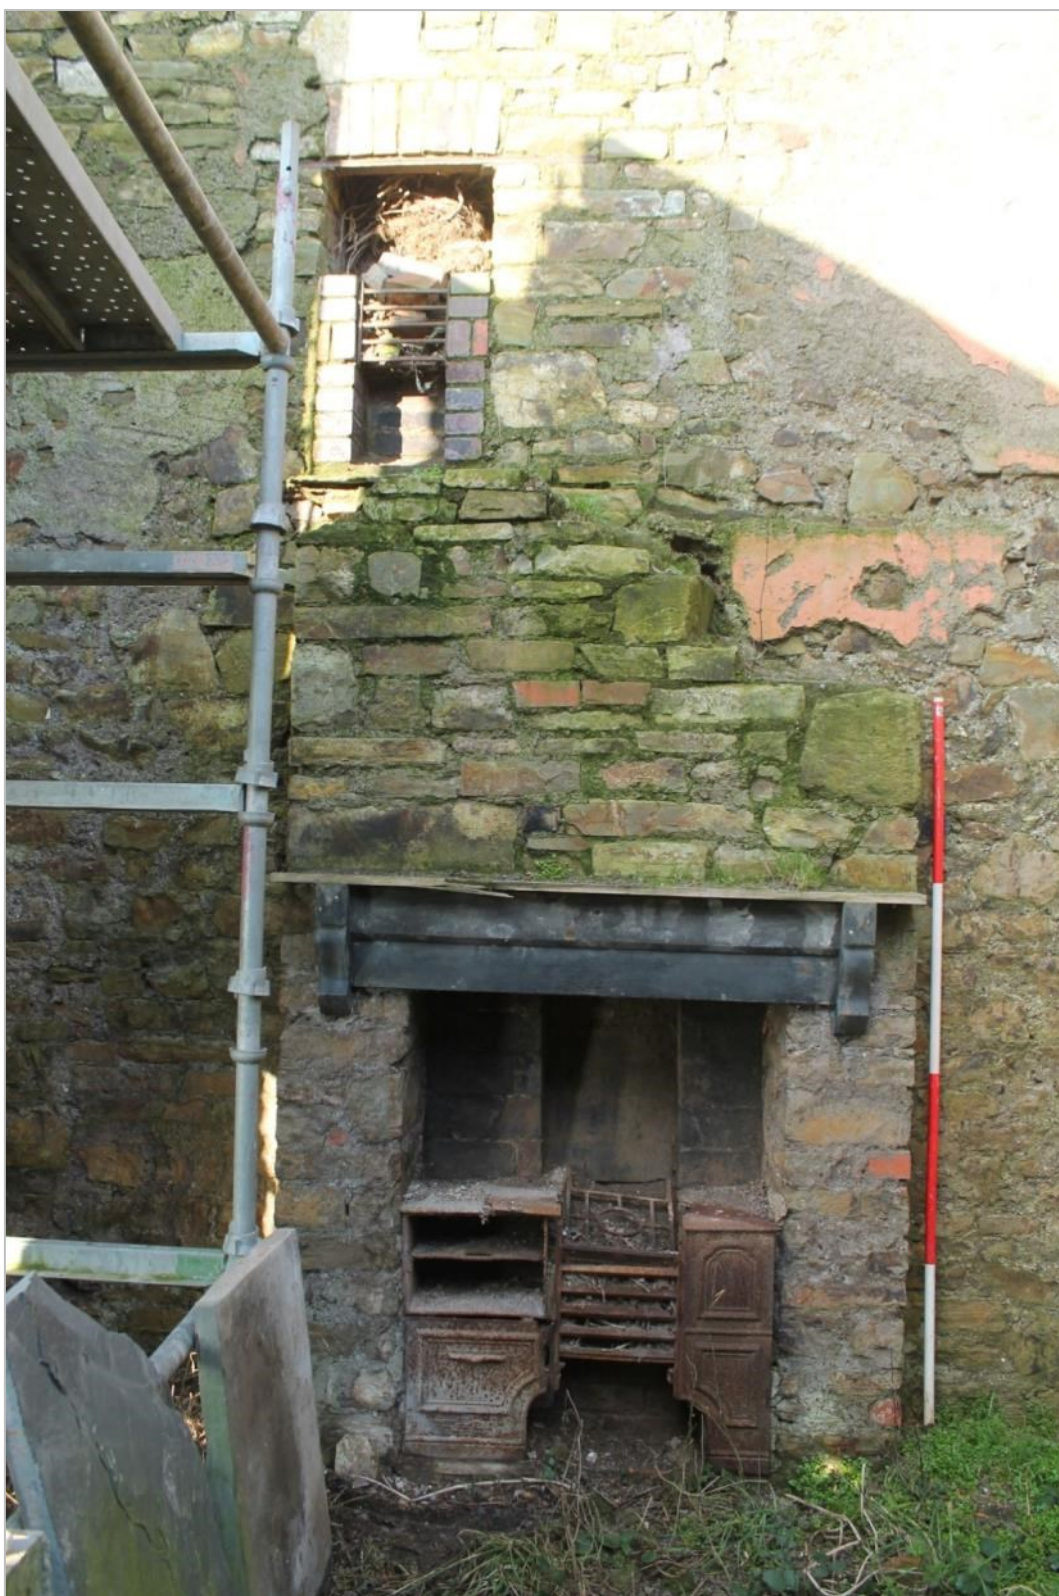
Photo 12: The iron range, firebrick lined flue and corbeled chimney breast of the ground floor fireplace in the northern gable end (DAT Photo 110325_0018)

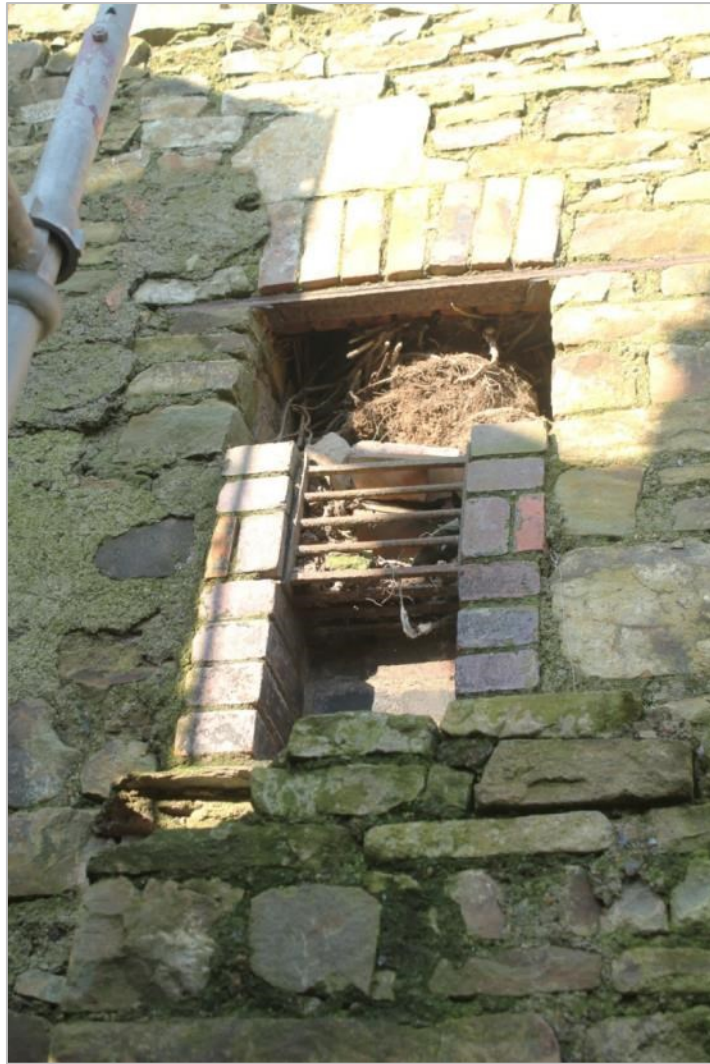
- 4.4.4 The first floor fireplace was situated in line with the western edge of the ground floor chimney breast and comprised a single, narrow iron grill set within a fire bricked lined flue (offset from the ground floor flue). There appeared to be a thin iron lintel upon which sat brick voussoirs (Photo 13).

Photo 13: The single, brick lined first floor fireplace in the northern gable end (DAT Photo 110325_0023)

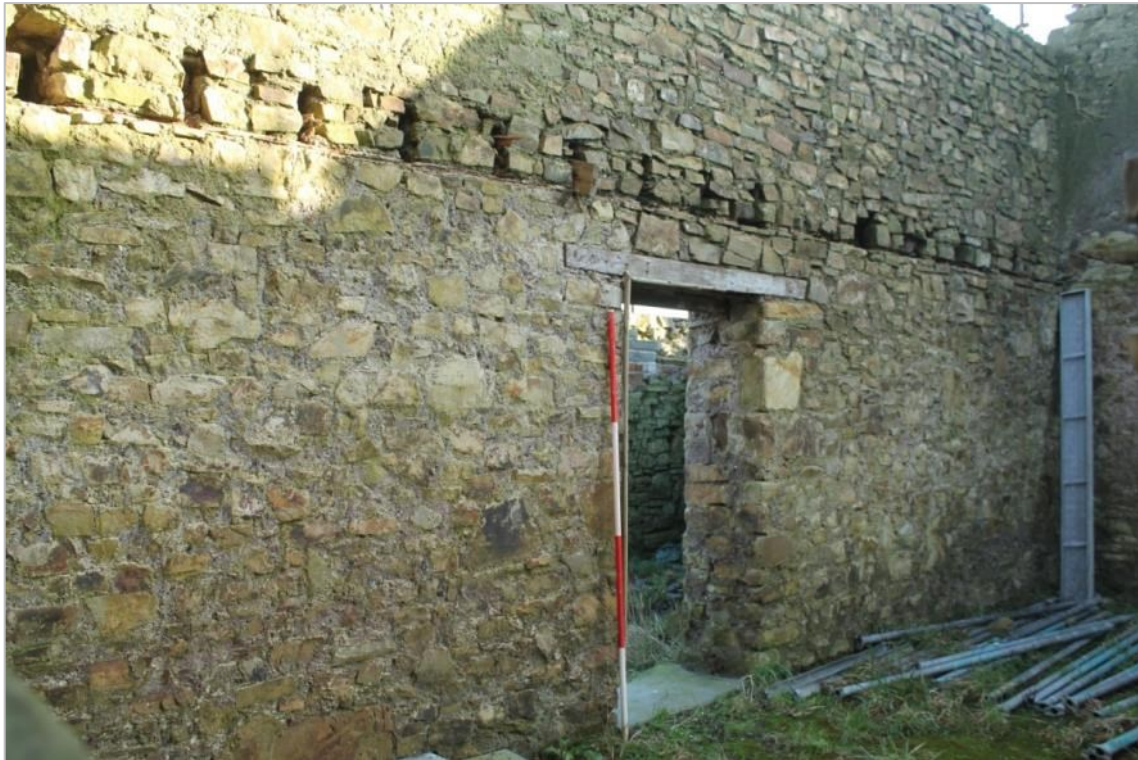
- 4.4.5 The west facing elevation of the central partition wall between the two cells of the building was featureless save for beam slots and a central door which gave access to the rear of the building (Photo 14). The door appeared to retain its original wooden lintel and worn shale stone threshold. A portion of the wooden door frame also survived. There were no visible traces of rendering or plaster on this wall and it was in very good condition.
- 4.4.6 The north facing internal elevation of the southern gable end also retained its ground and first floor fireplaces (Photo 15). Little evidence of any internal render at ground floor level survived but the wall at first floor level appeared cement rendered.

Photo 14: The west facing internal elevation of the partition wall in Crundale Mill and its central door and first floor beam slots (DAT Photo 110325_0027)

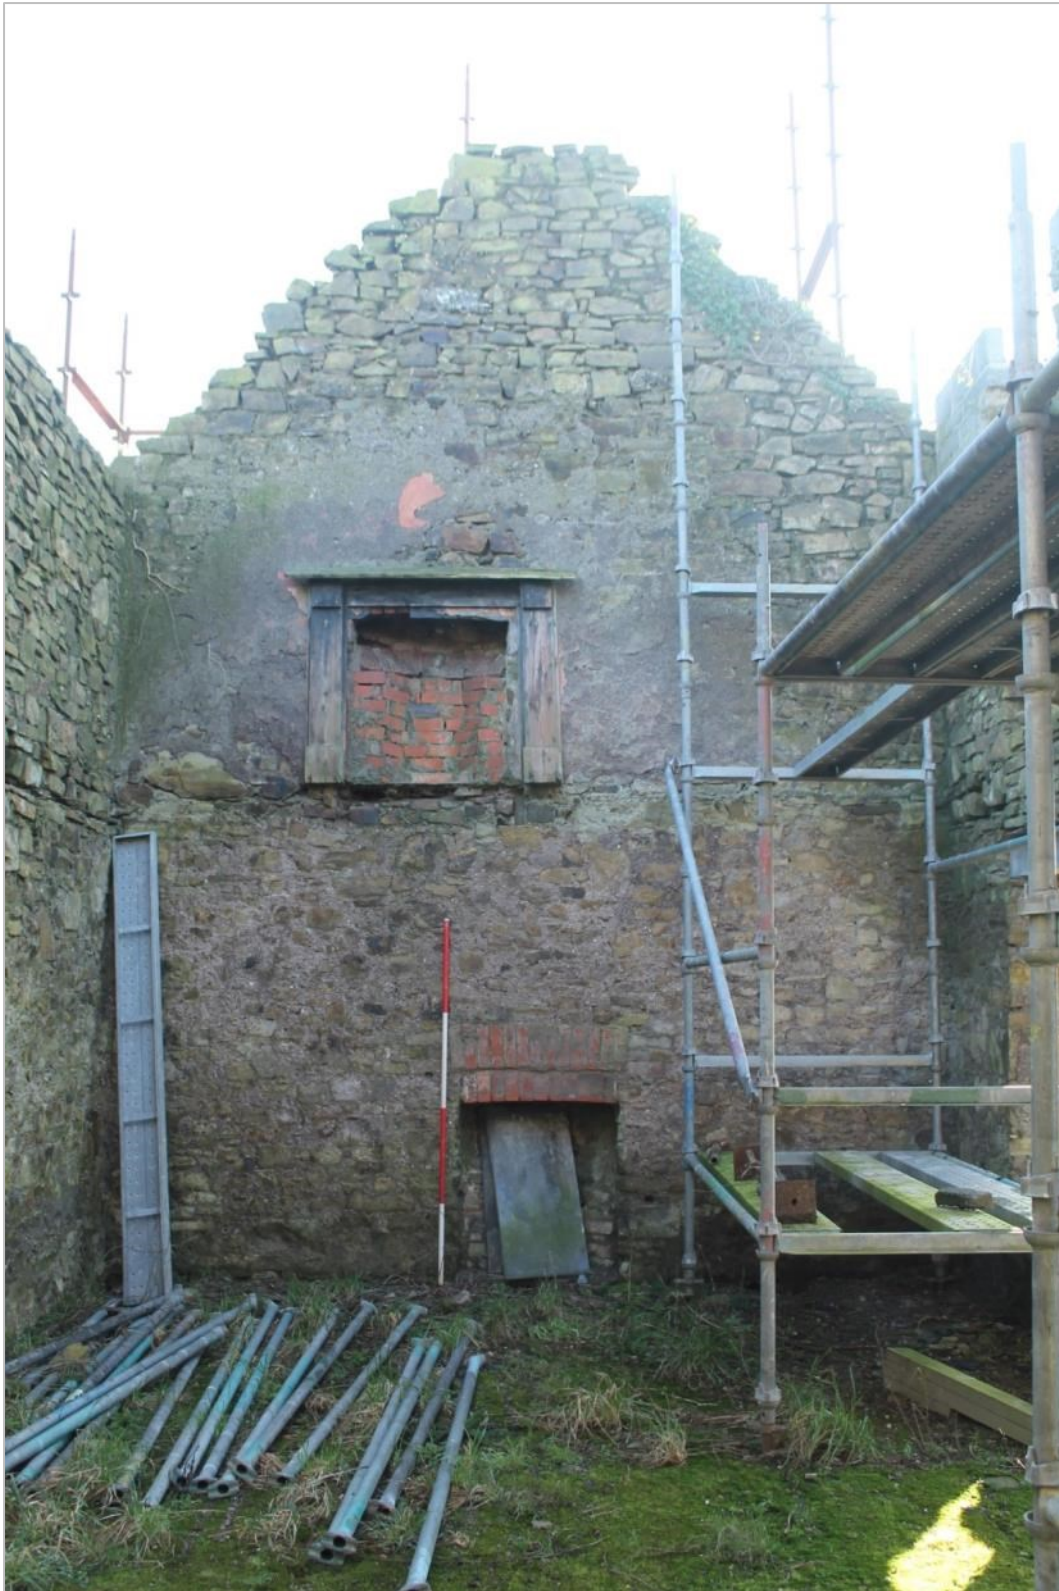
- 4.4.7 The southern ground floor fireplace comprised a modest, brick lined flue with red brick voussoirs and an inserted row of red bricks forming a lintel (Photos 15 & 16). The first floor fireplace was slightly bigger and offset from centre with a red brick lined flue (Photos 15 & 17). Unlike the other fireplaces, this seemed to have been a bit haphazardly constructed (or a late modification) for the bricks were crudely pointed with cement. It was possible to identify red brick voussoirs beneath peeling rendering on which patches of red plaster survived. A simple wooden mantelpiece and surround had been placed over the render.

Photo 15: The internal elevation of the southern gable end with its two, *in situ* fireplaces (DAT Photo 110325_0024)

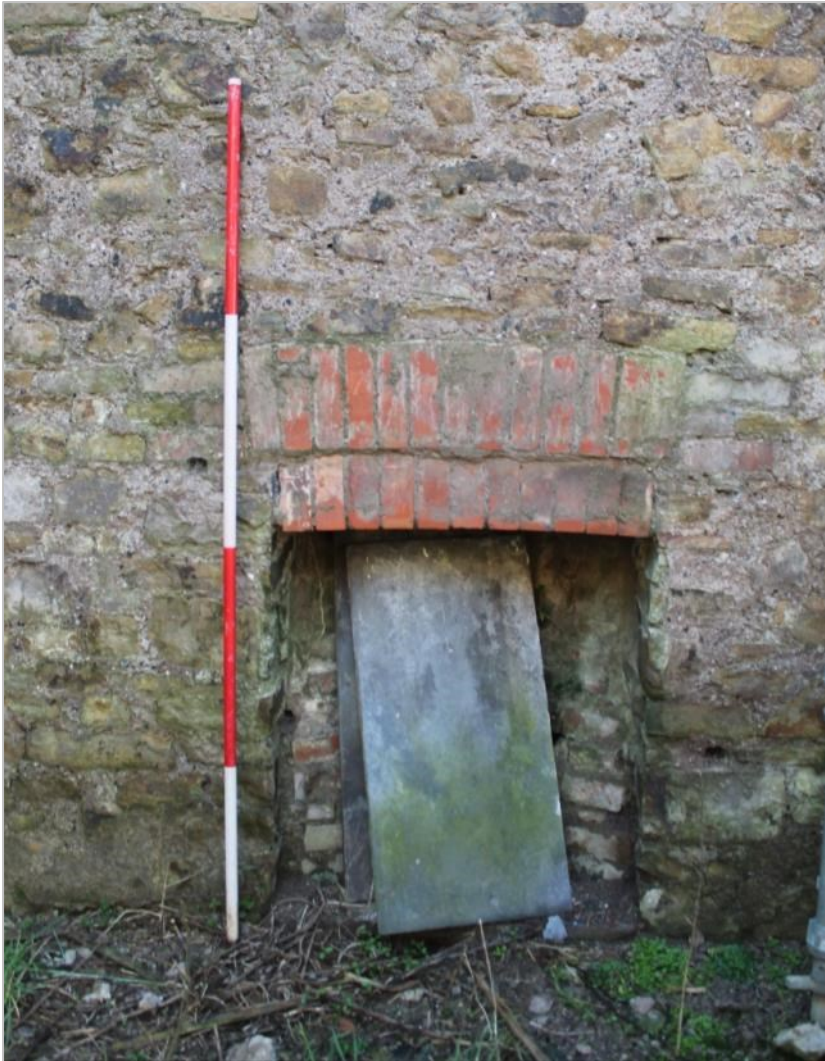
Photo 16: The ground floor fireplace in the southern gable end
(DAT Photo 110325_0025)

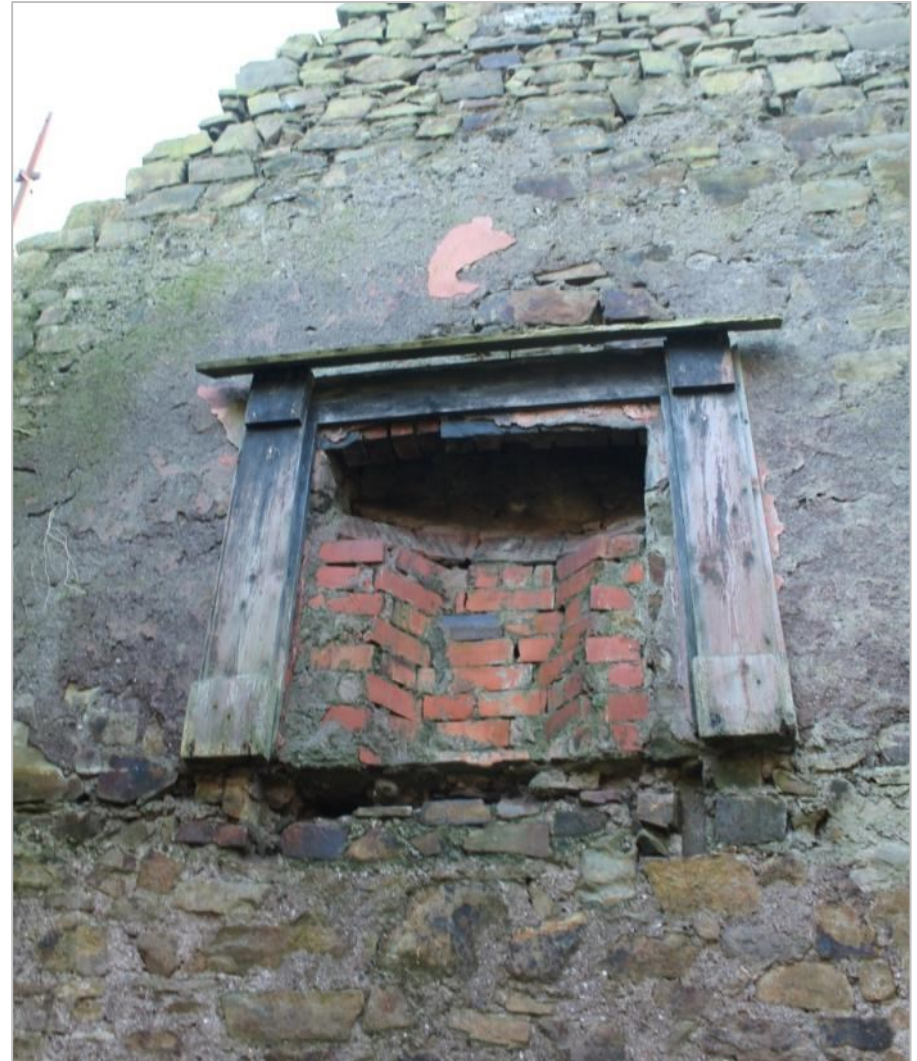
Photo 17: The first floor fireplace in the southern gable end
(DAT Photo 110325_0026)

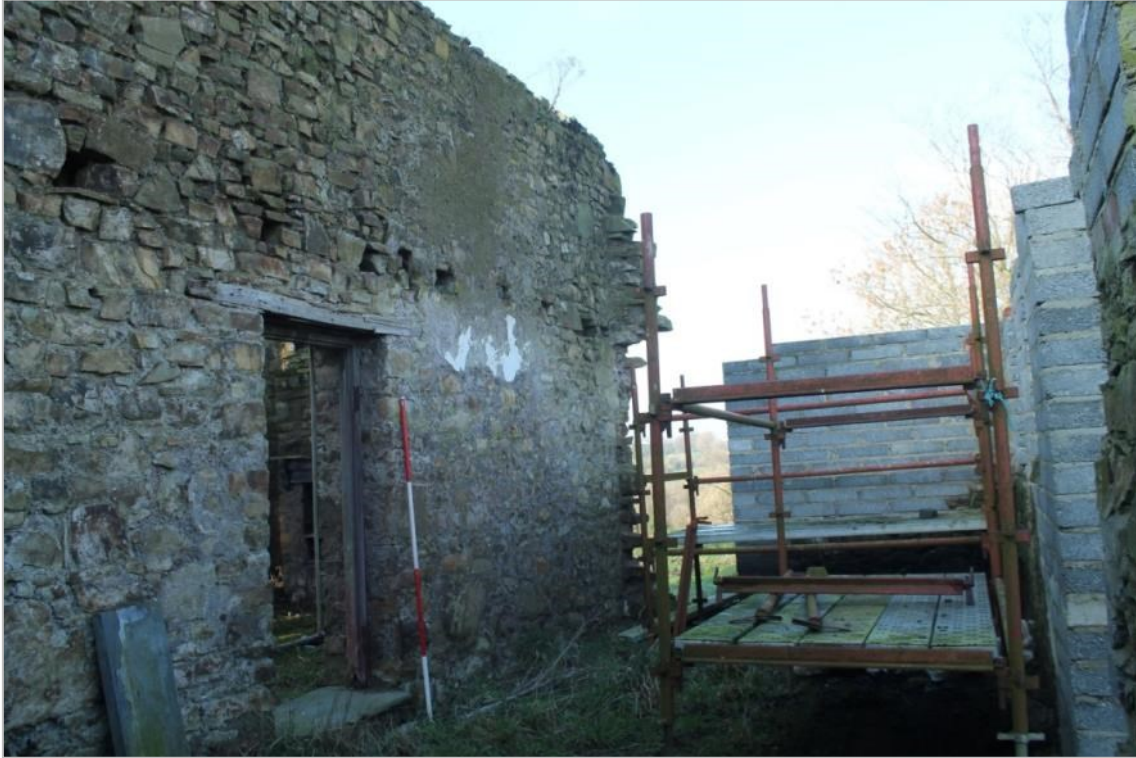
- 4.4.8 The first floor beam slots visible in the east facing internal elevation of the partition wall indicated the ceiling level at the rear of the building (Photo 18). There were remnants of lime render and white painted plaster on the lower half of the wall, and a large patch of possible cement render near the northern end at first floor level. The central doorway also retained its wooden lintel.

Photo 18: The east facing internal elevation of the partition wall
(DAT Photo 110325_0014).

- 4.4.9 As previously described, the northern wall and eastern walls in this eastern cell of the building were in the process of being rebuilt with breeze blocks faced with the stone rubble (Photo 18).

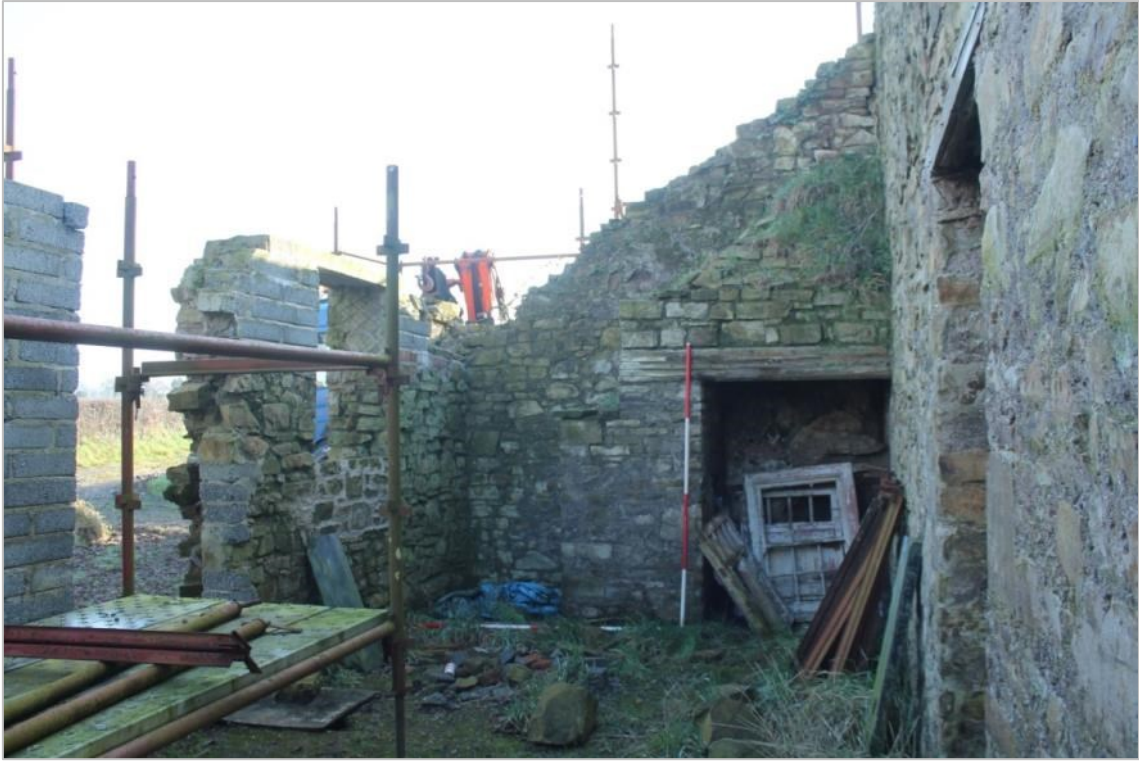
- 4.4.10 The north facing internal elevation remained intact and an oven had been built into its western corner (Photo 19). The oven was stone built, lime mortared, with a timber lintel, was rectangular in plan and had a corbelled flue built into the wall. Its red brick chimney stack photographed during the site visit in 2013 (Photo 1) had long since been dismantled. The eastern side of the oven was stepped to accommodate an internal niche and scars on the lime washed internal walls of the oven indicated the absence of a fire hood in the south-western corner of the oven. The precise function of this oven is unknown but it is contemporaneous with the building. If the range in the northern gable had served as the main oven, it is possible that this oven had a more singular use; perhaps for bread making.

Photo 19: The oven in the south-western corner at the rear.
(DAT Photo 110325_0010)

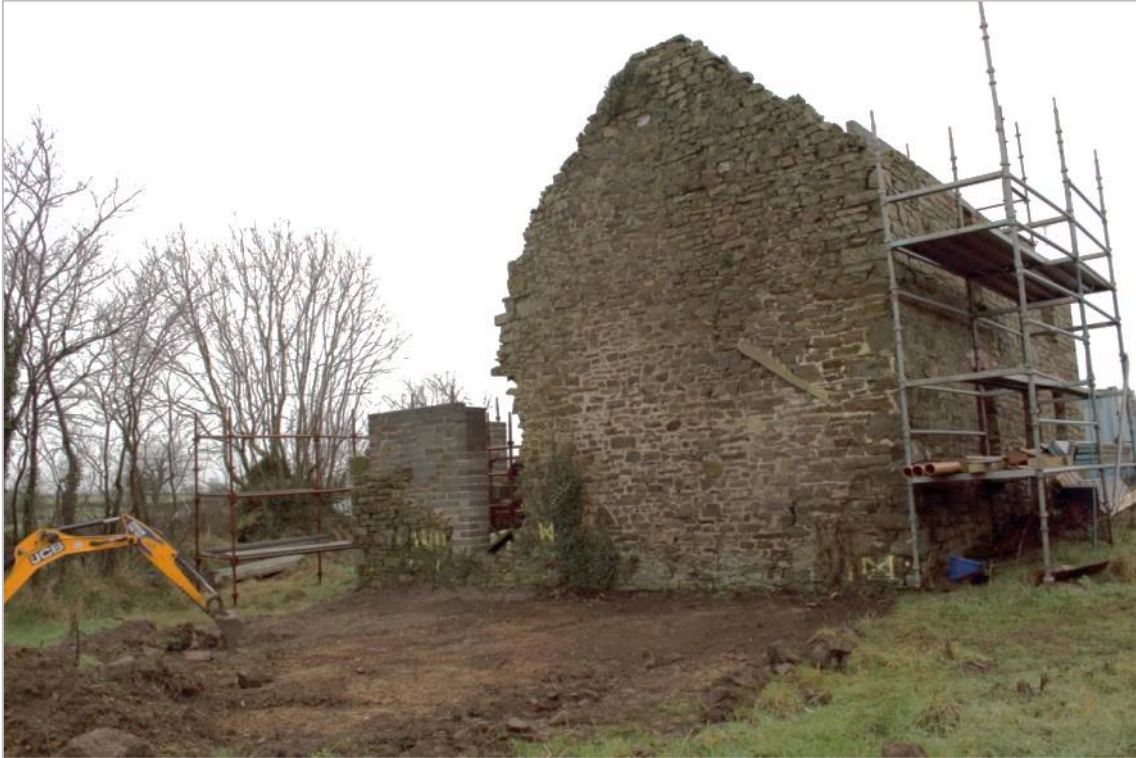
Photo 20: The stripped footprint of the proposed extension at the northern gable end of Crundale Mill (DAT Photo 110325_0048)

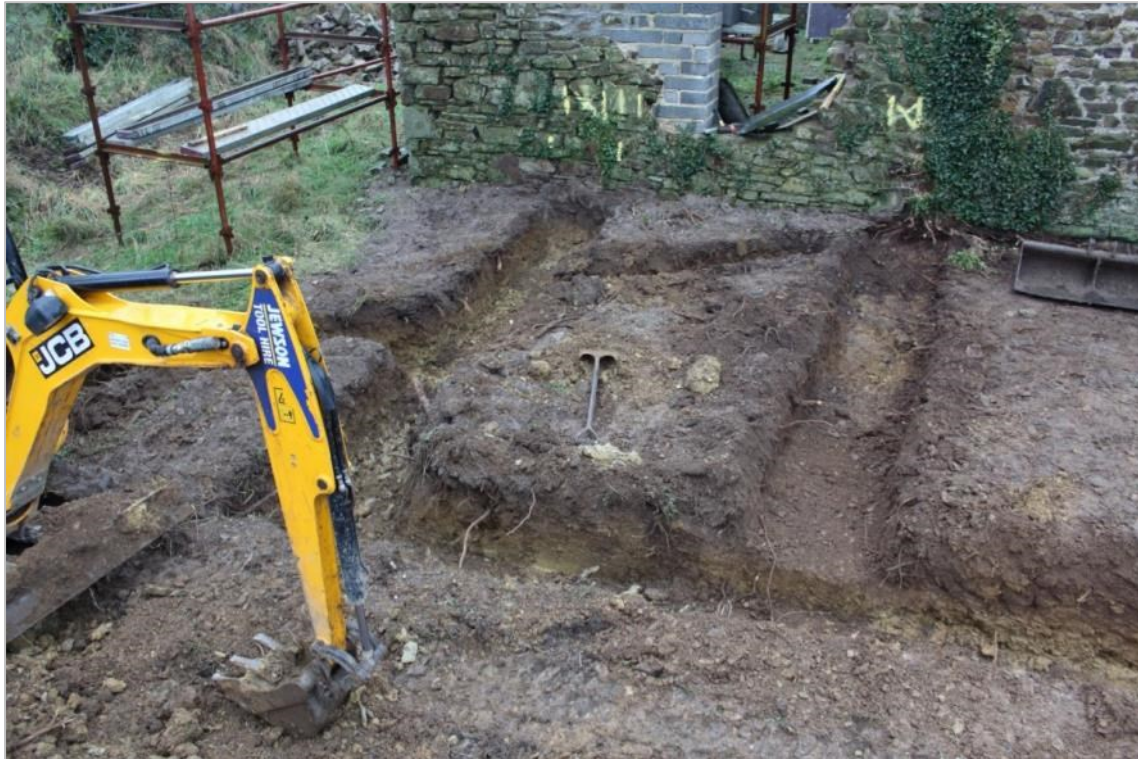
- 6.2 Excavation for the foundations of the proposed extension comprised a "U"-shaped trench to the north of the northern gable end. The completed trench measured approximately 4.5m wide and 8m long. The trench was approximately 0.6m wide and between 0.4m and 0.5m deep. Additional shallow drainage trenches did not exceed 0.2m in depth (Photos 21 & 22).

Photo 21: The eastern extent of the foundation and drainage trenches at the northern end of Crundale Mill (DAT Photo 110325_0064)

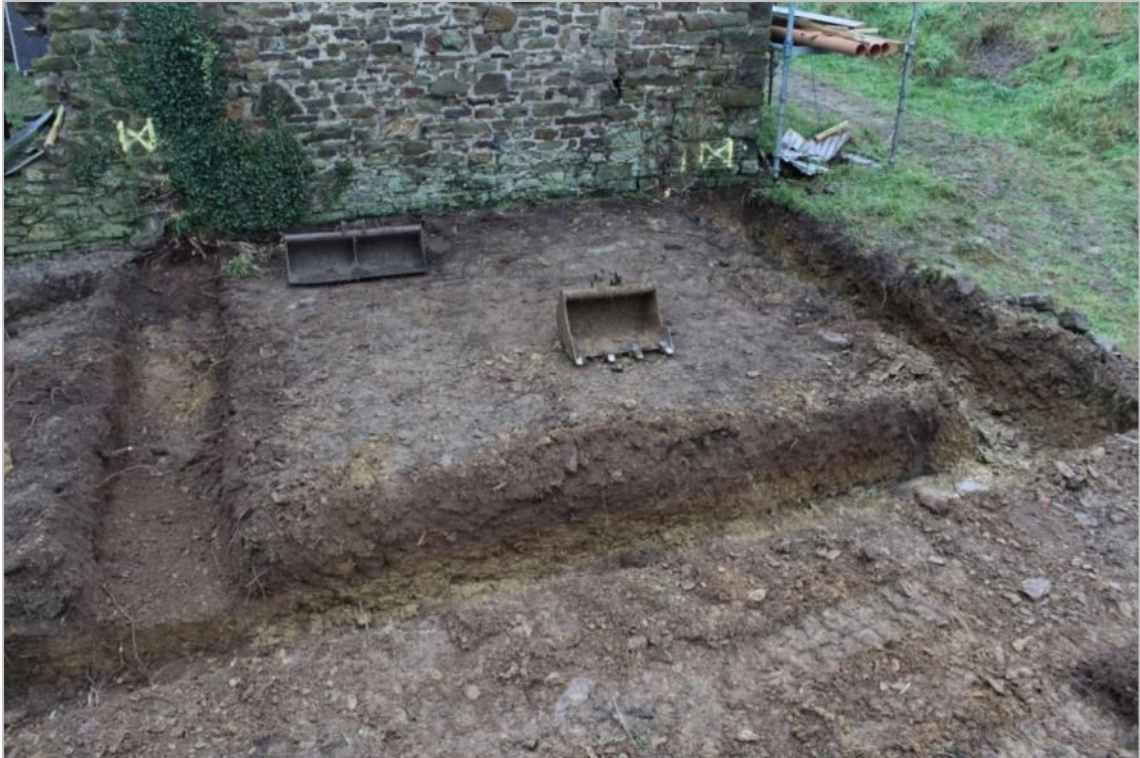
- 6.3 Orange-brown gravelly subsoil (102) varying between 0.2m and 0.3m in thickness, overlay bright yellow, shattered mudstone bedrock (104) (Photo 22). No features or archaeological deposits were observed in this area. There was scant evidence of the former building or structure seen on historic OS maps and the humic topsoil indicated that this area had been cleared in the recent past. Furthermore, there was a very large spoil heap in front of the house which could comprise demolition material from the former building.

Photo 22: The western extent of the foundation and drainage trenches at the northern end of Crundale Mill (DAT Photo 110325_0065)
