**CRUNDALE MILL, CRUNDALE,
PEMBROKESHIRE
ARCHAEOLOGICAL WATCHING BRIEF
AND BUILDING RECORDING
(SM98112 17827)**

**RHIF YR ADRODDIAD / REPORT NO. 2017/12
RHIF Y DIGWYLLIAD / EVENT RECORD NOS. 108836 & 110325**

**CRUNDALE MILL, CRUNDALE, PEMBROKESHIRE
ARCHAEOLOGICAL WATCHING BRIEF
(ERN 108836)
AND BUILDING RECORDING
(ERN 110325)
(SM898112 17827)**

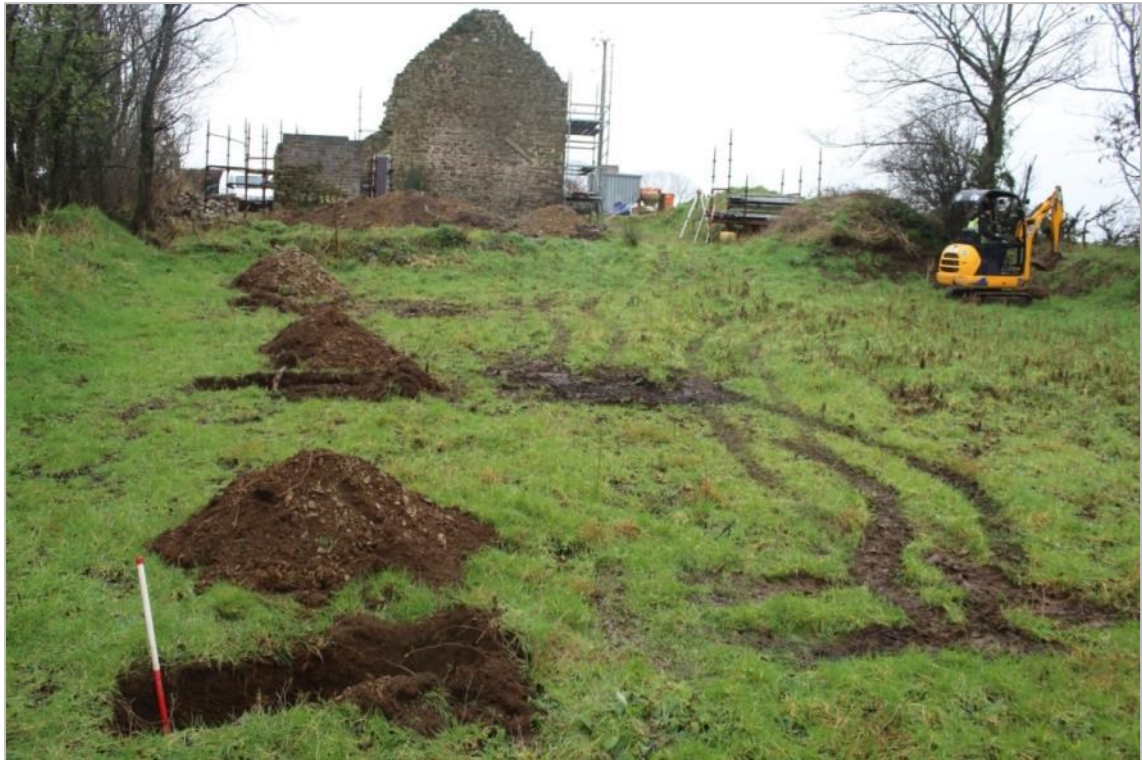
- 6.4 Three test pits were dug in the small field adjacent to the north of the house (Figure 7) to assess the depth of topsoil in advance of an installation of a sewage pipe, soakaway and septic tank in this area. The test pits were located along the north-eastern field boundary, around 1.5m in from the hedge and measured between 1.3m and 1.6m long and 0.6m and 1.1m wide (Photo 24). The depth of each pit varied between 0.6m and 0.85m in depth. Within the test pits a sequence of soils was revealed that comprised from the top rich loamy topsoil up to 0.25m thick (105) above orange-yellow subsoil (102). Shattered mudstone bedrock (104) was revealed around a depth of 0.6m (Photo 25). No deposits or features of archaeological significance were observed in the test pits.

Photo 24: The three test pits in the field north of the house (DAT Photo 110325_0069)

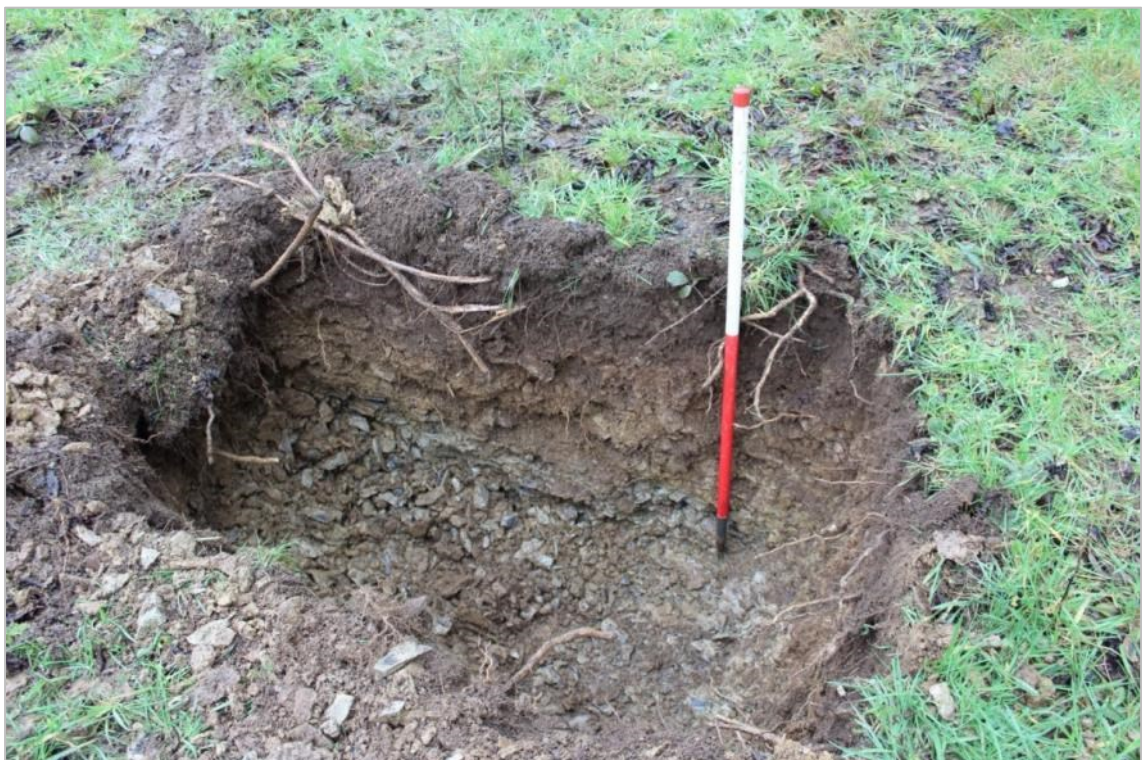
Photo 25: A sample section of the sequence of soils revealed in the test pits in the field adjacent to the house (DAT Photo 110325_0066)

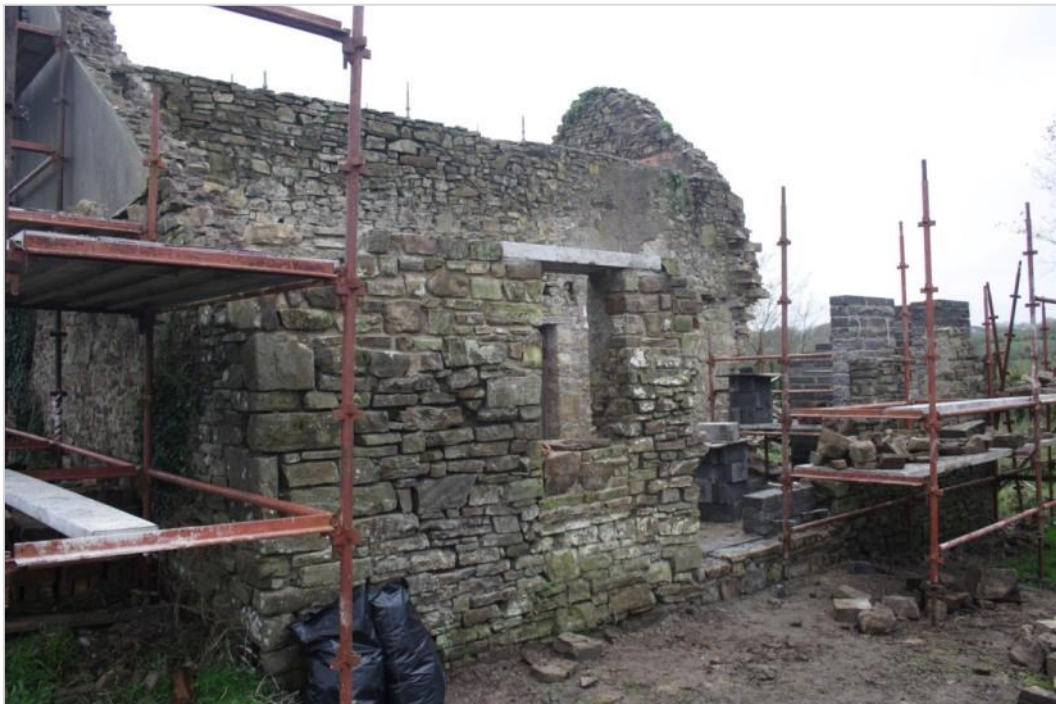
Photo 2: Eastern façade of the building, where some dismantling and rebuilding of the wall has been undertaken

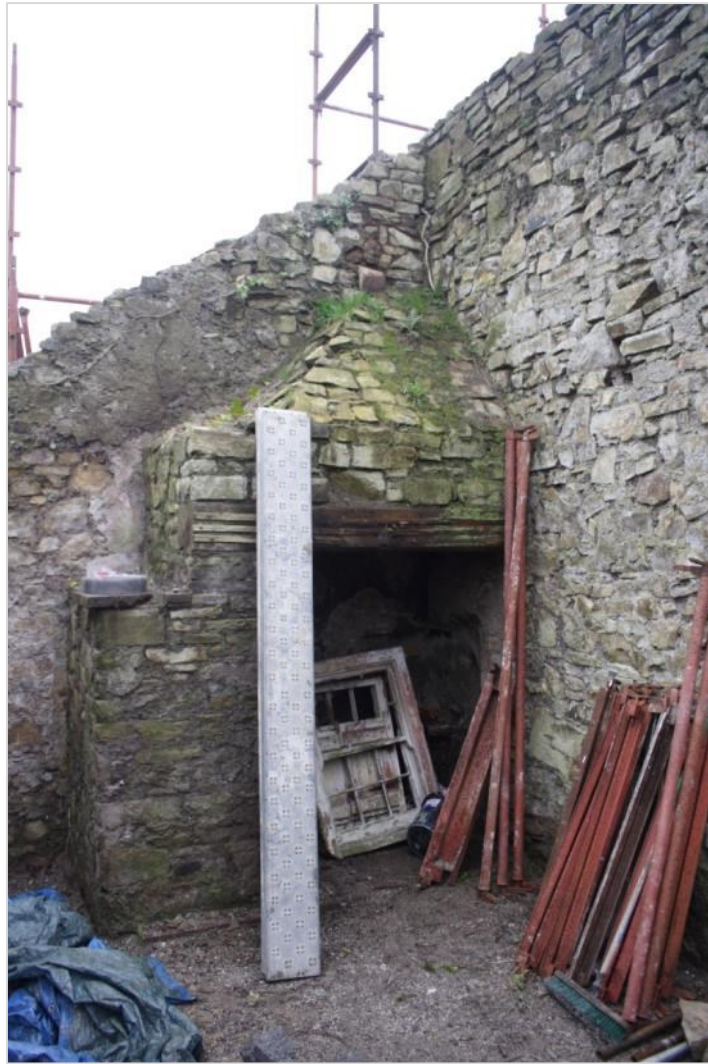
Photo 5: Remains of larger fireplace built into eastern part of building (southwestern corner) with remains of bread oven
