Archaeological Watching Brief

at St Cybi's Church

Llangybi

Ceredigion

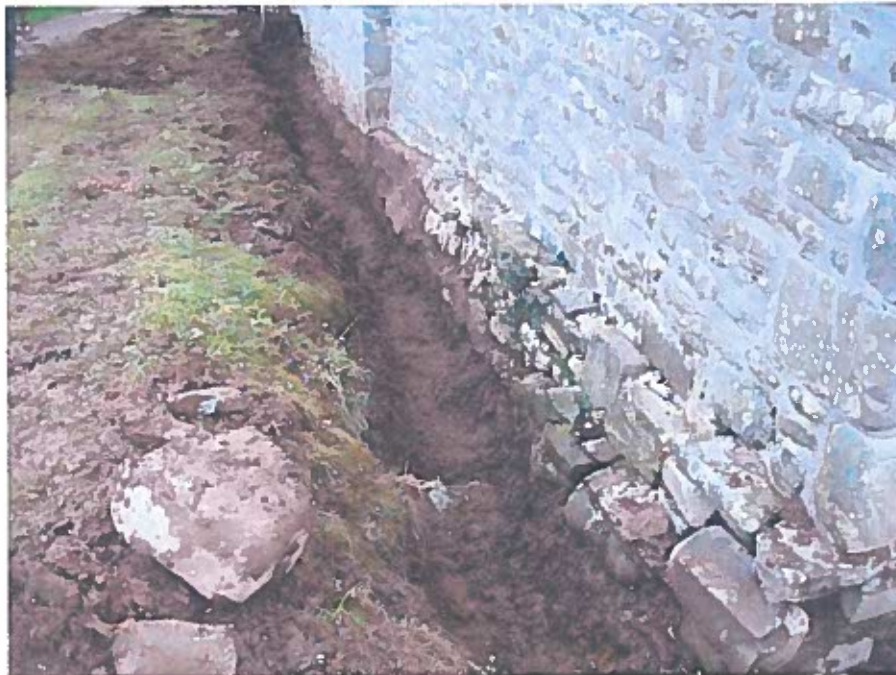
Plate 2: South wall of chancel

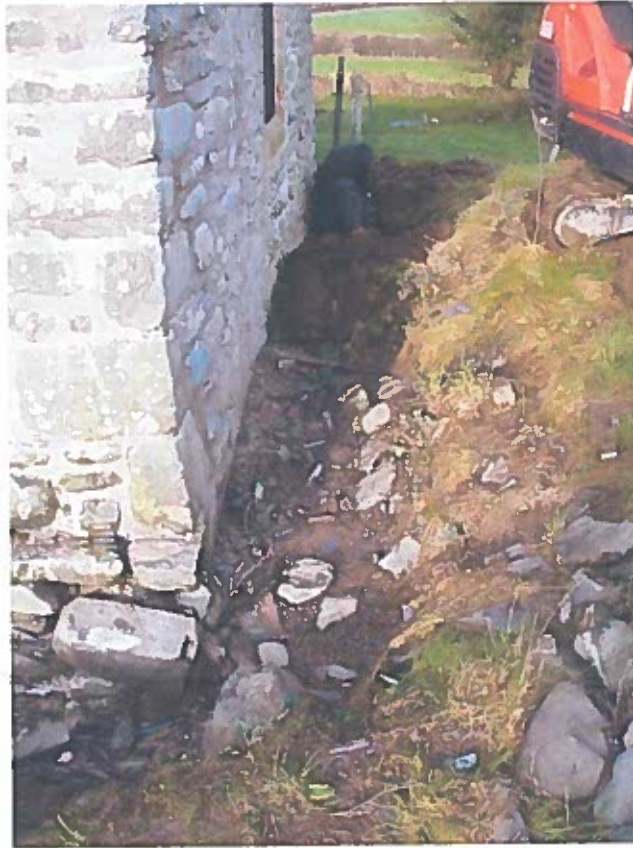
The drainage trenches re-excavated around the chancel were probably part of the 19th century remodelling of the church; it is known that the east window is an 1880s insertion into an earlier frame dating to at least 1850. The bell cote can also be shown to be of an 1880s date while the roof is likely to date from the 1850 work. It would seem probable that in any of these two phases some attention would have been paid to the drainage of the building. During the course of this current investigation it was noted that the ground around the chancel, in particular, was very wet a situation that probably existed in the 19th century. This concentration of damp around the eastern end of the church may explain why there was, apparently, no need to extend the drainage scheme to the west of the church during the 19th century; the current drainage trench being dug into undisturbed soil.

Plate 3: East wall of chancel

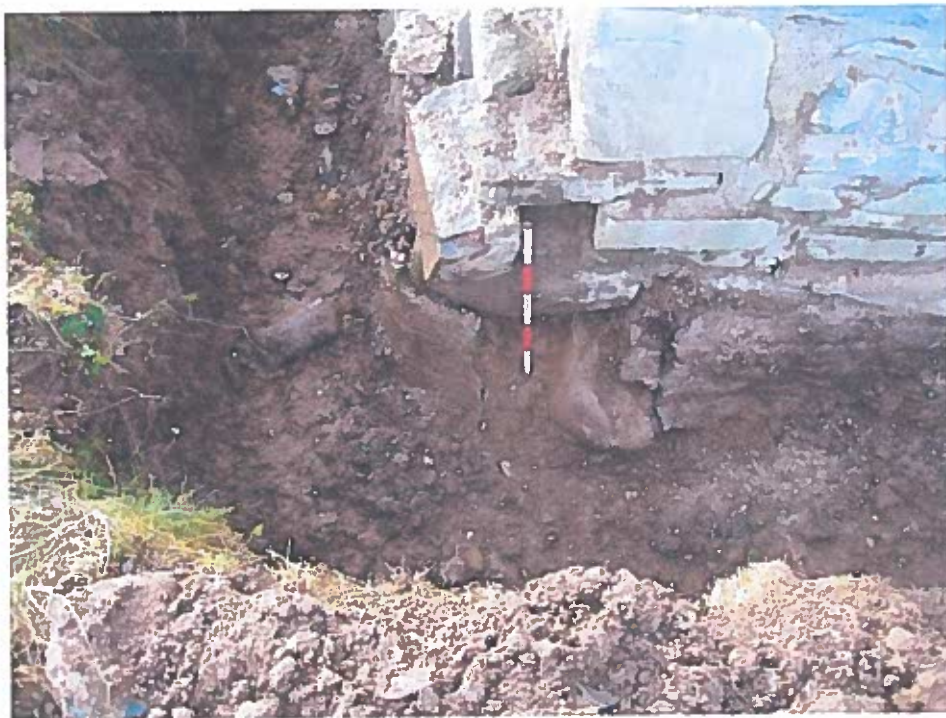
The previously cut French drains were re-excavated and the foundation footings exposed. The trench was between 75 and 80cm wide and varied between 100cm and 130cm deep, depending on the surrounding ground level. The footings below the north and south chancel walls contained large boulders and may belong to an earlier phase of building. Below the footings of the chancel east wall a layer of fine yellow/buff sand was noted. The footings below the east wall were different suggesting again a later phase of building. The ground immediately to the east of the chancel was disturbed and loose.

Plate 4: South corner of chancel showing early boulder foundation along south wall and 19th century foundations below east wall

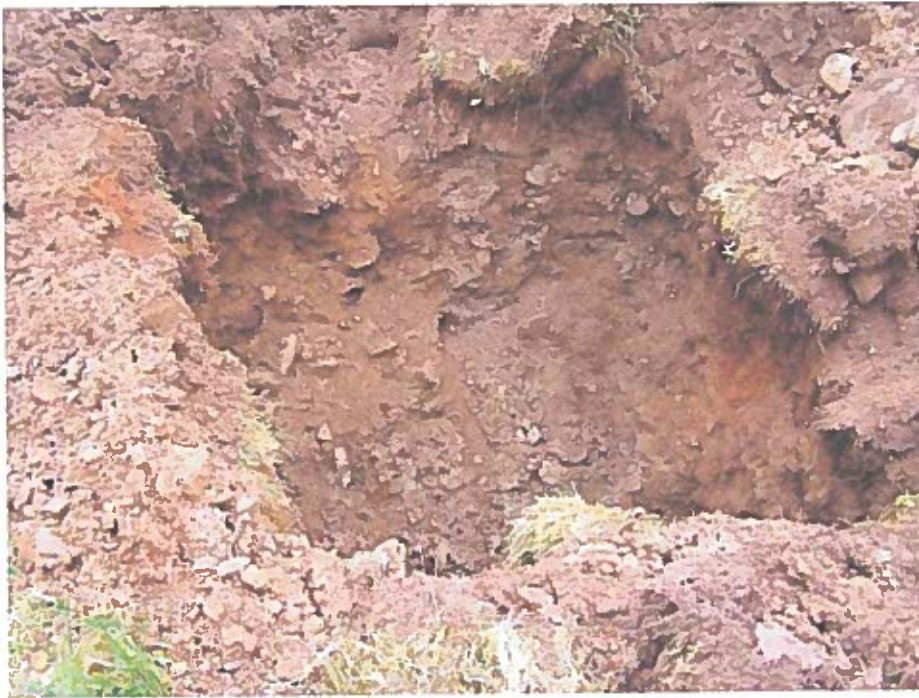
Soakaway 1 was located some 310cm from the northwest corner of the nave and was 100cm square. The soil was a loose packed brown loam and was soft and sandy in texture, well mixed with small, rounded stones. The soil was remarkably clean of any finds from its upper layers but two fragments of human femur were recovered at 95cm below ground level.

At 130cm below ground level an inhumation was noted. The skeleton was badly degraded with only the lower limbs, pelvis and lumbar vertebrae remaining articulated. A number of ribs, some of the upper limb bones and a quantity of thoracic vertebrae were present but disarticulated. There was no sign of either the skull or the cervical vertebrae. Since this burial was at the lower limit for the soakaway it was covered with a layer of soil and a geotextile membrane and left in situ.

Plate 5: Soakaway 1

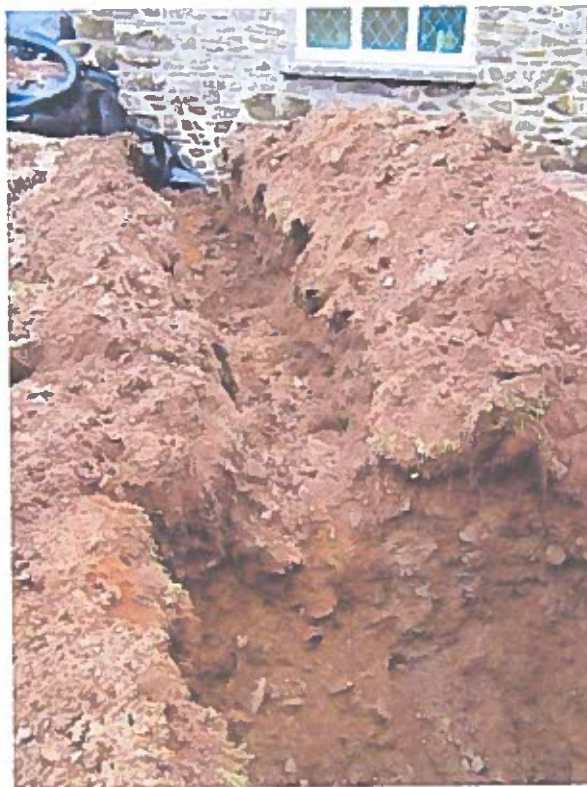
Soakaway 2 was sited 310cm north of the vestry wall to the northwest of the church. Again it was 100cm square. Further fragments of ceramic roof tile of a probable medieval date were recovered from the topsoil but below this the ground presented as undisturbed. The soil was again sandy in texture but well mixed with degraded limestone fragments. At 120cm below ground level a large natural rock outcrop of shale was noted in the south east corner of the soakaway. It was felt that the outcrop would not affect the function of the soakaway and it was left in situ.

given the presence of a substantial stone outcrop in the bottom of the pit, an element of local knowledge may be at play and this part of the churchyard simply not used for burials.

Plate 6: Soakaway 2
