# CAREW FRENCH TIDAL MILL AND CAUSEWAY, CAREW, PEMBROKESHIRE (SN 04155 03831)

# ARCHAEOLOGICAL WATCHING BRIEF DURING REPAIR AND REMEDIATION WORKS 2017

RHIF YR ADRODDIAD / REPORT NO. 2017-72 RHIF Y PROSIECT / PROJECT RECORD NO. 111174

> Chwefror 2018 February 2018

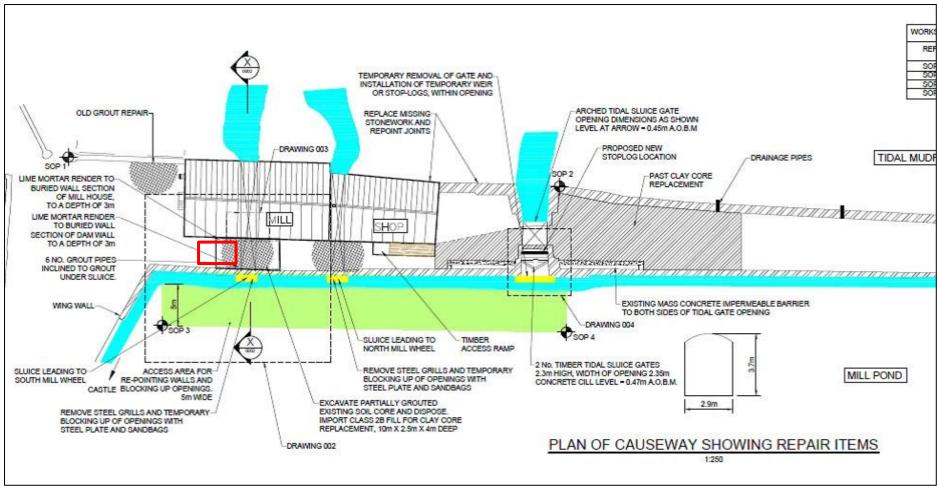
**Figure 2:** Plan of Carew French Mill and Causeway showing the proposed scheme of repair works and the excavated test pit outlined in red. (Reproduced courtesy of Atkins © Atkins Limited (2017))

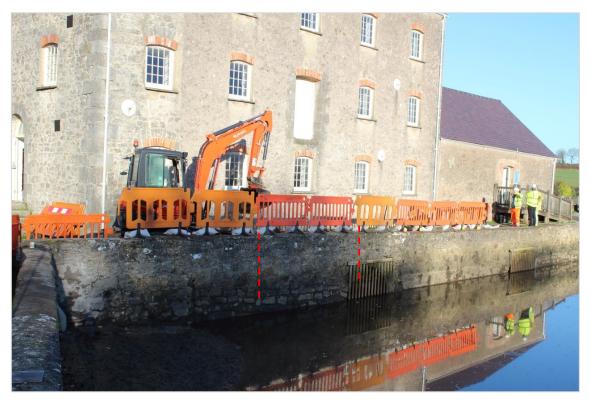
4.1 The inspection trench was excavated over the sluice leading to the southern mill wheel (Photo 1). The trench was situated over the midsection of the sluice and extended south beyond the southern extent of the sluice structure (Figure 2).

**Photo 1:** Illustrating the location of the inspection trench over the sluice leading to the south mill wheel (red dashed lines mark approximate location of inspection trench).

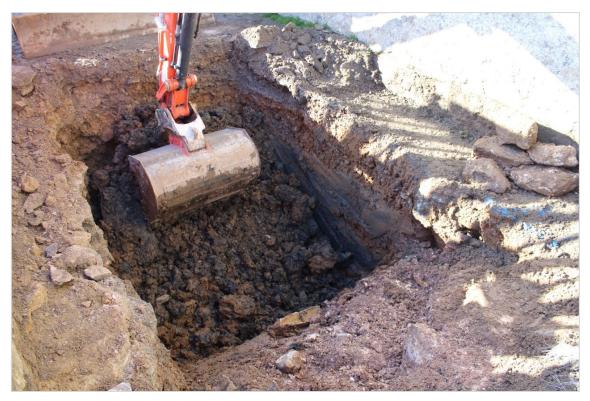
4.2 The upper layers of the trench comprised the present road surface (approximately 0.15m thick). Underlying this was a silty layer of made ground up to 0.40m thick. This layer was rich in crushed mortar and contained fragmented frogged bricks as well as frequent small stones and a number of large flat worked stones. Lying beneath this made ground, at a depth of approximately 0.70m were alluvial clays light brown in colour; though growing significantly darker in colour with depth. Photo 2 illustrates the stratigraphic sequence observed.

**Photo 2:** The stratigraphic sequence observed in the southeast facing section of the inspection trench.

- 5.2 The excavation of the inspection trench revealed an upper layer associated with the present road surface overlying a layer of made ground. This in turn was overlying redeposited alluvial clay deposits.

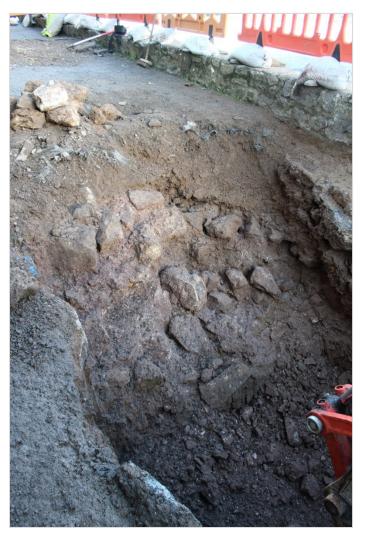
- 4.3 During the excavations the outer southwest face of the stone arch of the sluice was exposed (Photo 3). The arch appeared constructed from large worked stones. The arch extended roughly 2.0m from its apex indicating how substantial the sluice arch probably is. The alluvial deposits butted up against the stone arch, suggesting that they were natural alluvial clays excavated during construction of the causeway and then redeposited as packing when required.
- 4.4 The trench was excavated to a depth of approximately 2.0m. At the base of the trench in the northwest facing section an apparent *in-situ* wall was observed (Photo 4). Due to the constraints of the watching brief it was not possible to ascertain whether this was footings associated with the current east causeway wall or an earlier phase of construction. These stones were not disturbed and remained *in-situ*.

**Photo 3:** Outer southwest facing wall of the sluice arch exposed during excavations.

- 5.3 The outer southwest face of the stone arch of the sluice was exposed. Constructed from large worked stones; the arch extended roughly 2.0m from its apex indicating how substantial the sluice arch probably is

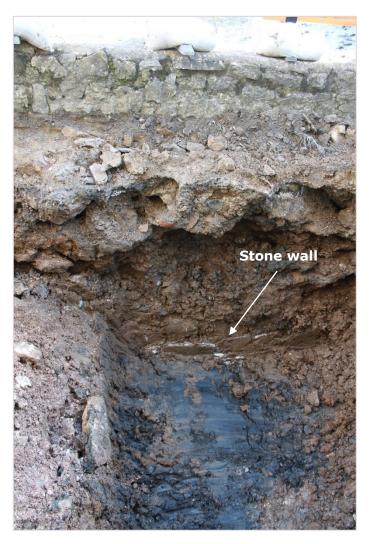
**Photo 4:** Evidence of a stone wall observed at the base of the trench in the northwest facing section.

- 5.4 At the base of the inspection trench *in-situ* worked stones were observed in the northwest facing section of the trench. Under the constraints of the watching brief it could not be determined whether they were footings associated with the current east causeway wall or an earlier phase of construction.
