CAREW CASTLE CAFÉ, CAREW, PEMBROKESHIRE 2018: ARCHAEOLOGICAL WATCHING BRIEF

SN06575 03775

DYFED ARCHAEOLOGICAL TRUST
RHIF YR ADRODDIAD / REPORT NO. FS18-010
RHIF Y PROSIECT / PROJECT RECORD NO. 112372

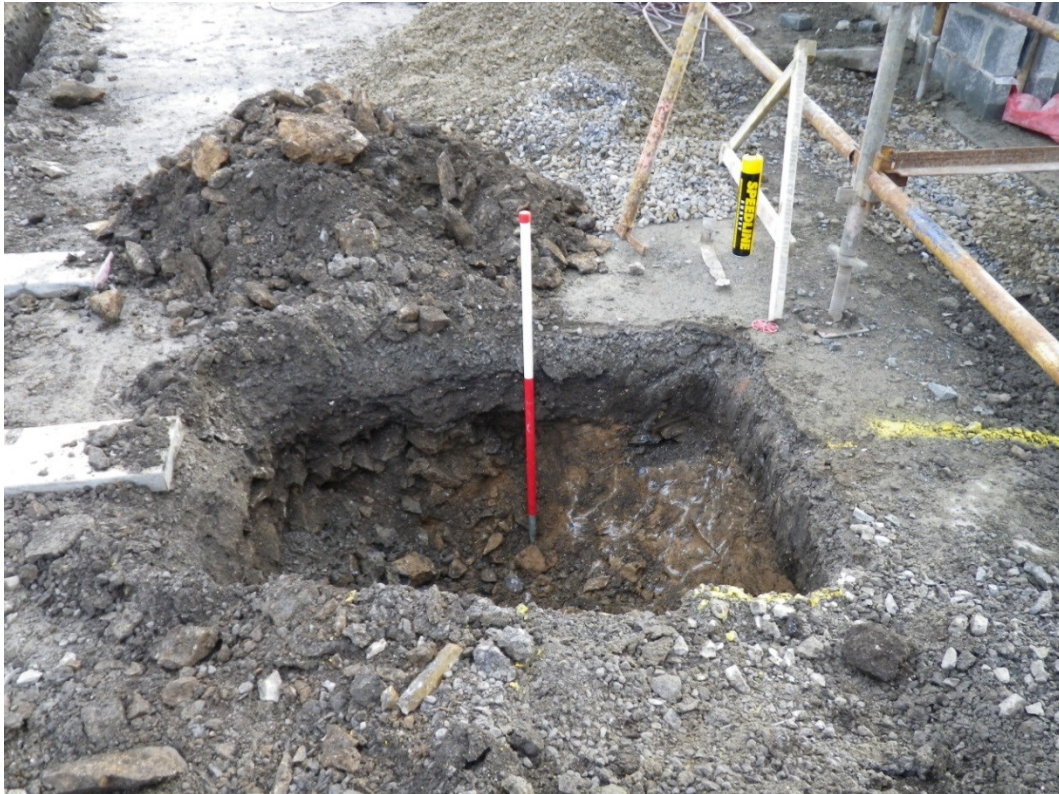
2.2.10.6 The westernmost of these rectangular trenches (Figure 5) appears to have been located within the former excavation area from the 1990s (Photo 7). Bedrock was exposed in places around 0.25m depth with dark soil and rubble mix above. The trench was deeper to the north, possibly due to a dip in the bedrock level. The maximum depth of the trench would appear to be around 0.80m depth.

Photo 7: View east across western rectangular trench showing bedrock and mixed dark soil and rubble layer above

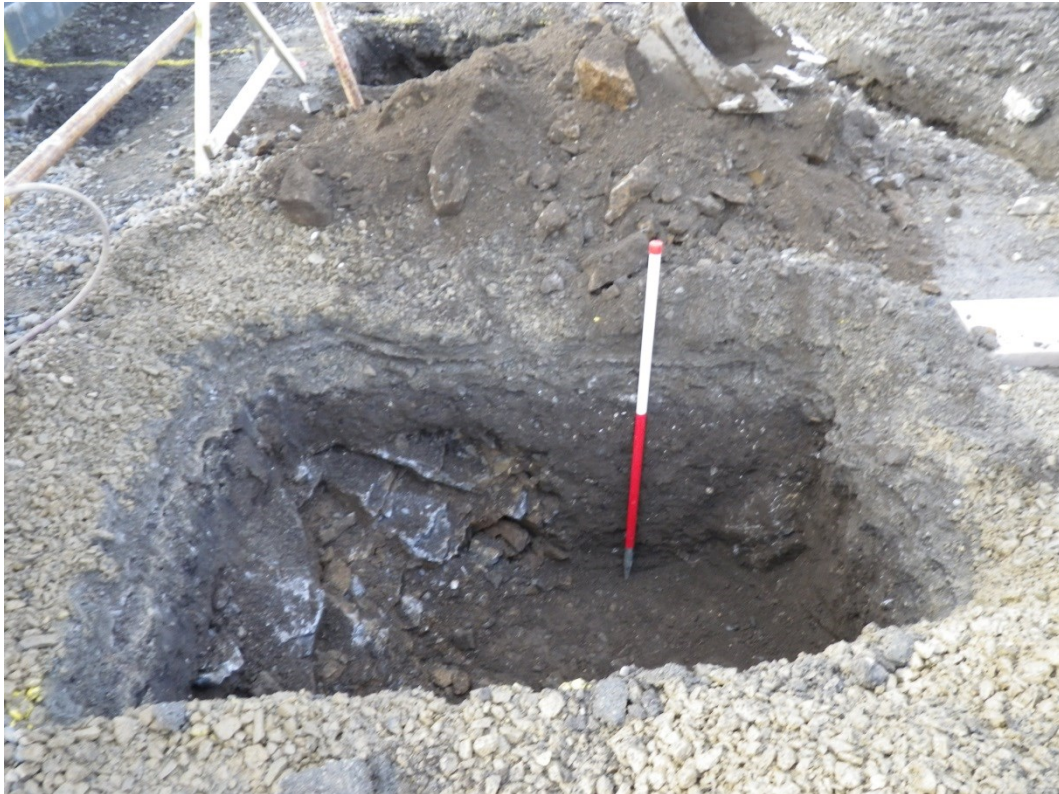
2.2.10.7 The eastern rectangular trench (Figure 5) must have been dug through previously unexcavated ground. Bedrock was again exposed at a shallow depth on the southern side of the trench, possibly at around 0.30m below ground level. The photographs clearly show an east to west aligned ditch or gully crossing through the trench of around 0.50m depth and 1m width (maximum) filled with a dark silty soil with few inclusions. The ditch was U shaped in profile (Photos 8 and 9). The northern edge of the feature extended beyond the edge of the excavated trench. It is possible that the deeper area within the western trench related to a continuation of this feature to the west.

Photo 8: East facing section of eastern rectangular trench showing clear rock-cut ditch profile (with western trench just visible behind)

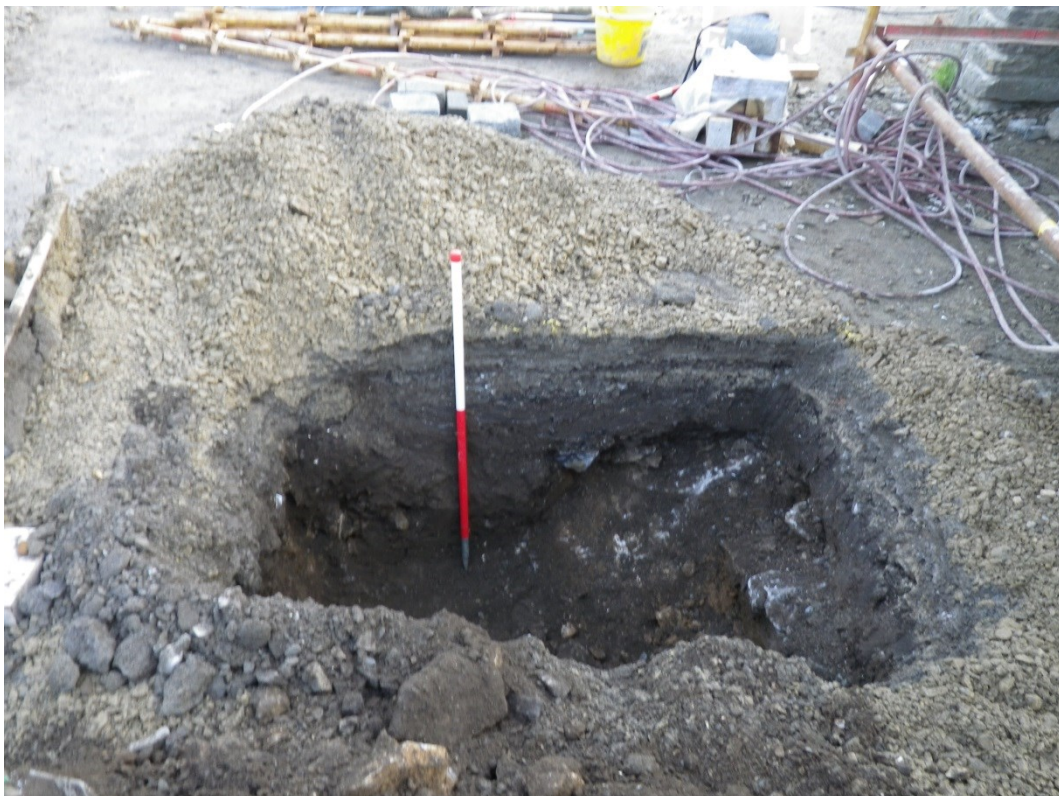
Photo 9: West facing section of eastern rectangular trench showing clear rock-cut ditch profile

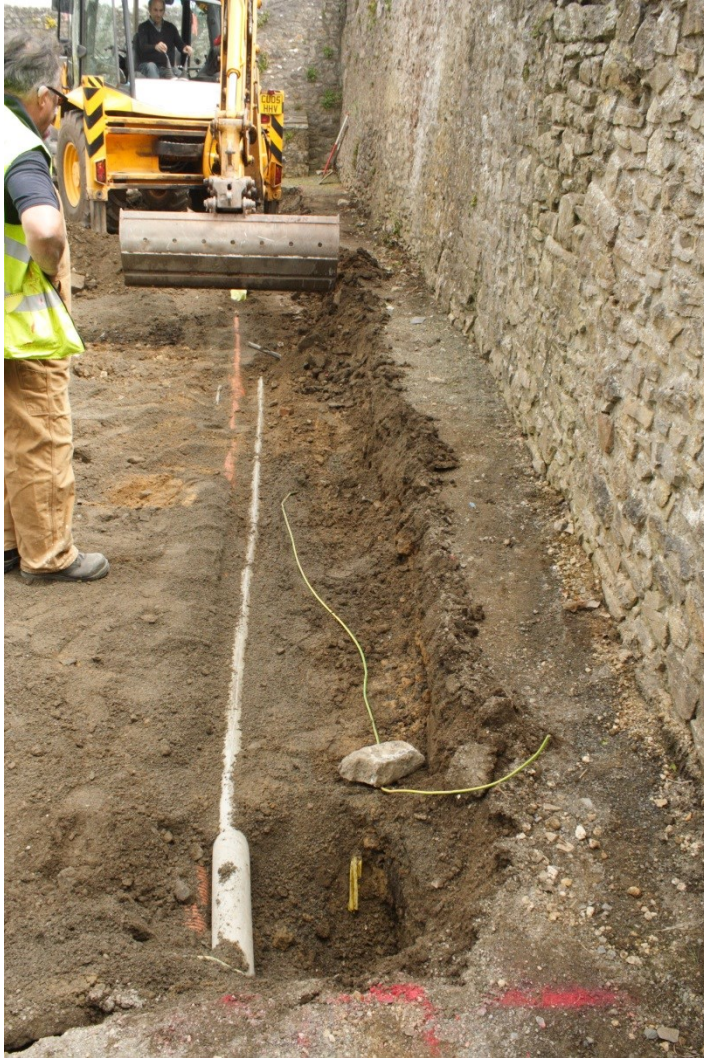
- 4.2.2 Close to the southern edge of the excavated area two service ducts were exposed: a grey one containing BT cables and an orange one containing the electricity supply (Photo 11). These ducts were installed when the adjacent visitor centre was built and the service trench was observed by the PCNP archaeologist in 2013 (Photos 1, 2 and 3). They lay around 1m – 1.35m from the southern wall of the walled garden, before turning to the northeast near the eastern end of the footprint of the building, towards the entrance to the walled garden. Redundant earthing and electricity cables were also found within this southern 'toe' of the slab, indicating that the ground had been disturbed here previously.

Photo 11: Southern edge of café footprint showing exposure of orange and grey service ducting and redundant earthing cable, viewing east

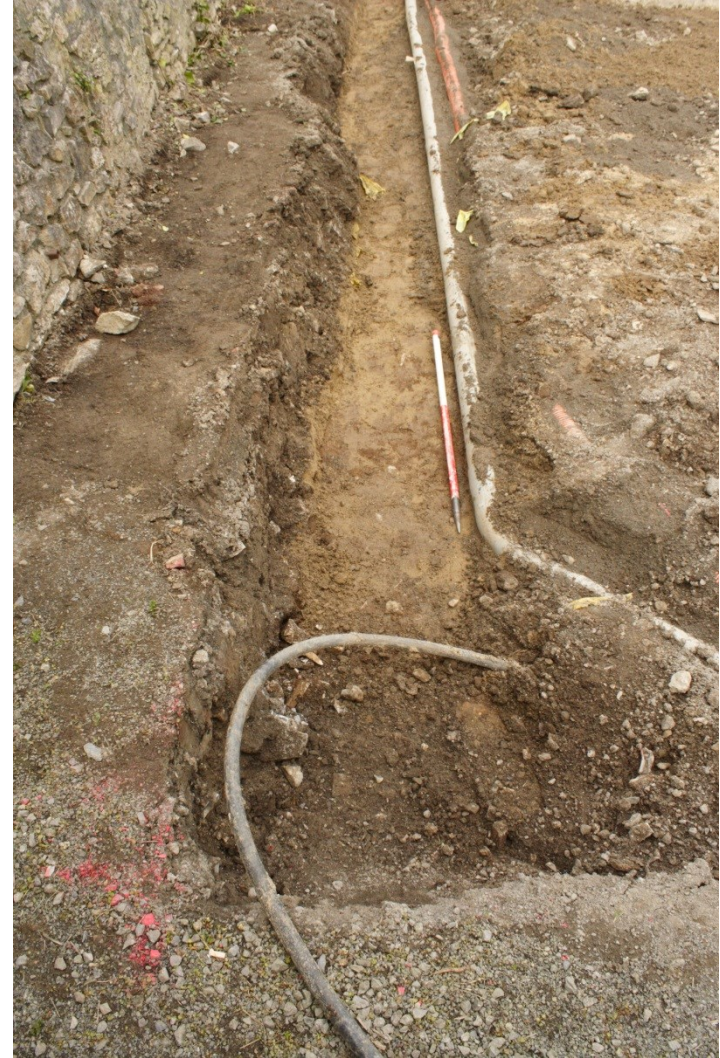
Photo 12: View west along orange and grey service ducting following removal of 'toe' with sand exposed beneath, and with redundant electricity cable visible

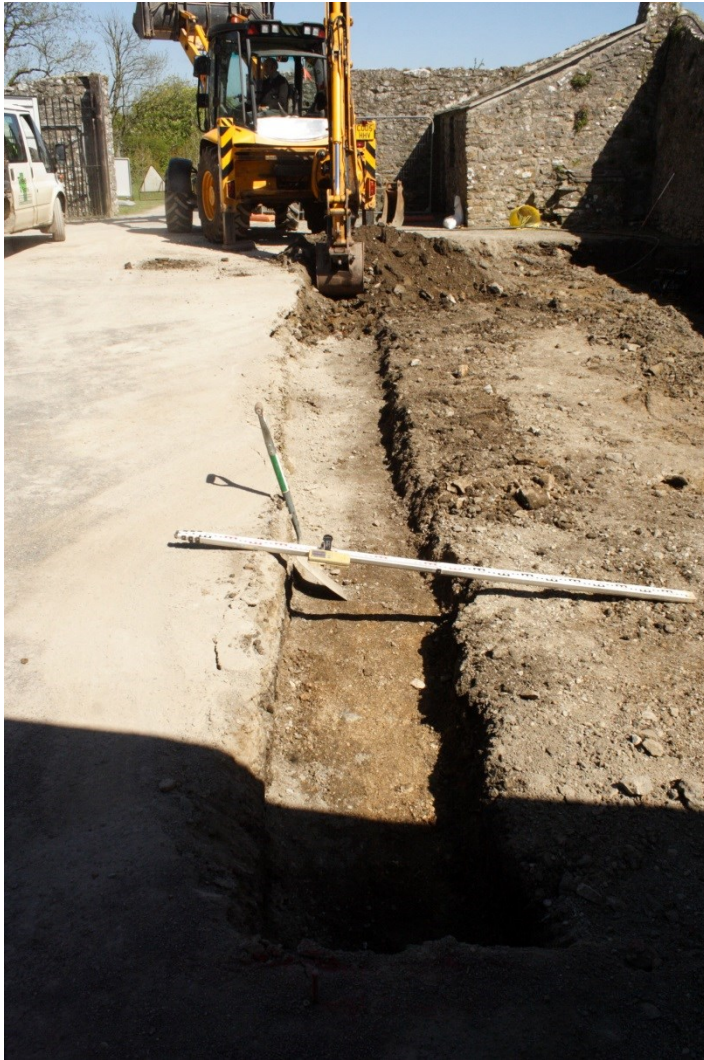
- 4.2.4 The northern 'toe' trench was lowered by around 0.20m from the main stripped area at the western end and around 0.10m at the eastern end (Photos 13 & 14). The trench exposed sands and mortar at the eastern end, as noted along the southern 'toe' similar to that seen in the evaluation trench. The western 'toe' trench exposed similar material at the same depth, although with the service ducts at its southern end. The depth of the northern 'toe' trench was lessened to the east due to the presence of archaeological remains as identified during the evaluation. The depth of ground reduction was around 0.50m in total, the same depth exposed in the evaluation trench.

Photo 13: View east along northern 'toe' trench within footprint of café

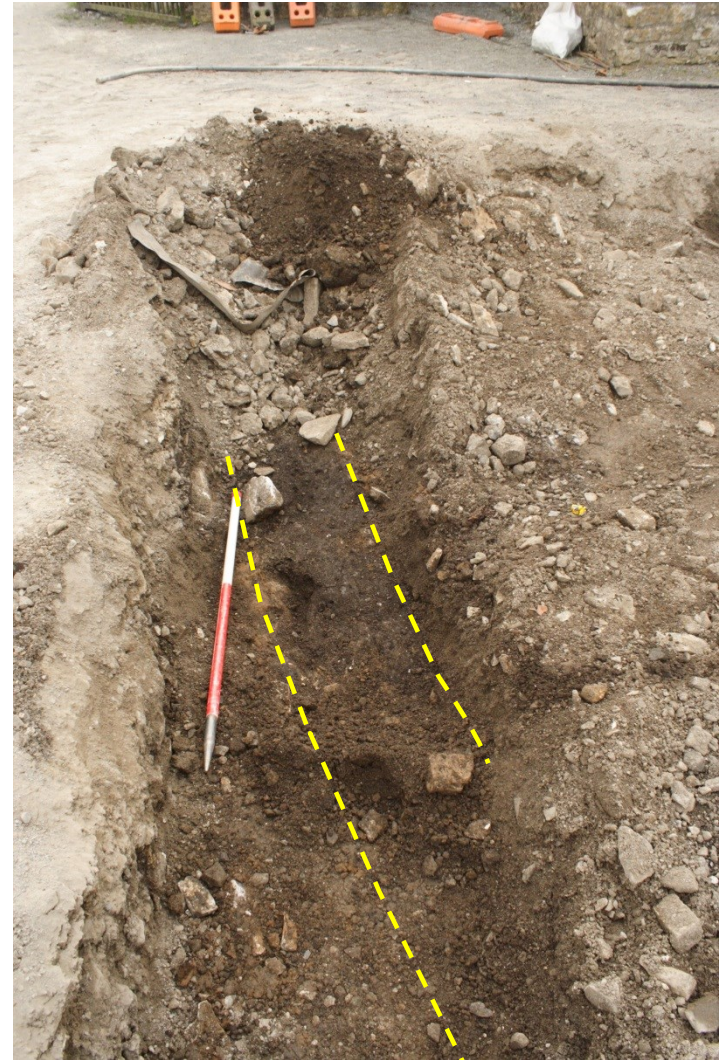
Photo 14: View west along northern 'toe' trench within footprint of café, showing alignment of service trench

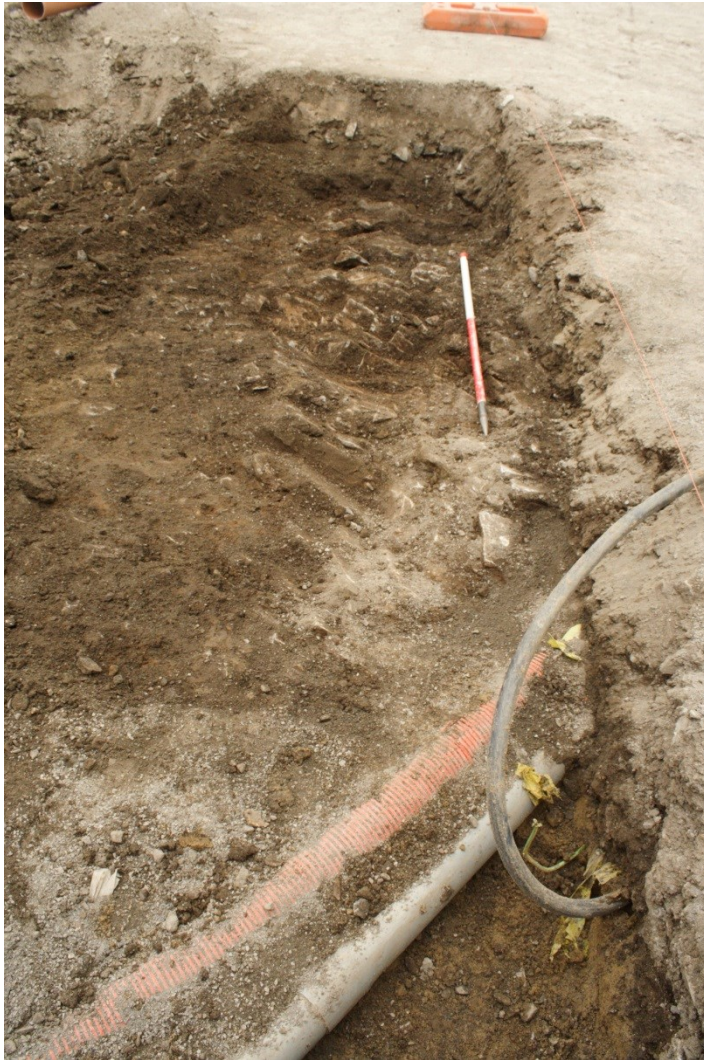
- 4.2.9 As noted above it was partially exposed in a few places in the southern 'toe' trench of the foundation, where it had been covered in sand from the service trench which was removed by hand by the attending archaeologist. The ditch fill in this area was much less stony than that detected in the evaluation, consisting of mid-brown silty clay with a few large stone inclusions.

Photo 15: View north along eastern end of café footprint showing bedrock exposed along 'toe' trench and edge of rock-cut ditch with service ducts in foreground

- 4.2.11 The area where the top of the ditch was exposed was not reduced in level any further. The remains were then covered with spoil removed from the 'toe' trenches to protect it, prior to the raft foundation being constructed over the area, leaving the ditch *in-situ*, which was a requirement of scheduled monument consent for the development.

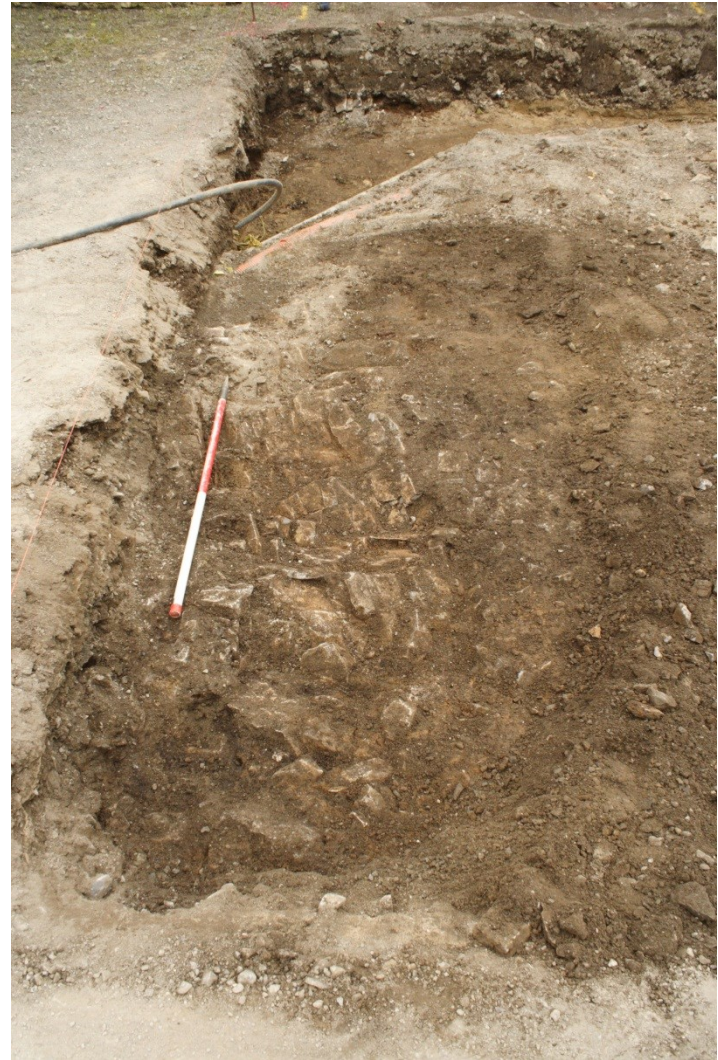
Photo 16: View south along eastern end of café footprint showing bedrock exposed along 'toe' trench and edge of rock-cut ditch with service ducts in background

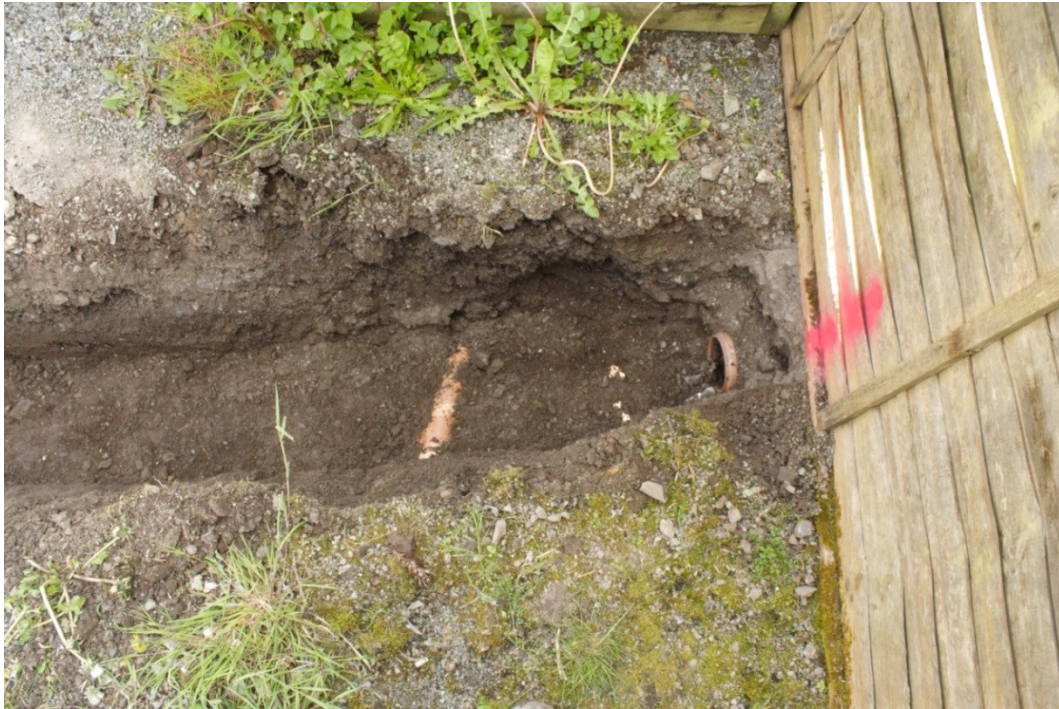
Photo 19: Plastic drain pipe exposed at the base of the service Trench B at the fence line, installed and observed in 2013, viewing east.

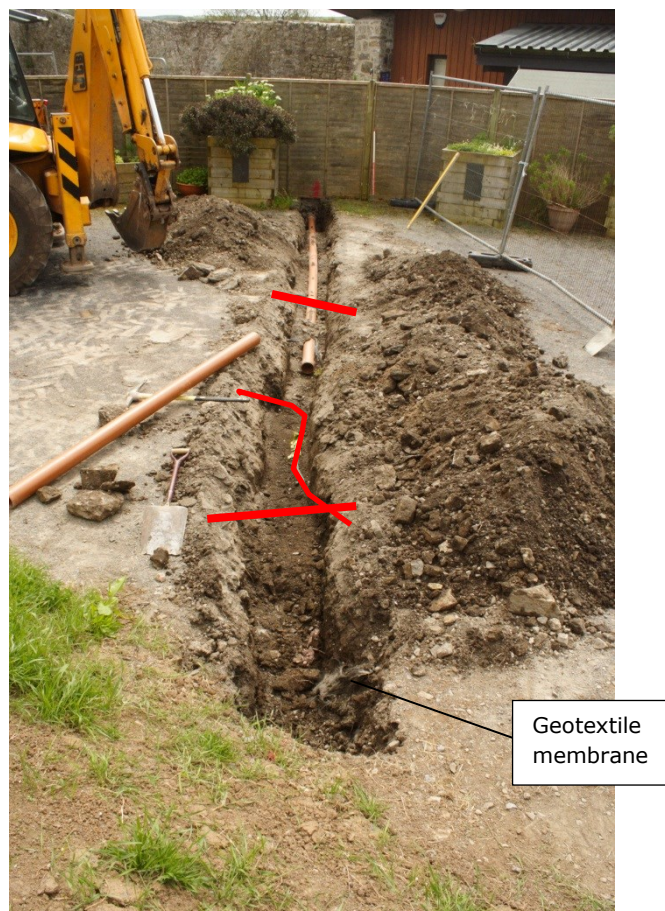
Photo 20: Electricity cabling recorded crossing the line of service Trench B (highlighted in red) viewing southeast.
(Note the geotextile material in foreground associated with existing soakaway)

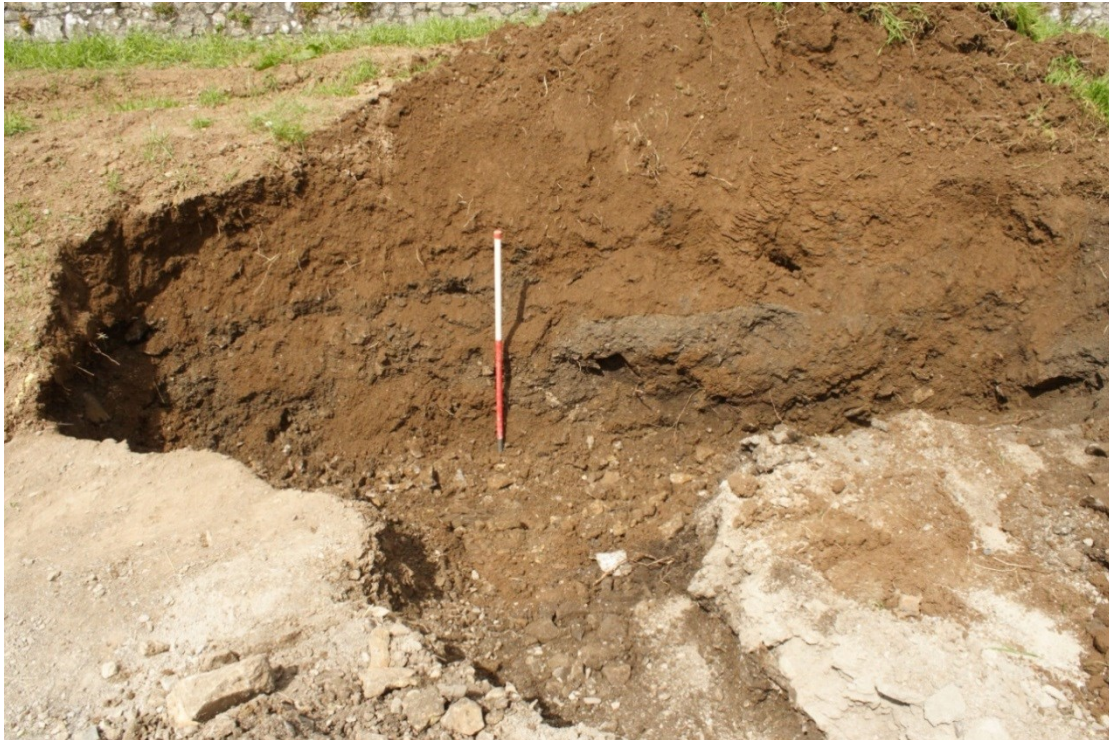
- 4.3.4 At the north-western end of Trench B a soakaway measuring 5m x 1m was excavated. This lay directly north of an existing soak away presumably excavated for the visitor centre (Figure 7, Photo 21), but not archaeologically observed in 2013 as the area had been previously excavated. Bedrock was exposed across the whole soak away before being dug down to c.0.80m to create the fall needed for the drain. This area had been previously excavated and therefore there were no archaeological layers detected. The soakaway avoided the lines of the previously excavated north to south rock-cut ditches, although the existing soakaway noted on its southern side will have cut through the remains of the western rock-cut ditch.

Photo 22: View northwest showing soakaway dug at the northwest end of service Trench B, with clean bedrock exposed at base.

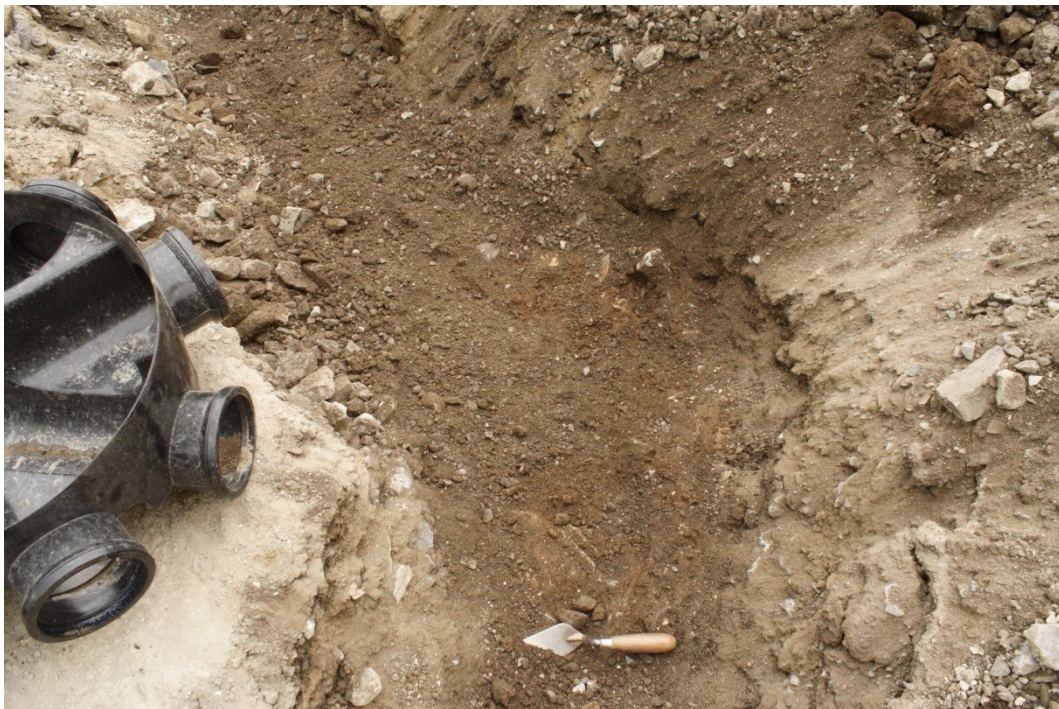
- 4.4.3 At the southeastern end of the drainage trench adjacent to the café footprint an area for a new manhole was excavated to a depth of around 0.40m (Figure 6). This was excavated under archaeological control as it lay within the alignment of the early medieval ditch; however no archaeological horizons were exposed, presumably lying beneath the excavated level. A pipe trench was also inserted to connect into the café footprint, but this was at a very shallow level and also did not expose or damage any archaeological remains.

Photo 24: Southeastern end of drainage Trench C
in area of proposed new manhole following cleaning
