**DYFED ARCHAEOLOGICAL TRUST  
GLASTIR ADVANCED TARGETED ADVICE**

**Aberceiro A000027923**

**DAT REPORT NO. 2018-52**

# **Glastir Advanced Historic Environment Feature (HEF) Management Plan**

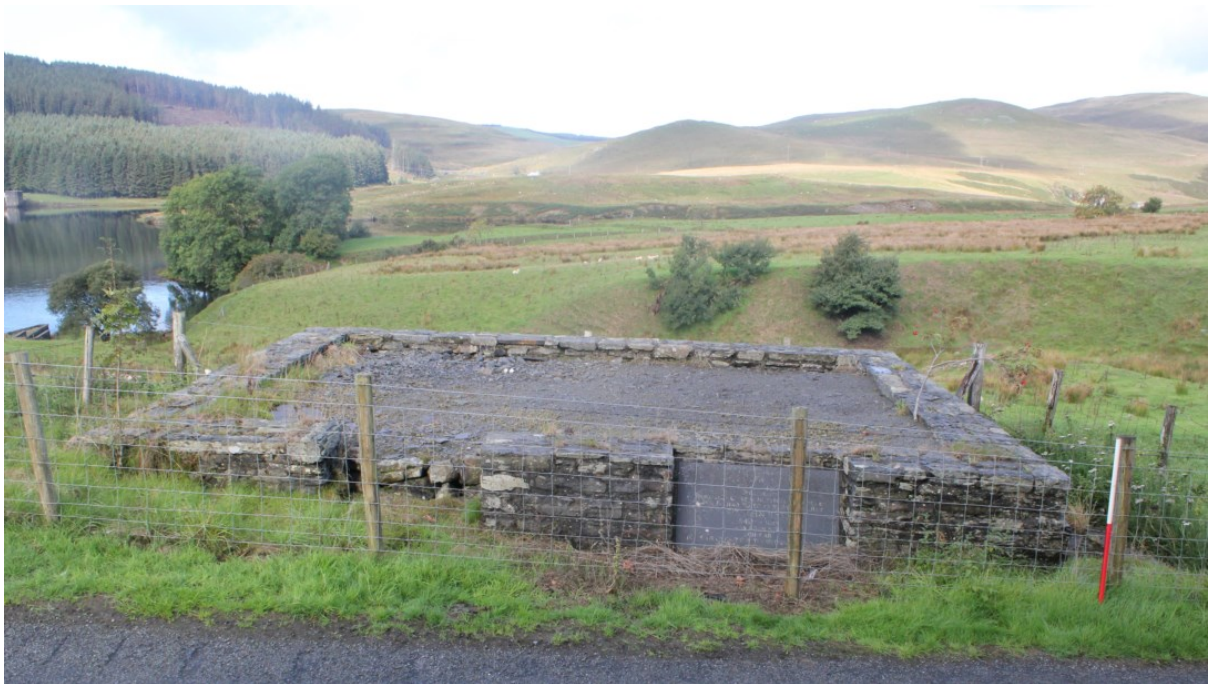
The current condition of the structure is good, and appears to be well maintained.

Figure 1. The cottage remains of the birthplace of Sir John Rhys, Professor of Celtic Studies at Oxford University

The structure should continue to be maintained, vegetation cleared from the structure regularly and if necessary point up the stonework with lime mortar.

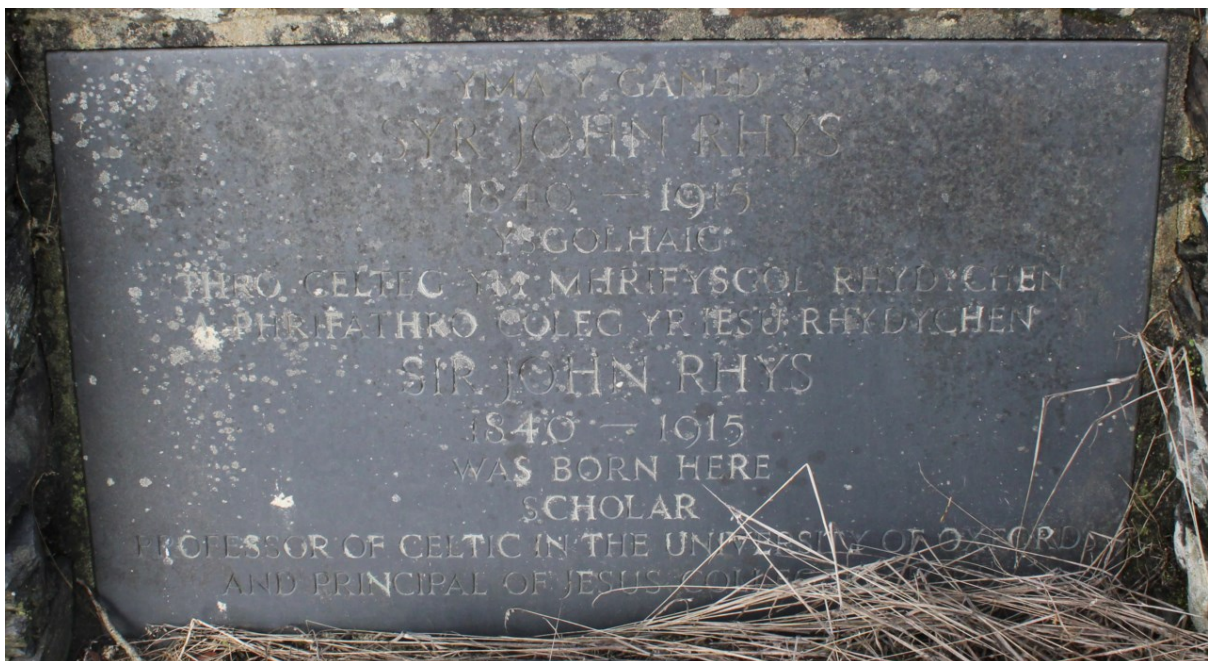
Figure 2. Memorial plaque to Sir John Rhys.

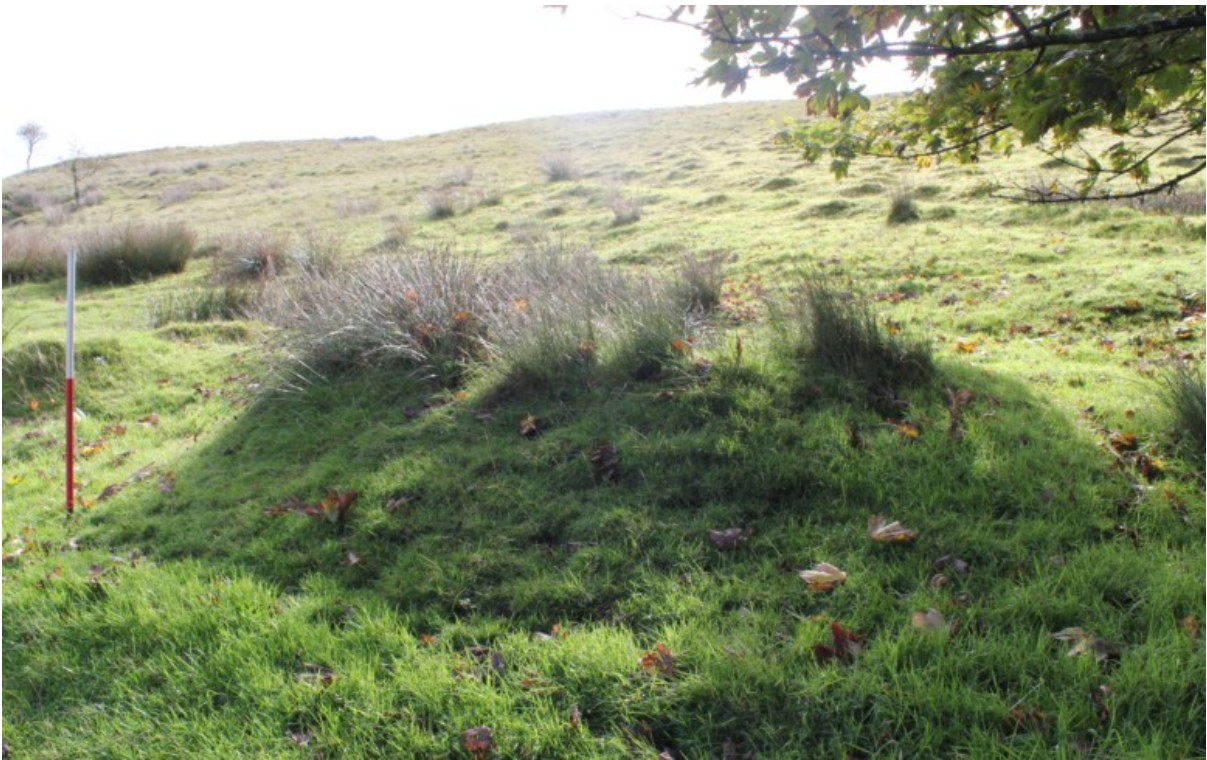
Current condition is good, it is located in permanent pasture and is in a stable condition.

Figure 3. A circular feature, probably a rick stand or corn drying kiln.

The monument should remain as it is currently; in a lightly grazed management regime, so that scrub does not encroach over it.

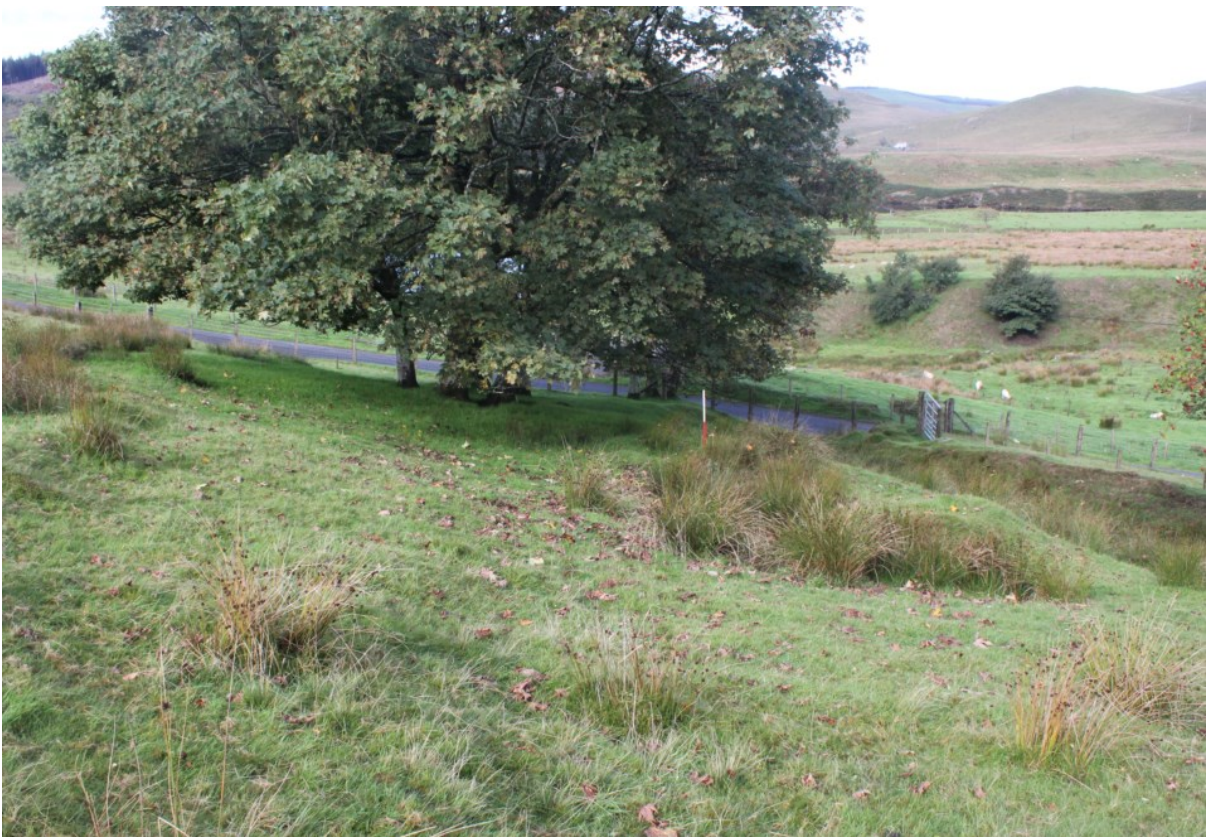
Figure 4. Looking west across the earthworks to the south of Aberceiro Farm

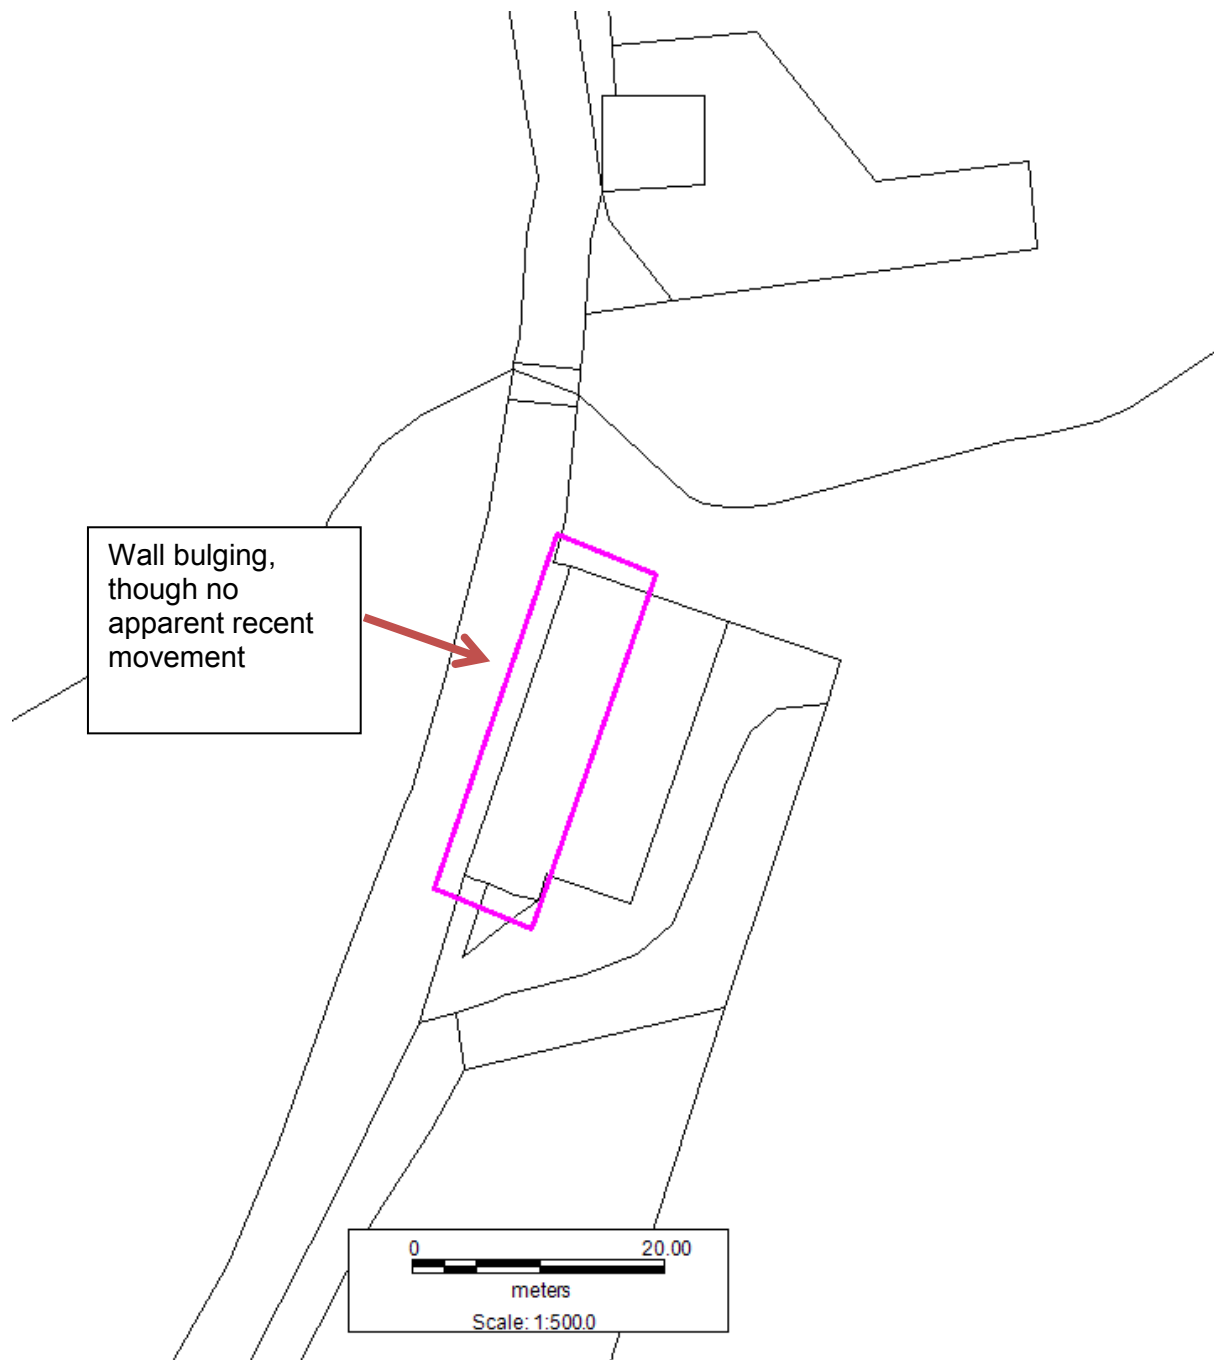
There is some water ingress through the roof and the stability of the walls should be assessed by a qualified professional.

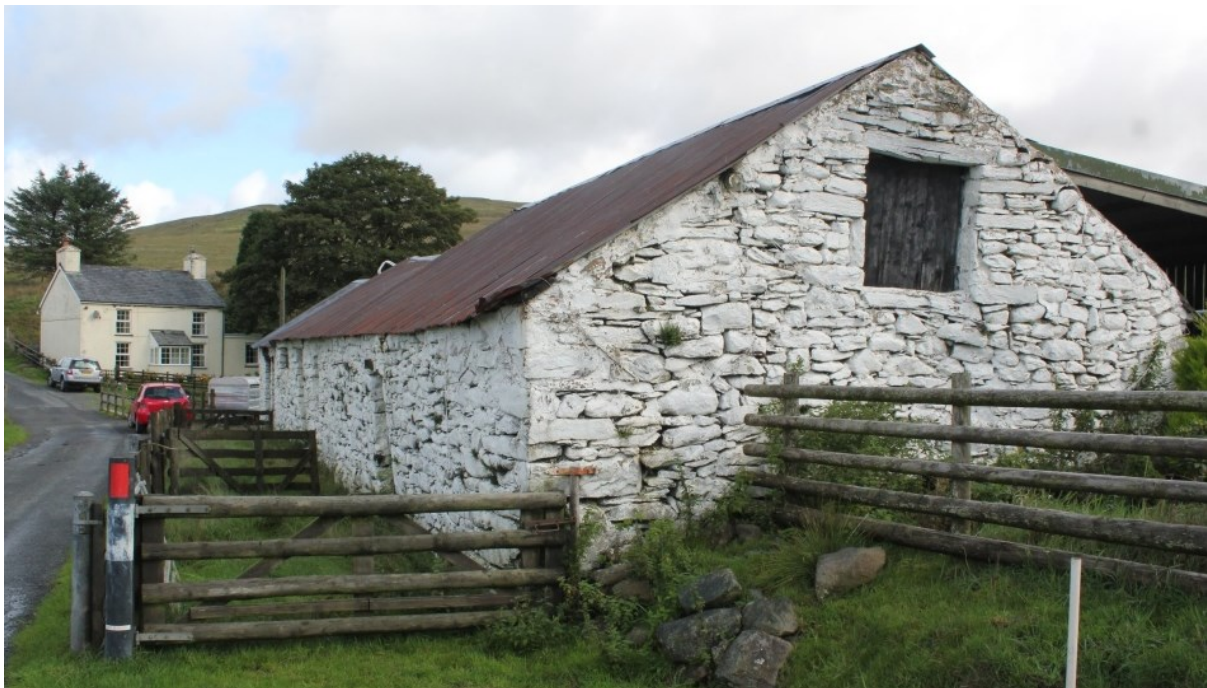
The building is in fair condition and the current owner endeavours to maintain it. It would benefit from some repairs or renewal to the tin roof which is leaking in some places. The wall bulges on the west side by the former gable end of the cottage, though the current owner believes this hasn't moved in decades.

Figure 5. The farm building from the south end.

The building will require some repair and maintenance to ensure that it does not deteriorate. Repairs will ensure that the building is retained in a weatherproof condition. Any works should endeavour to repair rather than replace, to retain the historic integrity of the building. The building is largely constructed with an earth building matrix and lime mortar has only been used in some areas as a pointing finish. This selective pointing should be respected in any repairs.

Seek advice from a conservation professional to assess the building and to advise on repairs and stability of the structure. Intervention should be minimal to maintain the historic fabric of the building.

Maintenance is a continuous process and once the building has been repaired it should be regularly inspected to identify any problems. Limewashing should be undertaken every few years to retain its appearance and to offer weatherproofing.

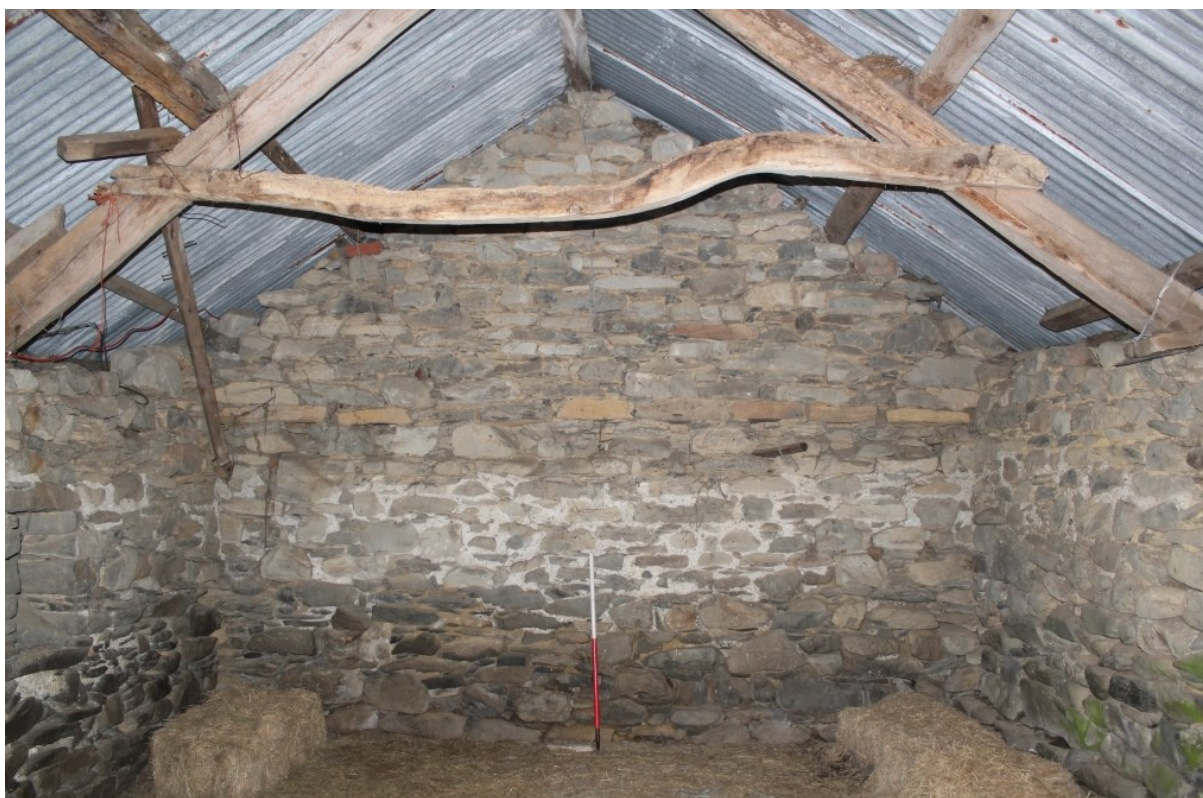
Figure 6. The interior of the farm building (north gable) showing selective areas of lime pointing.

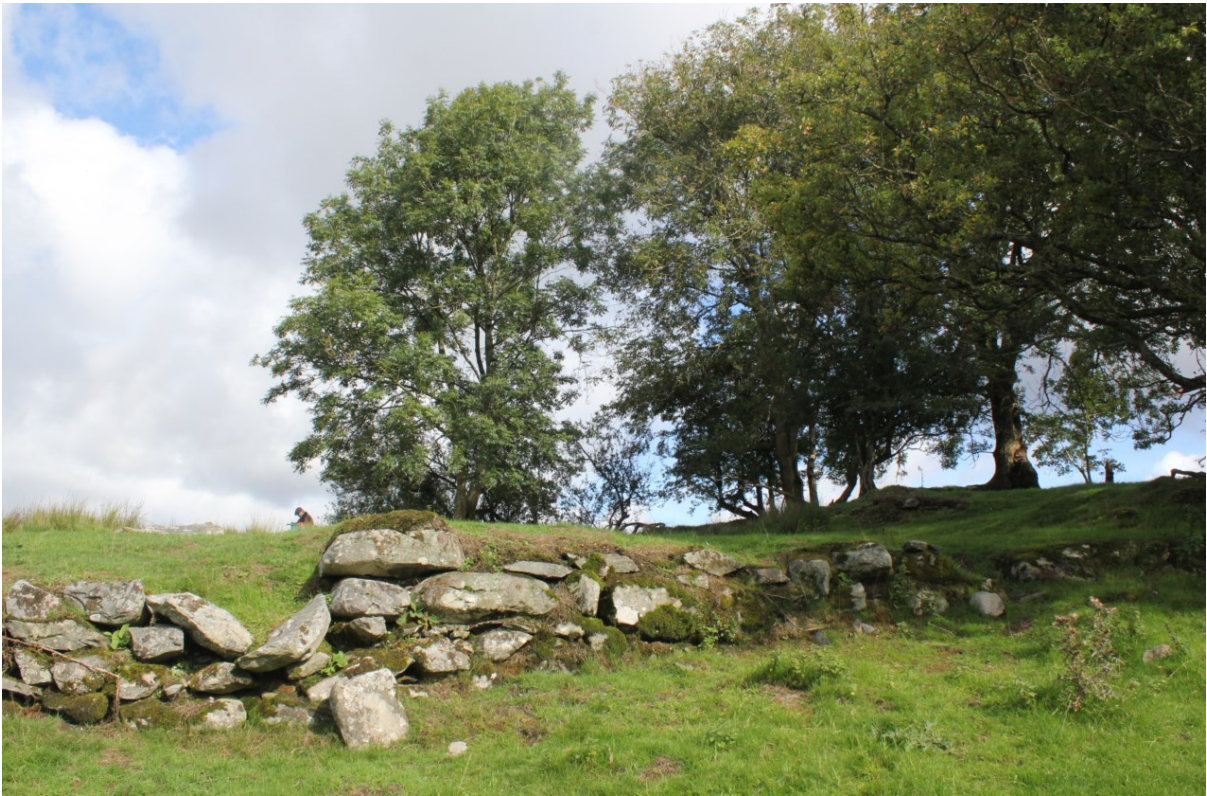
Figure 7. The site of the former farmstead of Siop Ceiro.

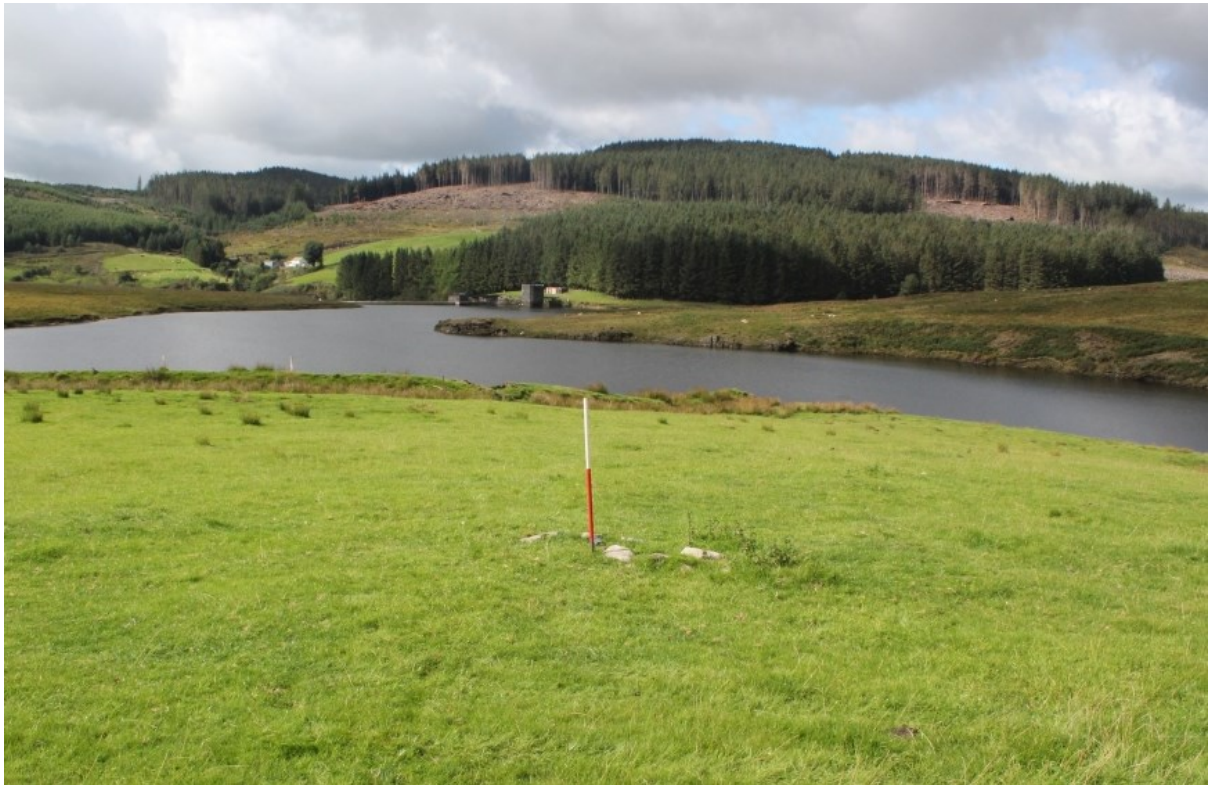
Current condition of the monument is good, it is located in permanent pasture and is in a stable condition.

Figure 8. A small pile of stone which probably represents a clearance cairn.

The monument should remain as it is currently; in a lightly grazed management regime, so that scrub does not encroach over it. It should remain undisturbed, with loose stone neither added nor taken away from the monument.

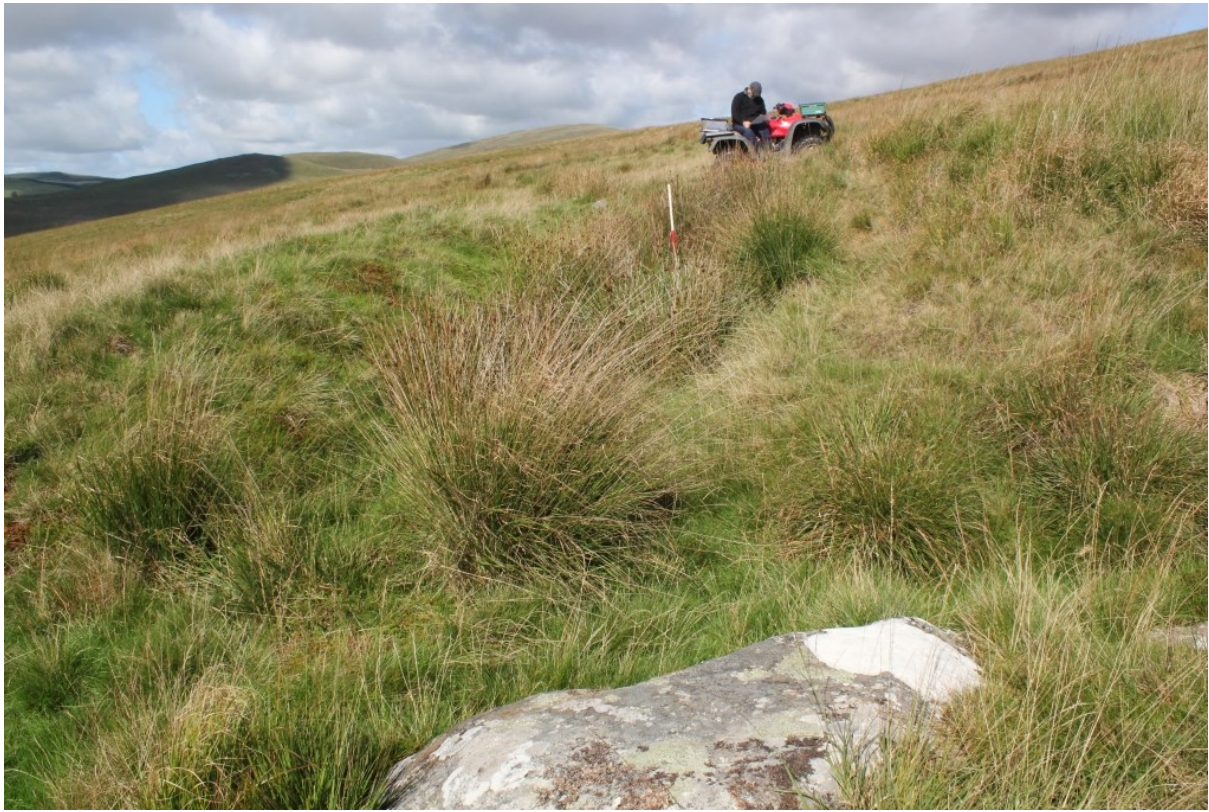
Current condition of the monument is good, it is located in permanent pasture and is in a stable condition.

Figure 9. Looking west along the possible mine working.

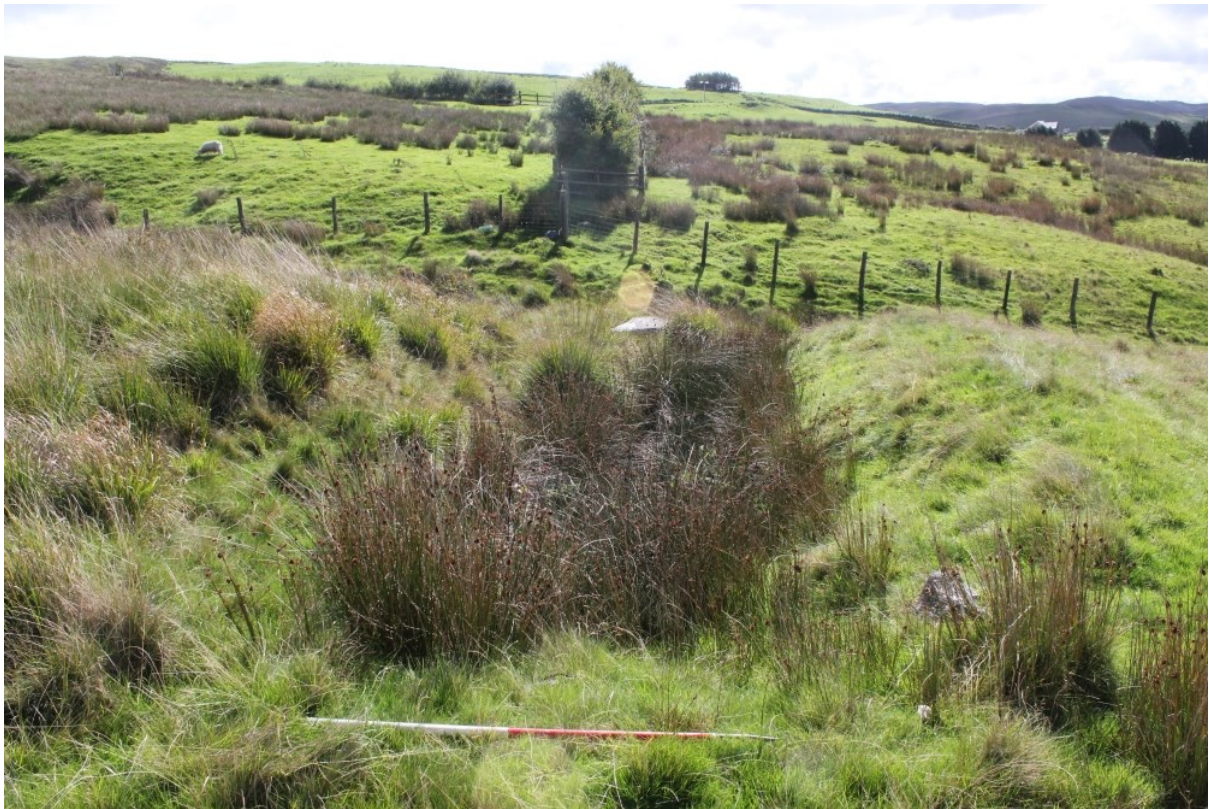
Figure 10. Looking southeast along the earthwork trench.

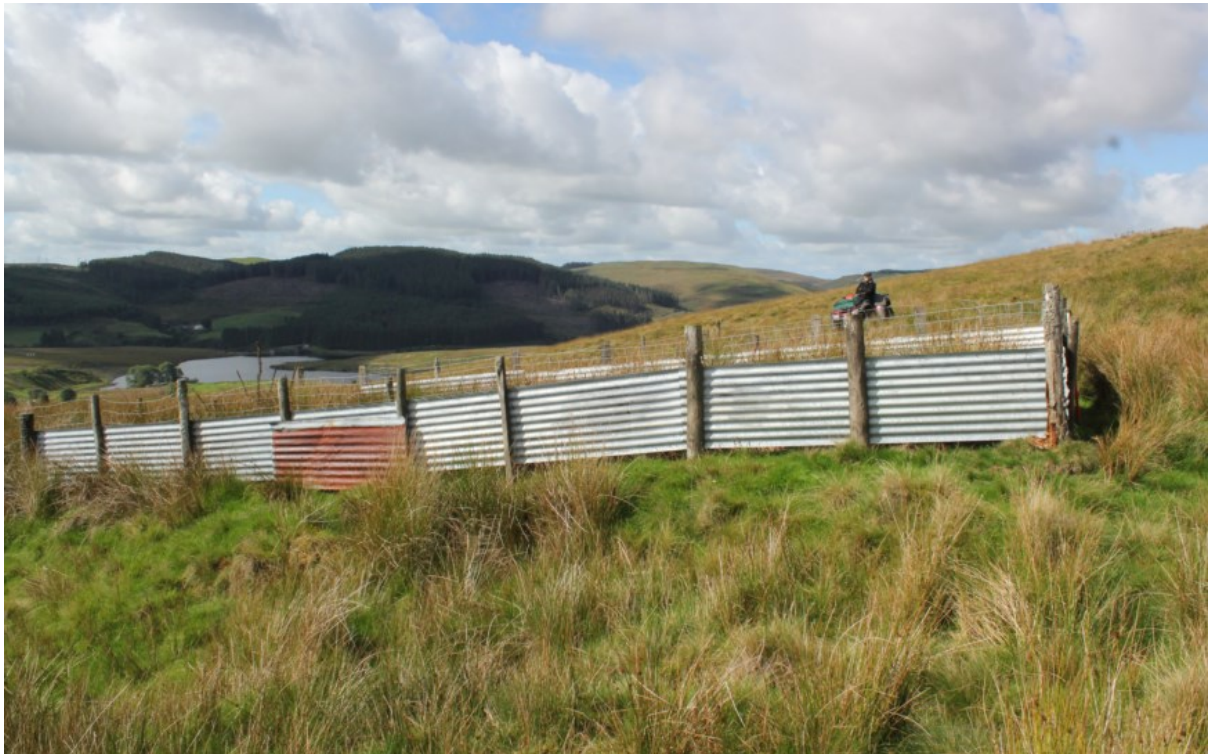
Current condition of the structure is good though no longer actively maintained.

Figure 11. A modern pen for holding sheep during the 'double fetch' sheepdog trials.

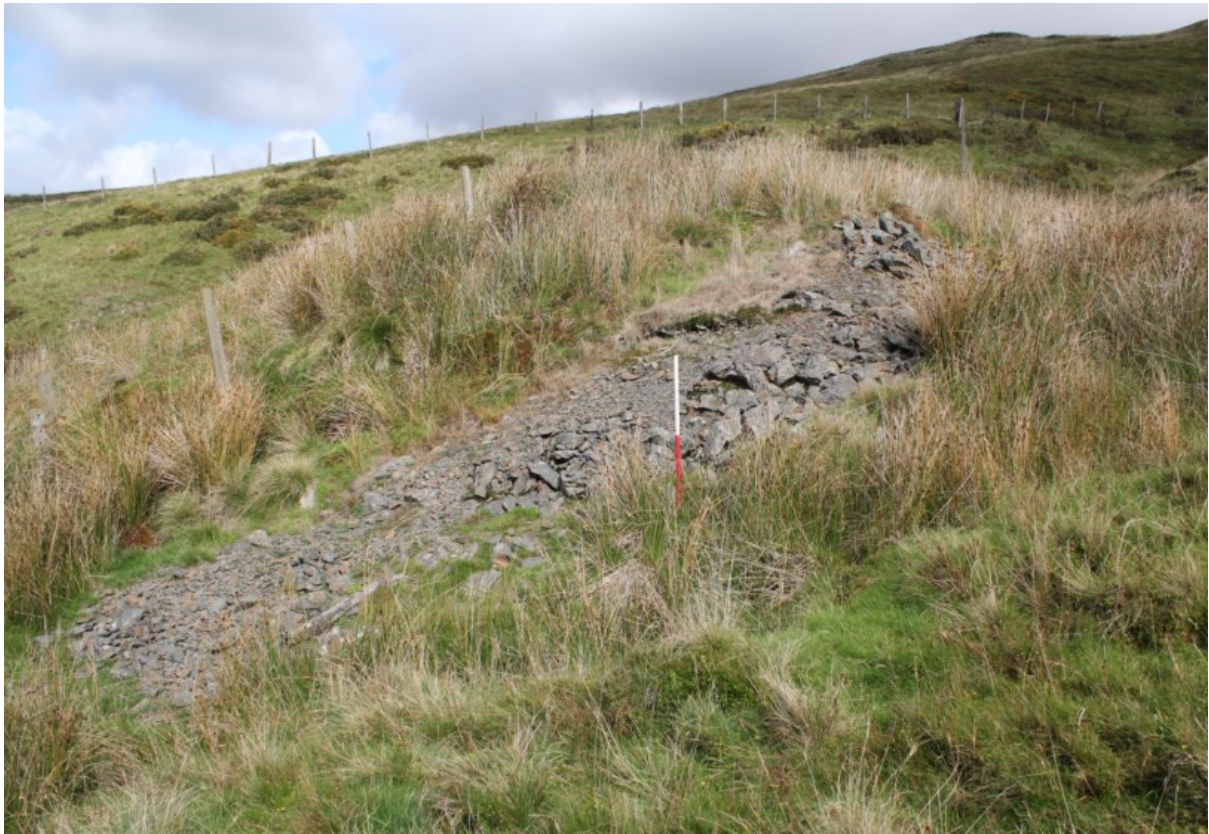
Current condition of the monument is good, it is located in permanent pasture and is in a stable condition.

Figure 12. A spoil heap of loose rock indicates the location of the trial lead workings.

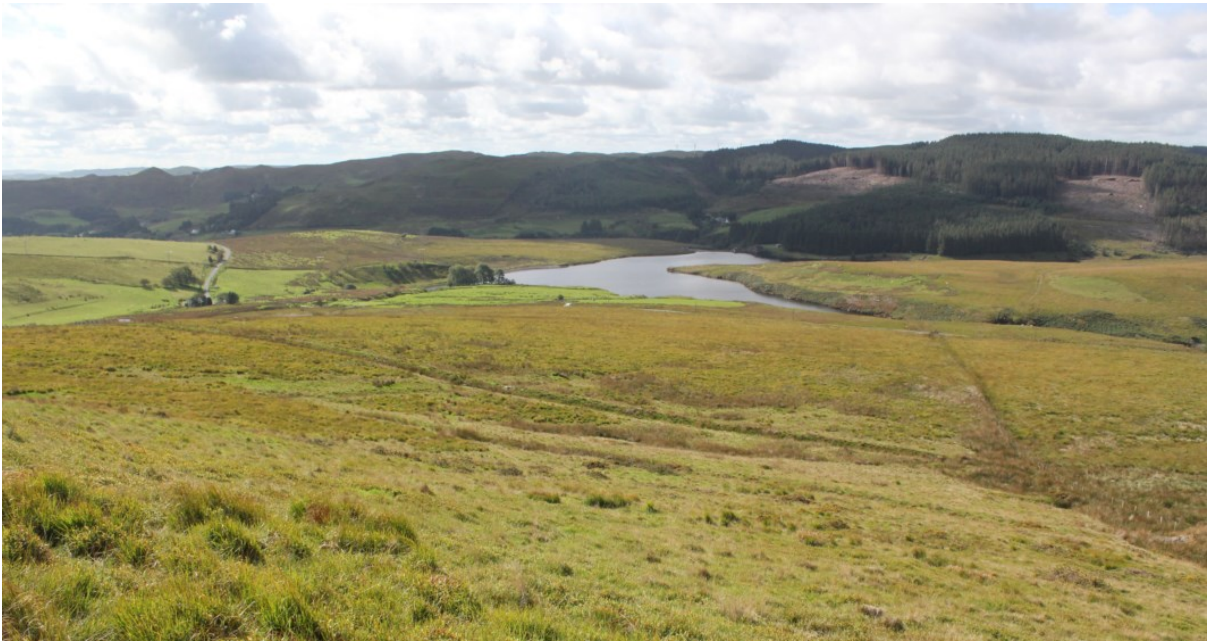
The current condition of the site is good, located in permanent pasture and is in a stable condition.

Figure 13. An earthwork enclosure PRN 112343 which sits in the corner of two long linear earthworks.

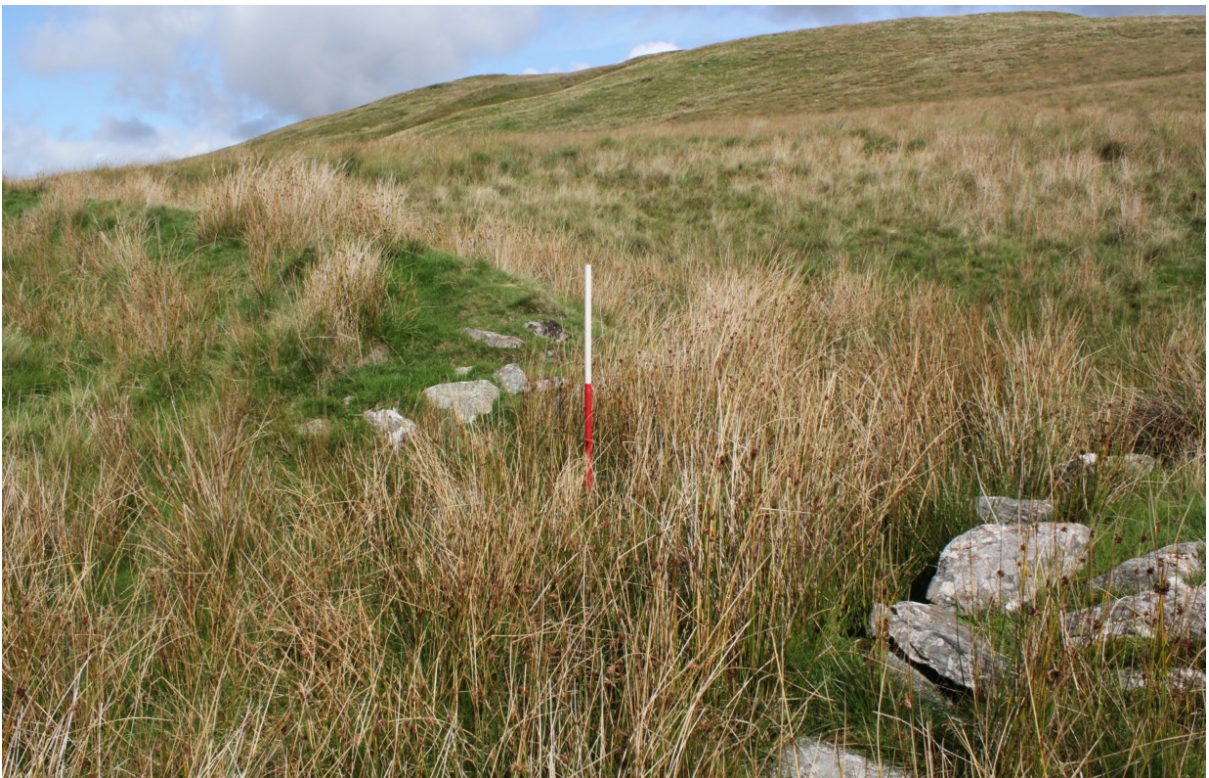
Figure 14. A gateway or entrance through the linear bank into the earthwork enclosure.

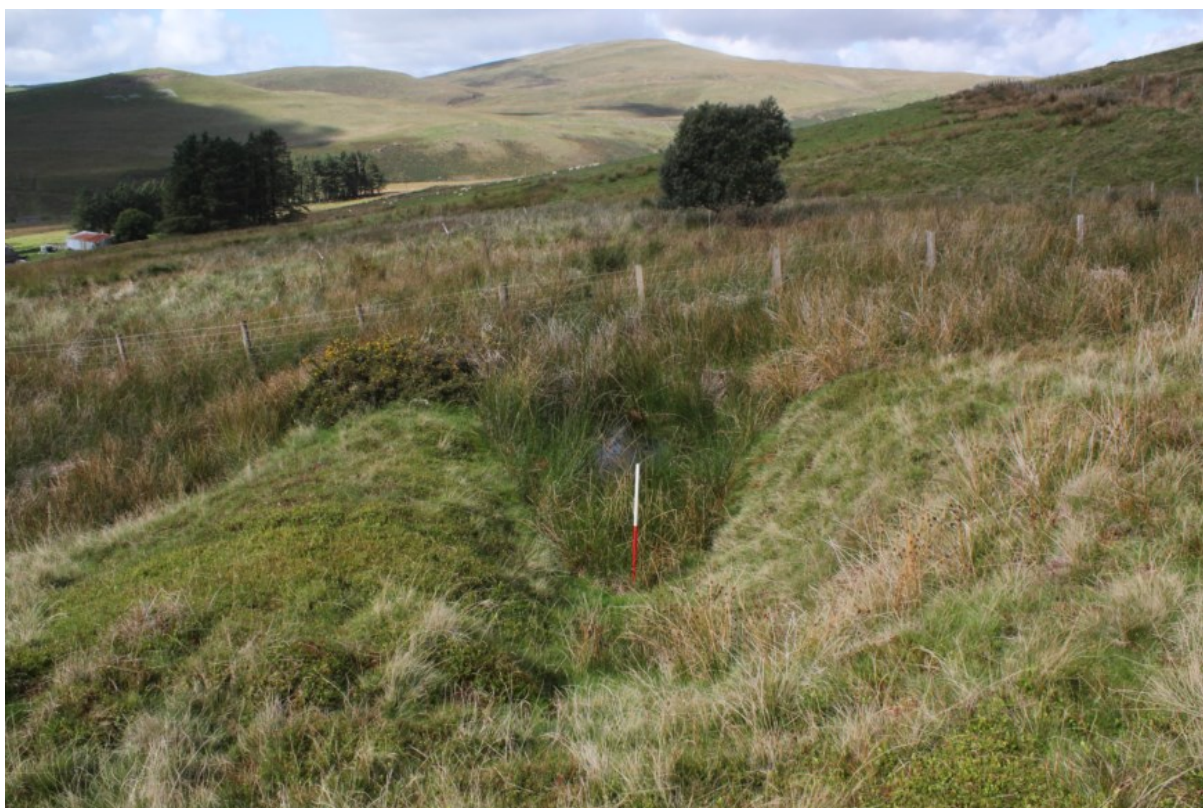
Figure 15. A possible trial lead working, looking northwest, PRN 112328.

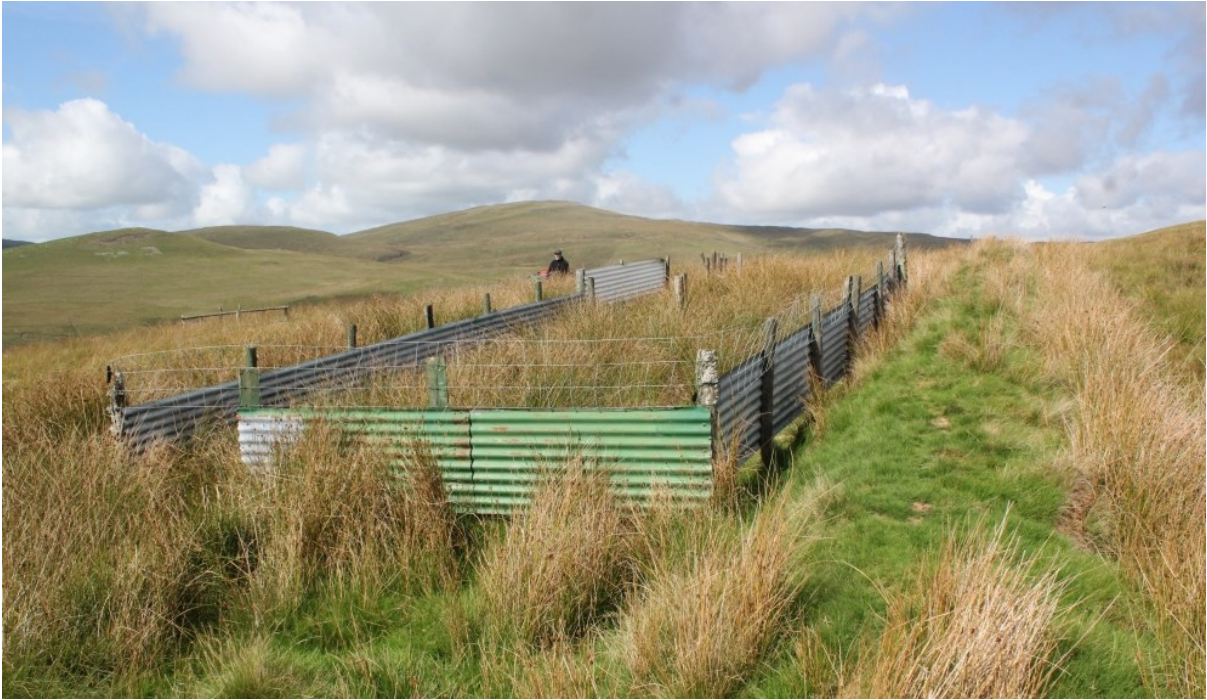
Current condition of the structure is good though no longer actively maintained.

Figure 16. A sheep pen used during sheepdog trials from 1995-2005.

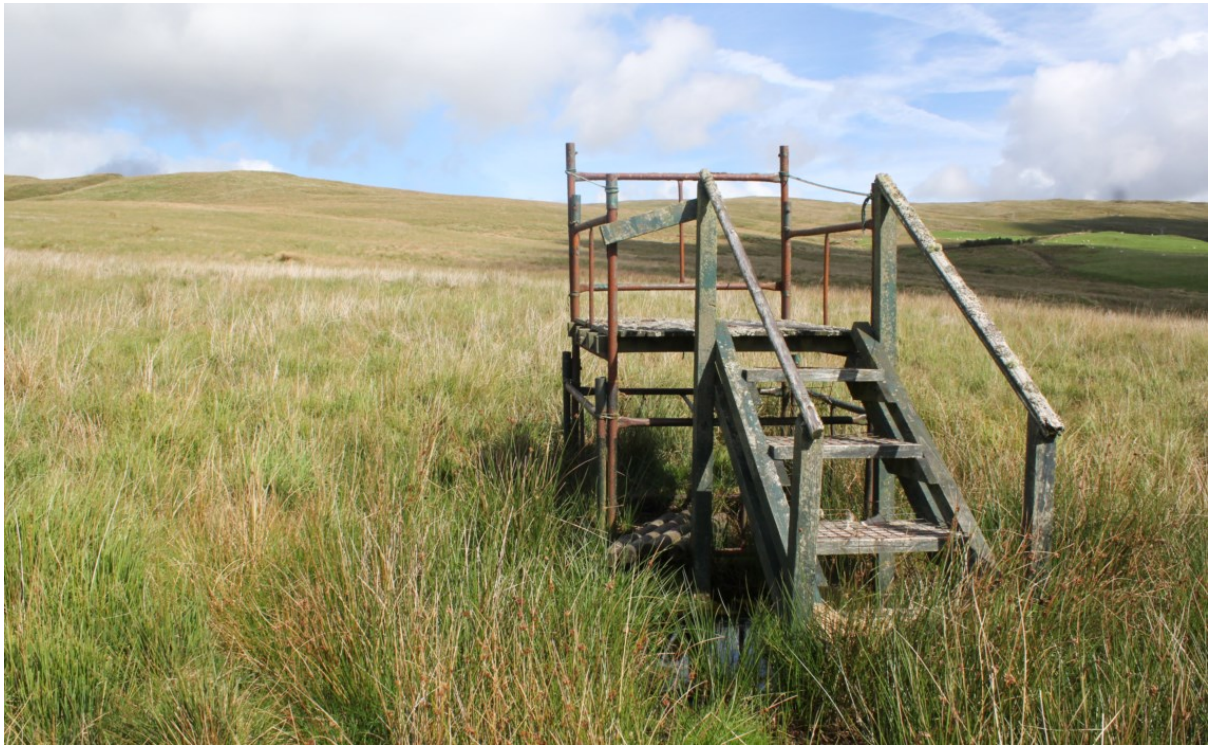
Figure 17. The 'sheepdog pulpit', built for a shepherd to observe and call to a sheepdog during competitive trials.
