ST CADOG'S CHURCH, LLANGADOG, CARMARTHENSHIRE: ARCHAEOLOGICAL WATCHING BRIEF 2018

RHIF YR ADRODDIAD / REPORT NO. 2018/53
RHIF Y DIGWYDDIAD/ EVENT RECORD NO. 114215

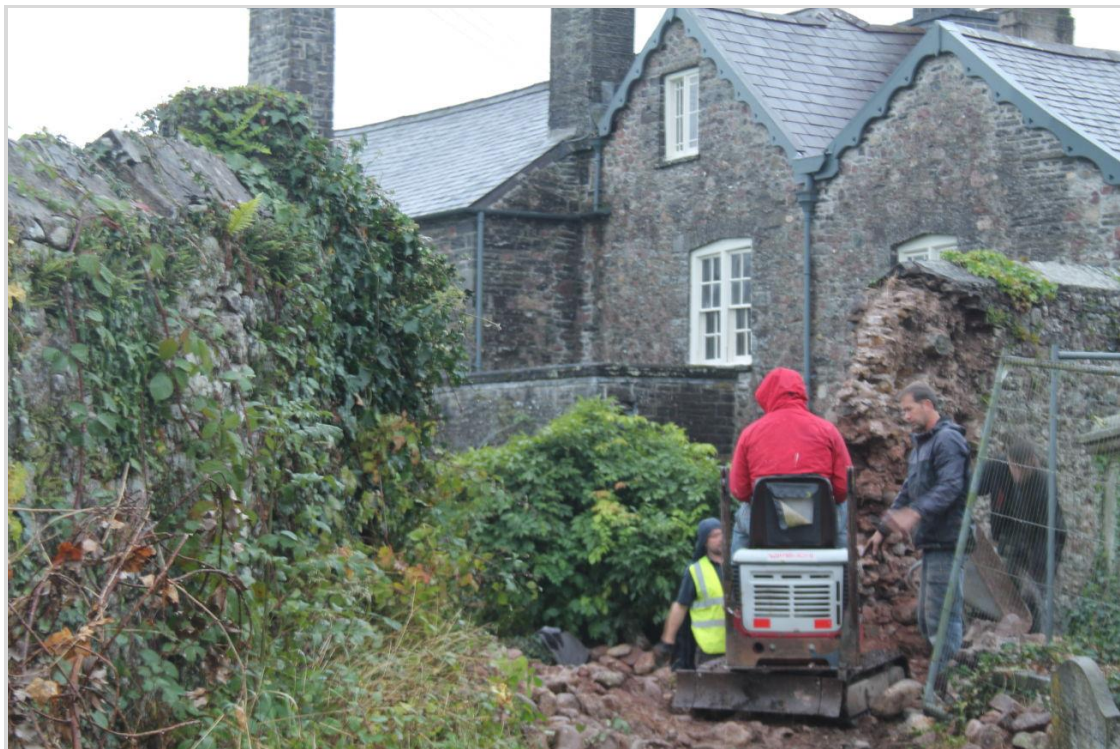
- 4.2 Wall dismantling was carried out partly by hand, but mostly through the use of a small mechanical excavator (Photos 1 & 2). Ivy was removed first in some places. The wall evidently had no foundations in the dismantled area, formed of roughly faced stone on the exterior and a rubble core (Photo 3). Many of the dismantled stones were retained for reuse in the wall reconstruction. The dismantled stretch of wall measured c.6m in length at the base and c.8m wide at the top.

Photo 1: Looking south from inside graveyard at wall being dismantled, with Church House (PRN 7116) beyond

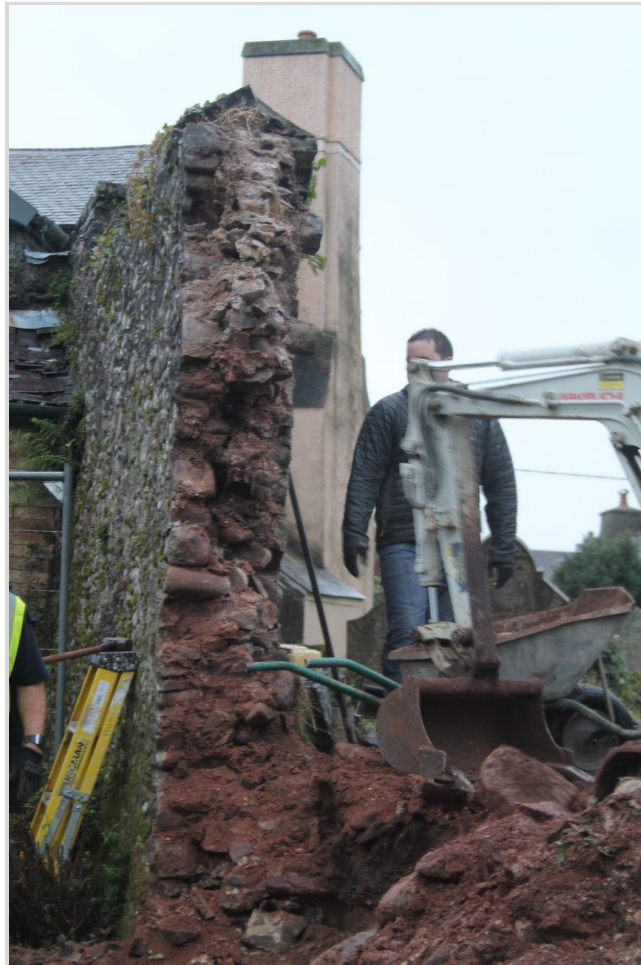
Photo 2: Looking southwest at southwest side of breached wall during dismantling

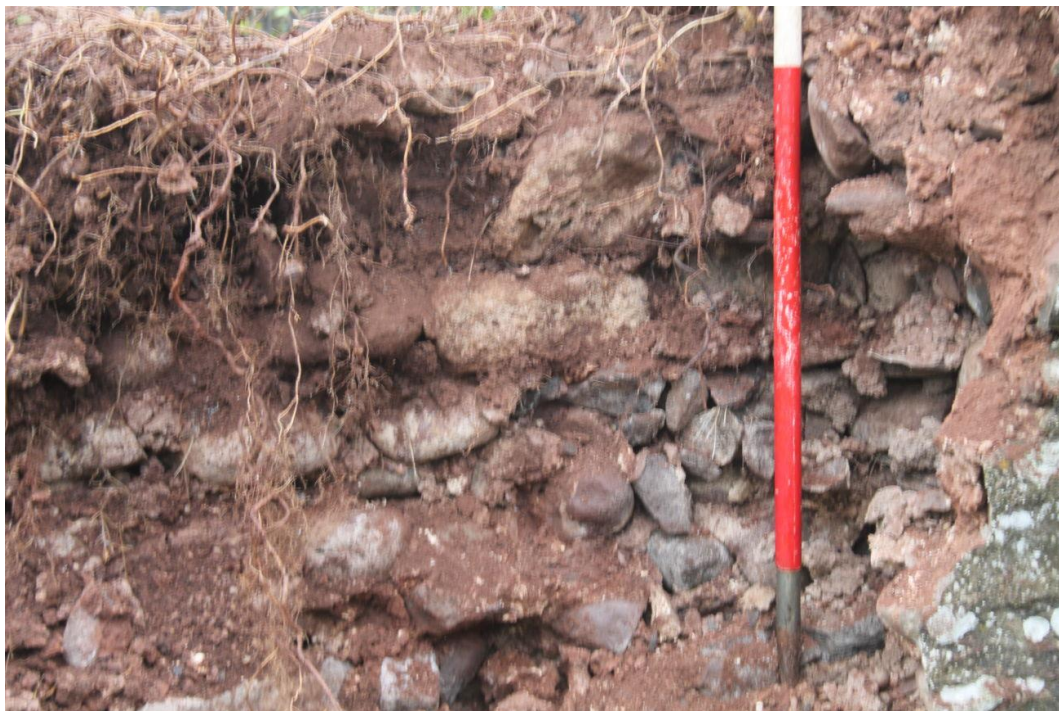
Photo 3: Looking northwest at core and churchyard side of wall structure before its removal, with a 1m scale (red bit is 0.5m)

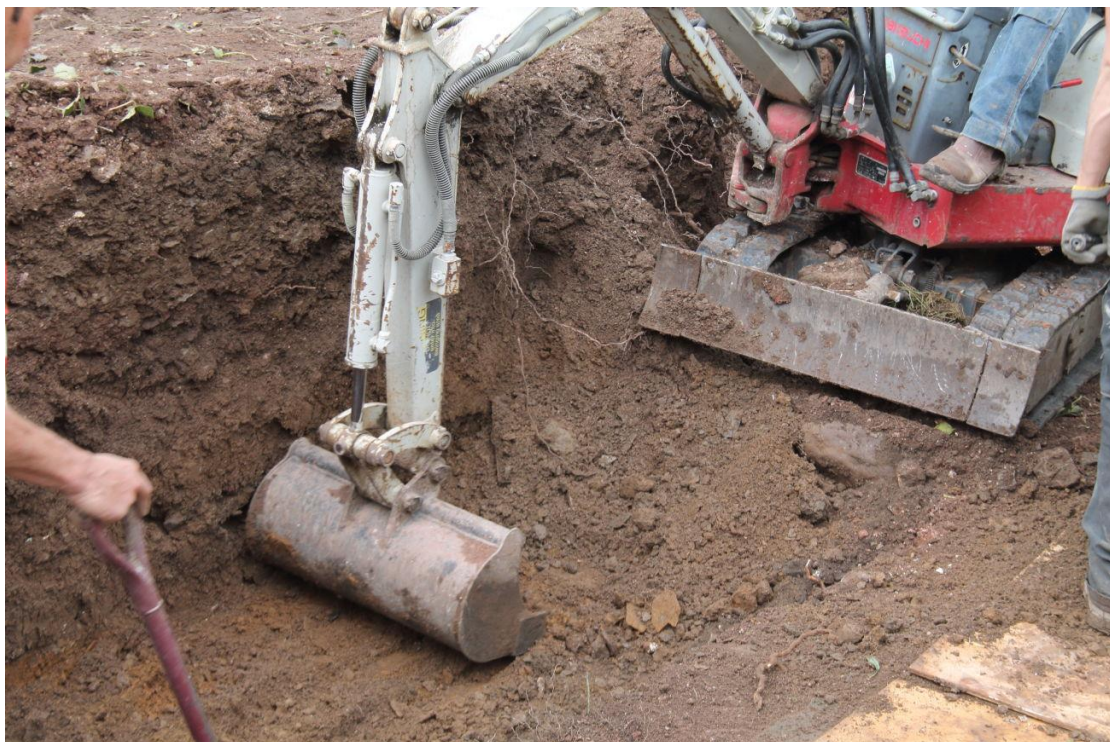
- 4.6 A natural brownish-orange deposit containing fifty percent shattered mudstone was found at 0.9m below the surface of the churchyard (Photo 4). Two human long bones were revealed in the section c.0.5m and 0.7m respectively below the surface and parallel to the trench edge. It is considered highly likely from their morphology and orientation that these are right arm bones of two separate *in situ* burials. Although partially exposed within the edge of the trench, these remained undisturbed by the remainder of the works.

Photo 4: Looking northeast at the excavated foundation trench for the wall rebuild under excavation, at its deepest, showing brownish orange natural

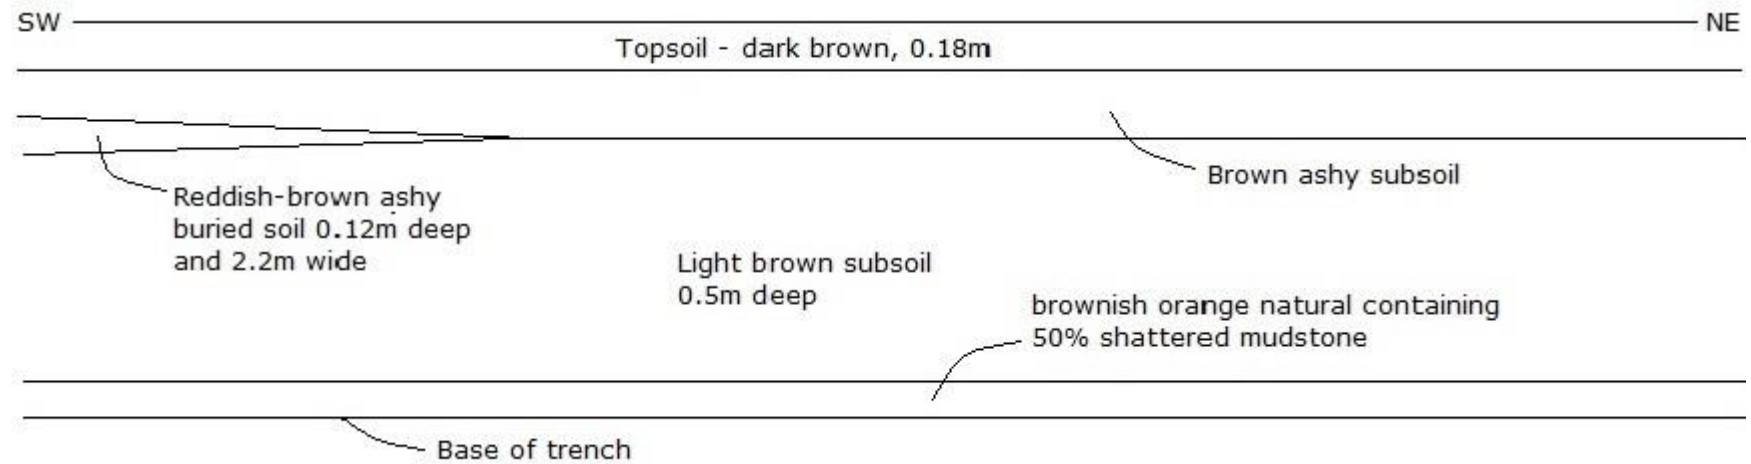
- 4.5 The foundation trench for the wall rebuild was excavated parallel to the church wall, but some 0.4m back from the churchyard face of the wall, enabling a wider and more substantial footing. The trench was excavated to a depth of 0.2m below ground level on the Church House side of the wall, which corresponded to excavation of a depth of 1m below ground level on the churchyard side. This created a section through the soils within the churchyard at this point (Figure 2; Photos 5-8). These layers comprised topsoil, subsoil and buried soils as described in Figure 2.

Figure 2: Sketch of the 6m wide section created through the ground of the churchyard on the north side of the excavation trench

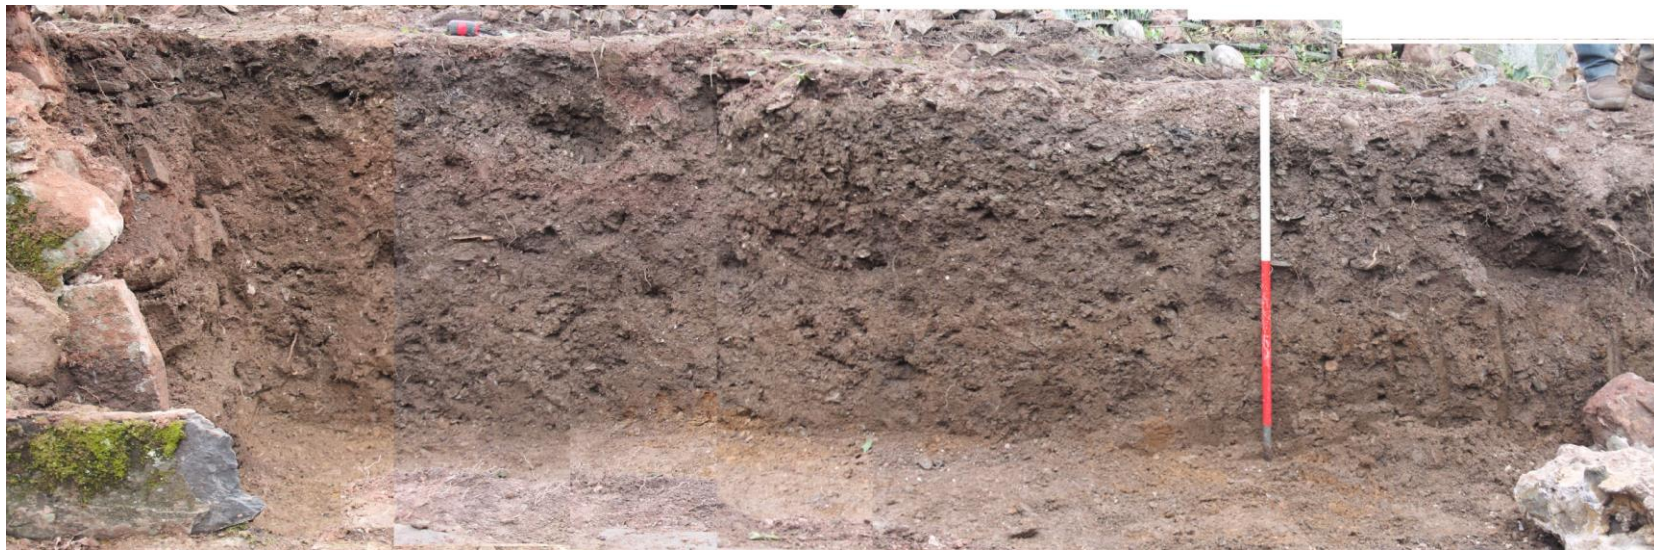
Photo 5: Looking north-northwest in a composite image of the long section behind the dismantled wall, with a 1m scale

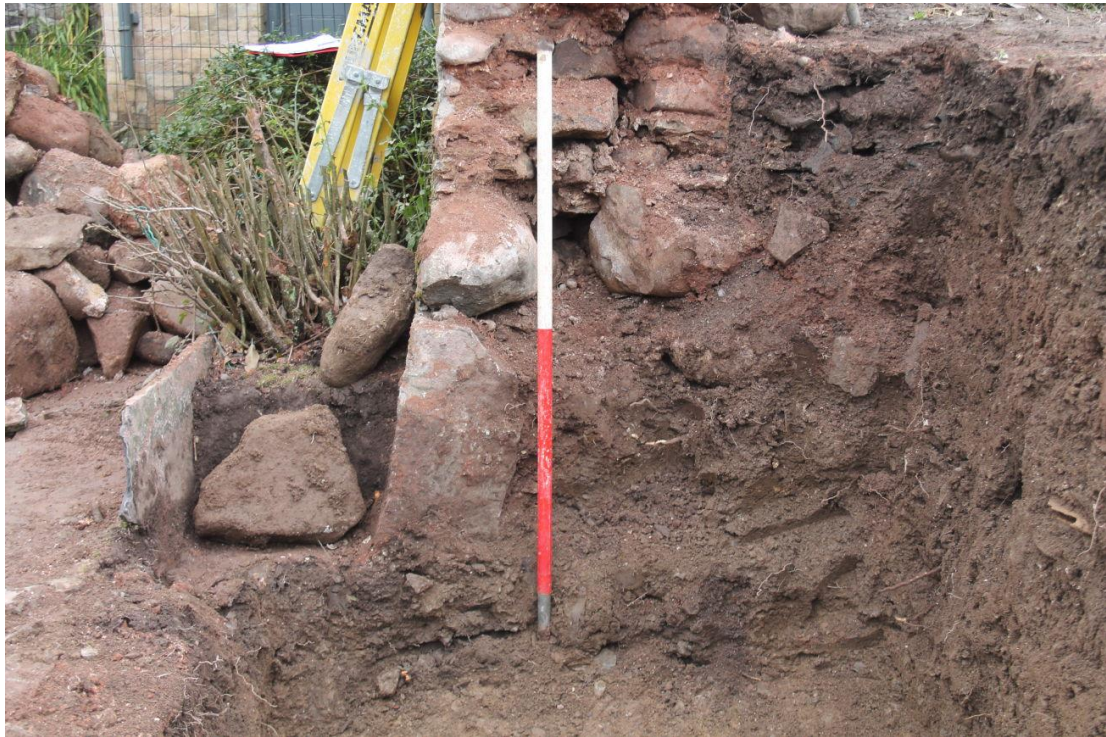
Photo 6: Looking southwest at section through wall and soils on southwest side of wall breach, with a 1m scale

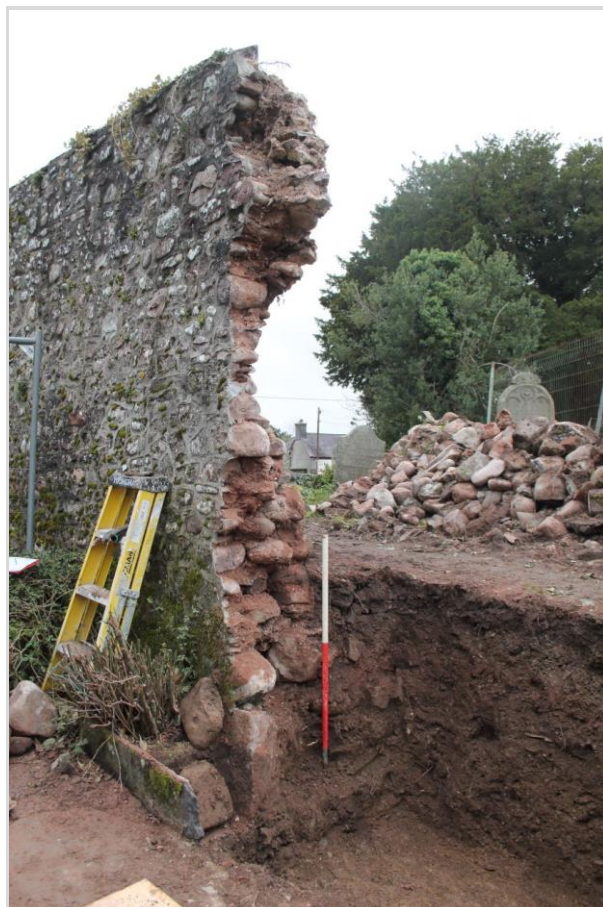
Photo 7: Looking west at section through wall and soils on southwest side of wall breach, with a 1m scale

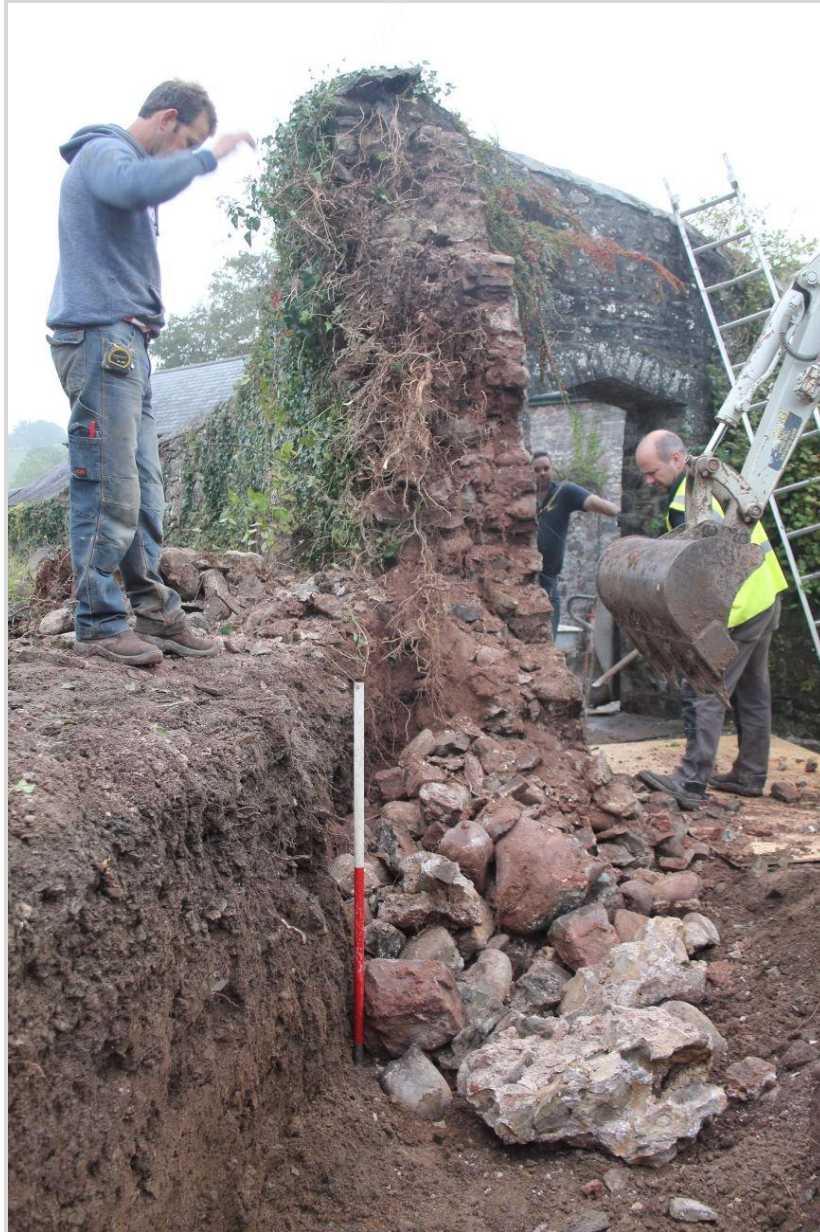
Photo 8: Looking north-northeast at northeast end of wall breach

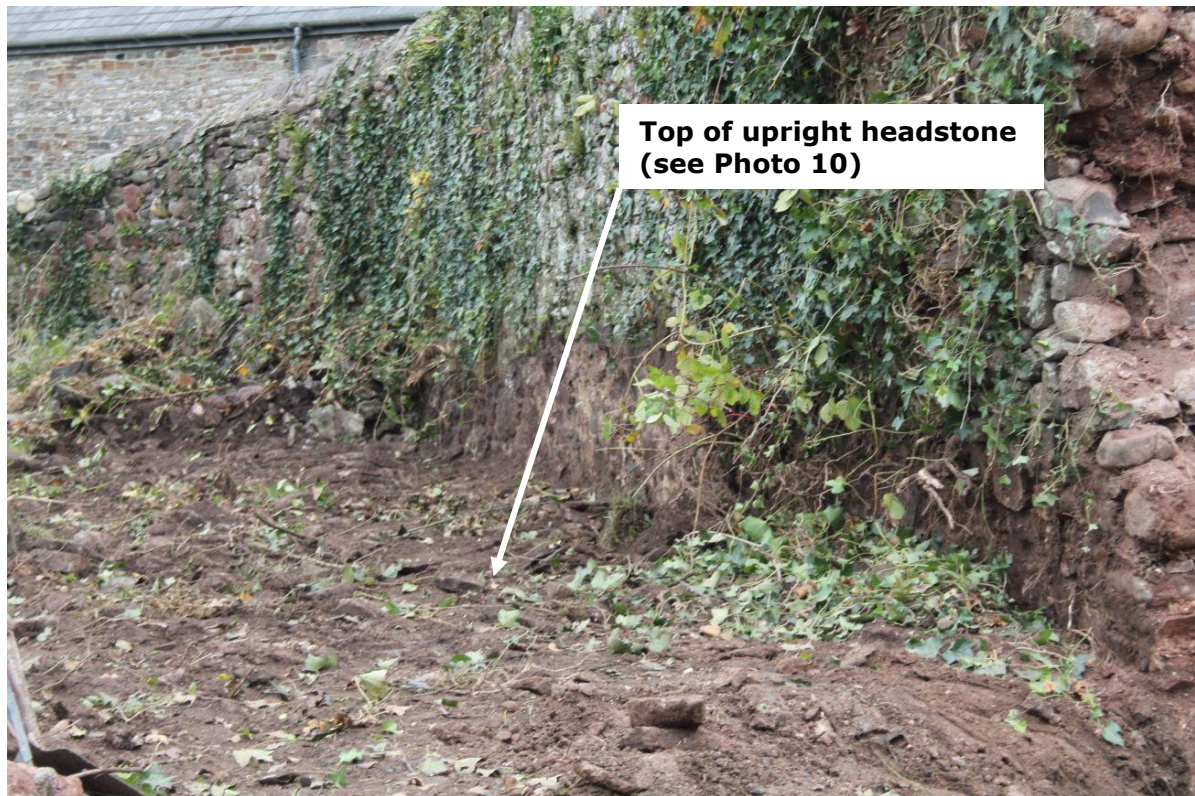
- 4.7 No archaeological finds were recovered during clearance of the approximately three square metres of soil and rubble along the churchyard side of the wall just north of the wall repair area, inside the churchyard. The top of an upright buried headstone was revealed during this clearance (Photos 9 and 10), which was orientated north-south as would be expected for an *in situ* burial. This headstone was not removed.

Photo 9: Looking north-northeast at area northeast of the wall repairs, after removal of rubble and soil, with top of upright headstone visible

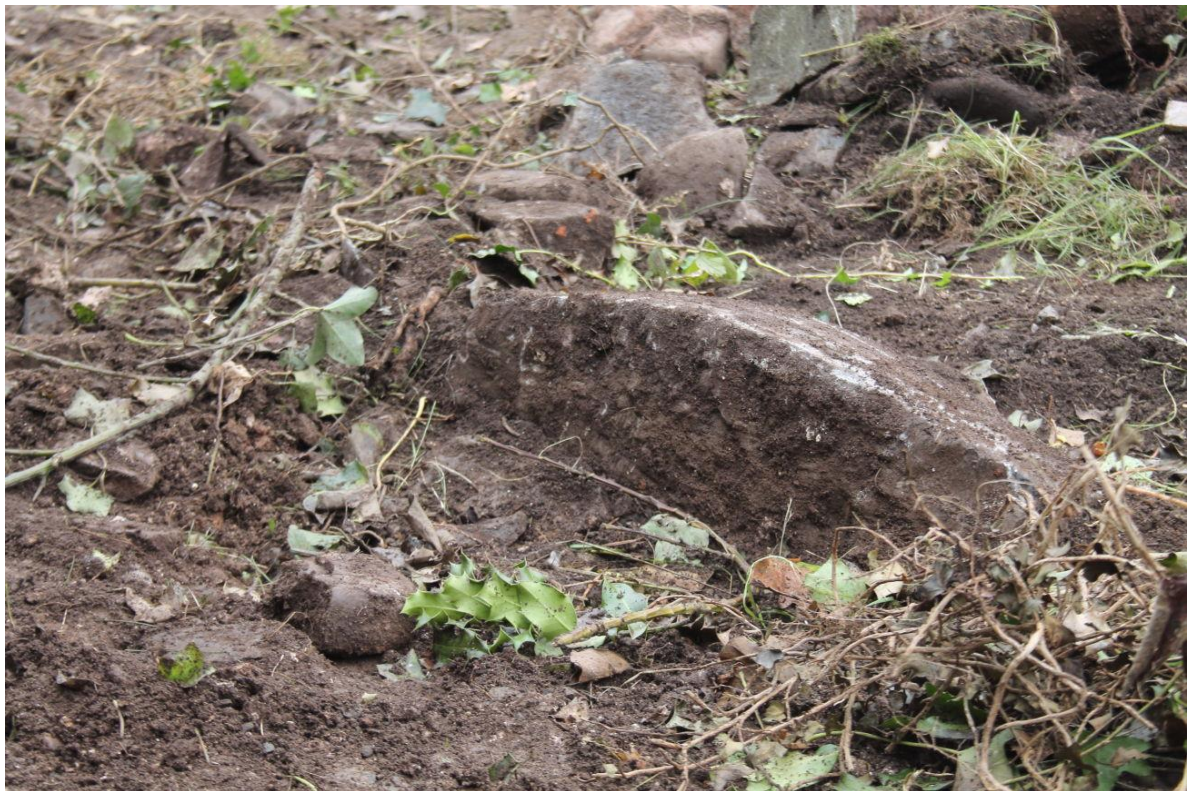
Photo 10: Looking southwest at close-up of top of upright headstone north of the area of wall repairs
