CAPEL ERBACH: BUILDING RECORDING SURVEY 2019

RHIF YR ADRODDIAD / REPORT NO. 2019-09
RHIF Y DIGWYDDIAD / EVENT RECORD NO. 117056

CADW PROJECT NO. DAT 150

Chewfwr 2019
February 2019

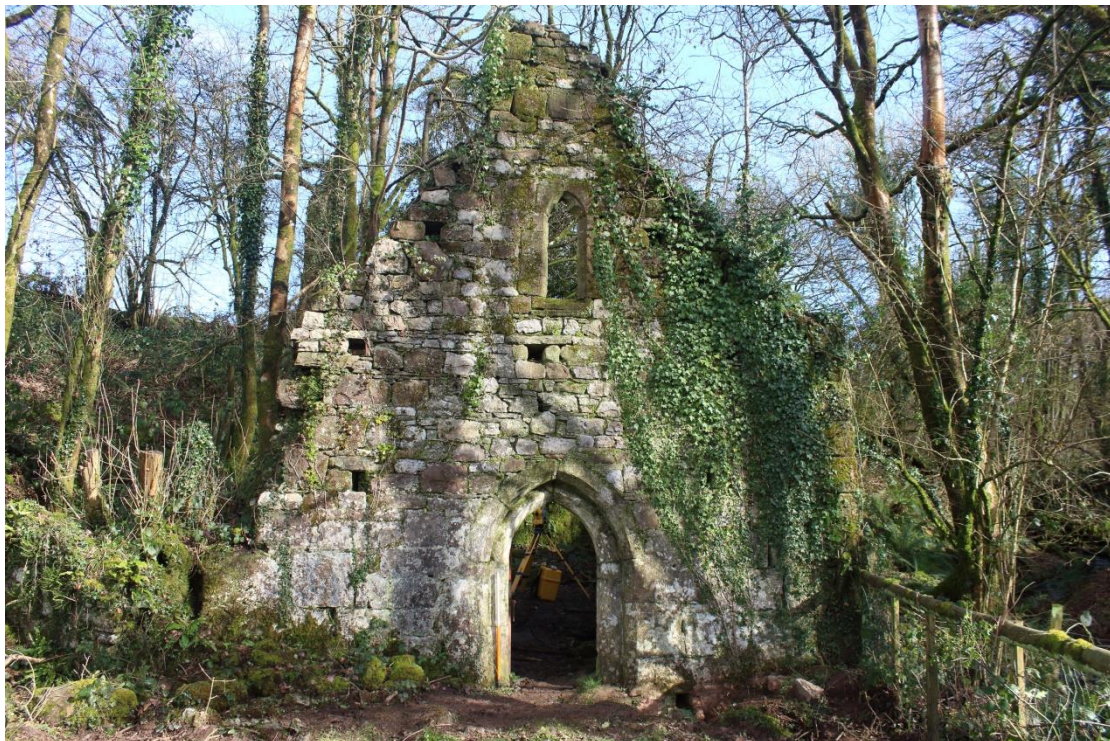
- 3.1.2 The western wall is 6.85m high and houses the bellcote, arched entrance doorway and the trifoliated lancet window. A small water spout emanates from the chapel to the right of the arched doorway (on the outside). To the left of the doorway (on the inside) the internal masonry suggests that there may have been a staircase which led to the bellcote.
- 3.1.6 Internally, above the door way, a large crack is beginning to form in the stonework and the arch is currently being held in place by acrow props (Seen in Photo 4).

Photo 2: Western wall (exterior view) housing the bellcote, arched entrance doorway, trifoliated lancet window and water spout.

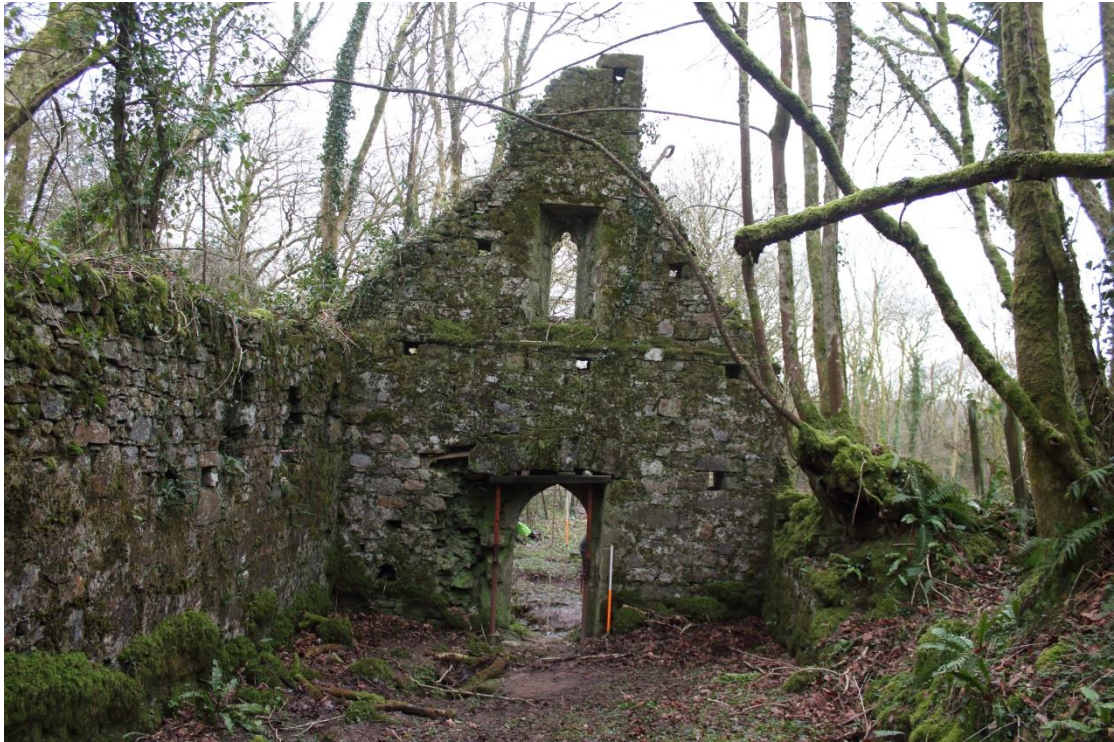
Photo 3: Western wall (interior view) housing the bellcote, arched entrance doorway, trifoliated lancet window.

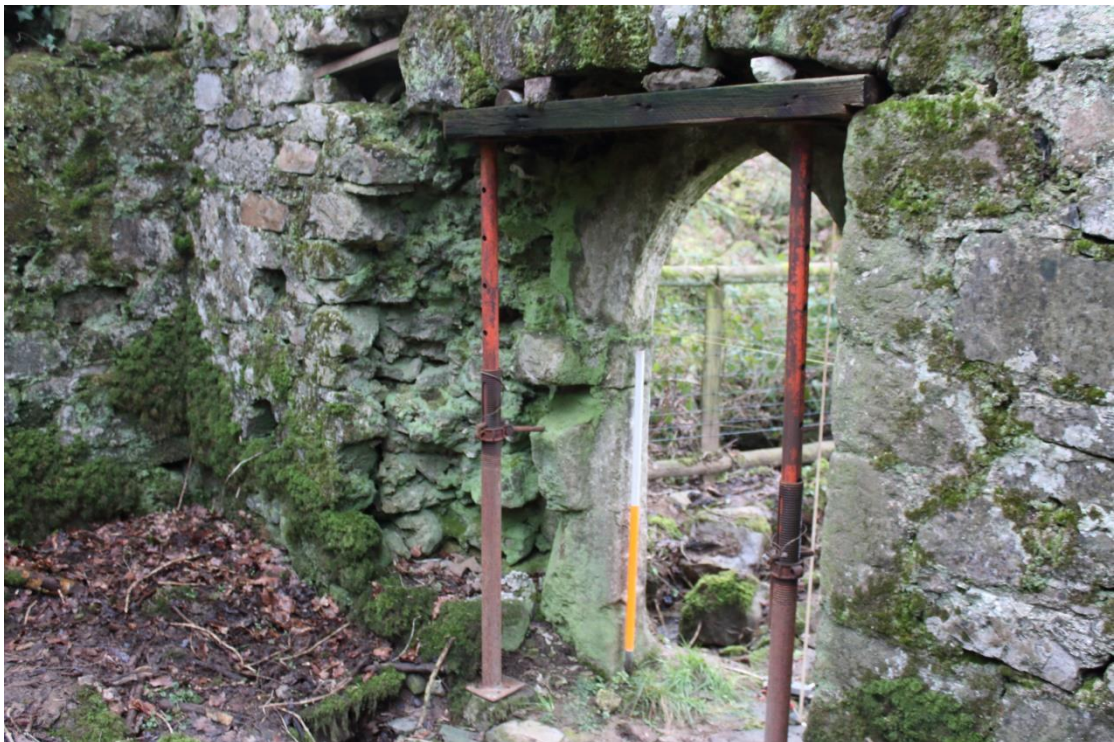
Photo 4: The arched doorway in the western wall, currently being held up by acrow props. To the left of the door the masonry suggests a possible staircase once led to the bellcote.

- 4.3 Generally the stability of Capel Erbach is under threat, ash trees grow in very close proximity – potentially putting stress on the walls which are already largely covered in vegetation and moss, and the arched doorway is beginning to collapse and currently held in place by acrow props. The chapel is certainly in need of some remedial work to at least stabilise its current condition before further damage occurs.

- 4.5 The current owner has made attempts to preserve the current condition of the chapel and expressed an interest in carrying out further remedial work for longer term solutions i.e. repairing the arched doorway and removing the nearby ash trees.

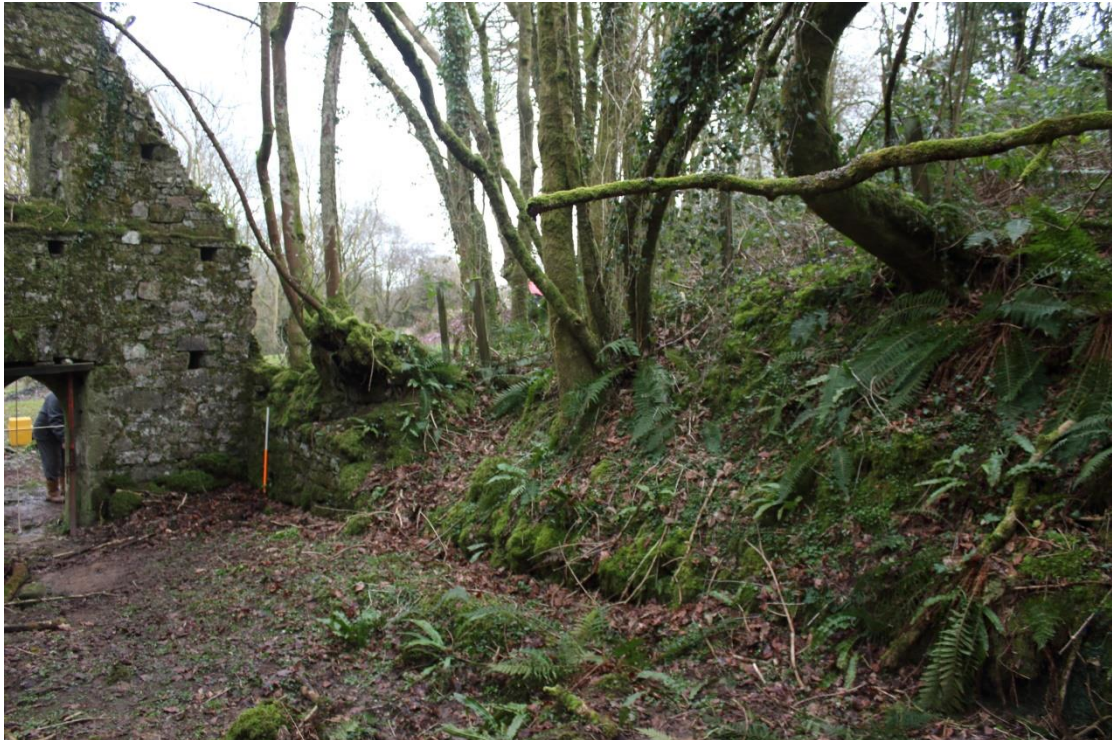
- 3.1.3 The northern wall only survives to a height of 1.50m at the base of a steep slope; it is mostly overgrown with vegetation and ash trees.

Photo 5: Northern wall (interior view).

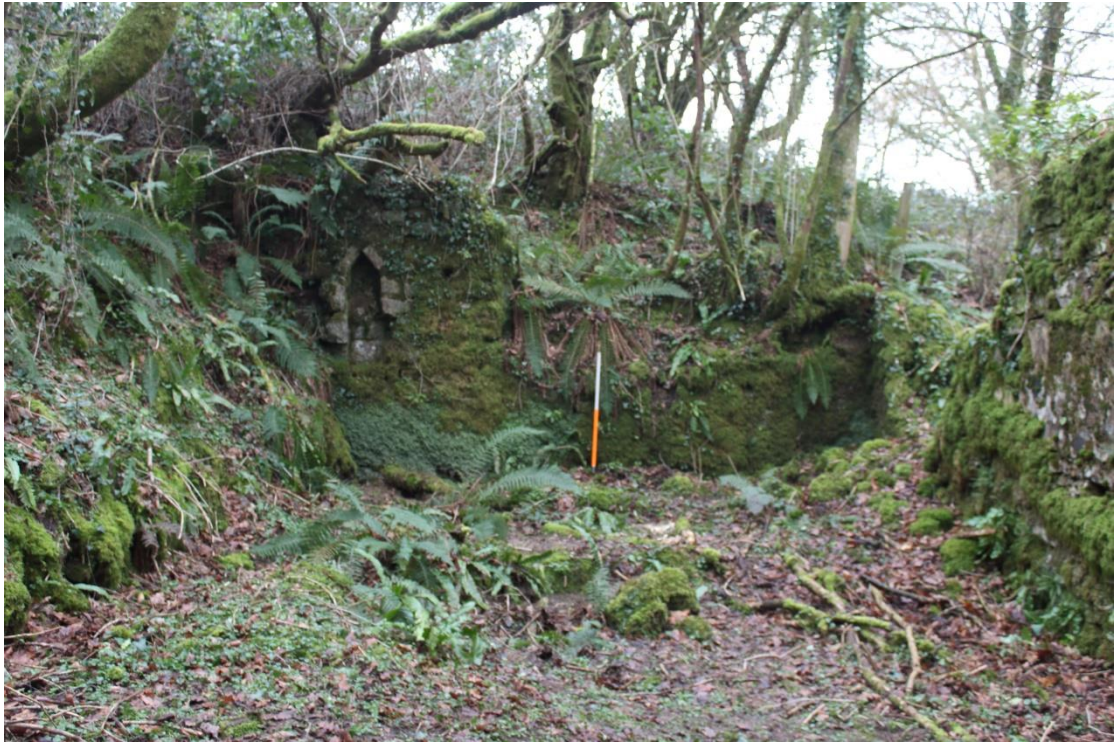
The eastern wall stands 2.70m high and in the northern corner there is a lancet stone niche (1.02m x 0.42m x 0.23m), presumably for housing an effigy. At the midsection of the wall there is a splay 0.38m deep, suggesting there was another larger niche or window present. At the south end of the wall there is subtle evidence of another possible niche similar to that seen towards the north. If so, this would suggest a symmetrical appearance to the east wall with two similarly sized niches either side of a larger one.

Photo 6: Interior view of the eastern wall with the small niche to the north of the wall.

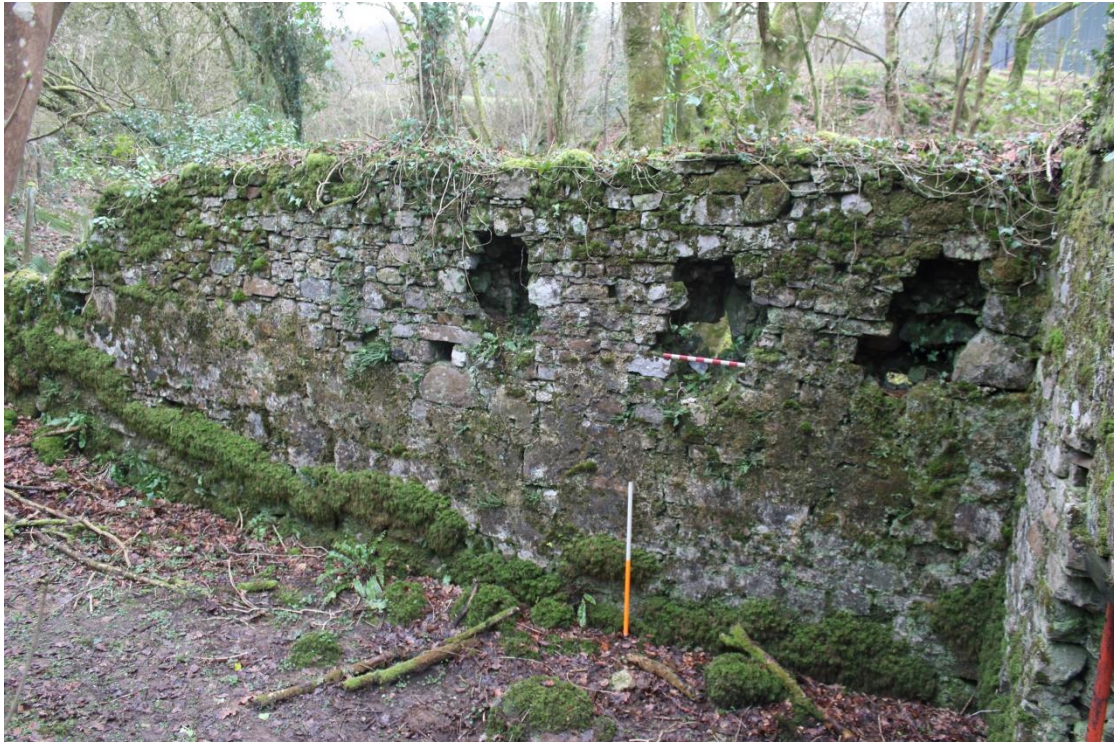
- 3.1.4 The south wall stands at 3.0m height across most of its length, although some collapse has occurred at its eastern edge. Rendering appears to survive across much of the wall to approximately half way up. Towards the western edge of the wall are three recesses. Each recess is at the same height and of similar level. Only the middle recess has an aperture but this appears to be more likely that a stone has fallen out of place rather than a window. There was no surviving evidence of the annex seen in the historic maps adjoining this wall, but where the wall has collapsed at its western end it is possible it was once an opening that is no longer discernible.

Photo 7: Interior view of the southern wall
