**SOUTH QUAY, PEMBROKE
NOS. 4, 5 & 6 CASTLE TERRACE,
NOS. 7 & 8 NORTHGATE STREET:
LEVEL 3
HISTORIC BUILDING RECORDING**

Prepared by Dyfed Archaeological Trust
For: Pembrokeshire County Council

REPORT NO: 2019/45

December 2019

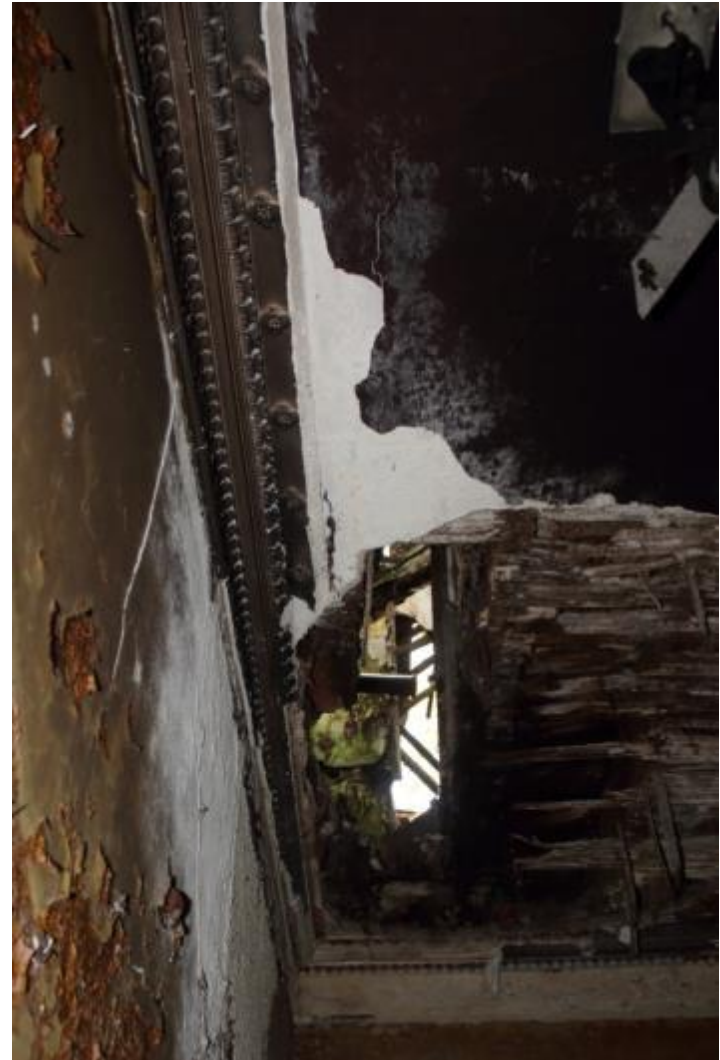
Photo 10: View of cornice detail above central passage from original front door showing partially collapsed roof

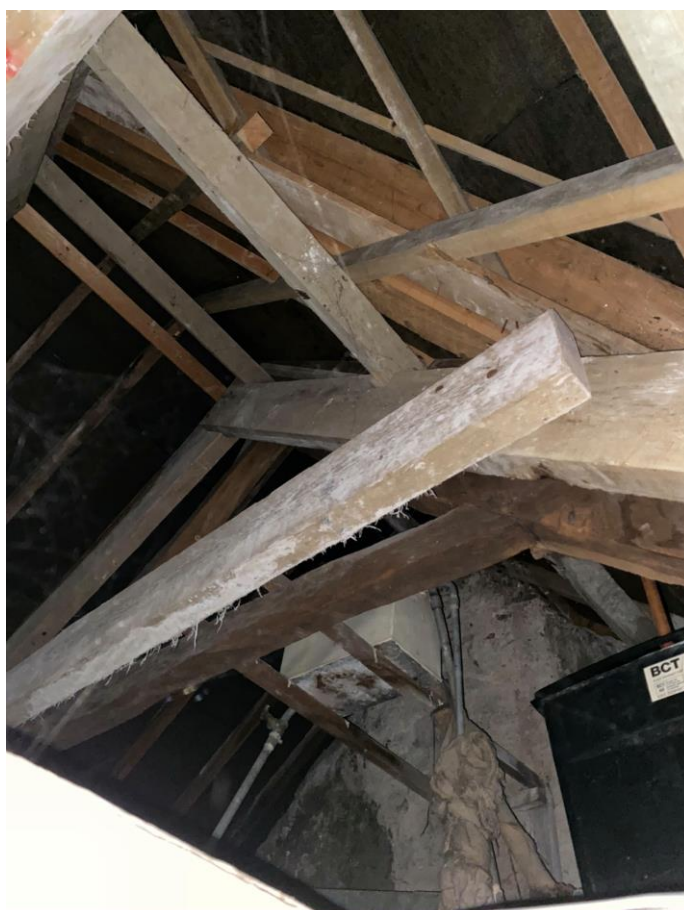
- 4.5.6 All other openings at first-floor level appear to be twentieth-century in their present form, along with the internal partition walls (Photo 51). There is an attic, through the door of which the A-frame roof-trusses were just visible; these are in somewhat poor condition and have been supplemented with secondary timbers over the course of the twentieth century.
- 4.5.7 There is an attic, through the door of which the A-frame roof-trusses were just visible; these are in somewhat poor condition and have been supplemented with secondary timbers over the course of the twentieth century (Photo 52).

Photo 52: View of roof timbers in No. 6 Castle Terrace through loft hatch to southwestern side, showing modern replacement trusses with earlier ones behind

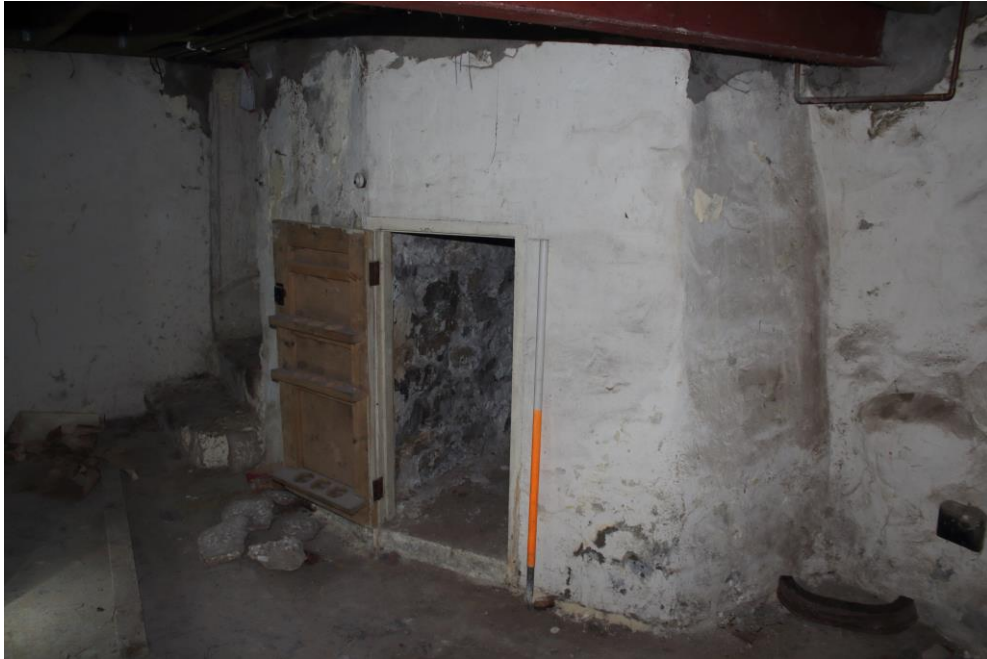
presence of bedrock at the bottom of its internal walls suggests the recess may have been adapted from a natural fissure (Photo 56). In more recent times concrete underpinning has also been inserted along its edges (Photo 54).

Photo 54: View southeast across projecting outshut at basement level below No. 6 Castle Terrace and opening to recess in centre, with stairs to east (left)

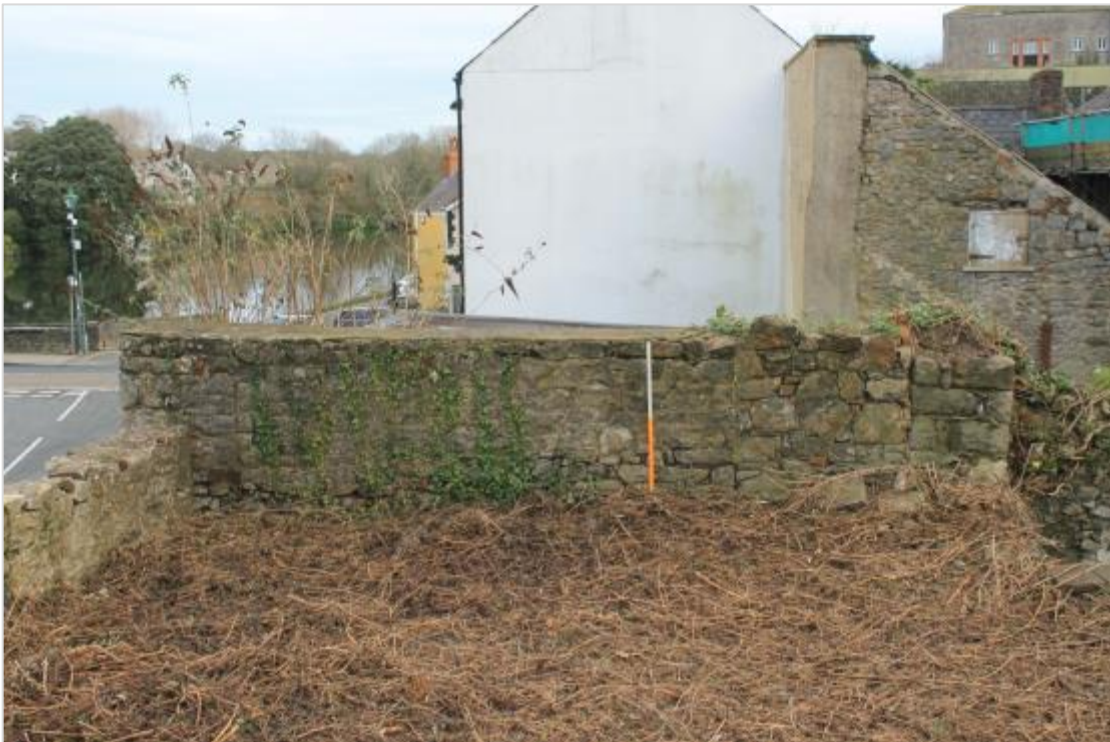
Photo 87: View east towards wall situated above covered passageway in
burgage plot at No. 4 Castle Terrace (note blocked opening to right of 1m scale)

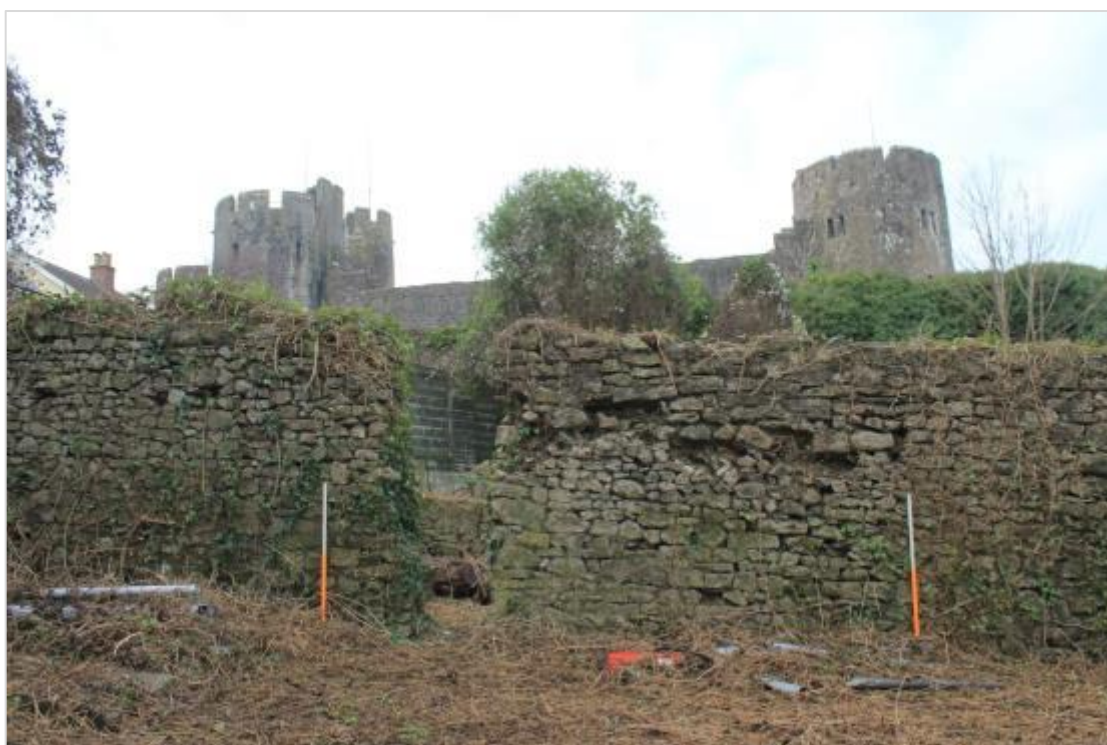
Photo 97: View west towards breach in wall (PRN 115030) dividing burgage plots at Nos. 5 and 6 Castle Terrace. End of wall at north side of breach possibly squared, south side is rough. Wall south of breach is wider than northern wall suggesting different phases of construction. 2 x 1m scale

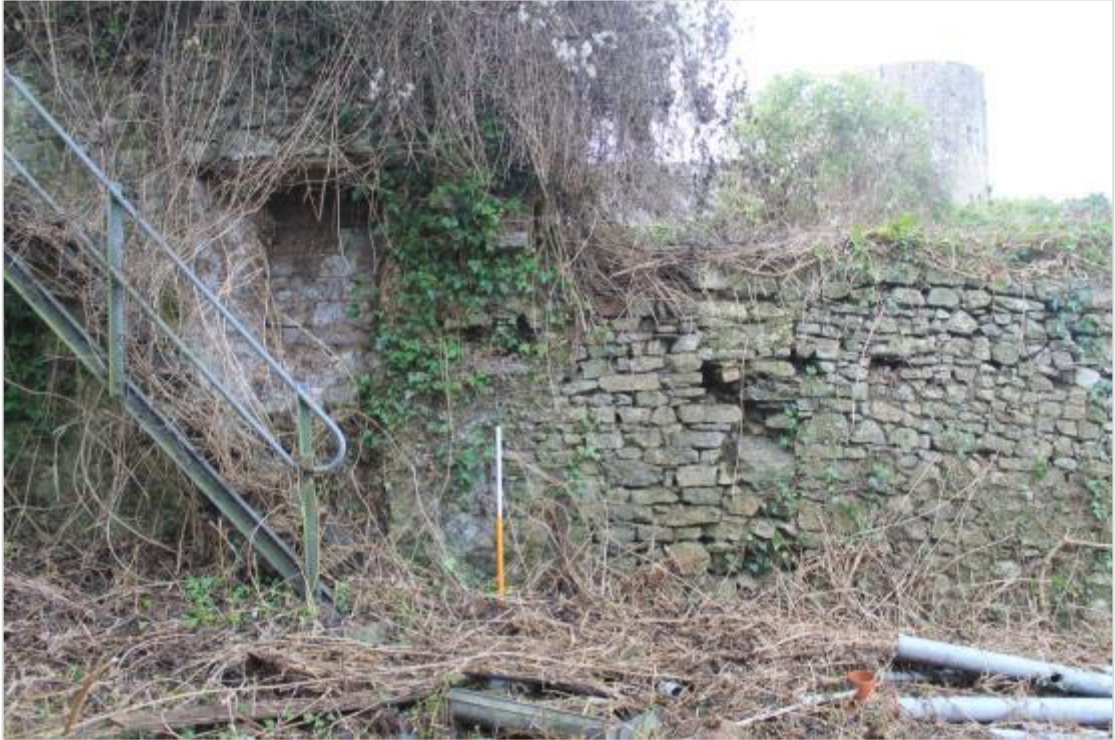
Photo 98: Southern end of east face of wall (PRN 115030) dividing burgage plots at Nos. 5 and 6 Castle Terrace. A joint is visible approximately 2m to the right of the 1m scale. Above the scale the stub of an east-west wall is visible (the other end of which can be seen in Photo 100). A blocked window is visible to the left of the scale (see Photo 115 for other side). 1m scale

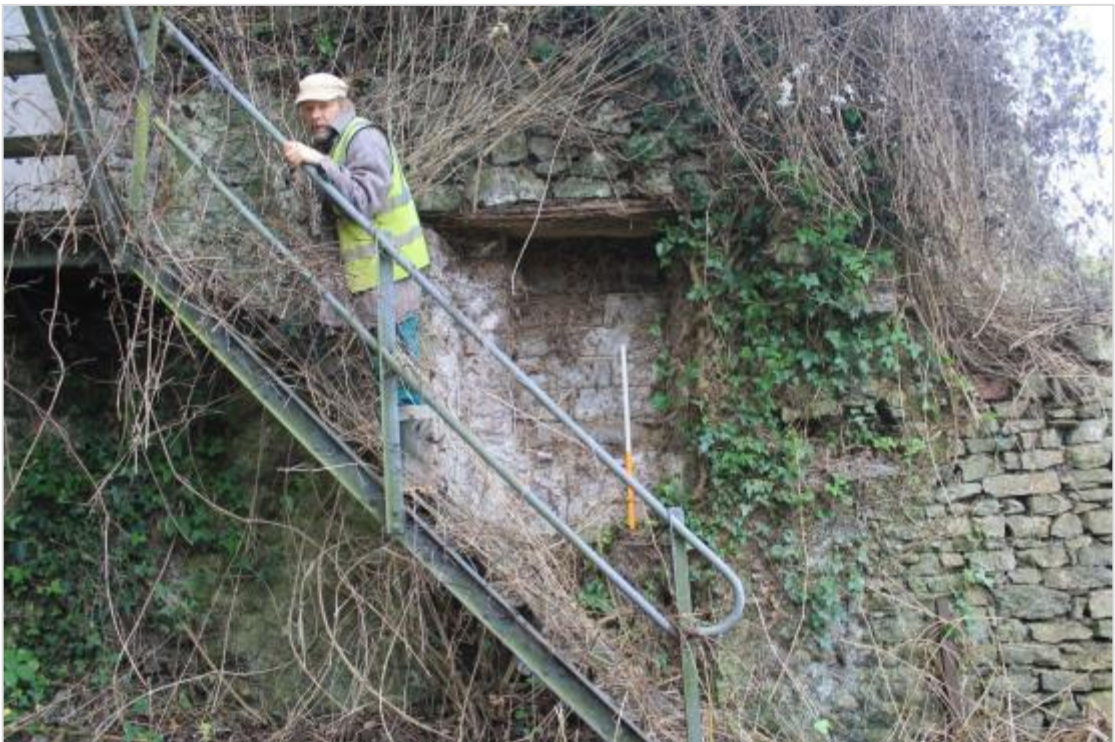
Photo 99: Close up of blocked window (see Photo 115 for other side) in southern end of east face of wall dividing burgage plots Nos. 5 and 6 Castle Terrace. 1m scale

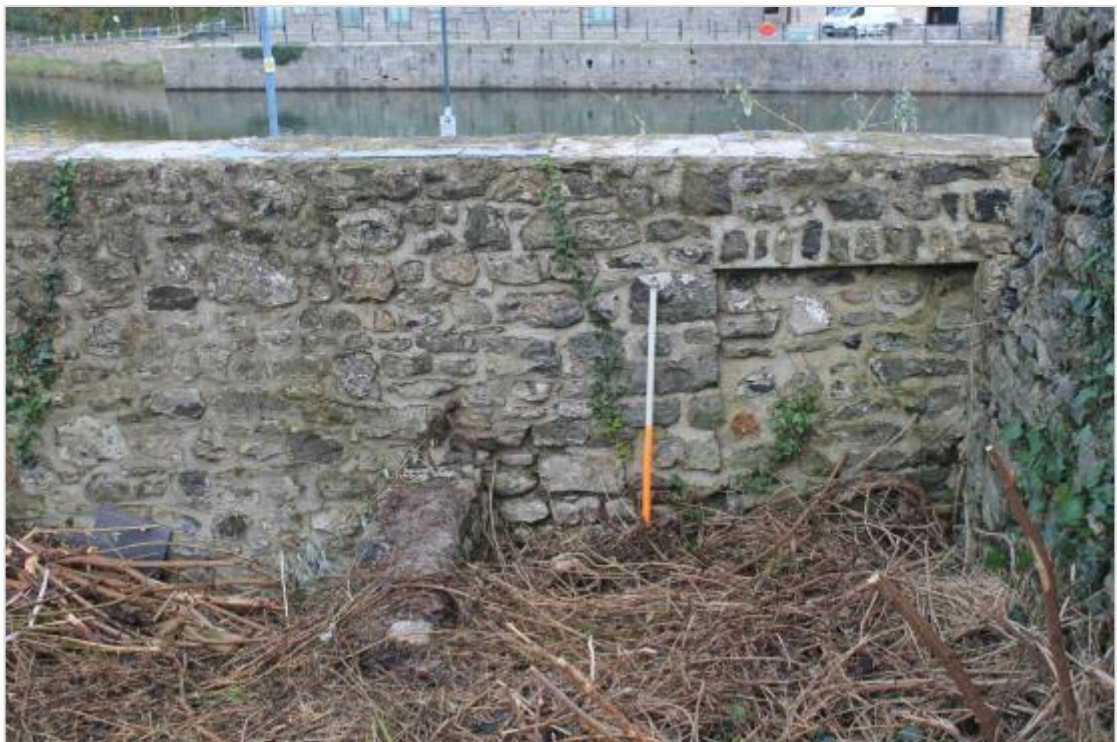
Photo 107: View north towards quayside wall at northern end of burgage plot at No. 6 Castle Terrace showing blocked entrance (see Photo 117 for other face of wall). 1m scale

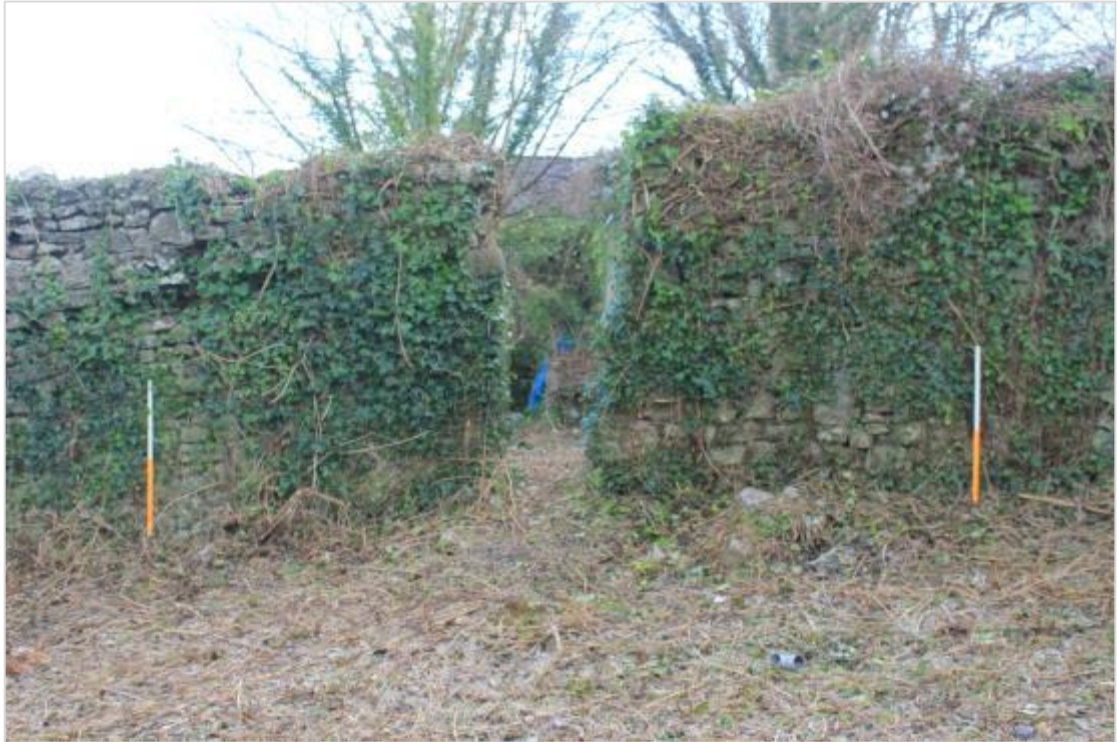
Photo 112: View east towards breach in wall (PRN 115030) dividing burgage plots Nos. 5 and 6 Castle Terrace. End of wall on left side of breach possibly squared: right side is rough. Wall left of breach is wider than wall on right, suggesting different phases of construction. 2 x 1m scale

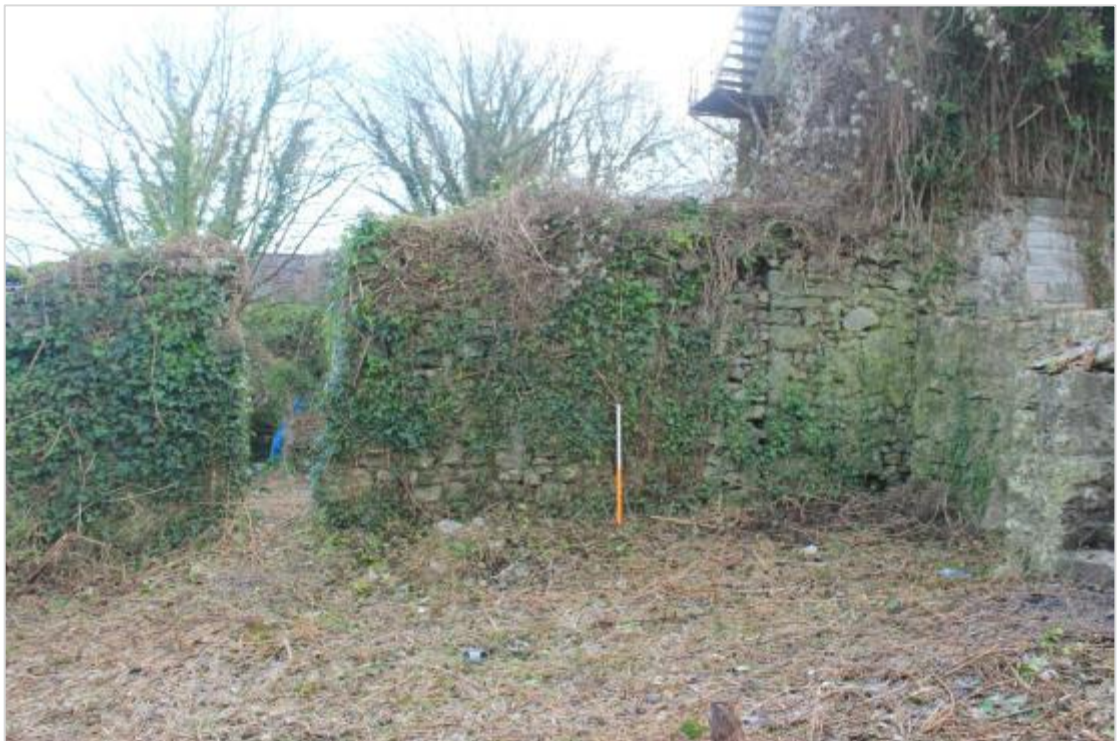
Photo 113: Southern end of west face of wall (PRN 115030) dividing burgage plots Nos. 5 and 6, Castle Terrace. Note masonry joint in wall to the right of the 1m scale: the wall to the left of the joint is quoined and the wall to the left of the breach also has remains of quoin work implying that the wall between the joint and the breach is a later insertion. 1m scale

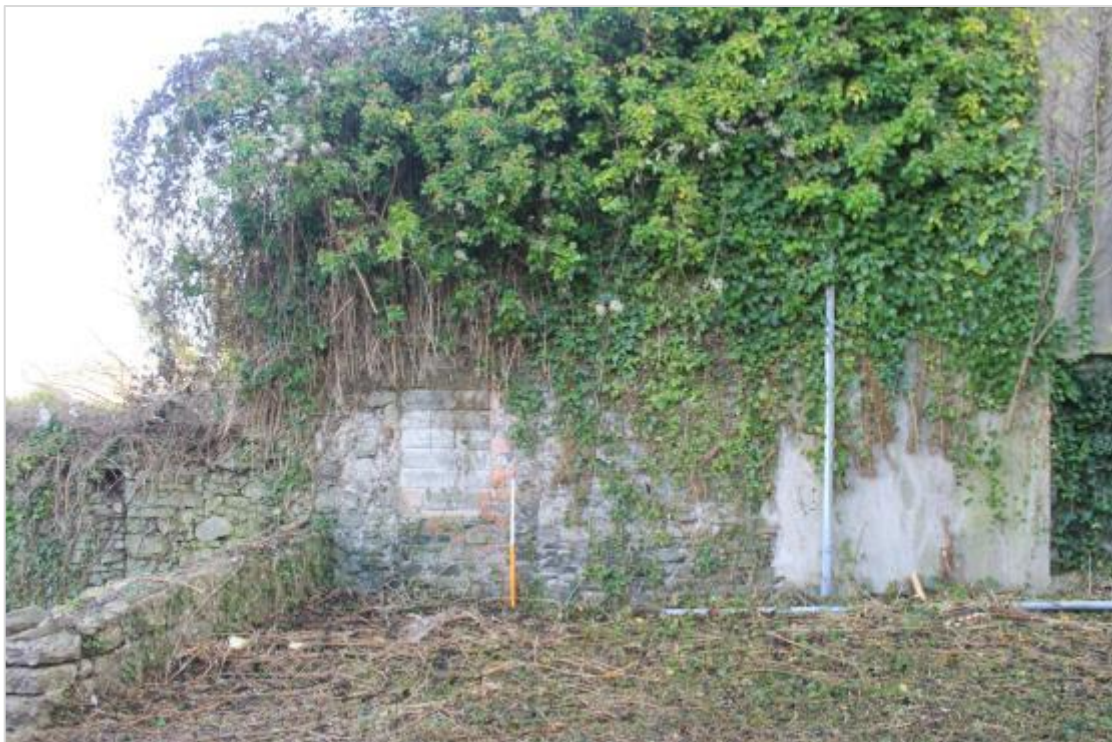
Photo 115: Blocked opening in west facing wall in burgage plot at No. 6 Castle Street (see Photos 98 & 99 for other side). 1m scale
