NATIONAL PARK CARAVAN SITE, SAGESTON, PEMBROKESHIRE HISTORIC BUILDING RECORDING (NGR SN 0532 0317)

REPORT NO. 2020-06
EVENT RECORD No.120803

March 2020

**NATIONAL PARK CARAVAN SITE,
SAGESTON, PEMBROKESHIRE:
HISTORIC BUILDING RECORDING**

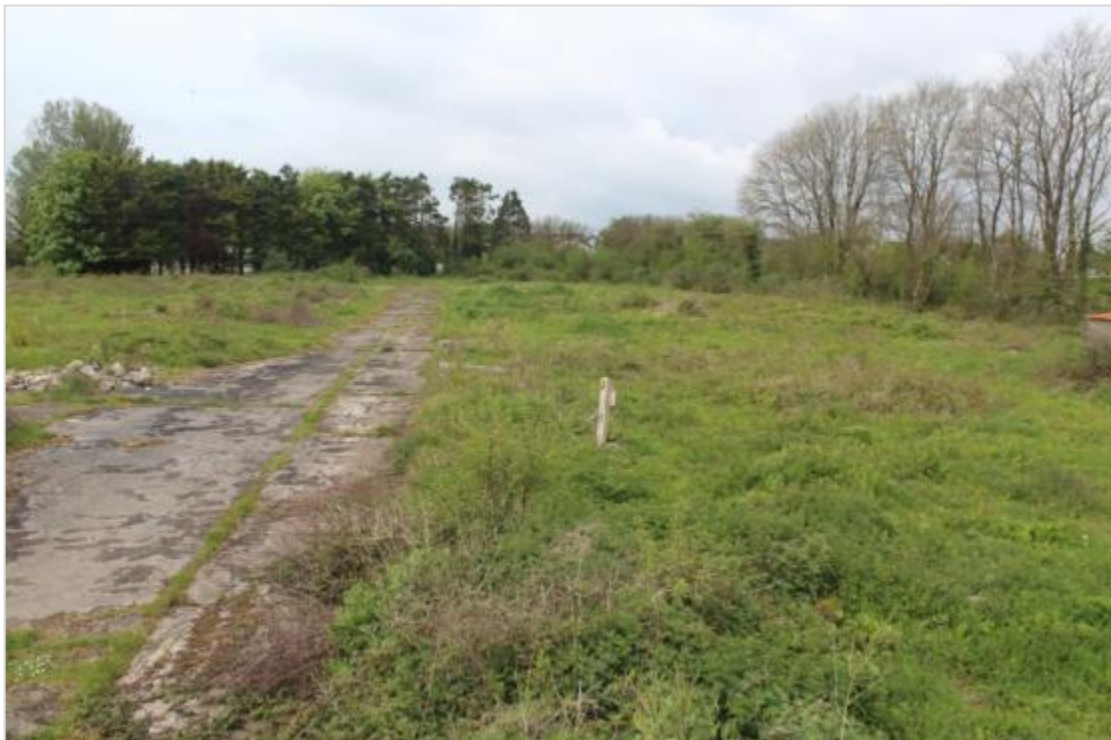
Photo 6: View west from main junction; the demolished remains of Building 124 is to the right of the post, beneath the vegetation.

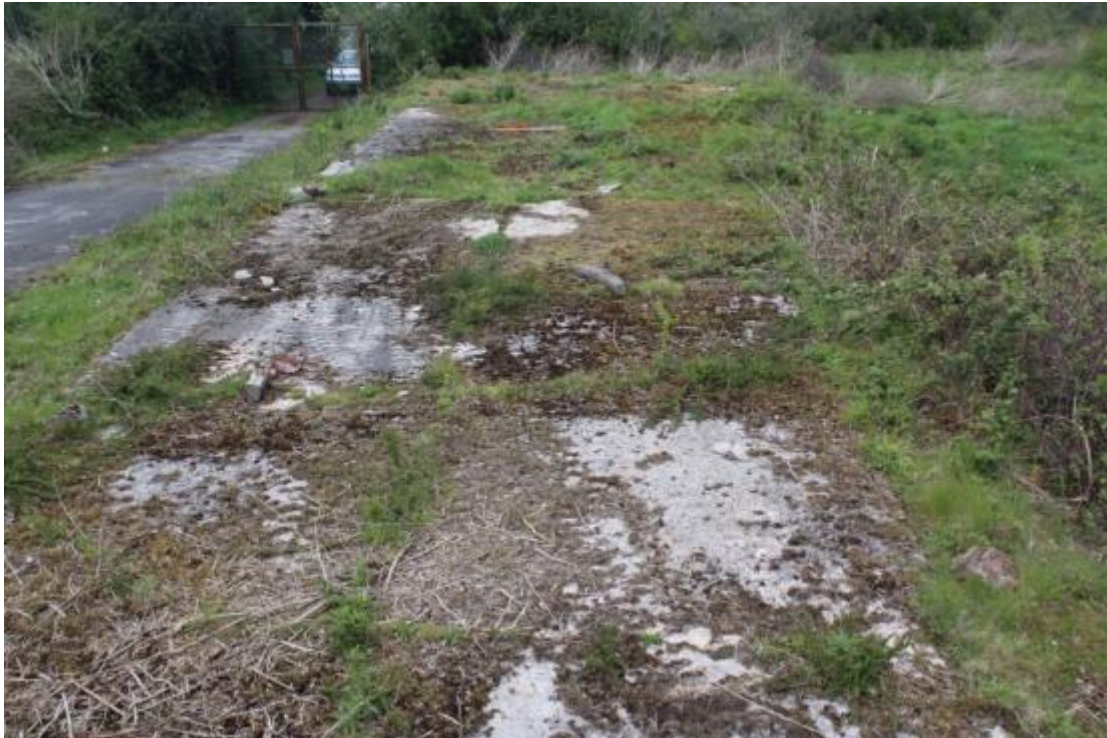
Photo 9: View north: Buildings 29 and 47 (Guards sleeping Quarters/Picket Post and Prophylactic Room) ;concrete raft is approximately 29m long and 5.8m wide; north end is c. 0.9m high from the ground. Brick pilasters/butresses are spaced around the outside of the plinth. A scar is visible halfway along the plinth, dividing 29 and 47; steps lead up from the west side.

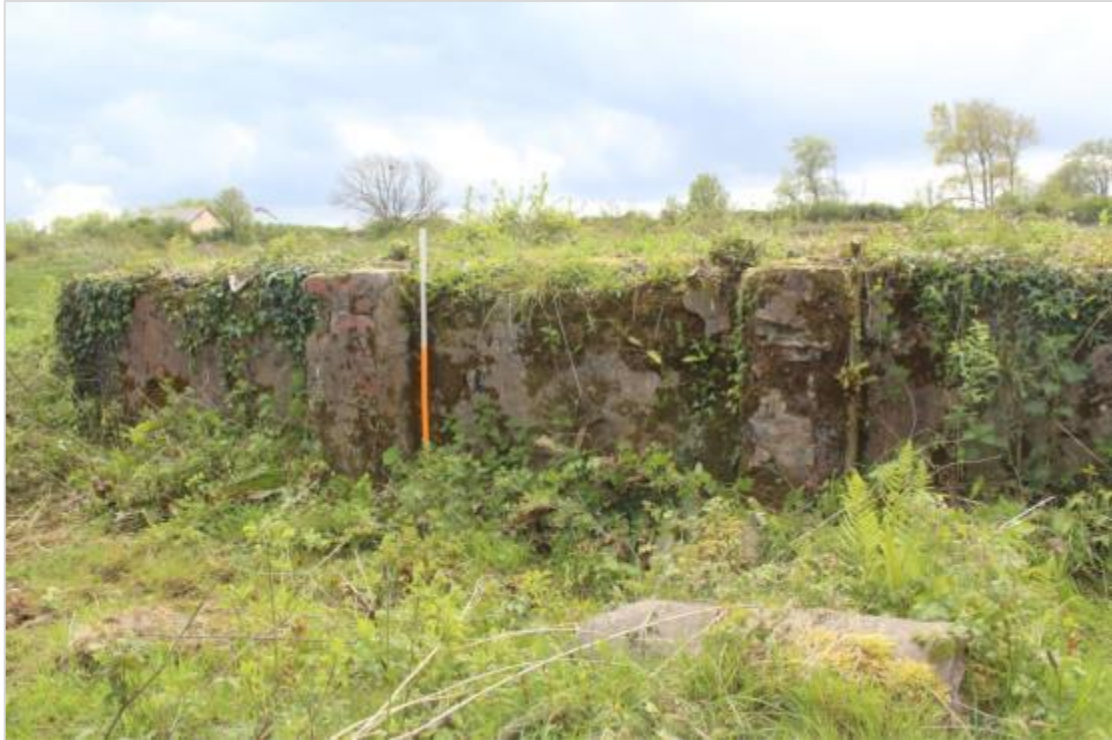
Photo 11: North face of Building 47, showing two of the pilasters/butresses.

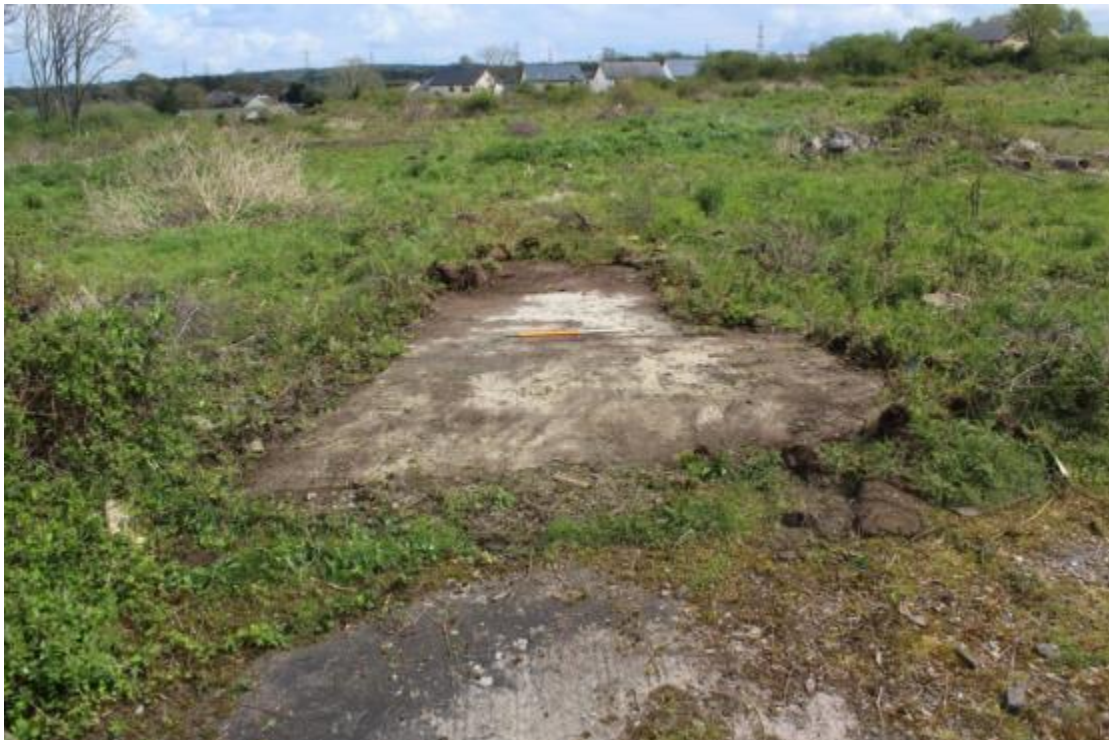
Photo 12: View east: Building 21; concrete floor - edges of floor are grassed over. The visible area is approximately 11.8m long and 3m wide.

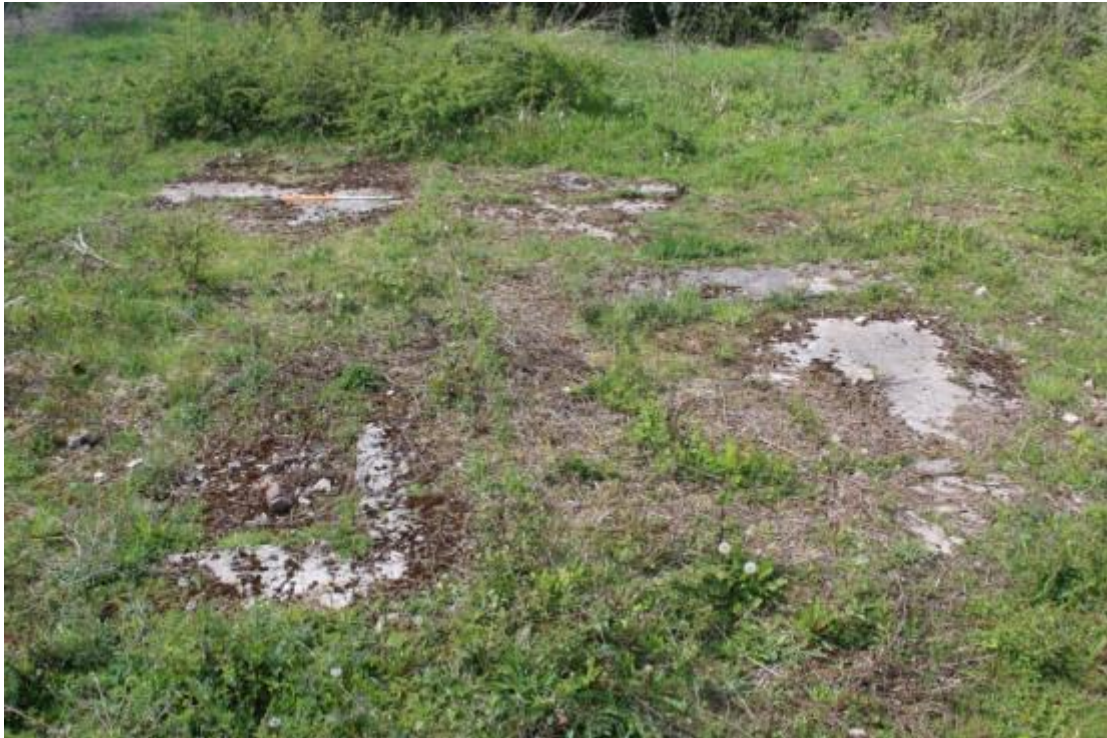
Photo 13: View west: Building 41 (NAAFI Quarters and Store); concrete floor; east and west ends under vegetation but a portion of the north and south sides well delineated. Area in photo measures approximately 11m long and 8m wide.

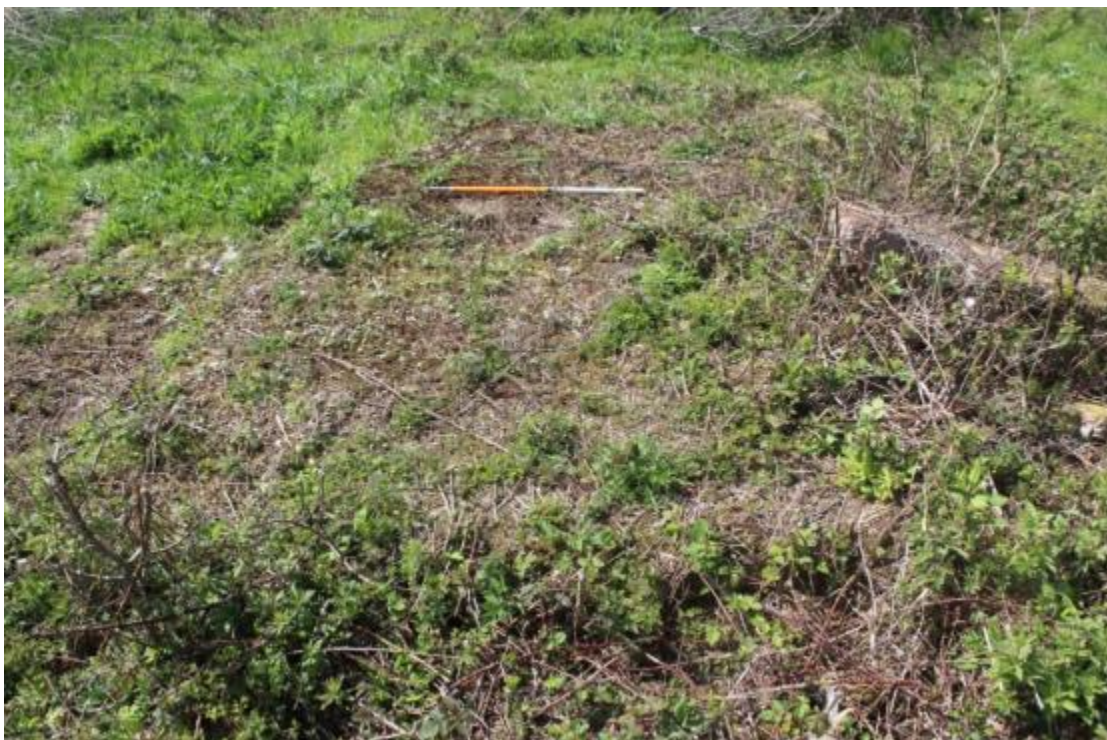
Photo 14: View east: Building 183; small concrete raft measuring approximately 4m by 4m; apart from southwest corner, edges of plinth are well delineated.

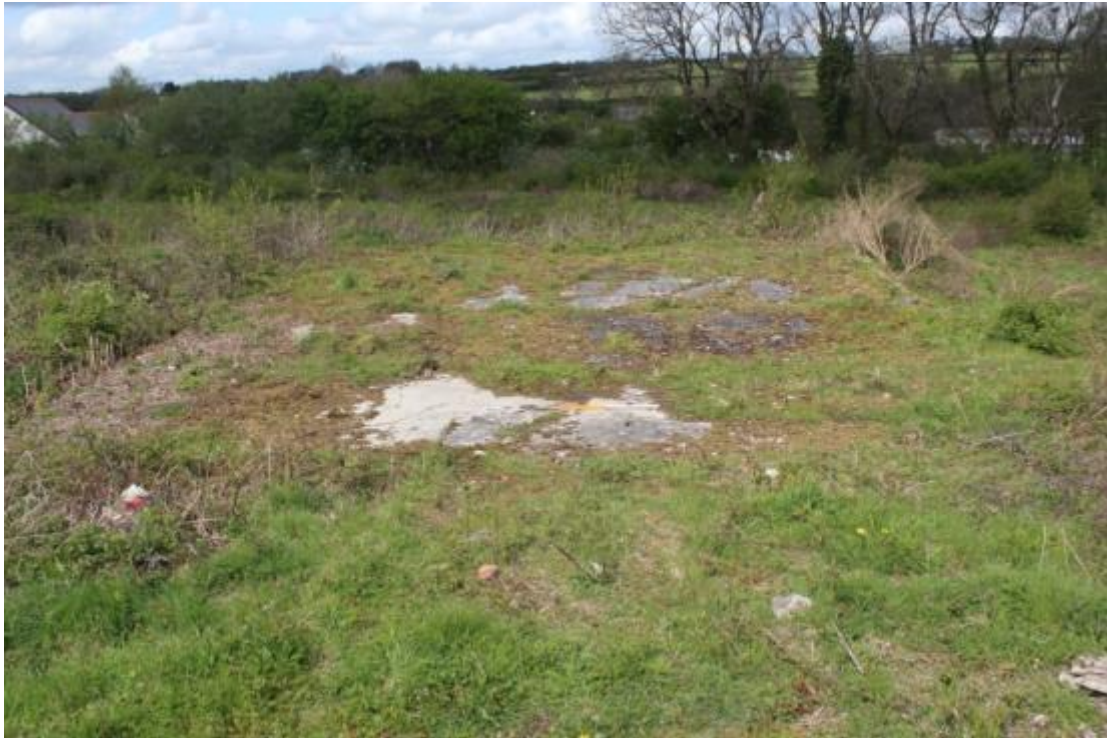
Photo 15: View west: Building 2 (Decontamination Annexe); concrete raft measuring 12.6m by 9.8m; east corner is roughly 1m high; two small extensions, at the north and south ends, shown in the 1946 plan are not visible.

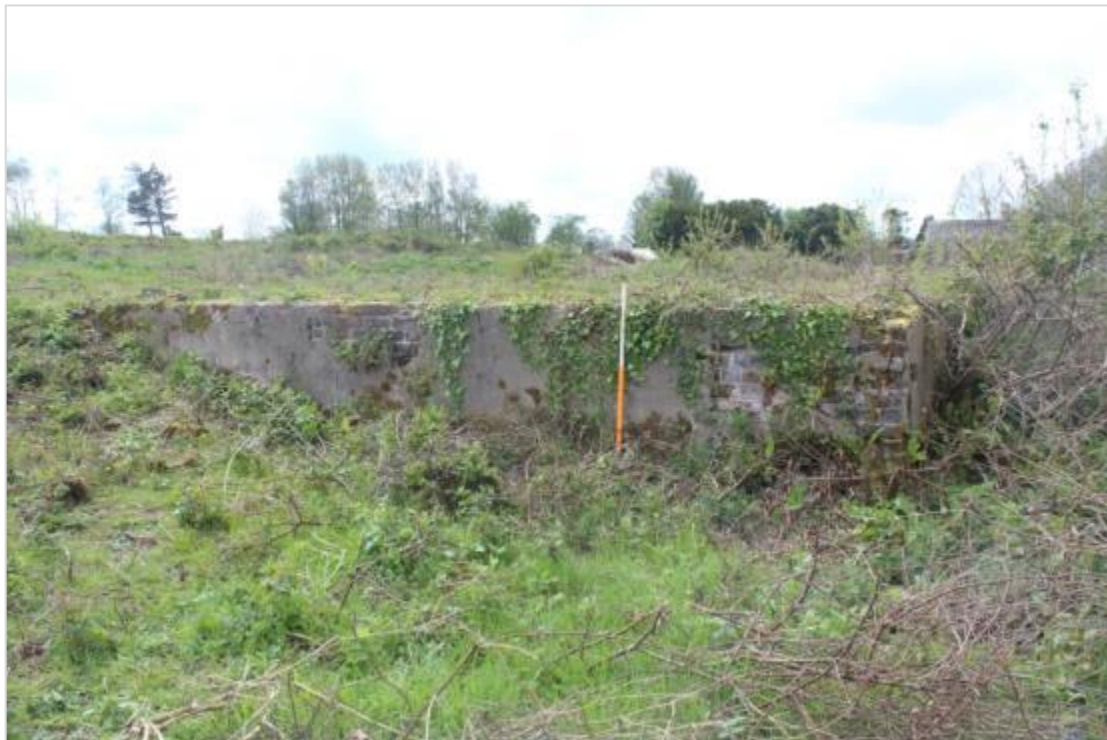
Photo 16: East face of Building 2 - approximately 1m high.

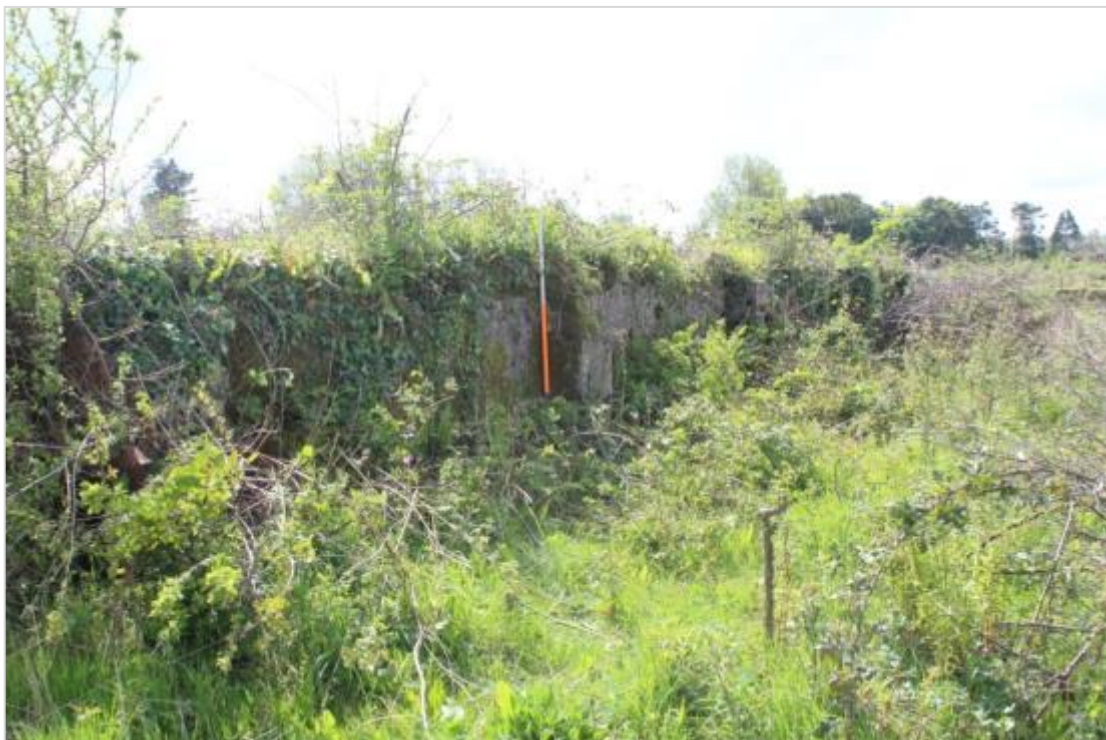
Photo 18: Building 37; oblique shot of north wall showing pilasters/butresses.

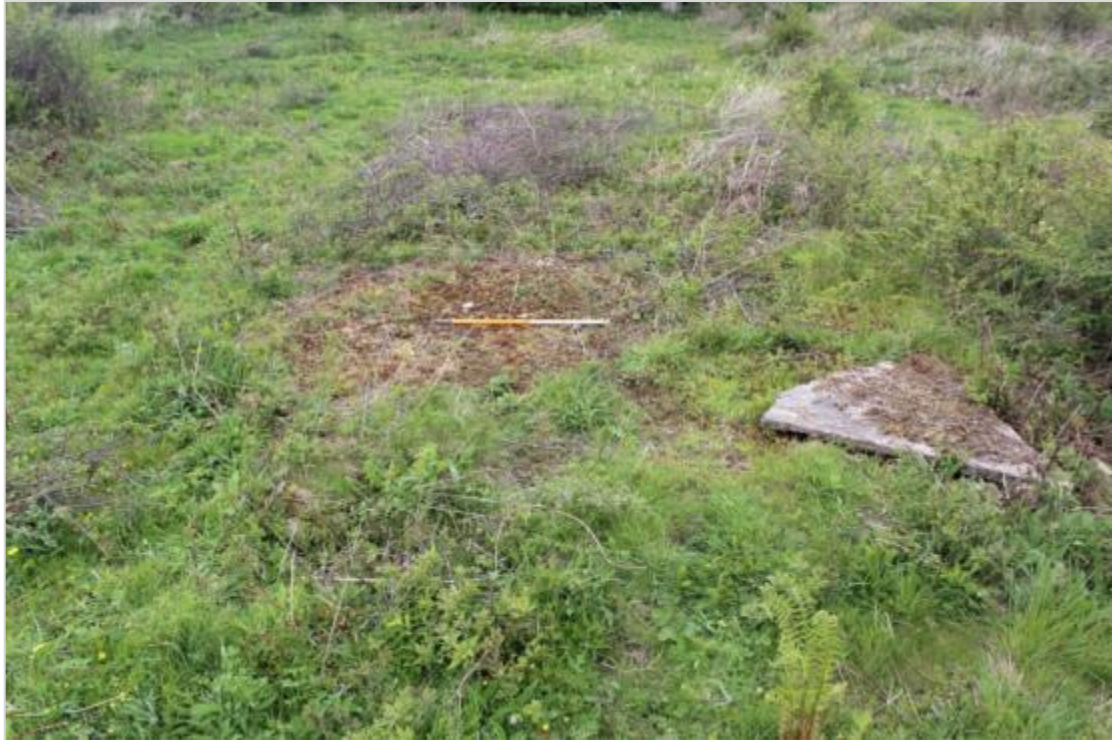
Photo 19: View north; Building 49 (Station Contractors Workshop and Yard); concrete floor measuring c. 4.95m by 3.4m; northeast corner and south edge damaged.

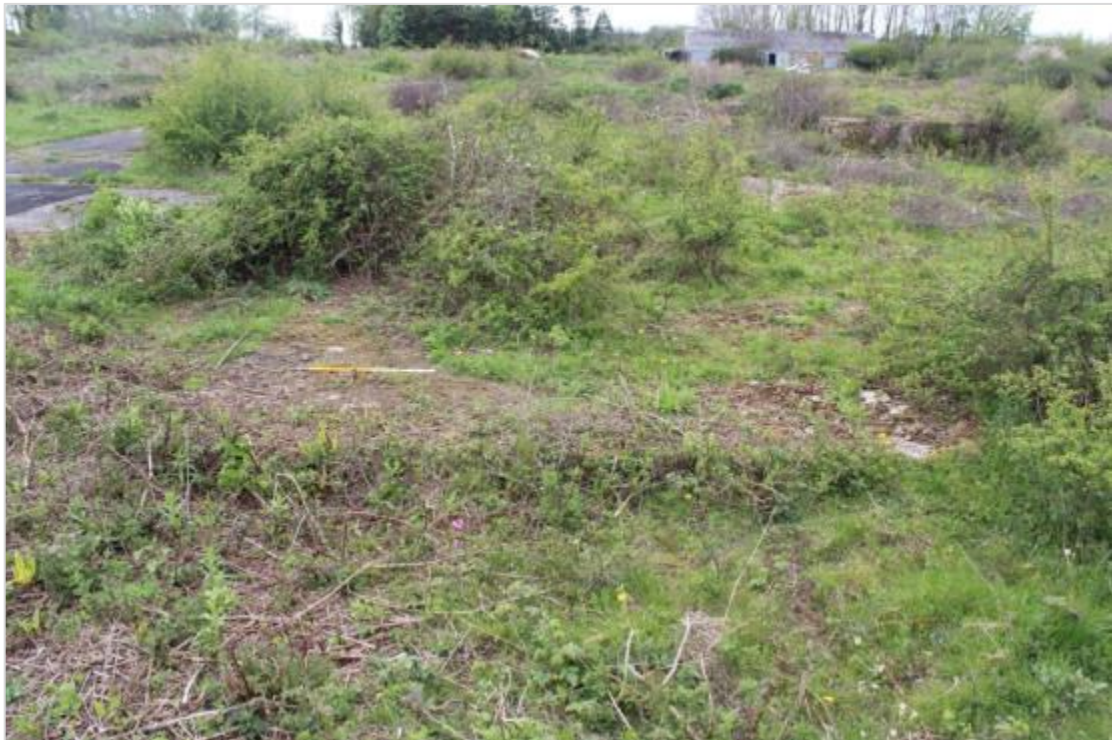
Photo 20: View west: Building 226 (AMWD Latrine); west end of concrete raft under vegetation; surveyable area measures 5.2m long and 5.5m wide.

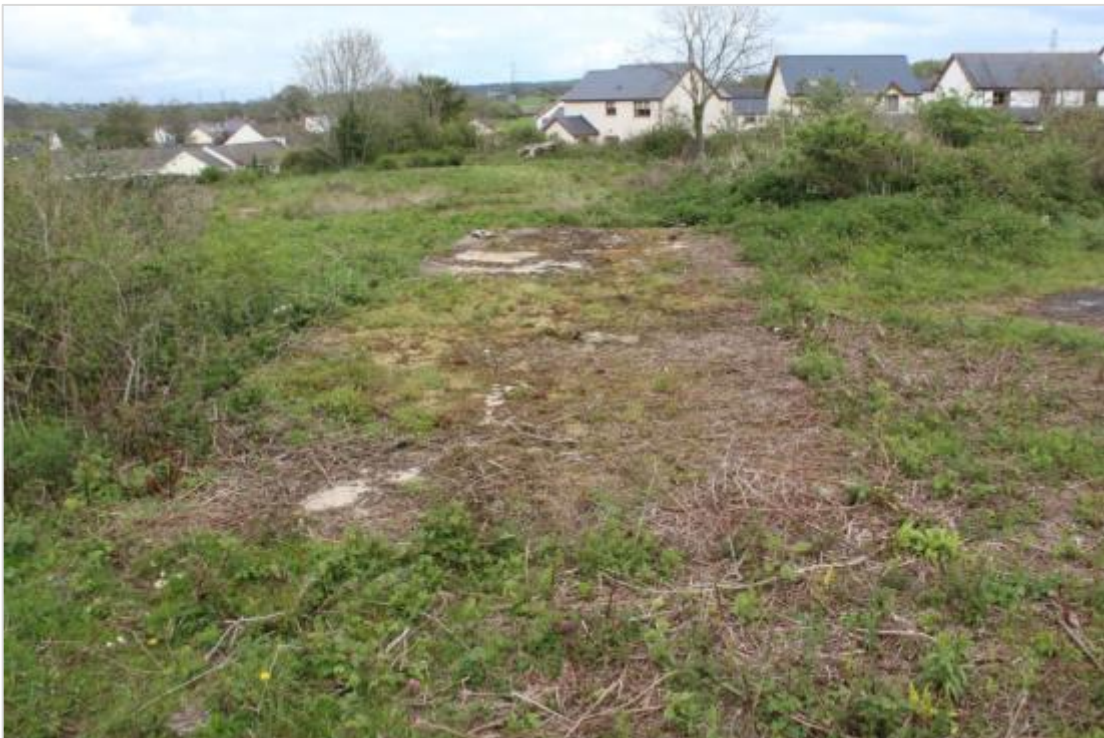
Photo 22: View east: Building 50 (AMWD Office); majority of this concrete raft survives apart from damaged northwest and southwest corners; measures 15.6m by 5.6m. Edge of north side of raft is c. 0.75m high.

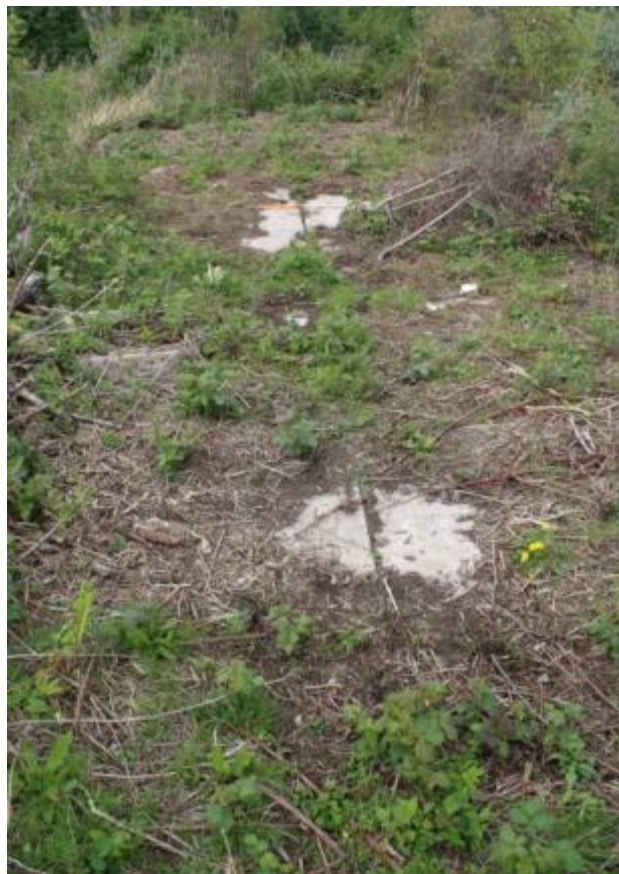
Photo 24: View north: Building 225 (AMWD Stores); concrete floor with seam running down the centre; north edge is damaged, south edge under vegetation; small section of well delineated east and west edges survive; observable area measures c. 14m by 5.6m.

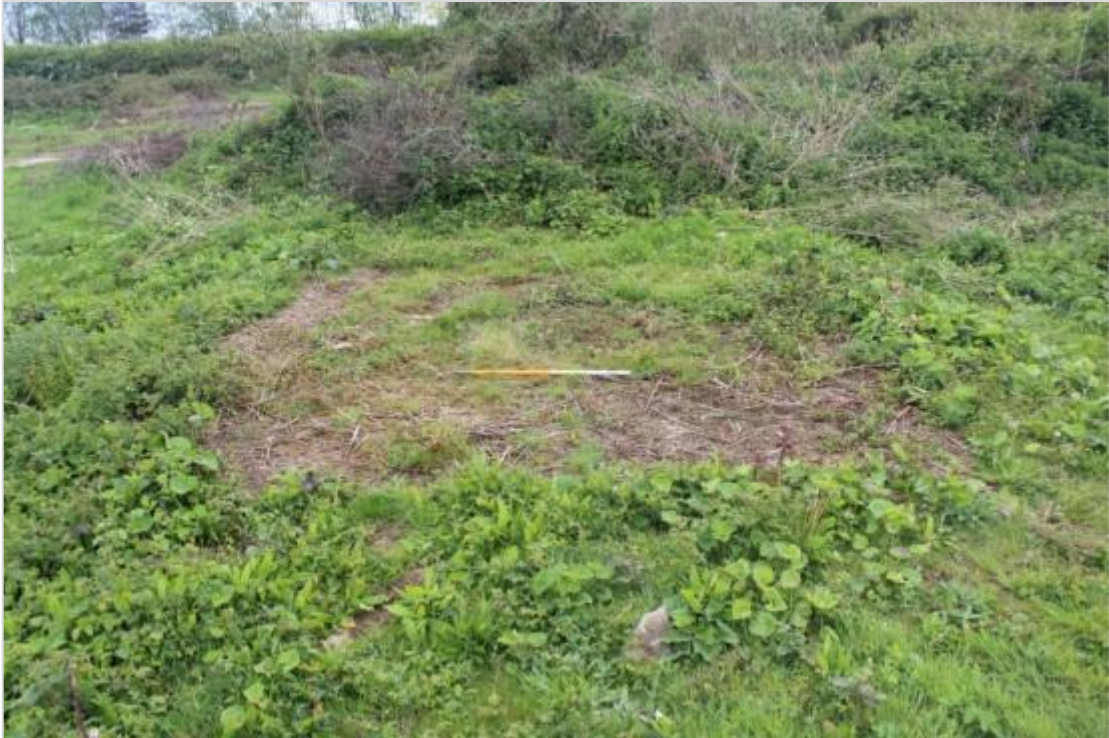
Photo 25: View south: Building 51 (AMWD Garage and Store); concrete floor; observable area measures 4.3m long by 4.5m wide; northeast corner damaged; southern end under vegetation; east and west edges are well defined.

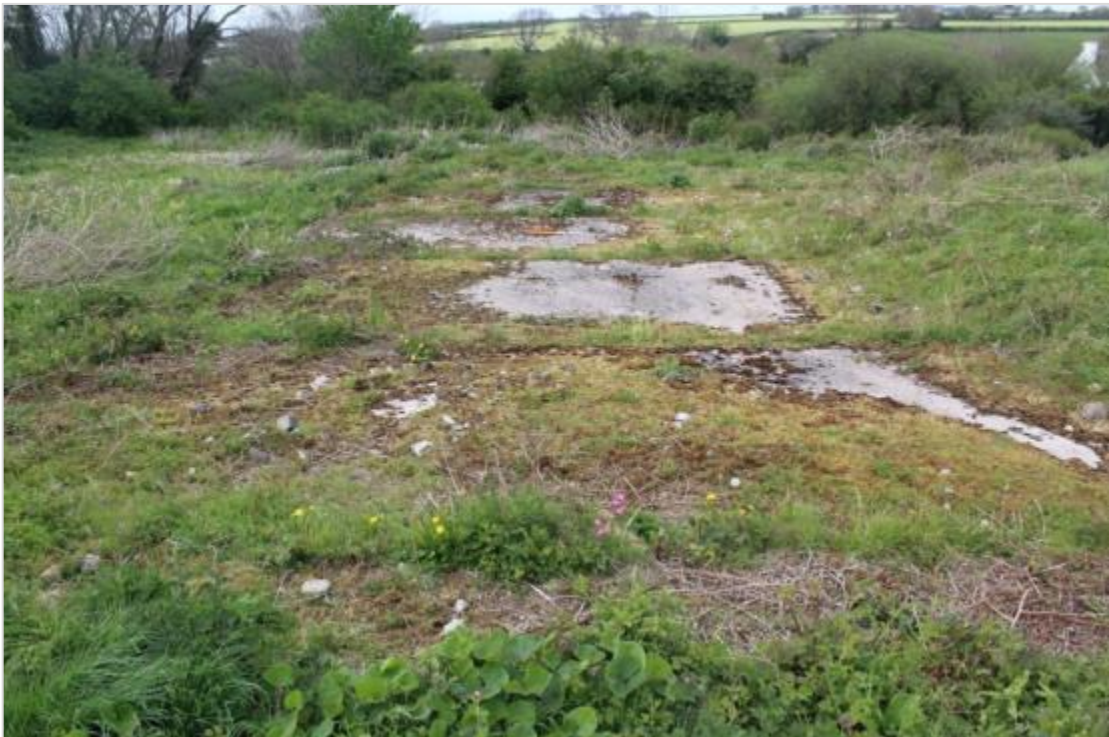
Photo 26: View north: Building 52 (MT Sheds – 14 Bays); northwest corner and section of southern edge is well defined - rest is under vegetation and a grassed spoil heap.

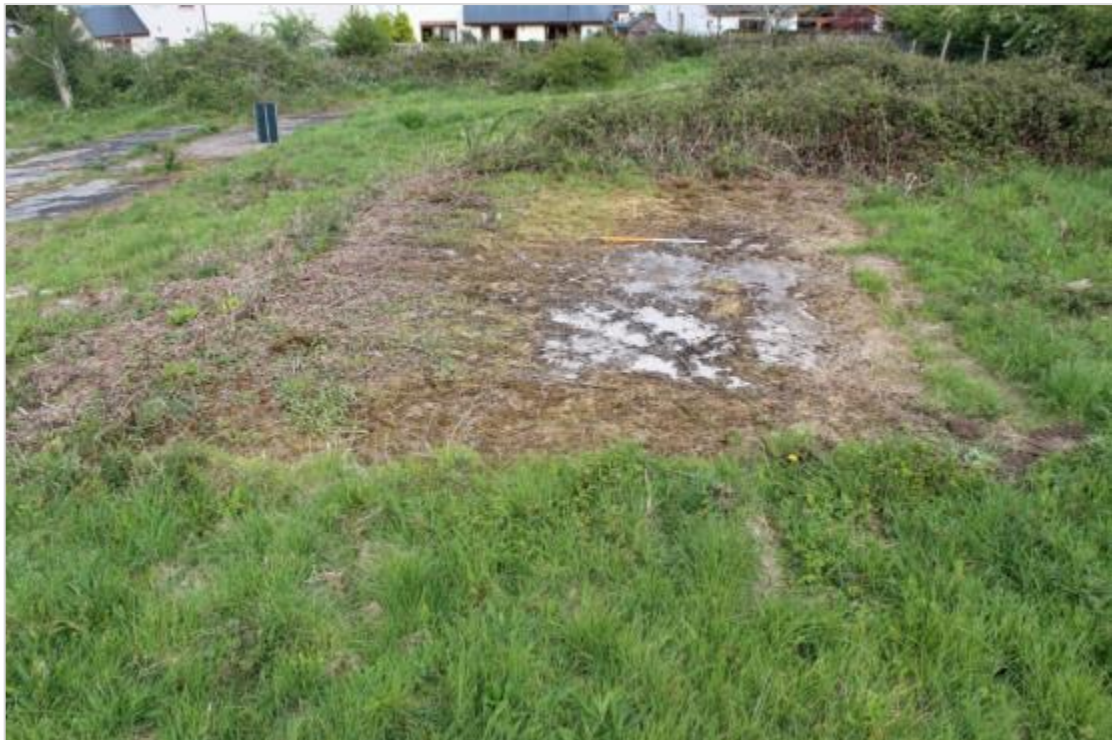
Photo 28: View east Building 63 (MT Office and WAAF Rest Room); intact, well-preserved concrete raft with good edges; measures c. 7.5m by 5.5m.

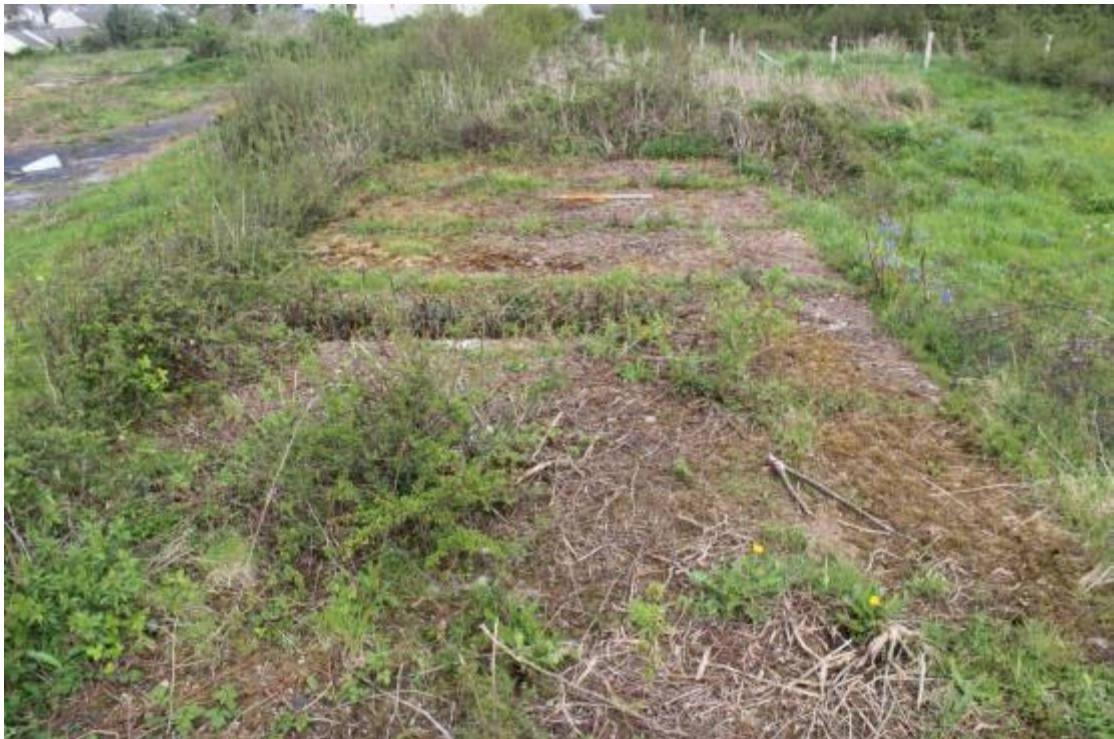
Photo 30: View east: Building 181 (Post Office); well preserved concrete raft measuring c. 10.9m by 4.7m; rectangular slot measuring 2.7m by 0.5 and 0.5m deep at roughly midway point.

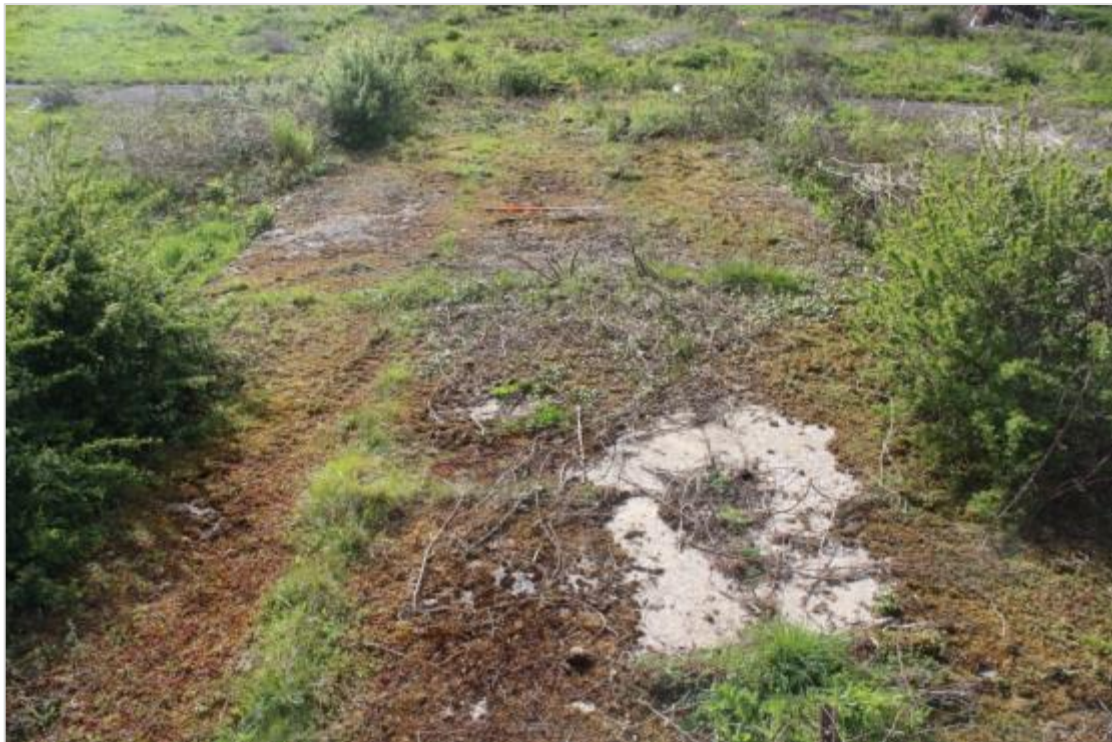
Photo 34: View west: Building 38; well-preserved concrete raft; intact, apart from damaged southeast corner; measures c. 18.6m by 5.6m.

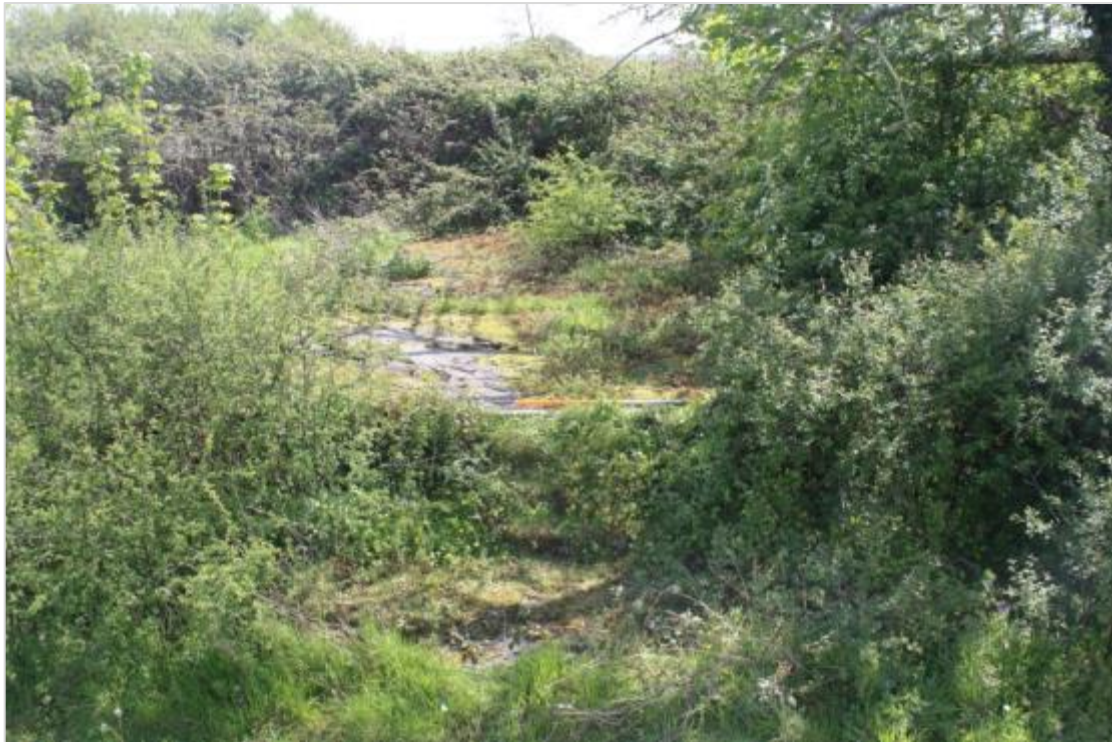
Photo 35: View south: Building 69 (Officers Barrack Hut); remains of concrete raft measuring c.7m by 4.8m; steps on the north side; southern half of raft truncated by A477 bypass.

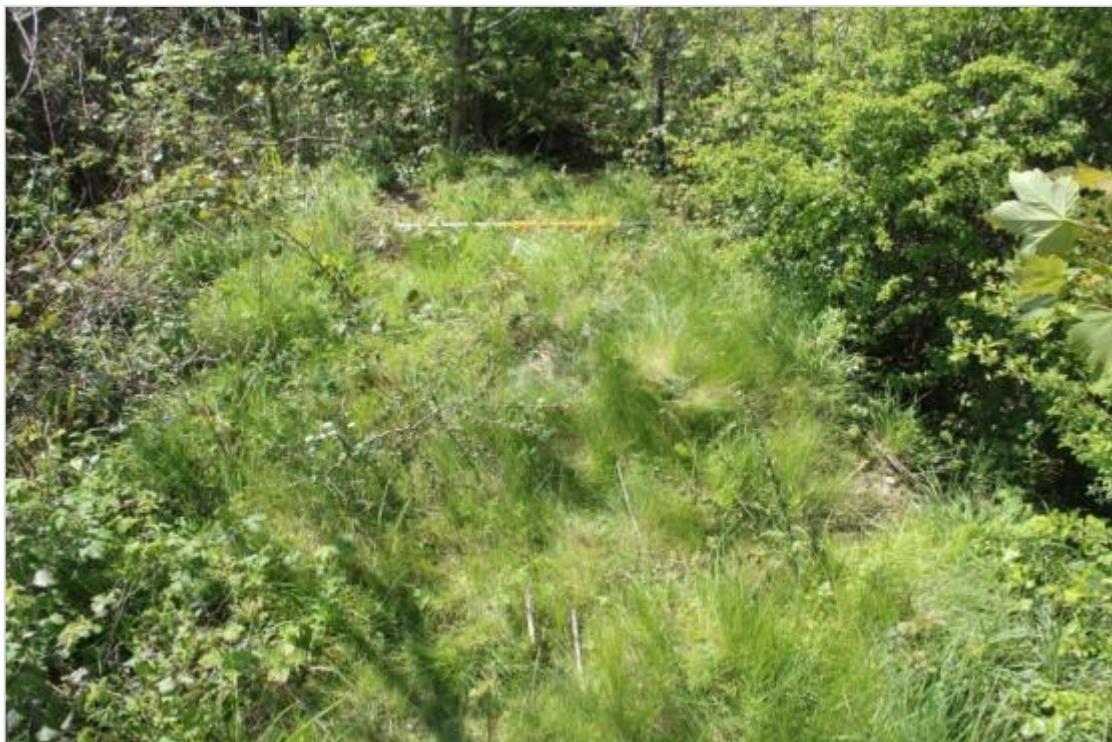
Photo 36: View west: east section of Building 12 (Officers Mess); majority is grassed over; steps on north side; observable area measures c. 2m by 3.6m; southern half truncated by A477 bypass.

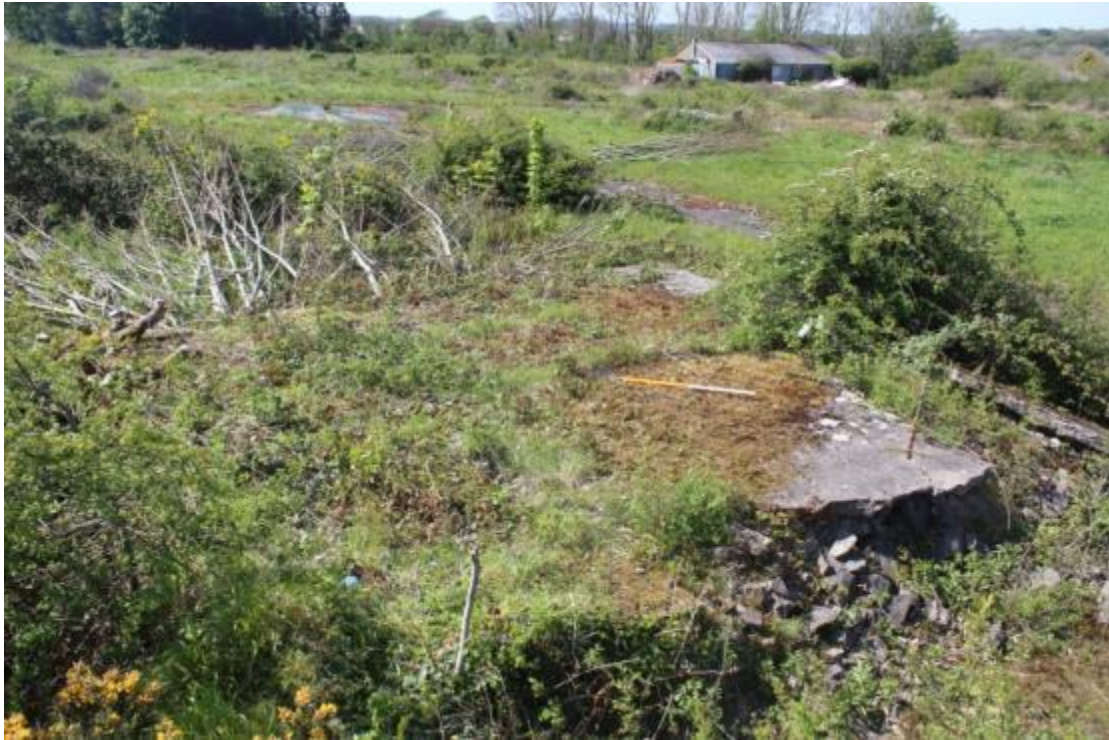
Photo 37: View northwest: Building 12 (Officers Mess); badly damaged, only good edge is on west side; graffiti visible in concrete floor; southern half truncated by A477 bypass.

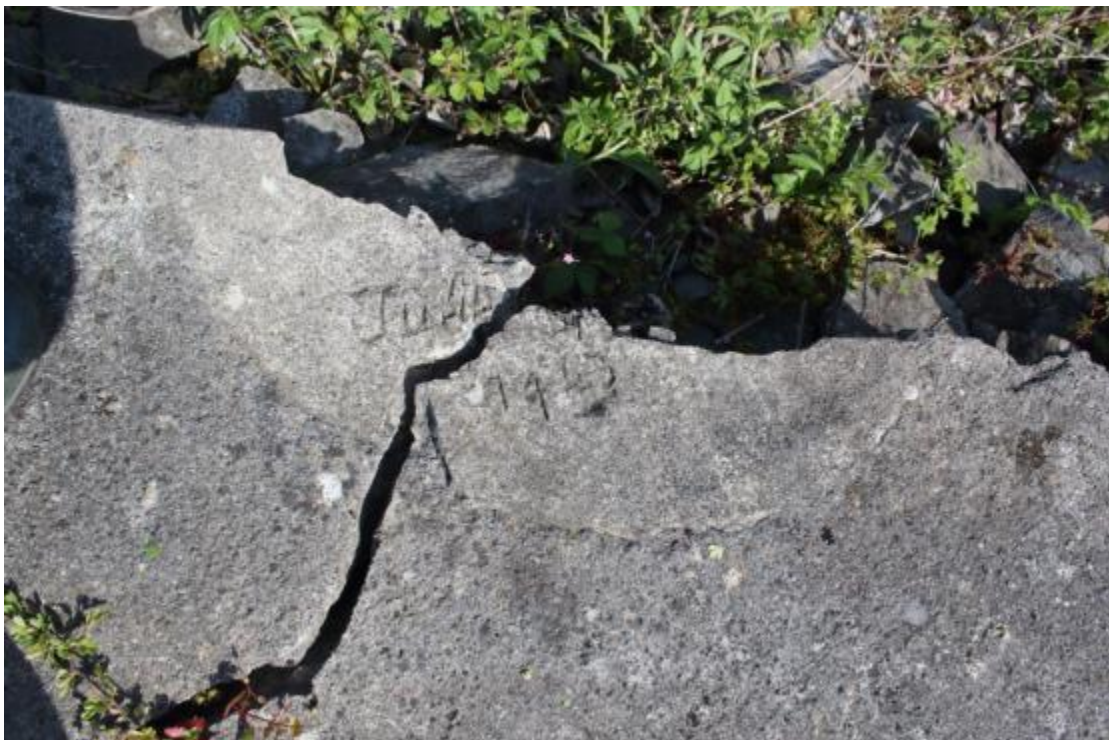
Photo 38: Graffiti in concrete floor of Building 12: dated 1943.

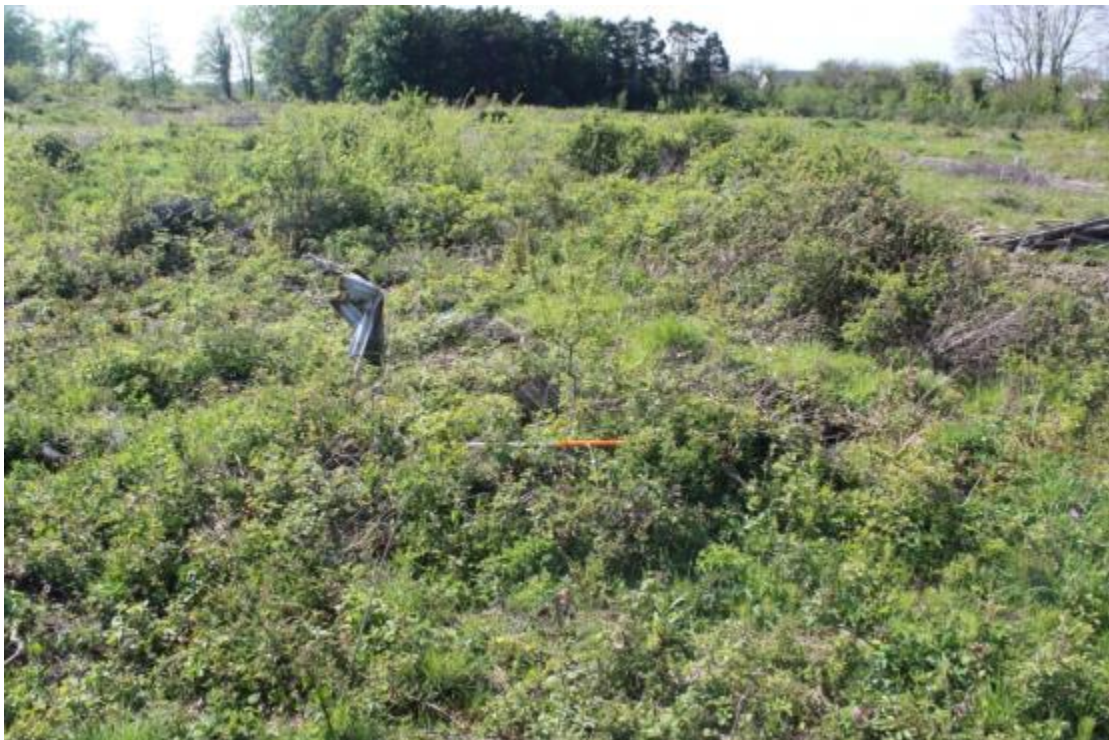
Photo 40: View west: Building 7 (SHQ Offices); badly damaged, rubble strewn, heavy vegetation cover; only section of north edge visible; area roughly measures 22m by 10m.

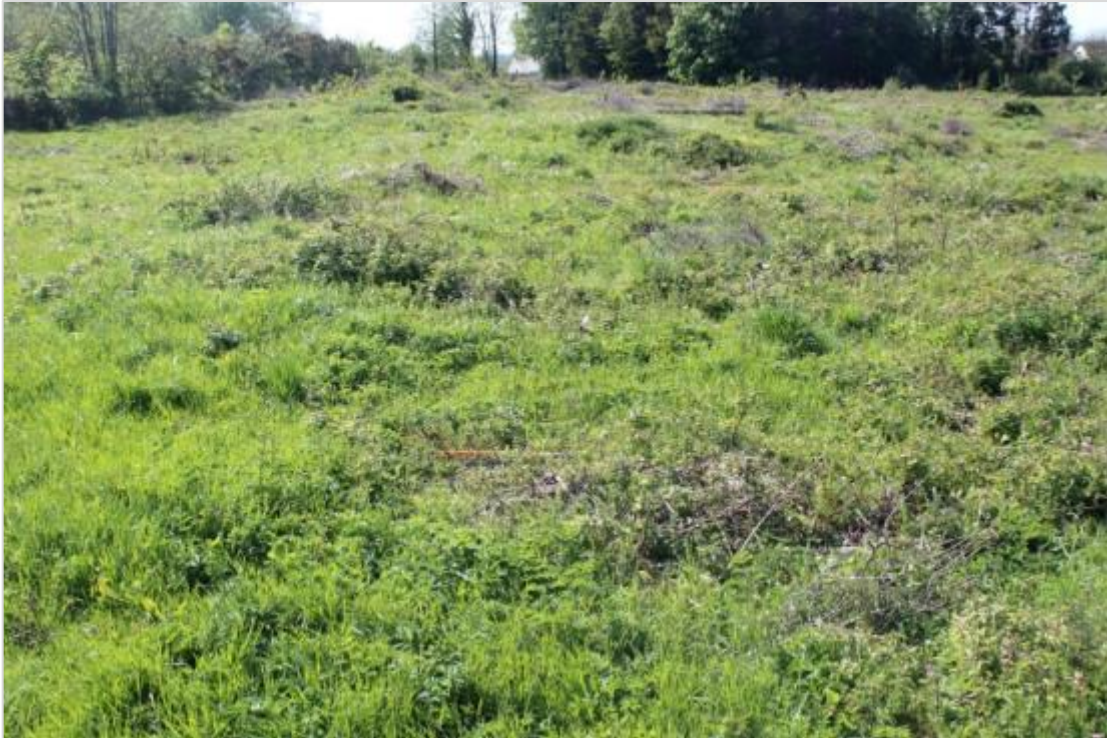
Photo 41: View west: Building 20 (Car Park and Bus Shelter); entirely covered by vegetation – no edges visible; area roughly measures 23m by 9m.

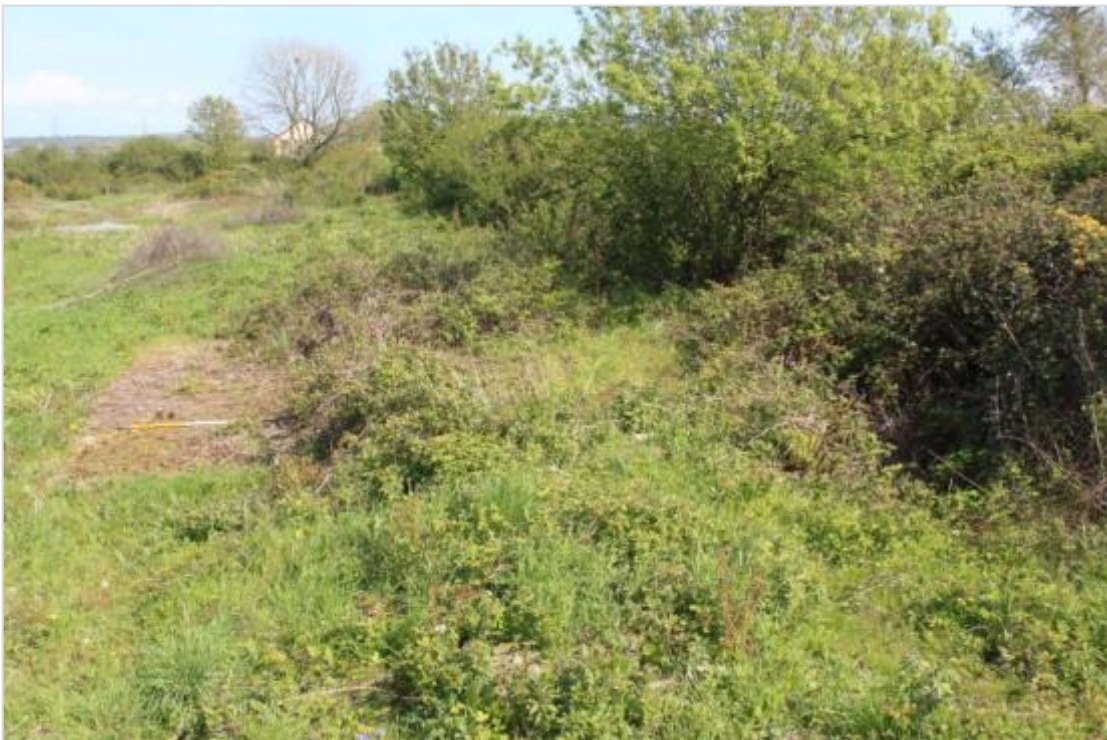
Photo 42: View east: Building 4 (Latrine); only northern tip of this structure is visible; rest truncated by A477 bypass.

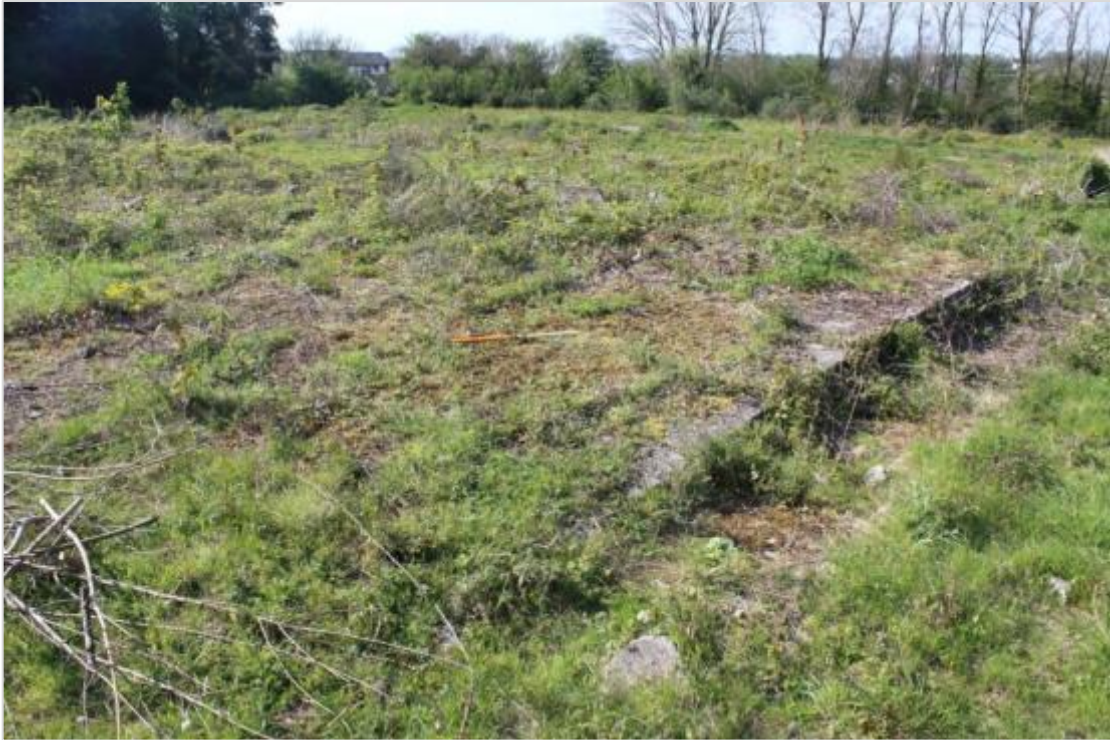
Photo 43: View northwest: Building 41 (NAAFI Quarters and Store); east edge well-defined; vegetation covers rest of structure; area roughly measures 29m by 8m.

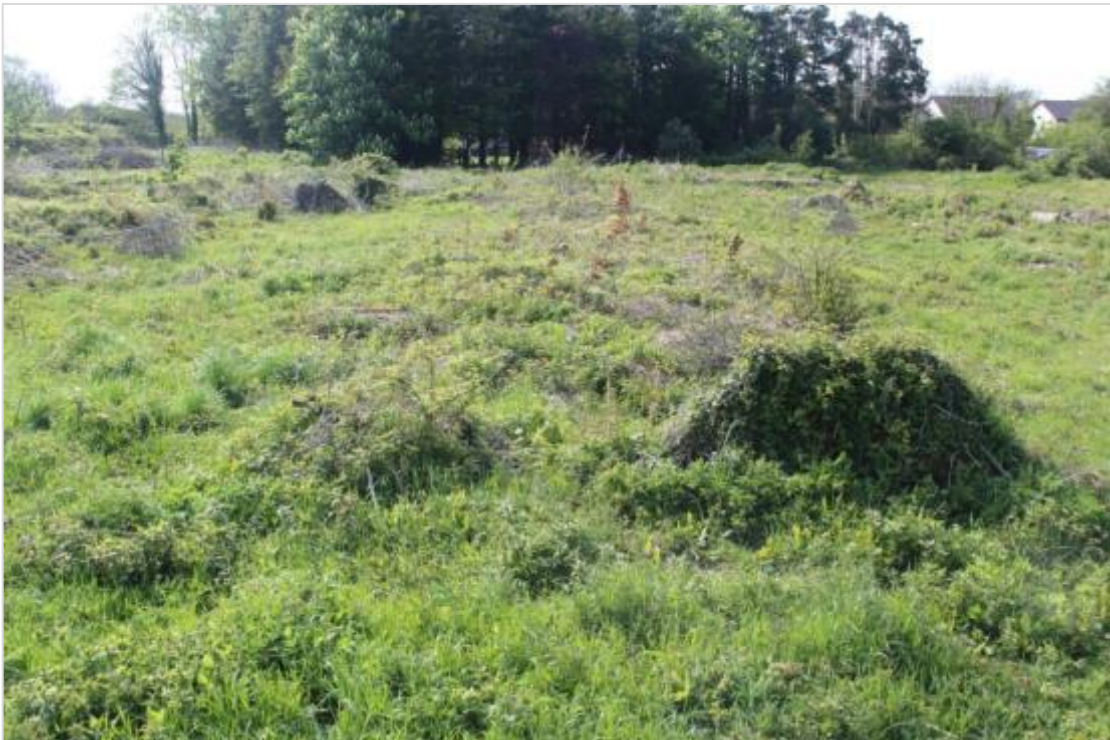
Photo 44: View west: Building 40 (Accounts Office); northeast corner intact, the rest is ill-defined (heavy vegetation cover); area roughly measures 26m by 8m.
