NATIONAL PARK CARAVAN SITE, SAGESTON, PEMBROKESHIRE HISTORIC BUILDING RECORDING (NGR SN 0532 0317)

REPORT NO. 2020-06
EVENT RECORD No.120803

March 2020

**NATIONAL PARK CARAVAN SITE,
SAGESTON, PEMBROKESHIRE:
HISTORIC BUILDING RECORDING**

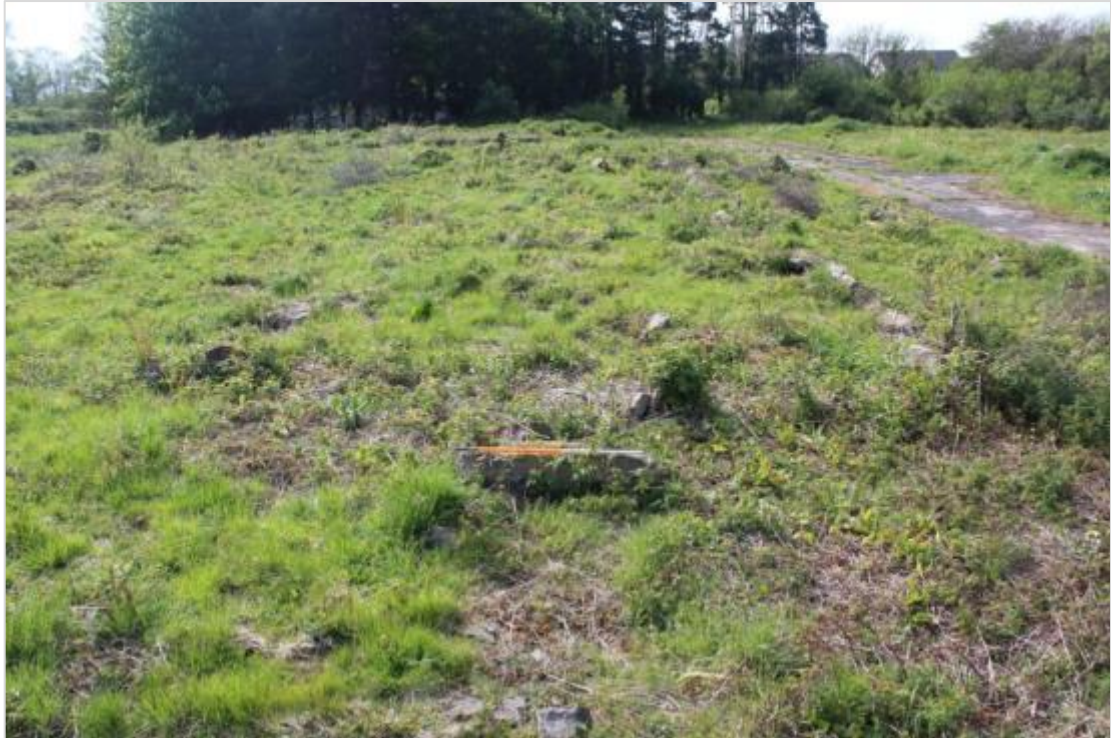
Photo 45: View west: Building 39 (Aircrew Intelligence – Barber and Shoemaker); well-defined north and west edges, rest is rubble strewn and grassed over; area roughly measures 29m by 7m.

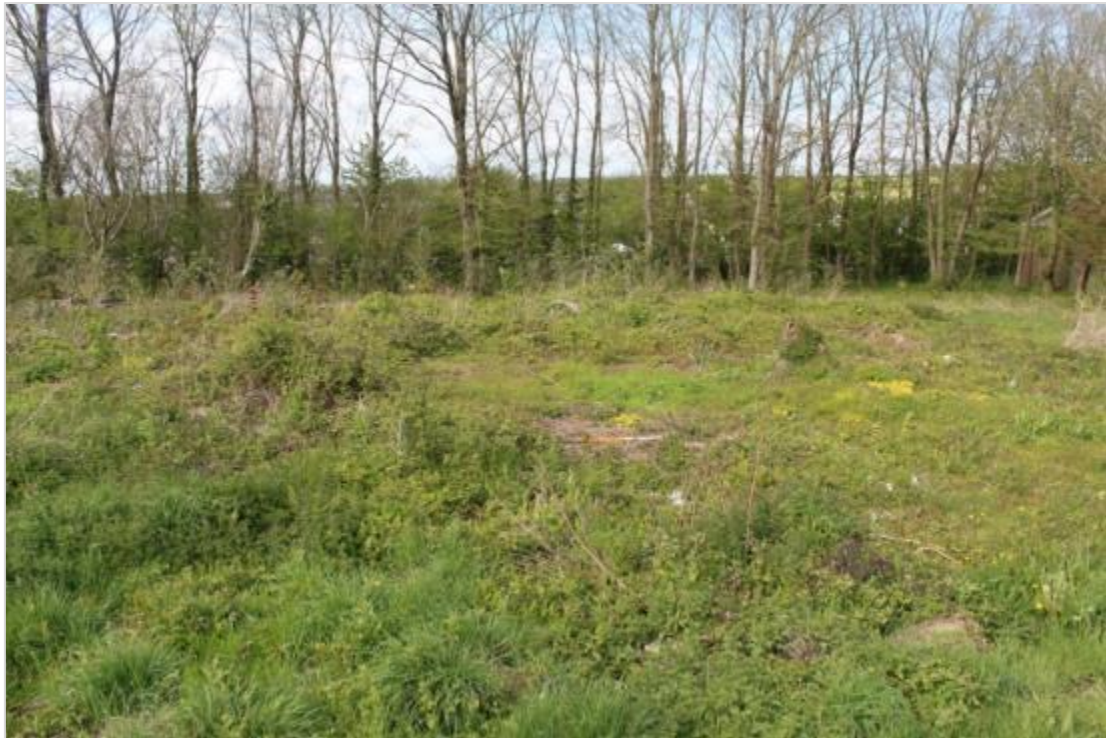
- 3.11 The western quadrant of the site seems to be the most damaged with no obvious visible edges of buildings appearing beneath the building rubble and vegetation (Photo 47). Buildings 42 and 43 have either been completely removed or have been grassed over (Photo 48). Possibly when the overburden is cleared the footprints of these buildings will become apparent.

Photo 47: View north: Building 3 (Sergeants Mess); ill-defined area of demolition debris, some wall lines discernable in amongst the rubble; area roughly measures 20m by 19m.

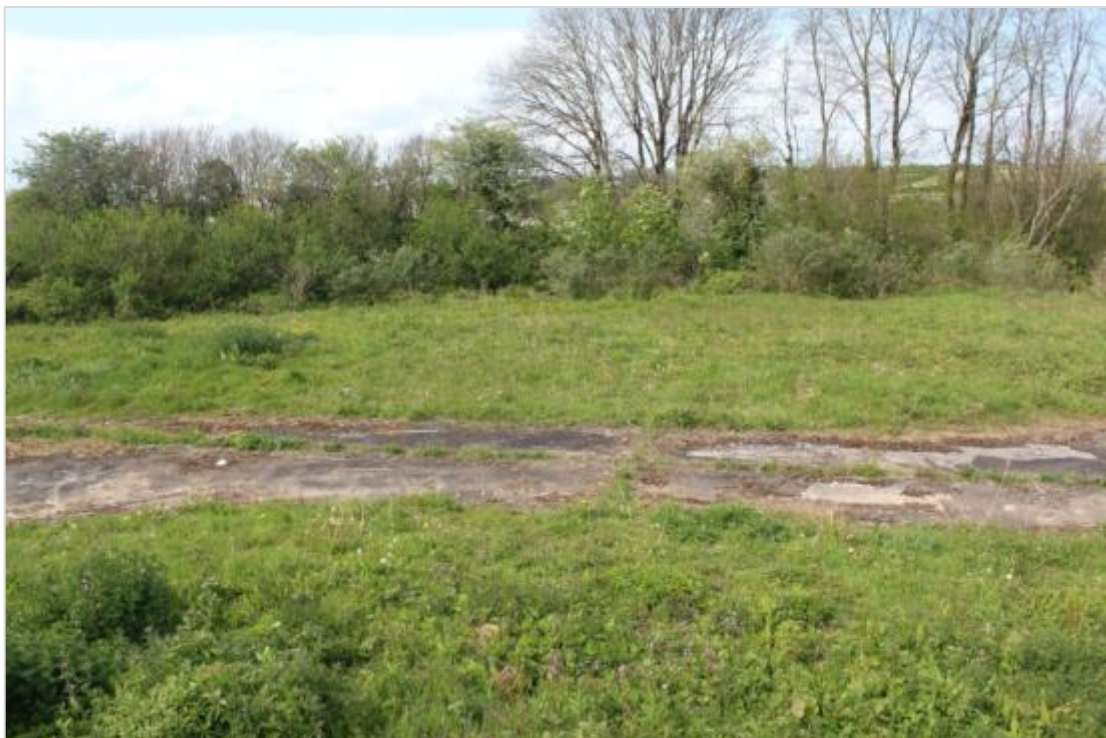
Photo 48: View north: location of Buildings 42 and 43 (Sergeant's Quarters and Ablutions and NAAFI Kiosk); either completely removed or under grass.

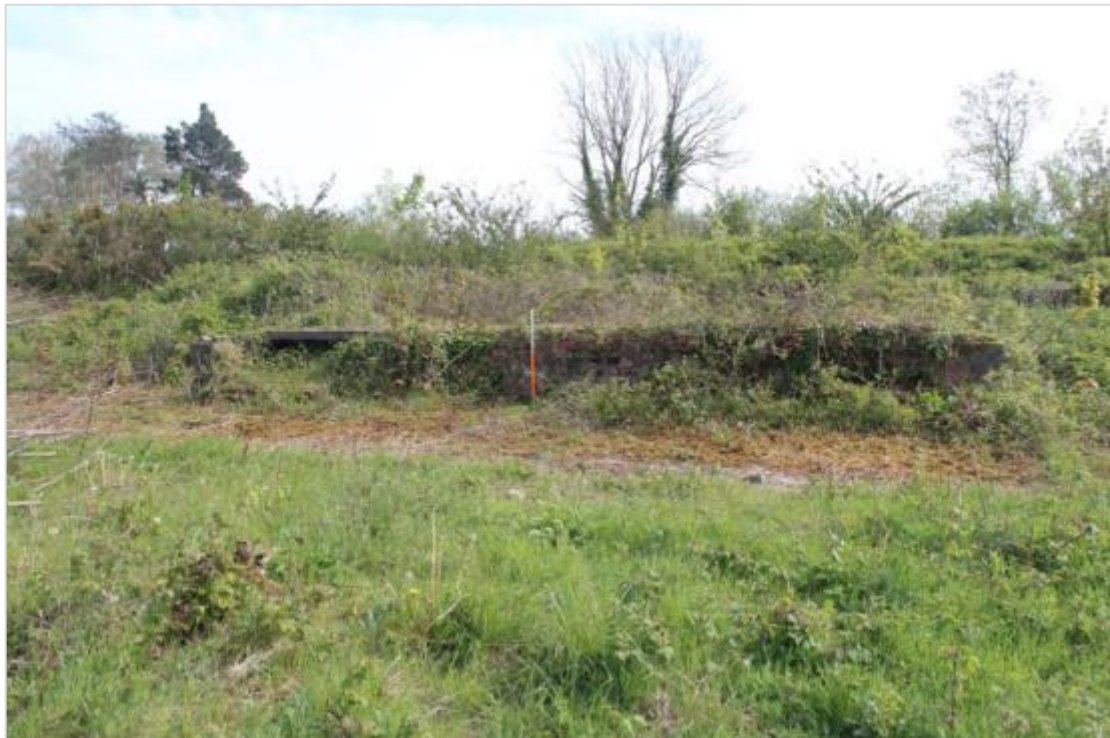
Photo 50: North wall of Building 10 (Dining Room and Institute); wall is approximately 0.9m high.

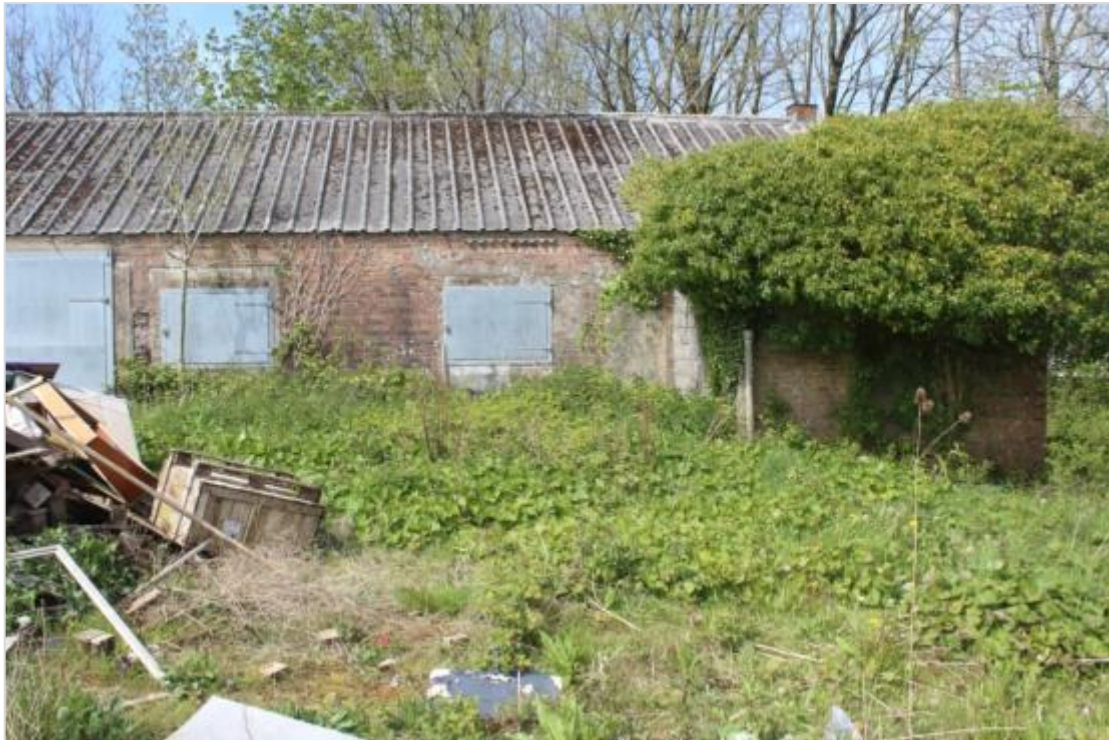
Photo 56: North end of east elevation showing various blocked openings associated with demolished wing (shown in the 1946 Air Ministry Plan).

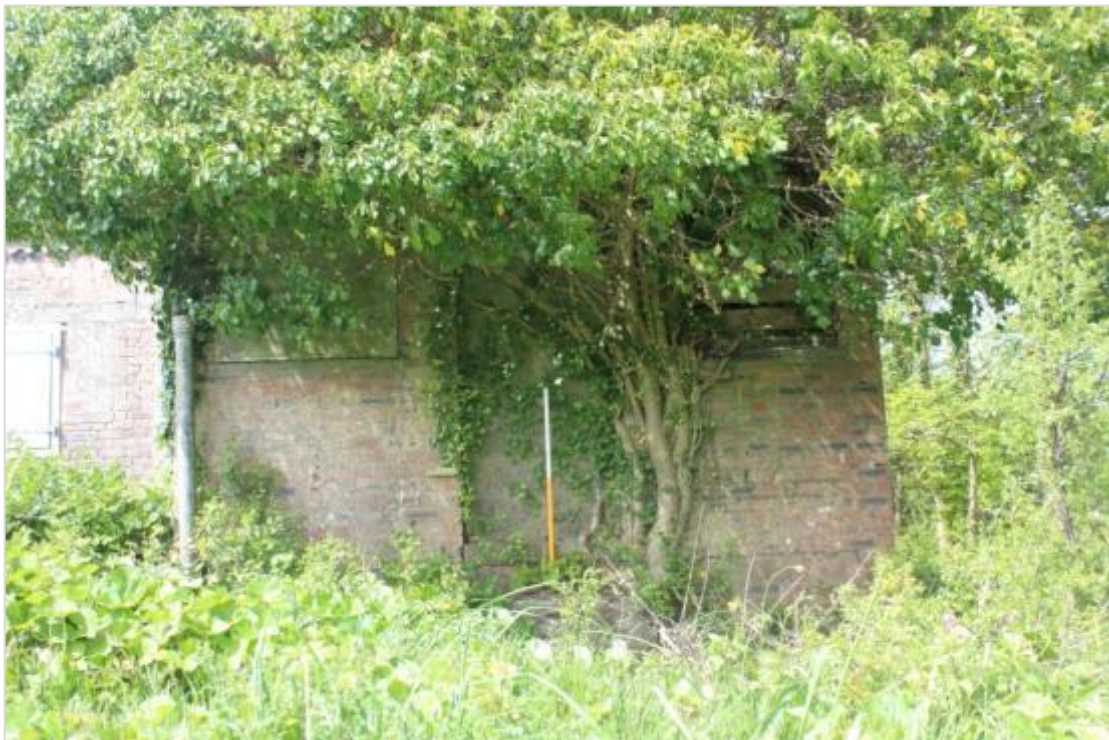
Photo 57: Later brick extension on east elevation with blocked doorway.

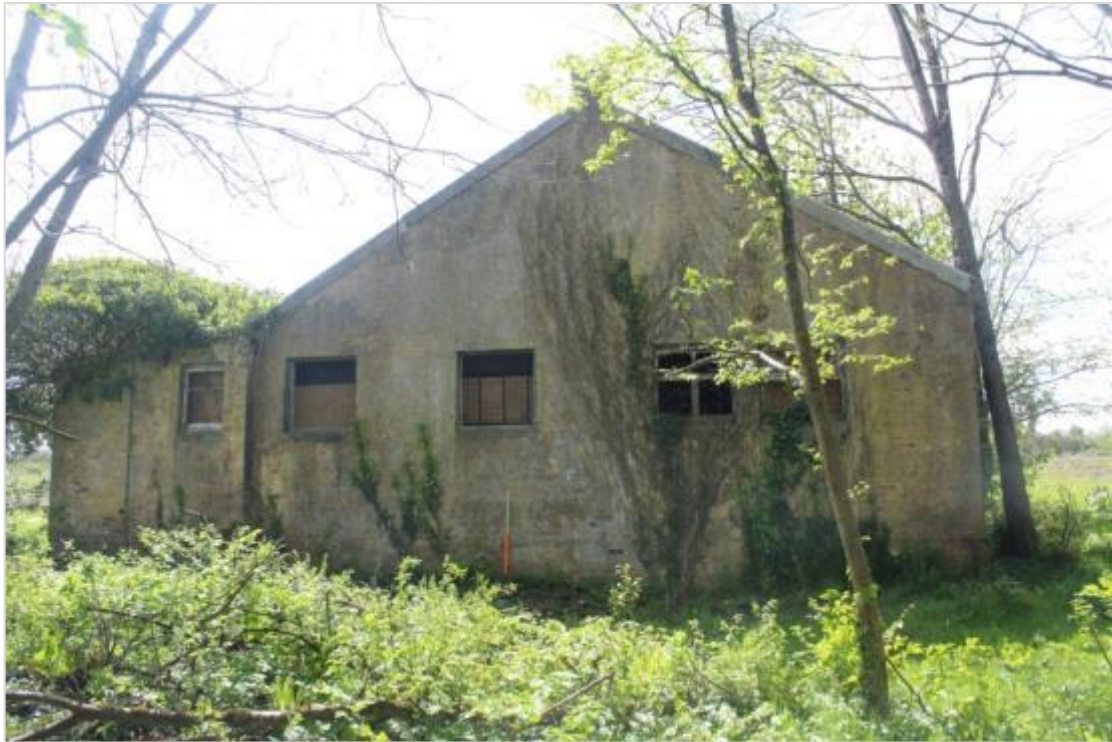
Photo 58: Cement rendered north elevation.

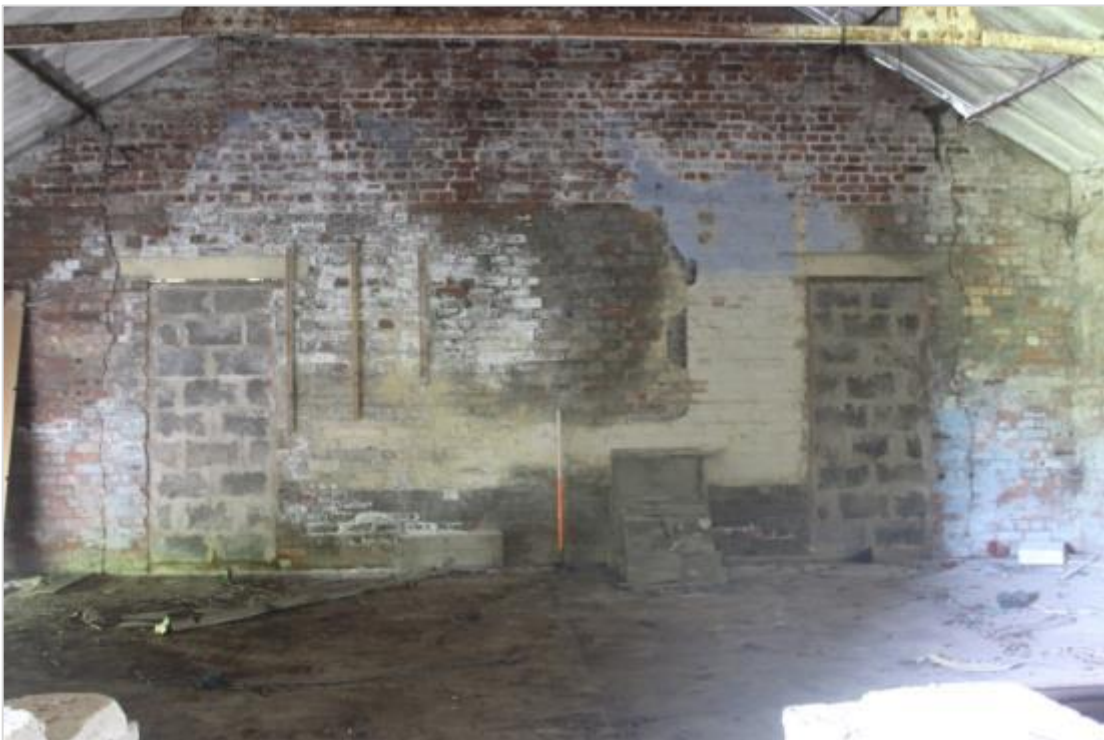
Photo 68: South wall of main room showing two blocked doors that opened onto garage on south side of building.
