TY'N-Y-COED, LLANWRDA, CARMARTHENSHIRE ARCHAEOLOGICAL BUILDING RECORDING

REPORT NO. 2020-22
PROJECT RECORD NO. 121729

February 2020

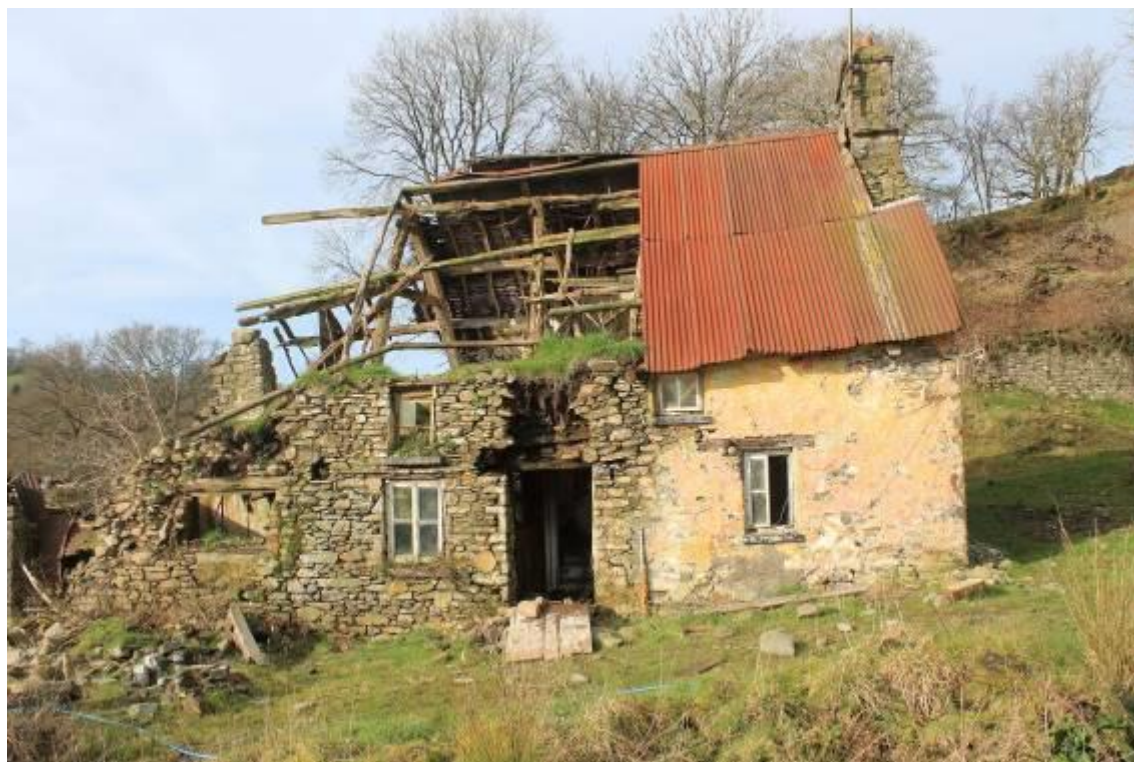
Photo 1: East facing façade of Ty'n-y-coed house. 1m scale

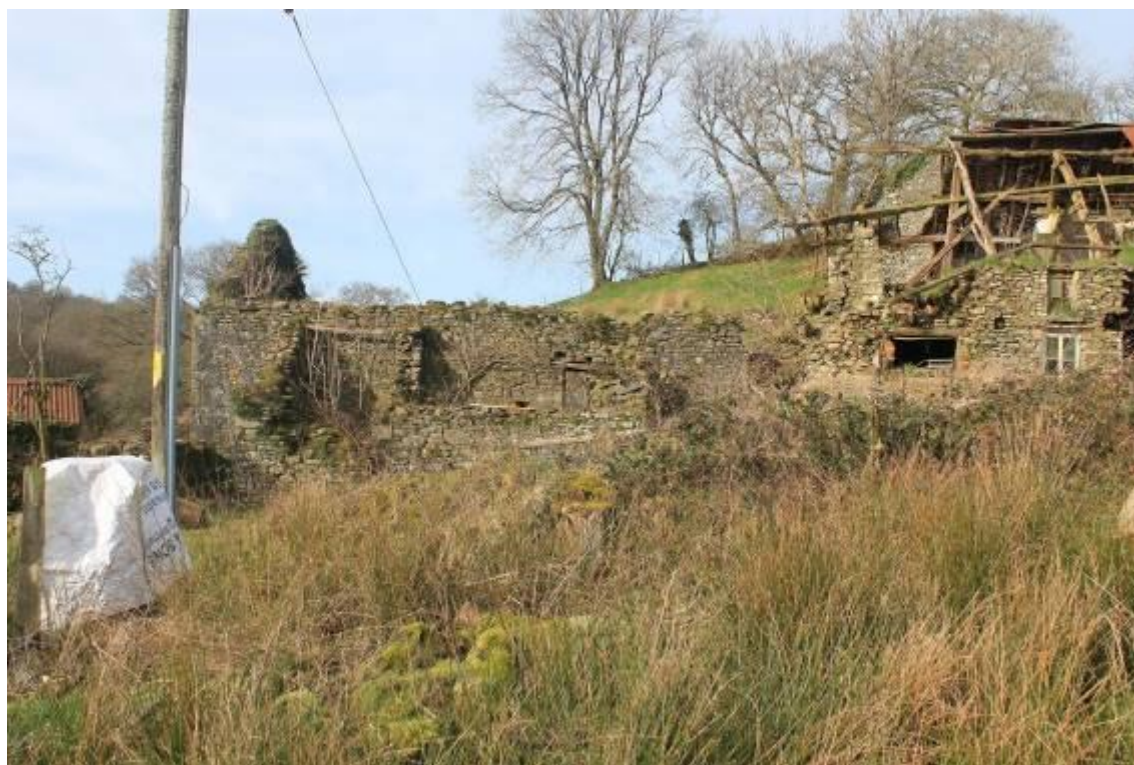
Photo 2: General view of east facing elevation of the byre. 1m scale

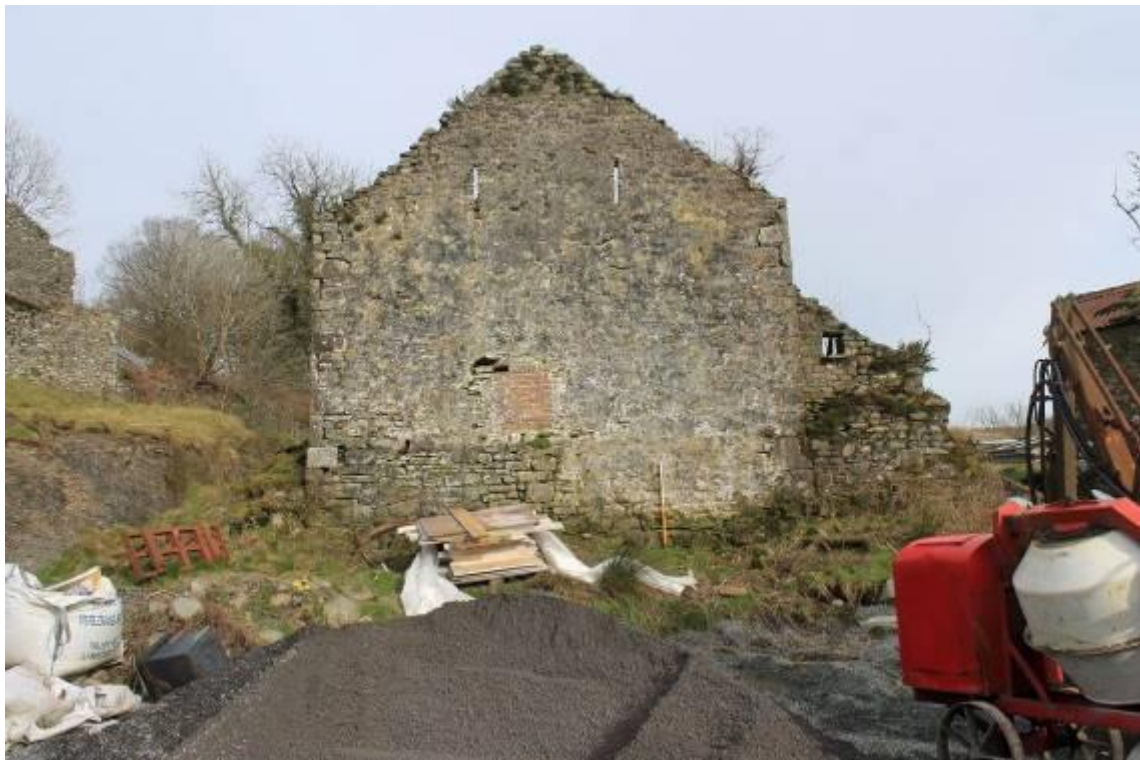
Photo 4: Southern elevation of byre. The surviving remains of a barn can be seen on the left. 1m scale

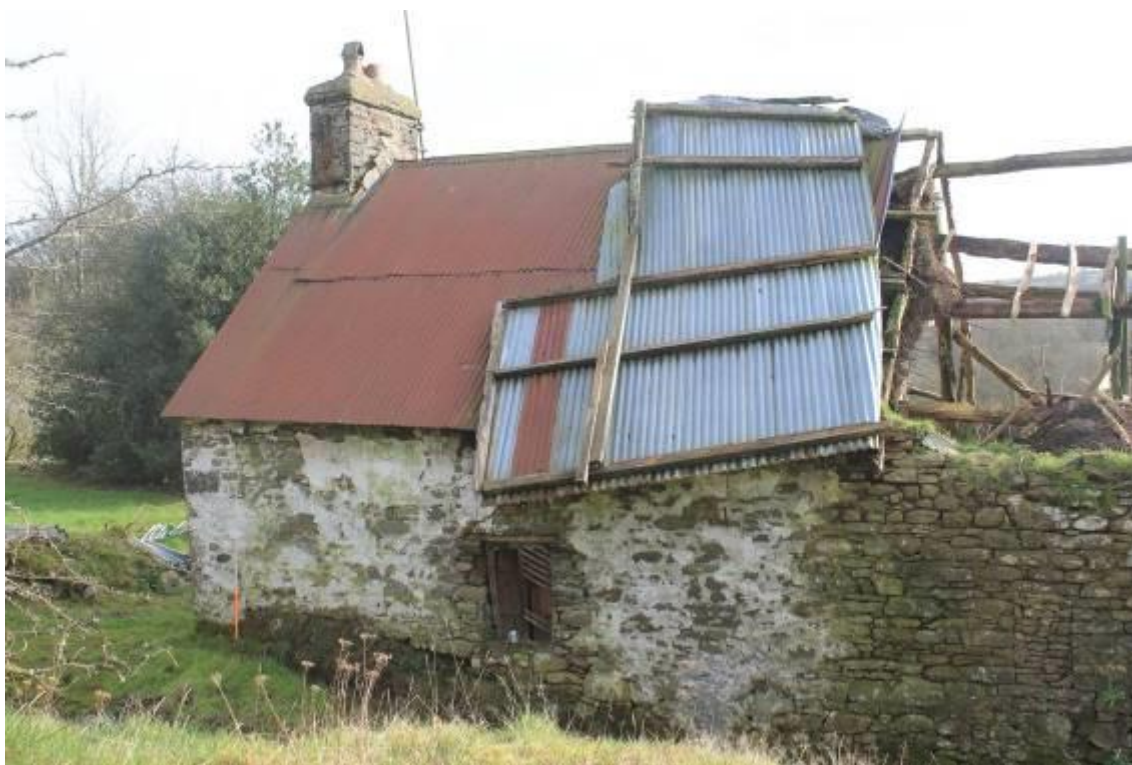
Photo 8: North end of west elevation (window located in dairy). 1m scale

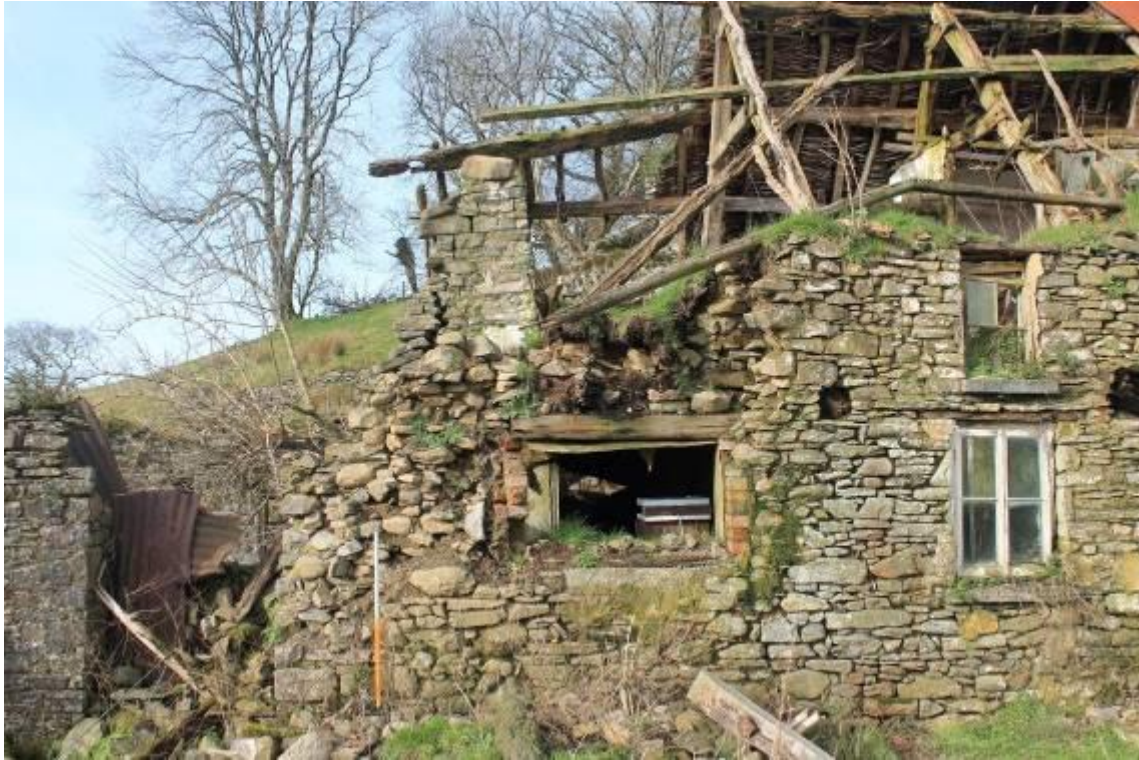
Photo 13: Detail of southern end of house showing modern window (right of 1m scale) and entrance to former cross-passage (left of 1m scale)

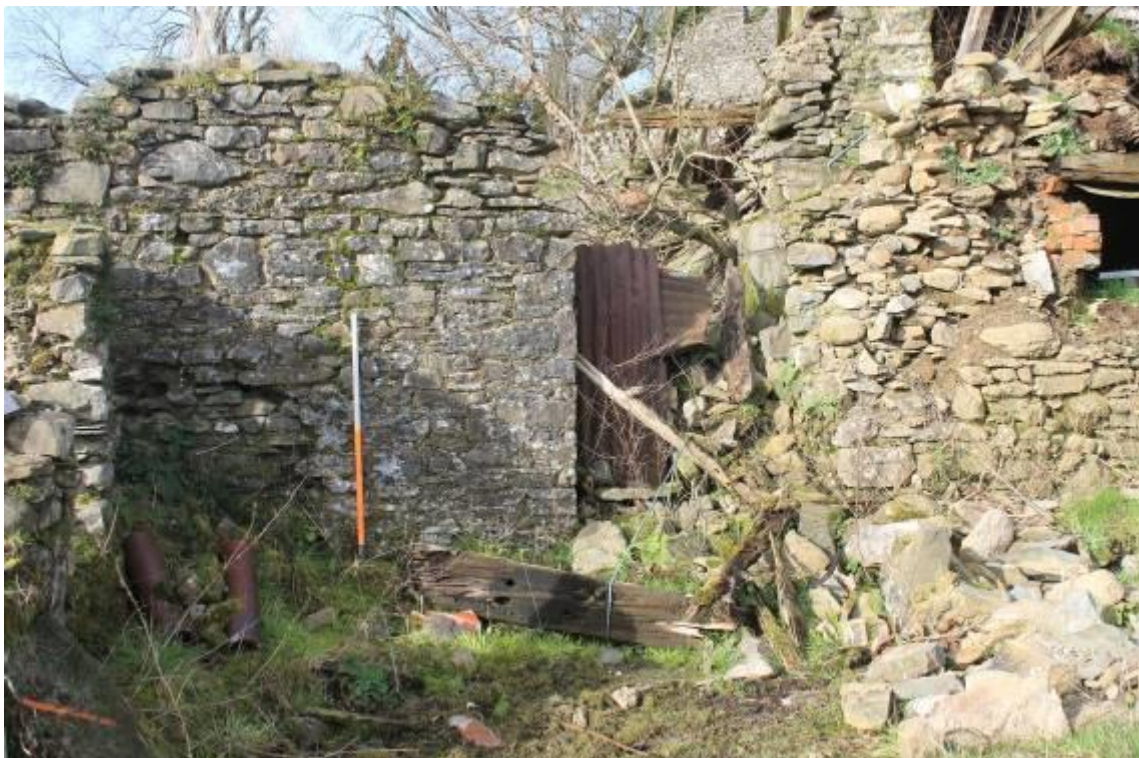
Photo 14: Entrance to former cross-passage (blocked by collapsed masonry).
1m scale

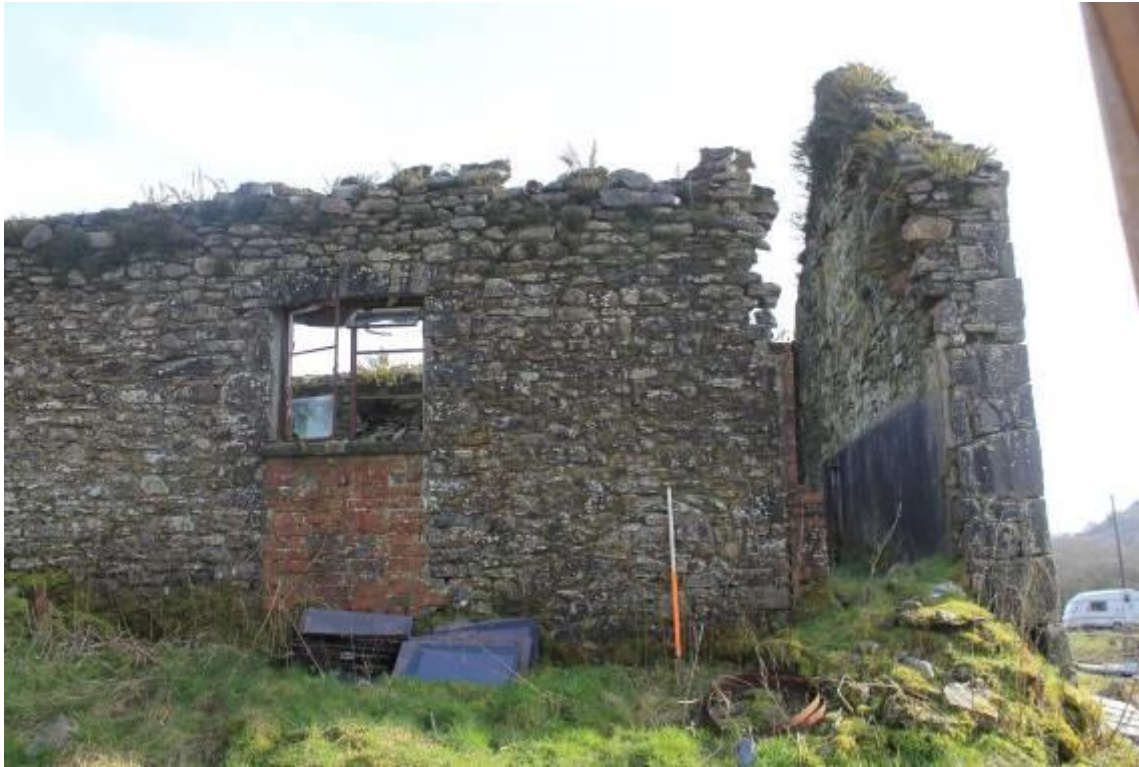
Photo 23: Blocked entrance with stone voussoirs (left of 1m scale) and corner entrance in west wall of byre. 1m scale

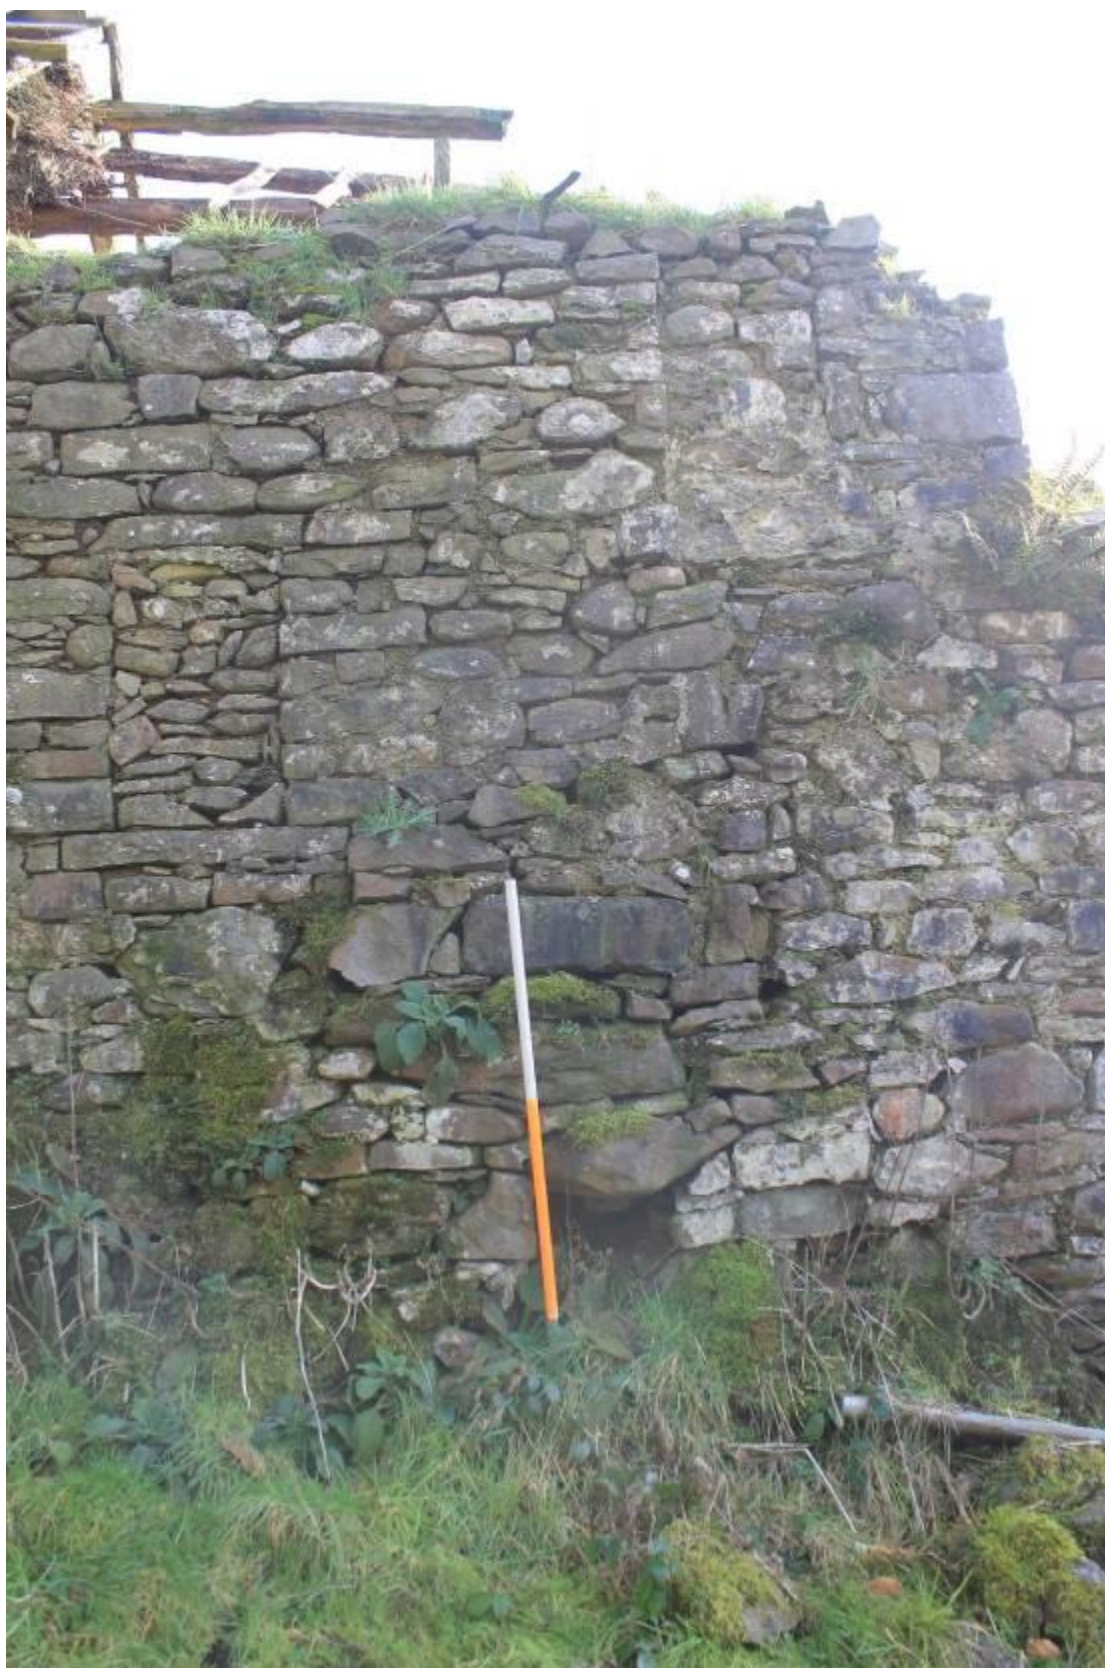
Photo 27: Two blocked windows in south end of west wall of house. 1m scale

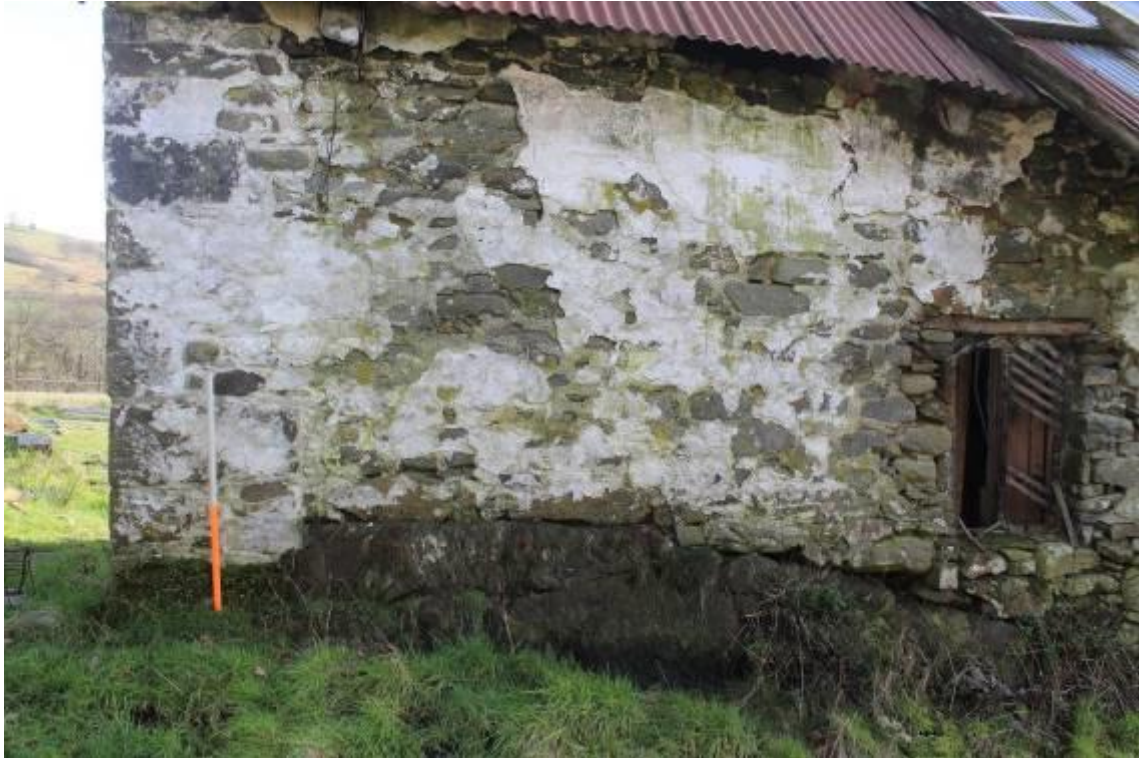
Photo 32: North end of west wall of house (note rising bedrock in wall). 1m scale

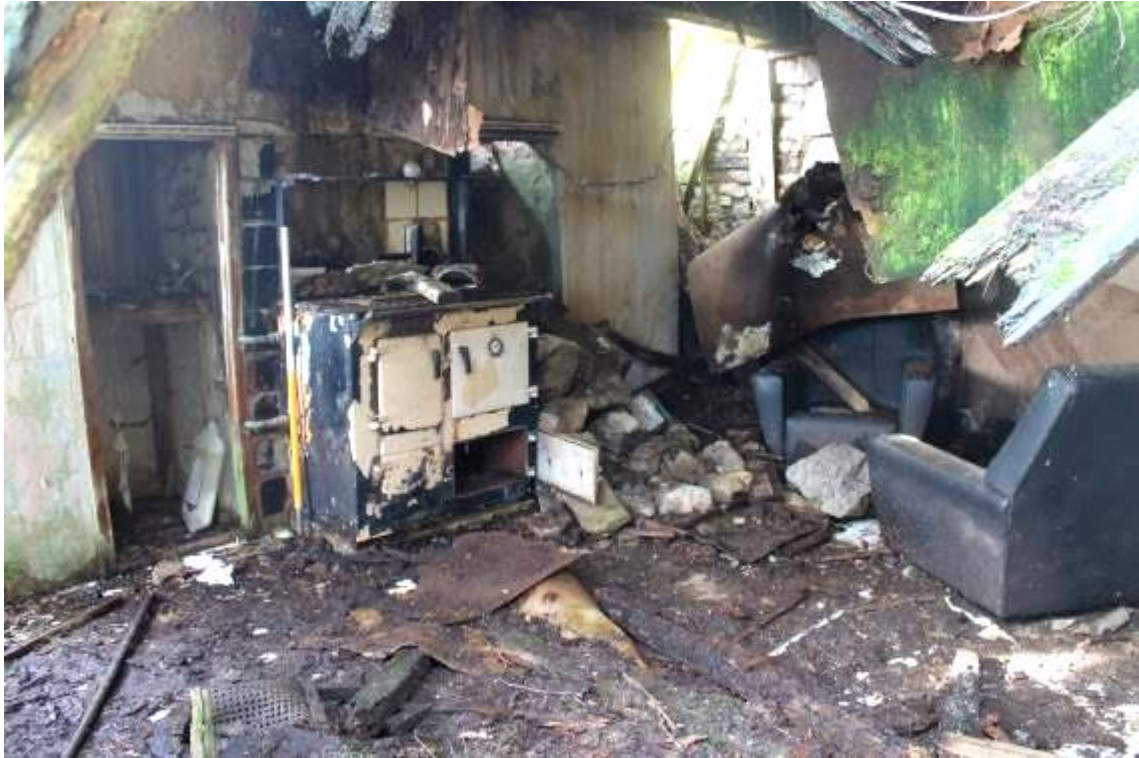
Photo 53: Fireplace in south wall of hall – recesses on either side of Aga represents original width of fireplace. Entrance to stone staircase on the far left.

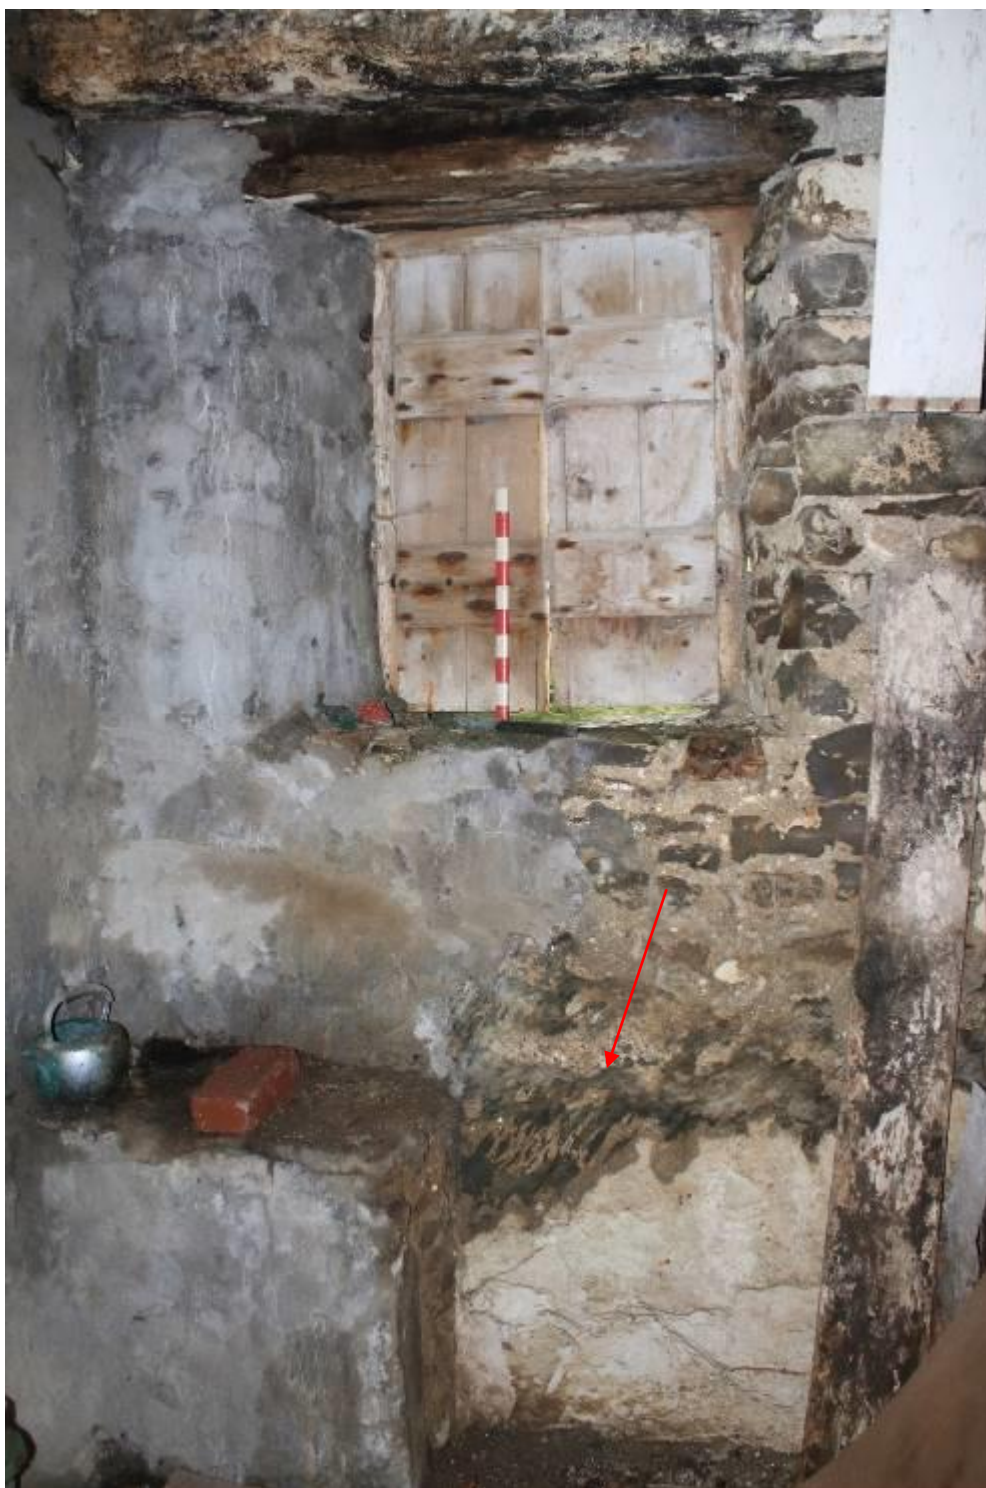
- 3.6 The difference in levels between the external bedrock and the internal dairy floor suggests that the dairy floor has been terraced into the bedrock to create a cooler room temperature. The height of the bedrock in relation to the west window can be seen in Photos 28, 29 and 32. Inside the dairy a small area of bedrock (0.65m higher than the floor) can be seen below the window in the north wall (Photo 60).

Photo 60: Shuttered window in north wall of dairy (top of bedrock arrowed)

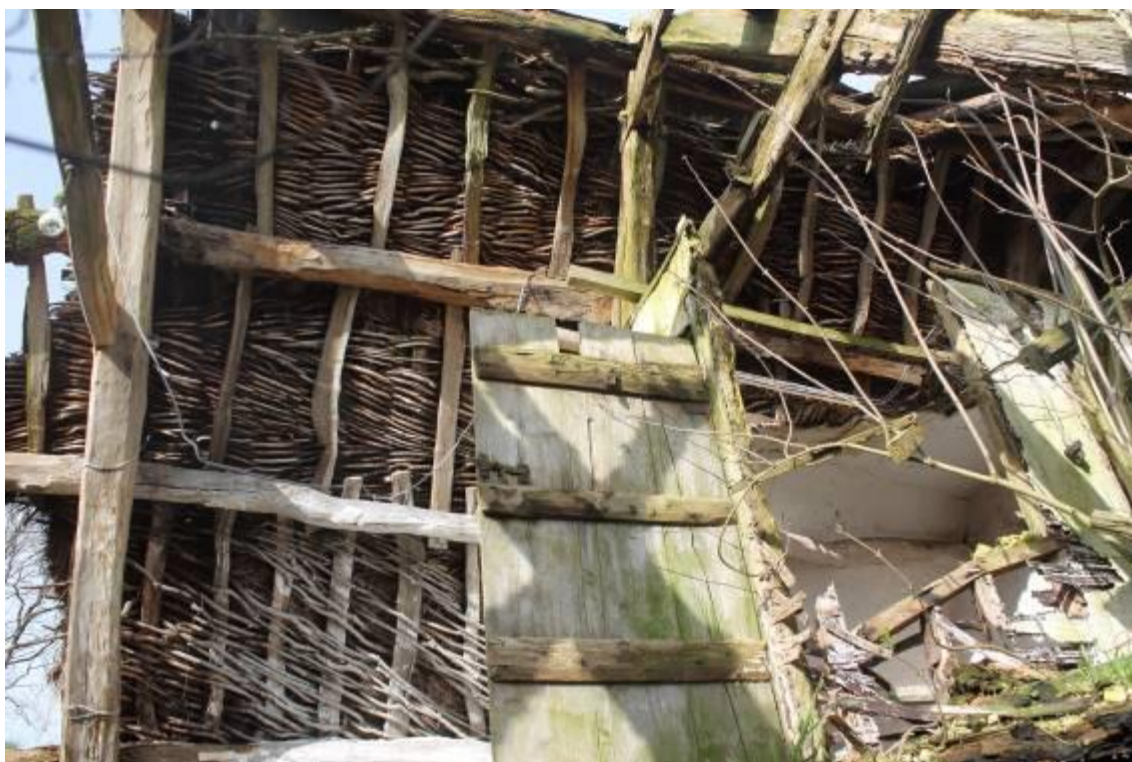
Photo 73: Exposed roof in south end of house showing part of yoked apex, purlins, split ash rafters and underthatch of hazel

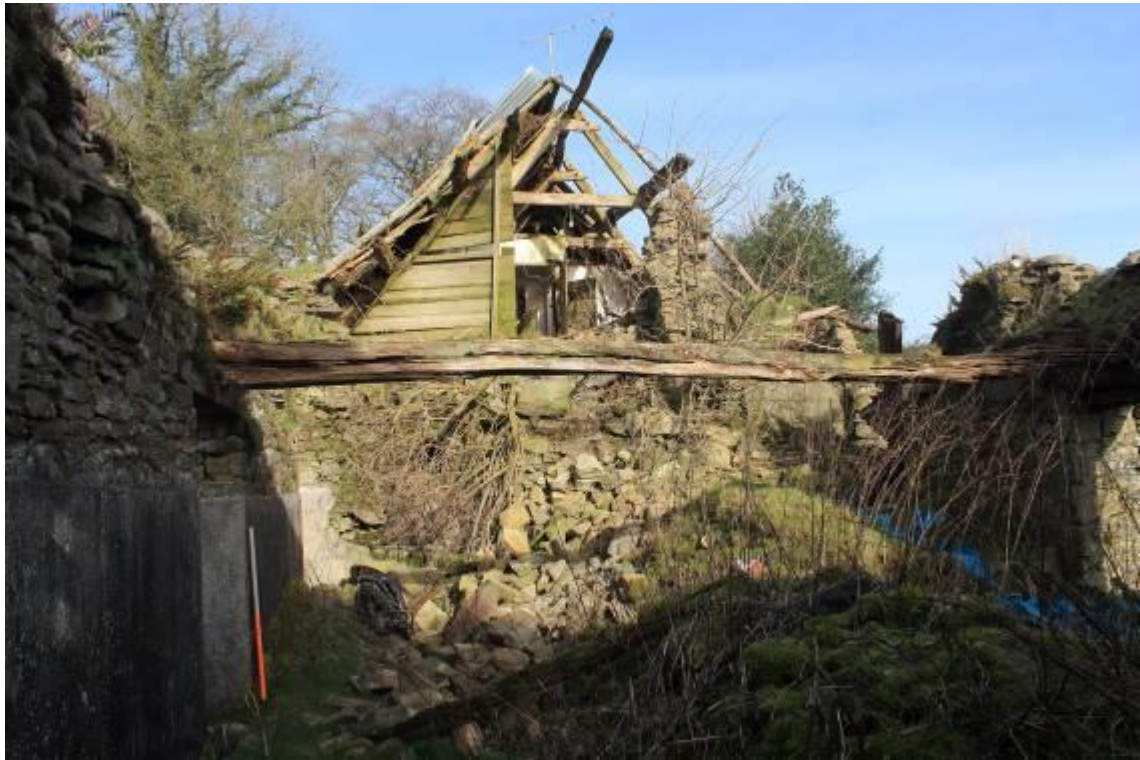
Photo 77: North end of byre (wall is obscured by collapse of south gable end); one of a pair of cross-beams shown.

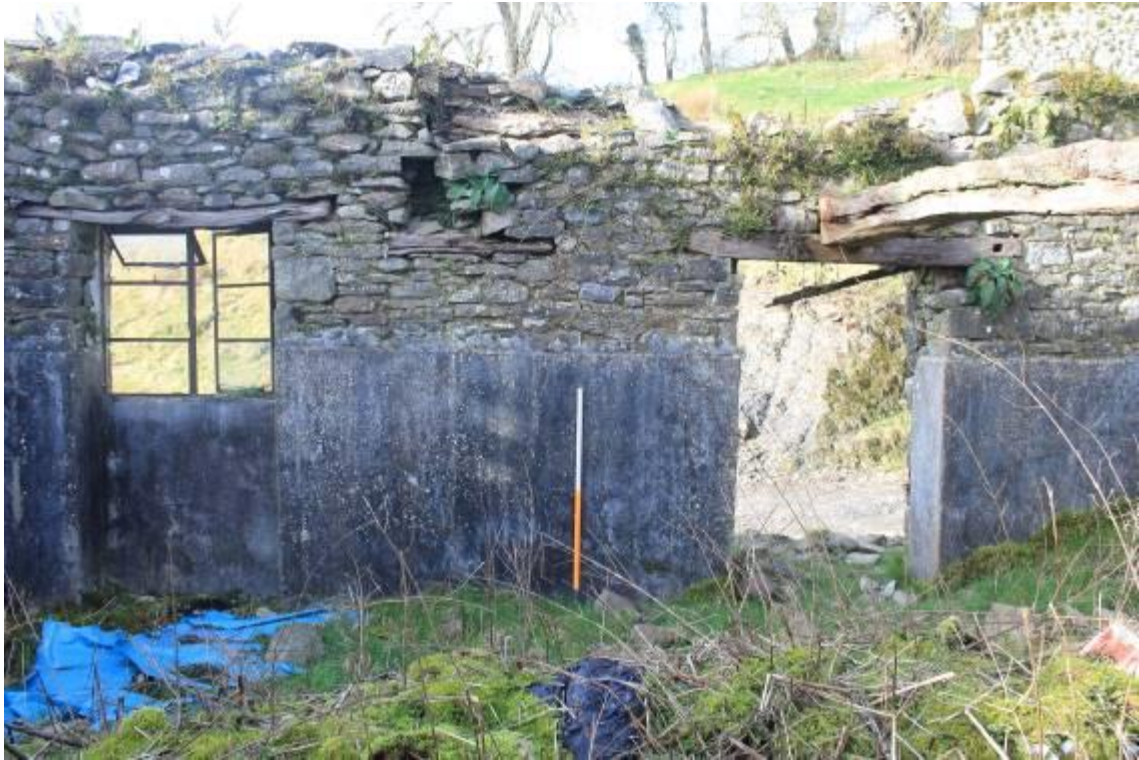
Photo 81: Two openings in west wall of byre (one blocked and window inserted)
(south end)
