YMCA, LLANELLI, CARMARTHENSHIRE

HISTORIC BUILDING RECORDING

REPORT NO. 2020-47
EVENT RECORD No.125512

September 2020

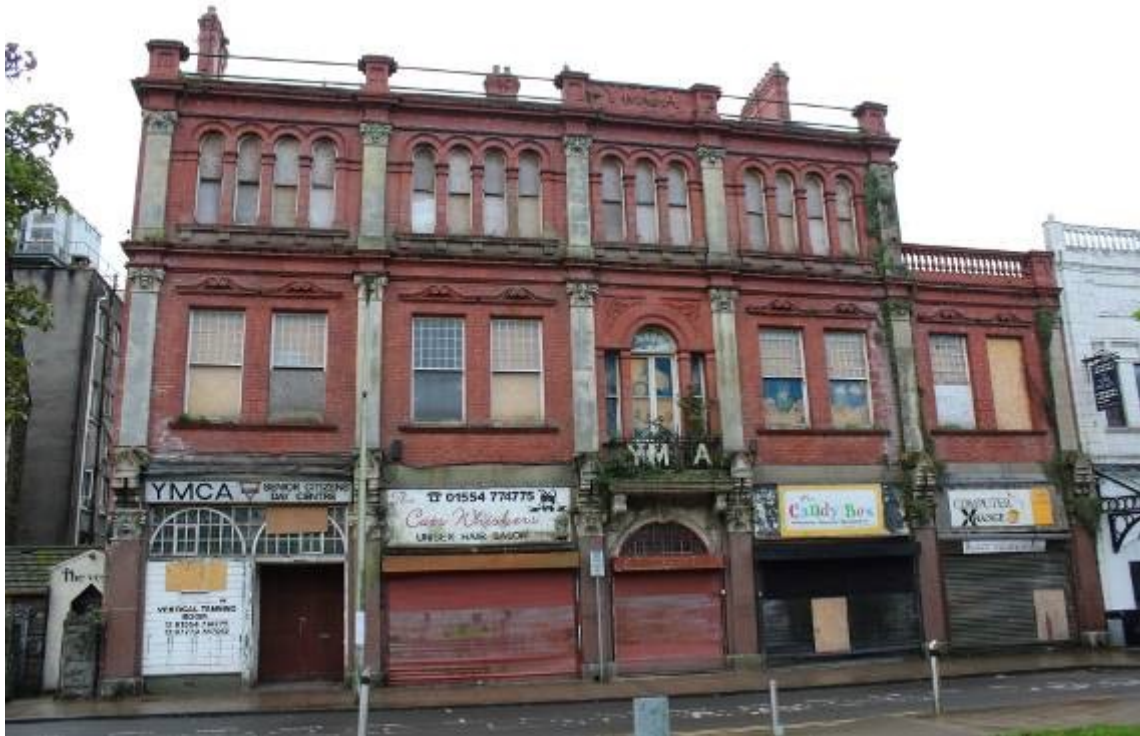
Photo 1: Southeast facing shot of the Stepney Street frontage to the YMCA.

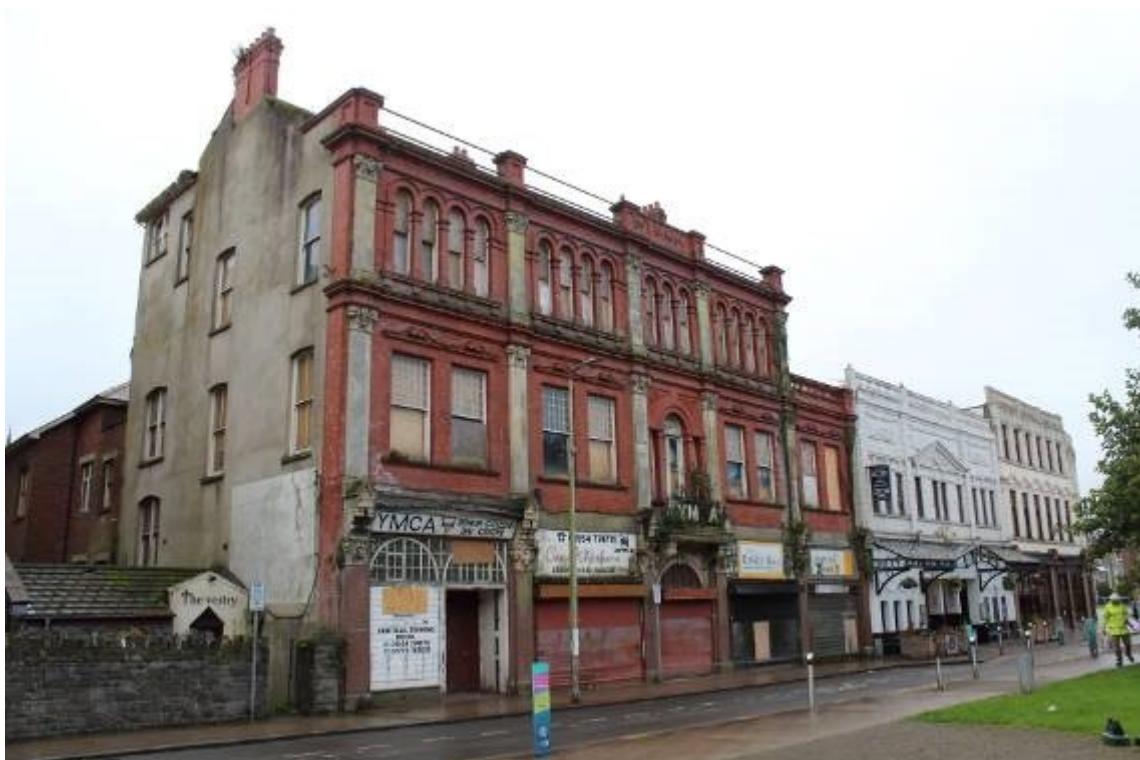
Photo 2: South facing shot of the YMCA in its street frontage setting.

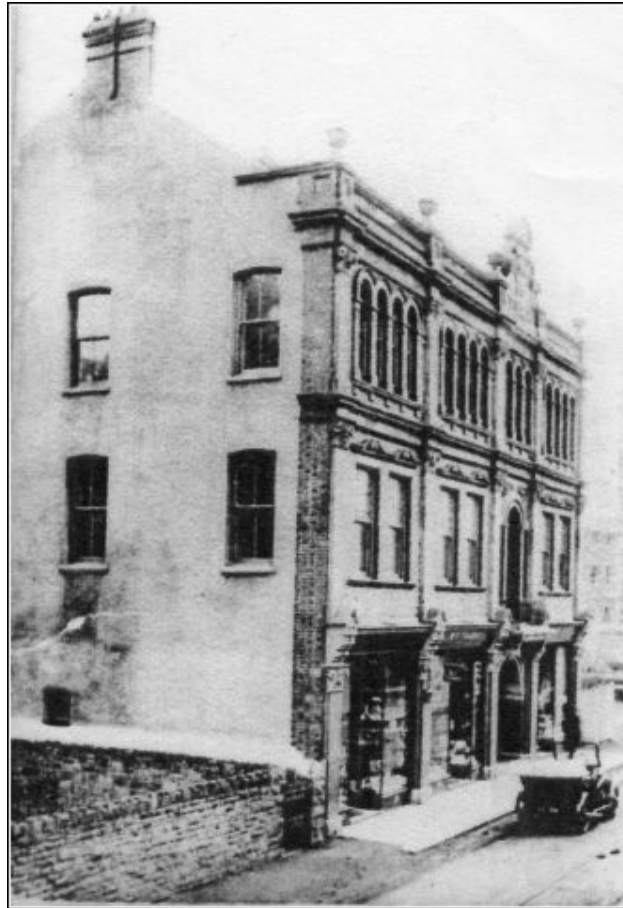
- 3.5 Initial photographs (Photo 1) indicate the building was built as a four-bay structure, but presumably accommodating the shops and rooms laid out in the initial contract. The 1916 Ordnance Survey map suggests that the additional shop may have been added on the west side of the building by that time (figure 3), and the façade shows no change in design other than in height. It is uncertain when the building was extended to the rear, to accommodate the promised gymnasium, but this extension is visible on Ordnance Survey maps of 1950. It is not known if the proposed swimming pool was ever eventually built.

Photo 3: The YMCA, taken shortly after its construction, showing the original 4-bay structure. Photo courtesy of Lanelli Library.

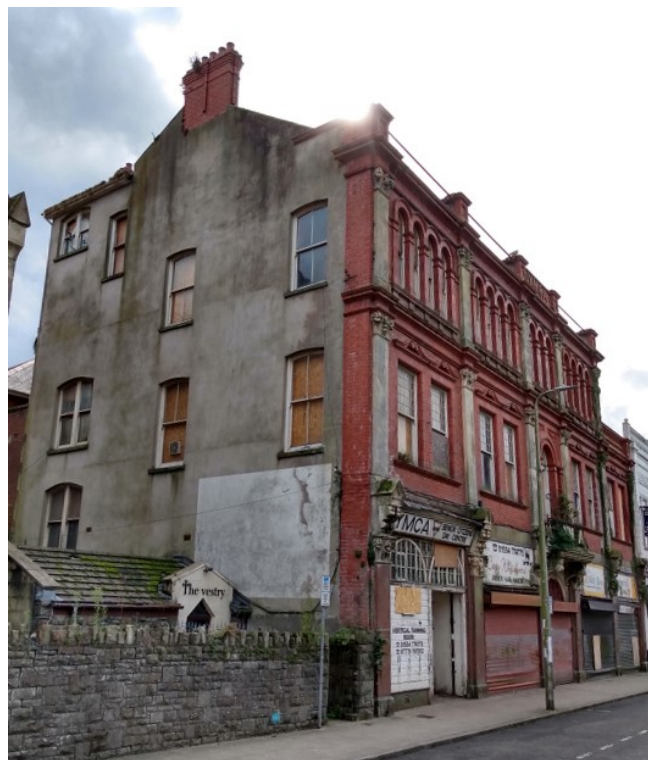
Photo 4: Current view replicating Photo 3, demonstrating remarkably little change in the outer appearance of the original structure below roof level.

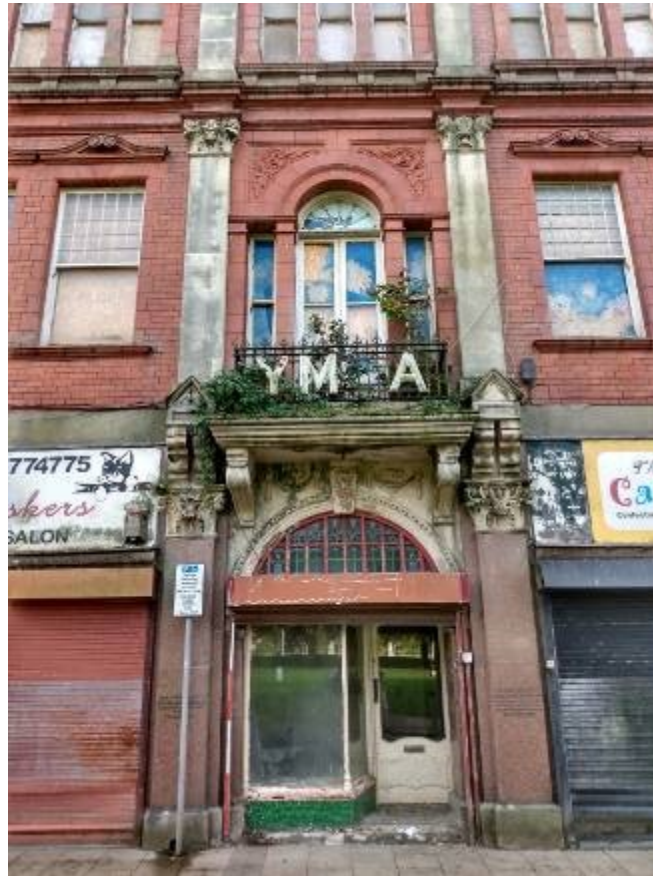
Photo 5: Southeast facing shot of the original central entrance to the YMCA, with shop conversion within. 2m scale.

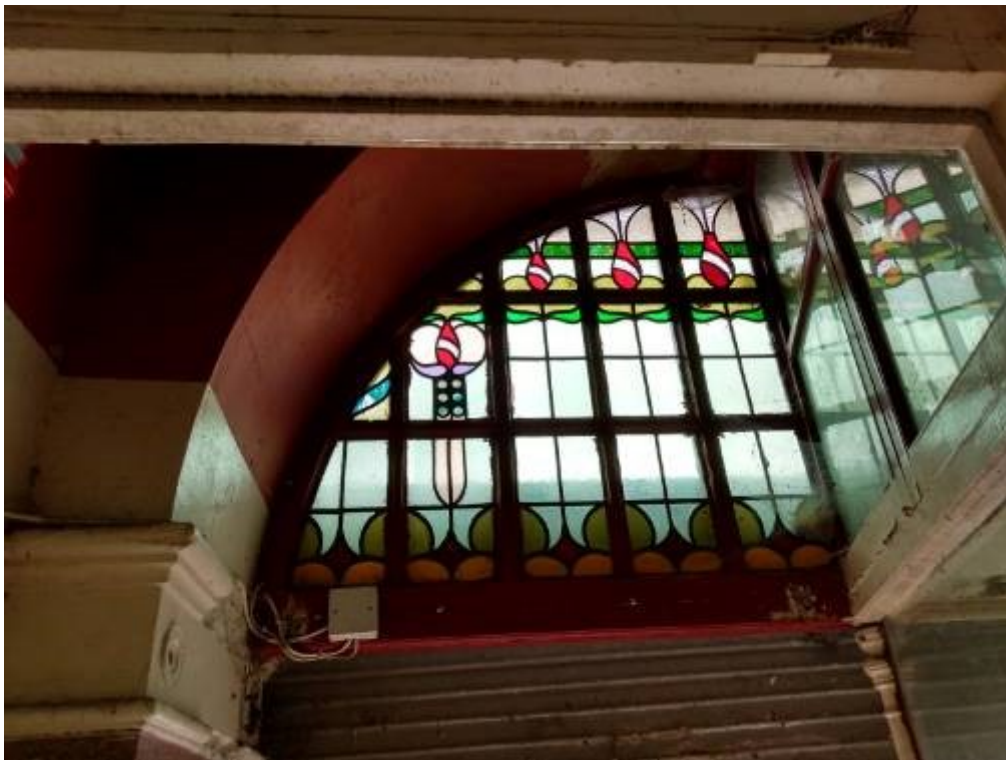
Photo 6: Detail of the window design above the original central entrance, as seen from the inside.

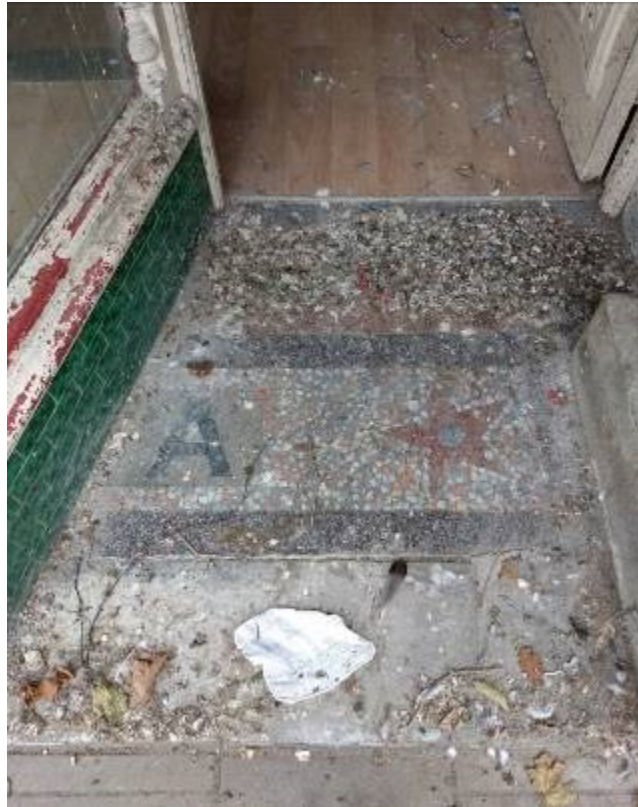
Photo 7: Detail of the original central entrance step, likely originally spelling 'YMCA', but since covered by the shop conversion.

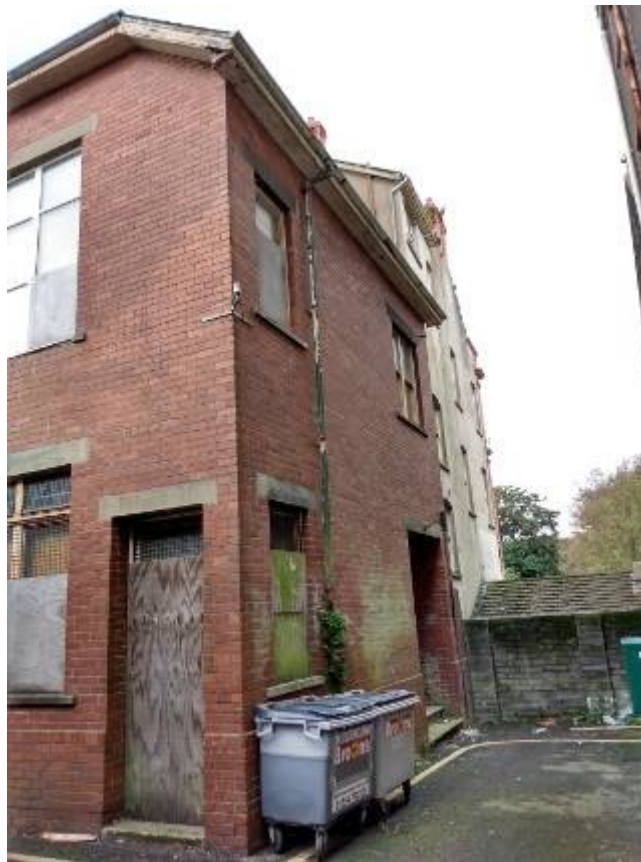
Photo 8: WNW facing shot showing the gable end of the mid-20th century rear extension to the YMCA.

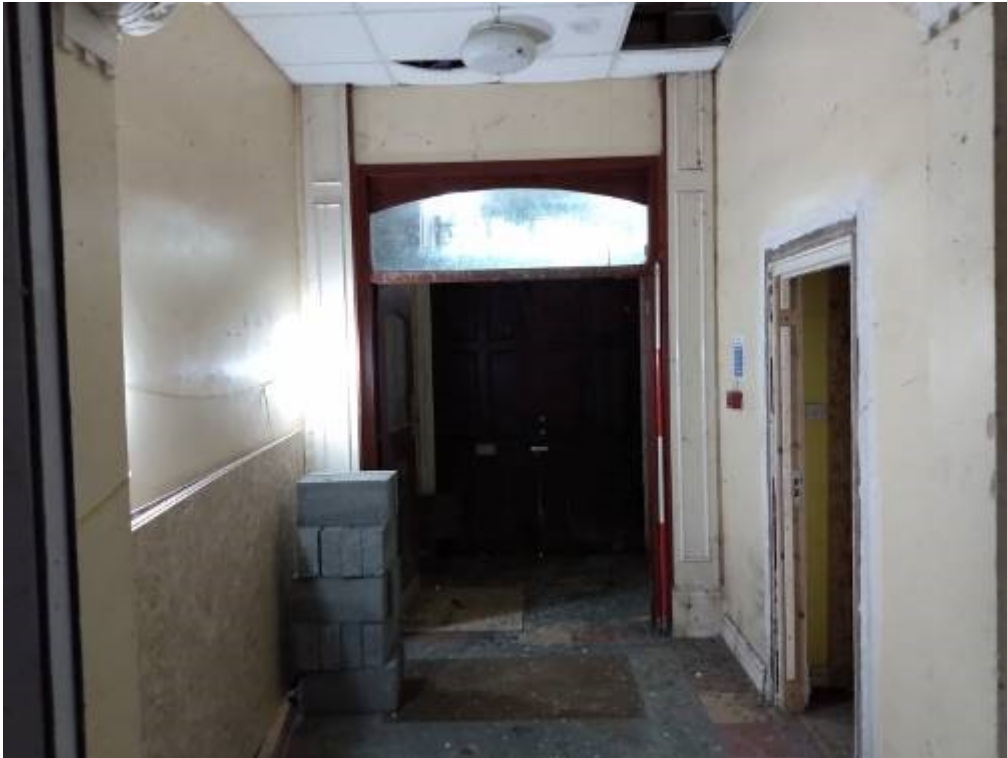
Photo 10: Northwest facing shot of the current main entrance. The left wall and decorated pillars may be original, the remaining features are later inserts
2m scale.

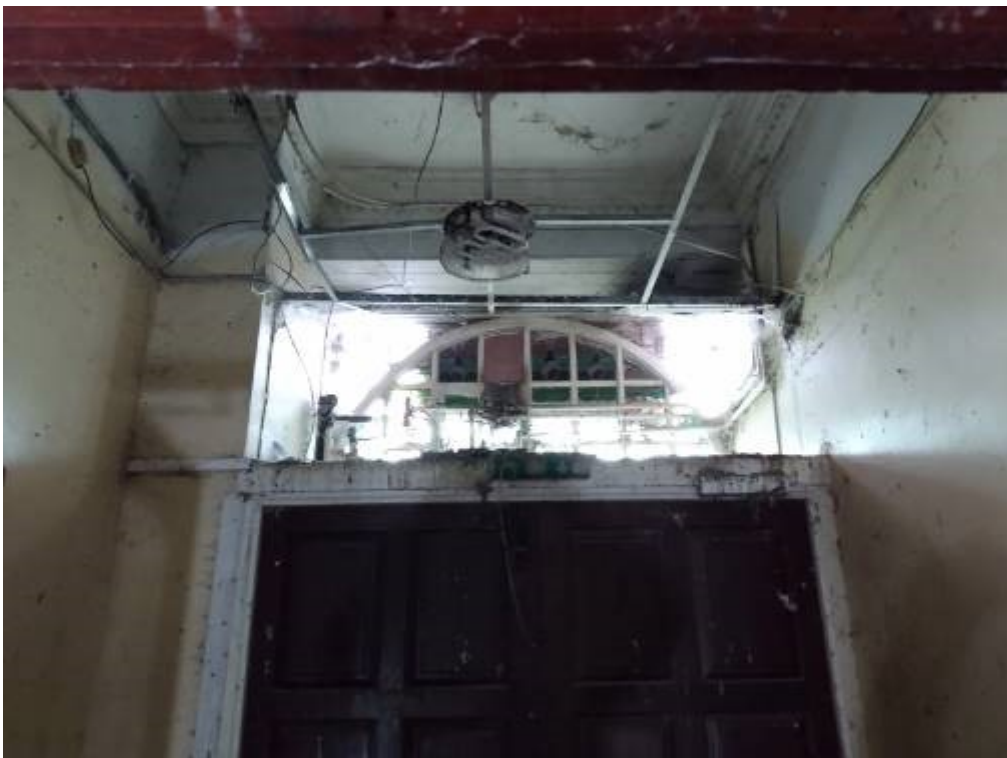
Photo 11: Detail of the window design and original ceiling above the later inserted doorway.

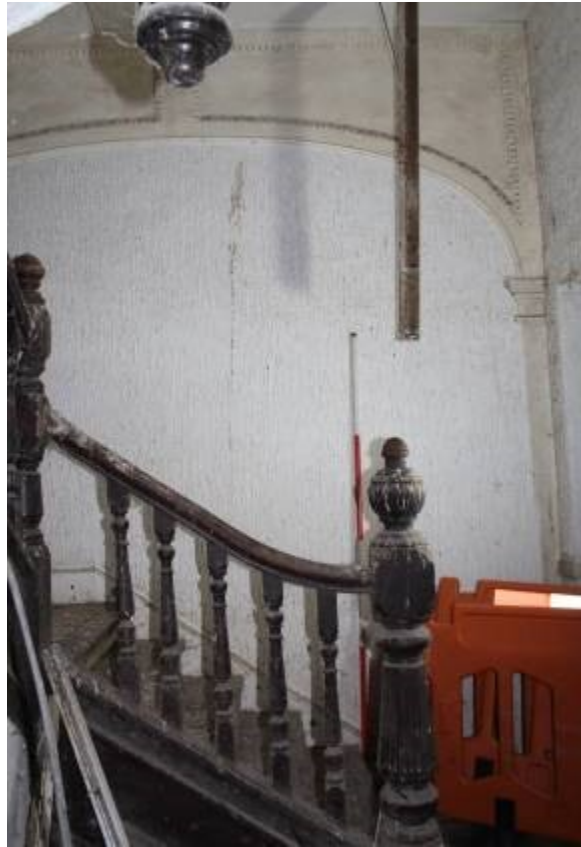
Photo 14: Southwest facing shot of the foot of the main staircase with the infilled archway behind. 2m scale.

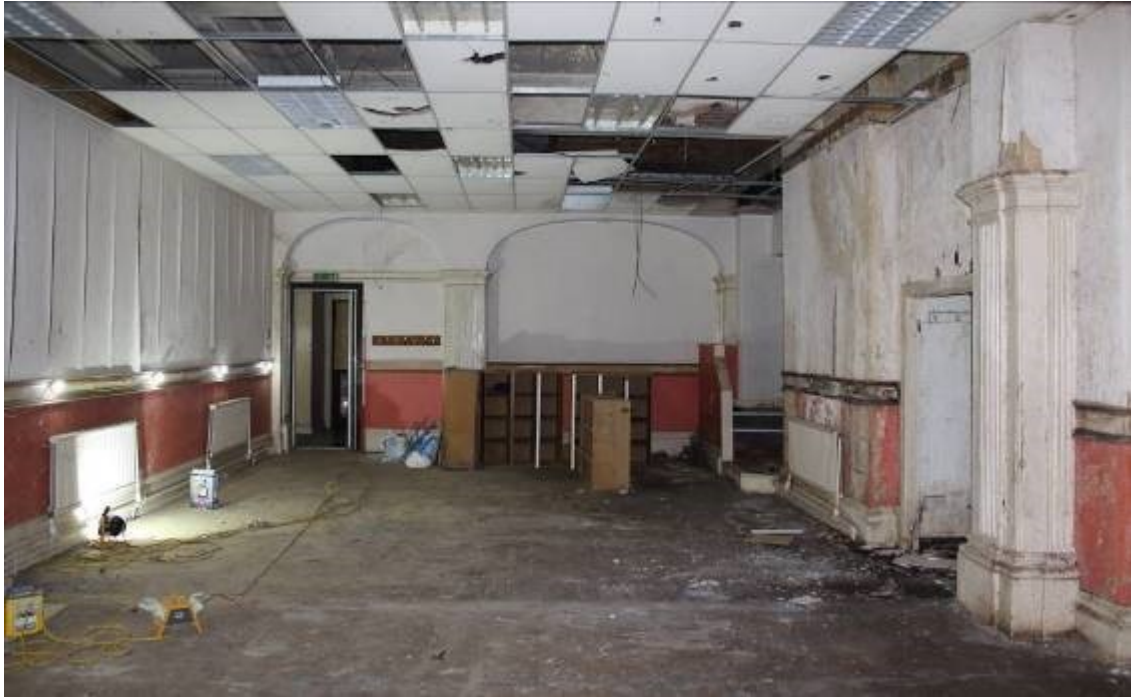
Photo 15: Northeast facing shot of the main hall room with infilled arches to the rear. 2m scale.

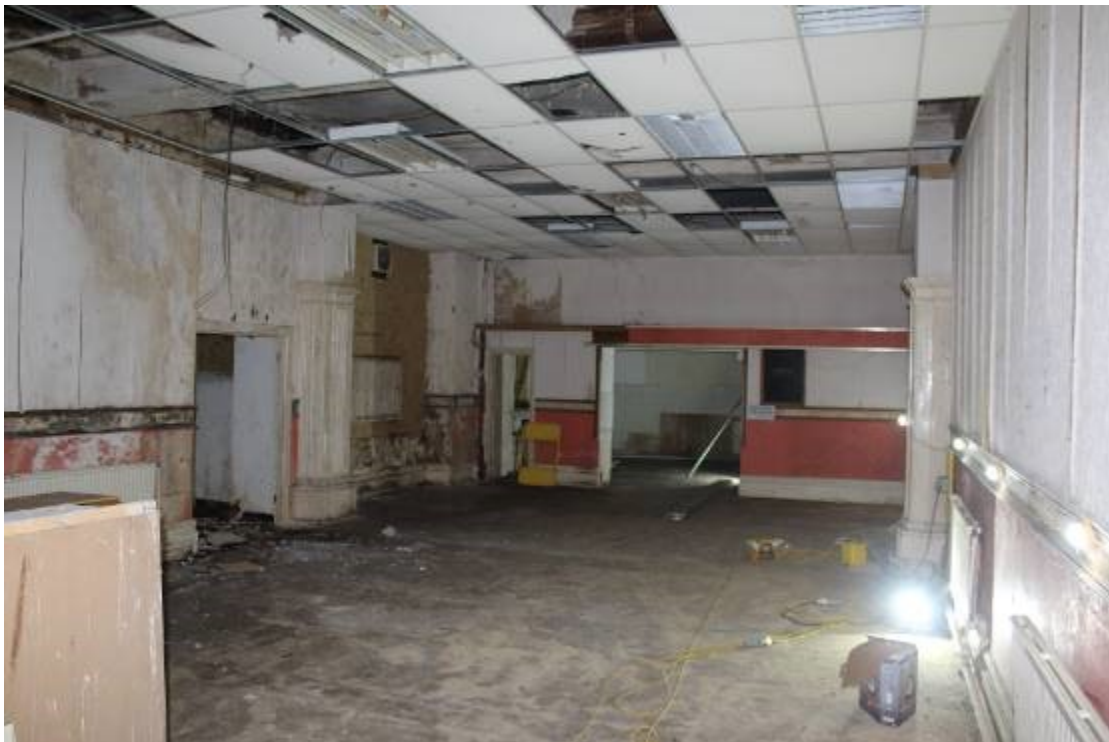
Photo 16: Southwest facing of the main hall room, with kitchen opening to the rear, potentially inserted through a former fireplace. 2m scale.

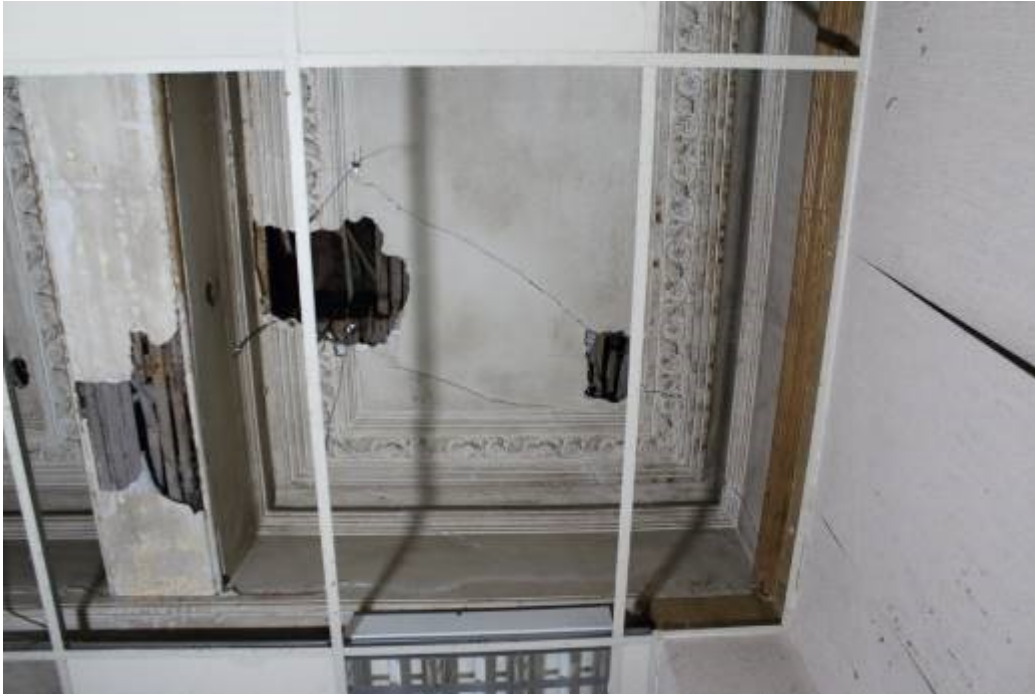
Photo 17: Detail of original ceiling within the main hall.

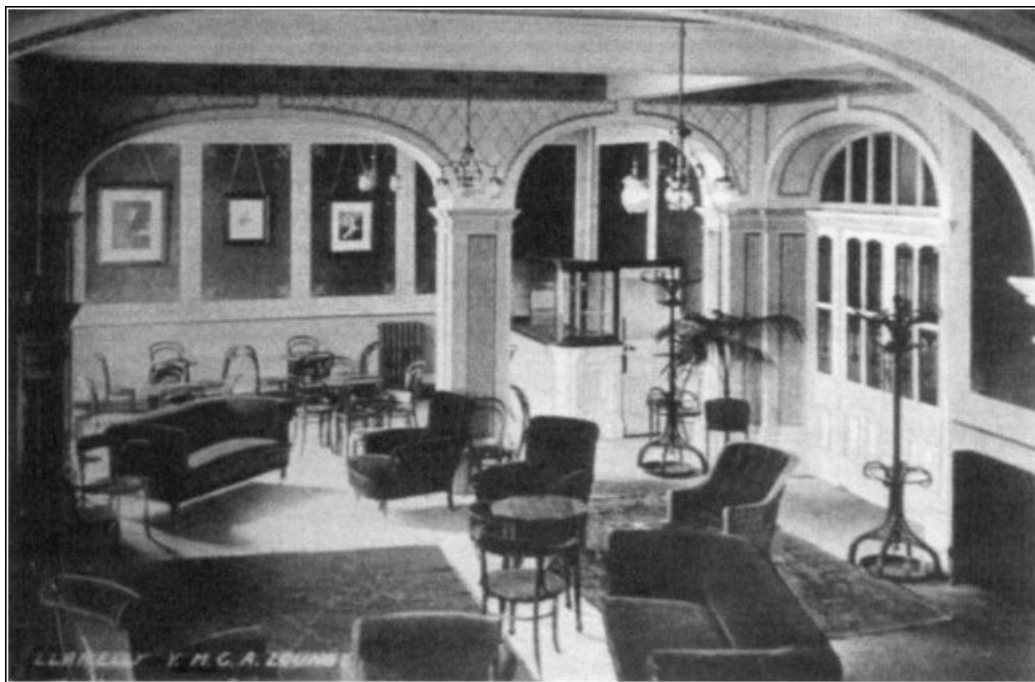
Photo 18: Interior shot for the YMCA shortly after construction. The presence of the arched openings suggests this is the ground floor, but as the openings do not correspond directly to remaining features, it is possible the external walls (including the doorway) and internal arches have since been altered or removed. Photo courtesy of Llanelli Library.

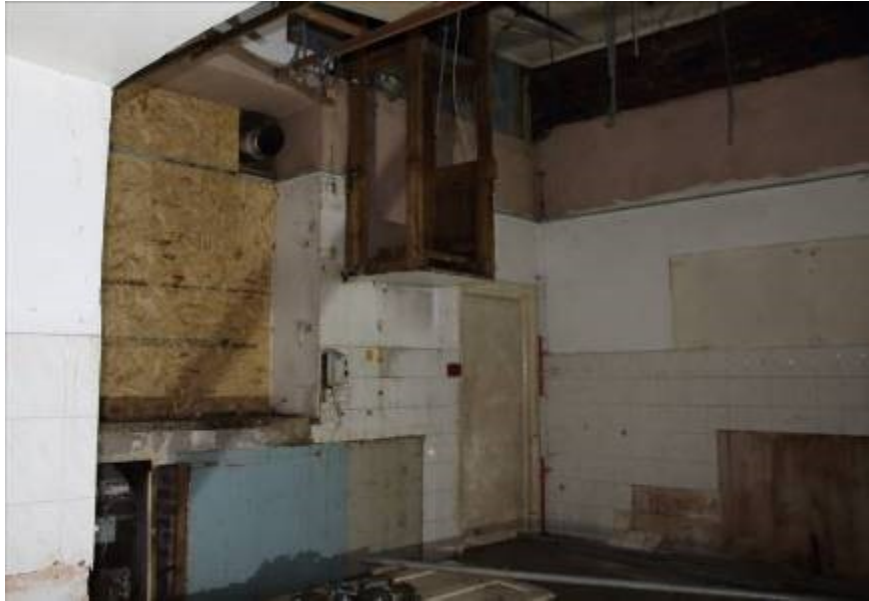
Photo 19: South facing shot of the kitchen, showing rear passage access and boarded-up original rear window. 2m scale

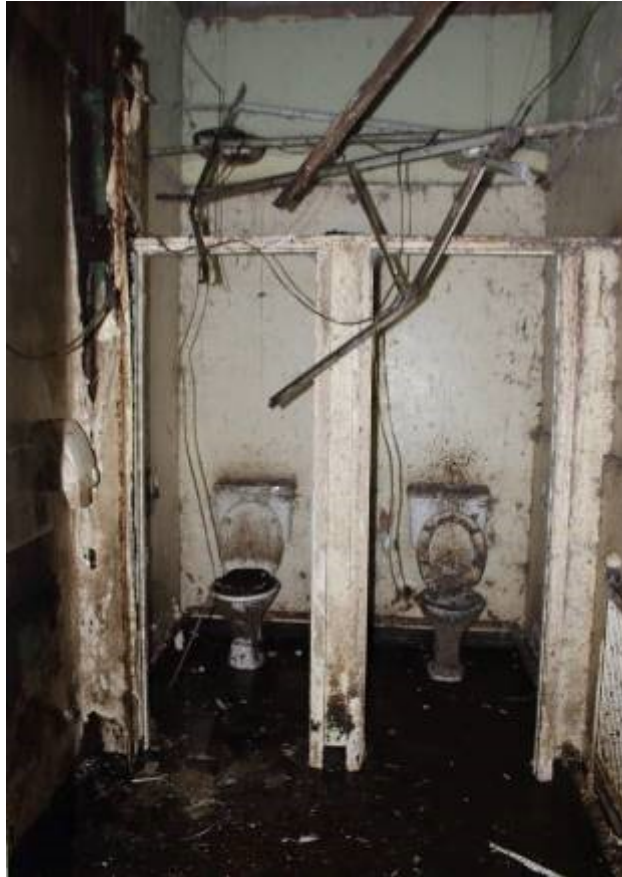
Photo 21: Southeast facing shot of toilet furniture in central WC block.

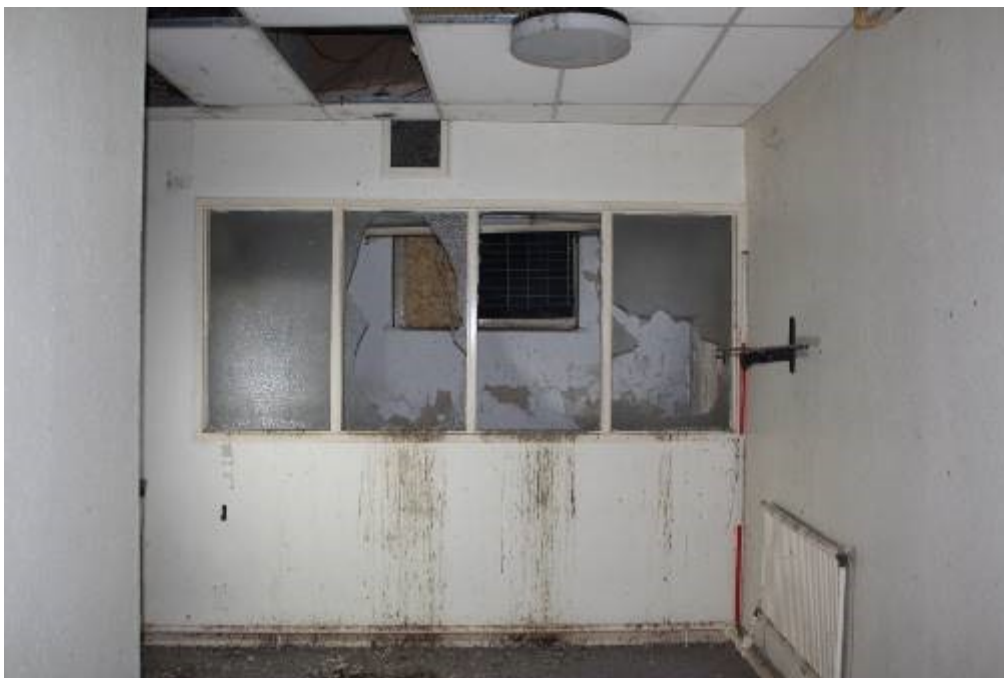
Photo 22: Northeast facing shot of side room to the main hall, showing windows to an internal corridor. 2m scale

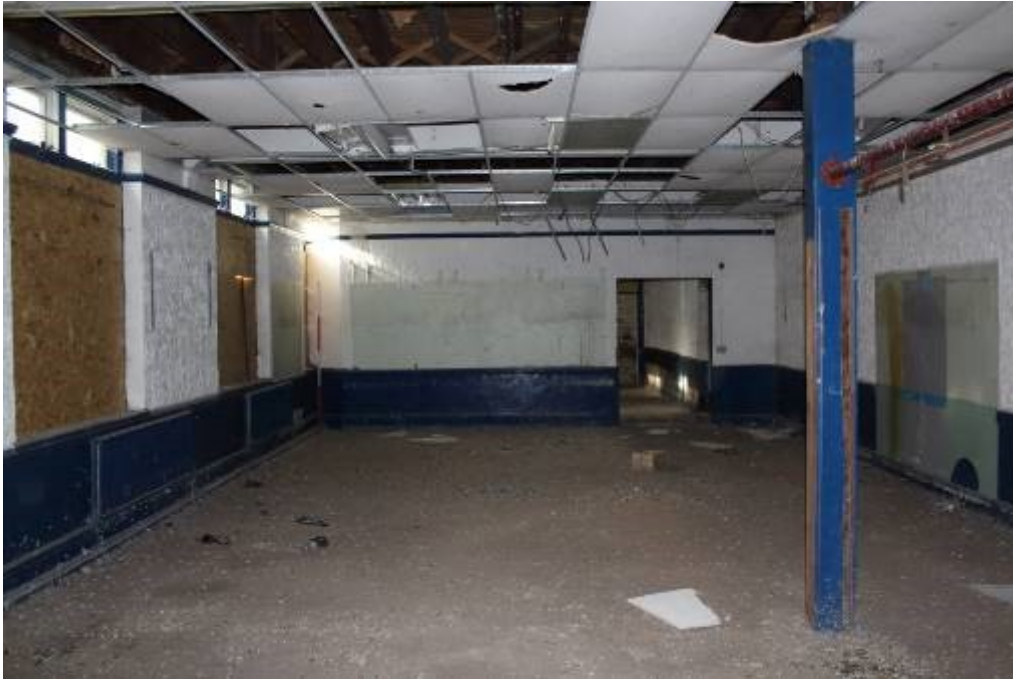
Photo 24: Southwest facing shot of the main ground floor room in the rear extension. 2m scale.

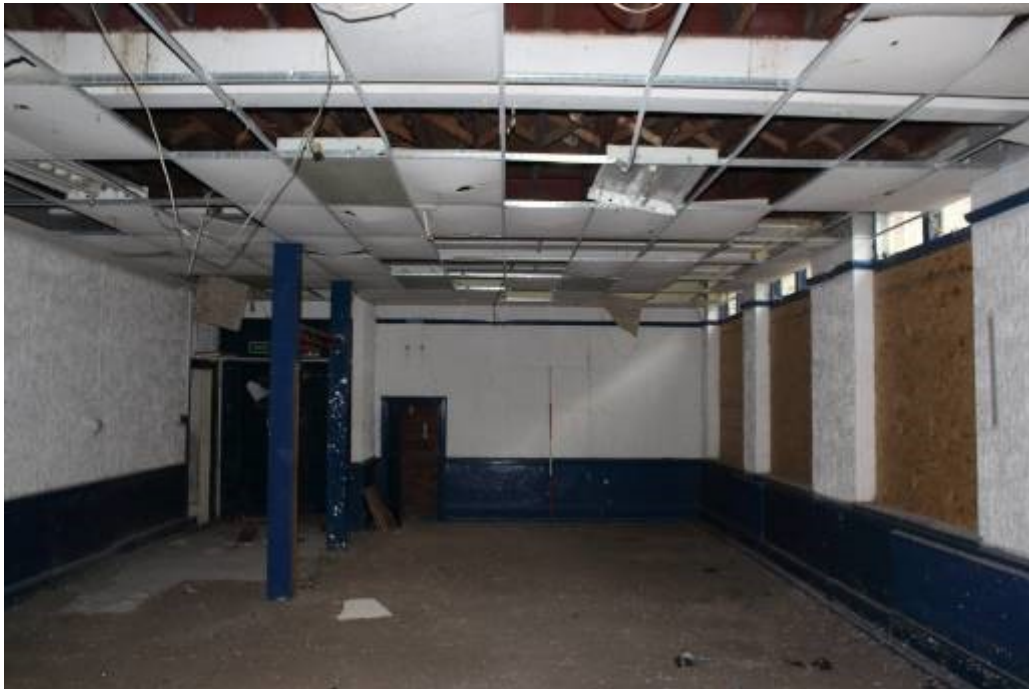
Photo 25: As previous photo, northeast facing.

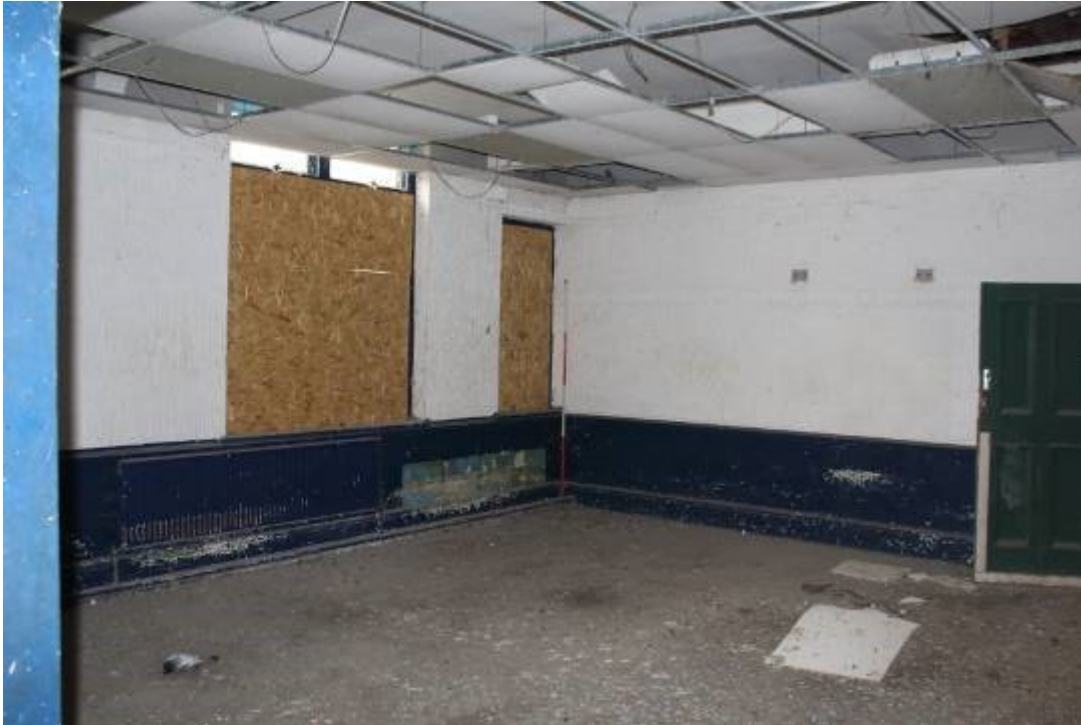
Photo 26: South facing shot of secondary ground floor room in rear extension.
2m scale.

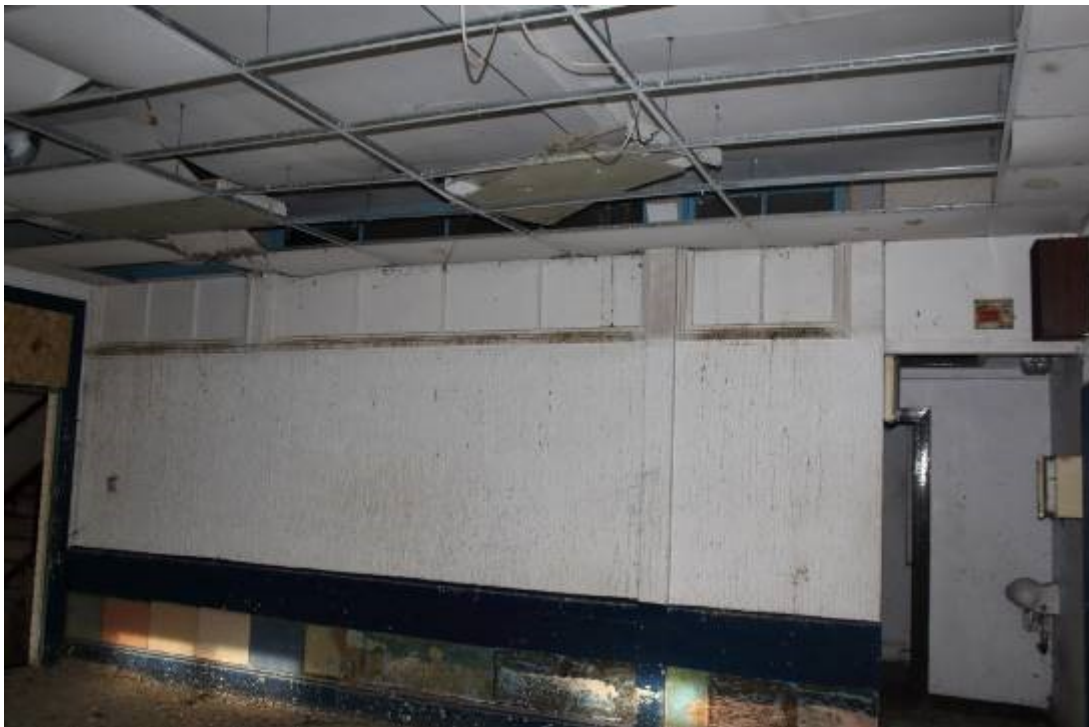
Photo 27: Northwest facing shot of window lights into the adjacent changing room area.

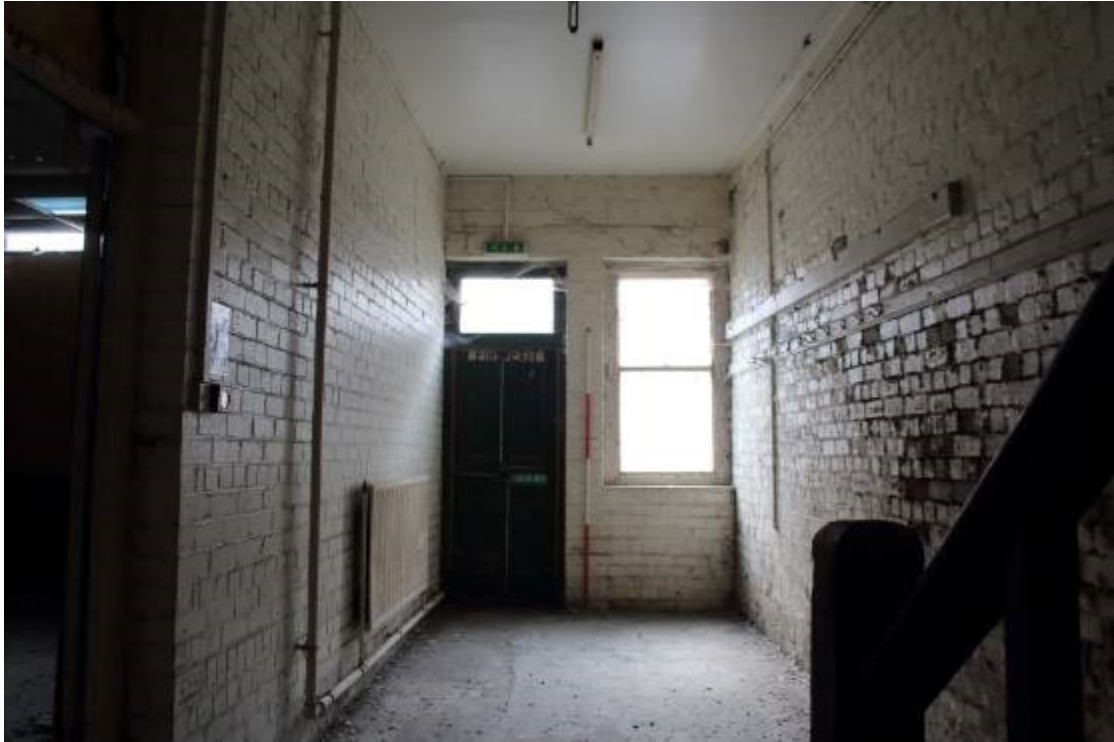
Photo 28: Southeast facing shot of the rear access on the southwest side of the building. 2m scale.

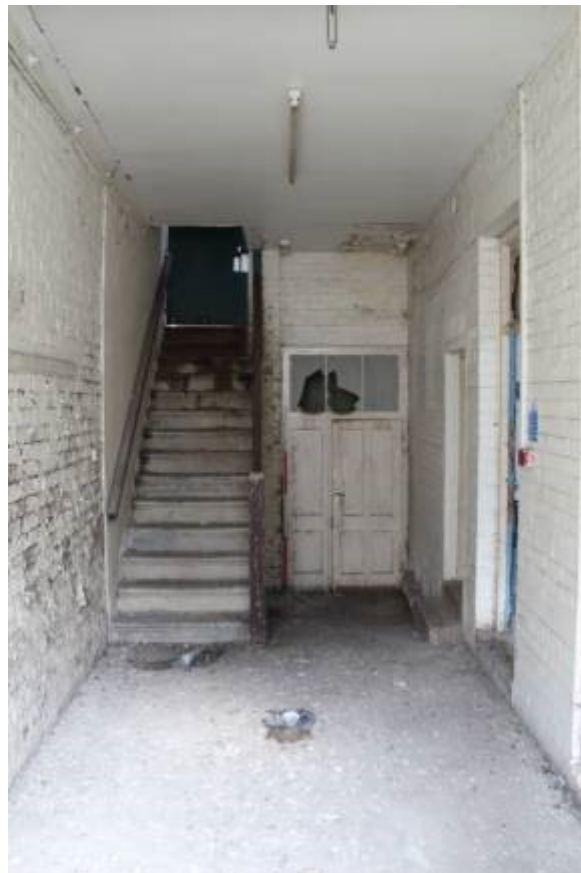
Photo 29: Northwest facing shot of rear access corridor, with simple stairs to the 1st floor, and door access to the rear passage/corridor behind the kitchen.

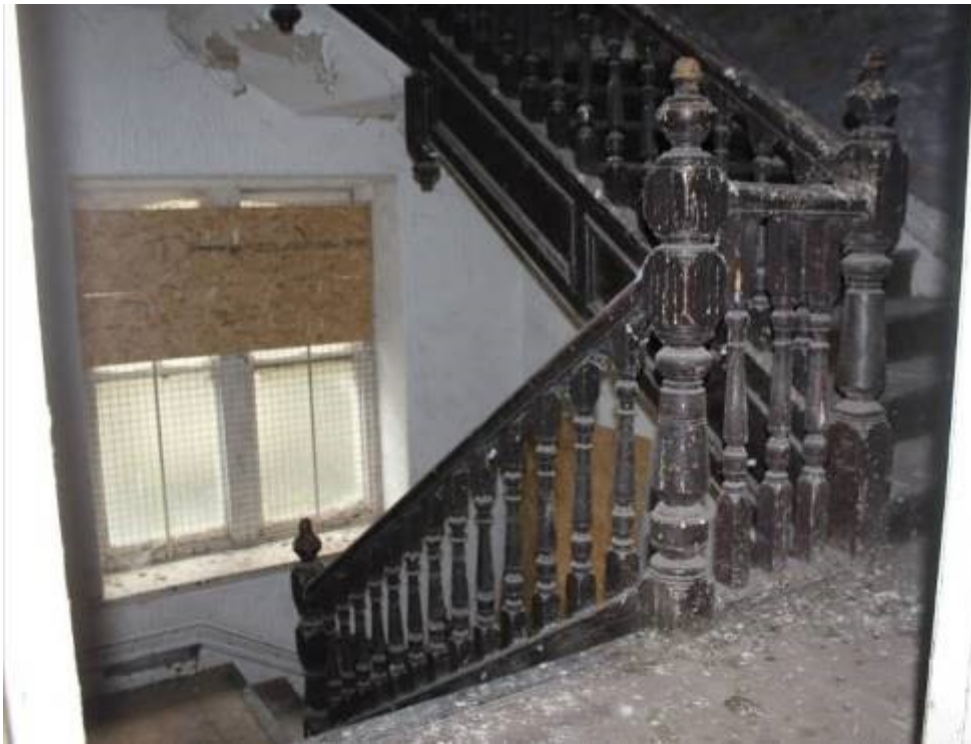
Photo 30: Northeast facing shot from the 1st floor landing showing the staircase and mid-floor window.

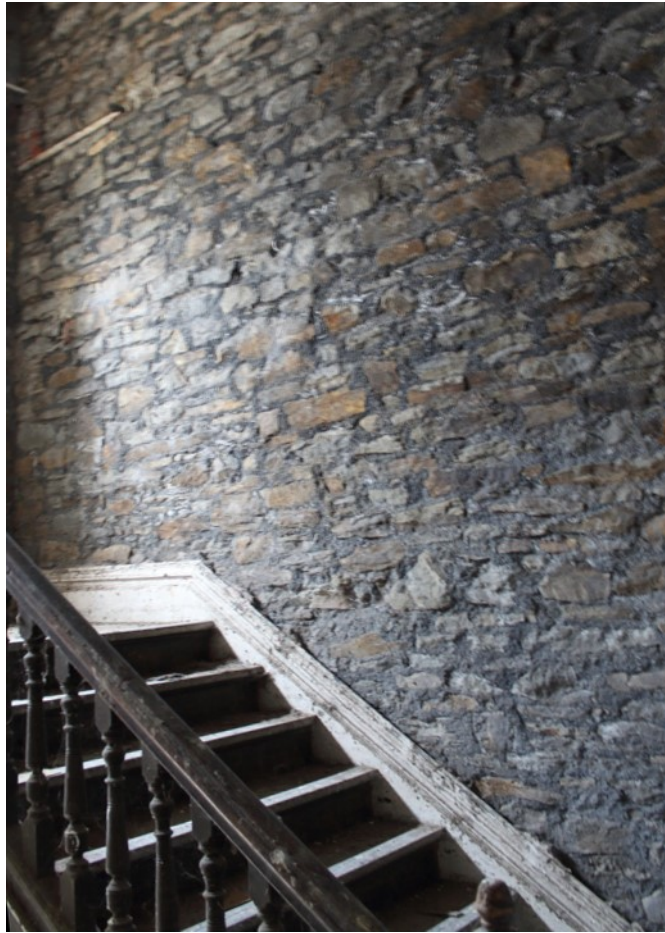
Photo 31: Southeast facing shot of the exposed masonry on the rear wall of the original building.

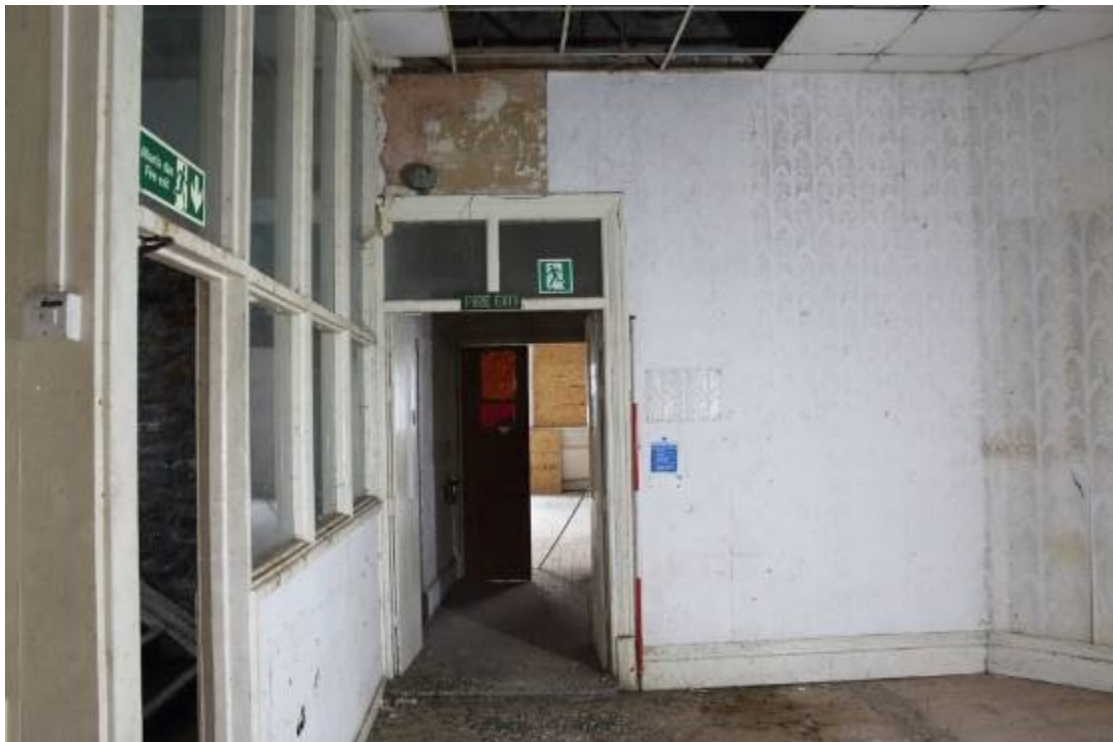
Photo 32: Southeast facing shot of the 1st floor landing.

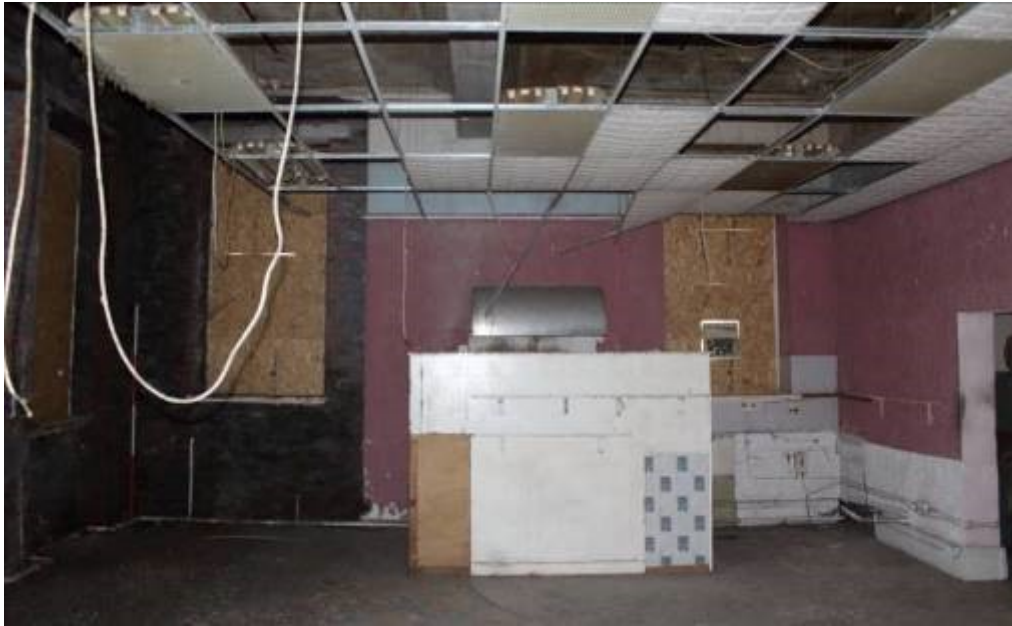
Photo 33: Northeast facing shot of the 1st floor frontage room, with kitchen vent visible. 2m scale.

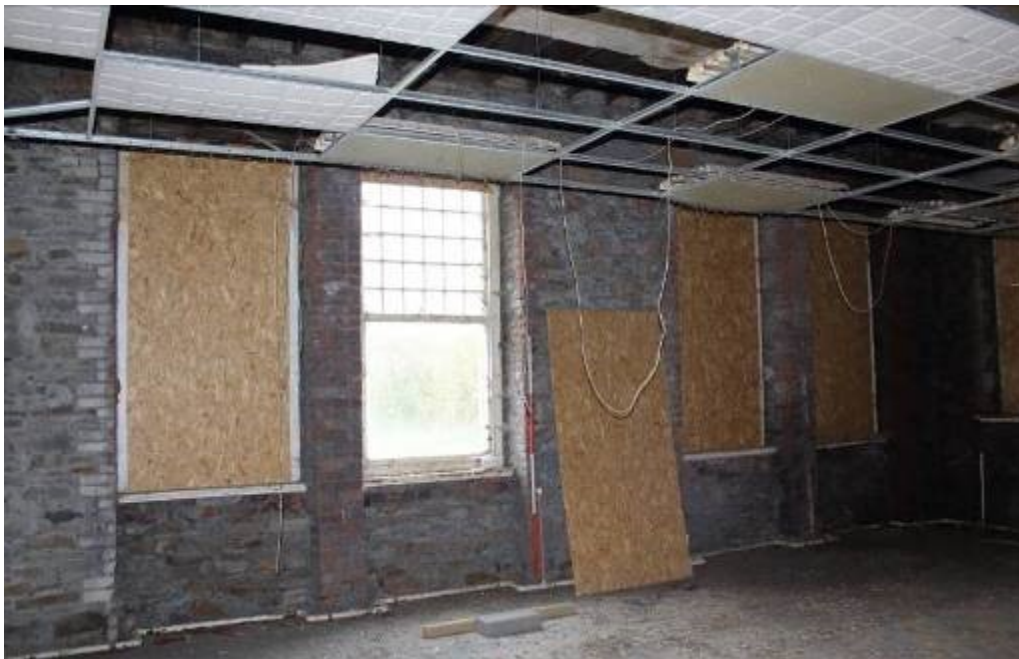
Photo 34: Northwest facing shot of the exposed inner face of the frontage wall. 2m scale.

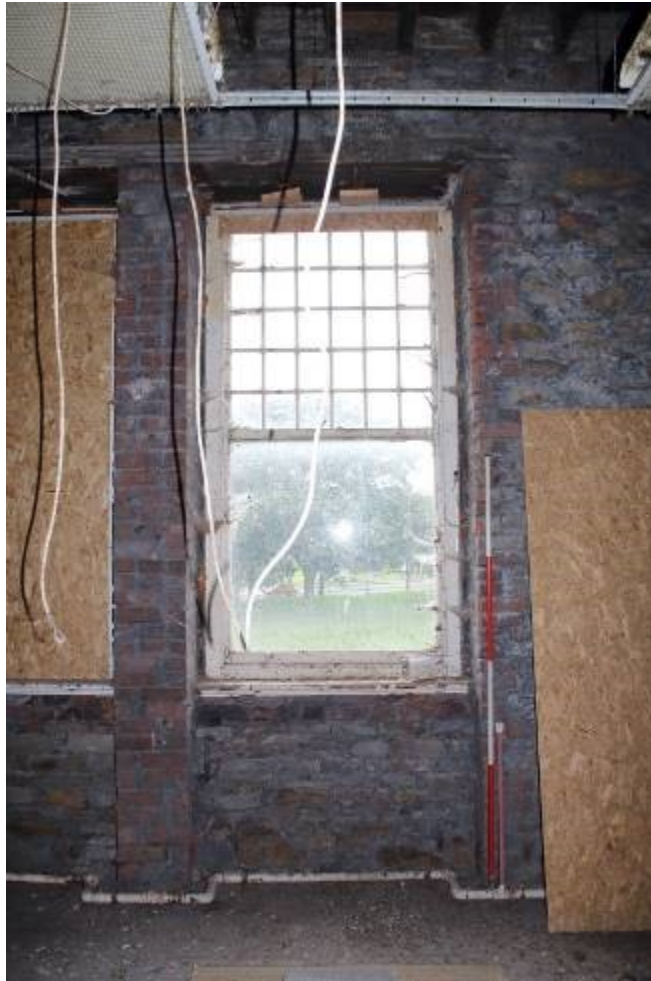
Photo 35: Detail of the frontage windows. 2m scale.

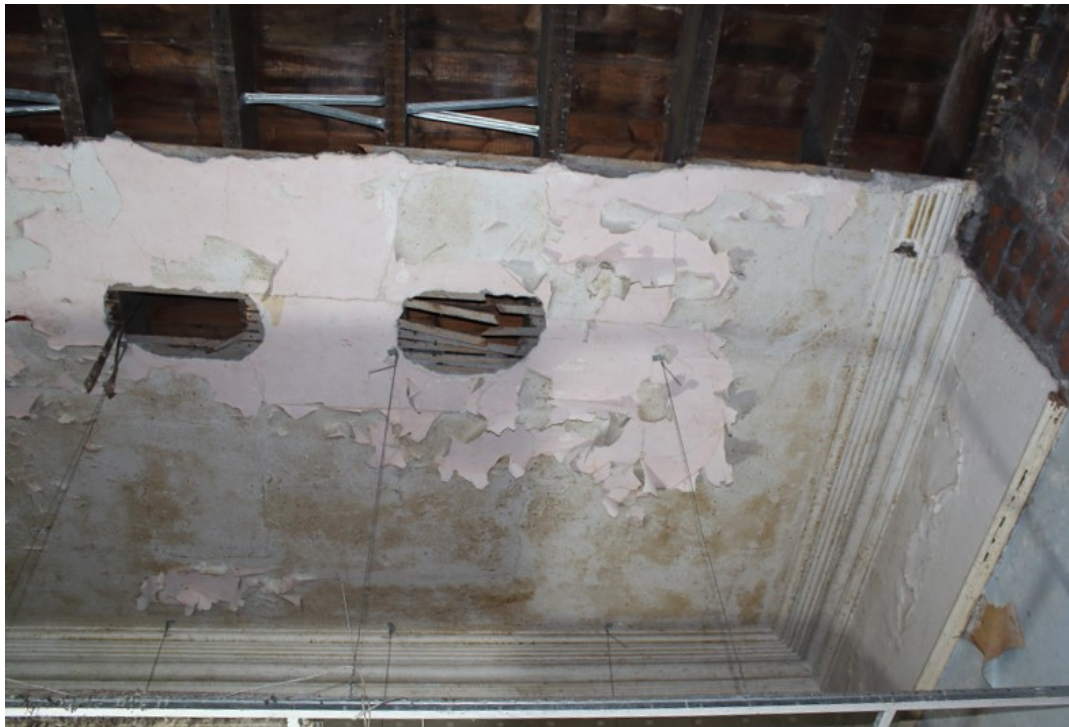
Photo 36: Detail of the original ceiling.

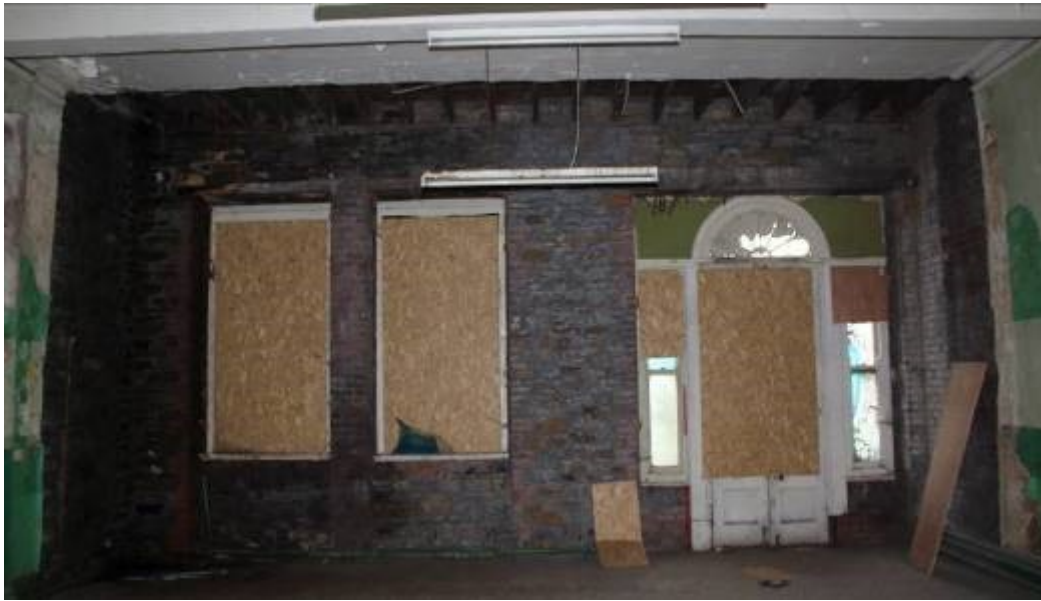
Photo 37: Northwest facing shot of the central 1st floor frontage room. 2m scale.
