YMCA, LLANELLI, CARMARTHENSHIRE

HISTORIC BUILDING RECORDING

REPORT NO. 2020-47
EVENT RECORD No.125512

September 2020

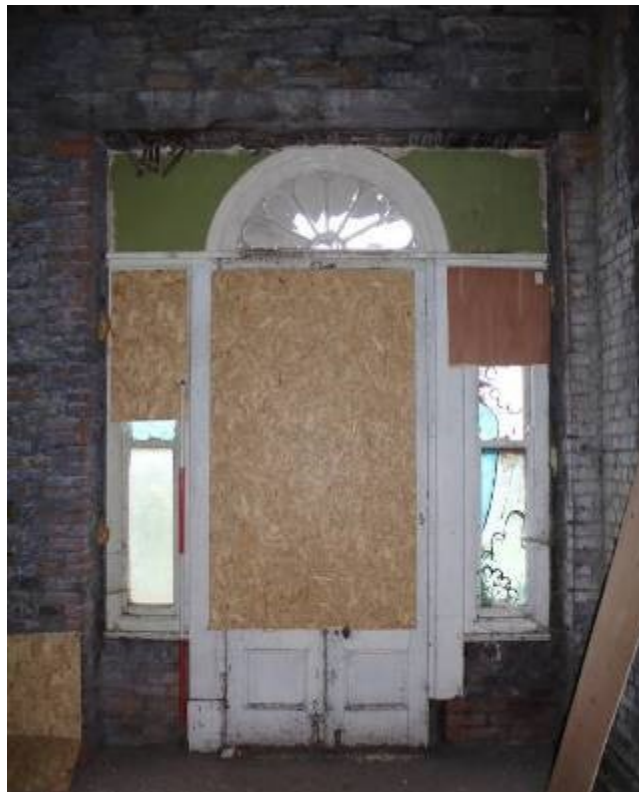
Photo 38: Detail of the balcony door. 2m scale.

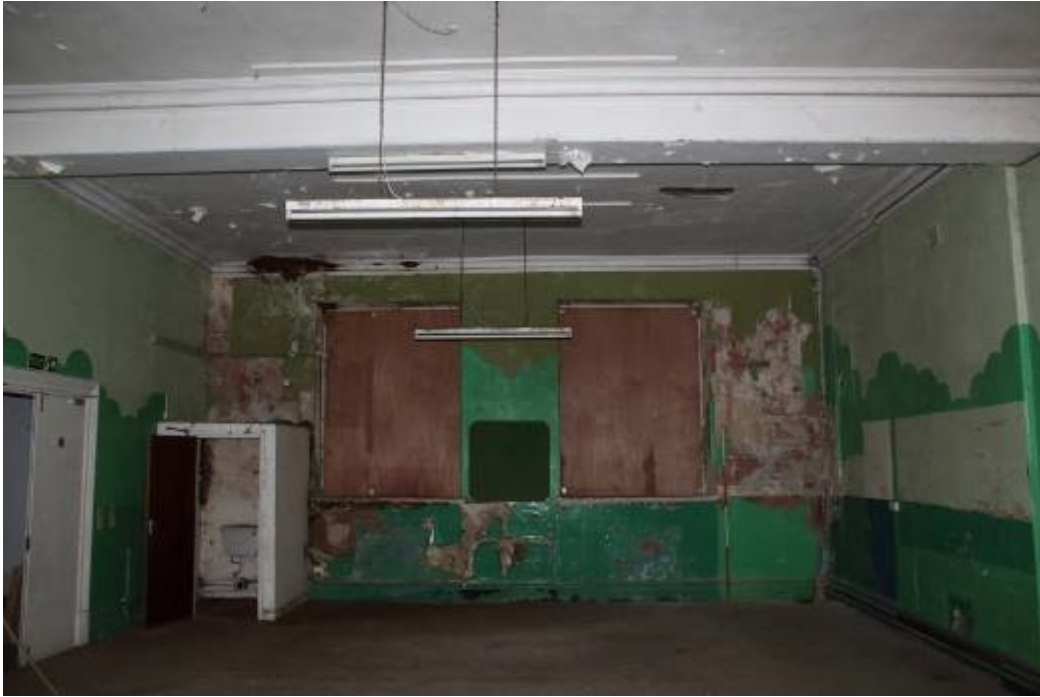
Photo 39: Southeast facing shot of the central 1st floor frontage room. 2m scale.

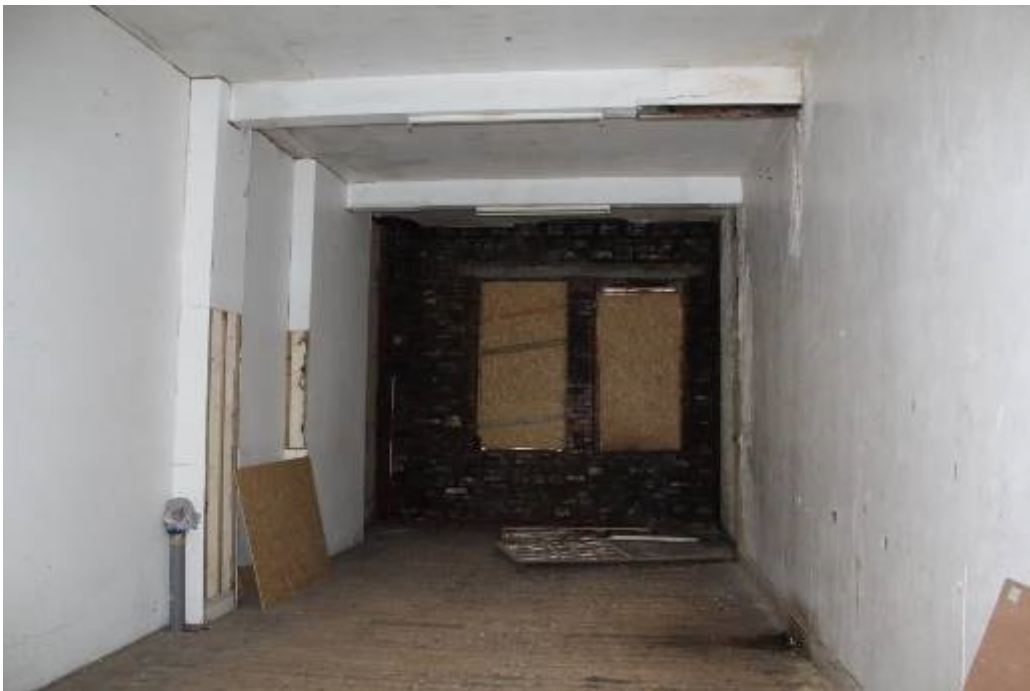
Photo 40: Northwest facing shot of the final 1st floor frontage room. 2m scale.

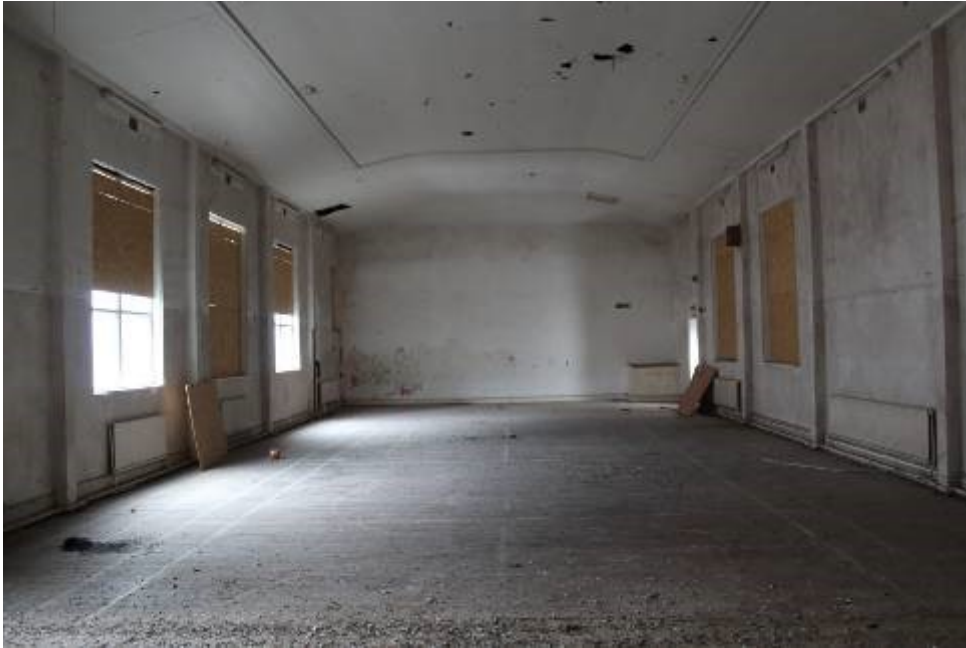
Photo 42: Southwest facing shot of the 1st floor gymnasium within the later extension.

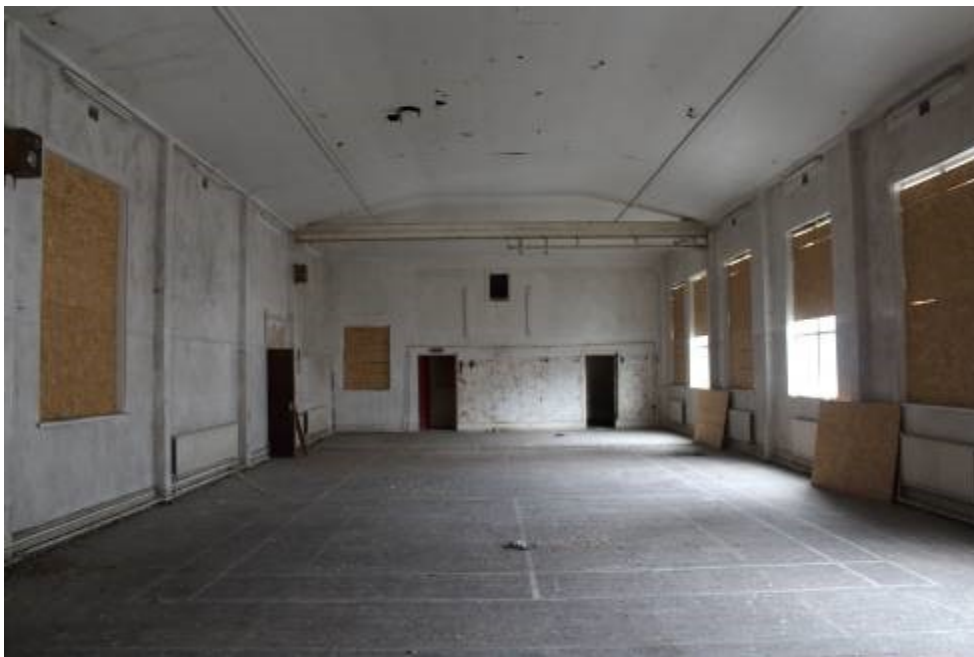
Photo 43: As above, in the opposite direction.

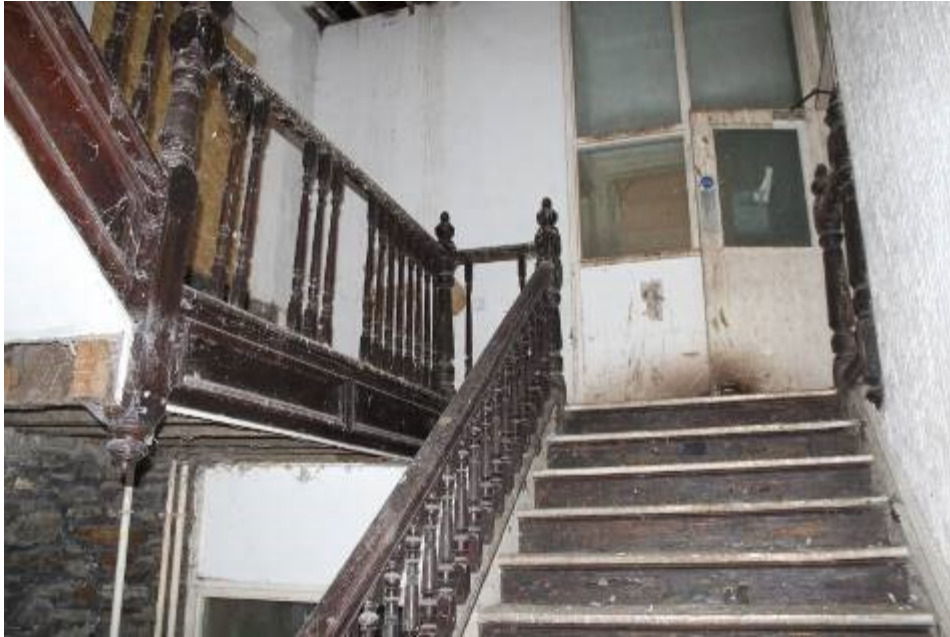
Photo 44: Southwest facing shot of the 2nd floor landing.

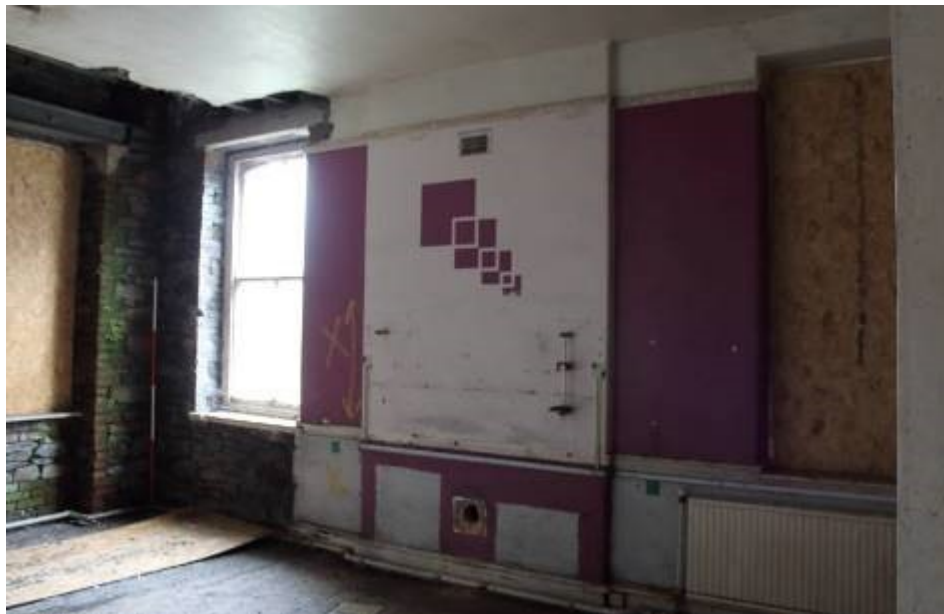
Photo 45: Northeast facing shot of initial 2nd floor frontage room, showing blocked fireplace in gable wall. 2m scale.

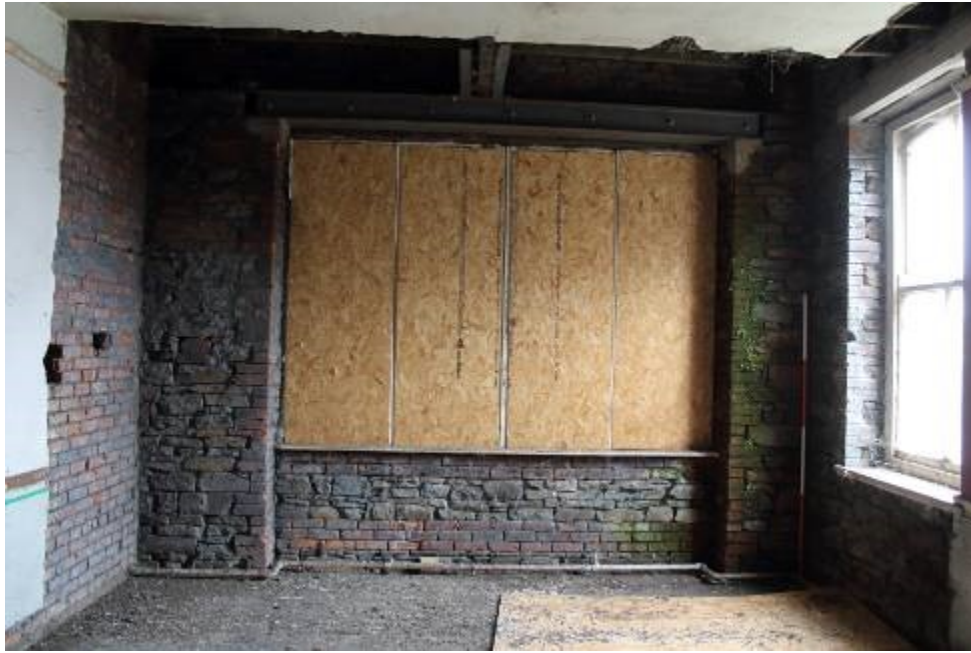
Photo 46: Northwest facing shot of initial 2nd floor frontage room, showing frontage wall detail. 2m scale.

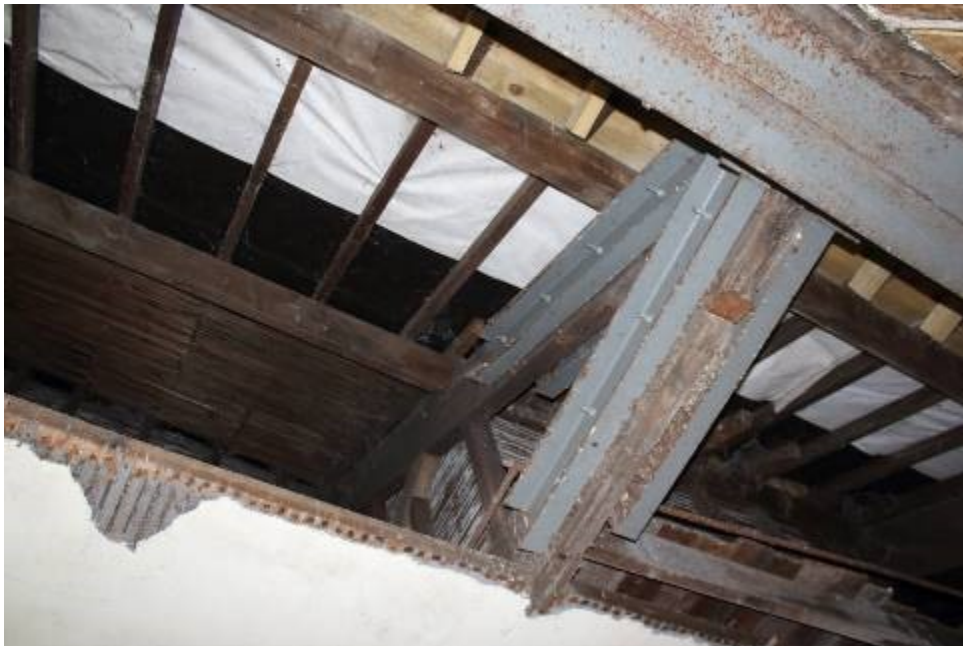
Photo 47: Detail of roof structure.

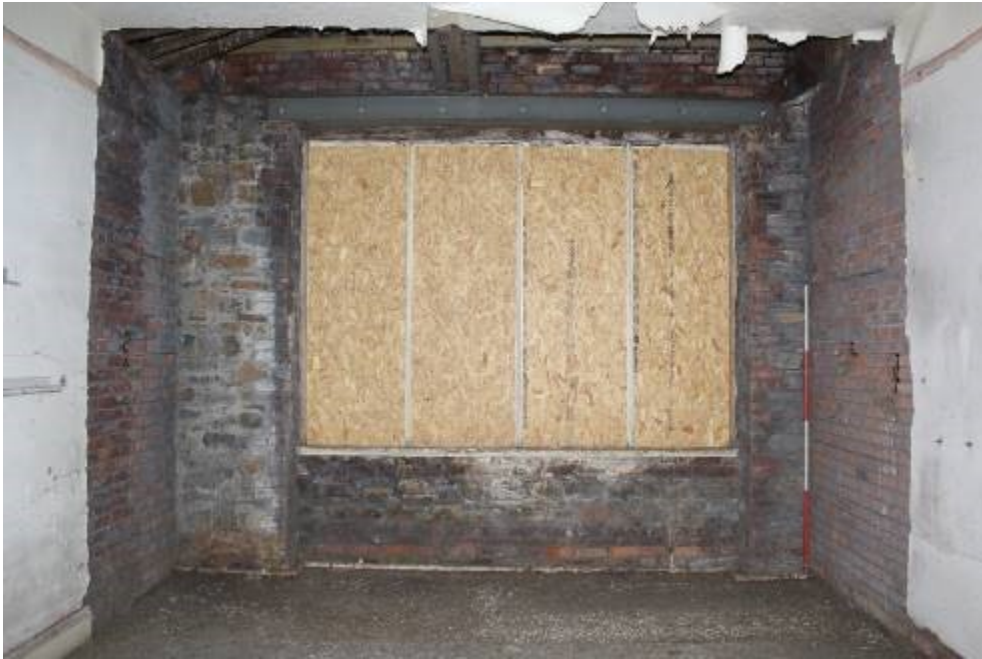
Photo 48: Northwest facing shot of the central 2nd floor frontage room. 2m scale.

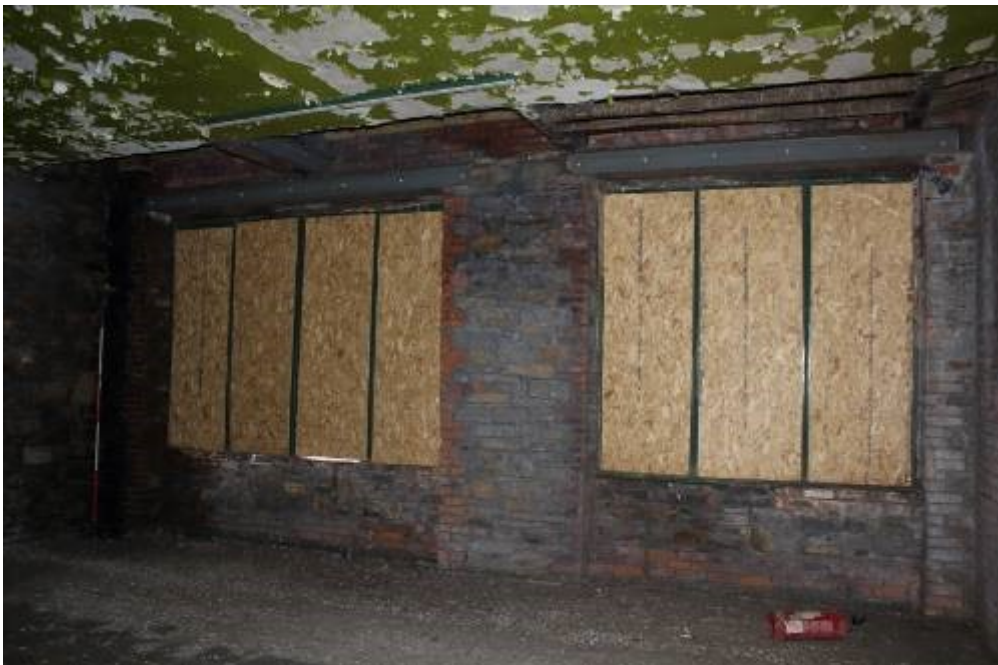
Photo 49: Northwest facing shoot of the western 2nd floor frontage room. 2m scale.

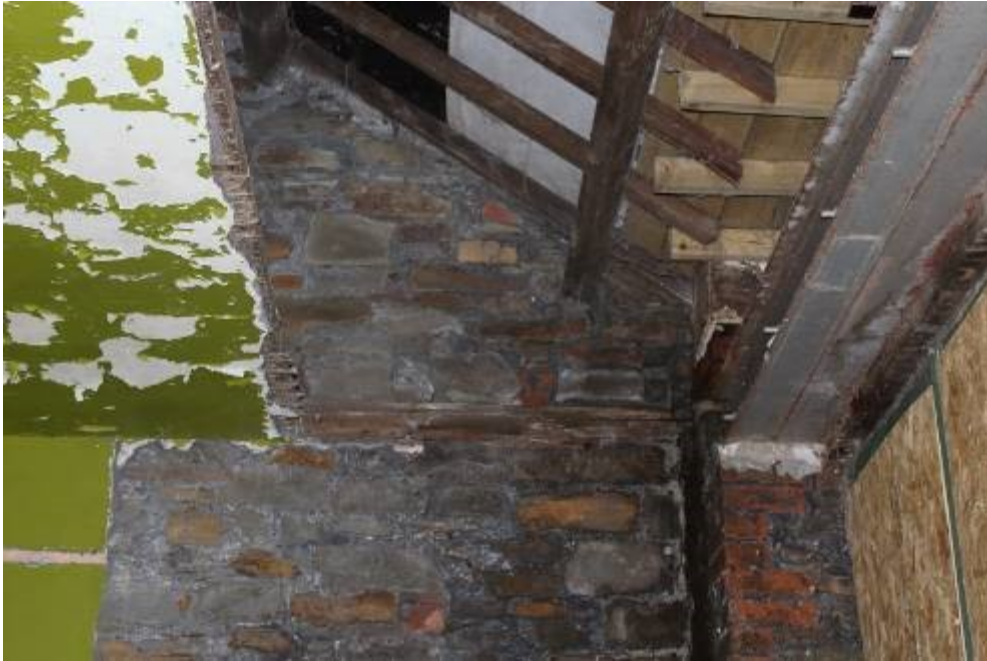
Photo 50: Detail of the interior face of the southwest gable wall and roof.

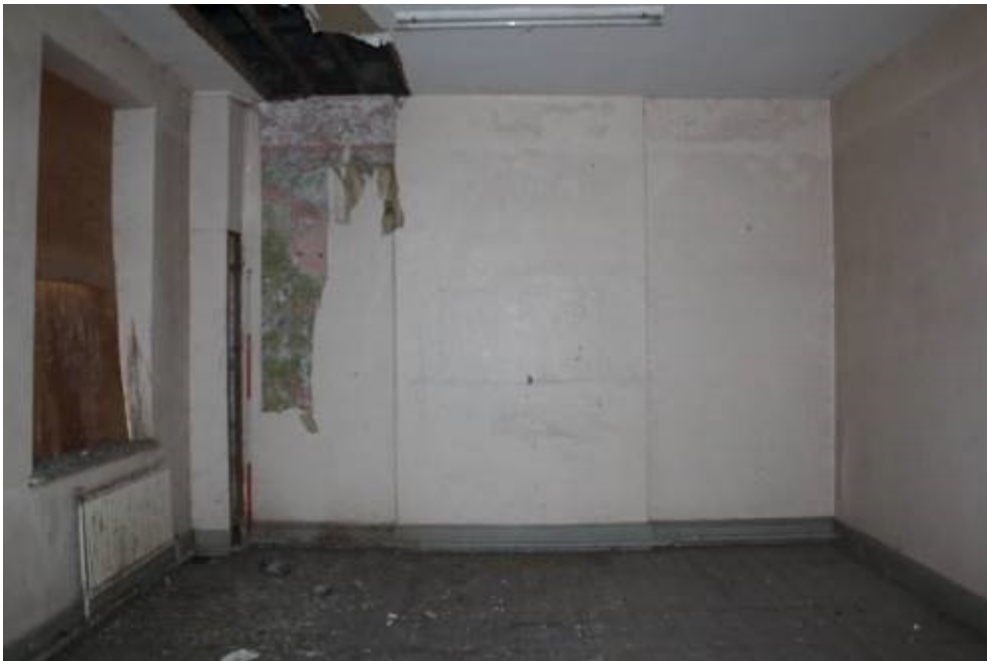
Photo 51: Southwest facing shot of the 2nd floor rear room, showing the blocked fireplace in the gable wall. 2m scale.

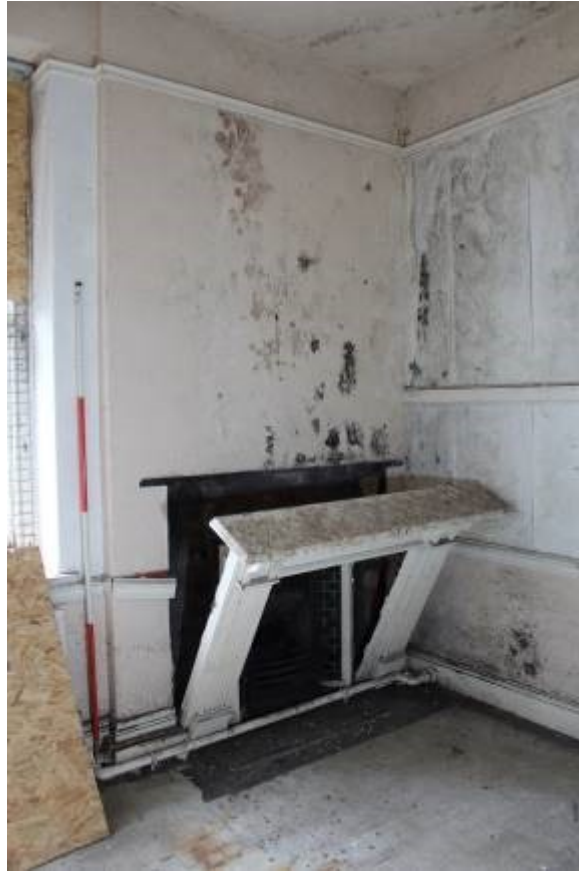
Photo 52: SSE facing shot of the final 2nd floor rear room. 2m scale.

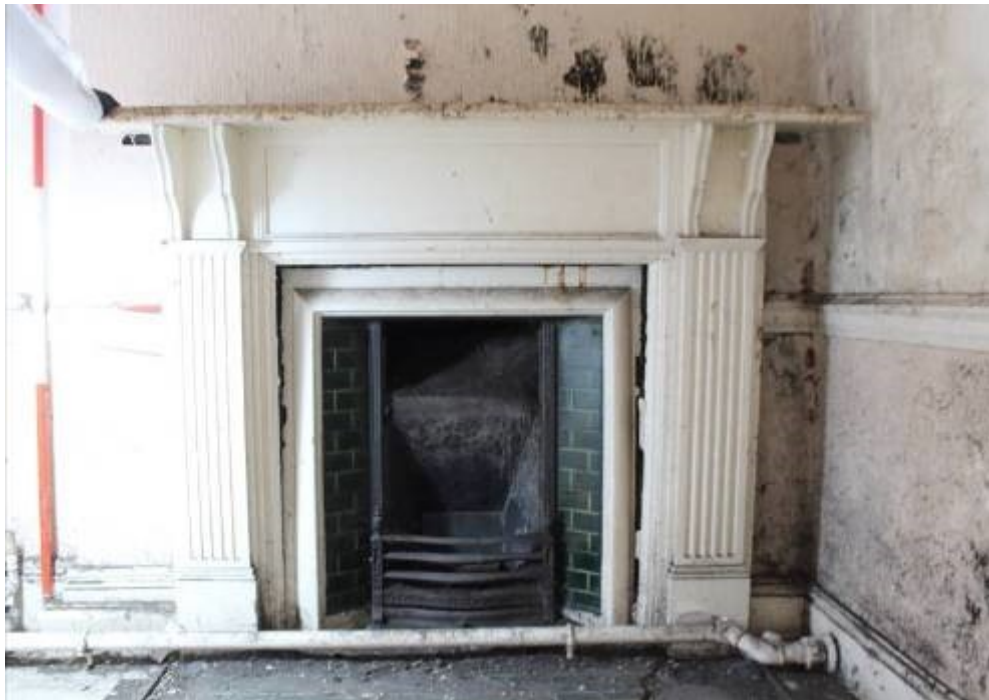
Photo 53: Detail of the fireplace within the 2nd floor rear room. 2m scale (in 0.5m segments).

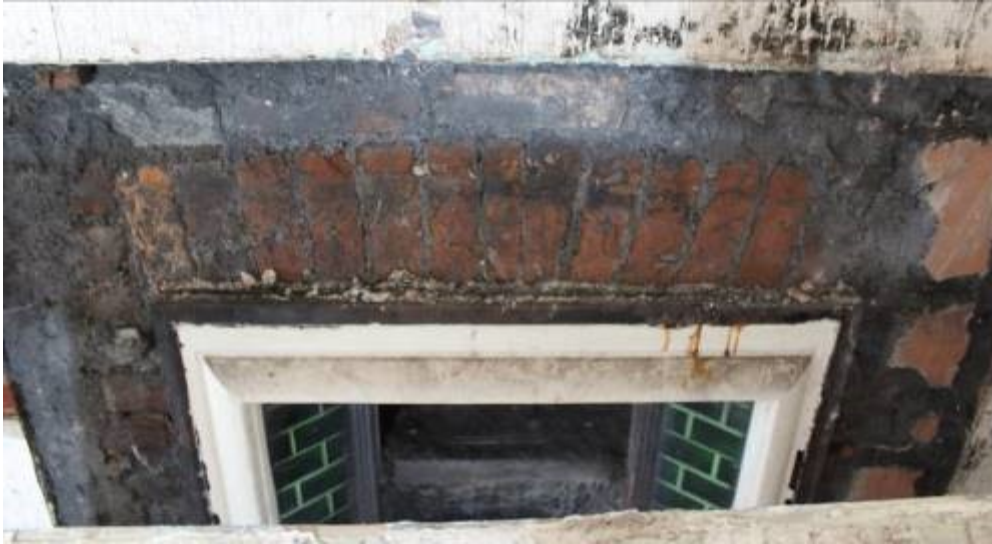
Photo 54: Detail of the brick lintel behind the fire surround.

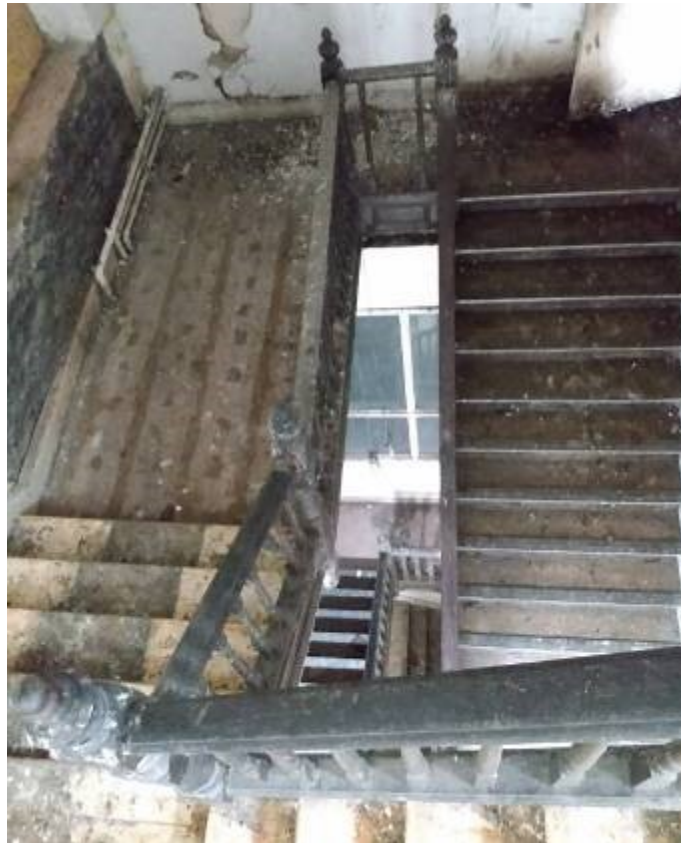
Photo 55: View down the stairwell from the 3rd floor.

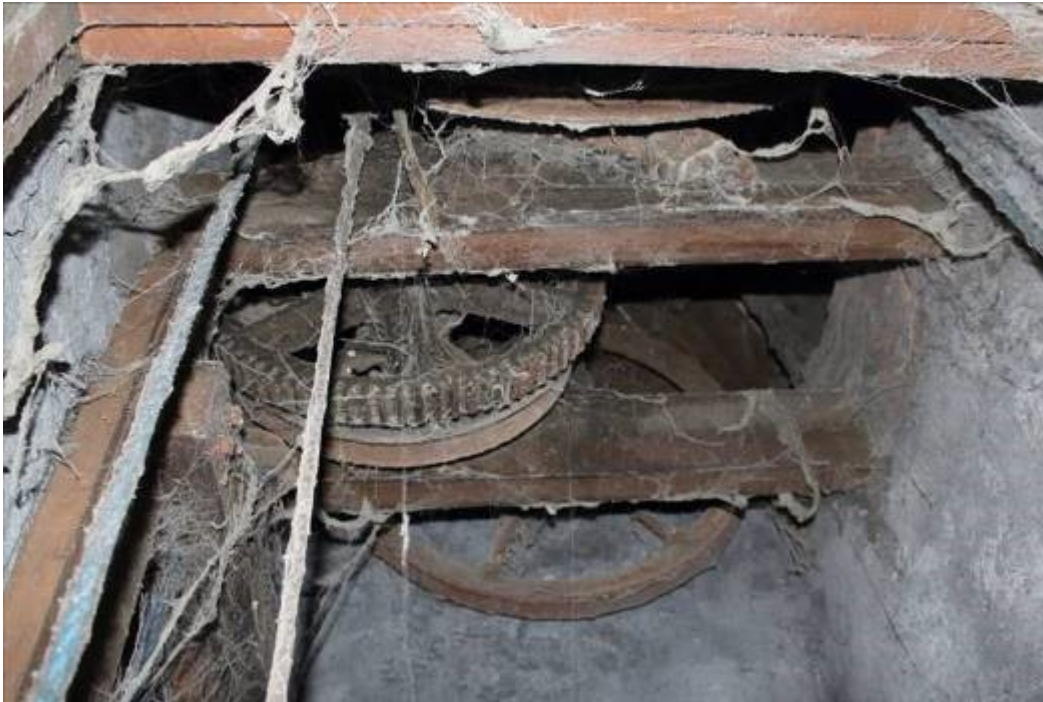
Photo 58: Detail of the dumbwaiter pulleys.

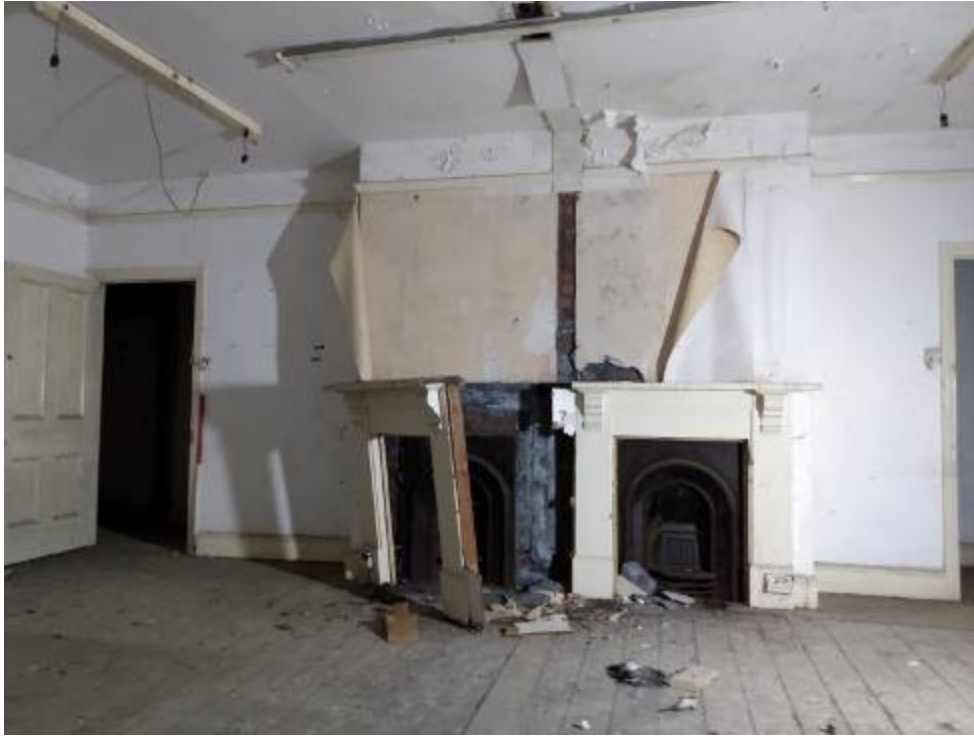
Photo 60: Southeast facing shot of the 3rd floor central frontage room, showing the fireplaces and the removed central division. 1m scale.

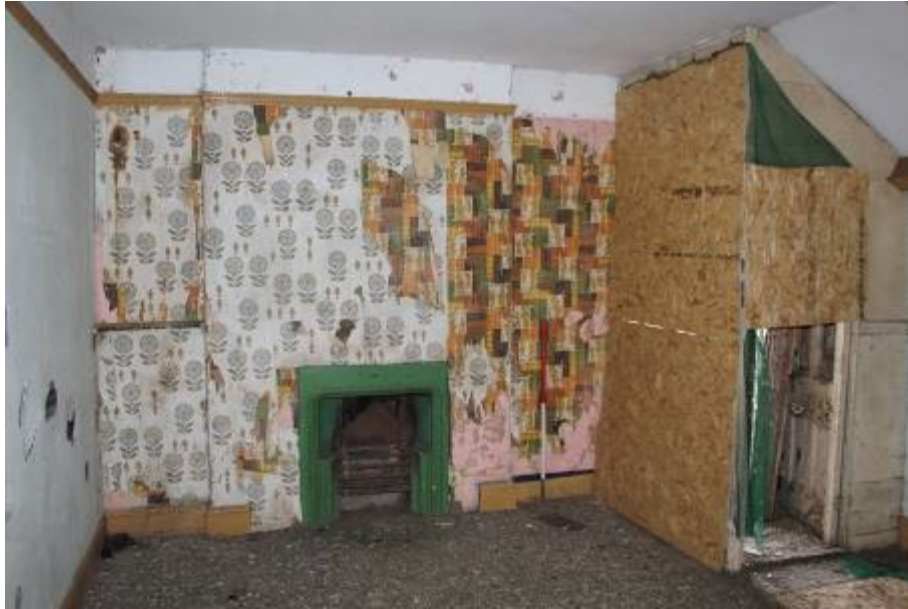
Photo 62: Southwest facing shot of the 3rd floor southwest frontage room, with enclosed fire-escape to the right. 1m scale.

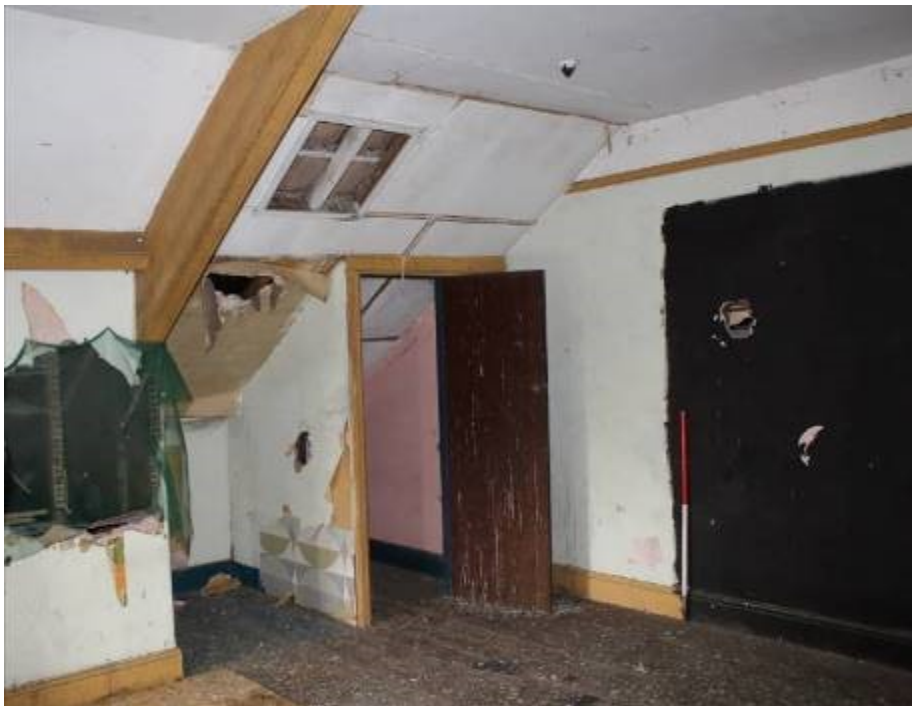
Photo 63: Northwest facing shot of the 3rd floor southwest frontage room, showing roof light. 1m scale.

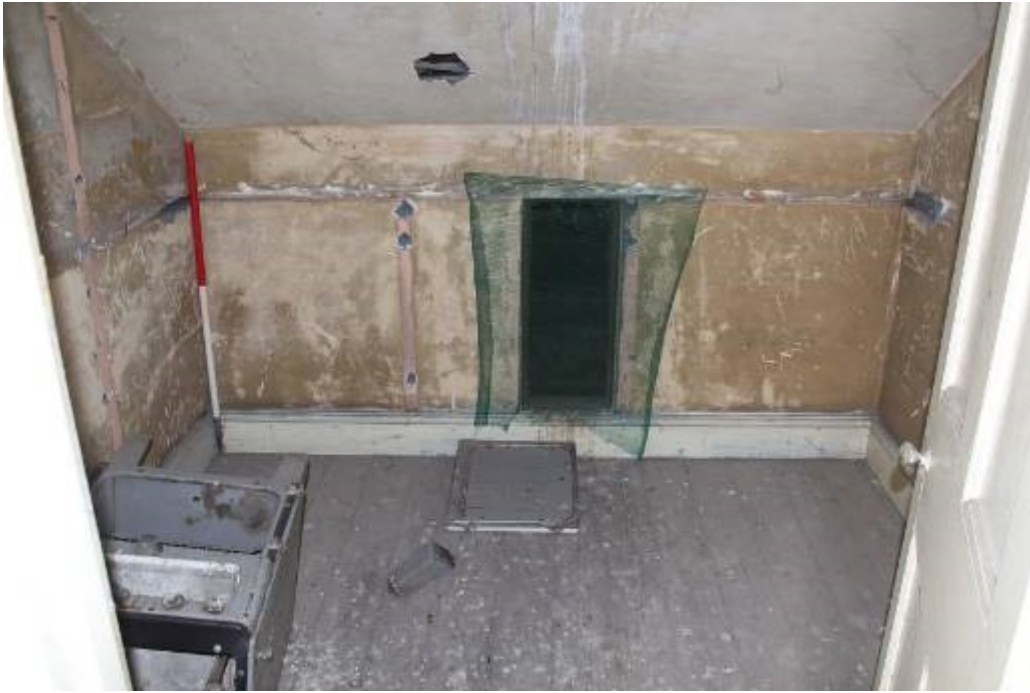
Photo 65: Southeast facing shot of 3rd floor rear room with oven. 1m scale.

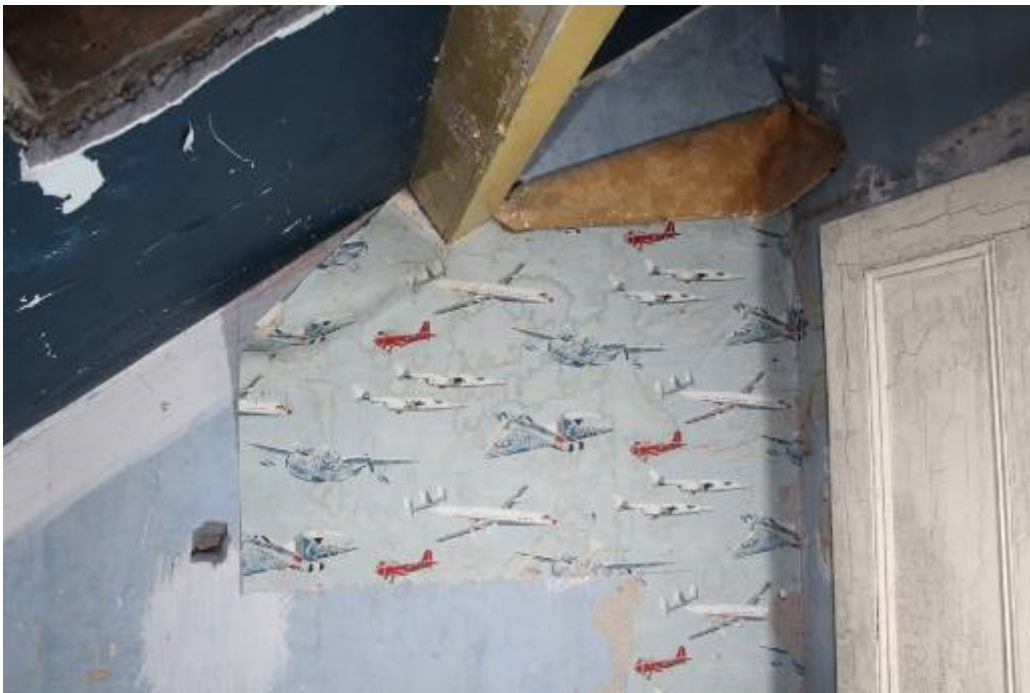
Photo 66: Southwest facing shot of 1950/60s wallpaper in 3rd floor rear room.

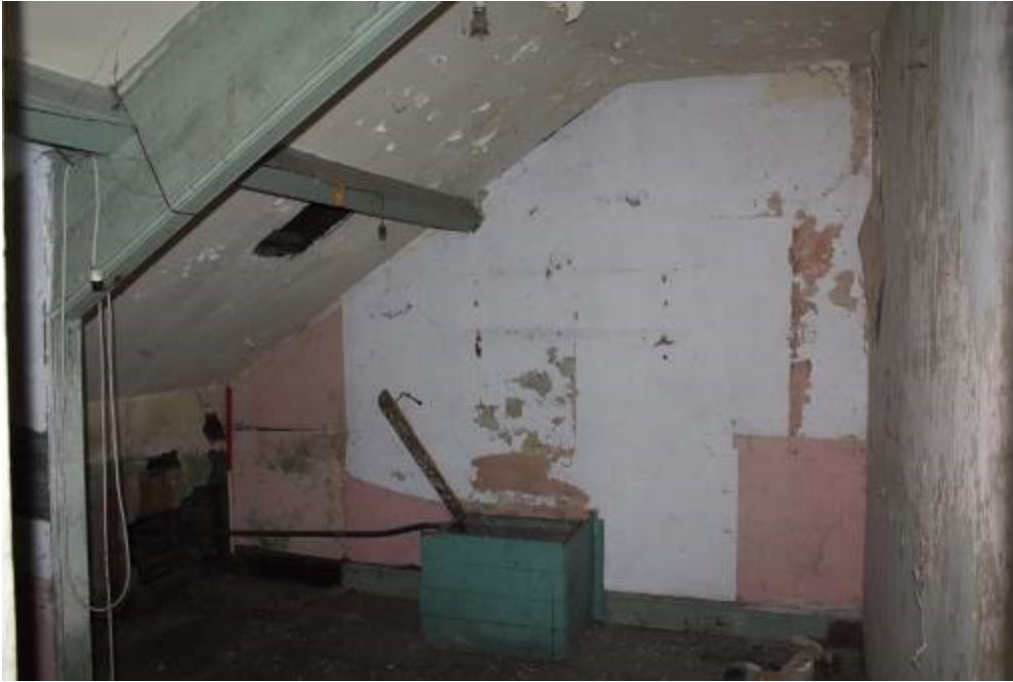
Photo 67: Southwest facing shot of 3rd floor rear gable-end room. 1m scale.

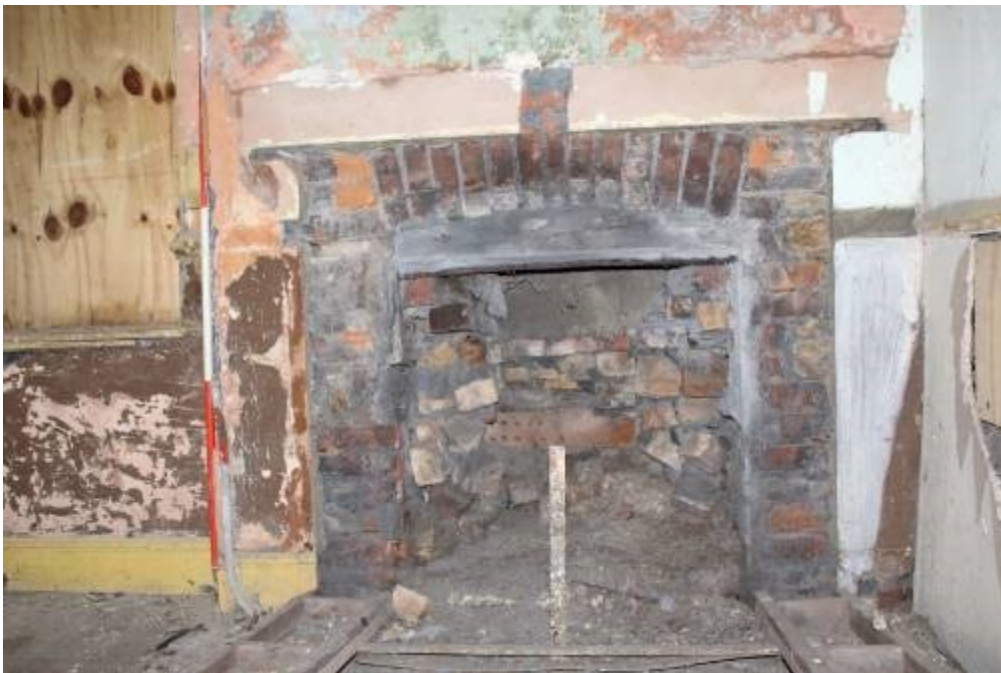
Photo 68: Southeast facing shot of the fireplace in the 3rd floor room above the staircase. 2m scale.

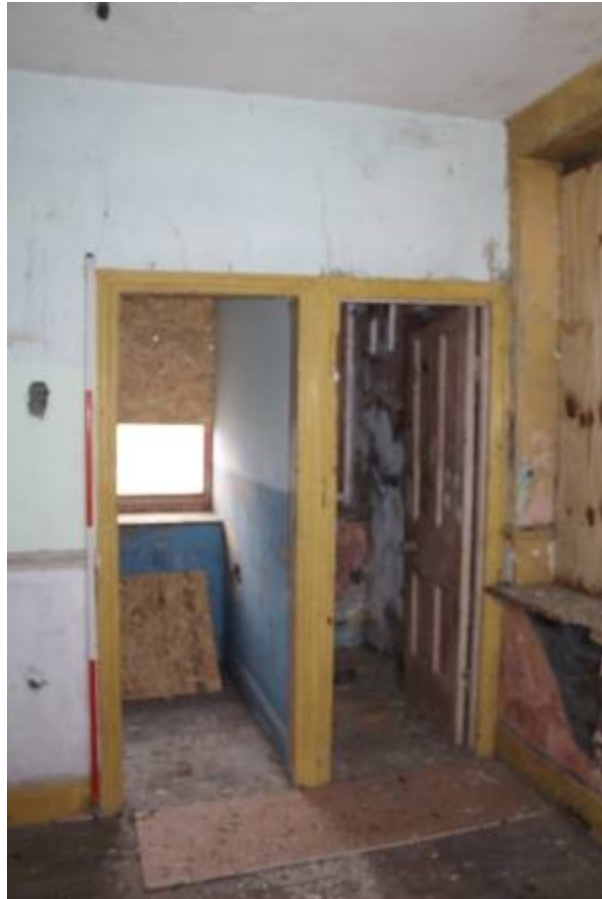
Photo 69: Northeast facing shot of the storage areas in the 3rd floor room above the staircase. 2m scale.

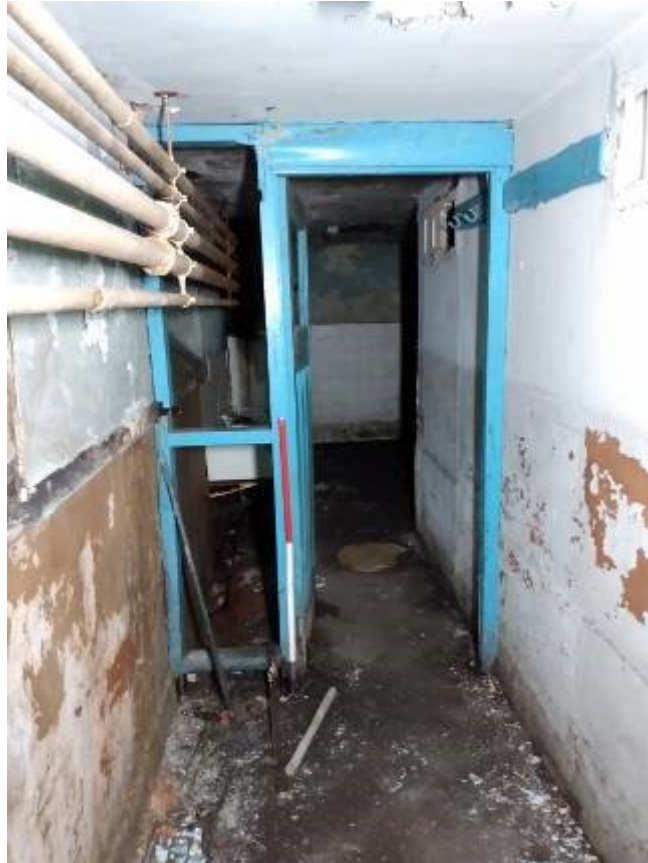
Photo 70: Southwest facing shot of the rear corridor and inserted doorway enclosing the basement WC. 2m scale.

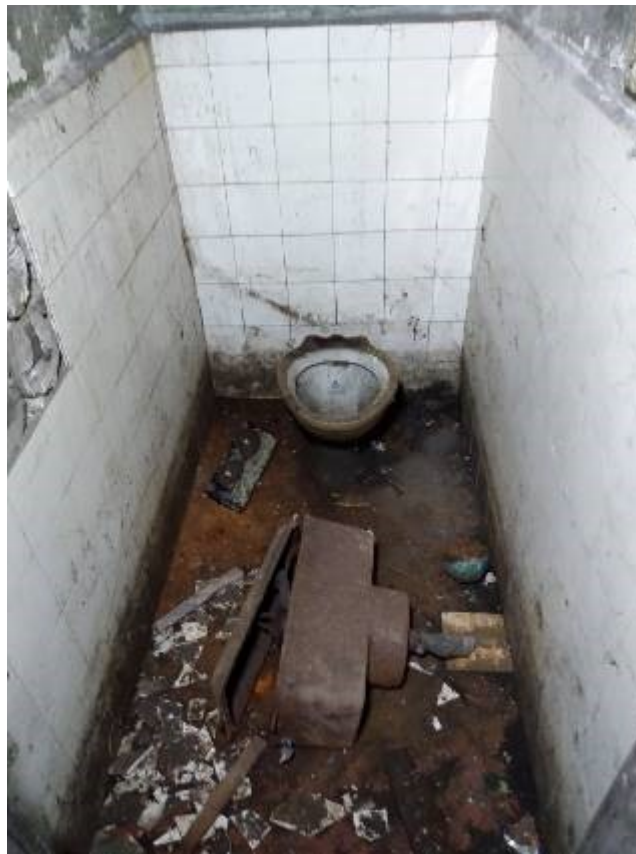
Photo 71: Northwest facing shot of the WC unit within the basement.

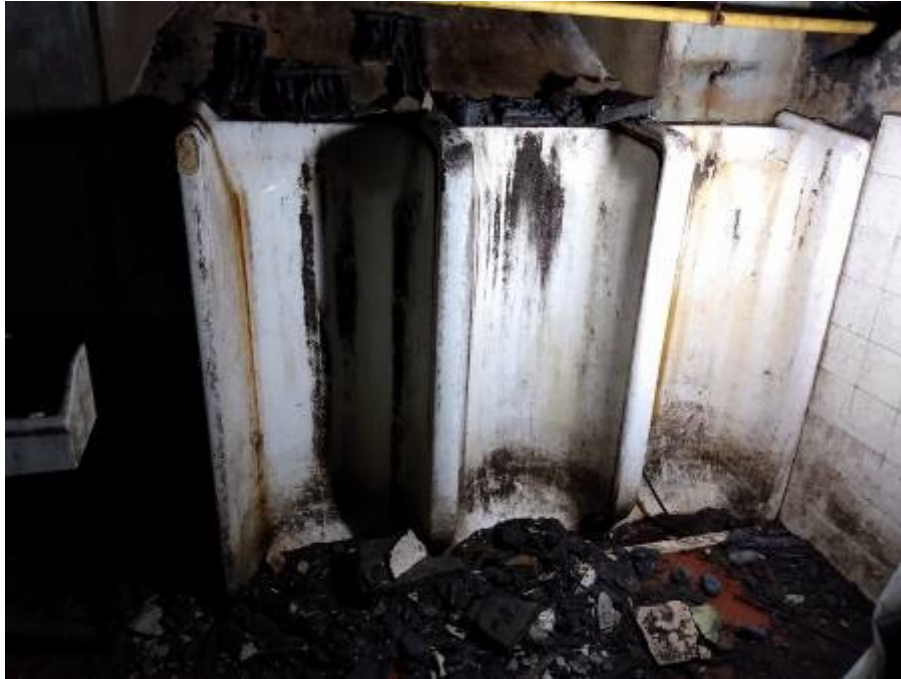
Photo 72: Southeast facing shot of the urinals in the basement.

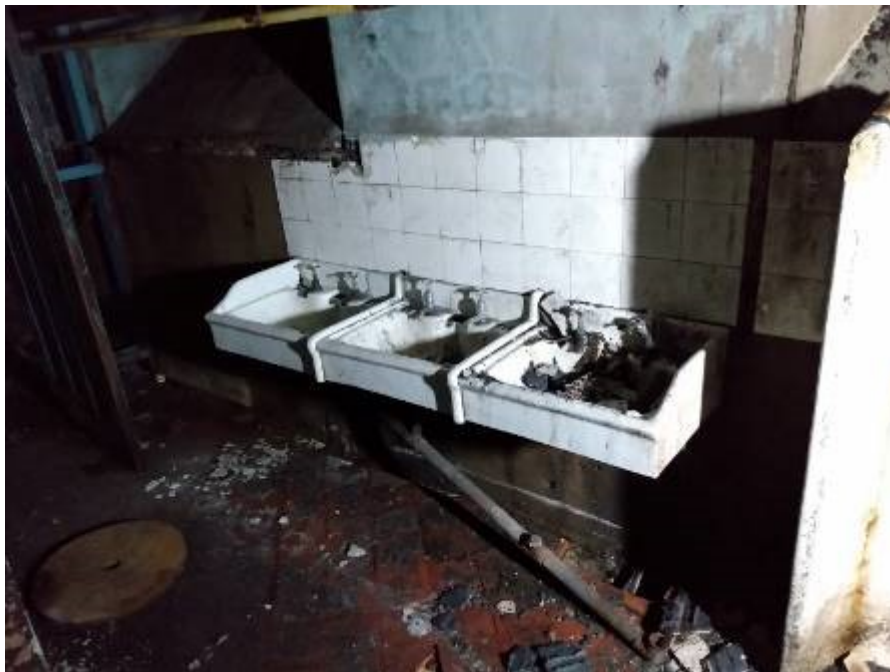
Photo 73: Southeast facing shot of the sink units in the basement WC, with the former access ramps in the wall to the rear.

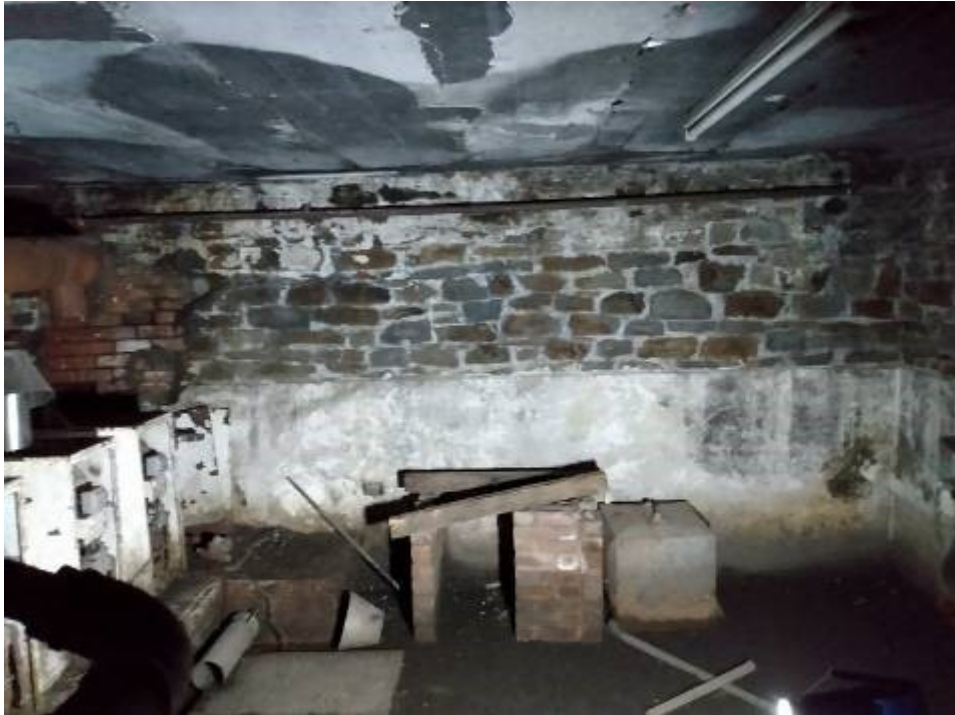
Photo 74: Southwest facing shot of the boiler room, and gable end of the original structure.

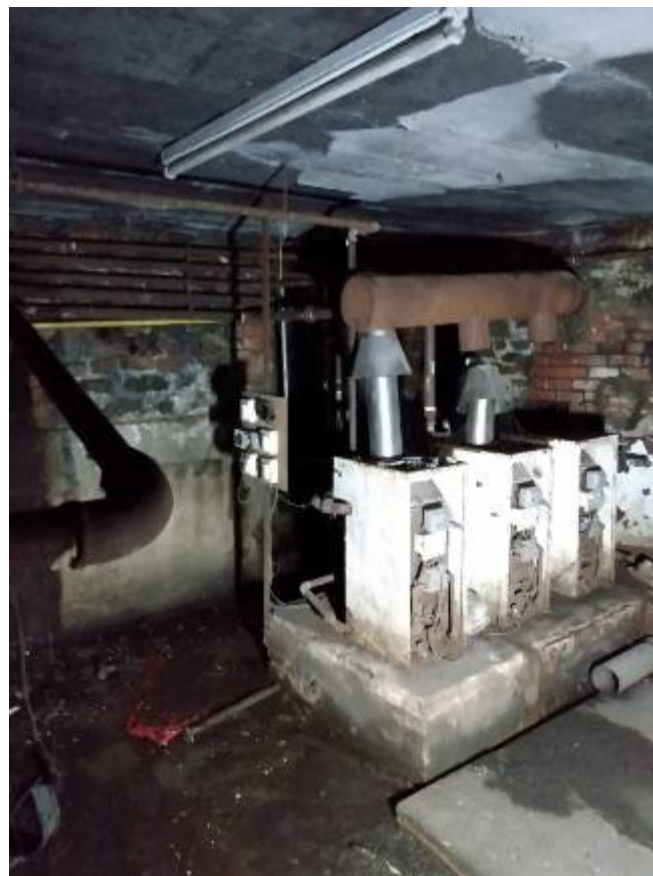
Photo 75: South facing shot of the boiler units within the basement.

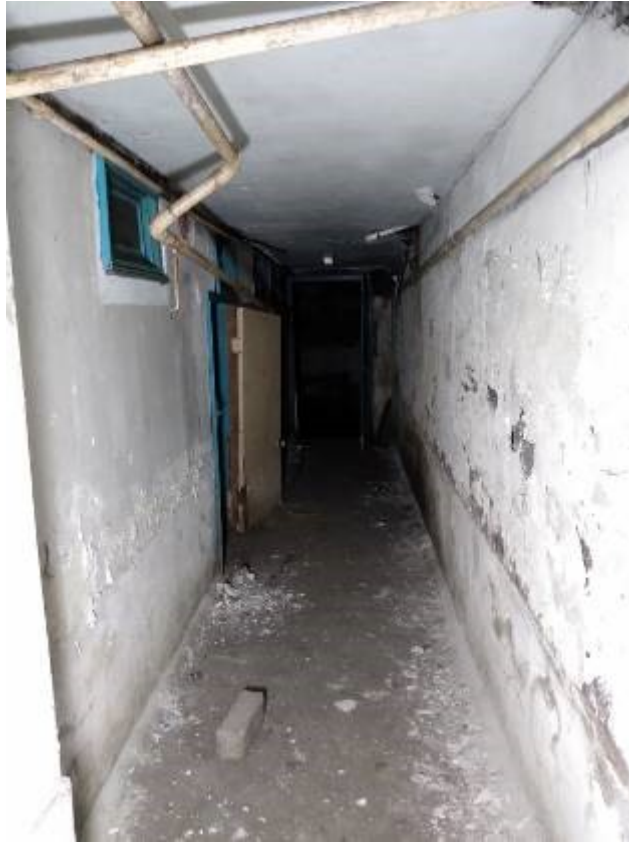
Photo 76: Southwest facing shot down the basement services corridor.

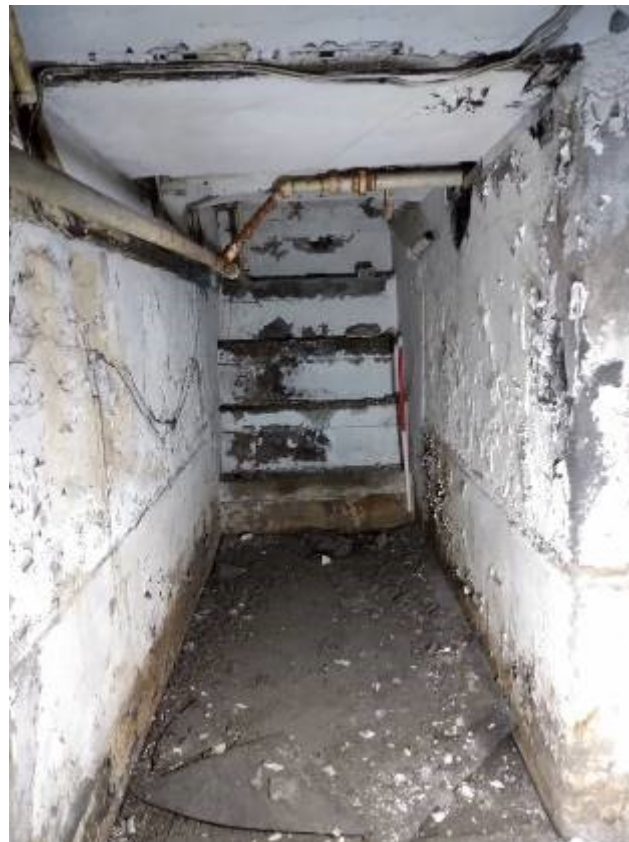
Photo 77: Southeast facing shot of the access stairs to the service part of the basement, presumably originally accessed via a hatch, currently blocked.
1m scale.
