# **MAES-MYNACH, CILCENNIN, CEREDIGION: HISTORIC BUILDING RECORDING**

Prepared by DAT Archaeological Services  
For: Mr Emyr Evans

REPORT NO. 2020-66  
EVENT RECORD No.125649

December 2020

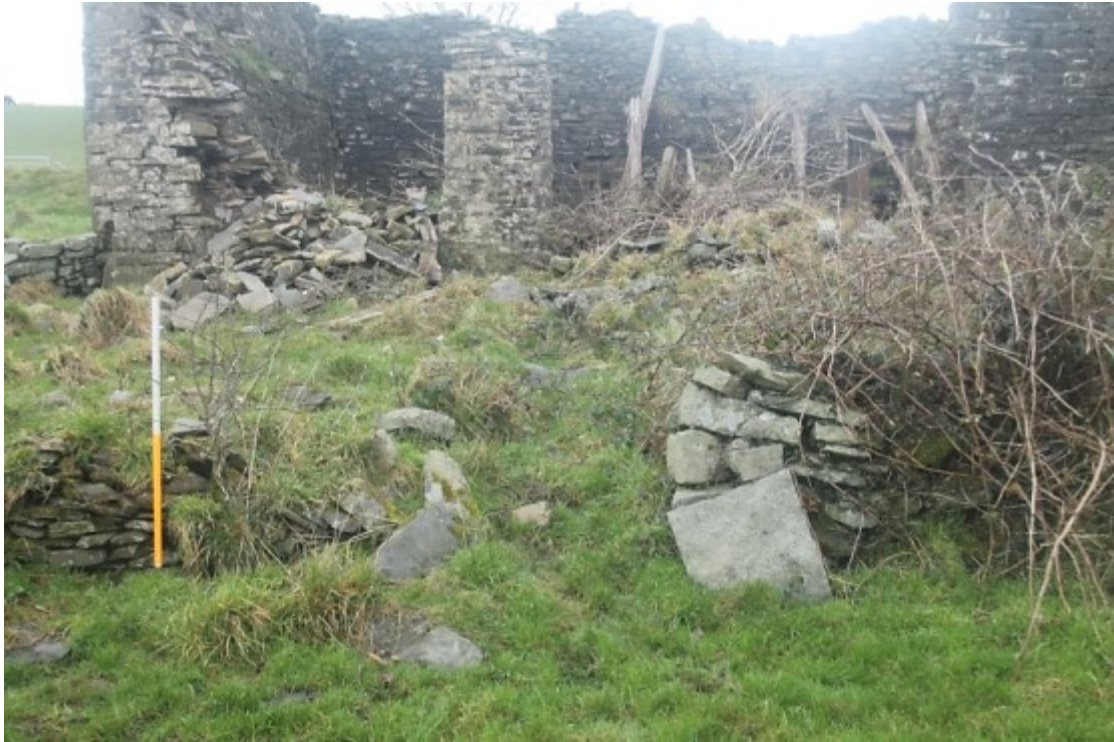
- 3.9 Beyond the front of the house is a small garden wall with a stone kerbed path leading to the front door (Photo 1). The frontage is very dilapidated with only a section of the east side and some upstanding masonry west of the front door remaining (Photo 2). A section through the wall at the front of the house shows a rubble infill (Photo 3). Part of a splayed window is visible on the east side of the front (Photo 6). Only the annex remains upstanding in the east elevation of the farmhouse (Photo 8). The east elevation of the annex, north of the doorway, is angled towards the west; presumably to retain a wide entrance into the farmyard (Photo 9). The west elevation of the farmhouse clearly shows a vertical butt-joint below the annex window, whilst above the window the roofline has been heightened in order to construct a catslide roof (Photos 14 and 15).

**Photo 1:** View north: remains of front garden wall (house in background)- 1m scale

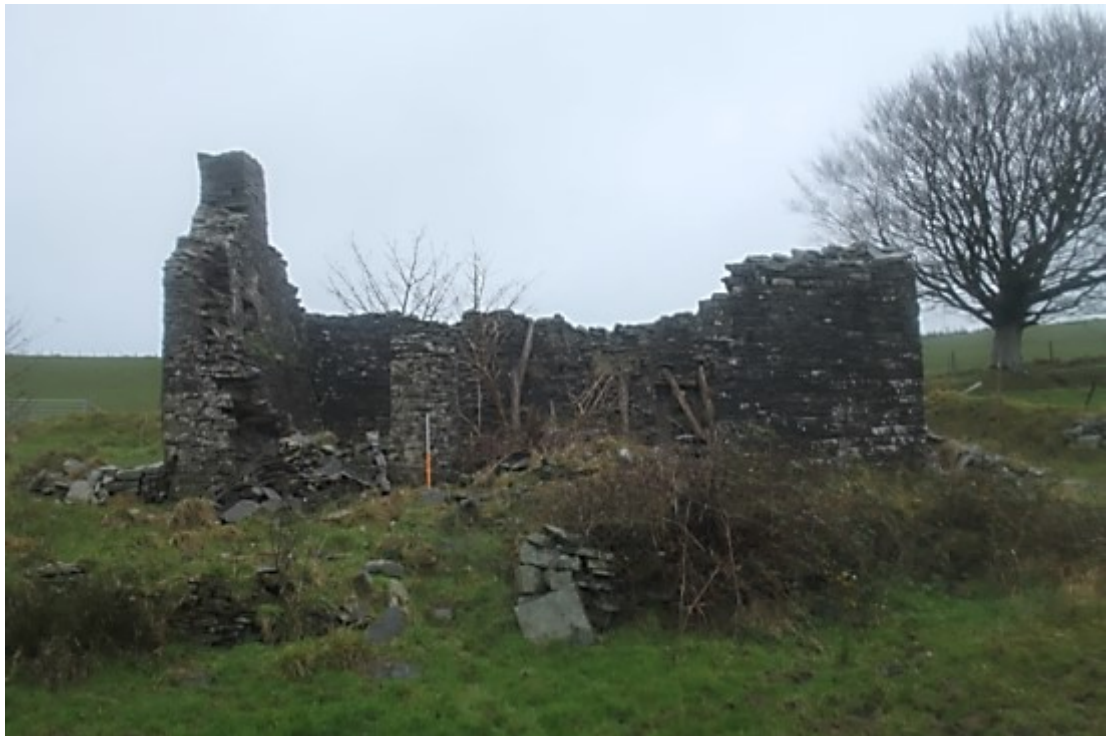
**Photo 2:** View north: remains of front elevation of house - 1 scale

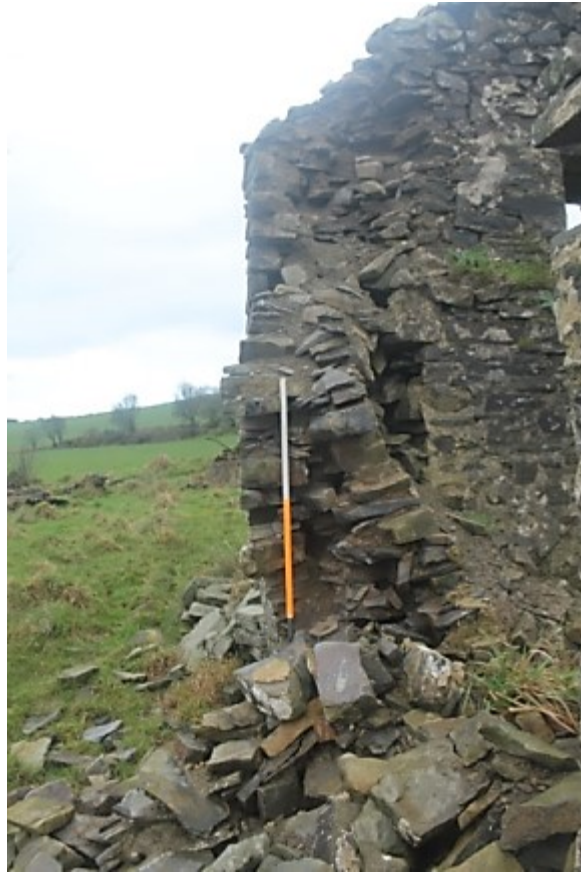
**Photo 3:** Exposed corework at west side of frontage – 1m scale

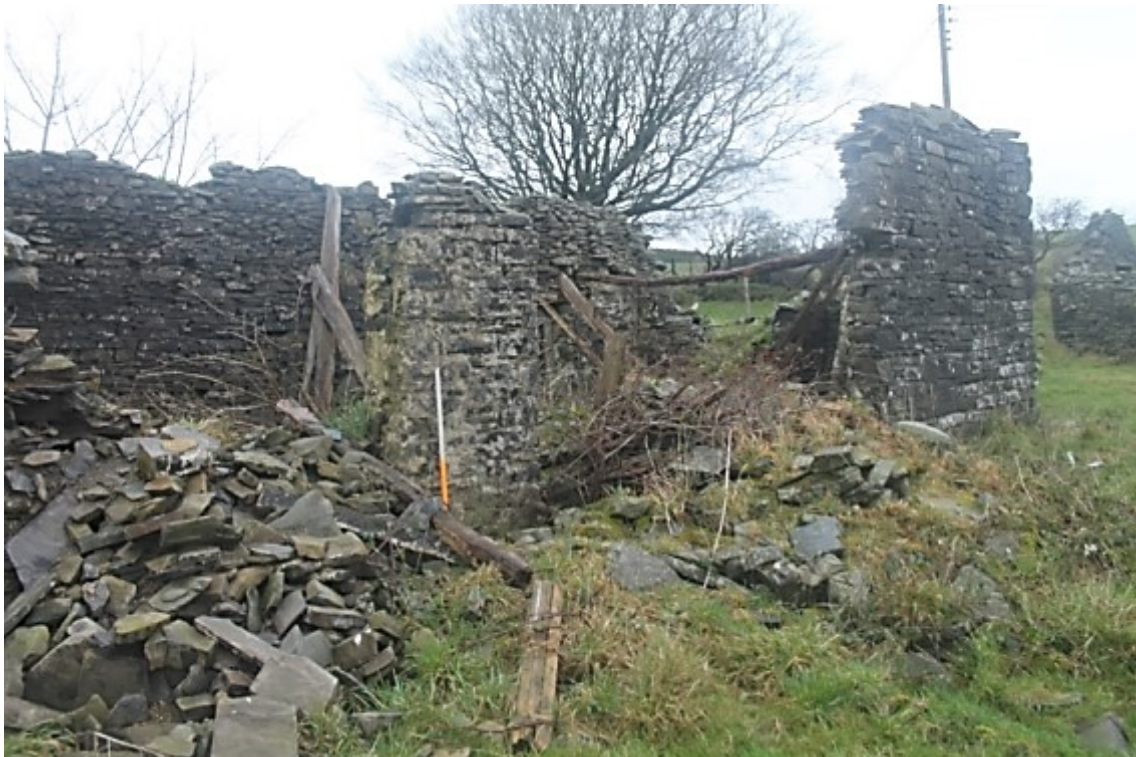
**Photo 4:** View northeast: oblique view of frontage – 1m scale

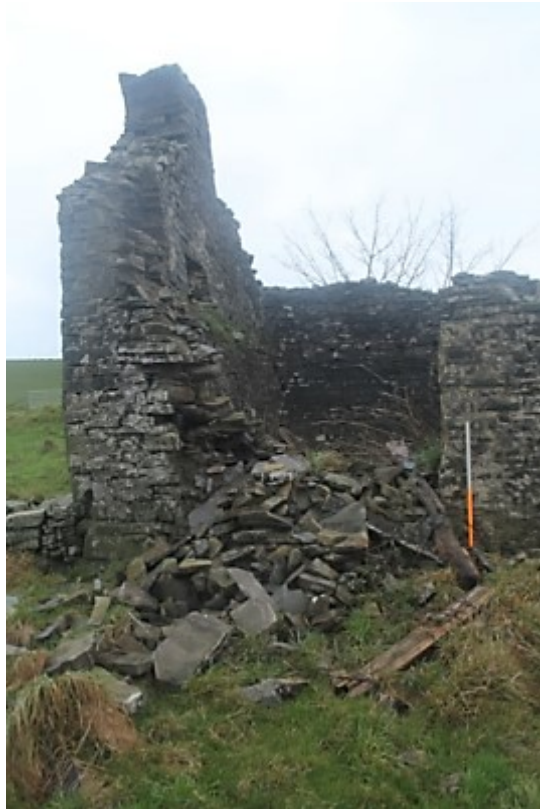
**Photo 5:** Fallen masonry at west side of house front – 1m scale

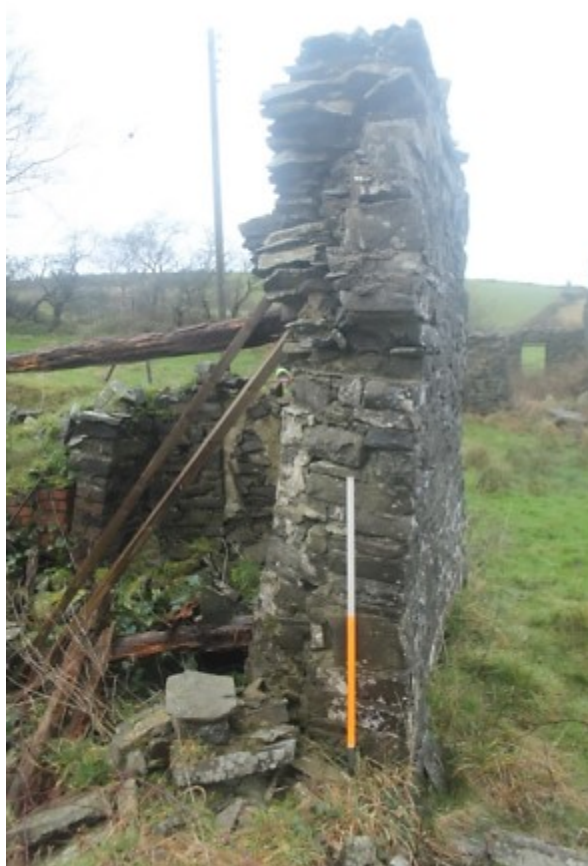
**Photo 6:** Remains of splayed window in east side of frontage – 1m scale

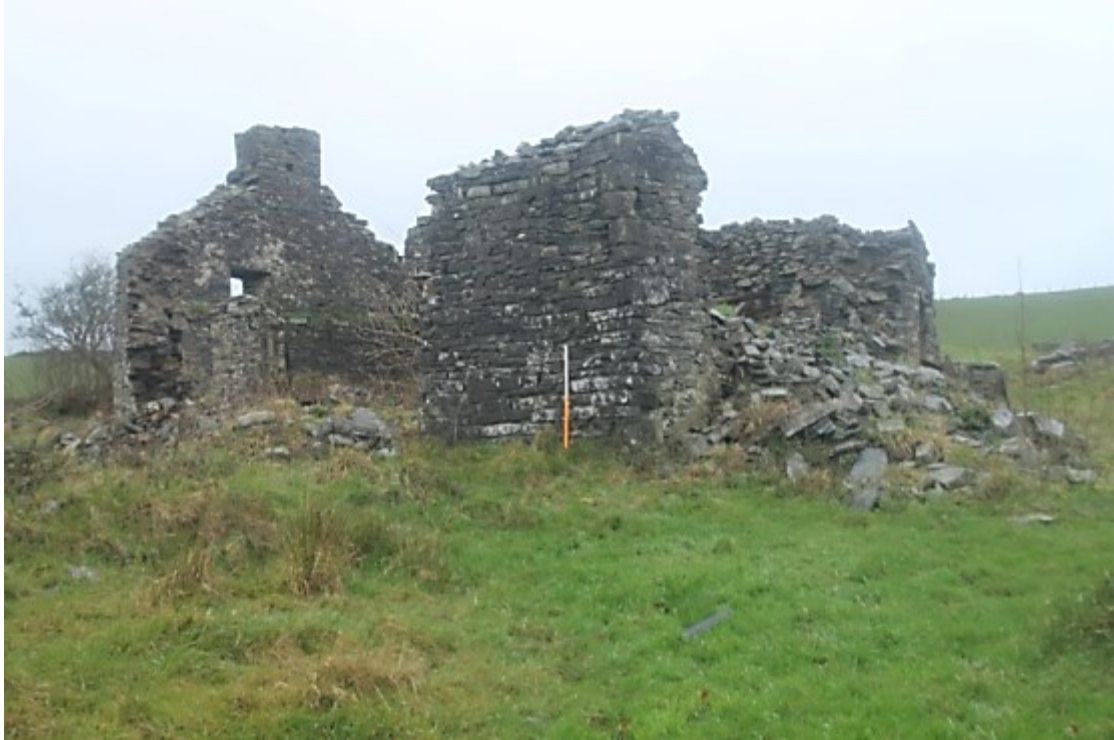
**Photo 7:** Southeast corner of farmhouse - 1m scale

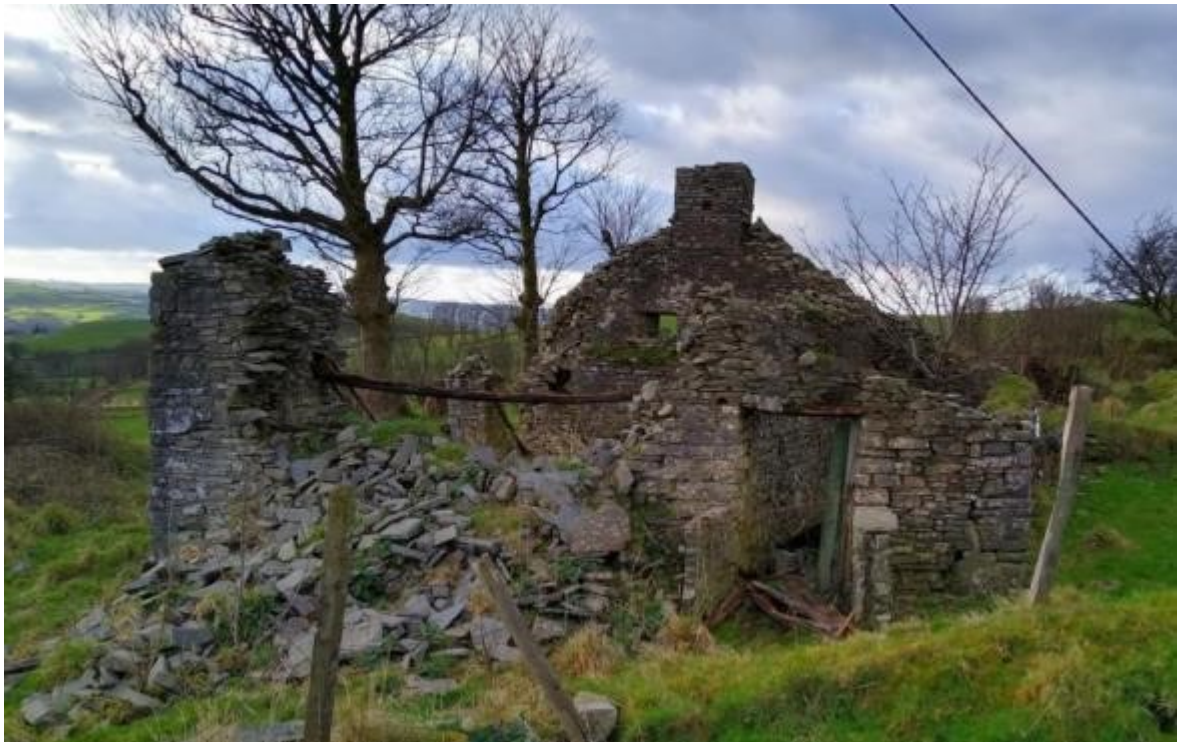
**Photo 8:** Remains of east elevation of house

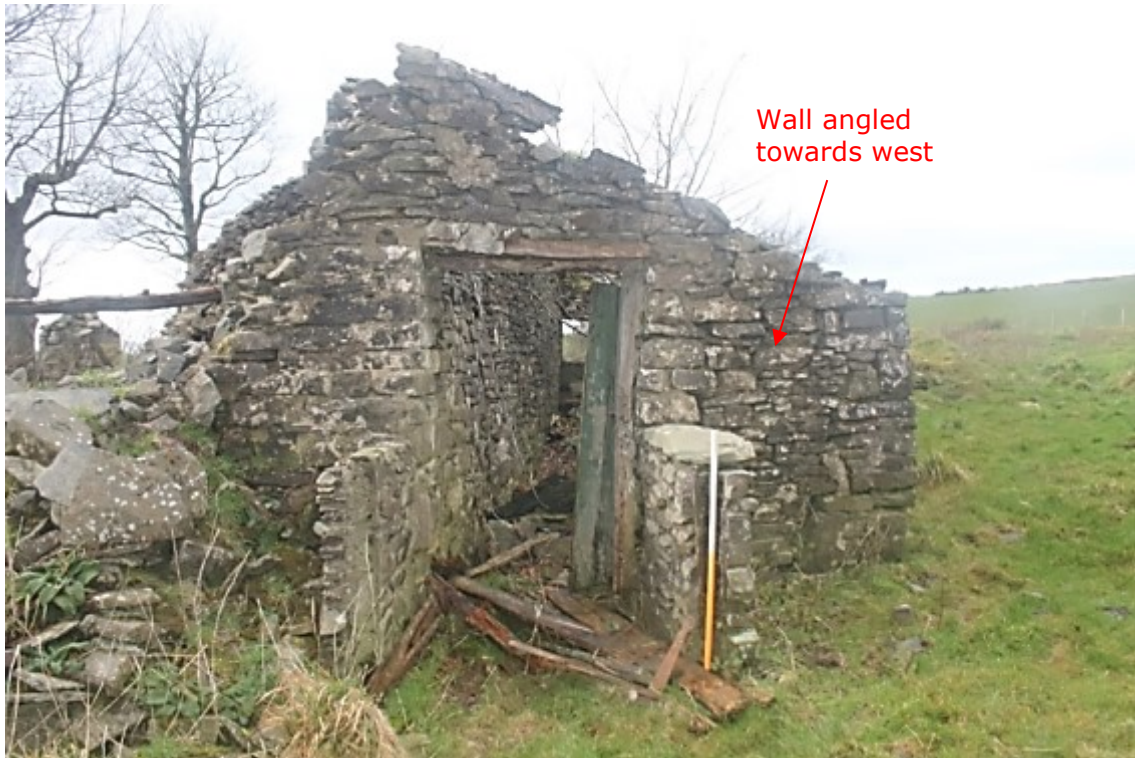
**Photo 9:** East elevation of annex and outside porch leading into scullery - 1m scale

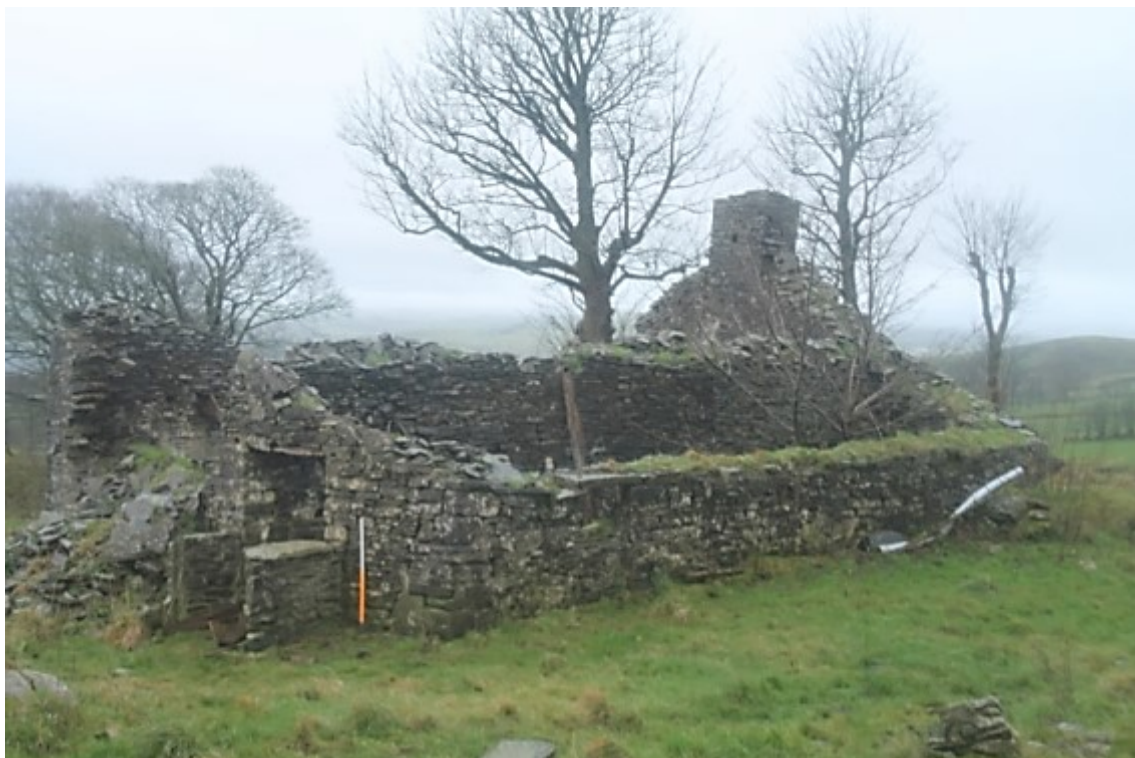
**Photo 10:** Northeast corner of rear annex - 1m scale

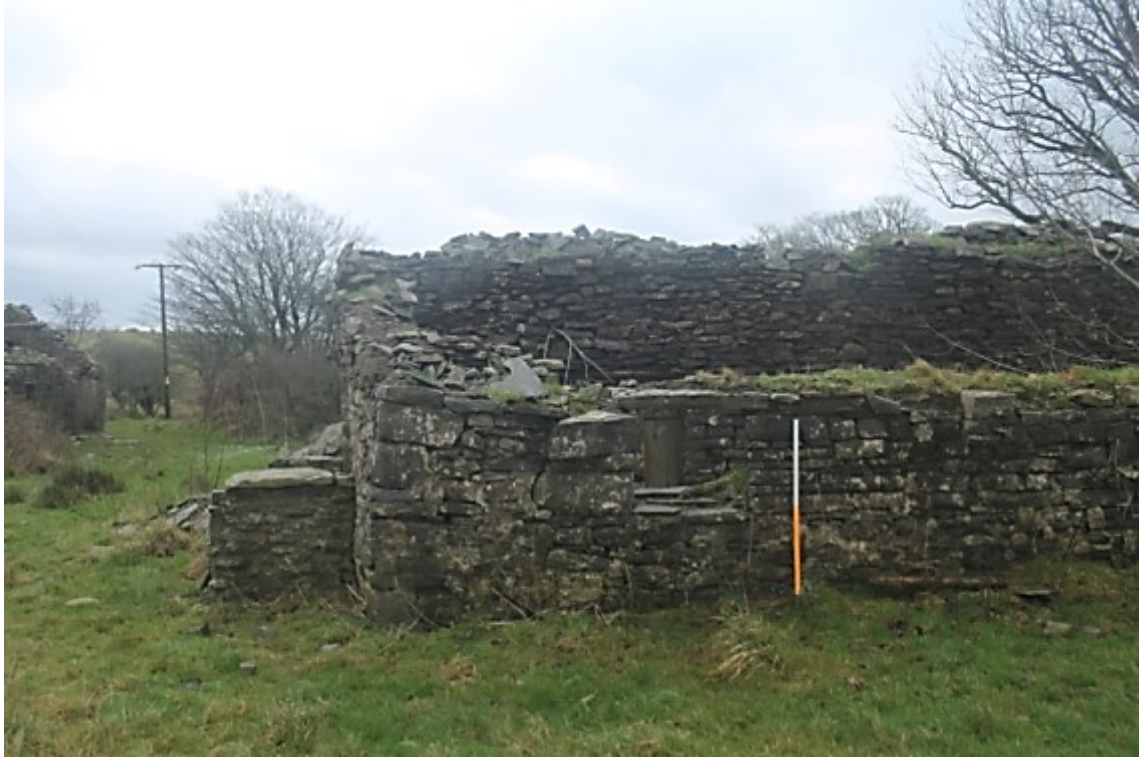
**Photo 11:** East end of rear annex and small stone porch - 1m scale

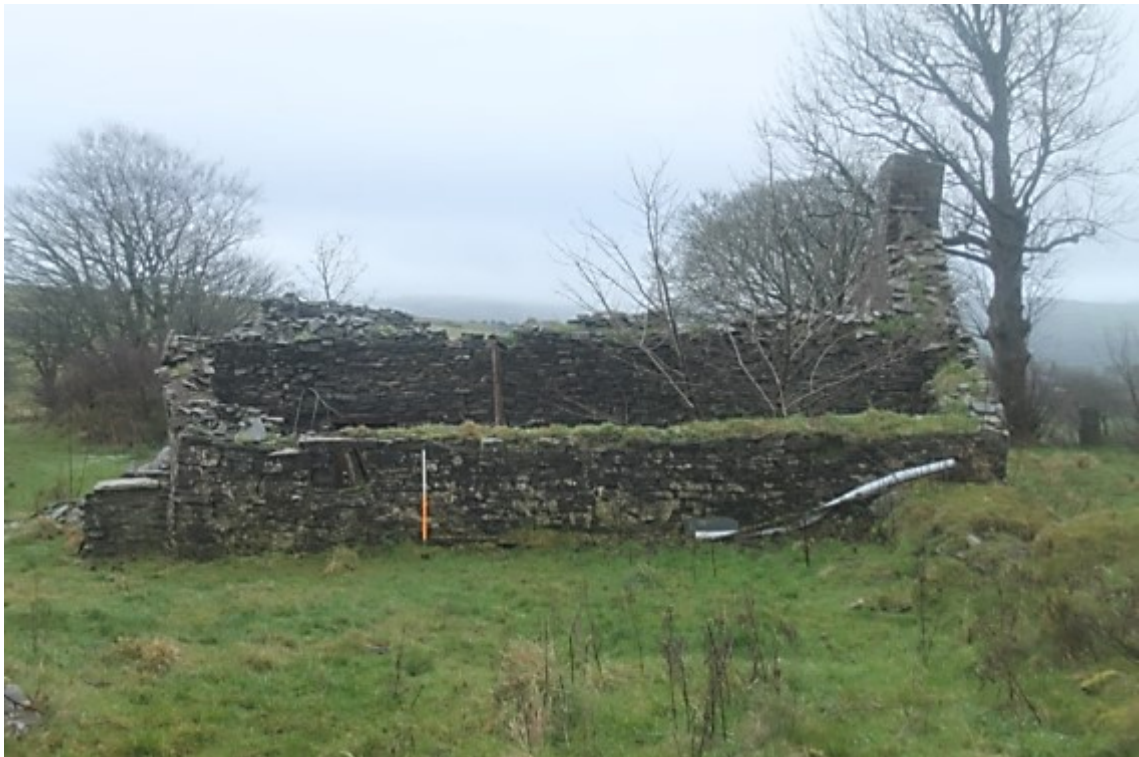
**Photo 12:** North elevation of rear annex – 1m scale

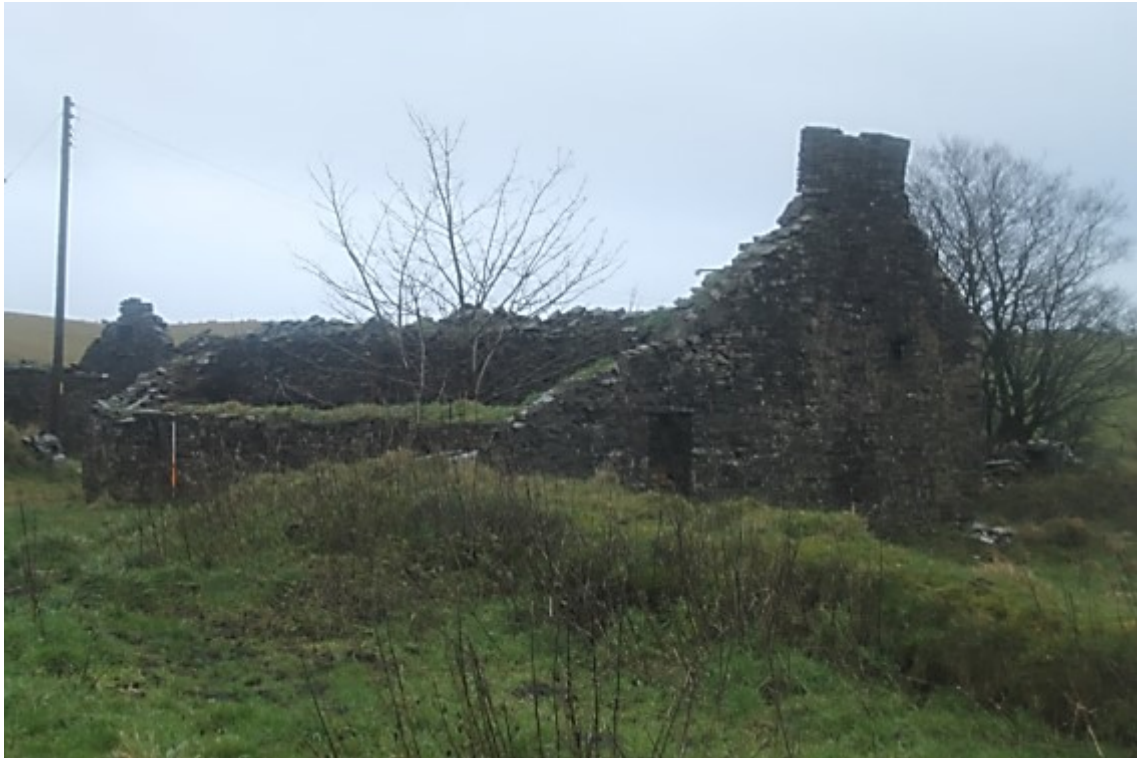
**Photo 13:** Northwest corner of rear annex - 1m scale

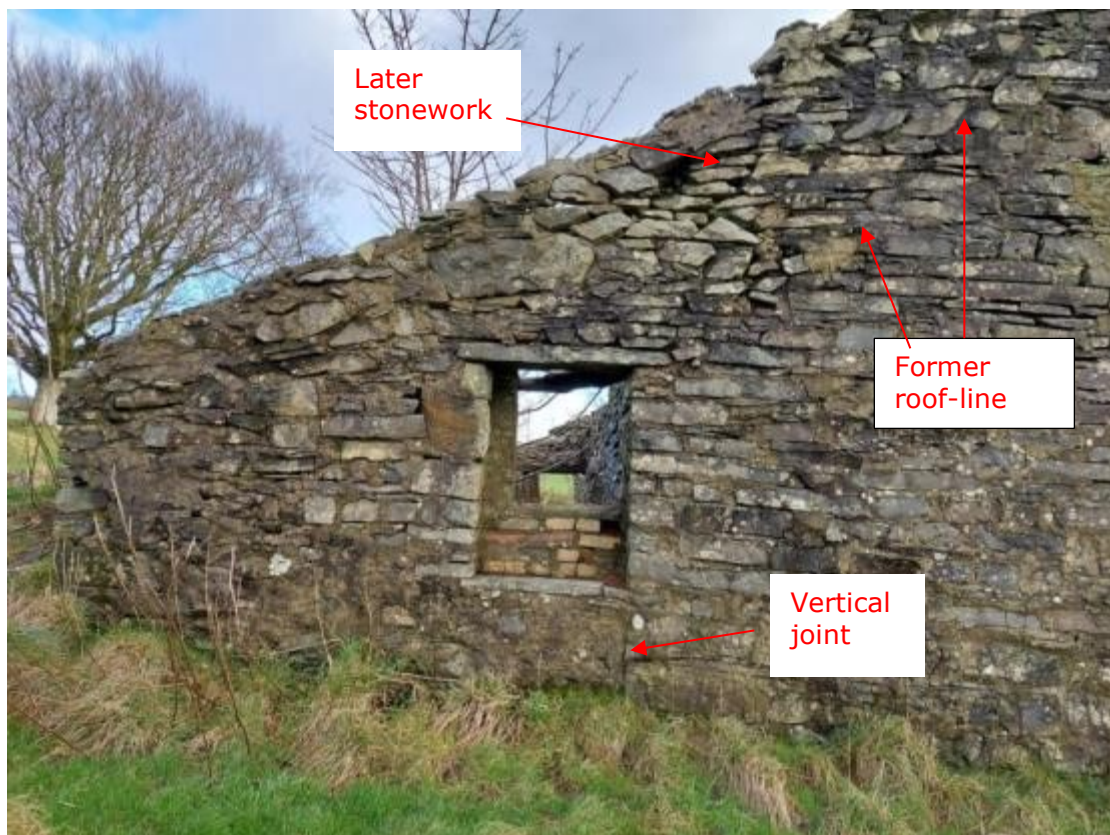
**Photo 14:** West elevation of annex

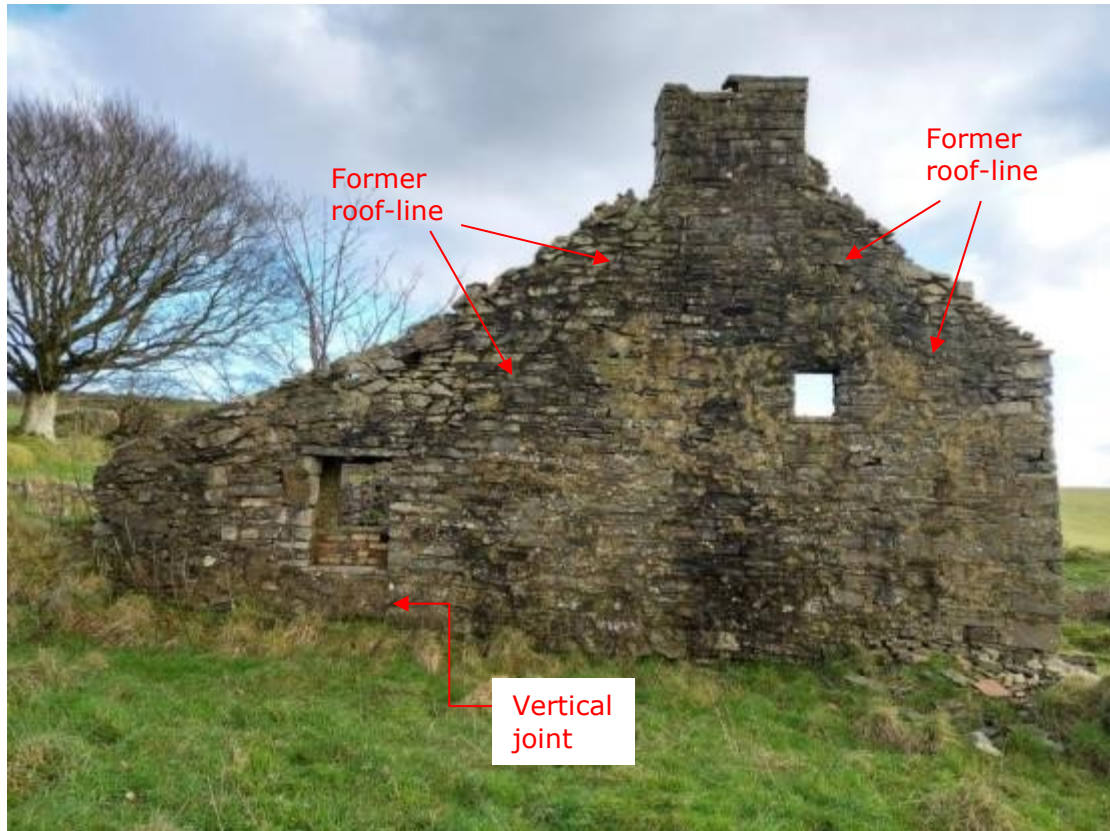
- 4.1 The addition of the annex to the rear of the house is evident by the vertical joint and the raising of the roof-line to create a catslide; as seen in the west elevation (Photos 14 and 15). The fact that the roof-line on the south side of the chimney (Photo 15) has also been raised, as well as the north wall of the house (Photos 17, 18 and 19) suggests that an upper floor was created at the same time. It is reasonable to assume that it was during this time that the window in the north wall of the house was blocked (Photo 27) having become redundant after the addition of the annex. The doorway connecting the house to the annex (Photo 19) and to the farmyard via the side door (Photos 9 and 28) might also have been created during this phase; hence the original door leading to the farmyard having been blocked (Photo 21). A difference in pointing seen in the north wall of the annex beside the slate bench (Photo 26) might indicate where the later extension of the annex westwards began - compare annex in 1<sup>st</sup> edition and 2<sup>nd</sup> edition OS maps (Figures 4 and 5).

**Photo 15:** West elevation of house and annex

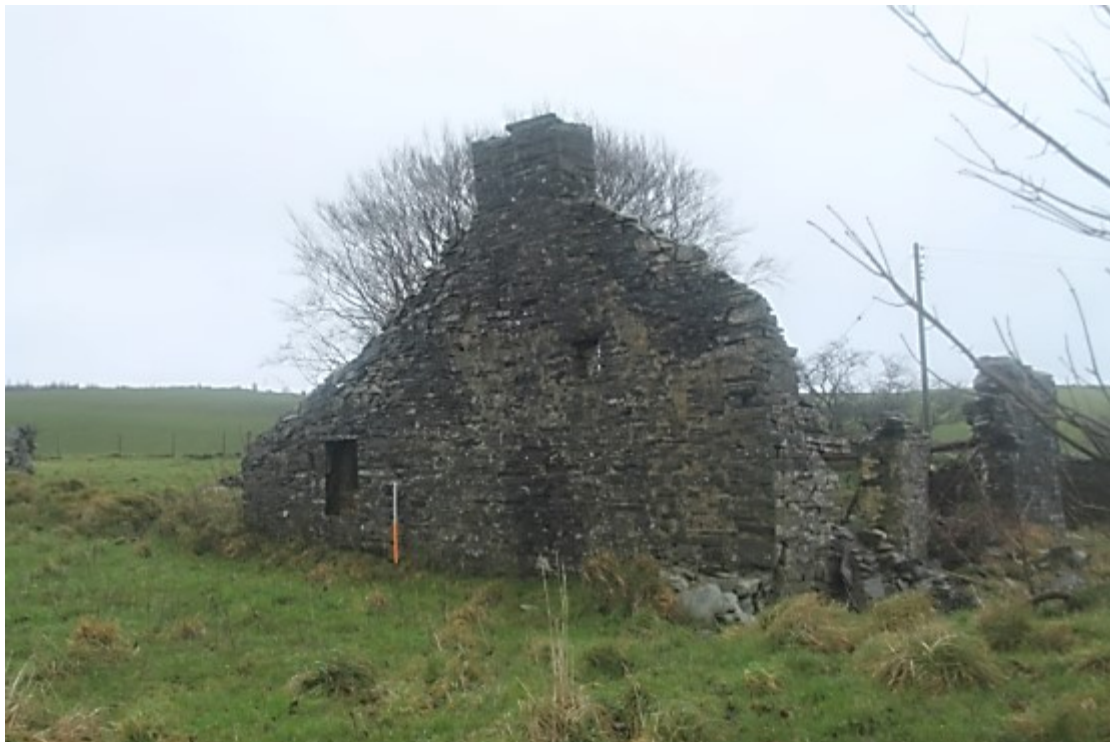
**Photo 16:** Southwest corner of house - 1m scale

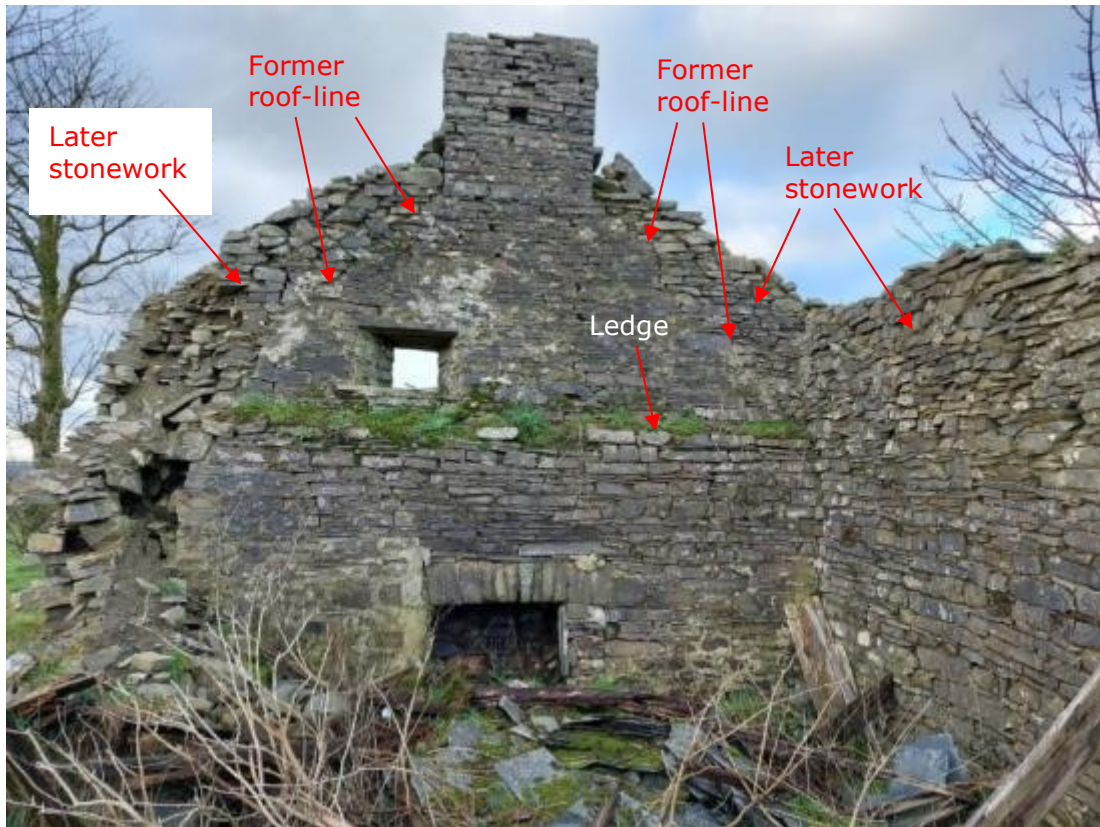
**Photo 17:** Interior west elevation showing fireplace and ledge to support upper storey

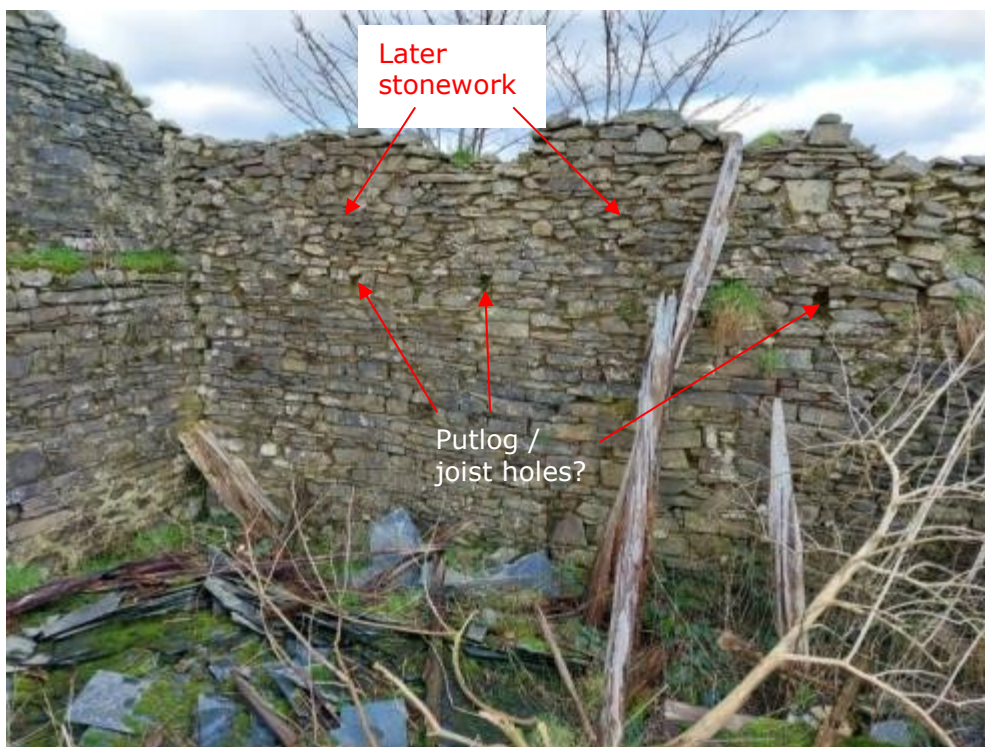
**Photo 18:** Northwest interior corner of parlour; note change of stonework above ledge for upper floor - 1m scale

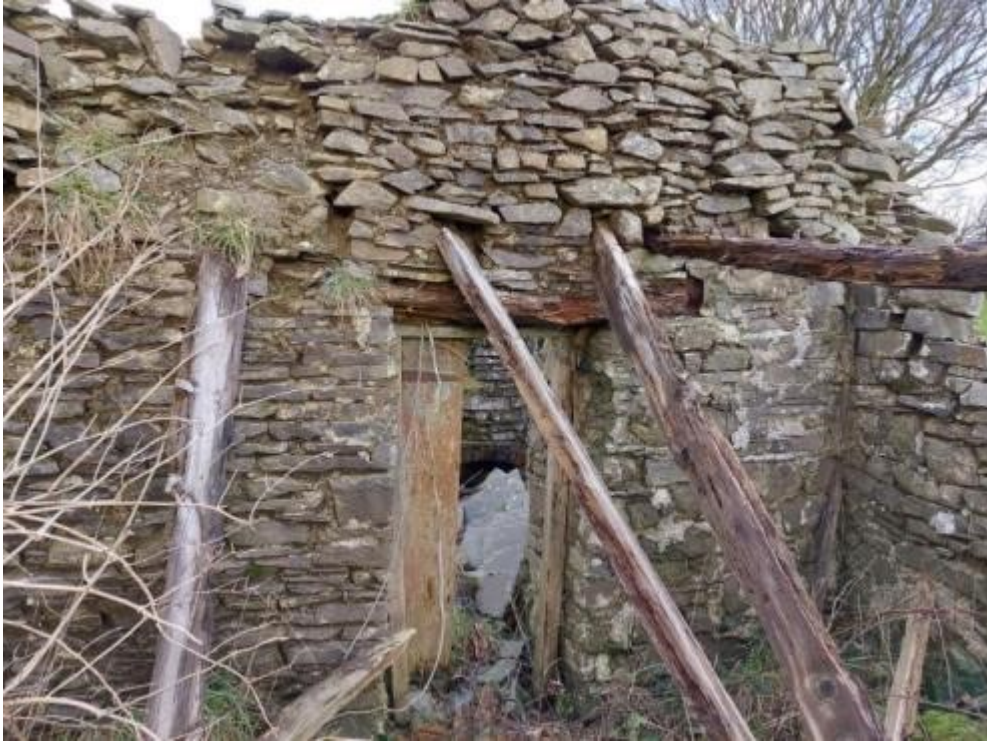
**Photo 19:** Northeast interior corner of kitchen with door leading to scullery with later stonework above doorway

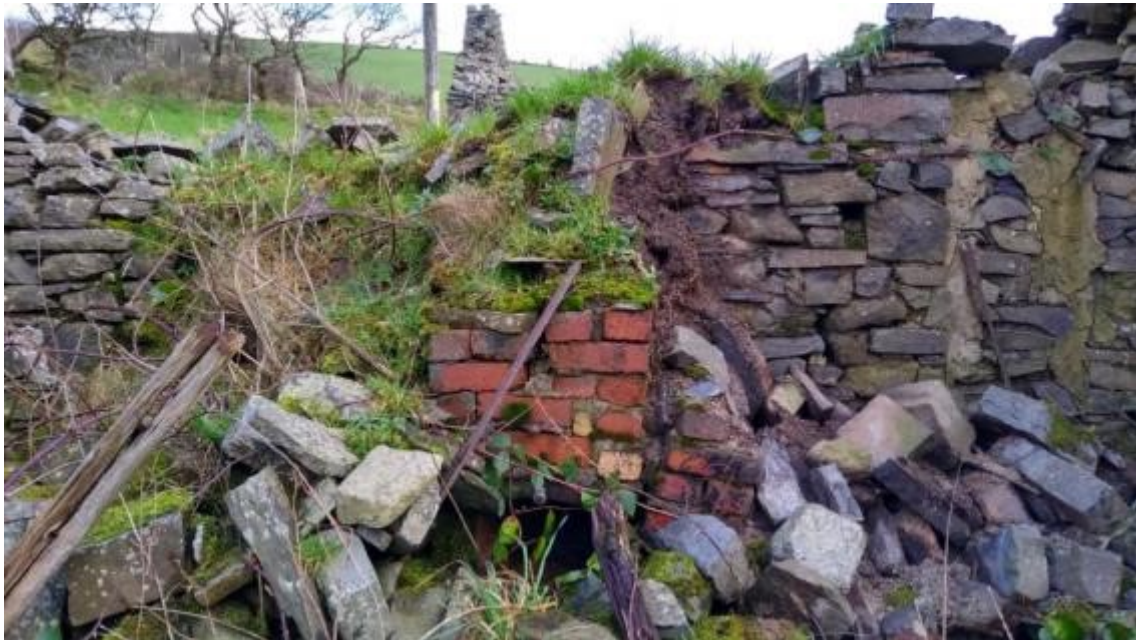
**Photo 20:** Interior east wall of kitchen (brick oven can be partially seen -1m scale

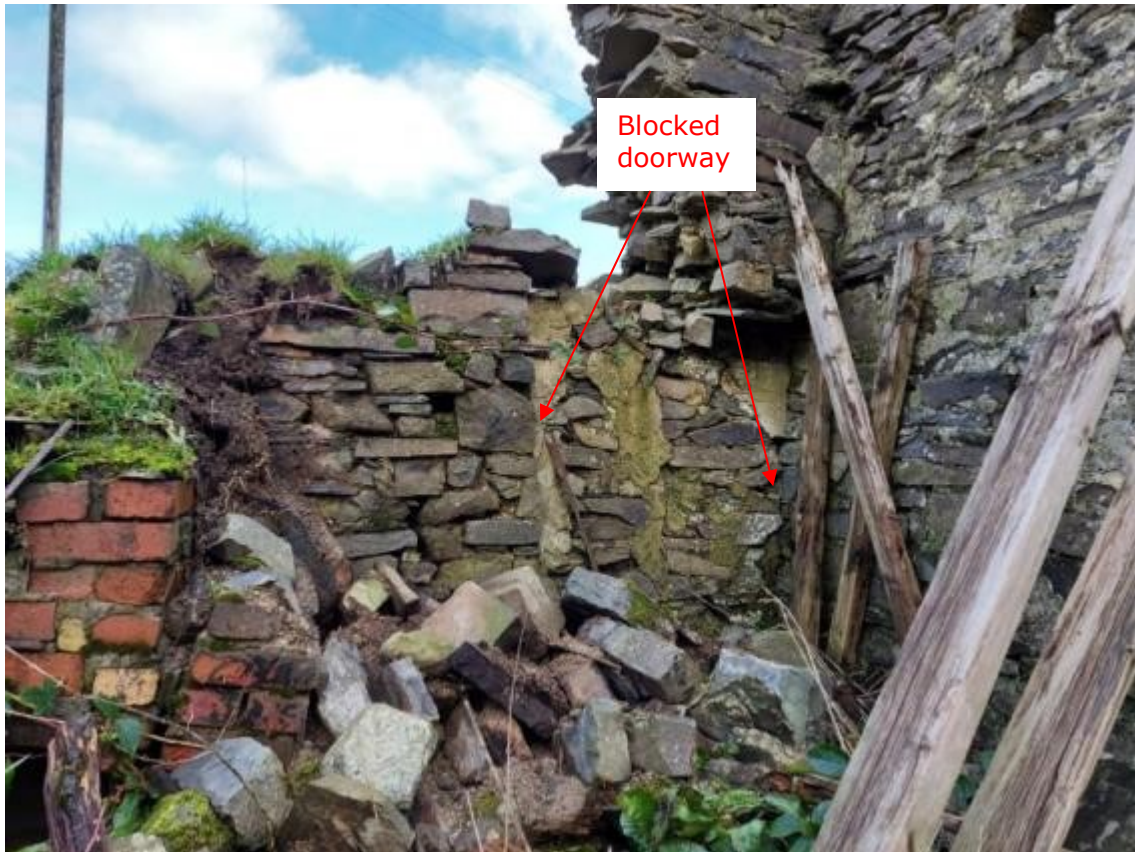
**Photo 21:** Blocked doorway in southeast corner of house

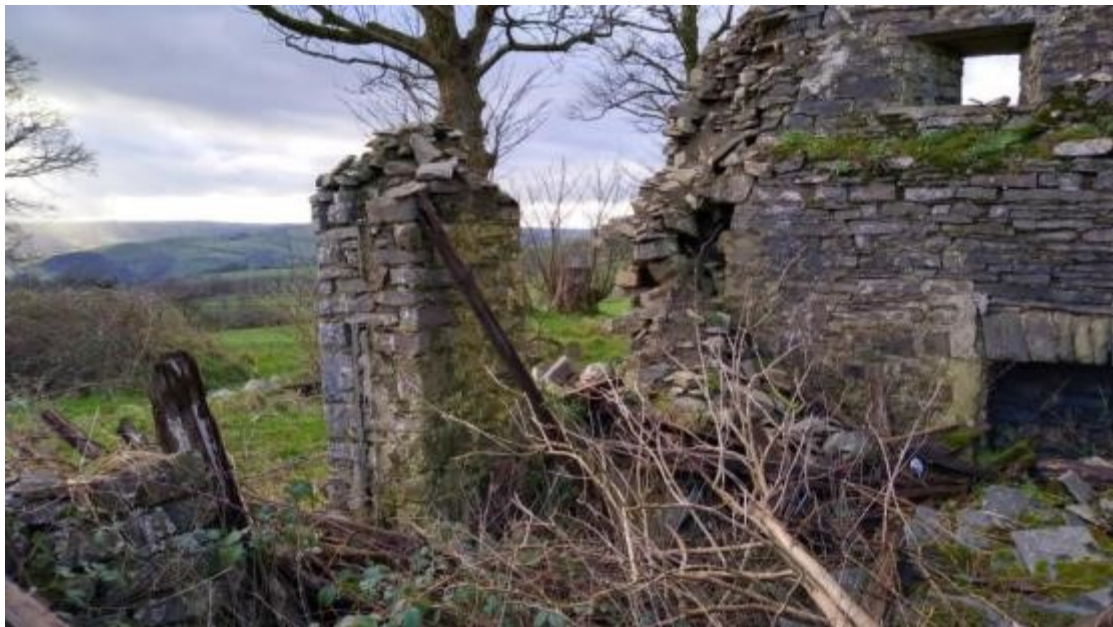
**Photo 22:** Southwest corner of parlour and remains of front door

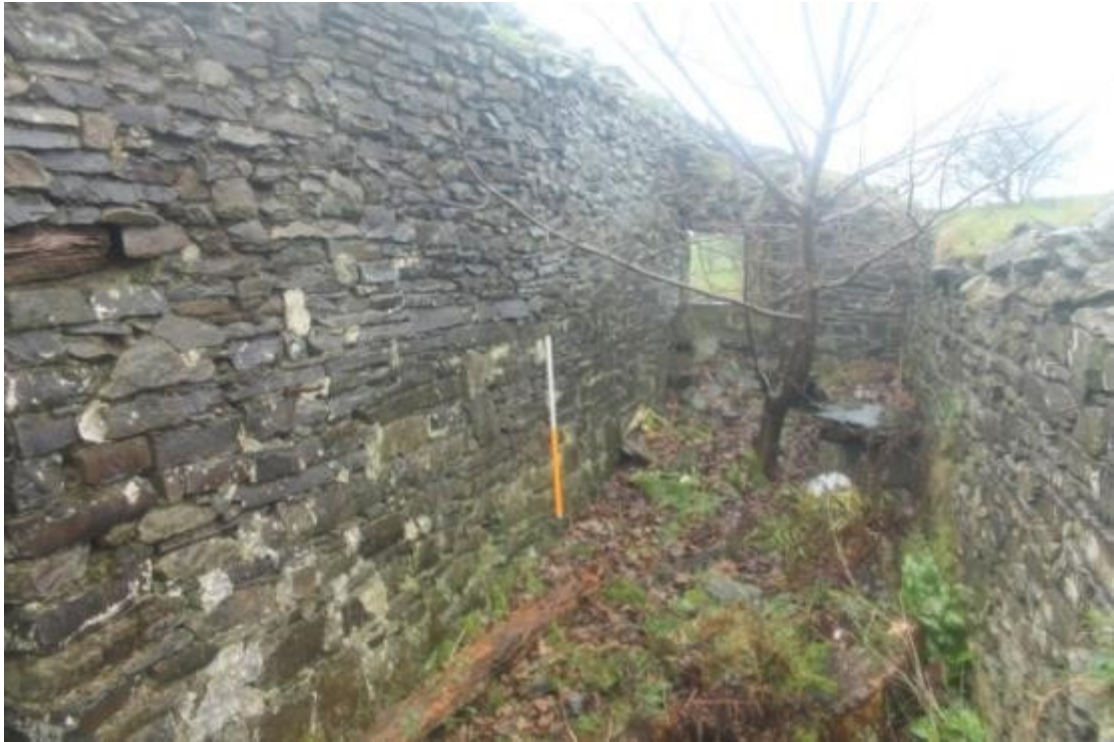
**Photo 23:** View west along annex - 1m scale

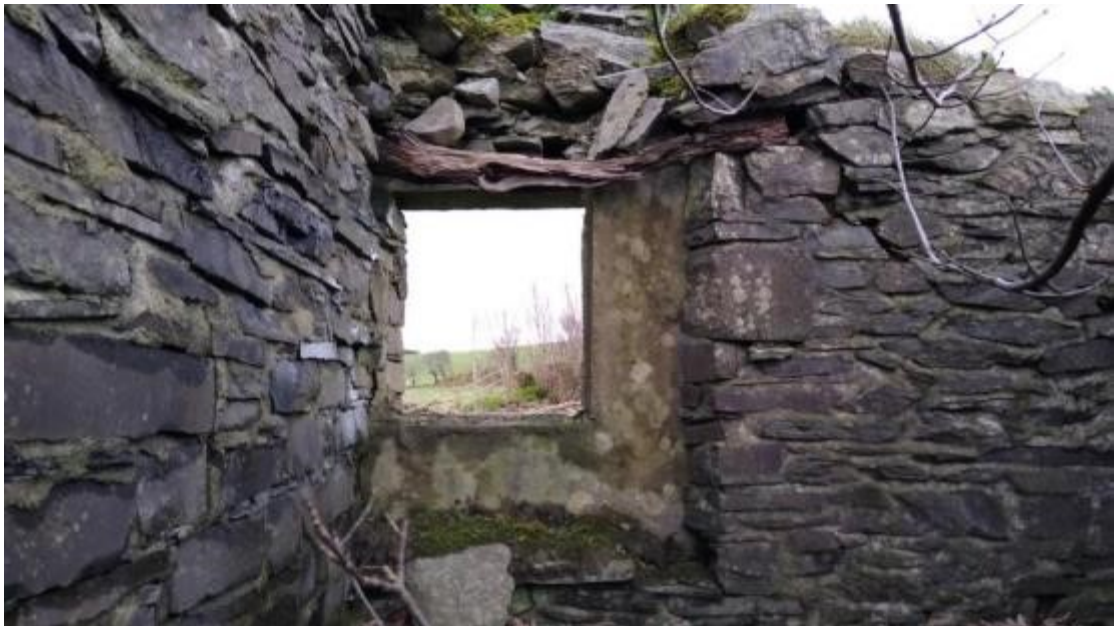
**Photo 24** Interior shot of modified window in west wall of annex

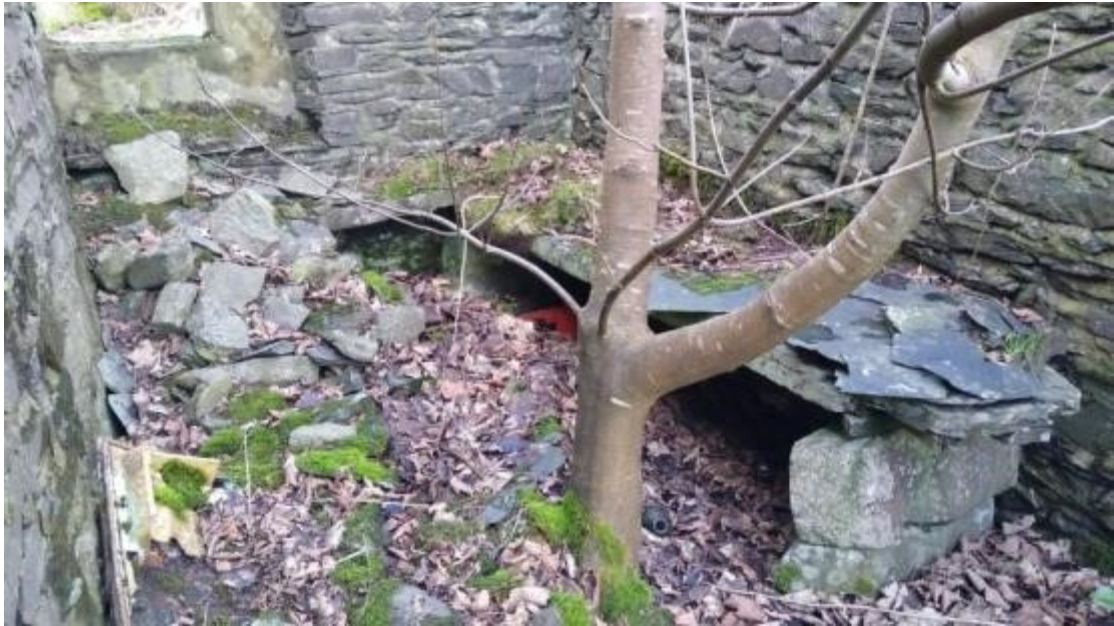
**Photo 25** Northwest corner of dairy with slate-slab benches

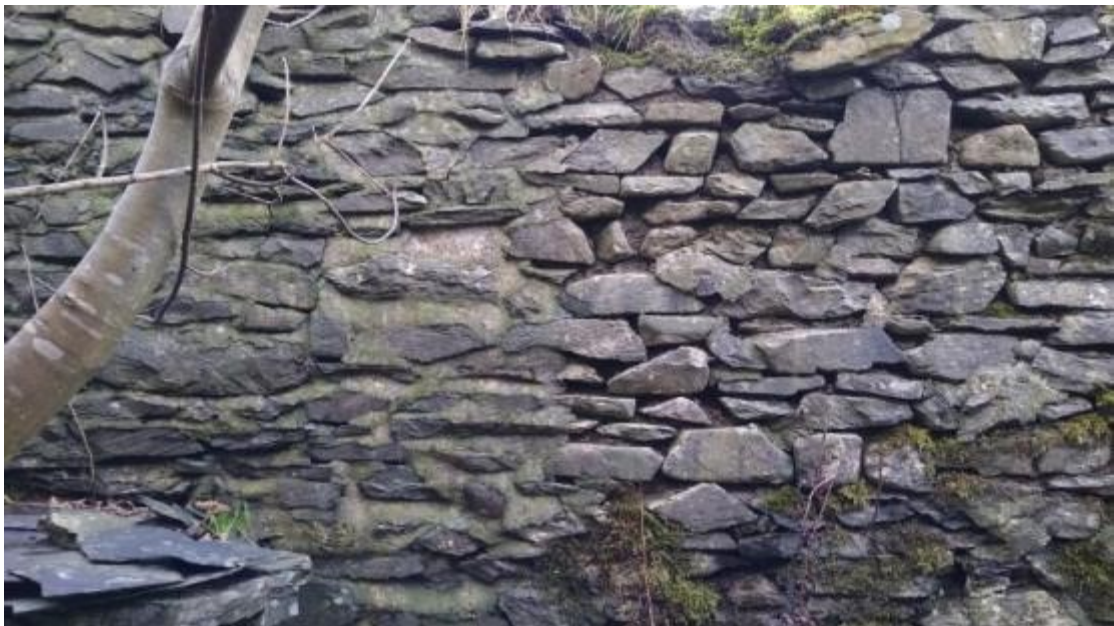
**Photo 26** Interior view of north wall of annex showing pointed and unpointed stonework

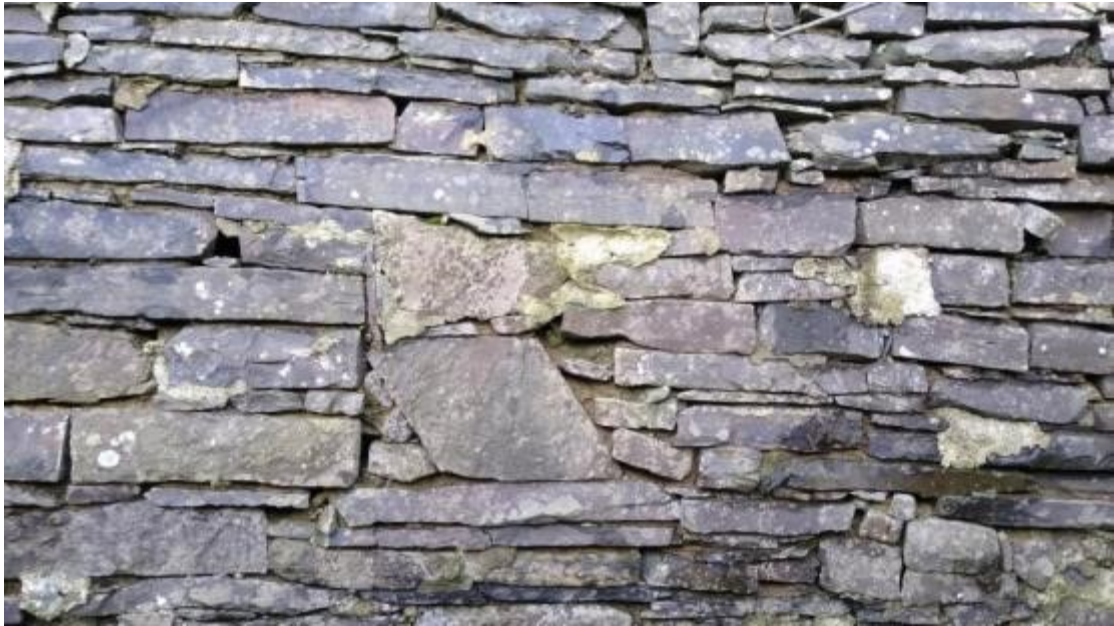
**Photo 27:** Blocked window in north wall of house

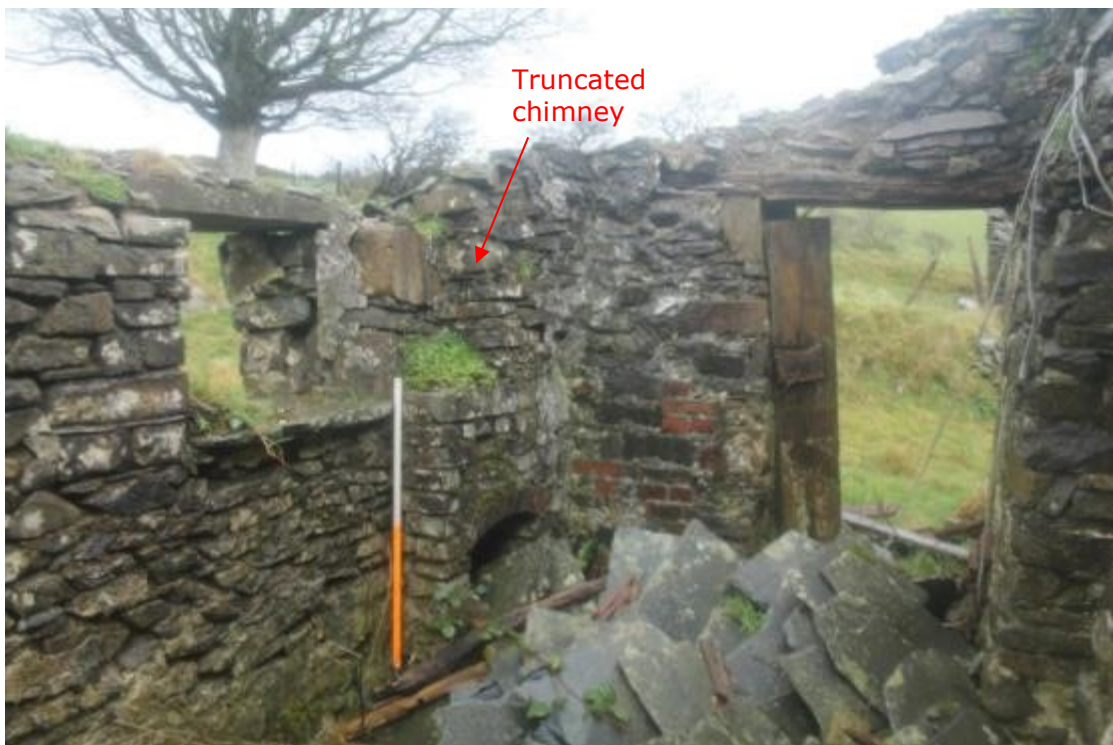
**Photo 28:** Looking at northeast corner of scullery with brick-arched fireplace and door leading to yard
