# **MAES-MYNACH, CILCENNIN, CEREDIGION: HISTORIC BUILDING RECORDING**

Prepared by DAT Archaeological Services  
For: Mr Emyr Evans

REPORT NO. 2020-66  
EVENT RECORD No.125649

December 2020

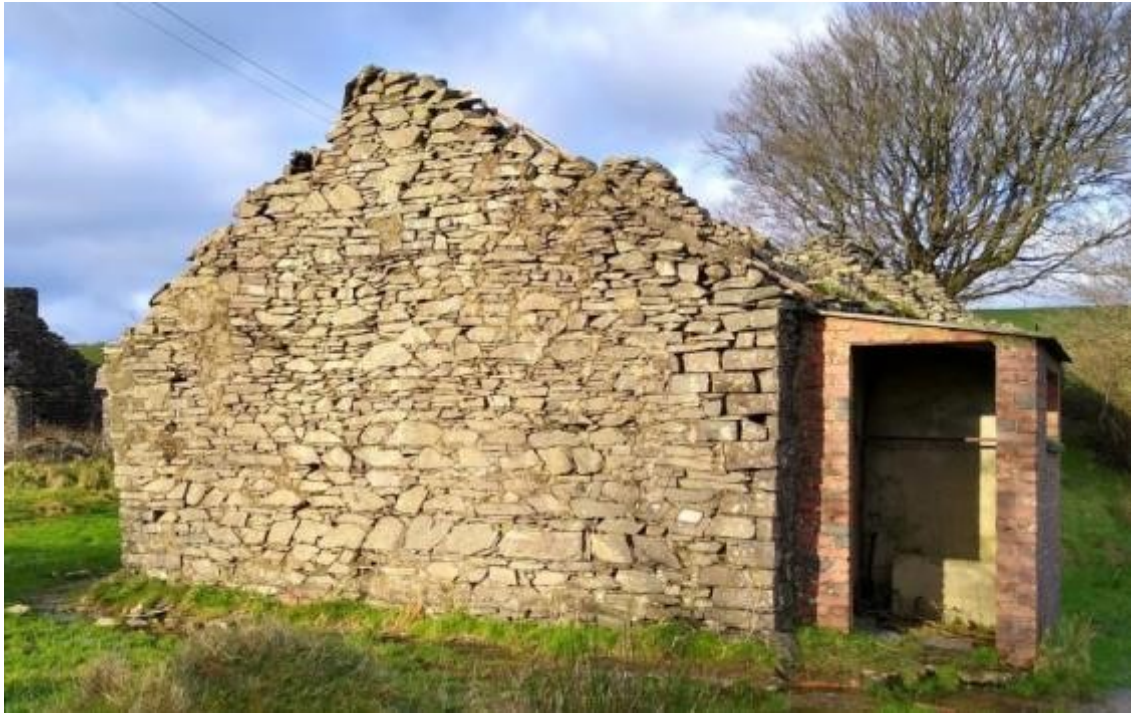
**Photo 29:** South elevation of cowshed with brick entrance to dairy.

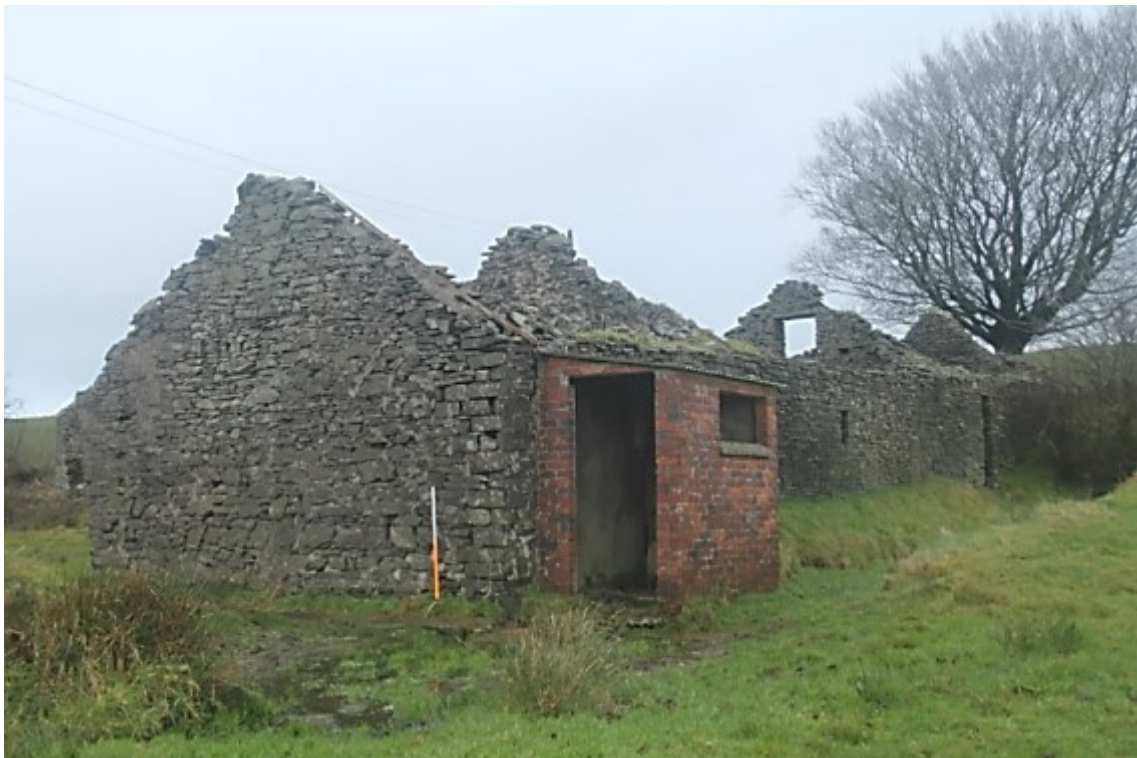
**Photo 30:** Southeast corner of cowshed with brick dairy – 1m scale

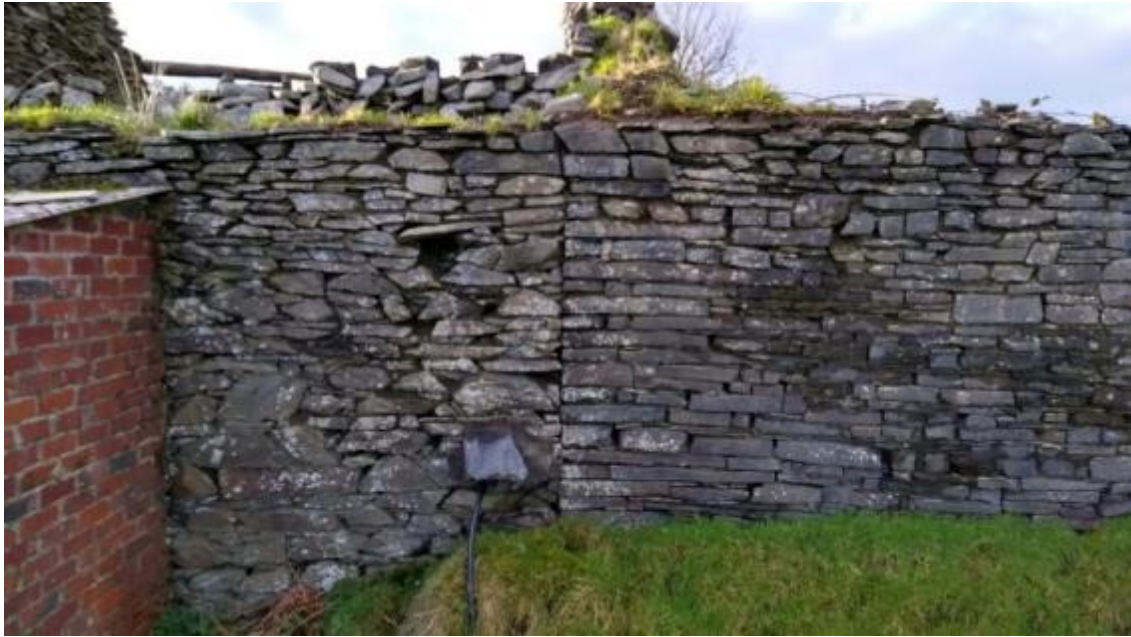
**Photo 31:** Vertical joint between cowshed and barn in east elevation

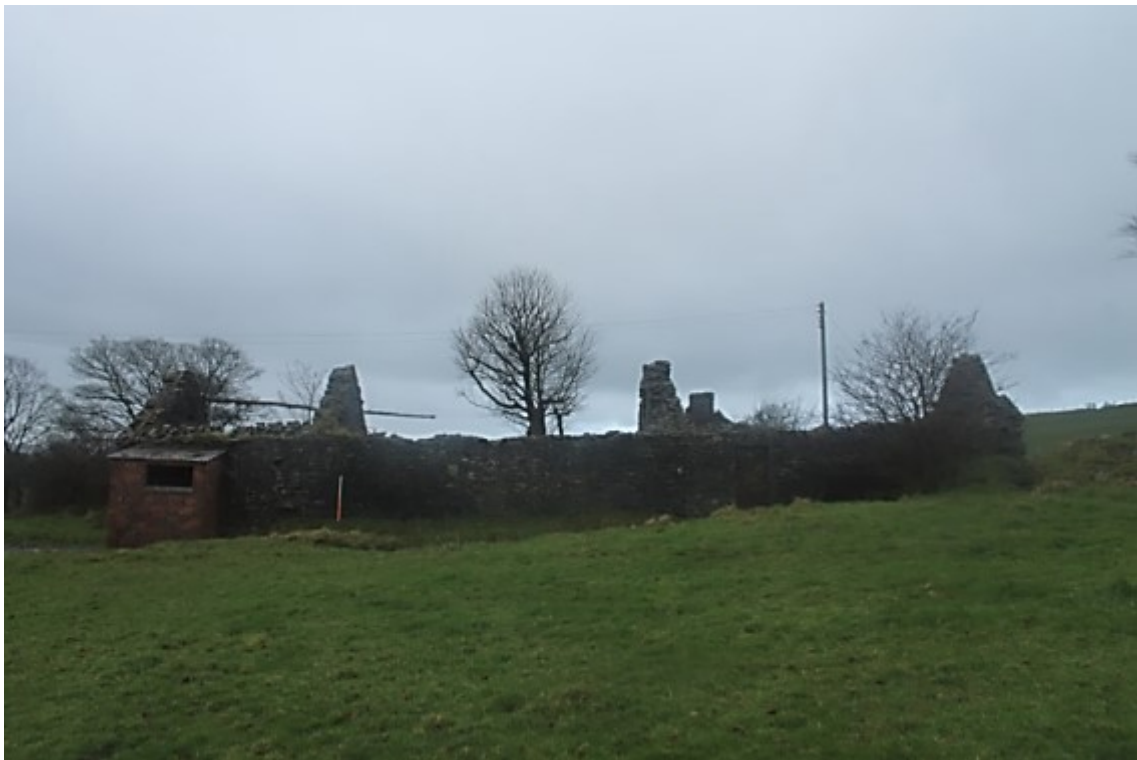
**Photo 32:** East elevation of outbuilding (a)

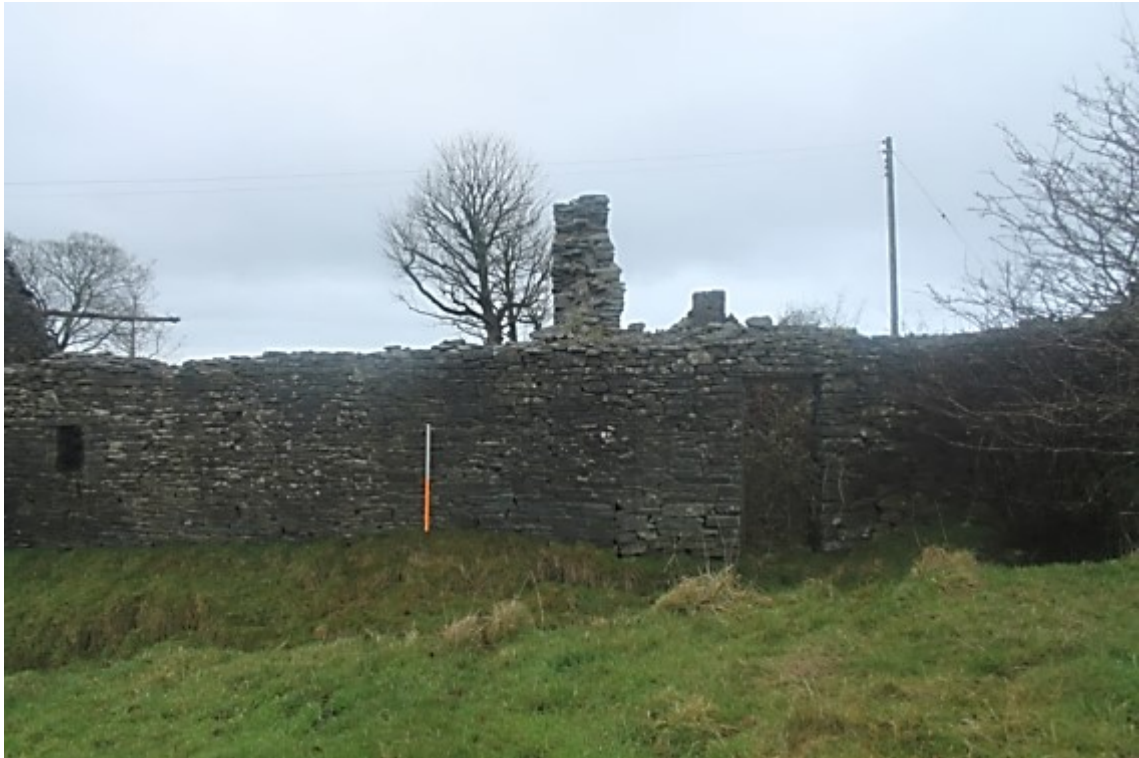
**Photo 33:** View of east elevation showing window in barn and door into granary  
– 1m scale

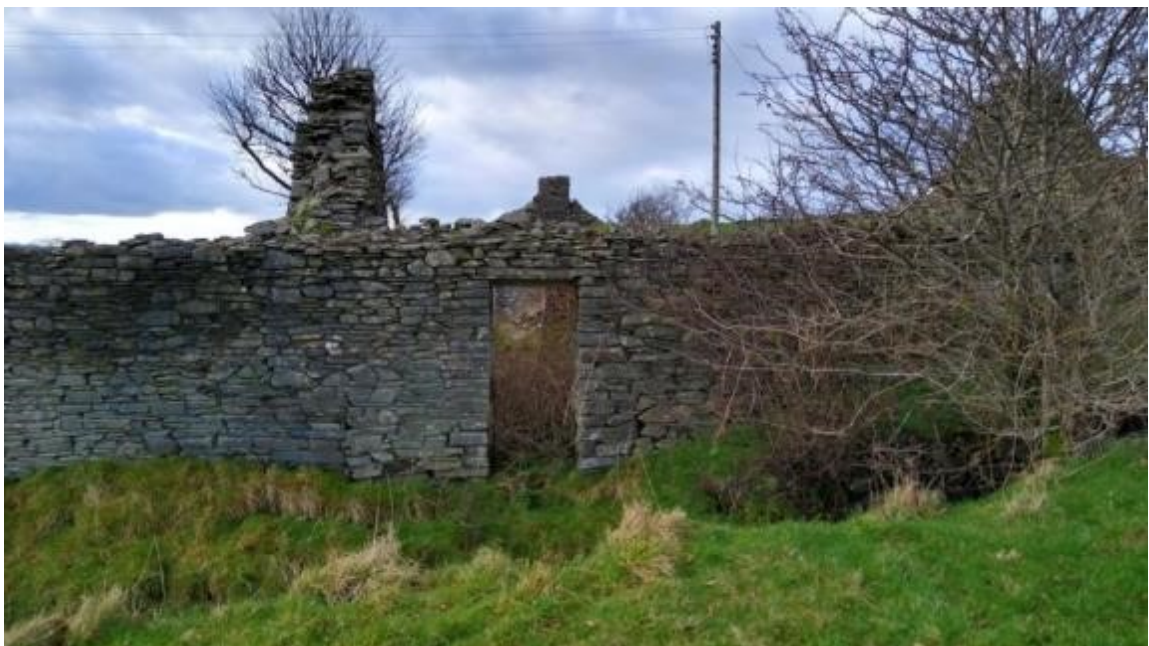
**Photo 34:** Close-up of doorway into granary

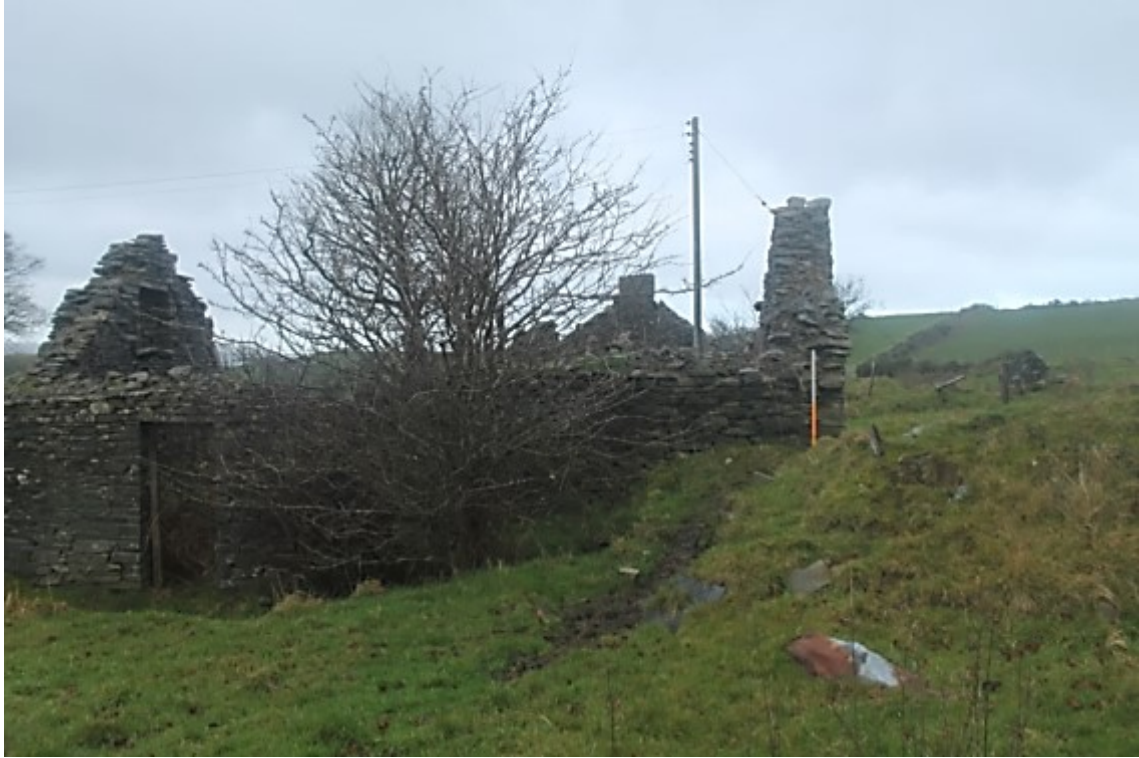
**Photo 35:** East elevation of granary – 1m scale

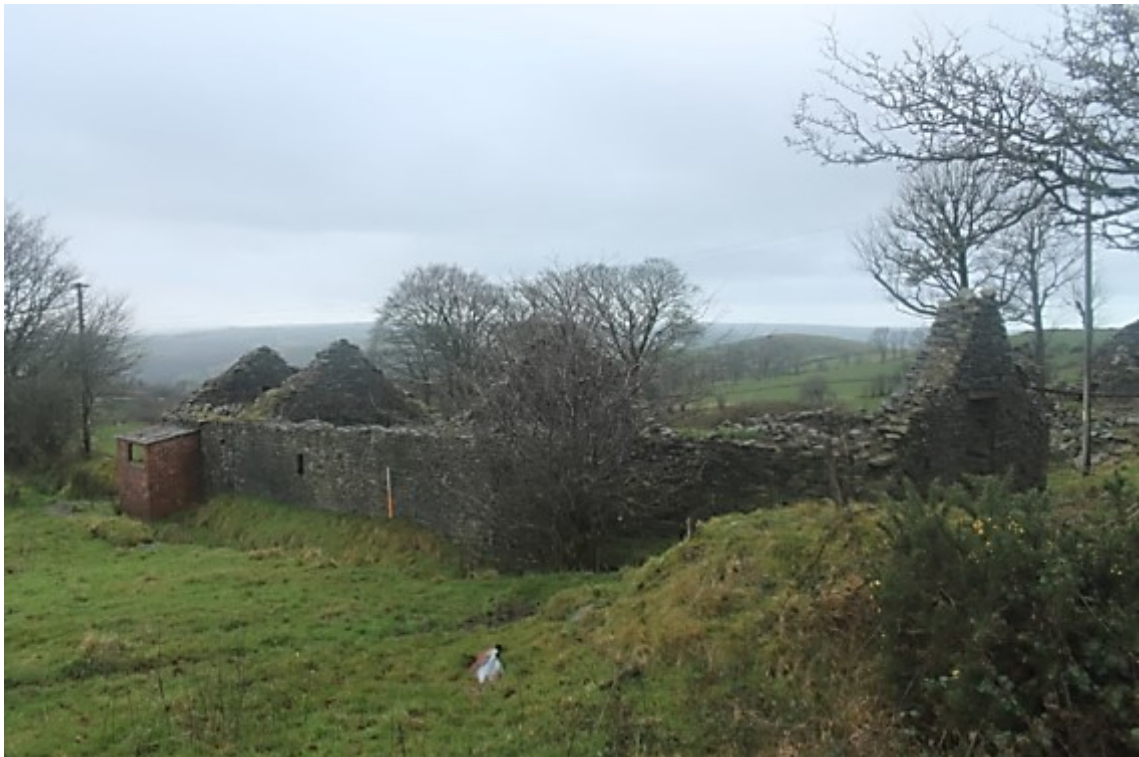
**Photo 36:** View southwest: oblique view of outbuildings – 1m scale

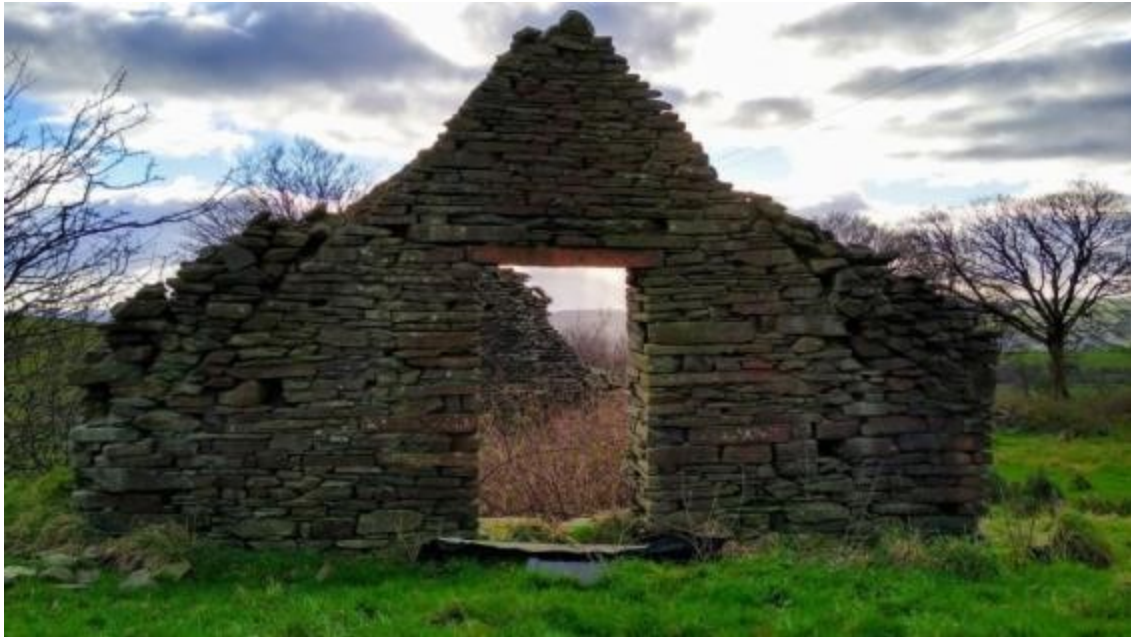
**Photo 37:** North elevation of granary. Note roofline has been modified

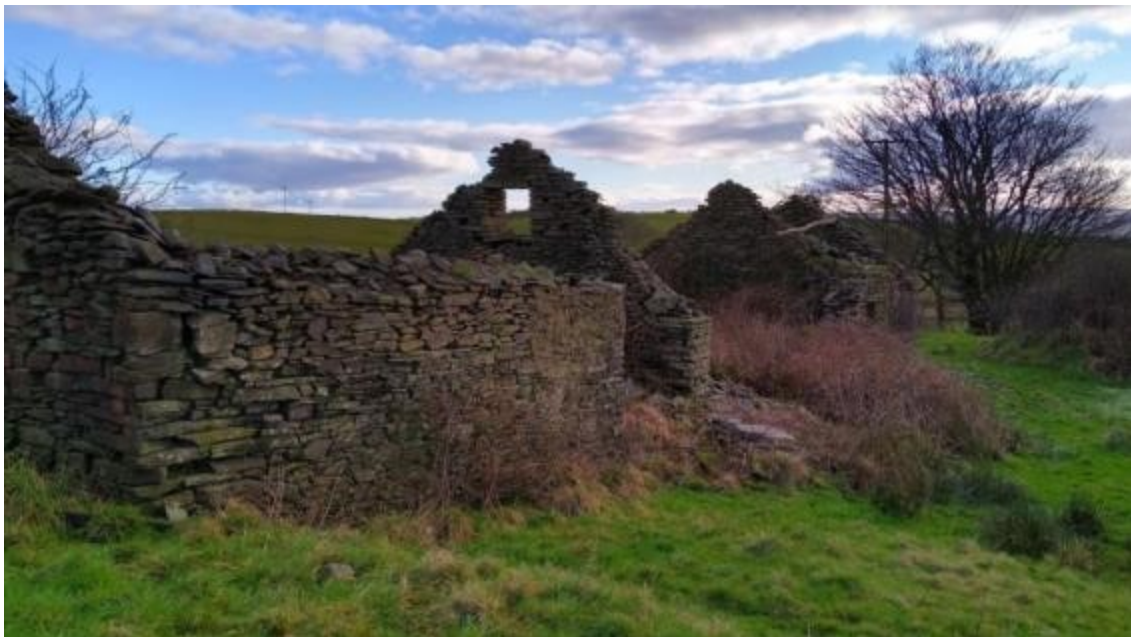
**Photo 38:** Northwest corner of granary

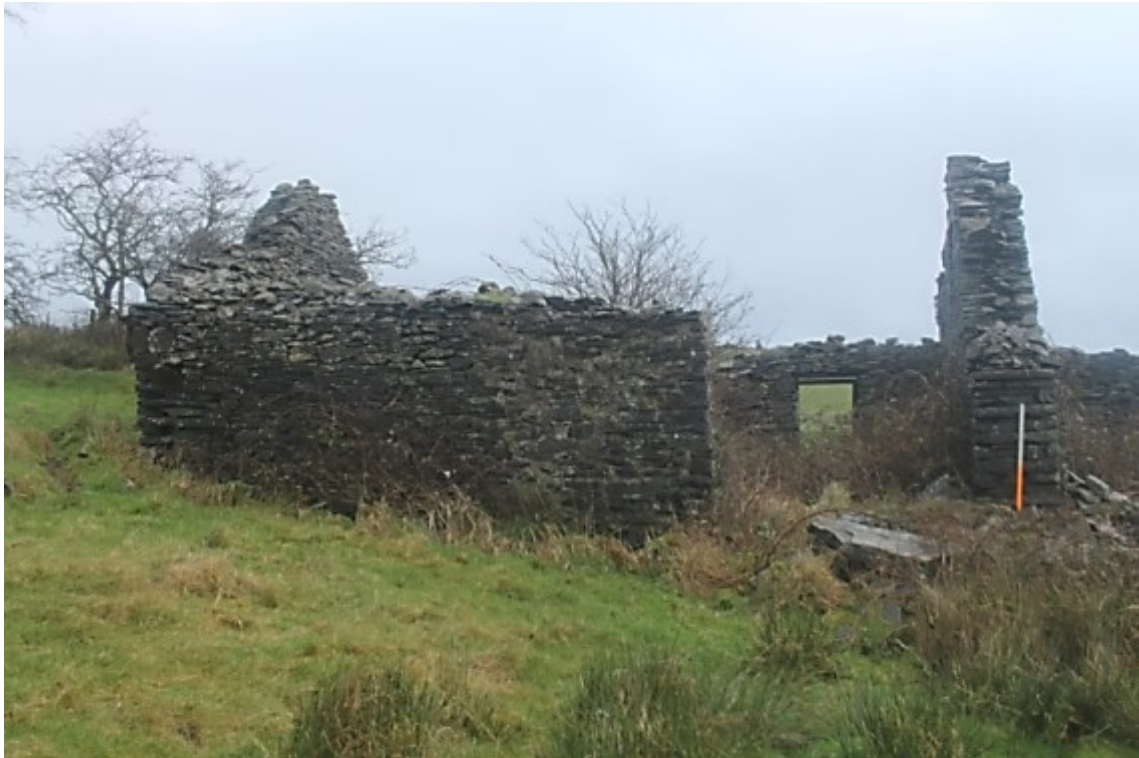
**Photo 39:** Entrance in west elevation of granary – 1m scale

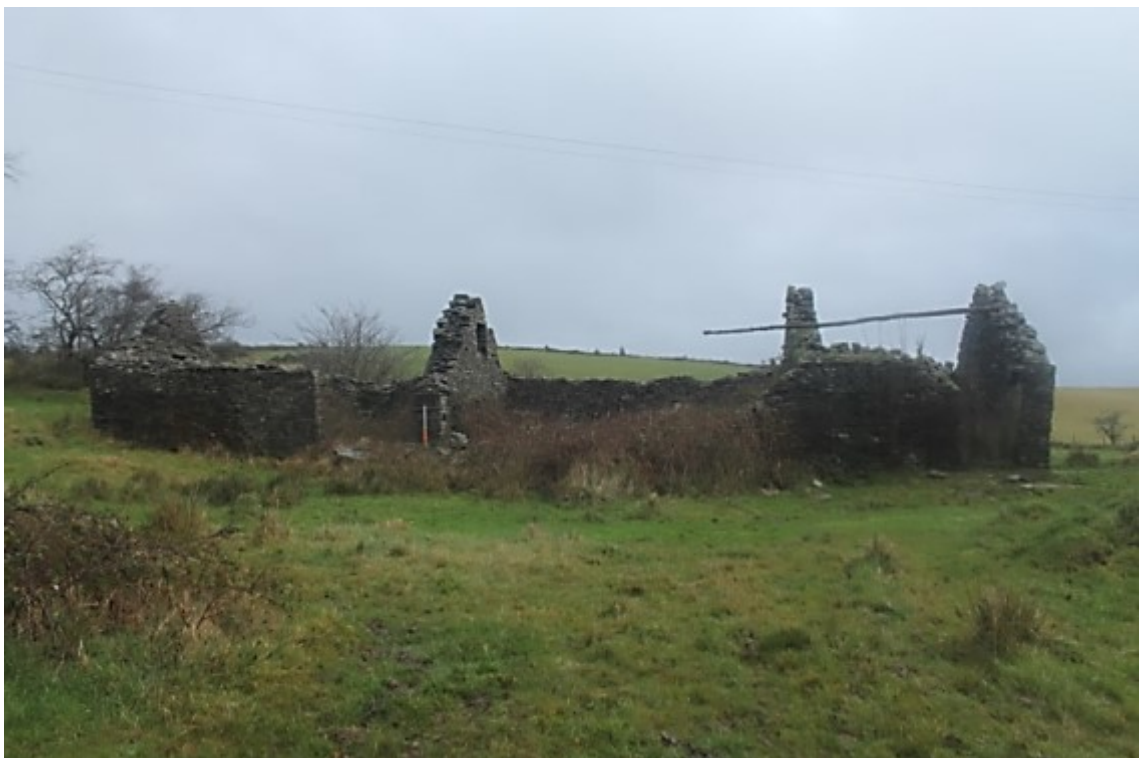
**Photo 40:** West elevation of outbuildings; undergrowth obscures remains of barn wall – 1m scale

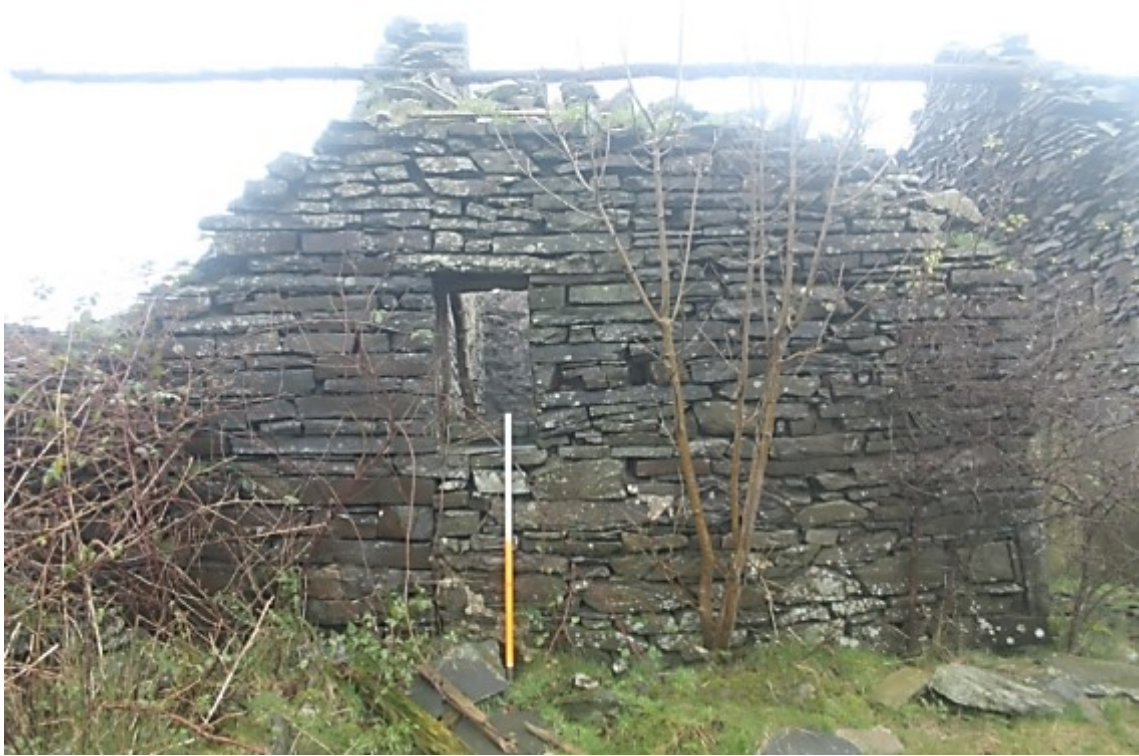
**Photo 41:** Window in west elevation of cowshed – 1m scale

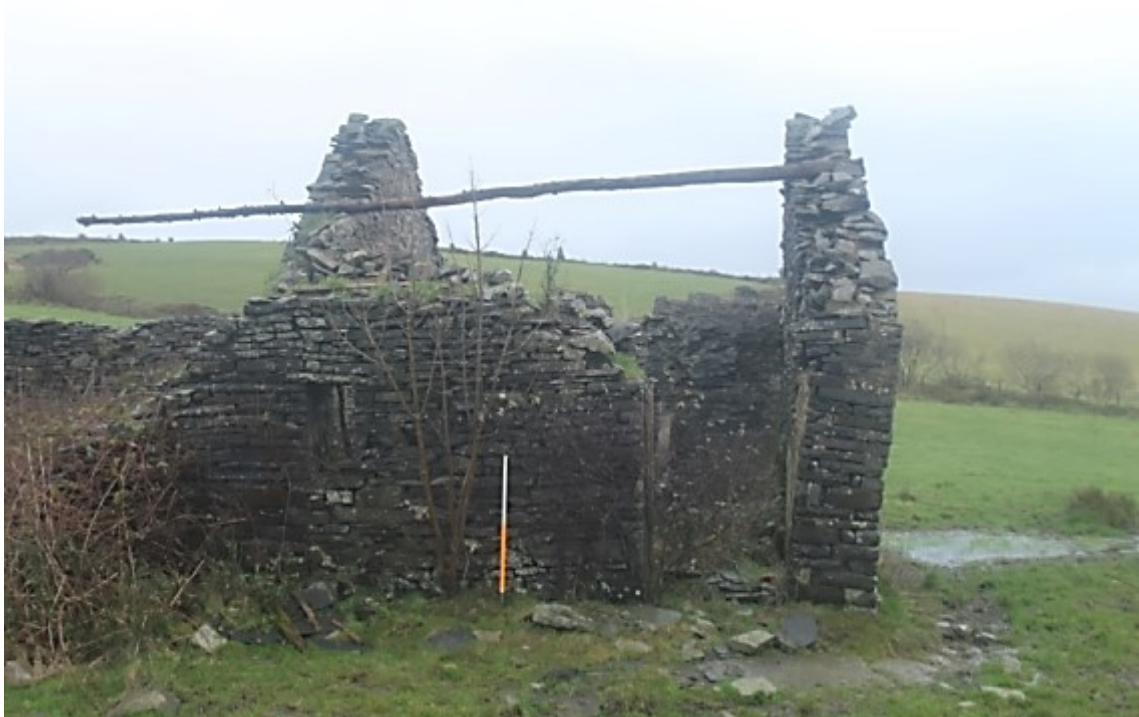
**Photo 42:** Entrance in west elevation of cowshed – 1m scale

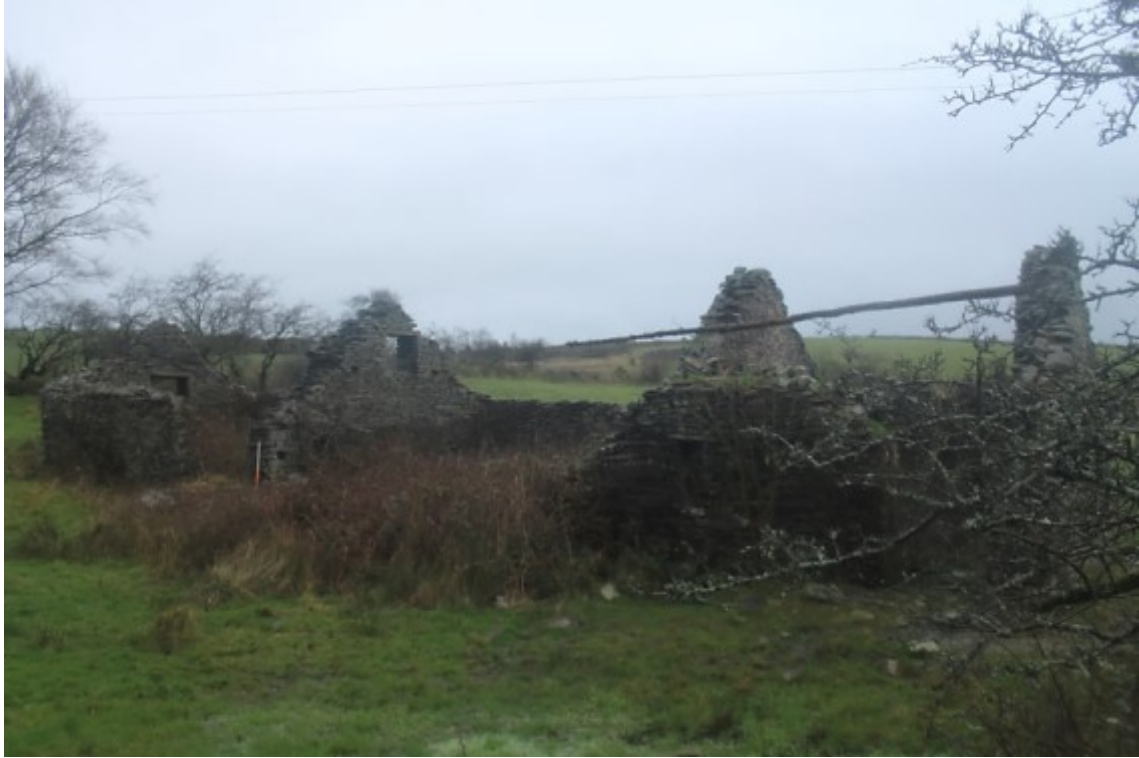
**Photo 43:** View northeast of outbuilding (a) – 1m scale

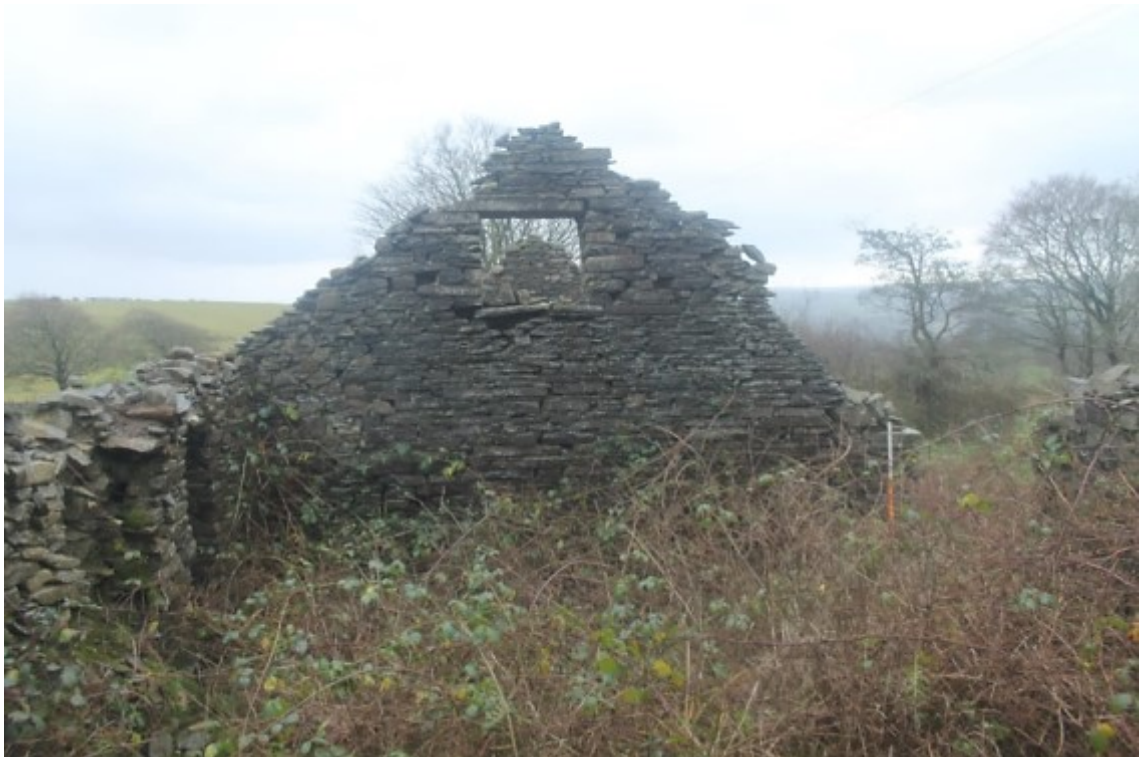
**Photo 44:** Interior south elevation of garnary – 1m scale

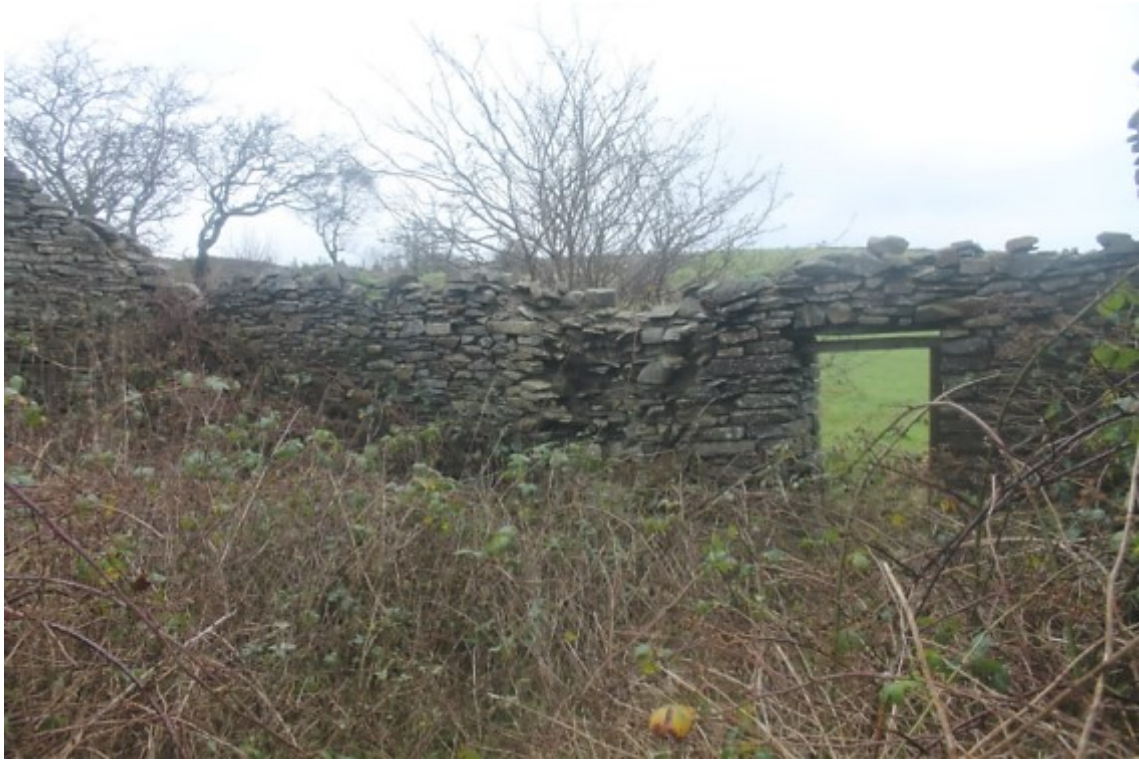
**Photo 45:** Interior east elevation of granary

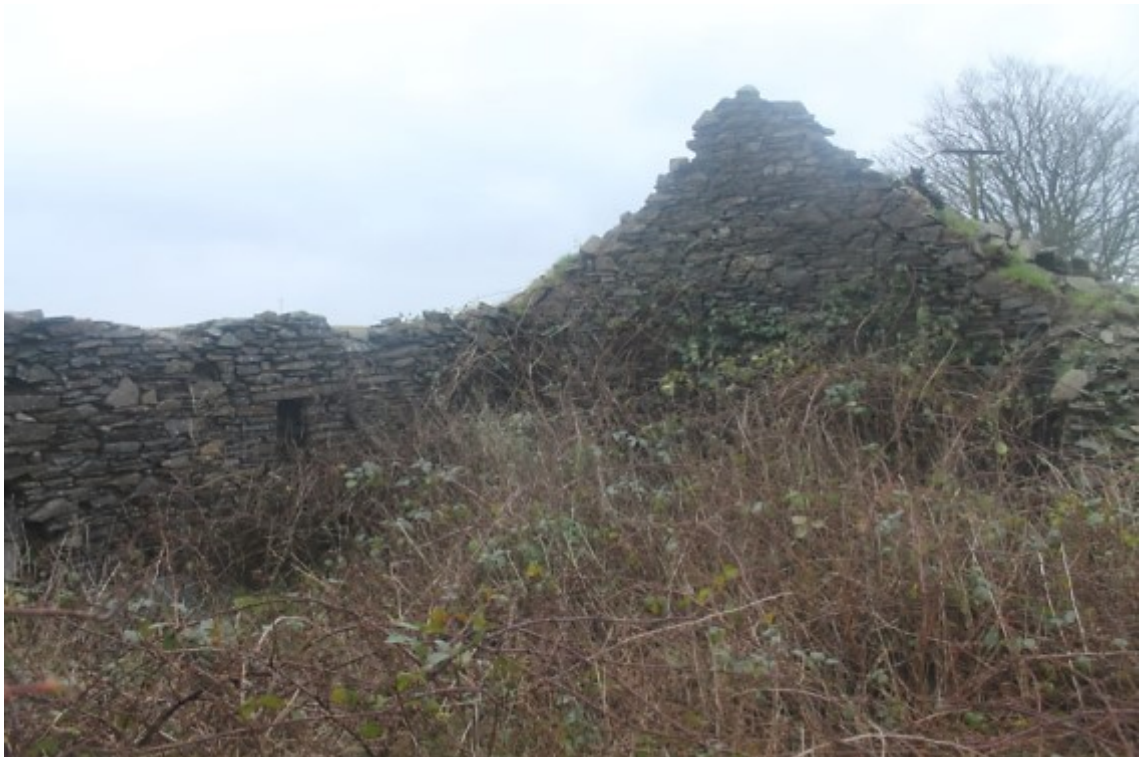
**Photo 46:** View of south elevation of barn

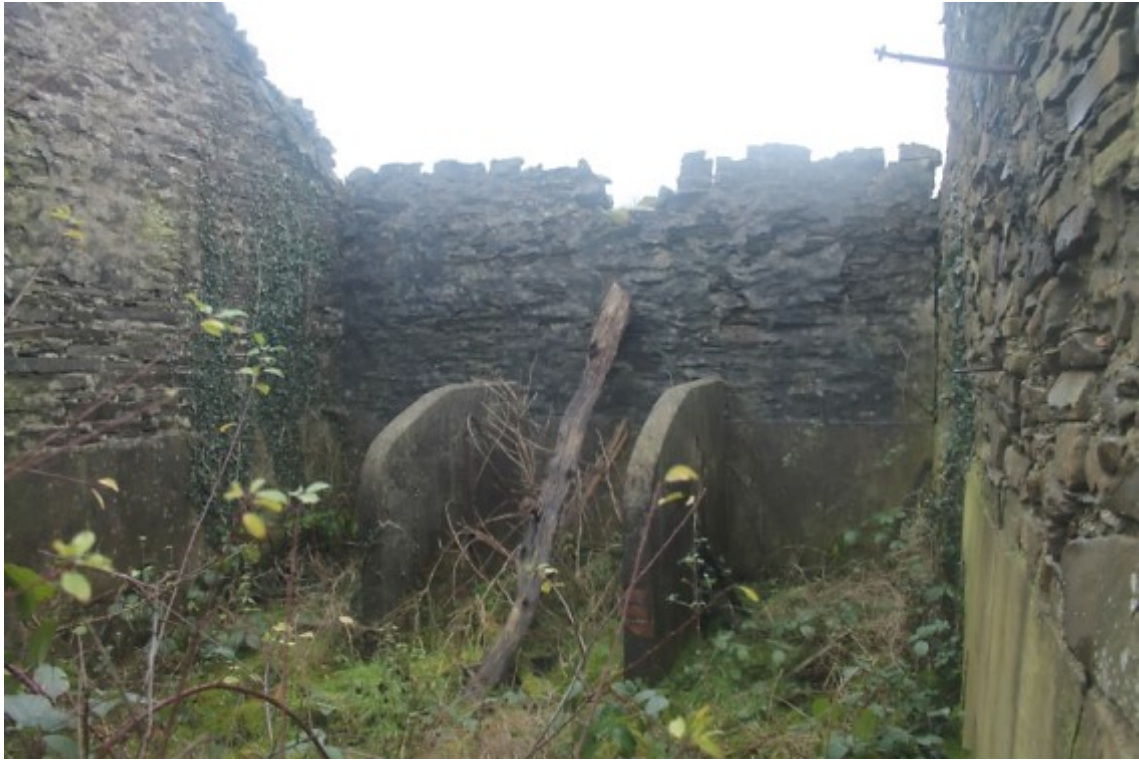
**Photo 47:** Stalls in east wall of cowshed

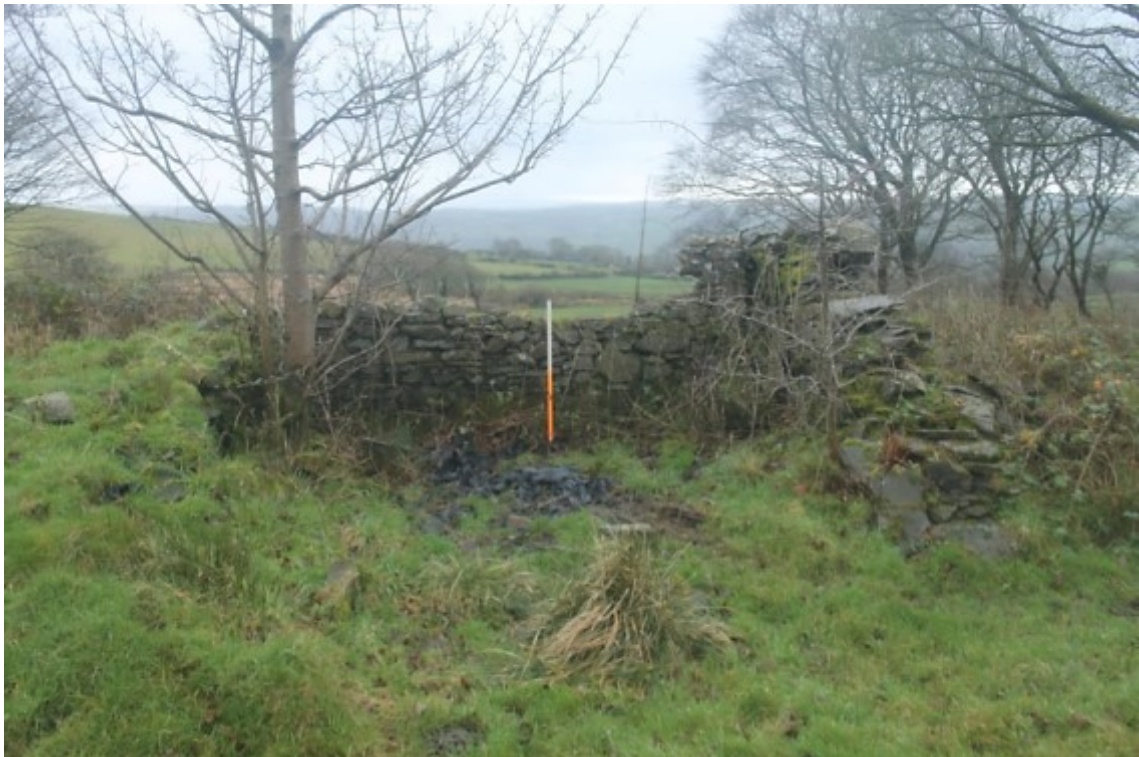
**Photo 48:** View south: remains of outbuilding (b) 13m south of the house - 1m scale

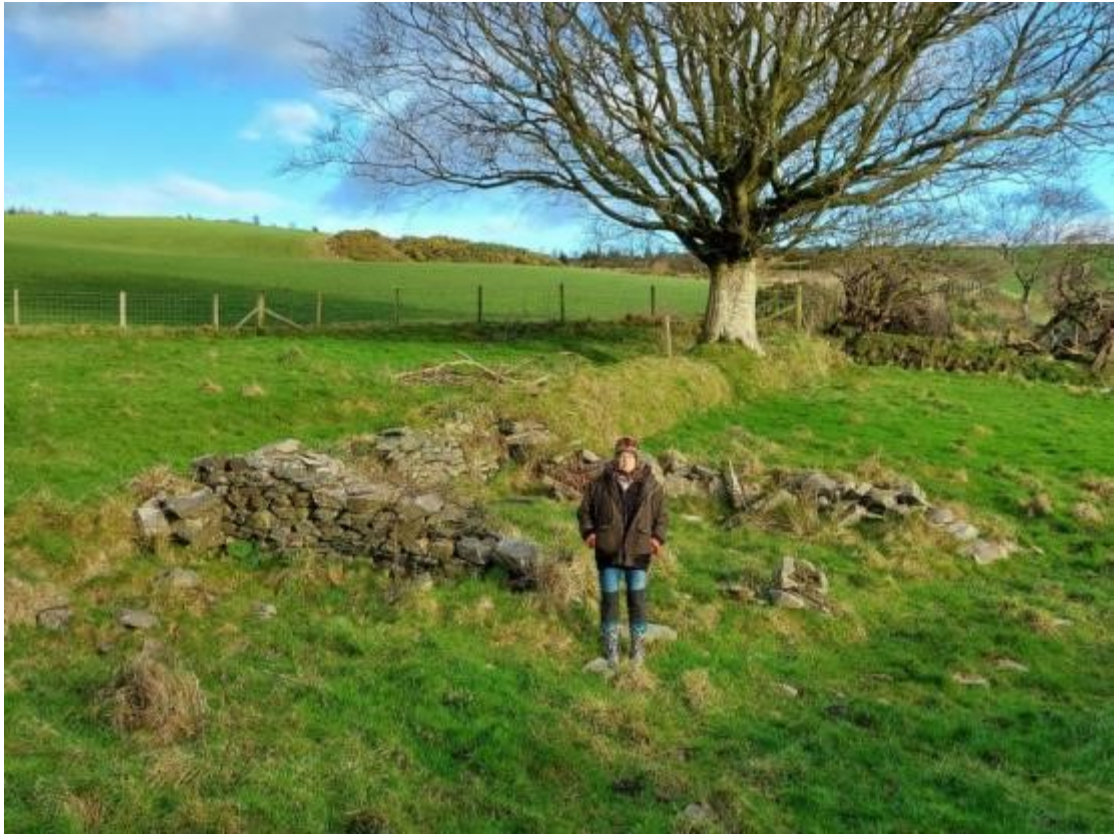
**Photo 49:** View northwest: remains of outbuilding (c) 10m north of the house.

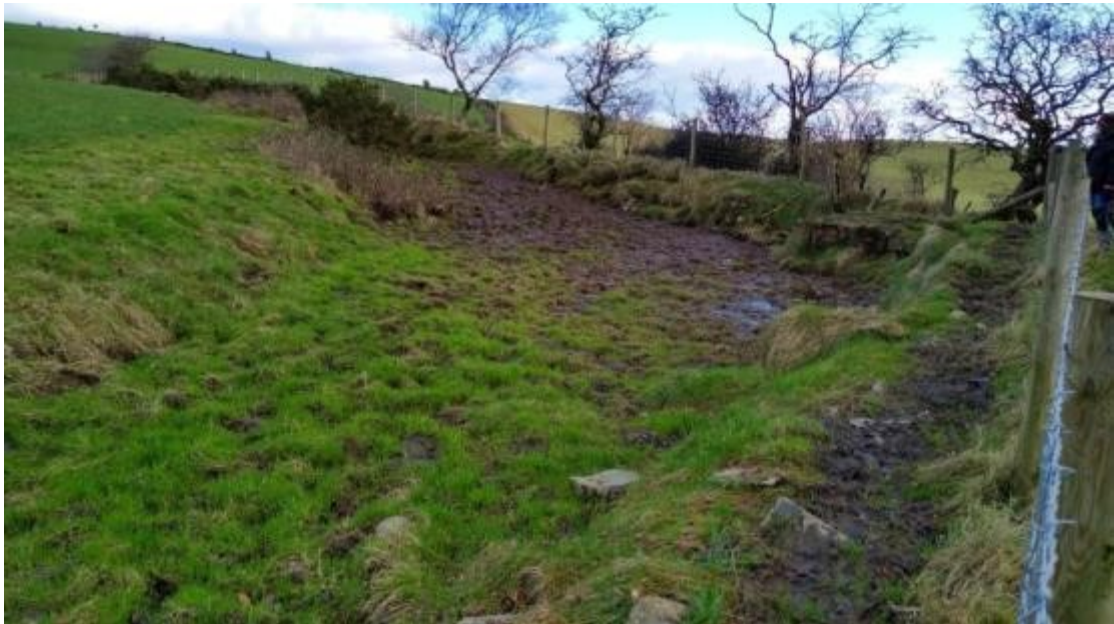
**Photo 50:** View southeast towards pond

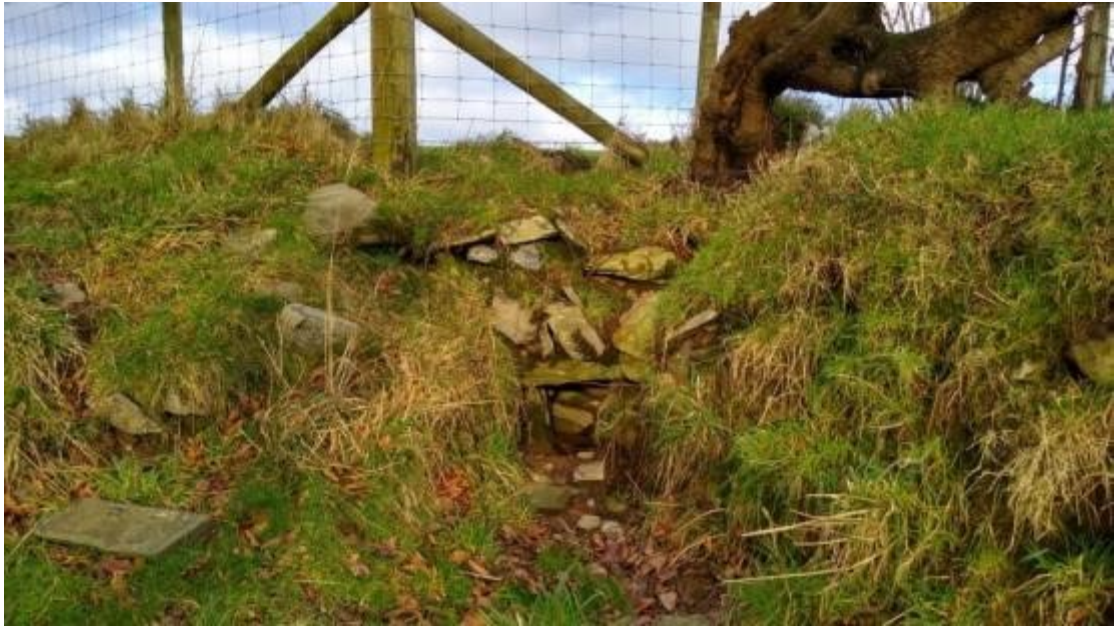
**Photo 51:** View north towards pond outlet

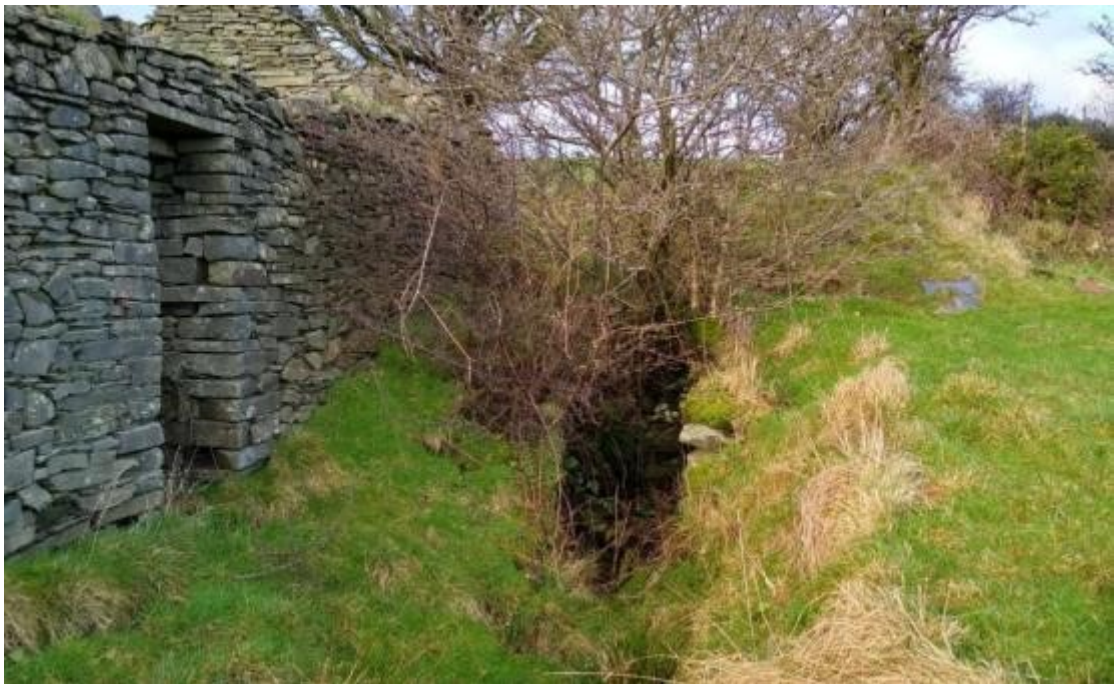
**Photo 52:** Possible wheel-pit situated a few metres east of the granary

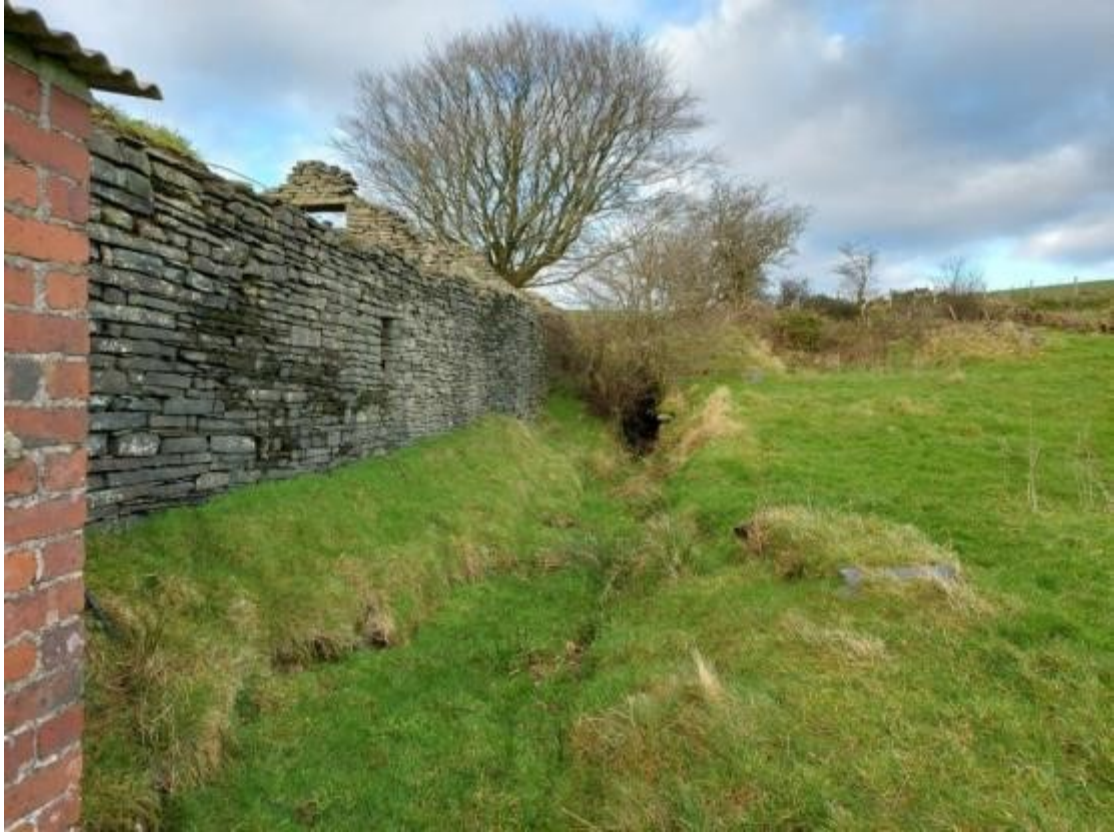
**Photo 53:** Possible tailrace and wheel-pit east of outbuilding (a)
