**PEMBROKE DOCK INFRASTRUCTURE
PROJECT, THE DOCKYARD, PEMBROKE
DOCK, PEMBROKESHIRE**

HISTORIC BUILDING RECORDING

(ENCLOSING WALL – STRUCTURE NO. 2.5)

REPORT NO. 2022-39
EVENT RECORD No. 128198

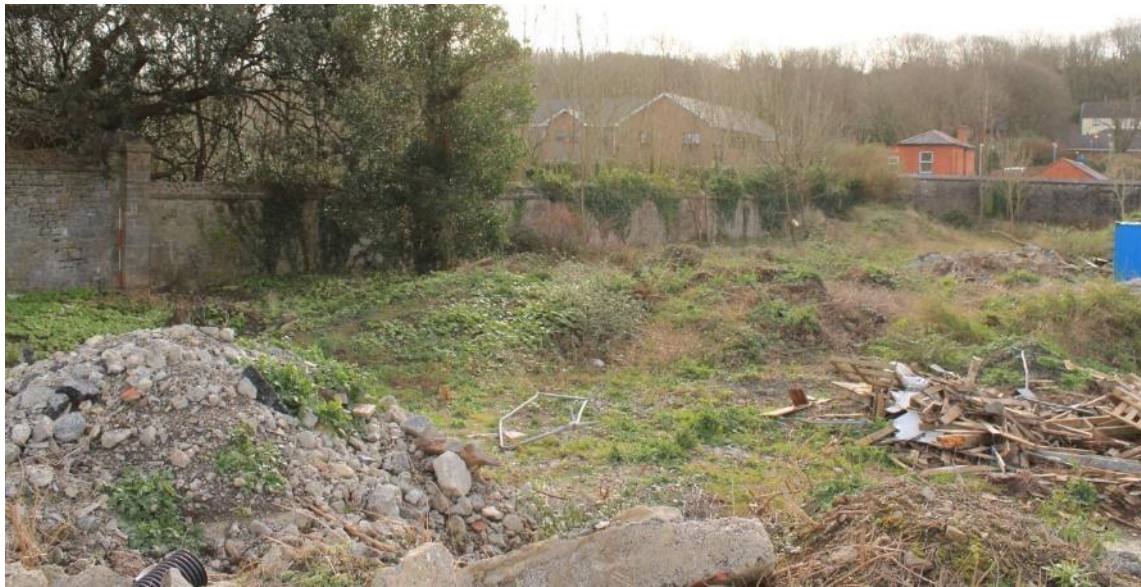
- 4.1 The enclosure wall to the west of the former Captain Superintendent's House (Structure No.2.5), also referred to as the 'Paddock Wall', is a single enclosure wall, L-shaped in plan enclosing an area of ground approximately 0.7 hectares (1.7 acres) in size. To the southwest the wall adjoins the main boundary wall of The Dockyard, to the northeast the wall adjoins the immediate boundary to the former Captain Superintendent's House (later The Port Hotel).
- 4.2 The wall runs for 70m from the Dockyard boundary wall, in a north-northeast direction, before turning a right -angle, with a rounded corner, to run 76m in a east-southeast direction as far as a modern boundary, although the wall itself appears to continue for another *circa* 12m beyond that point (Figure 11, Photo 1).

Photo 1: View southeast of the west side of the enclosure wall, adjoining the Dockyard wall to the rear.

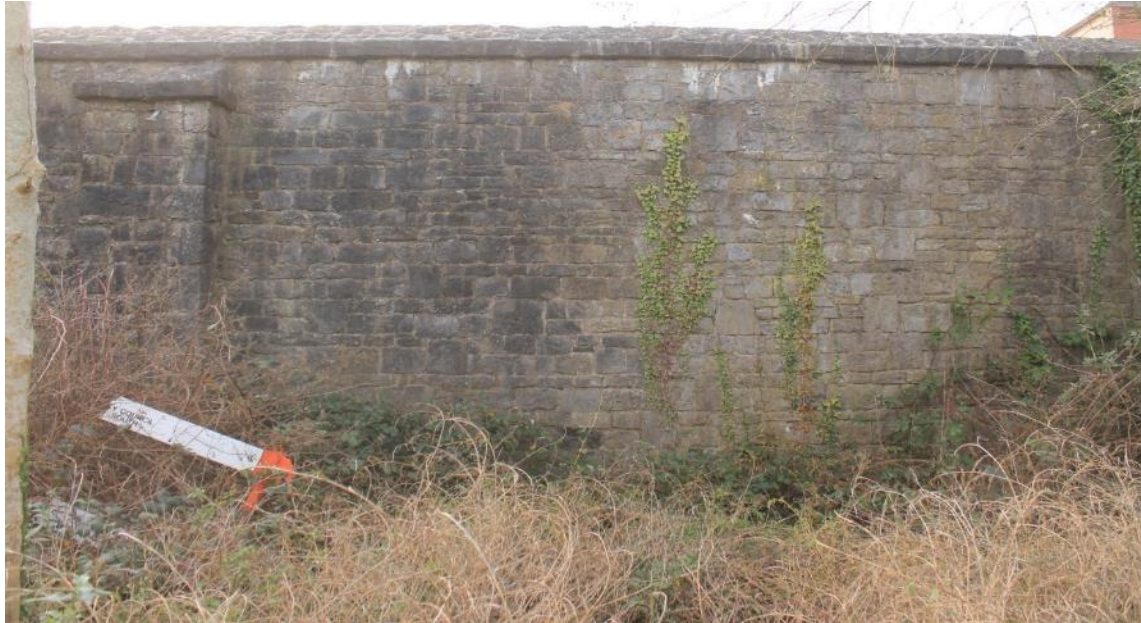
- 4.3 The main Dockyard boundary wall, as it runs along Fort Road, is approximately 3.5m high, built of squared and roughly faced limestone rubble with squared coping stones that project slightly, topped by smaller stones set in a mortar ridge (Photo 2). A series of squared internal buttresses are spaced at regular intervals.

Photo 2: South facing shot of the internal face of the main Dockyard boundary wall.

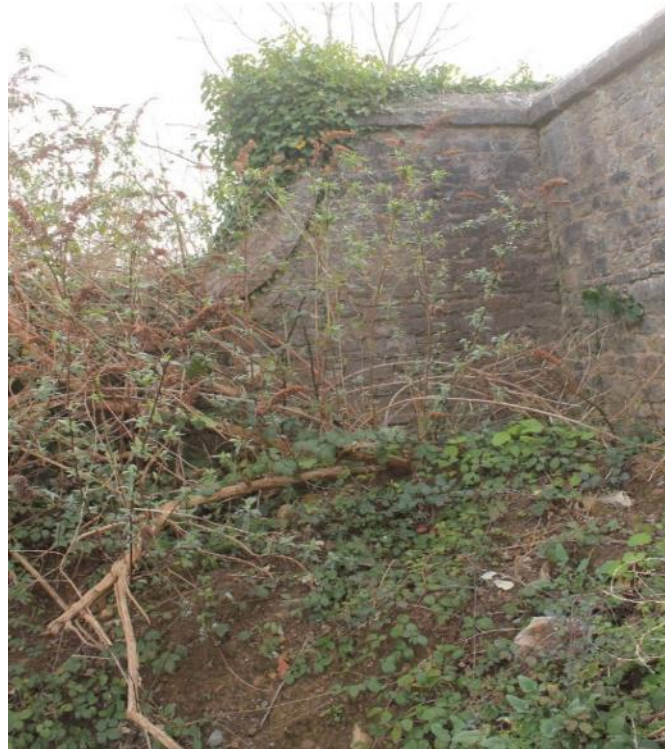
- 4.4 At the point the enclosure wall adjoins the Dockyard boundary wall the join is partly obscured, but may be at least partially tied in. At this point the enclosure wall is built in the same style as the Dockyard boundary wall, with squared and roughly dressed limestone rubble, topped by ridged coping that runs continuously from the Dockyard boundary wall. The wall is initially approximately 3.5m high but soon (after 2m) drops down to a height of approximately 2.5m, with the dressed stone coping following a curved line to this lower level (Photo 3).

Photo 3: West facing shot of the point at which the enclosure wall adjoins the main Dockyard boundary wall.

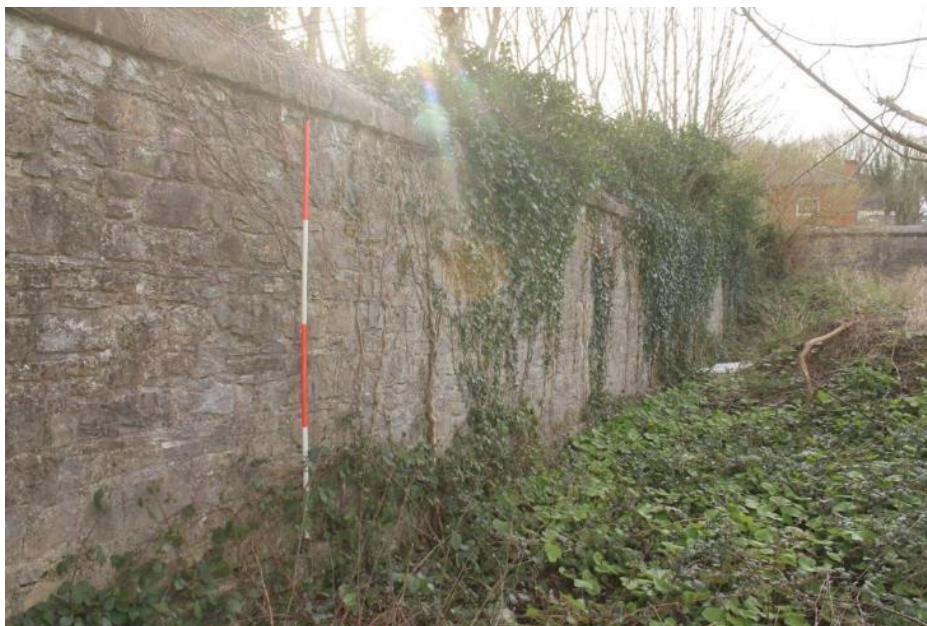
- 4.5 The enclosure wall then continues at this height for 60m. The 'exterior' west face of the wall appears consistent throughout this length. The stonework is placed in series of random courses, alternating larger and smaller stonework, set within a light cream lime mortar, occasionally set with abundant red sandstone inclusions (Photos 4 & 5).

Photo 4: Southeast facing shot of the enclosure wall. 2m scale.

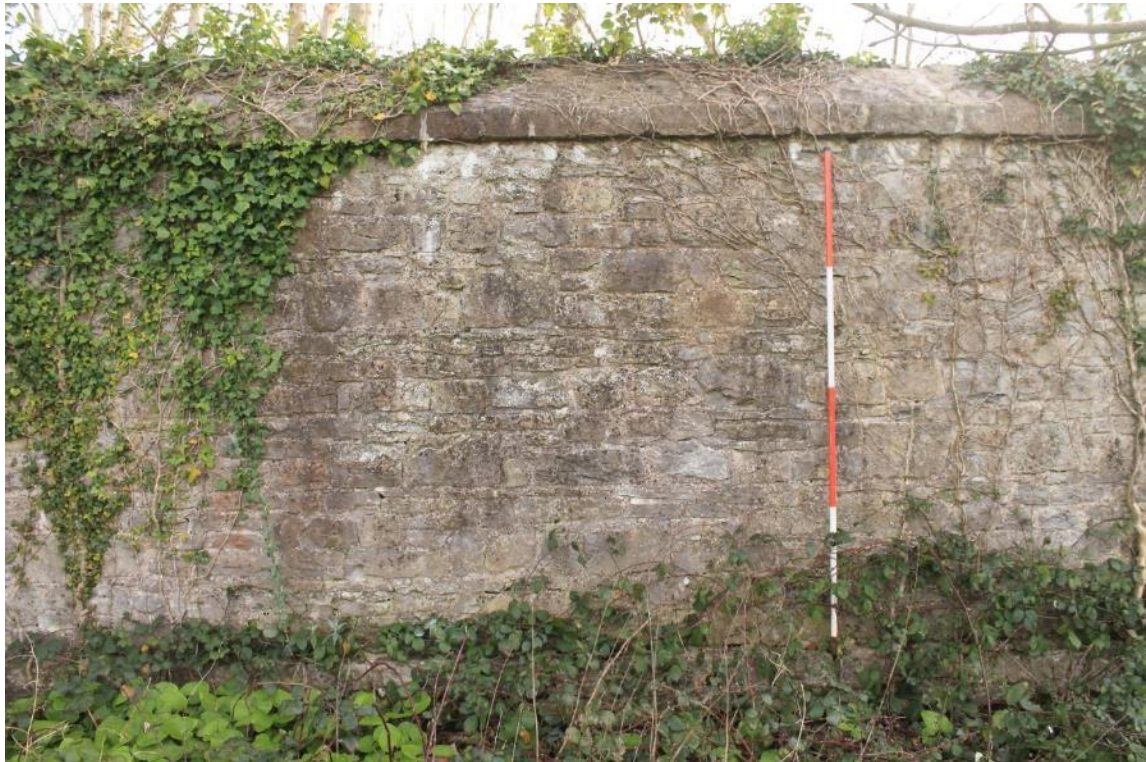
Photo 5: East facing shot of the enclosure wall. 2m scale.

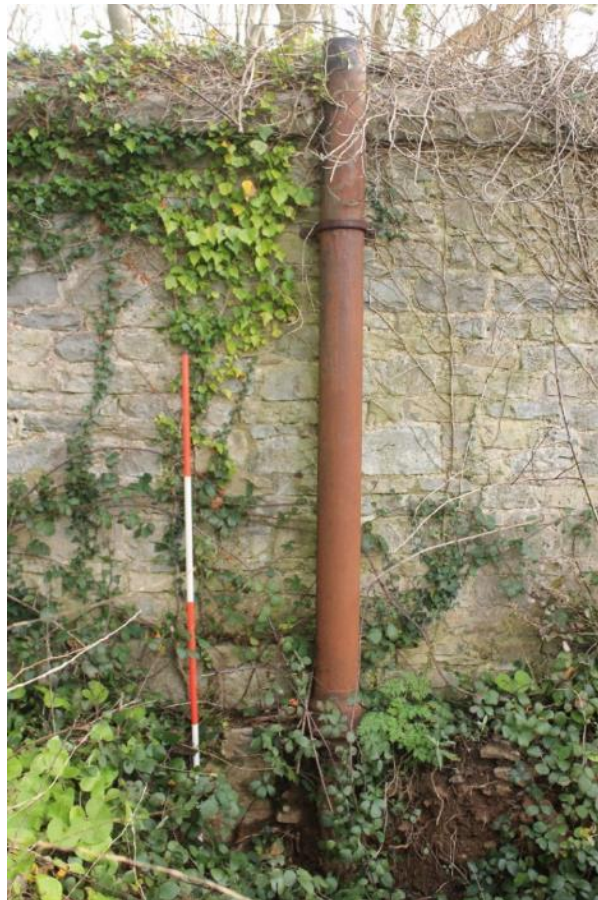
- 4.6 The foundations of the wall are exposed roughly midway along this length, adjacent to a manhole cover. The wall is sat on stepped foundations, the initial step 0.3m deep and protruding approximately 0.1m, then a lower step at least 0.6m deep, protruding approximately 0.15m. A later upright iron stench pipe has been attached to the face of the wall at this point, likely associated with the adjacent manhole cover (Photo 6).

Photo 6: East facing shot of the attached iron stench pipe, with exposed foundations adjacent. 2m scale.

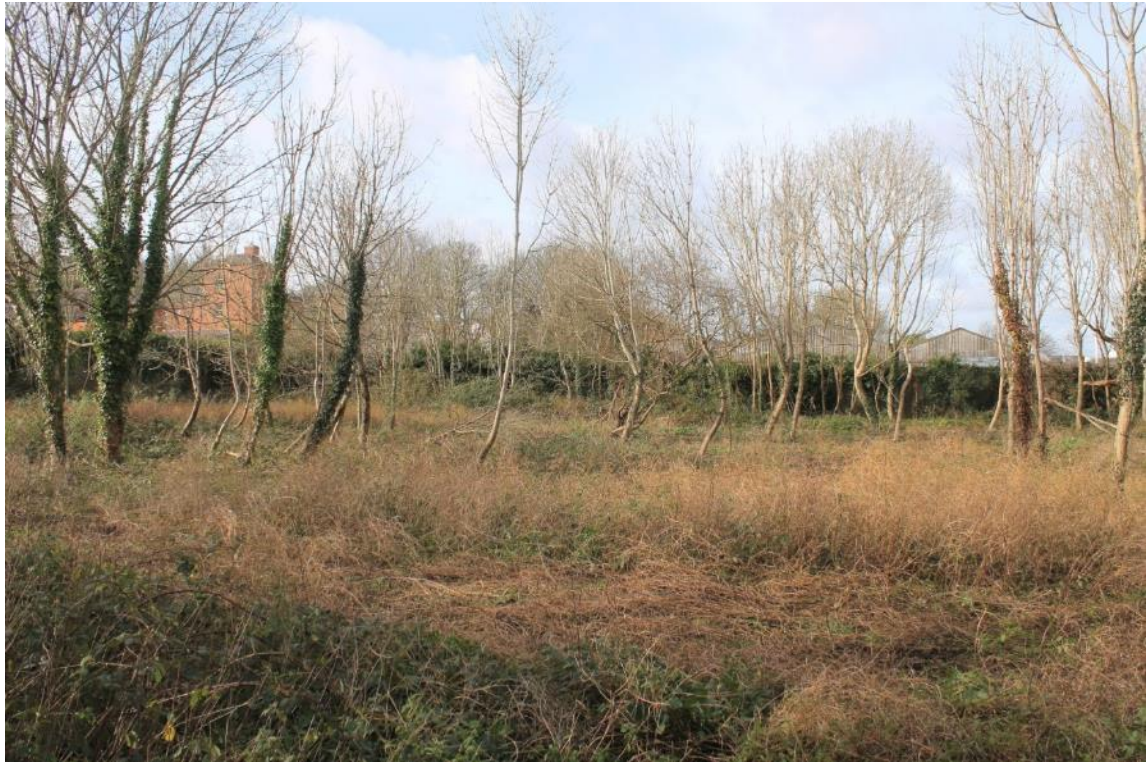
- 4.8 The 'interior' east face of this section of wall is largely ivy covered and fronted by small trees, but where visible it demonstrates a consistent building style (Photos 7 & 8). A series of four regularly spaced internal buttresses are recorded towards the northern half of this stretch of wall, but largely hidden by undergrowth, and further buttresses may exist to the south. The pillar at the north end forms a fifth buttress. The internal face of the wall appears to butt against the larger stonework of the pillar.

Photo 7: West facing shot of the interior of the enclosure wall.

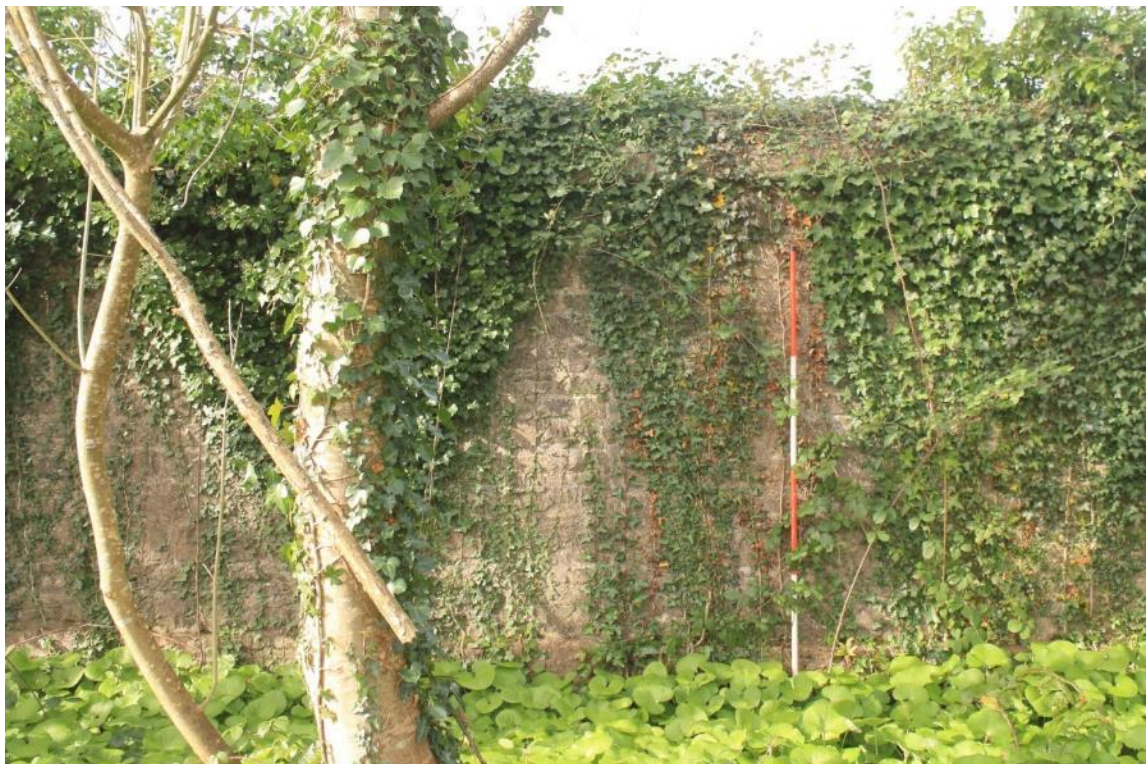
*Photo 8: West facing shot showing detail of the interior face of the enclosure wall.
2m scale.*

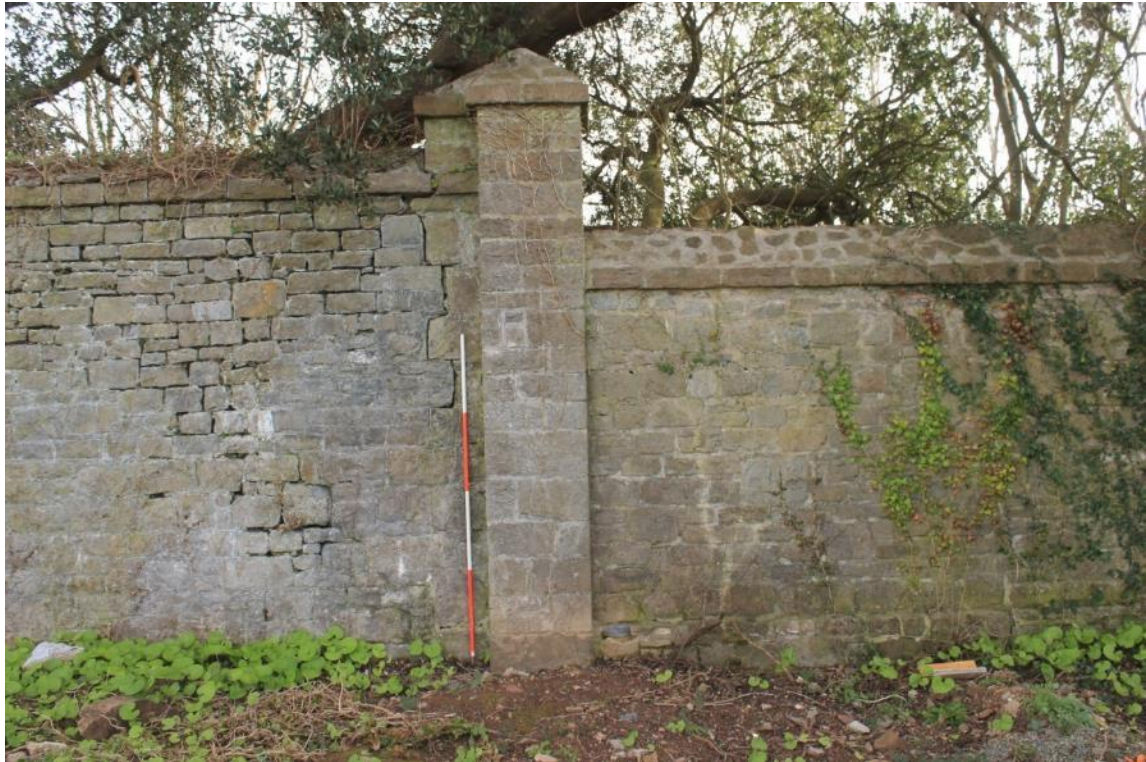
- 4.7 This section of the wall terminates at an asymmetrical masonry pillar, forming a narrow, squared appearance from the exterior side, wider to the interior (Photos 9 – 11). The pillar is 0.6m wide on the western face (protruding 0.15m), 0.8m wide on the eastern face (protruding 0.3m), 3.8m high. It is built of roughly dressed but neatly squared limestone blocks. It is topped flat coping stones, capped with a pointed coping of smaller stones set in mortar.

The adjoining coping on the wall to the south appears to have been repointed, or replaced in a similar style.

Photo 9: East facing shot showing the pillar at the end of the north – south stretch of the enclosure wall. 2m scale.

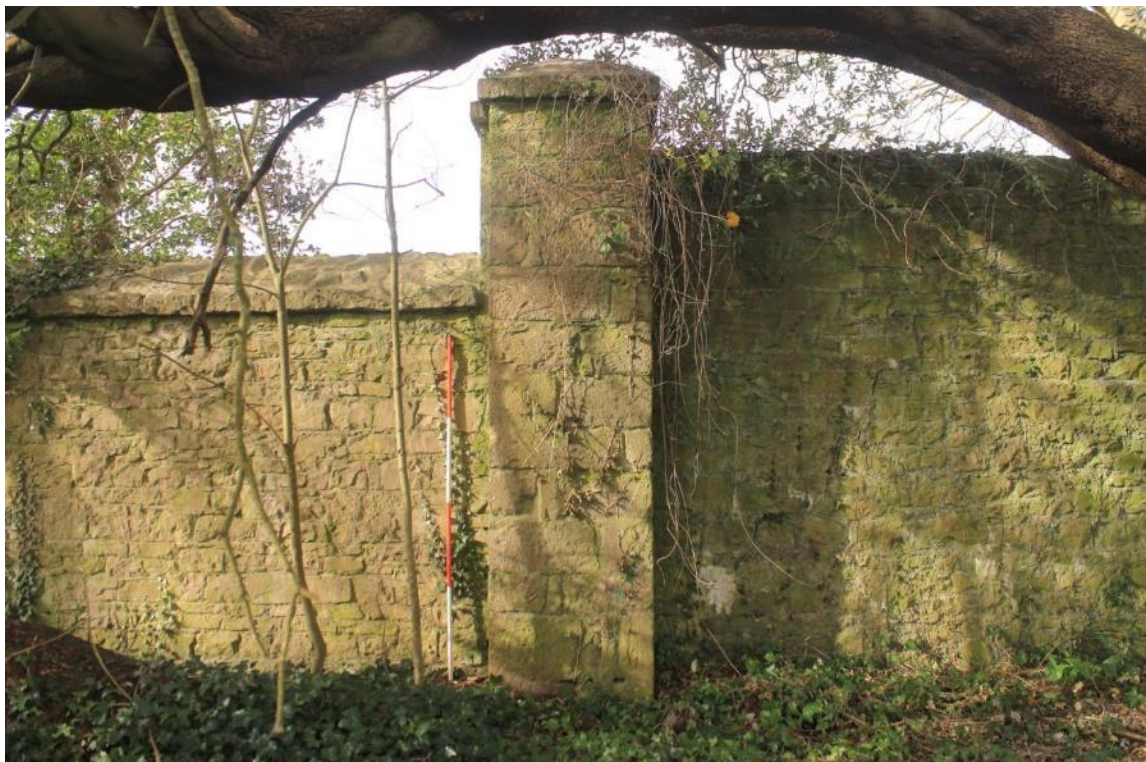
Photo 10: West facing shot of the interior of the pillar. 2m scale.

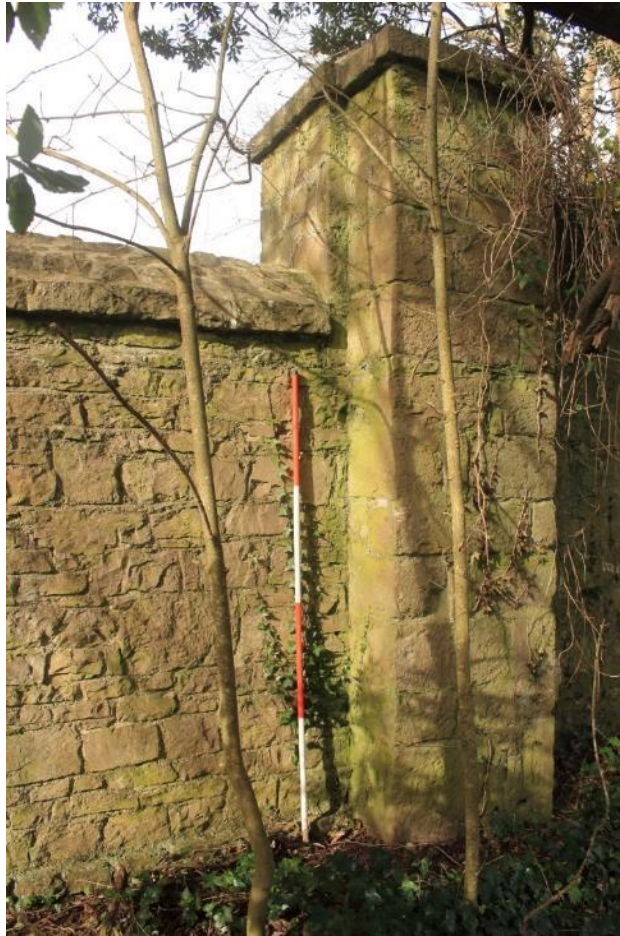
Photo 11: Detail of the pillar. 2m scale.

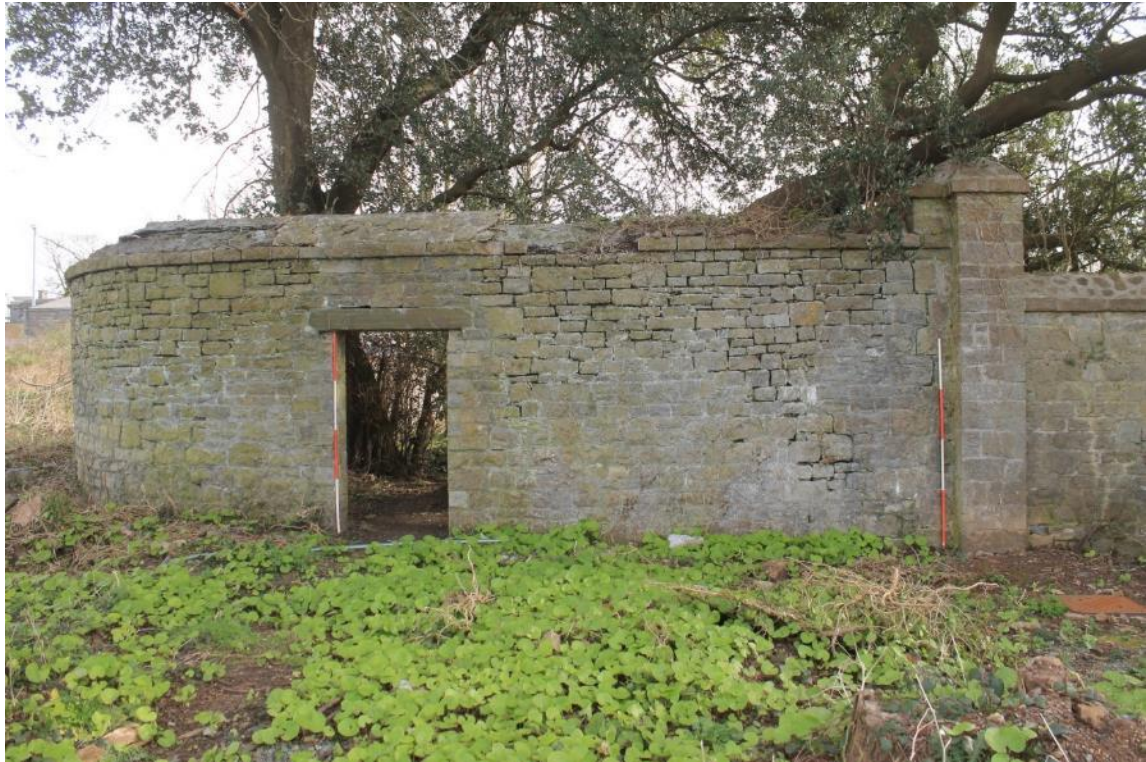
- 4.10 4.1m to the north of the pillar lies a doorway, 1.2m wide, 2.1m high, with a squared dressed stone lintel, and squared edging (Photo 12 & 17). Opposing metal brackets set into the masonry surround, with concrete mortar adjacent, suggests the external face of the opening has been blocked at some point. Missing stonework below the stone lintel may be part of this former blocking. No original gate or door fixings are apparent in the door surround.

Photo 12: East facing shot of the curving northwest corner, with doorway. 2m scale.

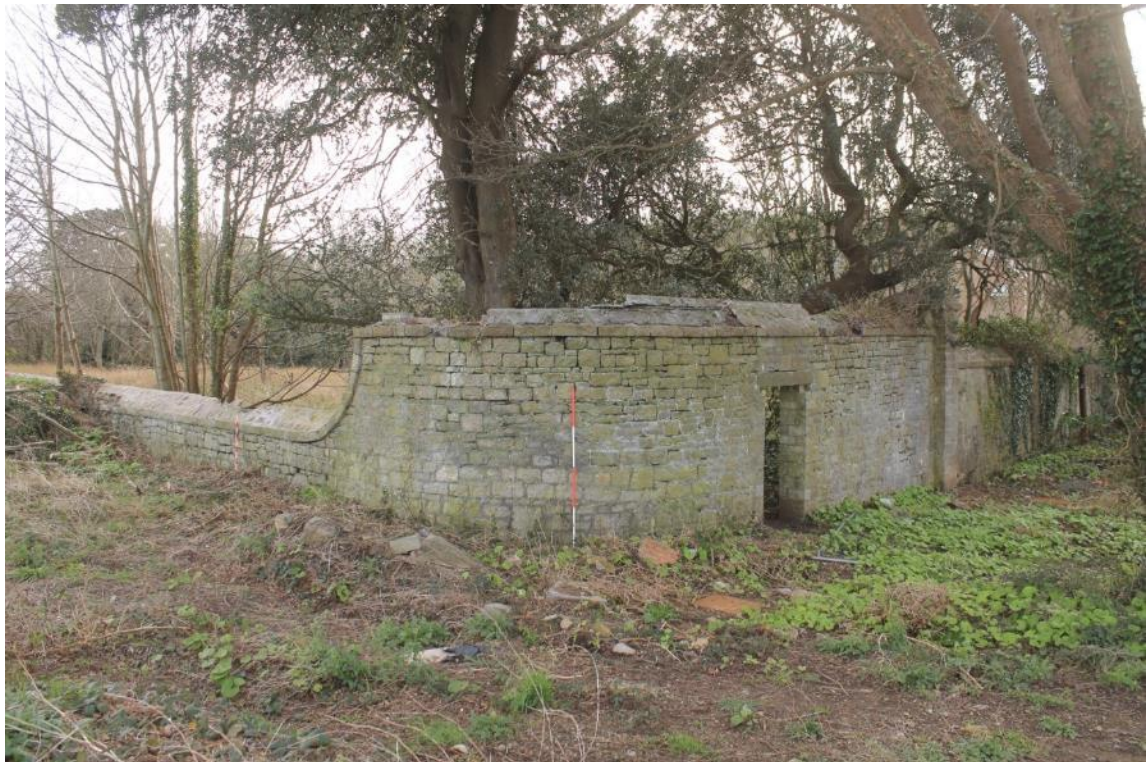
- 4.9 To the north of the pillar the wall height increases to approximately 3.25m and continues to form the curved northwest corner of the enclosure. The stonework and building style remain similar on the external face, but a change in mortar suggests much of this wall may be a rebuild or repair, although the line of coping stones are tied in to the pillar (Photo 12). The internal face shows a change to a rougher style of smaller stonework, and a clearer butt joint between the pillar and wall (Photo 16). The coping itself continues in the style of large squared stone topped by smaller stones set in mortar, but is no longer ridged, instead angled down from the internal face to the external face (Photo 14). The coping is placed on a layer of slate, which overhangs on the internal side around the curving corner.

Photo 13: Southeast facing shot of the curving northwest corner. 2m scale.

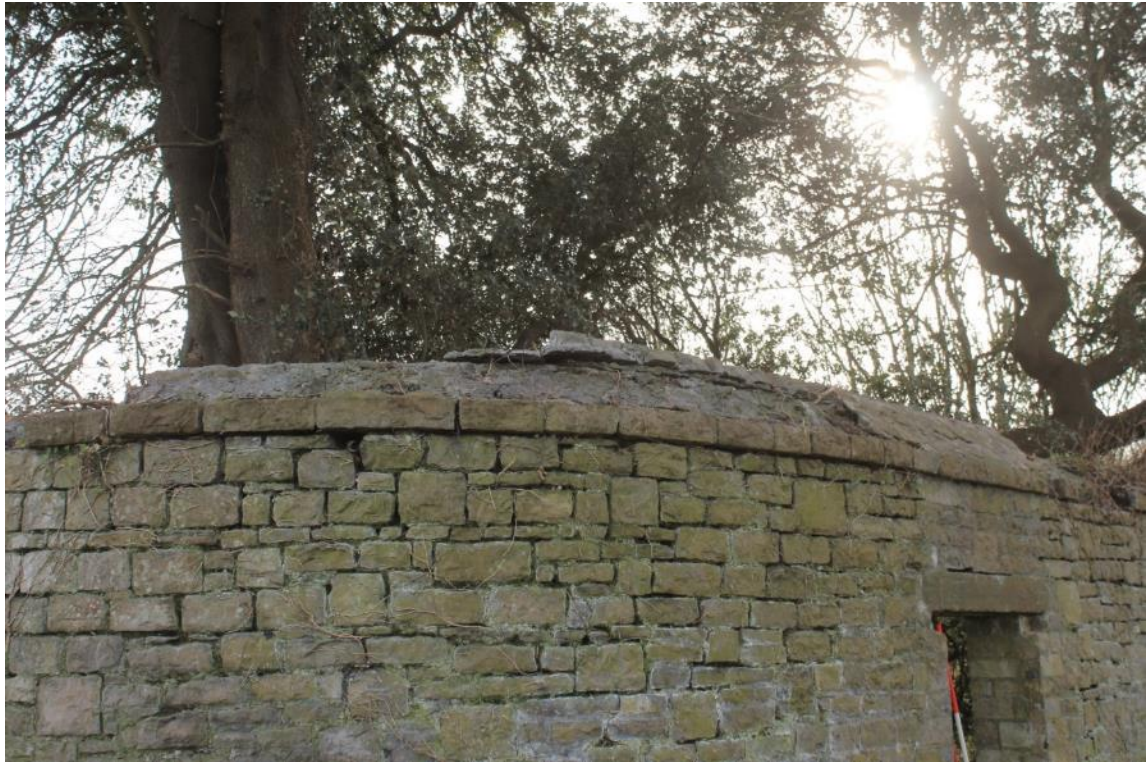
Photo 14: Southeast facing showing detail of the damaged coping on the northwest corner.

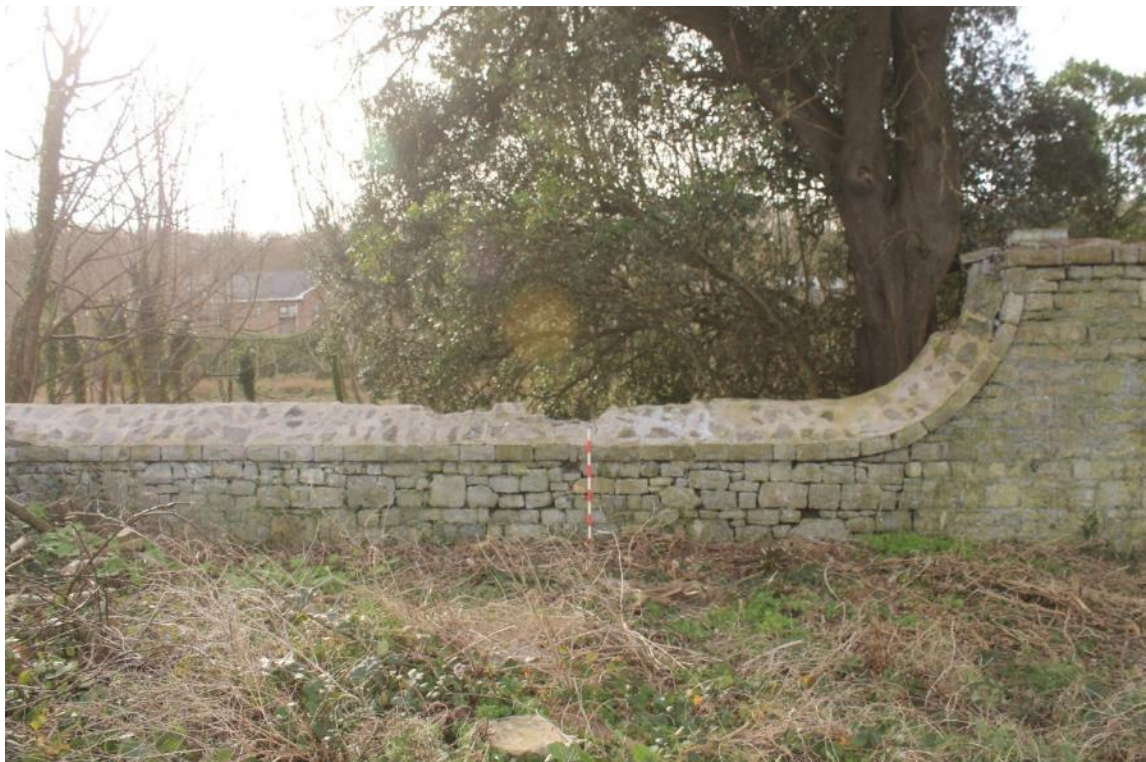
- 4.11 As the wall turns to run east-southeast the height of the wall drops to 1.2m on the exterior (north) face, 1.75m on the internal (south) face, with the coping curving down to the new height, mirroring the initial change in height close to the Dockyard Wall (Photo 15 & 18).

Photo 15: South facing shot showing the eastward continuation of the enclosure wall from the northwest corner. 1m scale.

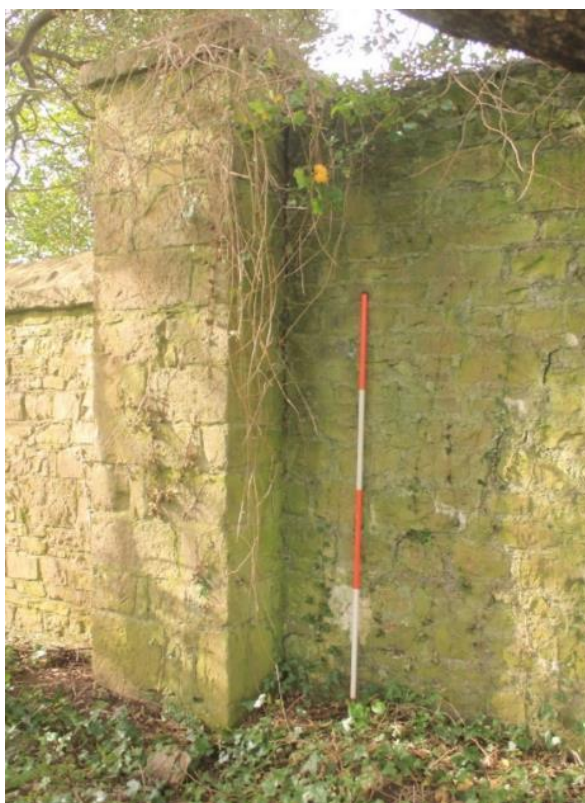
Photo 16: Southwest facing shot showing the butt joint between the corner wall and the pillar, visible to the interior. 2m scale.

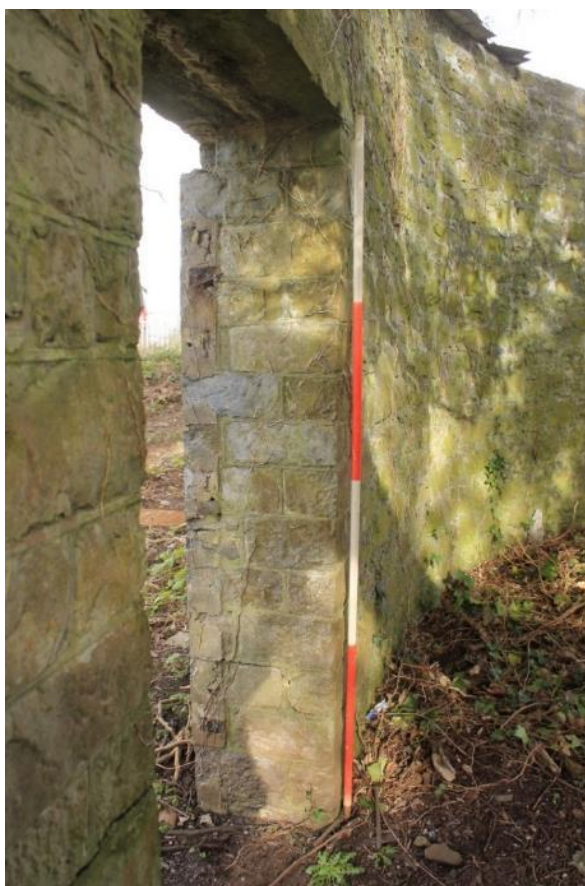
Photo 17: North facing shot showing detail of the frame of the opening in the northwest corner. 2m scale.

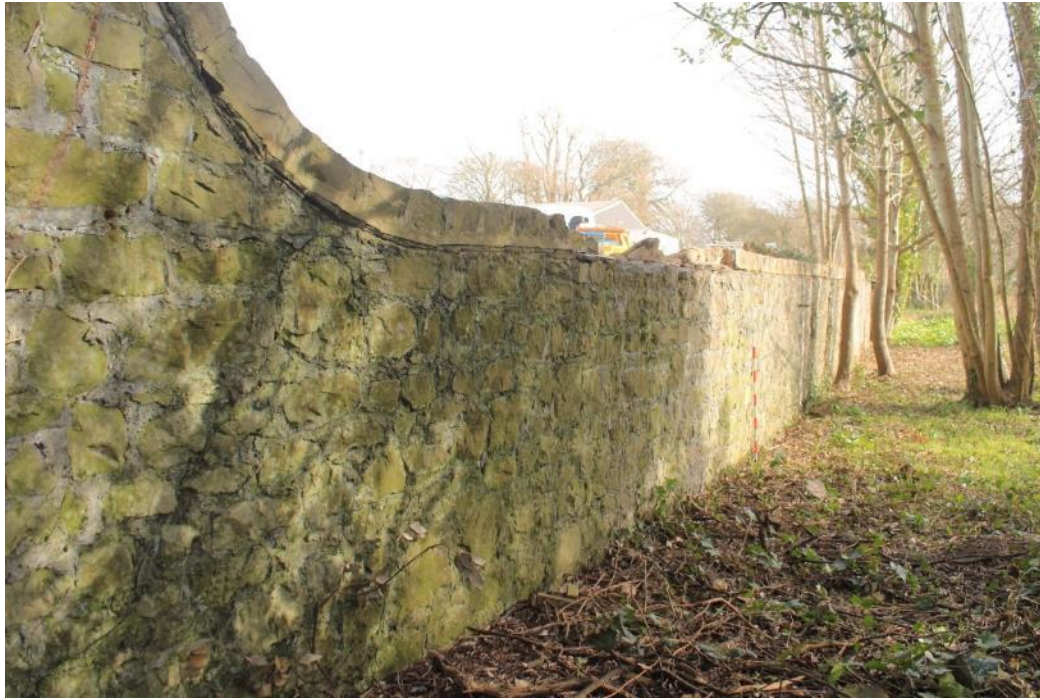
Photo 18: Northeast facing shot showing the continuation of walling east from the corner. 1m scale.

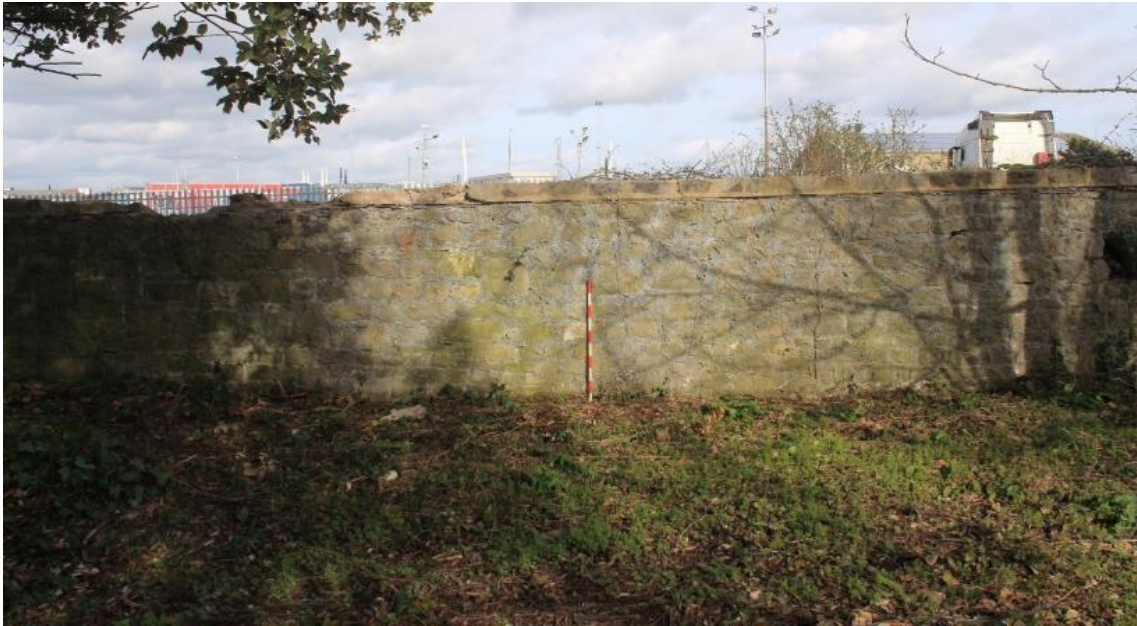
Photo 19: North facing shot of the internal face of the northern enclosure wall. The hole in the wall is just visible to right. 1m scale.

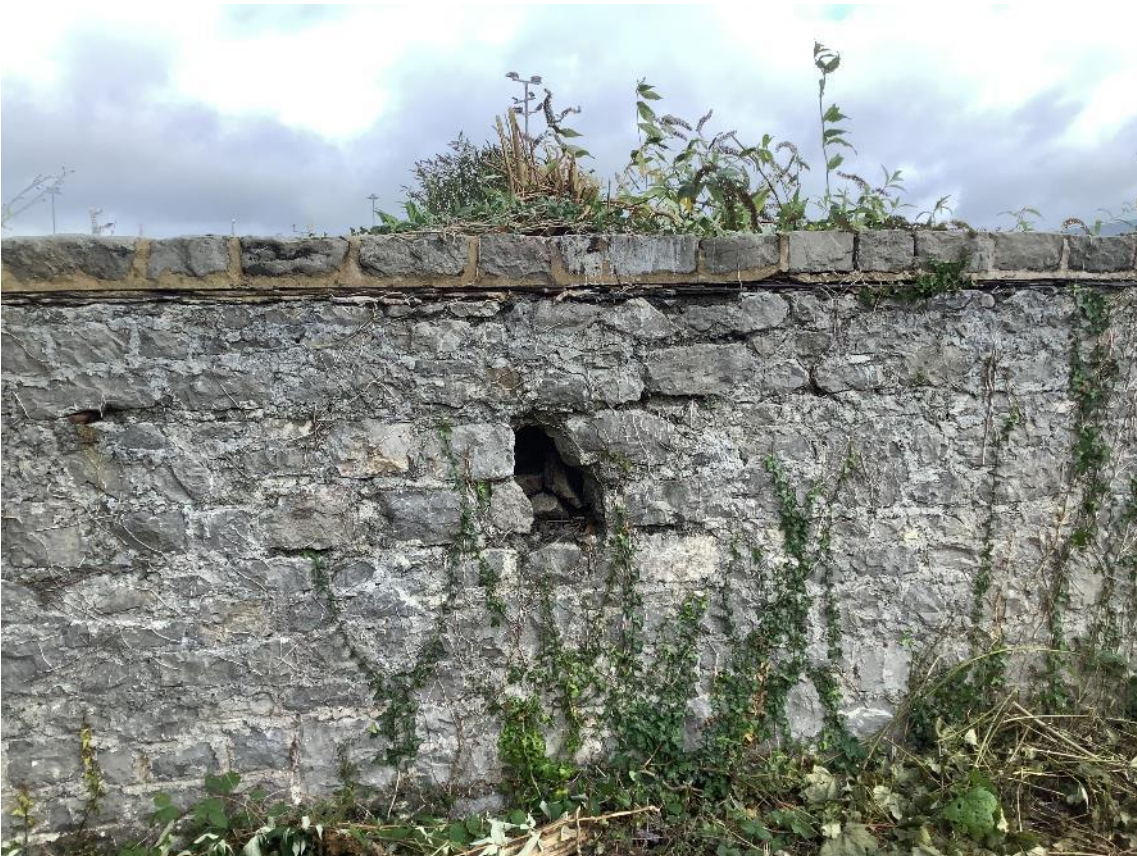
- 4.12 Approximately 13m along the wall an irregular hole lies in the southern wall face and extends through the width of the wall. The hole is *circa* 0.4m by 0.2m in size, the irregular nature suggesting it may have been caused by the removal of an inbuilt attachment, or substantial vegetation disturbance. In line with the top of the hole, set 1m to the west, a short, rounded metal rod has been mortared into the wall (Photos 19 & 20). No further evidence of structural attachments or changes in the stonework are noted in this area.

Photo 20: North facing shot showing the hole in the wall, with protruding metal bar to the left.

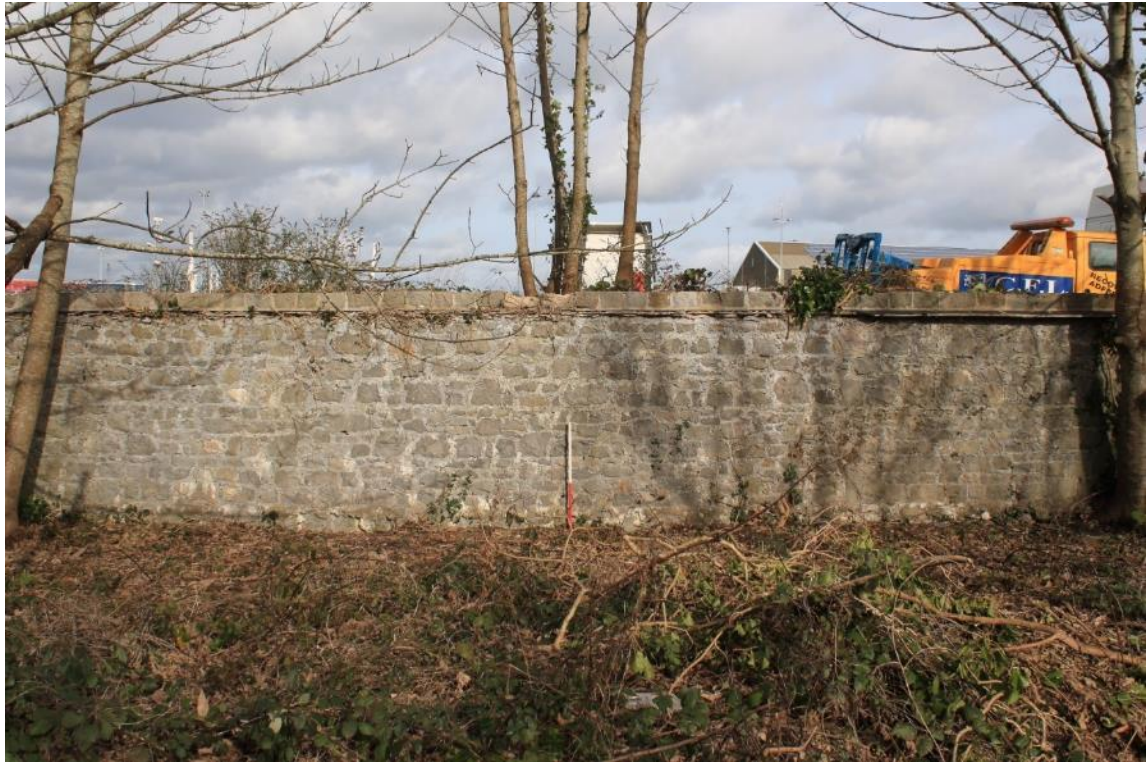
Photo 21: North facing shot of the internal face of the northern enclosure wall. 1m scale.

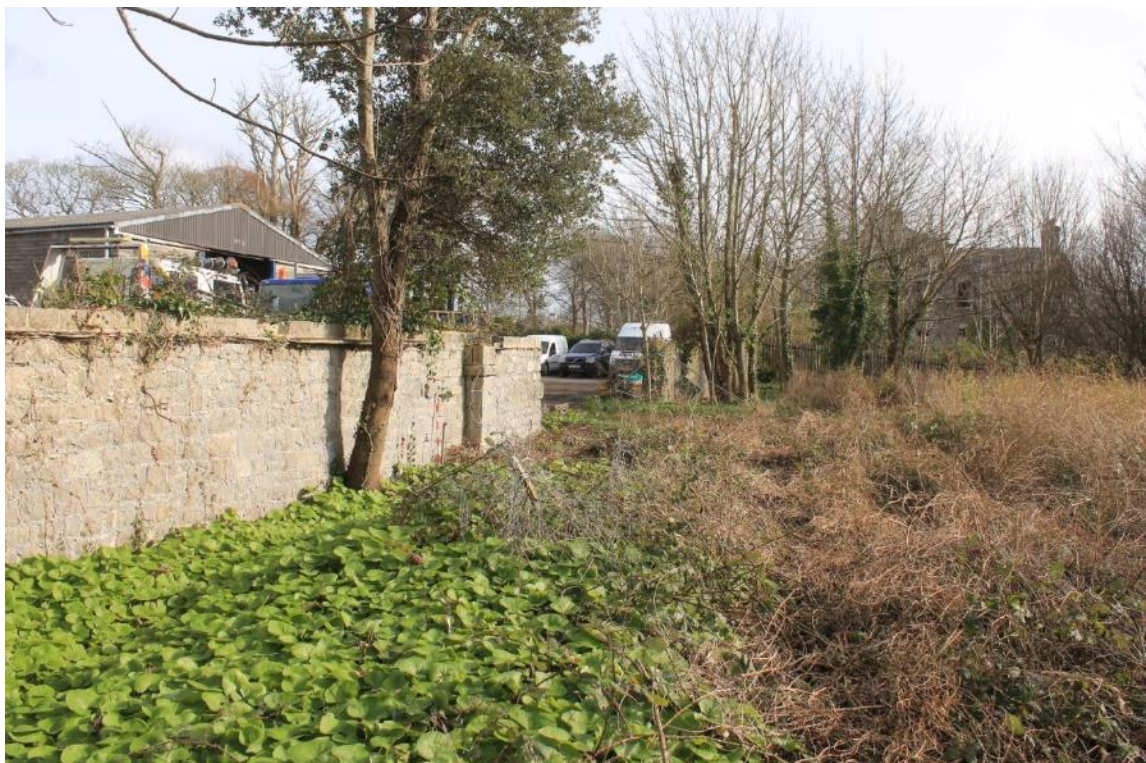
- 4.13 The northern wall of the enclosure continues from the corner for approximately 33m to a blocked doorway (Photos 19 – 22). The doorway is 1.5m wide, flanked by dressed limestone quoins, infilled by concrete breezeblock. The upper stones around the door have gone (Photo 23). A further 2.4m beyond the door an 8.3m wide section of the wall has been removed (Photo 22 & 24).

Photo 22: Northeast facing shot showing the removed section of the enclosure wall.

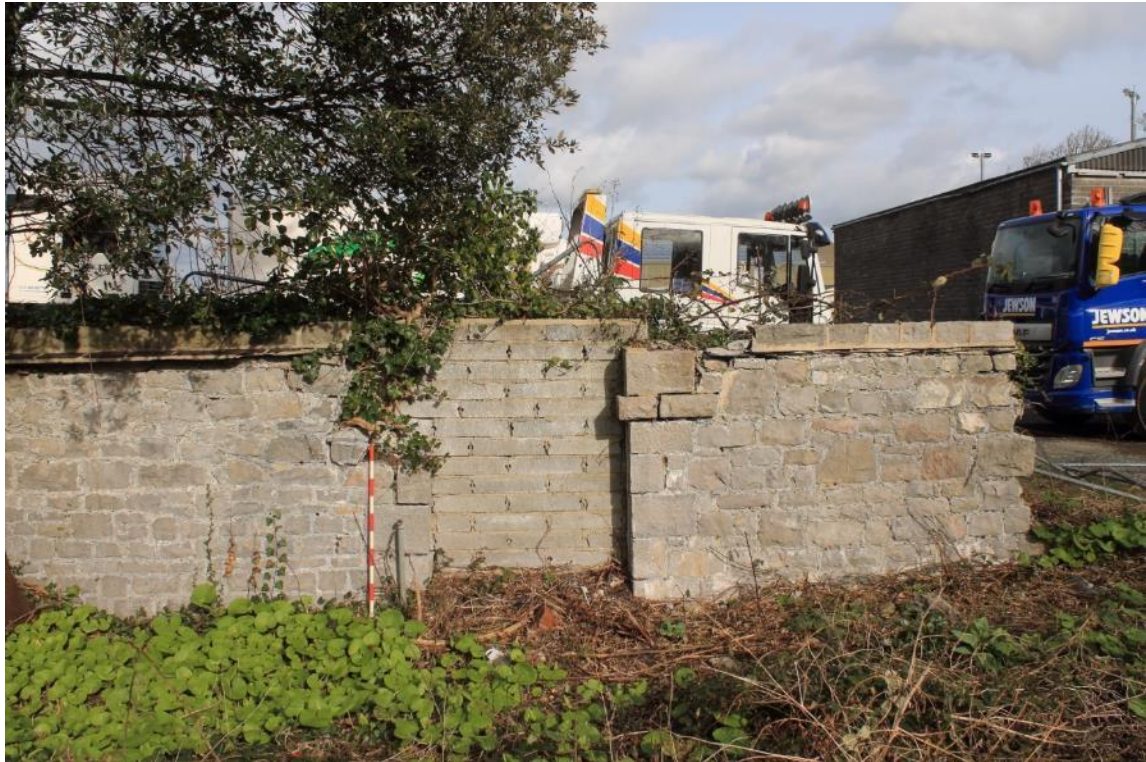
Photo 23: North facing shot of the blocked doorway in the northern enclosure wall. 1m scale.

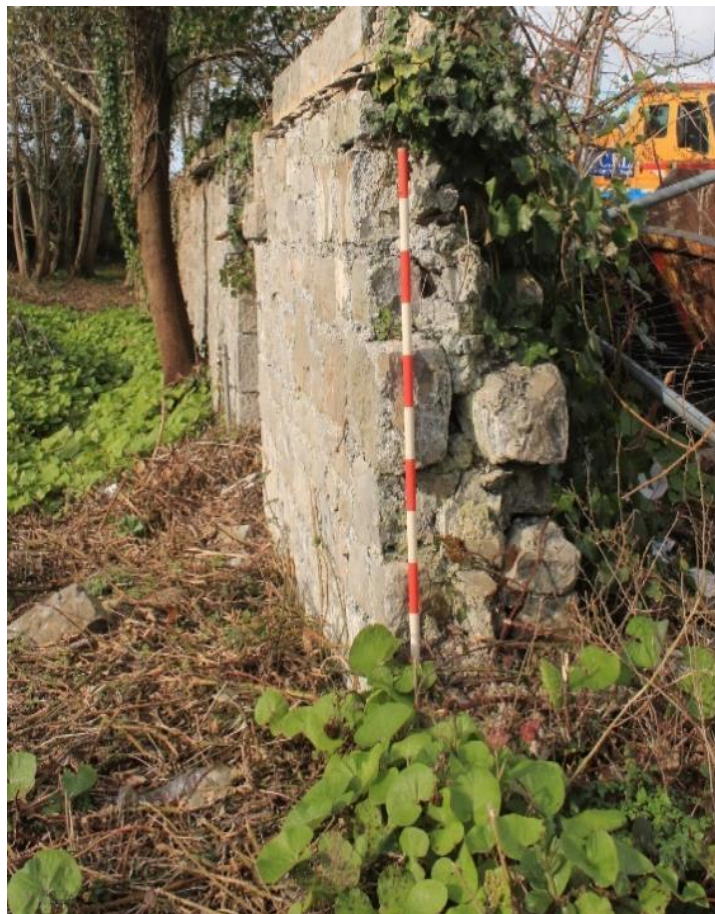
Photo 24: West facing shot of the edge of the removed section of wall, detailing the wall make-up. 1m scale.

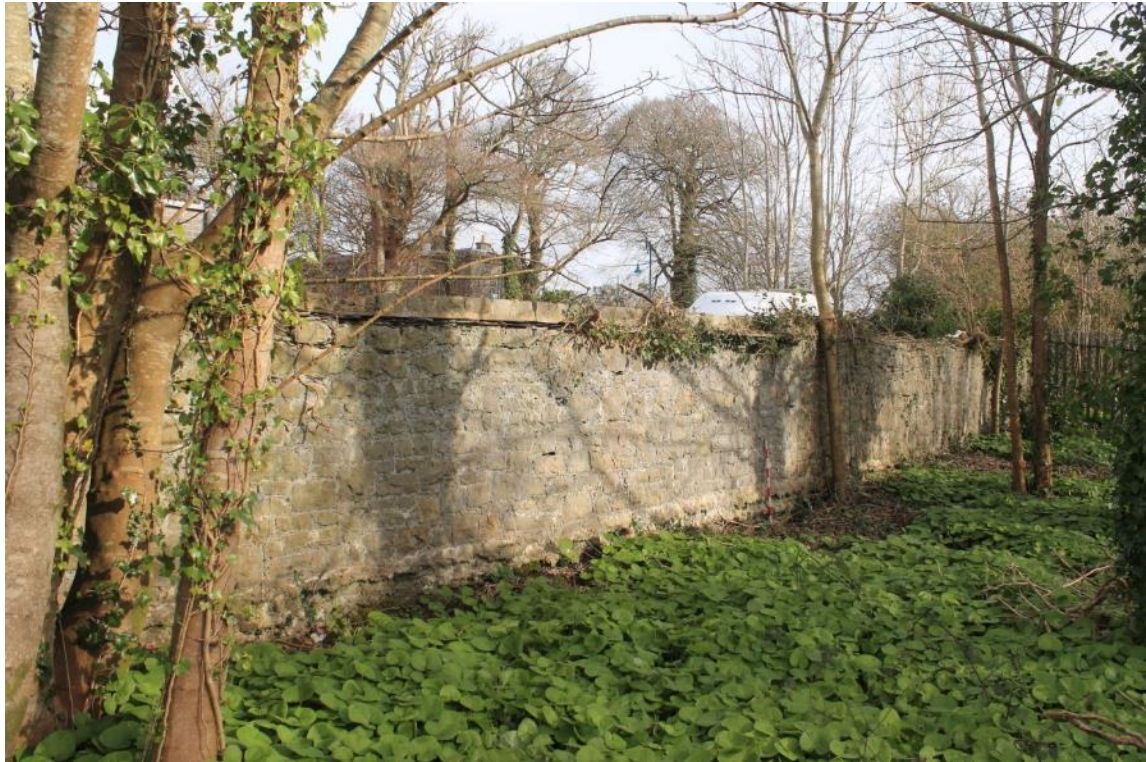
- 4.13 Beyond this the wall continues, at a height of 2m, for a further 28.5m (Photos 25 & 26) before further access is blocked by a modern metal fencing marking the current boundary to the former Captain Superintendent's House.

Photo 25: Northeast facing shot of the eastern end of the northern enclosure wall. 1m scale.

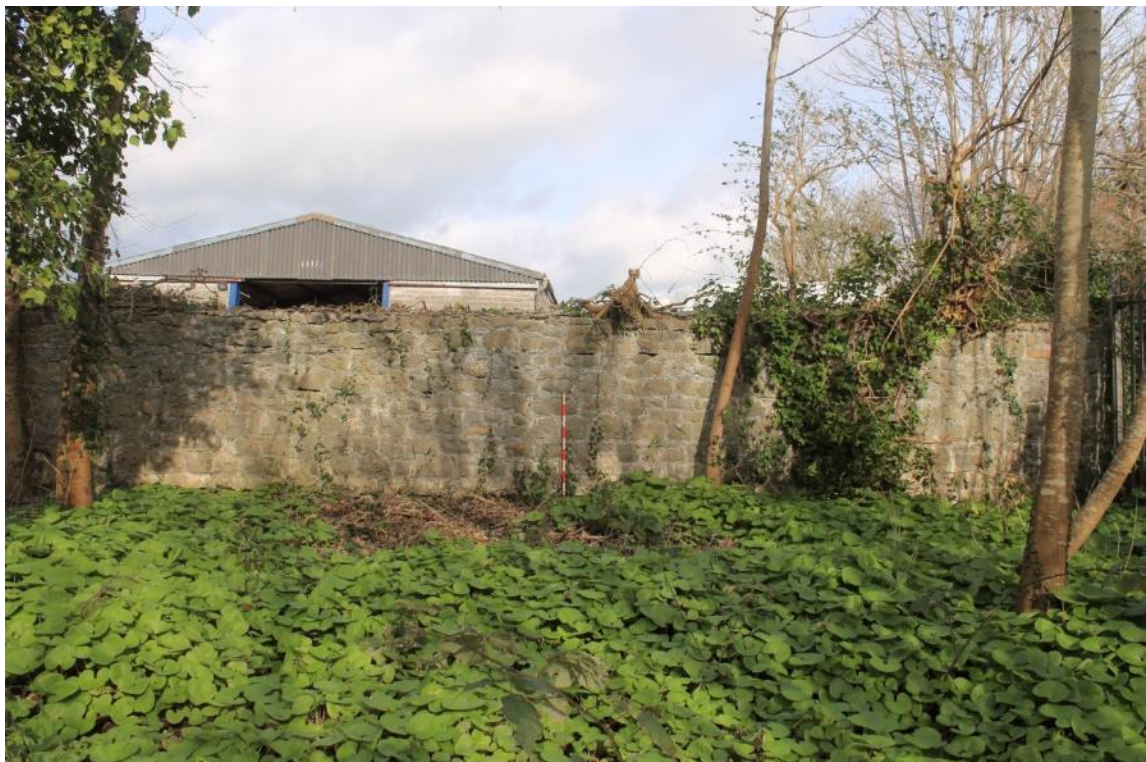
Photo 26: North facing shot of the eastern end of the northern enclosure wall. 1m scale.
