# **PEMBROKE DOCK SLIPWAYS, THE DOCKYARD, PEMBROKE DOCK, PEMBROKESHIRE: ARCHAEOLOGICAL WATCHING BRIEF**

Prepared by DAT Archaeological Services  
For: BAM Nuttall

REPORT NO. 2023-03  
EVENT RECORD No. 129719

September 2023

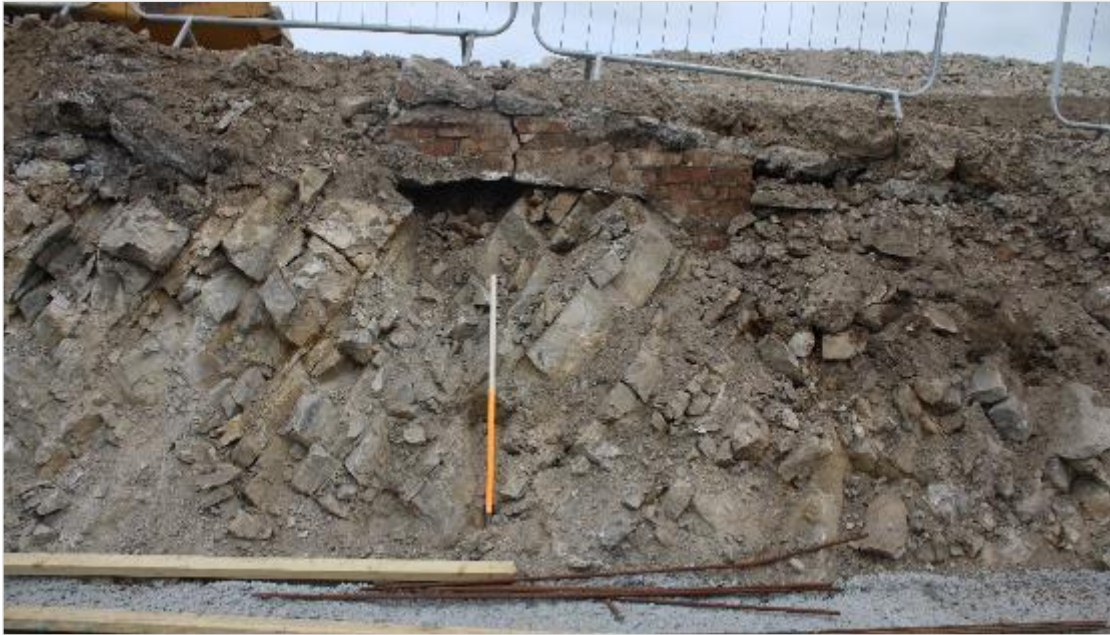
**Photo 04:** Showing brickwork constructed over bedrock below the surface of Slipway 2. View west. 1m scale.

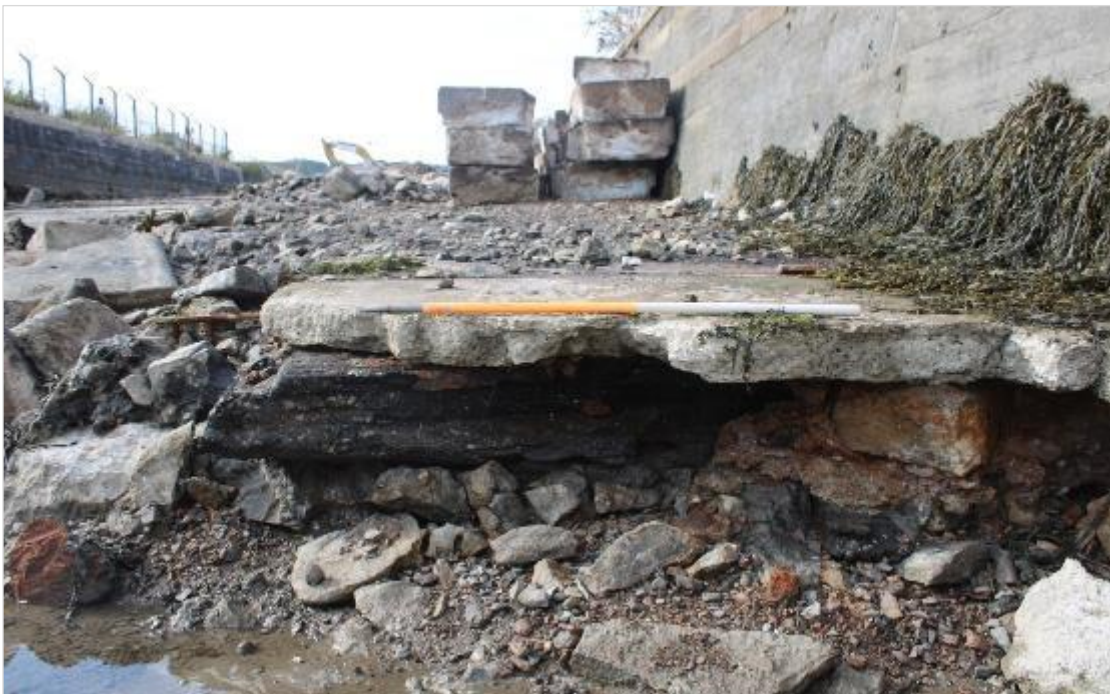
4.2.3 Large timbers had been used to support the concrete surface (Photos 05–06). Photo 07 shows a pair of these in-situ. They measured at least 3.8m long by 0.3m wide and were set 1.3m apart in a matrix that contained coal dust and masonry.

**Photo 05:** Showing a large timber beneath the concrete slab surface at the northern end of Slipway 2. View south. 1m scale.

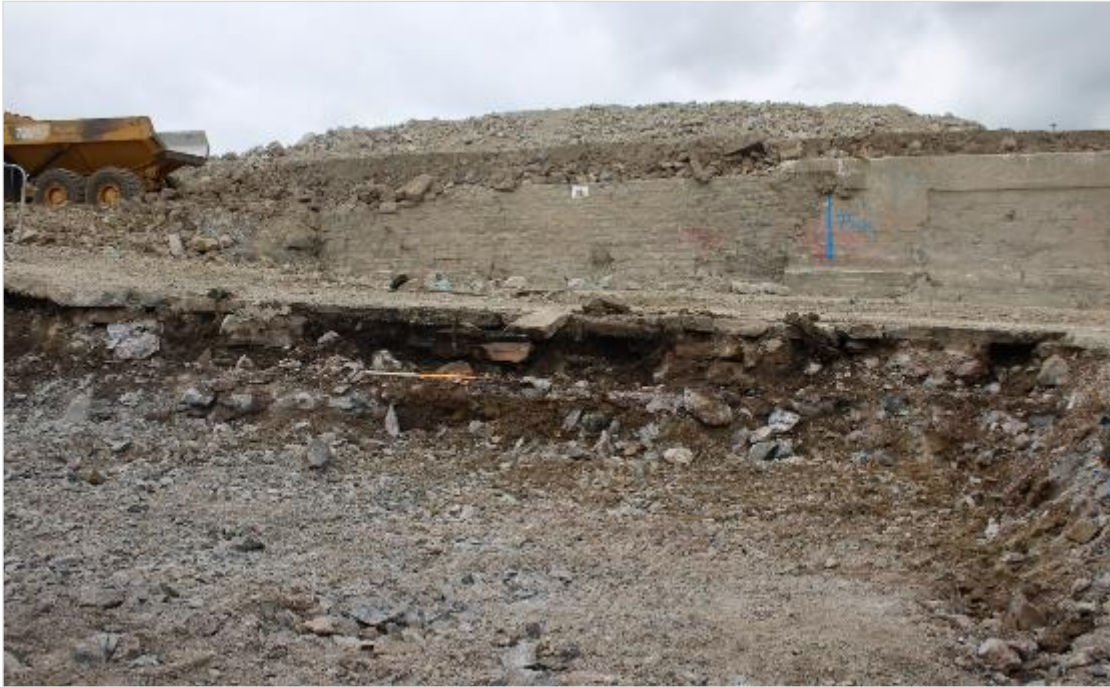
**Photo 06:** Showing timbers and masonry below the slabs of Slipway 2. View west. 1m scale.

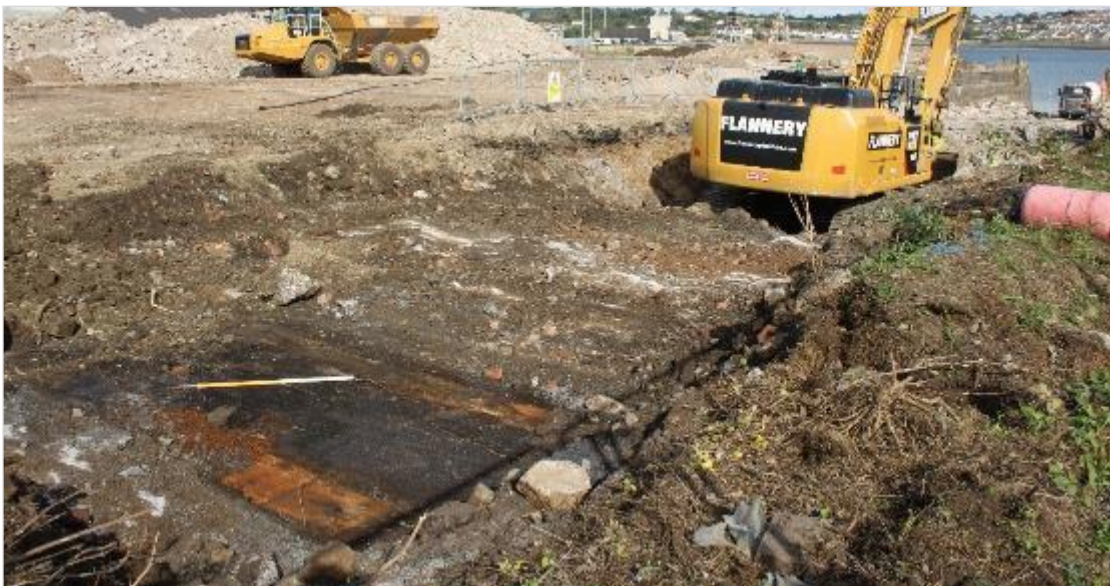
**Photo 07:** Showing a pair of substantial timbers set in coal dust/masonry at the top (south end) of Slipway 2. View north-west. 1m scale.

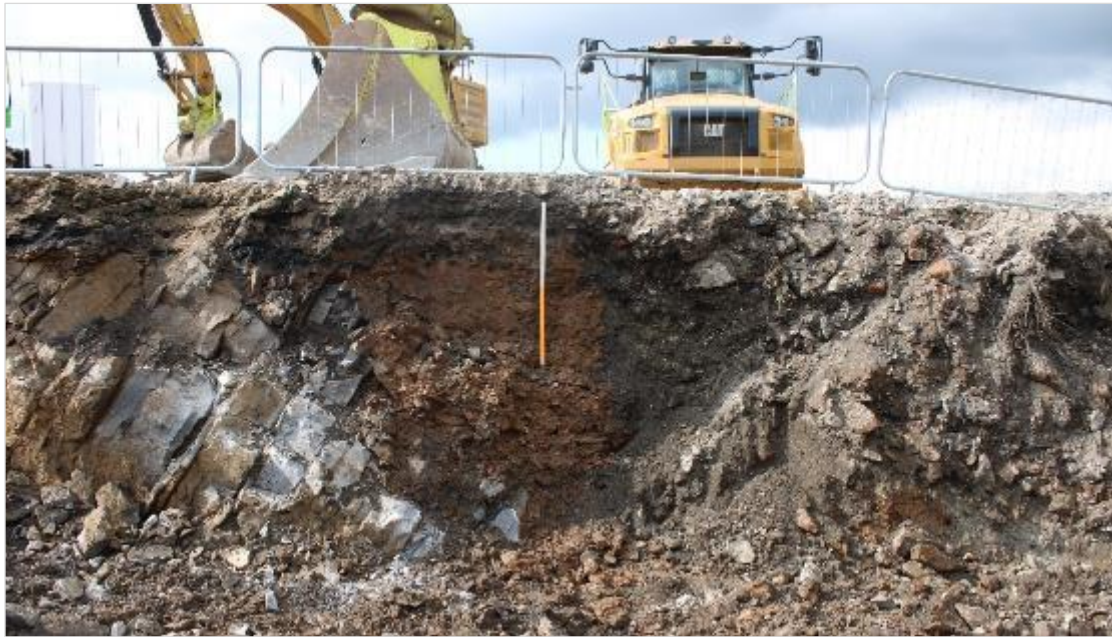
- 4.2.5 The excavation of Slipway 2 revealed a cut feature, [001], seen in the east facing section as the slipway level was reduced. A rectangular feature cut into the bedrock through a layer of ash/coal dust below the slipway surface (Photos 15–16), it measured 1.4m wide by 1.4m deep and was filled by a firm brown silty clay with very occasional small to medium angular pieces of limestone and one piece of plaster. No corresponding cut was visible in the opposite (west-facing) section.

**Photo 15:** Showing cut [001] revealed in section below Slipway 2. View west. 1m scale.

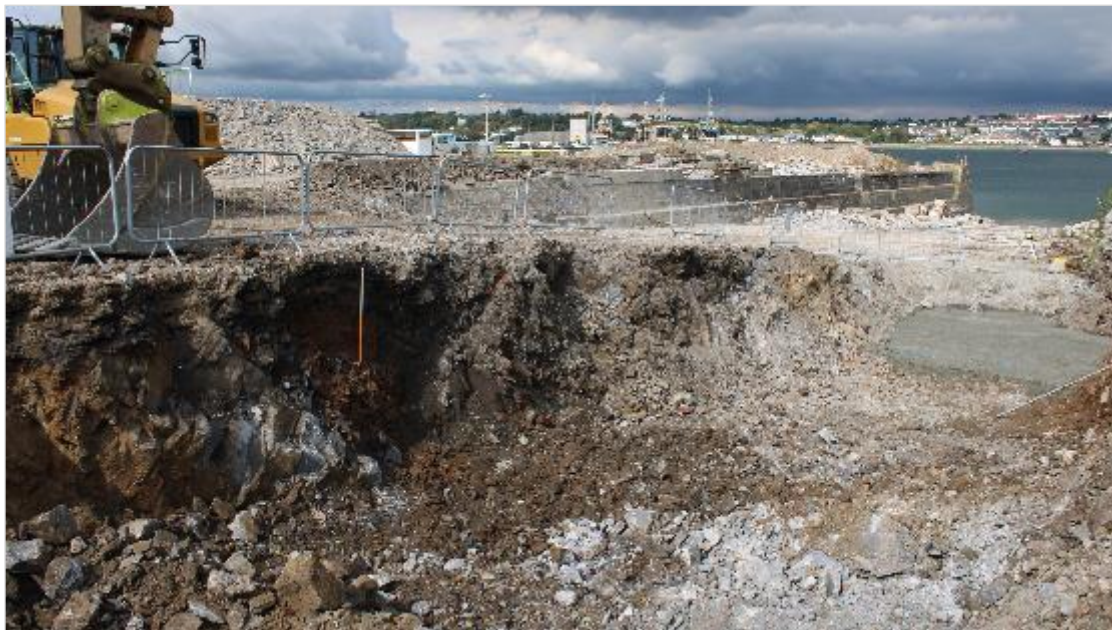
**Photo 16:** Showing the location of cut [001]. View north-west. 1m scale.

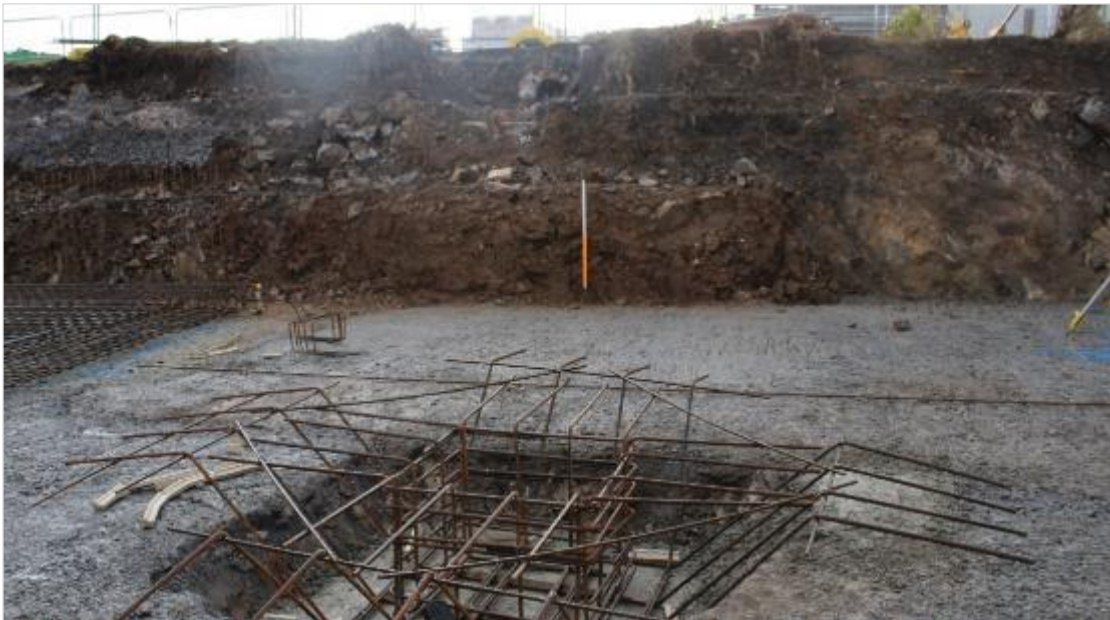
**Photo 18:** Showing cut [002] in the west-facing section created by excavation of Slipway 2. View east, 1m scale.

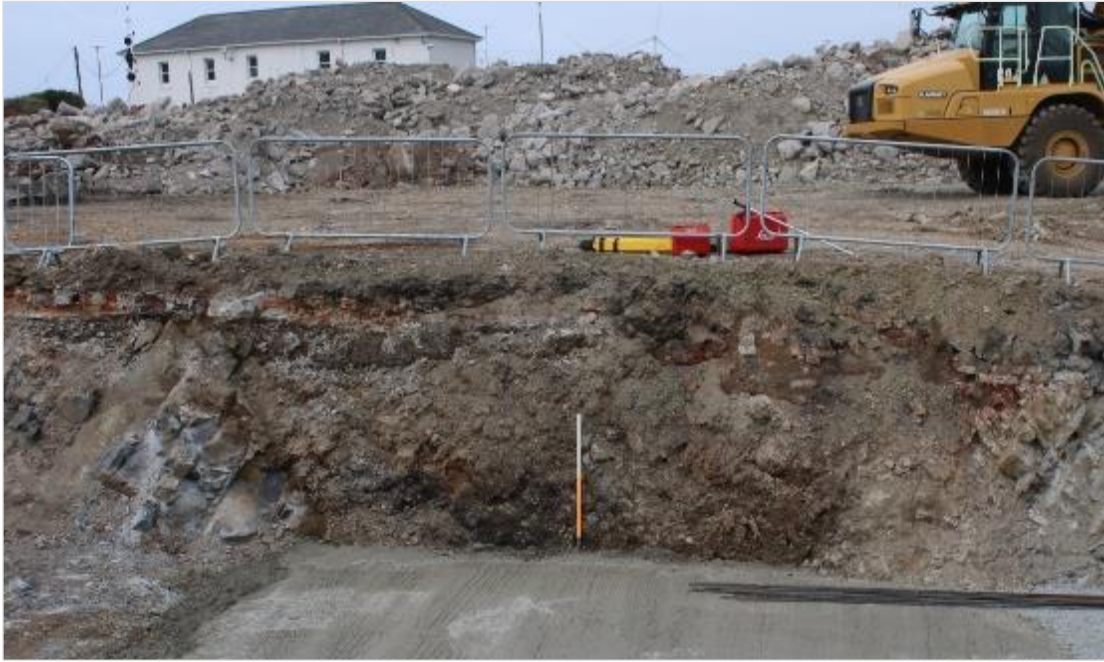
**Photo 21:** Detail of east facing section at the top (south) end of Slipway 2 showing cut [003] in the bedrock, with brick layer above. View west. 1m scale.

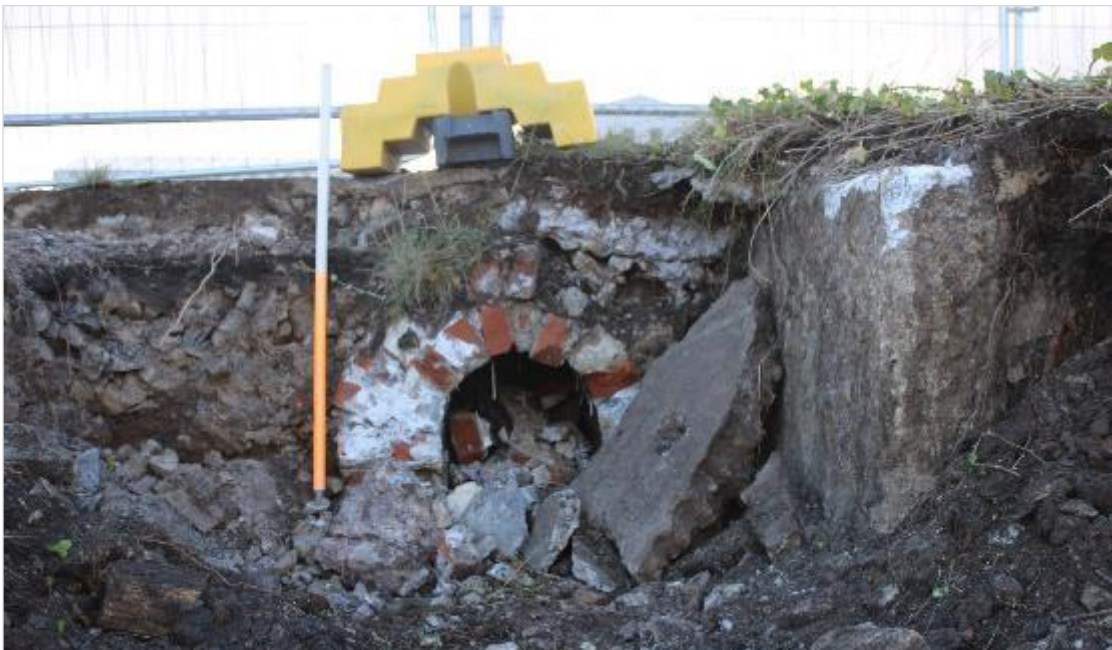
4.2.9 Two brick structures were observed during the Slipway 2 excavation. The first was a brick drain revealed by removal of part of the eastern wall of the slipway (Photo 22). It was at a higher level than the surface of the slipway (Photo 23).

**Photo 22:** Showing a brick drain revealed by removal of part of the wharf east of Slipway 2. View east. 1m scale.

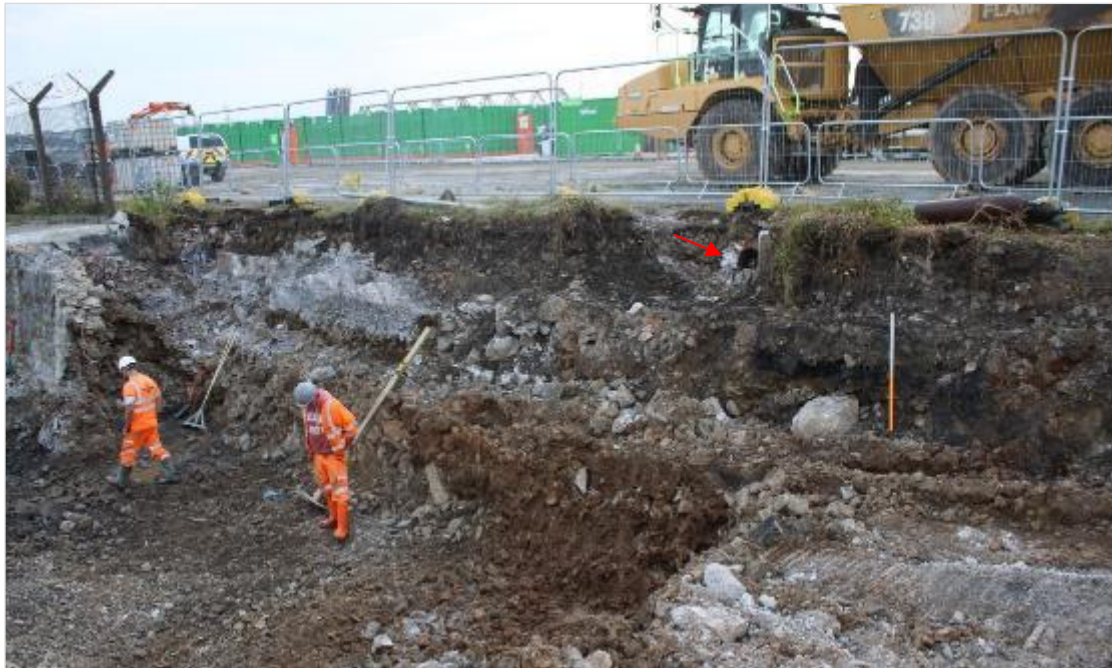
**Photo 23:** Showing the level of the brick drain (red arrow) revealed by removal of part of the eastern wall of Slipway 2. View north-east. 1m scale.

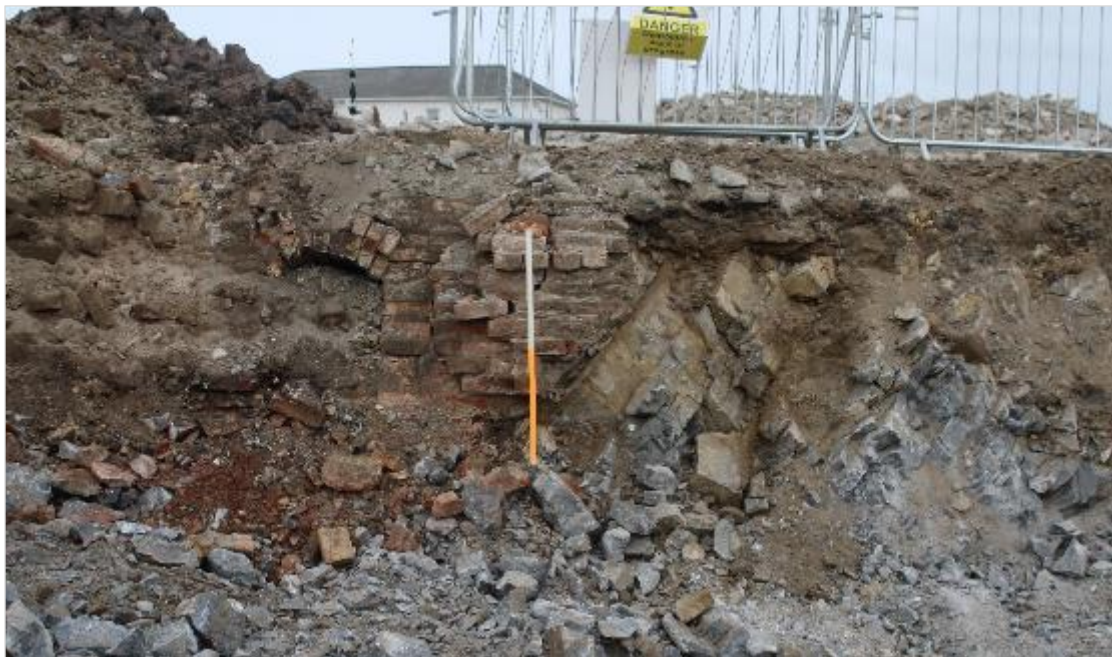
**Photo 24:** Showing a brick arch revealed in section during excavation of Slipway 2. View west. 1m scale.

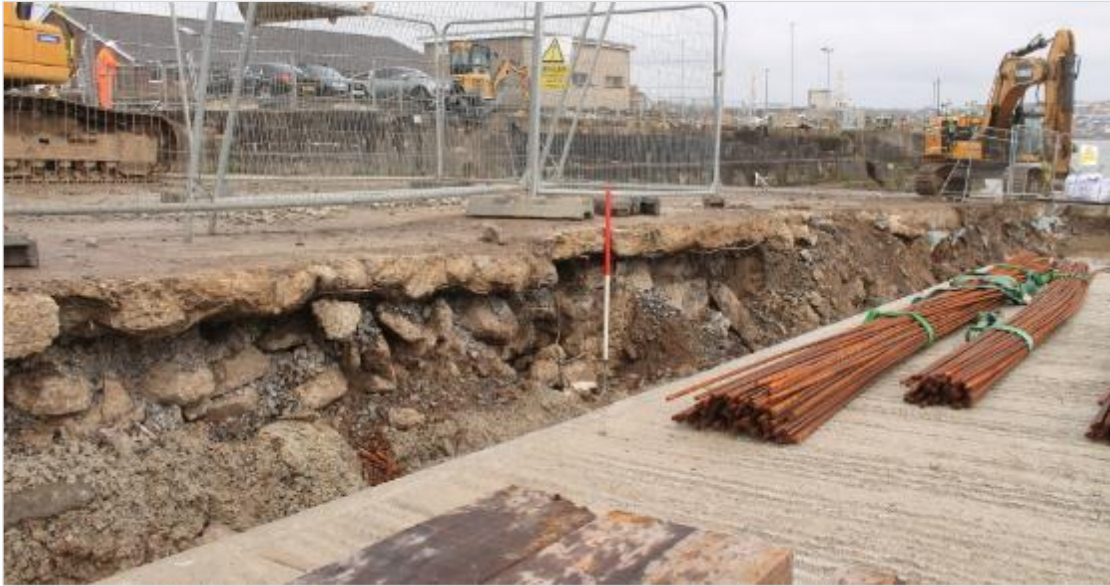
**Photo 33:** Showing deposits below Slipway 1, towards the northern end. View north-west. 1m scale.

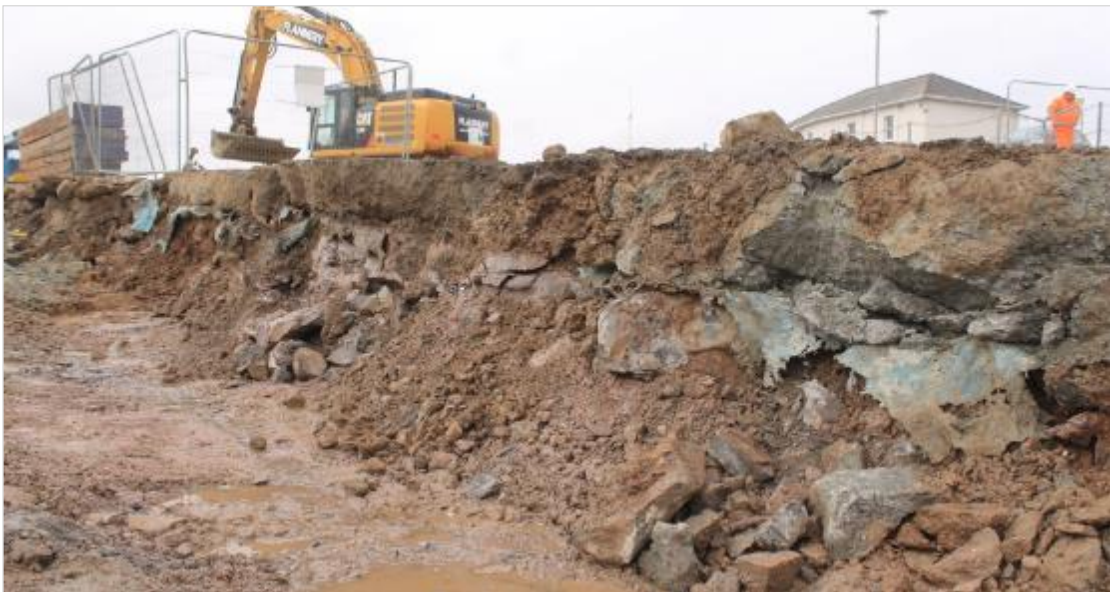
4.2.13 A further change in the nature of the lowest deposits was observed towards the southern half of the slipway. Both bedrock and aggregate, and a grey concrete containing small aggregate were present below the eastern surface in this area (Photos 34–35). To the west, the deposit was predominantly pinkish-brown concrete. Corrugated metal sheets appeared to separate this from the deposit and bedrock to the east (Photo 36). The presence of blue plastic sheeting below the concrete surface revealed that areas of the slipway were of relatively recent construction (see Photos 33–34).

**Photo 34:** Showing deposits and plastic sheeting below the concrete surface of Slipway 1, at the eastern side towards the southern end. Looking south-west. No scale.

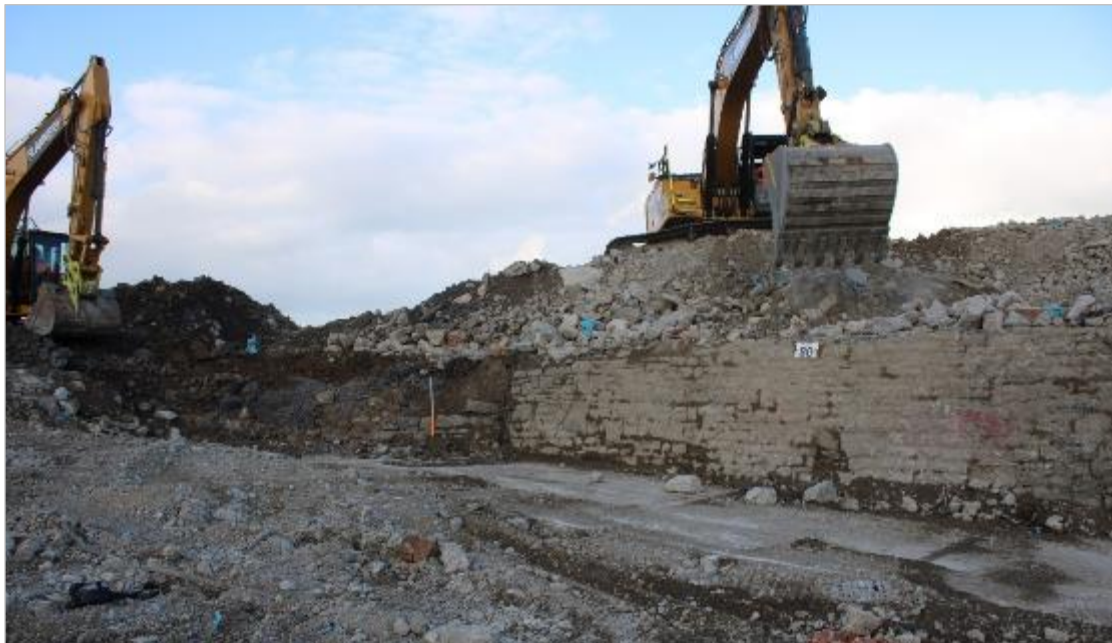
**Photo 46:** Showing a dogleg in the eastern wall of the wharf/western wall of Slipway 2. View south-west. 1m scale.

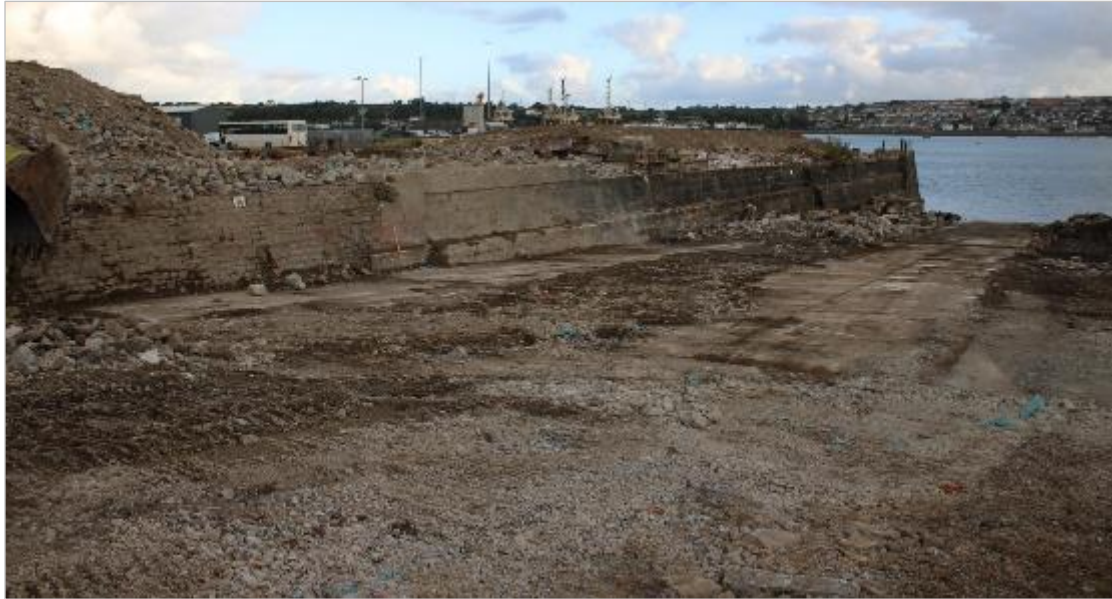
**Photo 47:** Showing a change of build/phase in the south end of the eastern wall of the wharf/western wall of Slipway 2. View north-west. 1m scale.

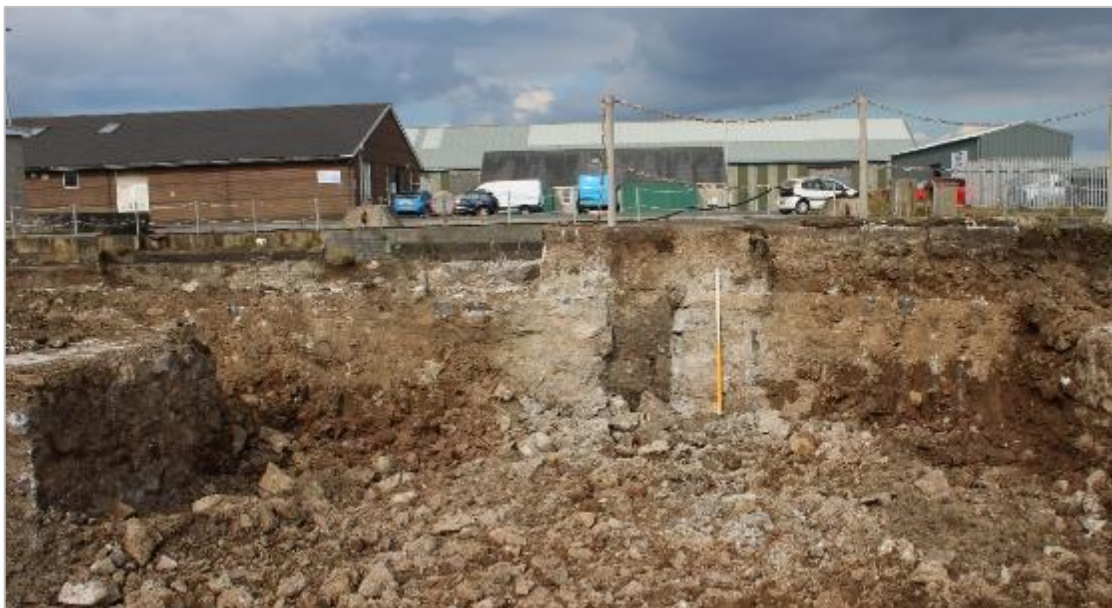
**Photo 48:** Showing a vertical notch in the internal face of the wharf wall. View west. 1m scale.

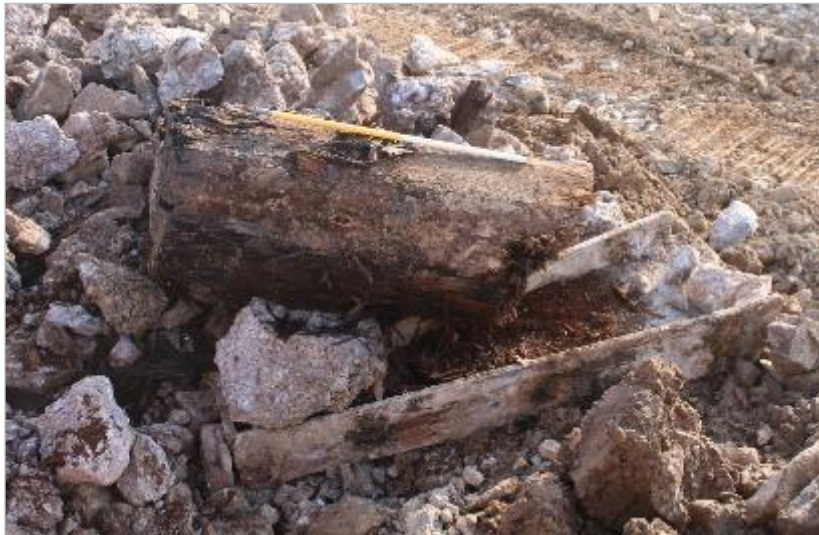
- 4.3.4 Removal of the concrete from the top of the wharf revealed a number of stone plinths within the fabric of the structure, several of which had metal stanchions set into them (Photos 49–54). A line of these was revealed within the western side of the wharf, where the plinths measured approximately 1.5m by 2m by at least 2m high. A large timber post was found next to one of the western plinths (Photo 49). A single plinth seen in section on the eastern side of the wharf during demolition was smaller than those on the western side (Photo 55).

**Photo 49:**  
Showing the  
remains of a metal  
stanchion and also  
a large timber post  
found next to the  
plinth containing  
this stanchion. 1m  
scale.

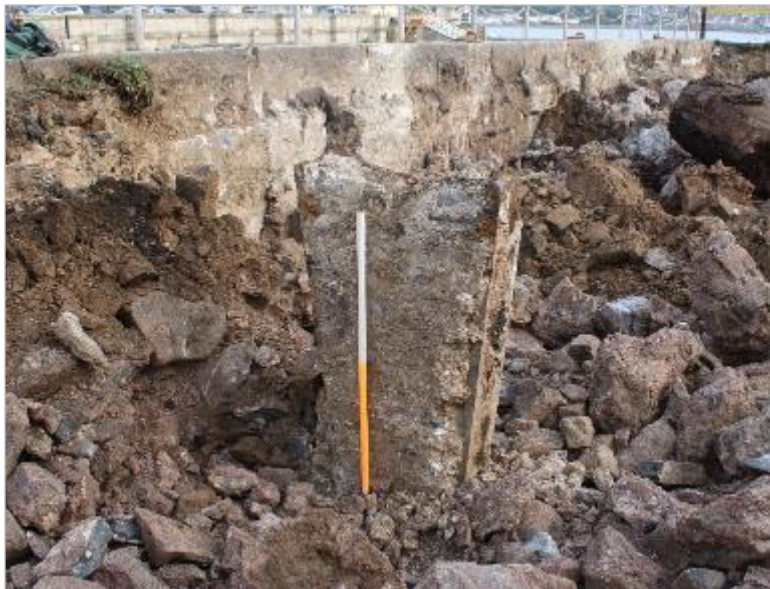
**Photo 50:** Remains of  
metal stanchion after  
removal of  
surrounding plinth.  
View north-west. 1m  
scale.

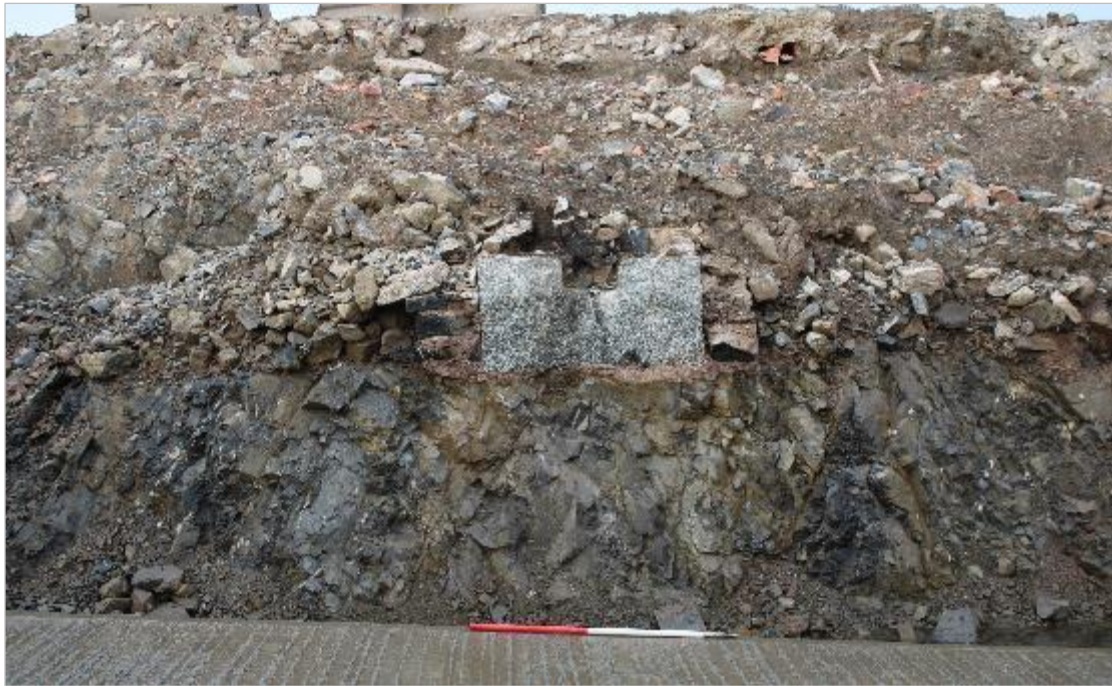
**Photo 55:** The remains of a smaller plinth and stanchion socket seen in section during demolition of the wharf. View west. 1m scale.

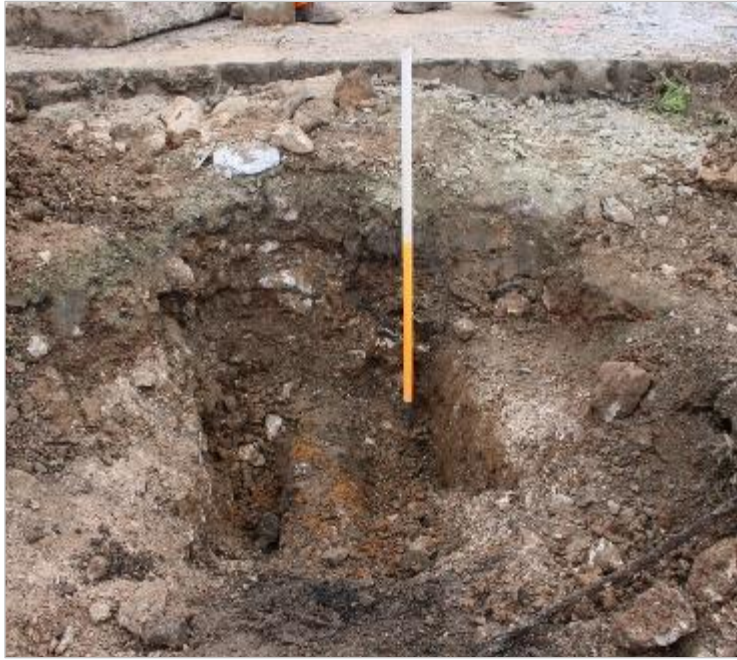
- 4.3.6 During the demolition of the wharf, several sections of a cast iron pipe on a north/south alignment were recorded and recovered from within the structure (Photos 62 and 66). A further section of pipe on the same alignment and set within a concrete sleeve was observed on the foreshore, below the north end of the wharf (Photos 63–65).

**Photo 62:** Showing a corroded iron pipe revealed below the surface of the wharf. View south. 1m scale.

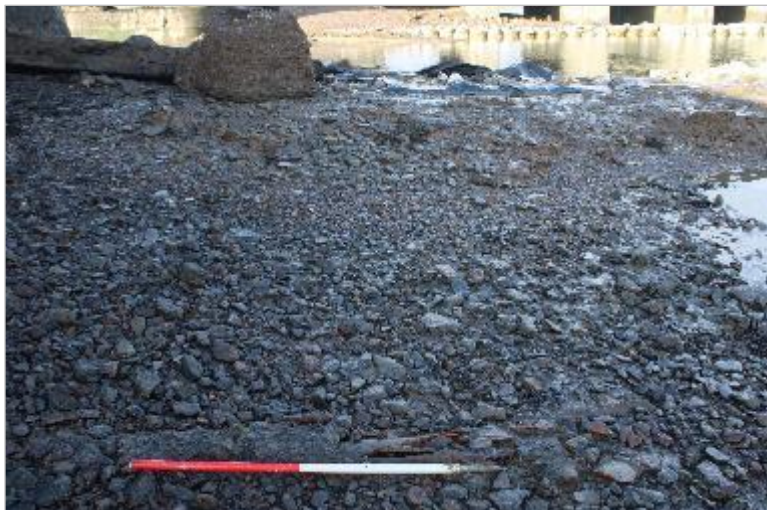
**Photo 63:** Showing a cast iron pipe within a concrete 'sleeve' crossing the foreshore north of the wharf. Probably carried outfall from the privy. View west. 1m scale.

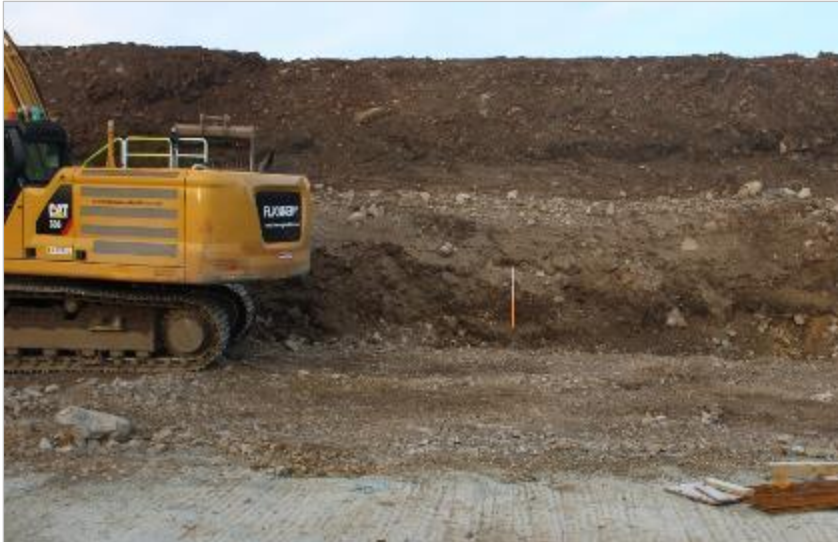
- 4.3.8 During removal of the infill of the wharf a possible cut [005] was observed in section (Photo 72). Cut [005] measured approximately 4m north/south at its excavated base, and a visible north/south width higher up of at least 6m. It was at least 1.5m deep.

**Photo 72:**  
Showing a possible cut revealed in section during demolition of the wharf. View west. 1m scale.

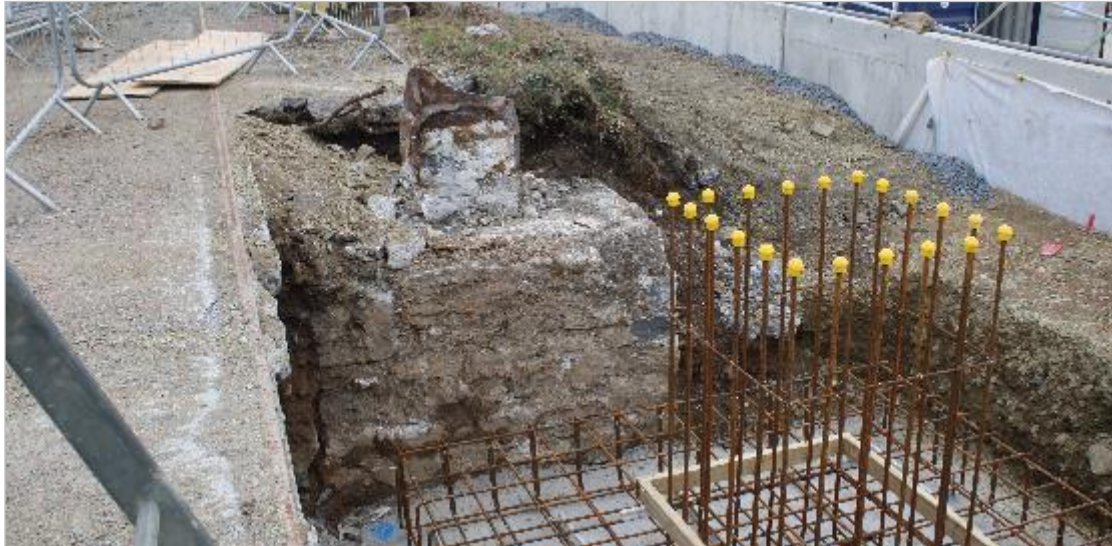
- 4.6.3 Excavation in the wharf between Slipway 2 and the graving dock revealed two blockwork plinths with metal stanchions set into them, identical to those found within the wharf between Slipways 1 and 2 (Photos 117–118).

**Photo 117:** Showing a rail and one of two blockwork plinths containing a metal stanchion revealed within the wharf between Slipway 2 and the graving dock. View south-west. No scale.
