# **WESTERN QUAYSIDE WAREHOUSE, HAVERFORDWEST, PEMBROKESHIRE**

## **HISTORIC BUILDING RECORDING**

### **LEVEL 2**

REPORT NO. 2023-30  
EVENT PRN. 129908

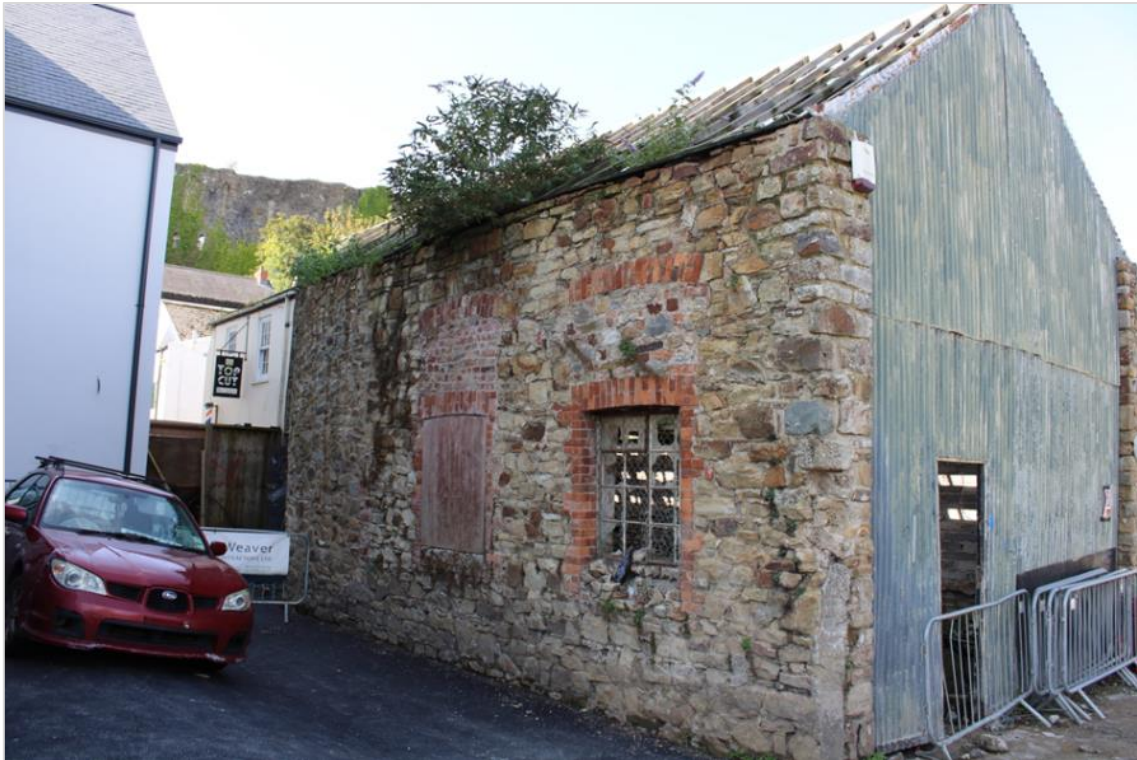
**Photo 2:** Image taken from the southeast of Western Quayside Warehouse.

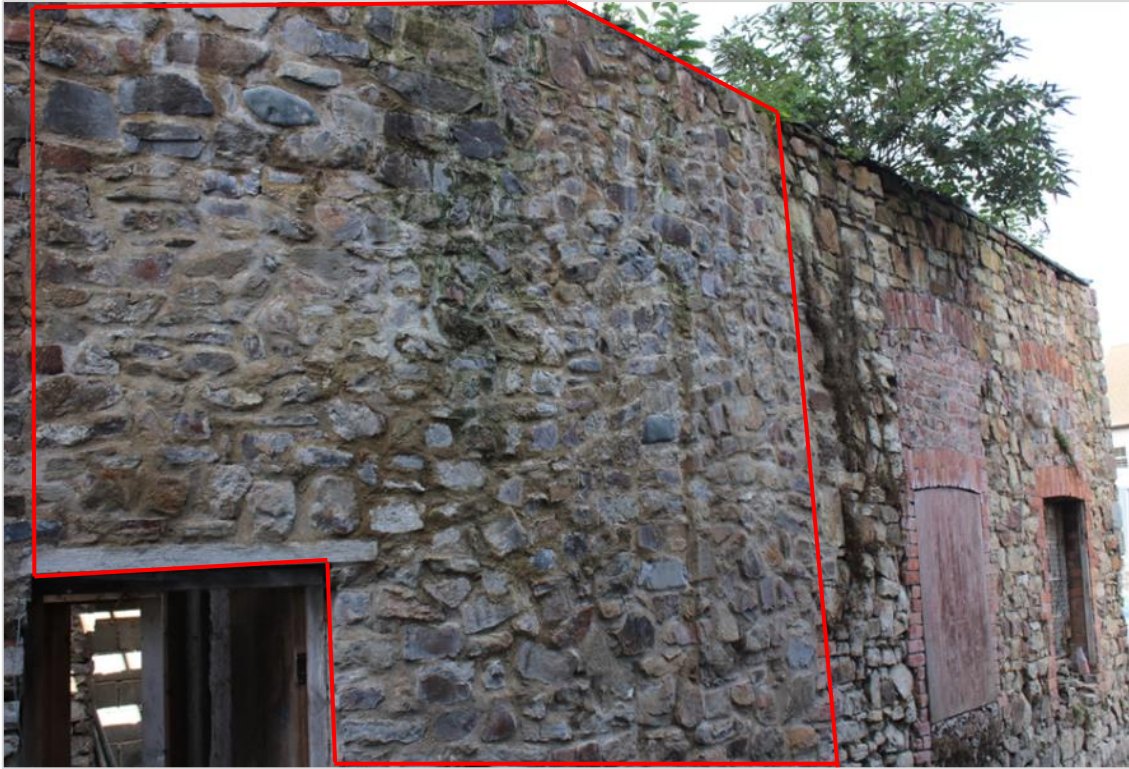
- 4.1.3 The southeast wall shows the building has been remodelled at various points in the past (for example, Photo 3). A mixture of stone, brick and breeze block have been utilised as well as a variety of mortars such as cement with sand. See Sections 4.2.4 (Photo 20) and 4.3.4 (Photo 39) for descriptions of the internal walls.

**Photo 3:** 4m panel of rebuilt masonry on the southeast wall.

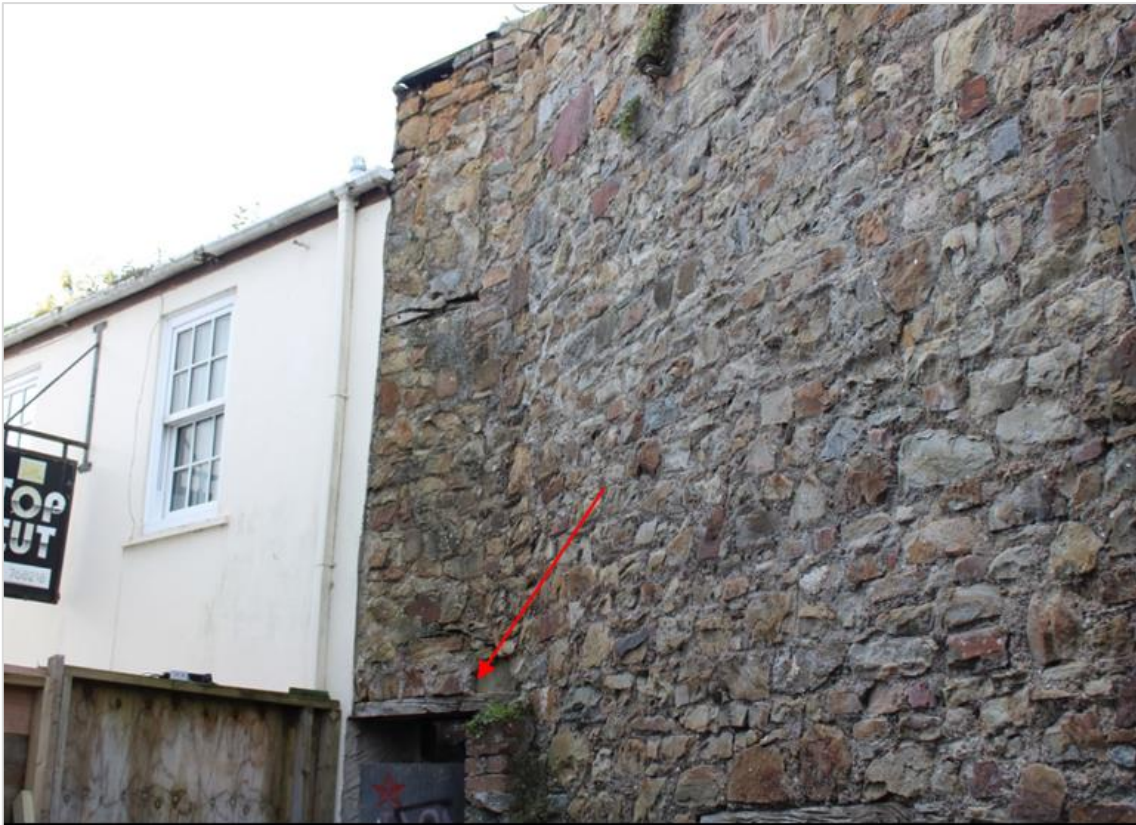
- 4.1.4 Evidence remains of the original western gable end wall which abuts another building, a modern addition, outside of the scope of this report (Photo 4). In the 2023 Atkins '*Haverfordwest Footbridge and Western Quayside Phase 2- Former Cleddau Foundry building: Structural Approach*' report, it was highlighted that it is not believed that any support is taken from, or given to, this other building.

**Photo 4:** The remains of the western gable end wall (indicated by a red arrow) and the modern building attached to the western end of the warehouse.

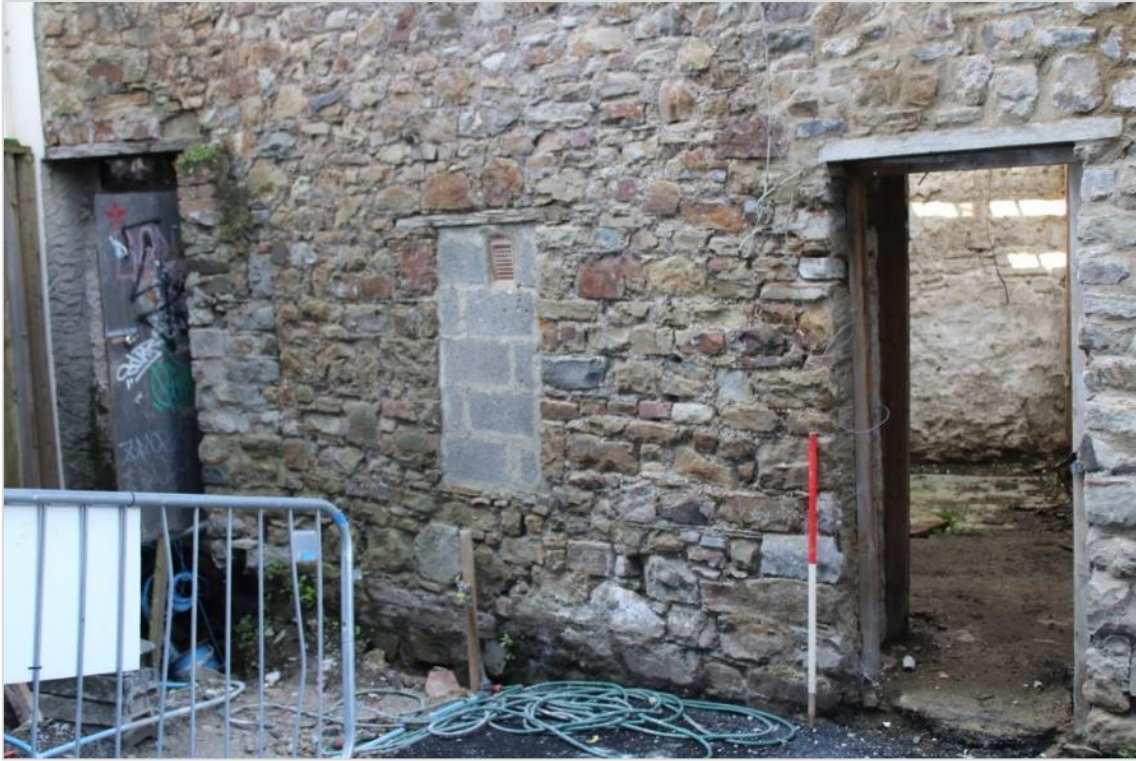
- 4.1.5 The warehouse's southeast and south walls each contain a door (Photo 5). One is located on the western end of the southeast wall and the other approximately 4m to the west on the south wall. Both have timber frames and a wooden lintel however, the door on the southeast wall has an additional modern concrete lintel. This may be contemporary with a panel of wall east of the door which has been previously rebuilt in like-for-like masonry. The reason for remodelling is unclear. Possibly there was an earlier window as there are a few bricks remaining which look like those that surround other windows on the building.

**Photo 5:** View northwest of doors on south and southeast walls and infilled window on south wall (scale 1x1m).

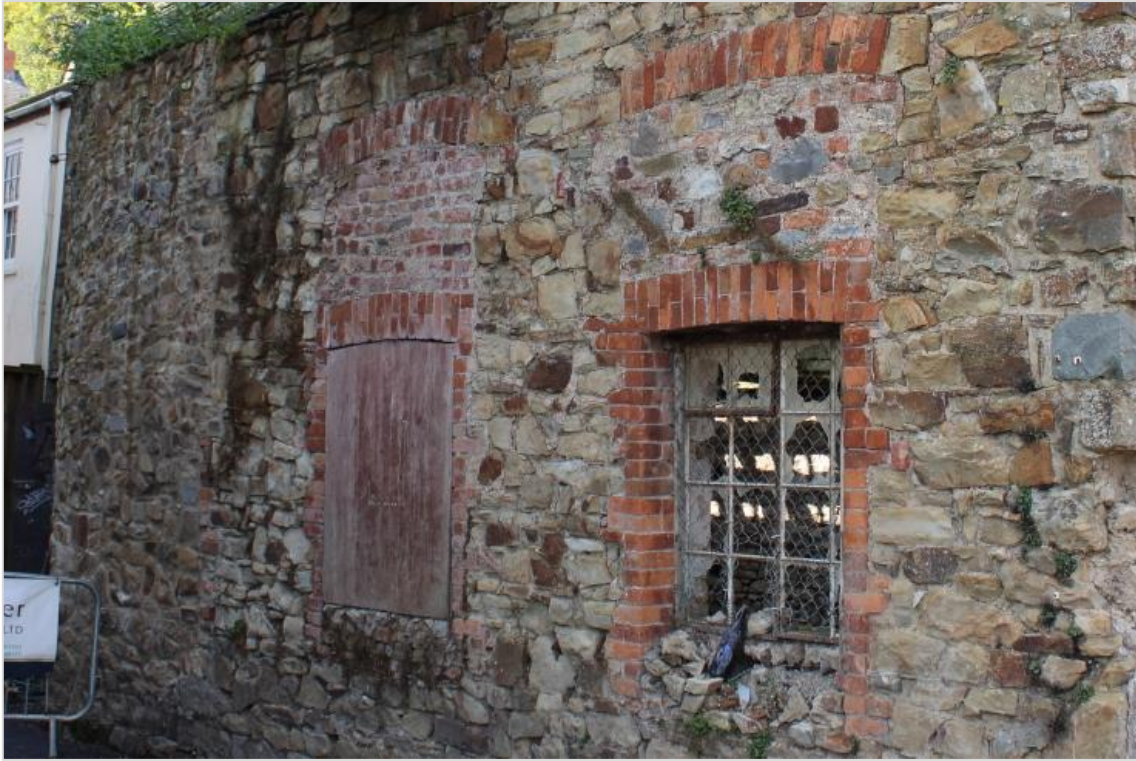
- 4.1.6 The building has one window in the south wall and two in the southeast wall. The south wall window is rectangular and smaller than the other windows on the building. It has been infilled with breeze block and a brick air vent but still retains its wooden lintel (Photo 5). Its internal description can be found in Section 4.2.12, Photos 29 and 30. On the southeast wall, one window has been boarded up and the other remains open (Photo 6). Both appear contemporary as they have the same design of a brick arch and a brick frame around the window. The open window may have had a cement sill but this has been heavily damaged and the board makes it unclear whether the blocked window had one. Within the open window are the remains of a metal frame with a small quantity of glass intact. Above both windows there is evidence of an earlier design with brick arches. These may have been two small windows, or the two remaining windows may have been larger and reduced in size. Both are infilled. The windows may have been contemporary due to their style, but they appear to have been infilled at different times as above the boarded window the infill is of brick and above the open window it is of roughly coursed stone. The descriptions of the features as viewed from inside the warehouse can be seen in Sections 4.2.5 (Photos 21 and 22) and 4.3.5 (Photo 40).

**Photo 6:** Windows on southeast wall. One remains open and has glass intact. Both windows have evidence of an infilled window above, one with brick (to the left) and the other (to the right) stone.

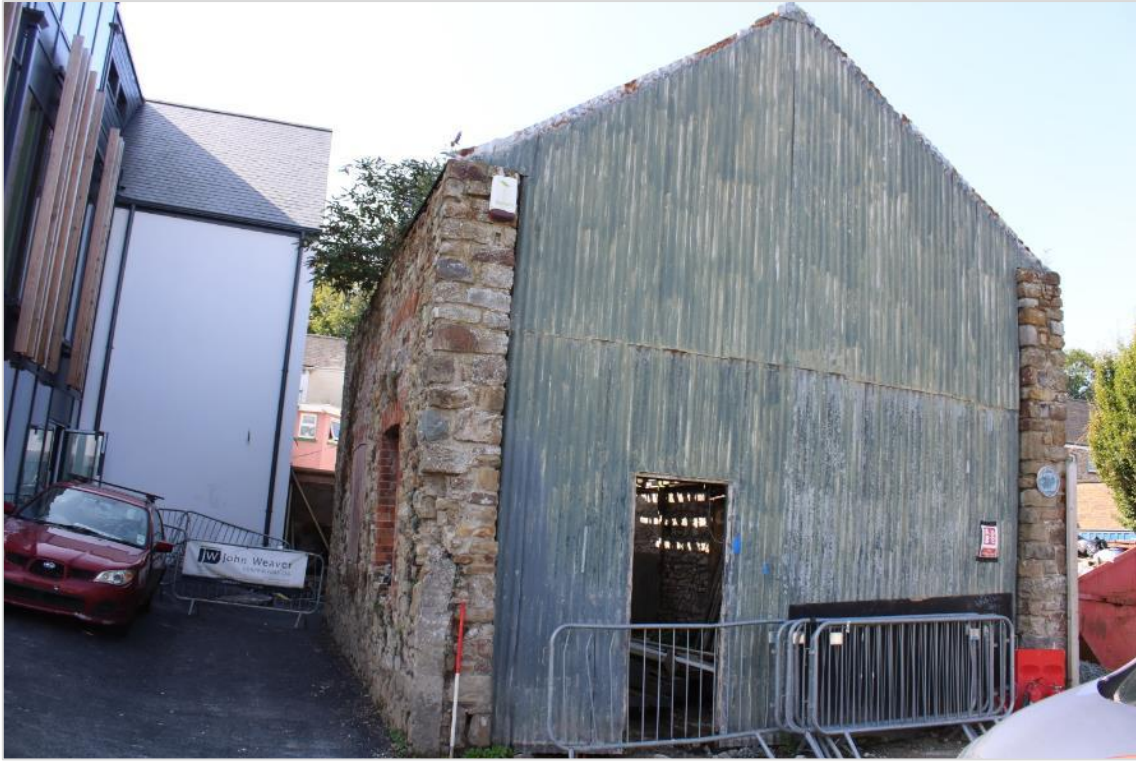
- 4.1.7 The northeast wall has been remodelled over time. Historic documents from the late 18<sup>th</sup> through to the 19<sup>th</sup> century show the building extended out from this wall but this has since been demolished and replaced with corrugated iron cladding fixed onto timber studwork. The edges of the wall are a modern stone face with a cement and sand mortar and show evidence of repair. A single door is located on the eastern end of the wall and has a timber frame (Photo 7).

**Photo 7:** West facing view of northeast wall. The edges have modern stone facing and northeast wall replaced with corrugated iron sheets on timber studwork (scale 1x 1m).

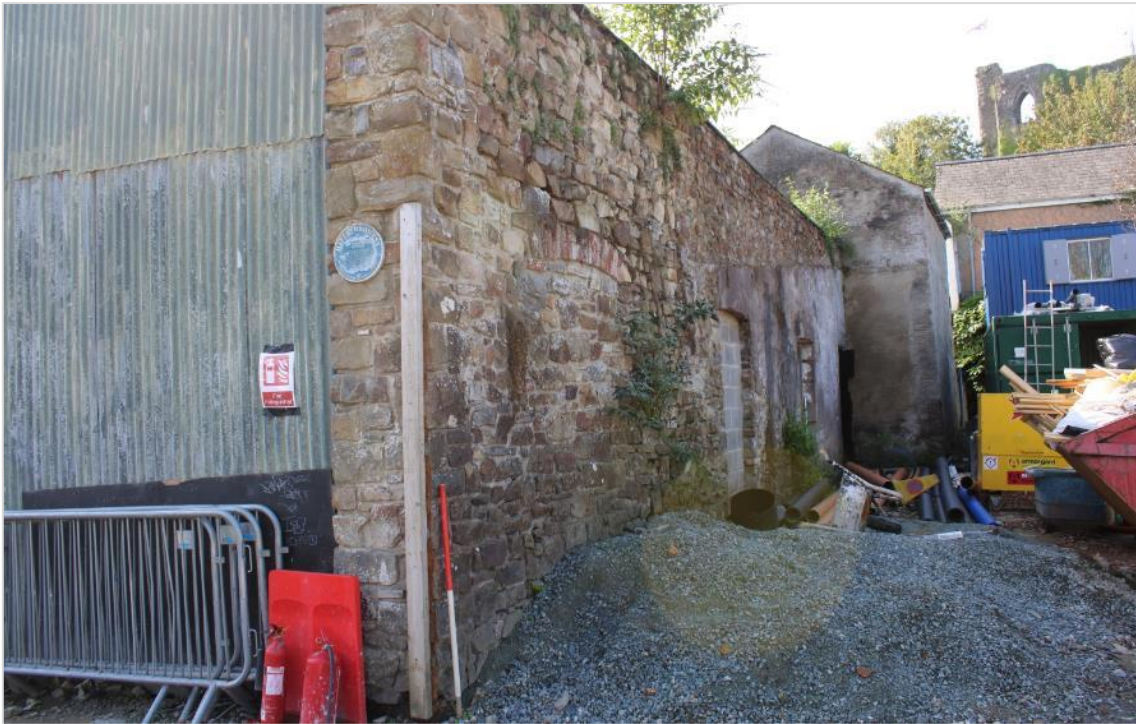
- 4.1.8 As with the other sides of the warehouse, the northwest wall (Photo 8) indicates different phases of use. Render over the masonry provides evidence of a historical lean-to (Photo 9). Within this area are two doorways and a window. The southern door is still in use and has a timber frame (Photo 10). The second door is infilled with breeze block and has a brick arch which can be observed under the render (Photo 11). This door also has evidence of historical repair on the lower masonry and its internal description can be seen in Section 4.2.7, Photo 23. The window has been infilled and covered in render suggesting it was not in use when the lean to was utilised (Photo 12). Under the render, a brick arch above the window can be seen as well as a timber frame and a concrete sill.

**Photo 8:** Complete northwest wall (scale 1x1m).

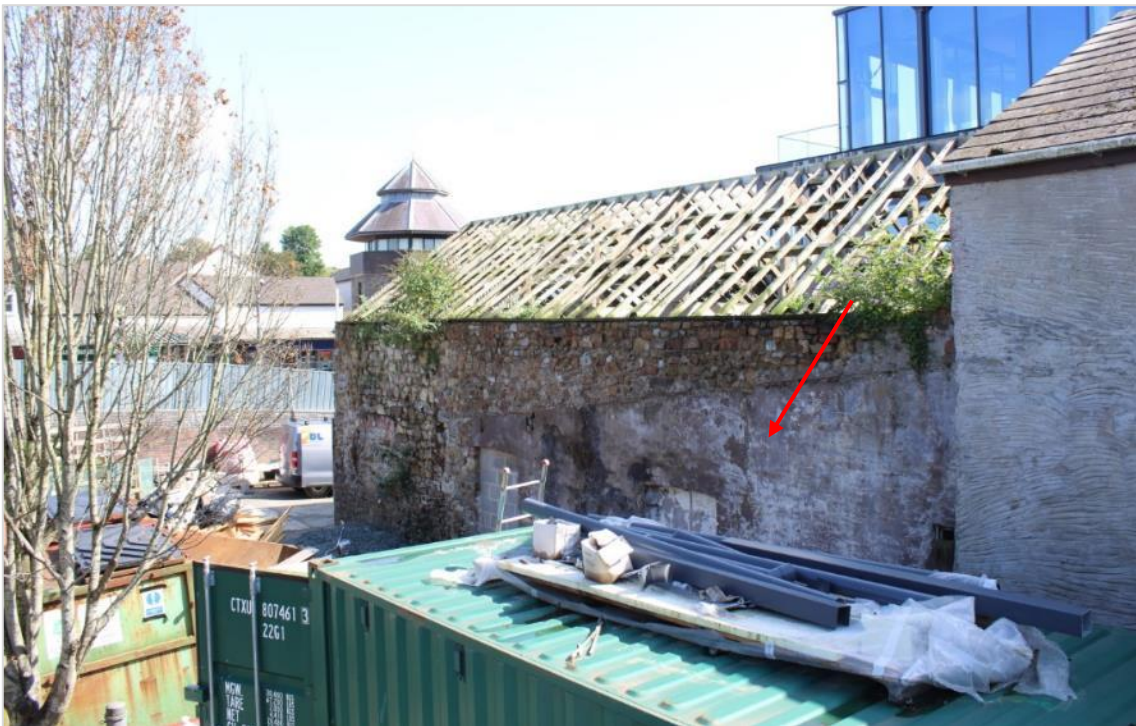
**Photo 9:** Eastern view of render from lean-to on the northwest wall (indicated by red arrow). Exposed single duo pitch roof.

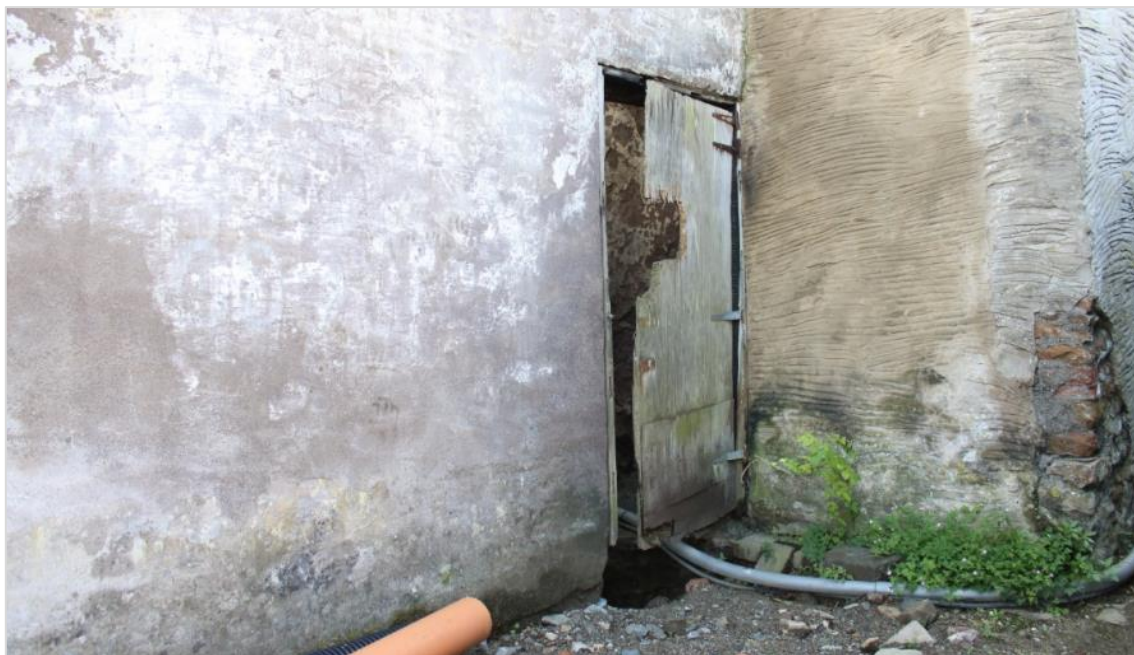
**Photo 10:** Southern door on northwest wall. Still in use and was part of the lean-to. The door has a timber frame.

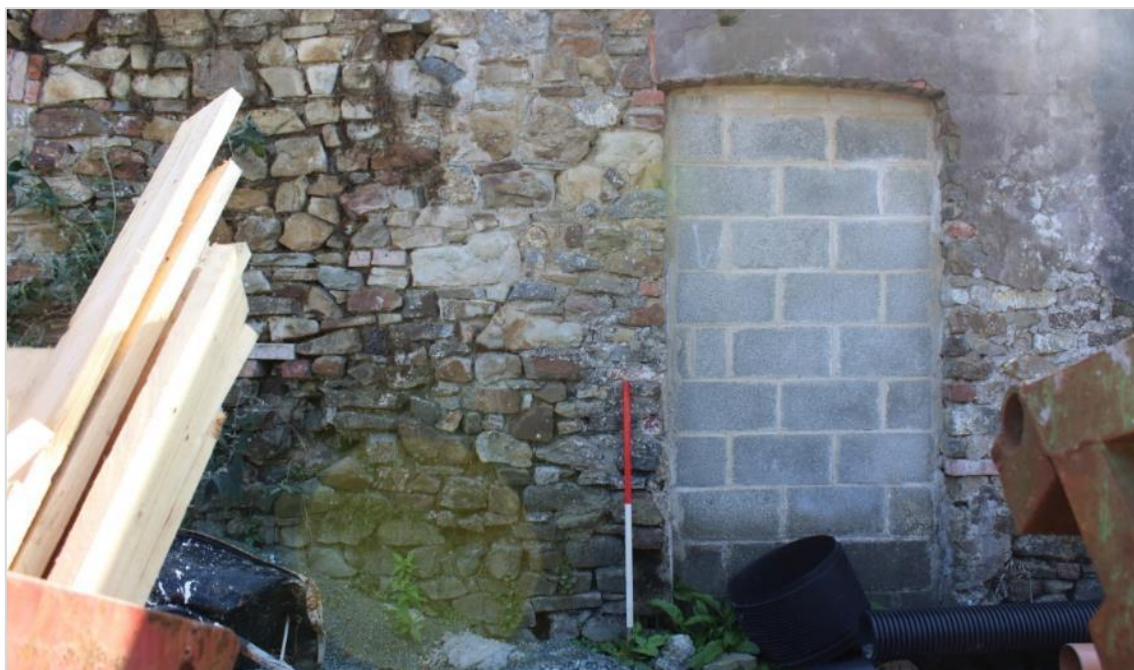
**Photo 11:** Southeast view of door in the lean-to. Infilled with breeze block. Evidence of a stone arch under render (scale 1x 1m).

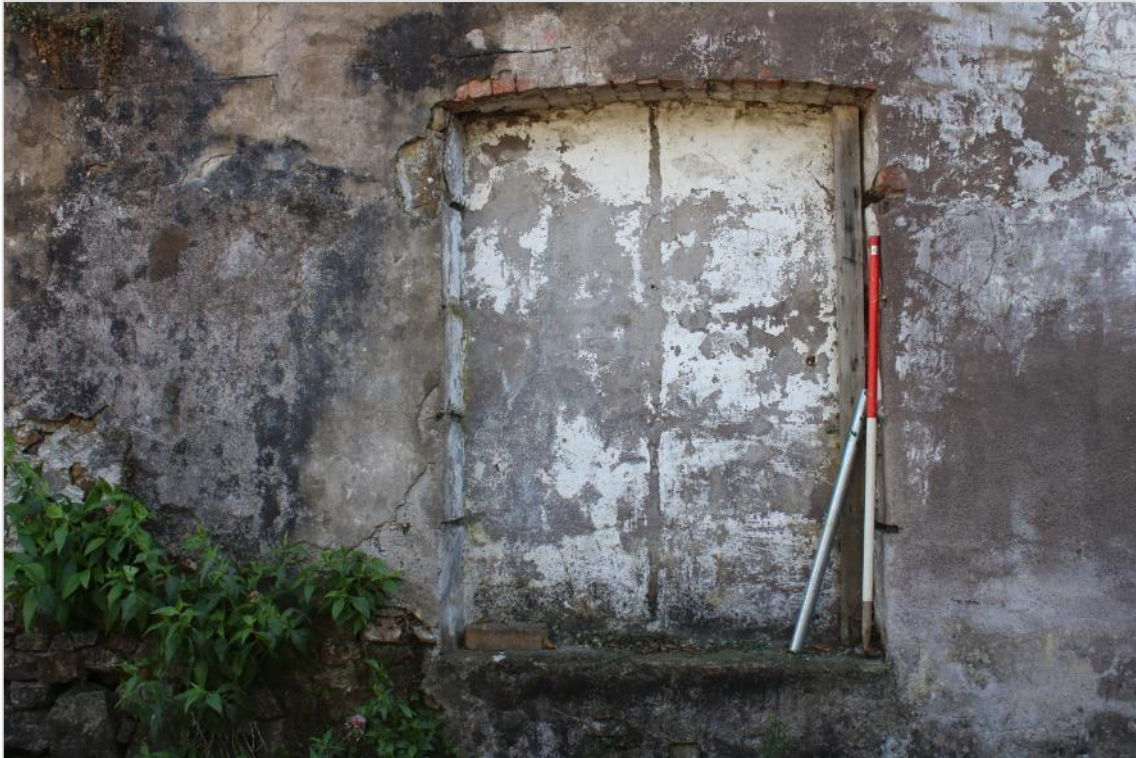
**Photo 12:** Infilled window on northwest wall. Covered in render suggesting it was infilled when the lean-to was in use. A brick arch can be seen under the render (scale 1x 1m).

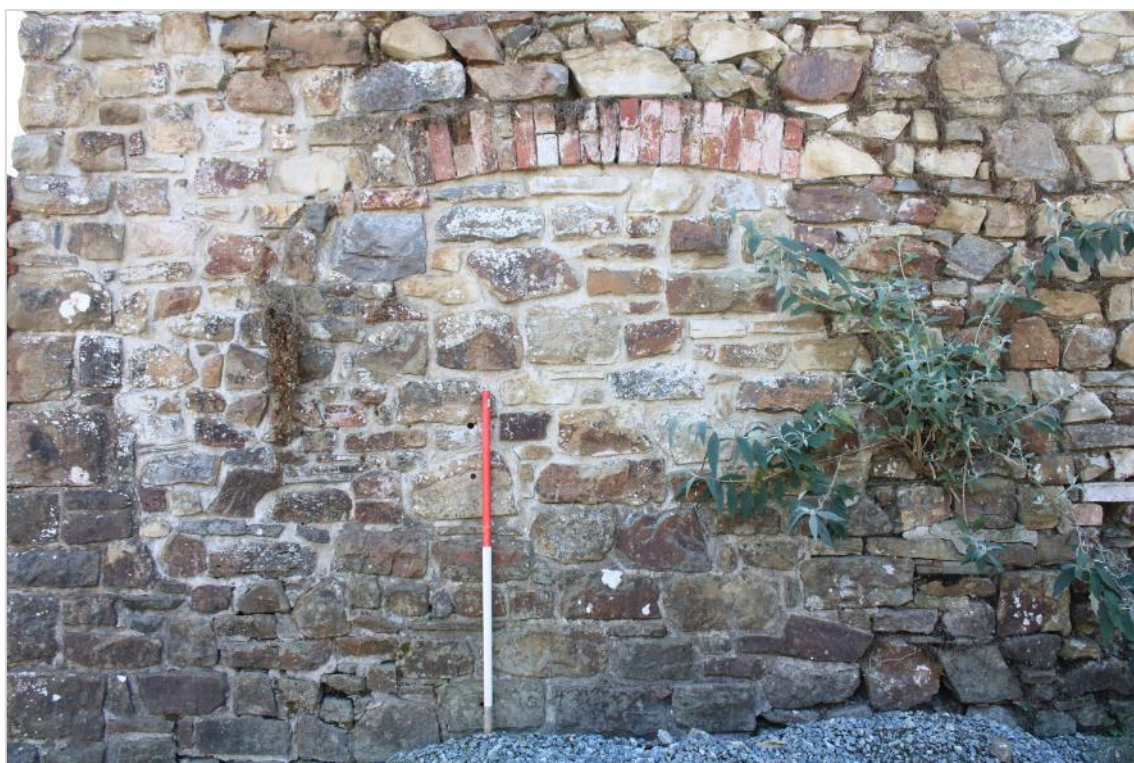
- 4.1.9 On the northern end of the northwest wall is a third window (Photo 13), infilled with stone. It is shorter than the other windows on this wall and has a brick arch above, although internally, this window appears taller and no brick arch is present. Comparative measurements were not taken as accessibility was poor to these features. See Section 4.2.8, Photo 24 for a description of the window's internal features.

**Photo 13:** The northern window on the northwest wall which was not within the lean-to. Window infilled with like-for-like stone and a cement mortar. The original brick arch can be seen (scale 1x1m).

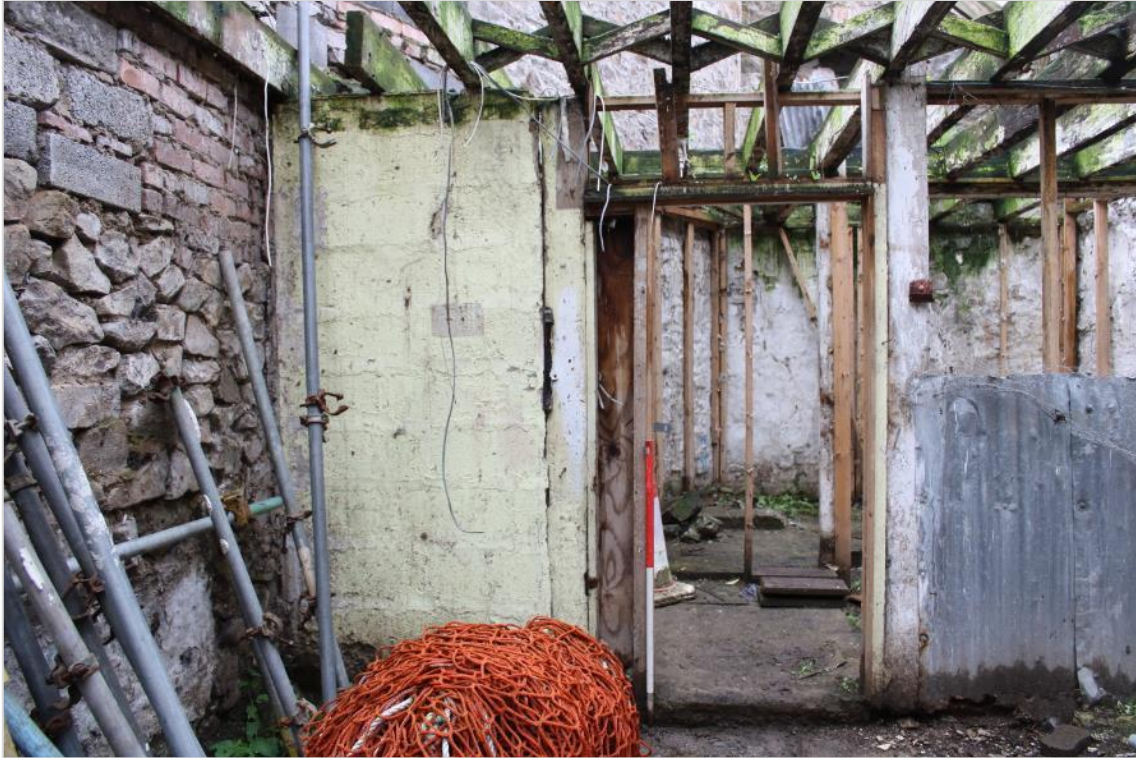
**Photo 14:** Breeze block section of wall which partitions the two interior ground floor rooms. The doorway is timber framed (scale 1x1m).

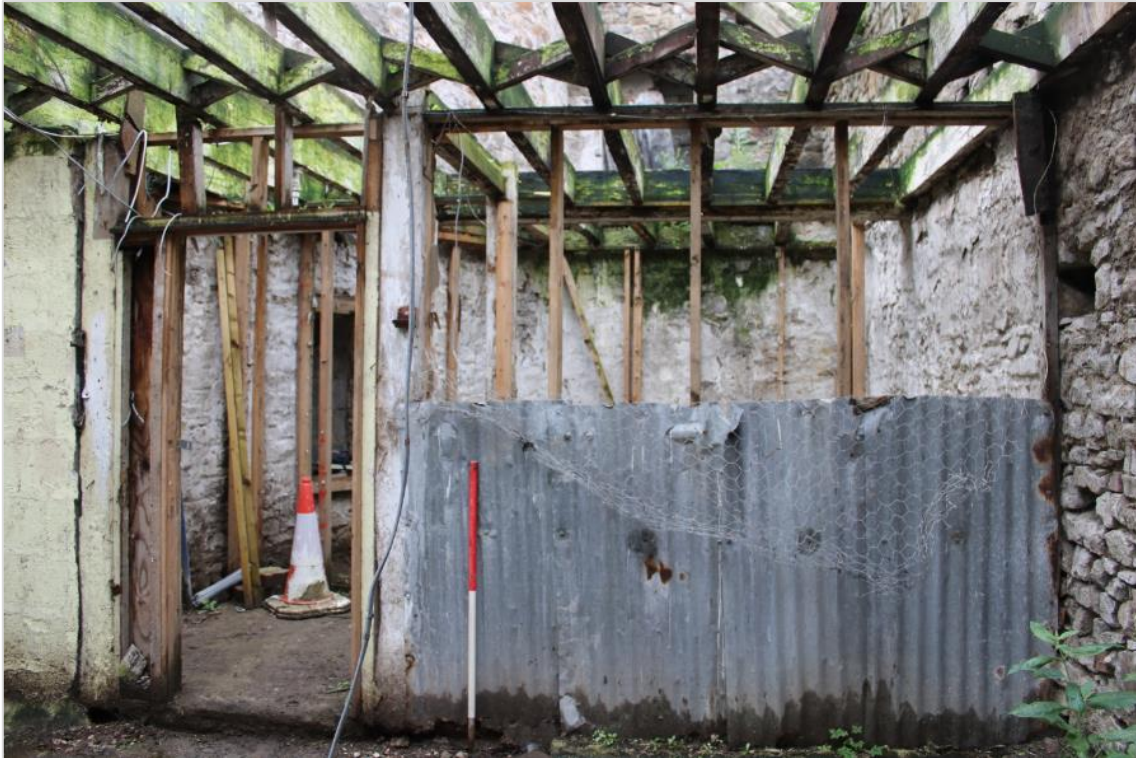
**Photo 15:** Section of partitioning timber studwork half covered in iron corrugated sheets (scale 1x1m).

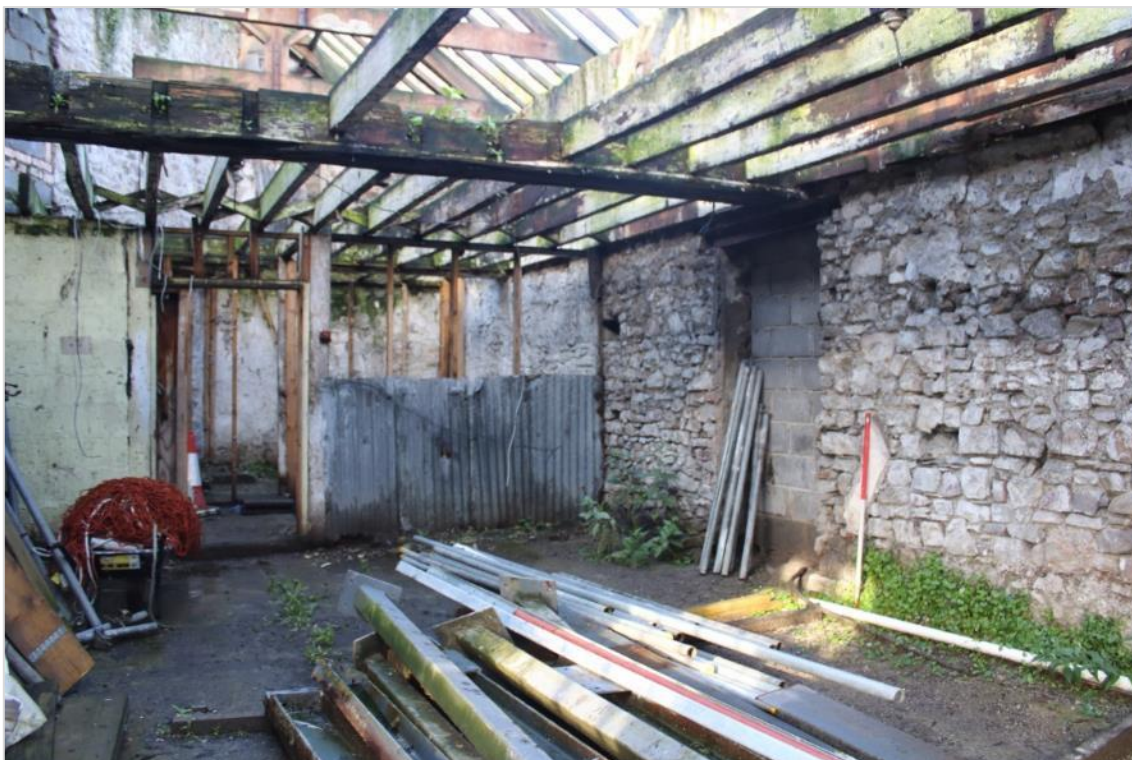
4.2.3 The northeast room is the largest (Photo 16). The walls are made of stone with evidence for remodelling over time (Photo 17). A mixture of brick, breeze block and like-for-like stone has been used. The original mortar is light grey in colour and contains frequent small stones, pieces of wood, possible ash deposits and other organic materials. Later mortar contains fewer organic materials and is a mixture of cement and sand. There is evidence for plaster on all walls, the greatest quantity on the northwest wall (Photo 18). The floor consists of an in situ concrete slab. A couple of metres from the southeast wall is a recessed strip (Photo 19). It was partially covered by construction equipment during the survey however, an earlier report '*Western Quayside Redevelopment – St Mary's Foundry Structural Condition and Approach to Repair Report 2021*' by Mann Williams, identifies this recess and describes it running northeast- southwest, the entire length of the room. Its use is unknown, but it is highly likely connected to the foundry.

**Photo 16:** West facing photo of main room. Different phases of construction and types of material used can be seen (scale 1x1m).

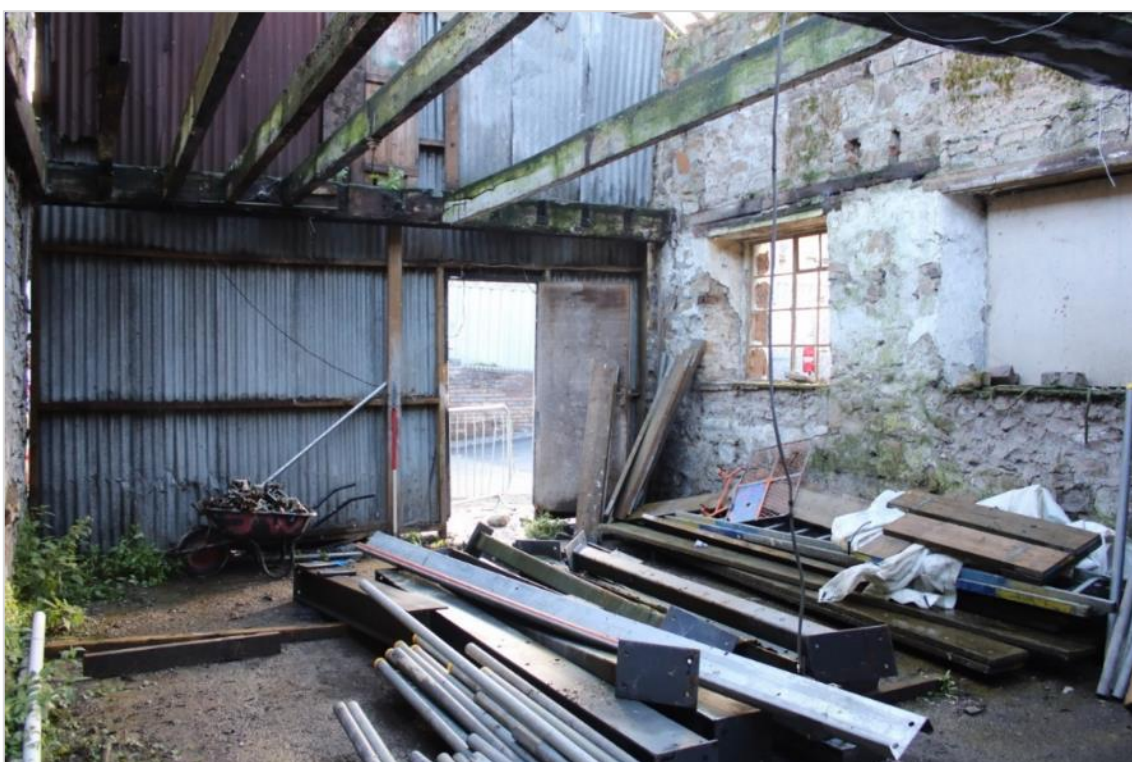
**Photo 17:** East facing photo of main room. Different phases of construction and types of material used can be seen (scale 1x1m).

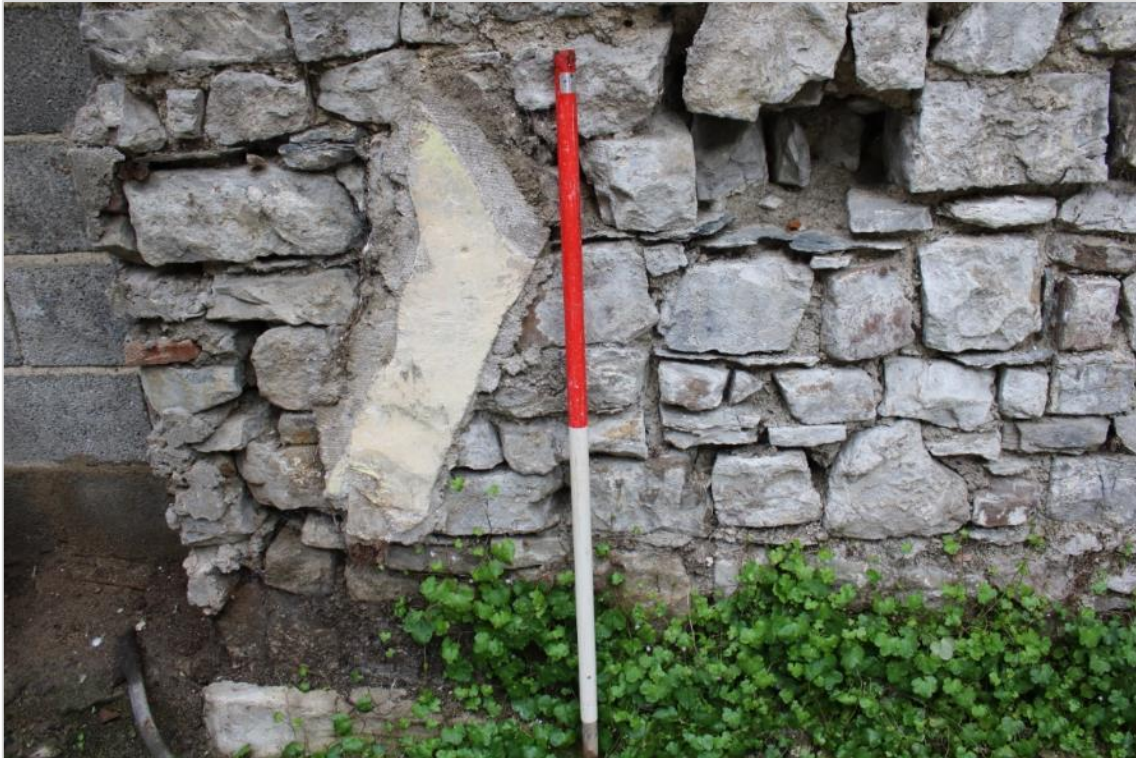
**Photo 18** Large section of plaster on northwest wall (scale 1x1m).

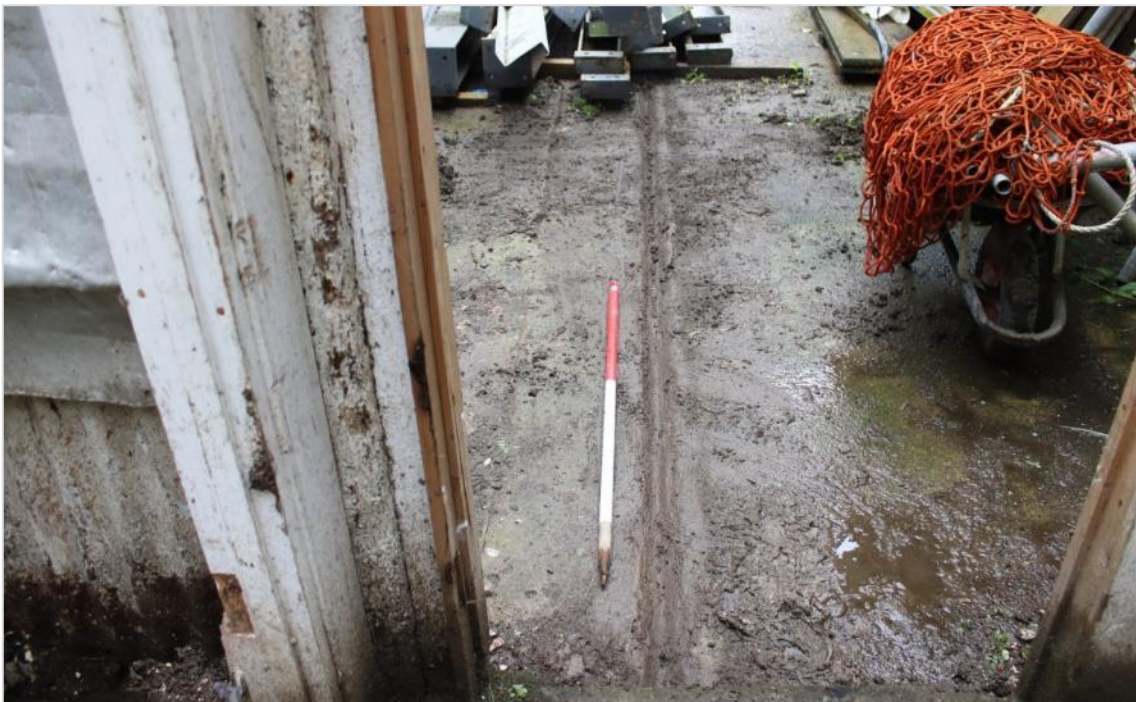
**Photo 19:** Northeast view of recess in main room. Construction equipment obscures the extent of this feature (scale 1x1m).

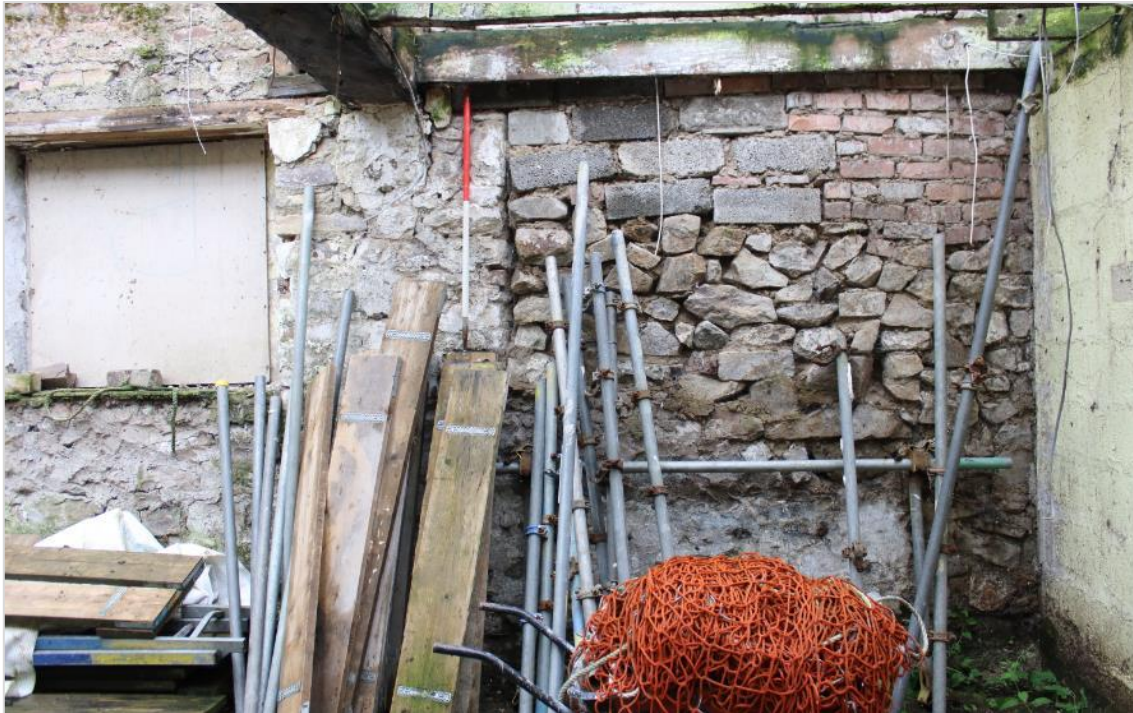
alterations were not contemporary. A clear divide between the original and new walling can be seen (Photo 20). The alterations are visible externally but are not as clear, and are described in Section 4.1.3, Photo 3. Externally, the breeze block and brick have been faced with stone, in keeping with the original stonework. Why this area was remodelled is unclear.

**Photo 20:** Southern section of southeast wall. Evidence of alterations using brick, stone and breeze block. A clear divide between the original stonework and new can be seen (scale 1x1m).

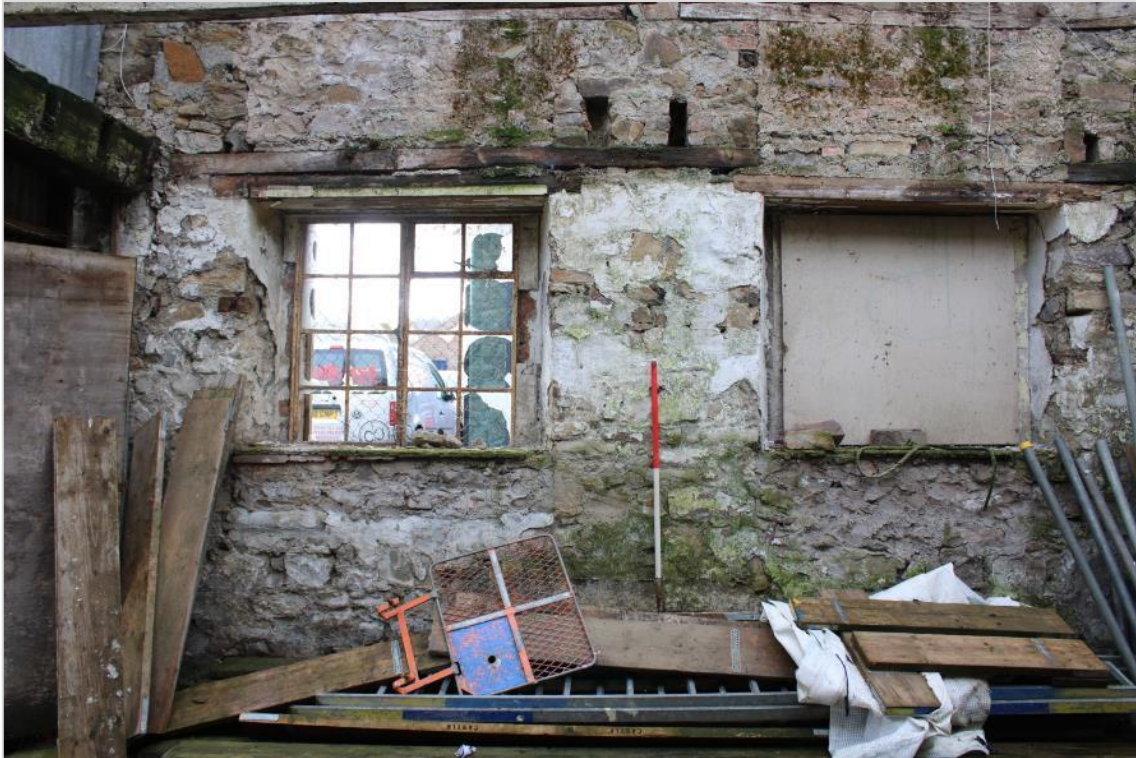
- 4.2.5 Located on the southeast wall are two windows (Photos 21 and 22). One remains open, the other is boarded. These can be seen externally and are described in Section 4.1.6, Photo 6. The windows are of the same size and design. They are set back creating a deep concrete sill, their width tapering from the interior of the building to the exterior and they have timber lintels. The open window has an additional concrete lintel.

**Photo 21:** Windows located on the southeast wall (scale 1x1m).

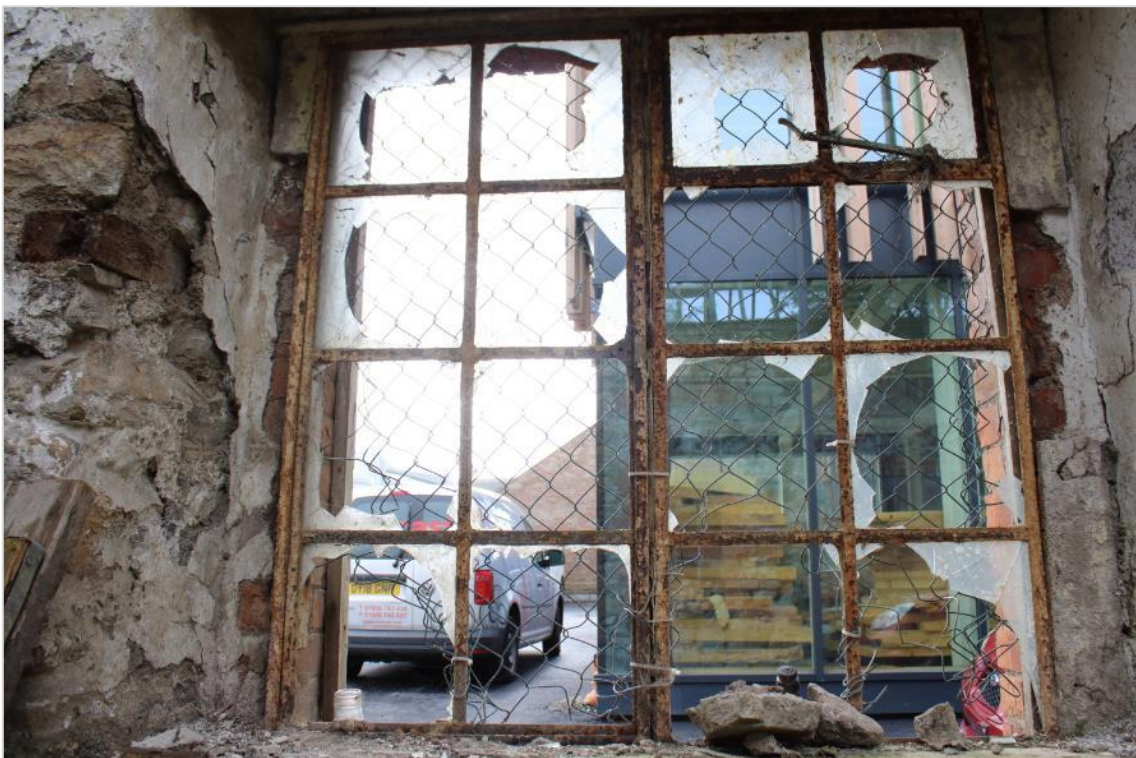
**Photo 22:** Open window on southeast wall; metal with modern wire. Glass is still intact.

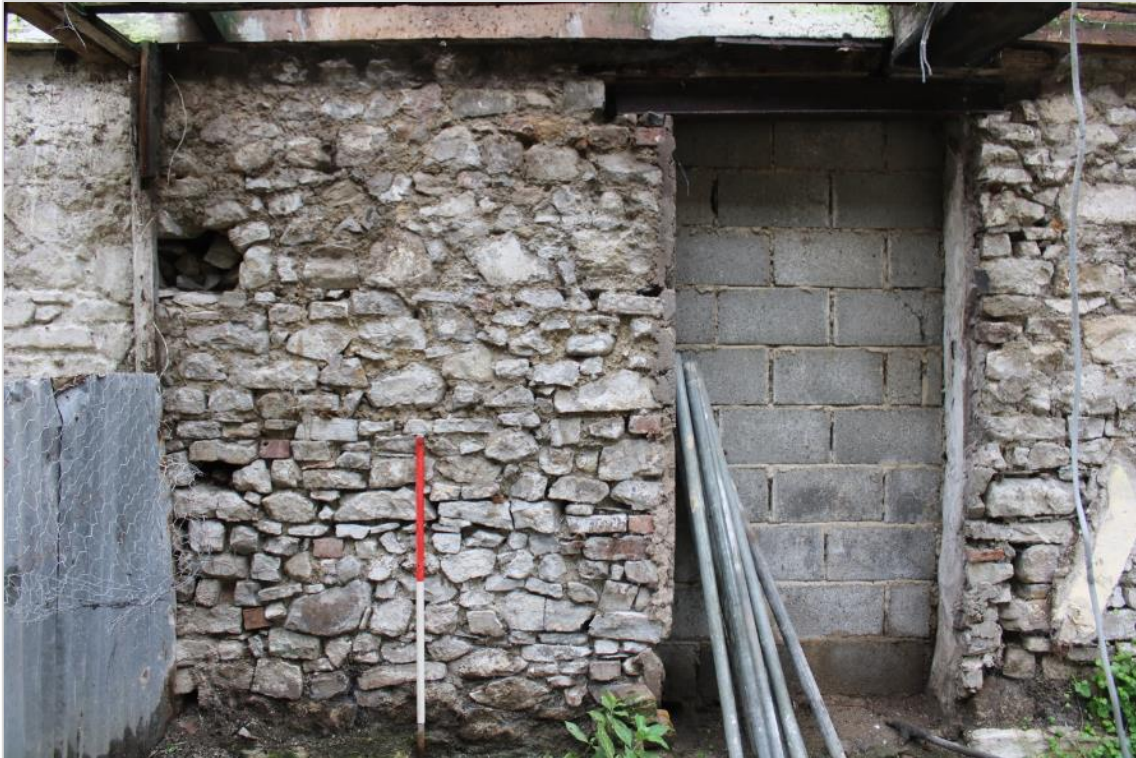
4.2.6 Remodelling and repair of the building also occurred on the northwest wall. As seen elsewhere in the room, brick, breeze block and stone has been used. Along this wall, there is evidence of damage with stones missing (Photo 23). In the wall there

are metal objects such as nails which may be linked to the building's use as a foundry.

**Photo 23:** Western section of northwest wall. Stonework shows evidence for remodelling. Damage can be seen by missing stones and door has been infilled with breeze block (scale 1x1m).

- 4.2.7 The northwest wall has a single door which has been blocked with breeze block (Photo 23). There is a steel lintel above the door and the interior of the doorframe has been covered in a mixture of cement and plaster. This door can be seen externally and is described in Section 4.1.8, Photo 11.
- 4.2.8 Breeze block and a layer of brick was used to infill a window on the northern side of the northwest wall (Photo 24). The brick may have been used to fill in the top gap which is too narrow for a breeze block. At the bottom of the window there is a concrete sill. This window can be seen externally and is described in Section 4.1.9, Photo 13. Externally, the breeze block has been faced with stone to look like the external wall and has a brick arch which is not seen on the inside.

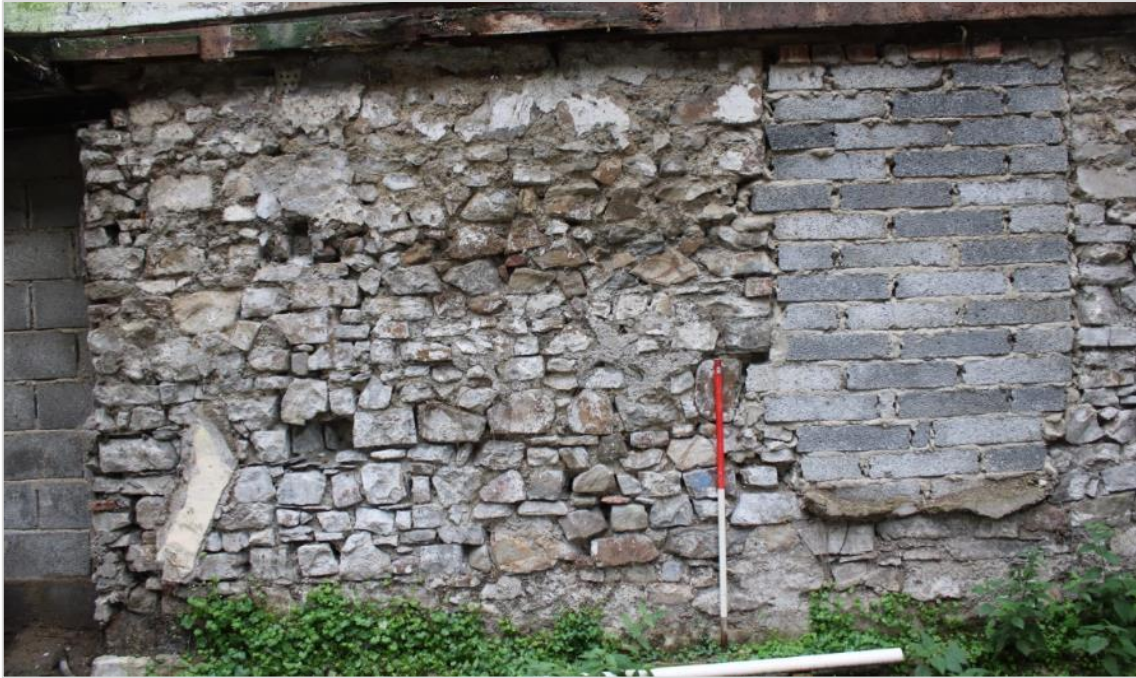
**Photo 24:** Northern section of the northwest wall with evidence of plaster, damage and a window infilled with breeze block (scale 1x1m).
