# **WESTERN QUAYSIDE WAREHOUSE, HAVERFORDWEST, PEMBROKESHIRE**

## **HISTORIC BUILDING RECORDING**

### **LEVEL 2**

REPORT NO. 2023-30  
EVENT PRN. 129908

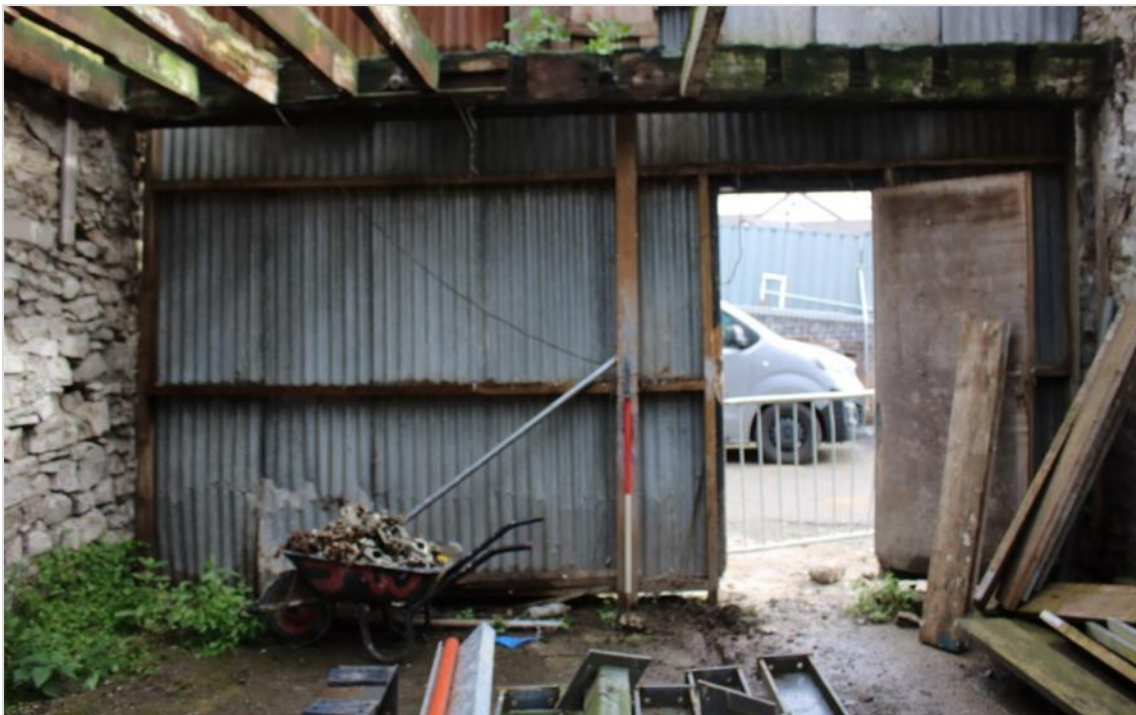
- 4.2.9 The northeast wall is a timber stud frame with iron corrugated sheets (Photo 25). This replaces an earlier masonry wall as seen in historic documents from the late 19<sup>th</sup> century. A single door is located to the east, and this has a timber frame.

**Photo 25:** Interior northeast wall (scale 1x1m).

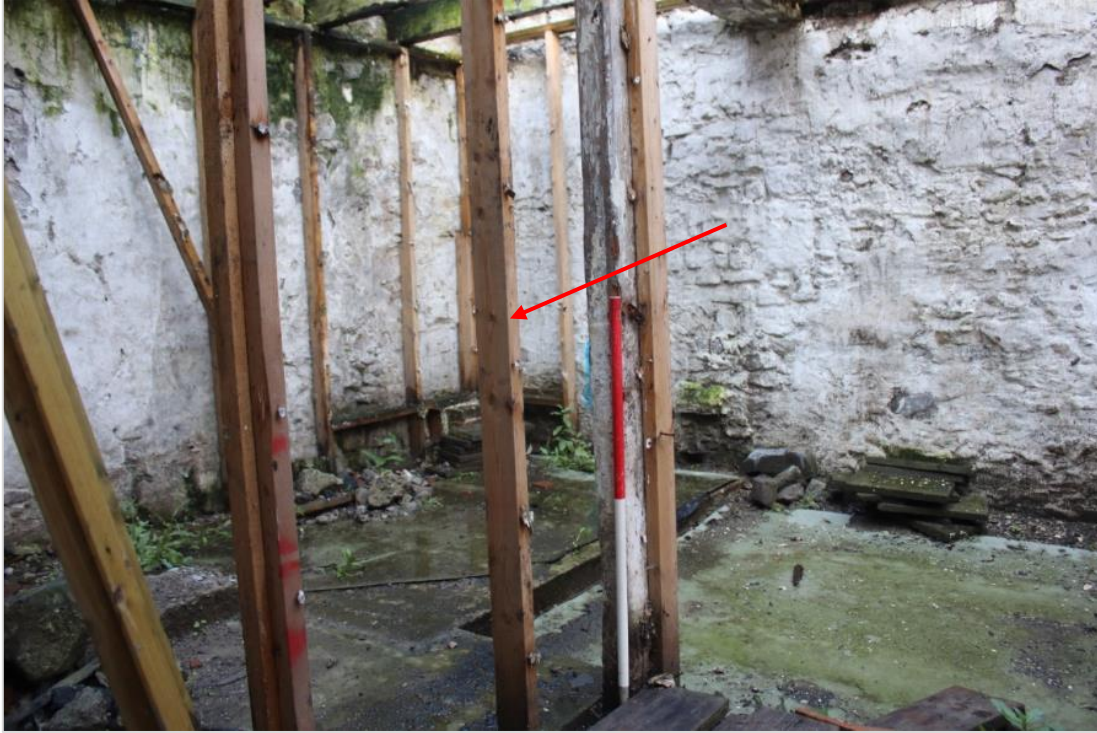
- 4.2.10 The smaller room to the southwest of the building has stone walls with evidence of remodelling, repair and the use of plaster/limewash. Brick, breeze block and stone have been used for the alterations with a cement and sand mortar. The original

mortar is a light grey colour and contains small stones, charcoal, wood and other organic material. The southern wall tapers resulting in the southwest wall being 3m wide. Timber studwork is found around the room including a timber studwork wall that comes out from the southeast wall, dividing the room into three zones (Photo 26). These zones are further defined by the floor (an in situ concrete slab) being at three different heights.

**Photo 26:** Western view of small room, divided by a timber stud wall (red arrow), the result enhanced by the in situ concrete slab being at different heights (scale 1x1m).

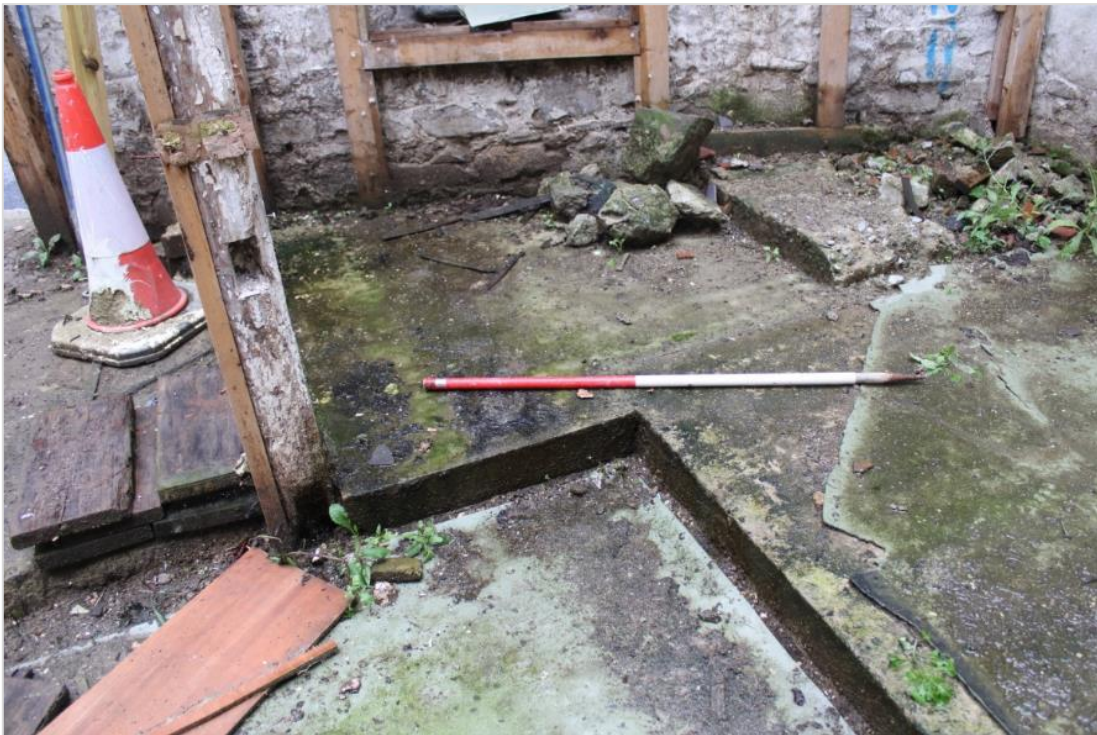
**Photo 27:** Southern view of small room showing the different levels of flooring (scale 1x1m).

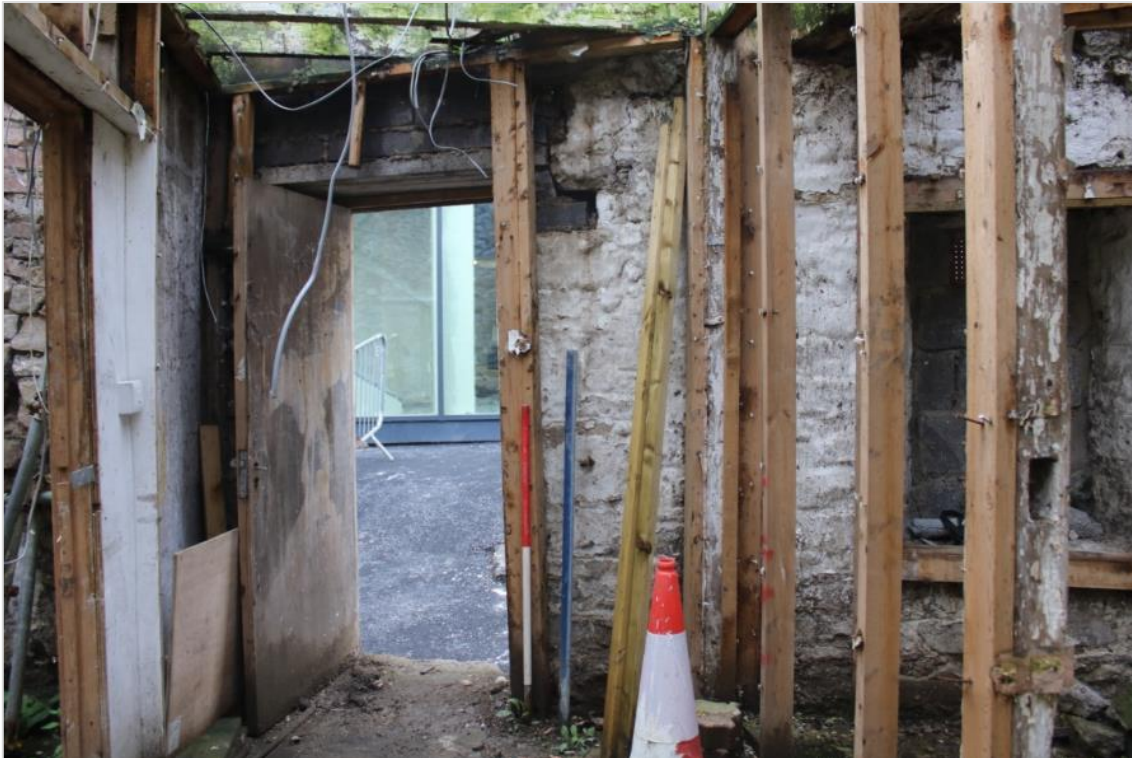
- 4.2.11 There is one door that leads outside, and it is still in use (Photo 28). There is a wooden lintel, but a concrete support has been added. Breeze block has also been added above the door, this is not seen externally. The door is described in 4.1.5, Photo 5.

**Photo 28:** The only door in the small room which leads outside (scale 1x1m).

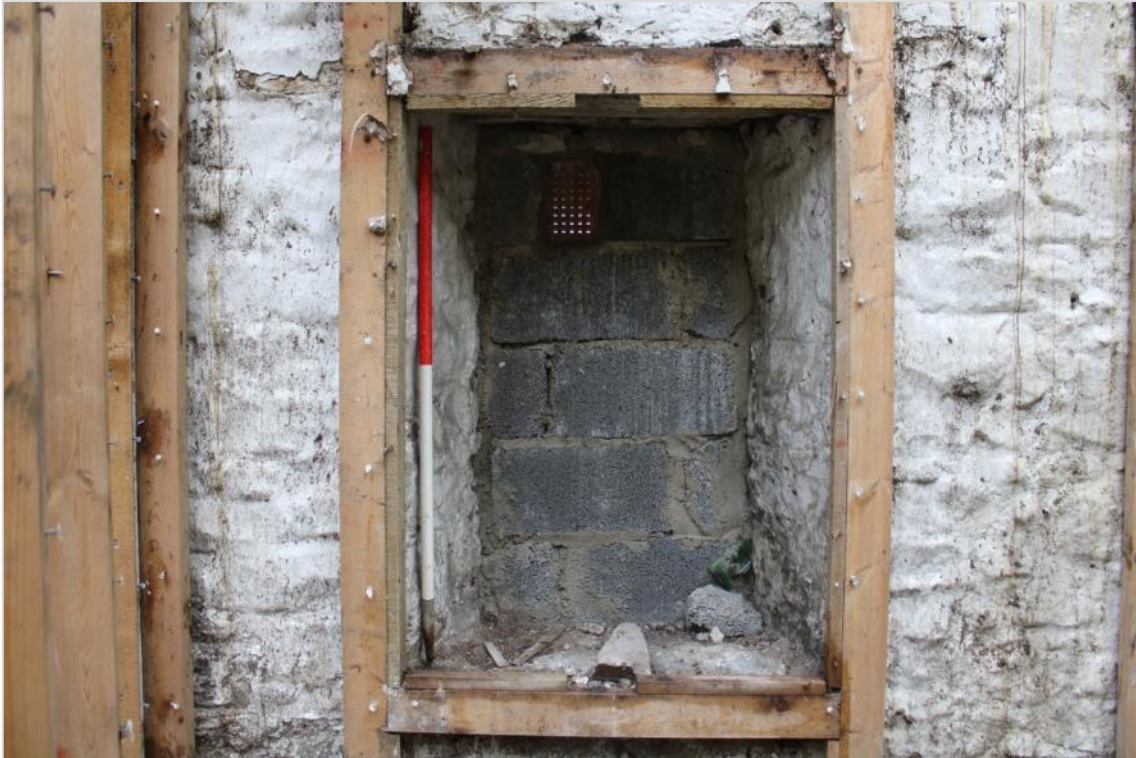
- 4.2.12 The room has a single window on the southern wall (Photo 29). It is blocked with breeze block and has a brick air vent. The window is set back into the wall creating a deep concrete sill. From the interior to the exterior, the window narrows. Around the window is limewash and to the west, a piece of metal protrudes from the wall (Photo 30) which may be linked to the foundry. This window can be seen externally and is discussed in Section 4.1.6, Photo 5.

**Photo 29:** Window in the small room. Sides taper in. Breeze block infill and brick air vent (scale 1x1m).

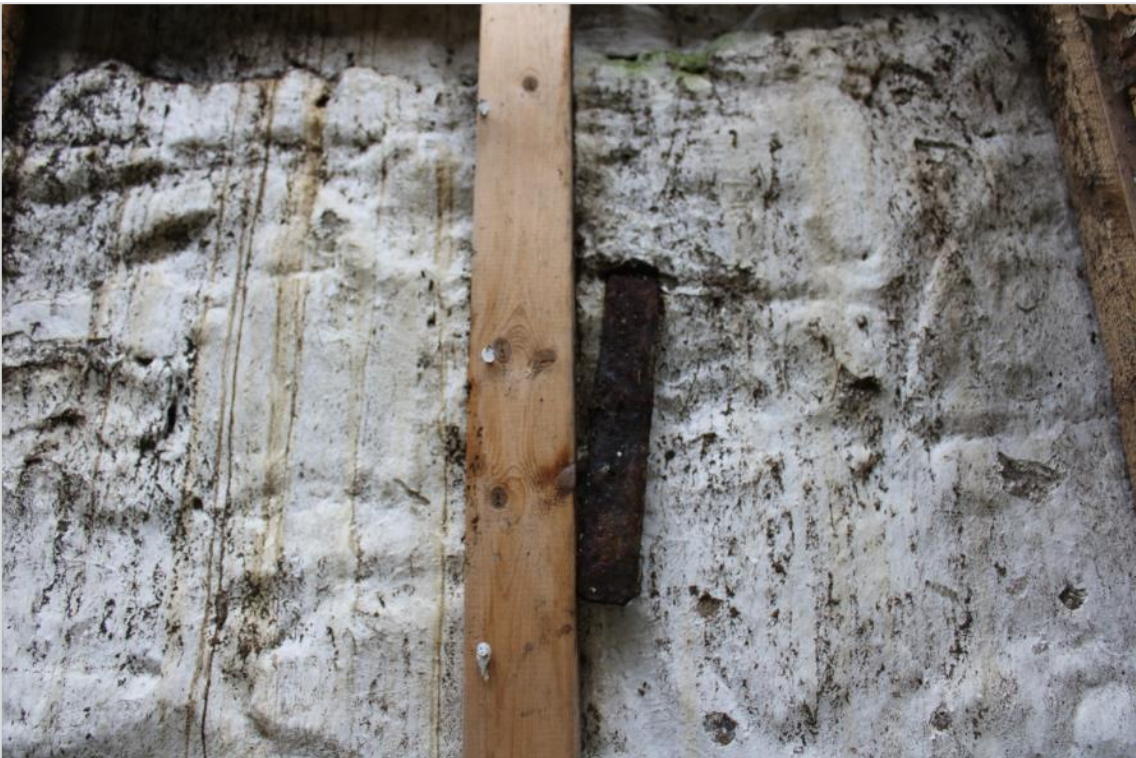
**Photo 30:** Metal within the southern wall to the west of the window.

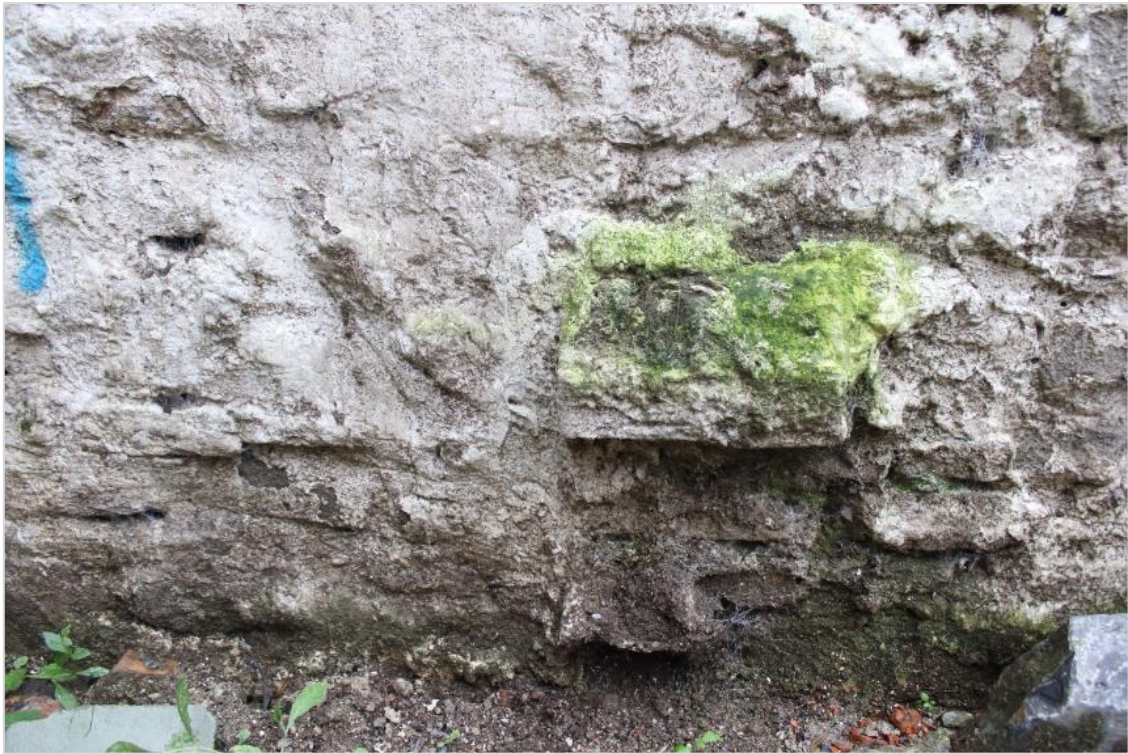
4.2.13 The southwest and northwest walls are covered in limewash. They contain no features, just evidence for alteration and repair in the past. There is a single stone which protrudes out of the northwest wall (Photo 31). Arguably, this may have been deliberate and had a function.

**Photo 31:** Stone protruding from northwest wall.

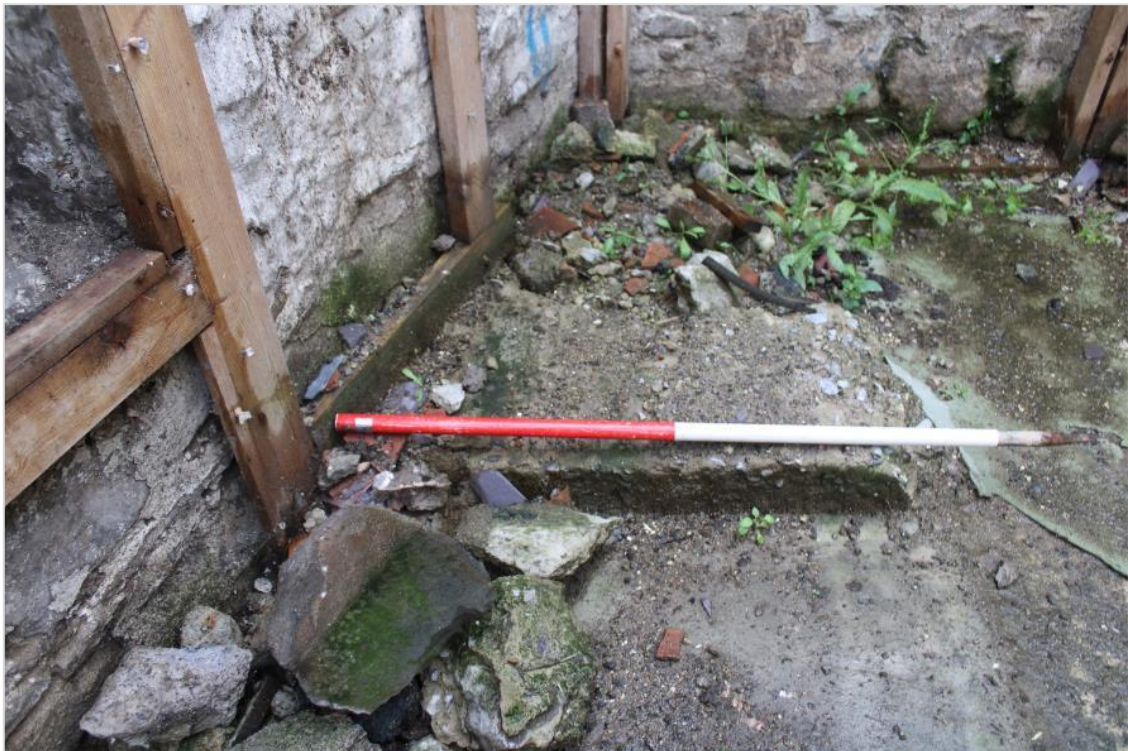
4.2.14 There are possibly the remains of two earlier walls in the room. One consists of concrete and comes off the southern wall (Photo 32). It measures 0.79m long, 0.42m wide and has a depth of 0.11m. In the western corner of the southwest wall, the stone wall has been replaced with bricks and in front of this is a brick pillar measuring 0.41m long and 0.26m deep (Photo 33).

**Photo 32:** Possible remains of an earlier concrete wall coming out from the southern wall (scale 1x1m).

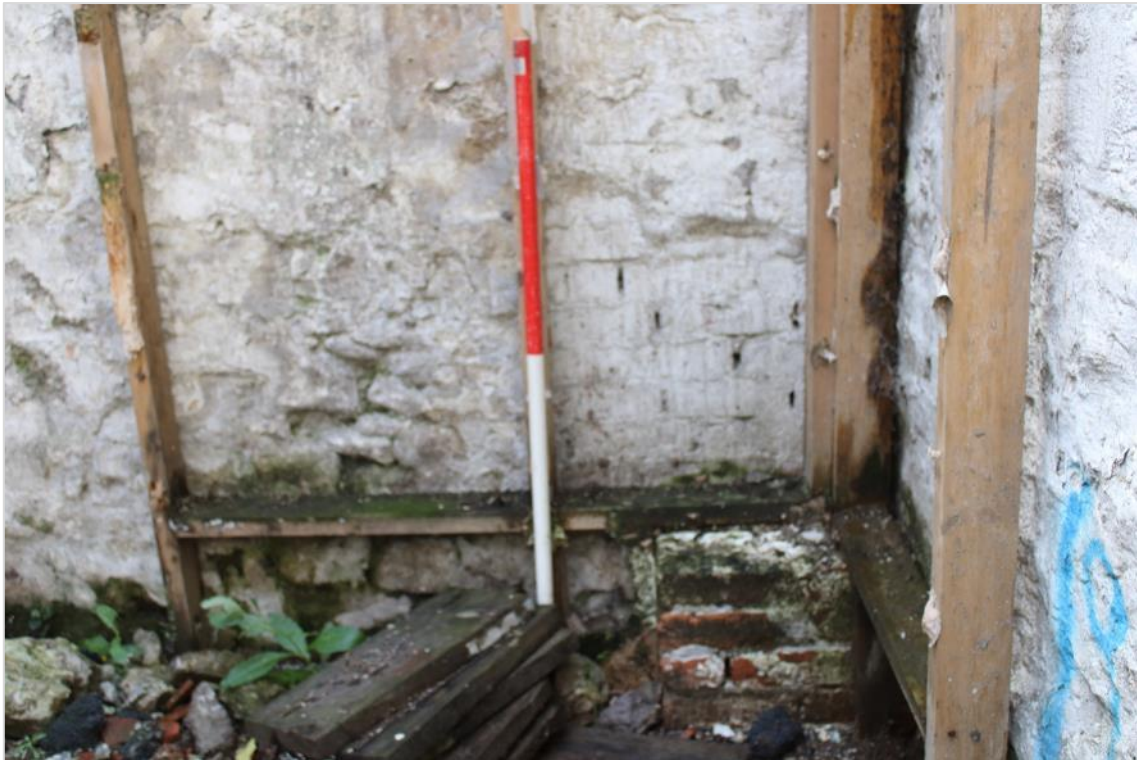
**Photo 33:** Possible remains of an earlier brick wall coming from the southwest wall (scale 1x1m).

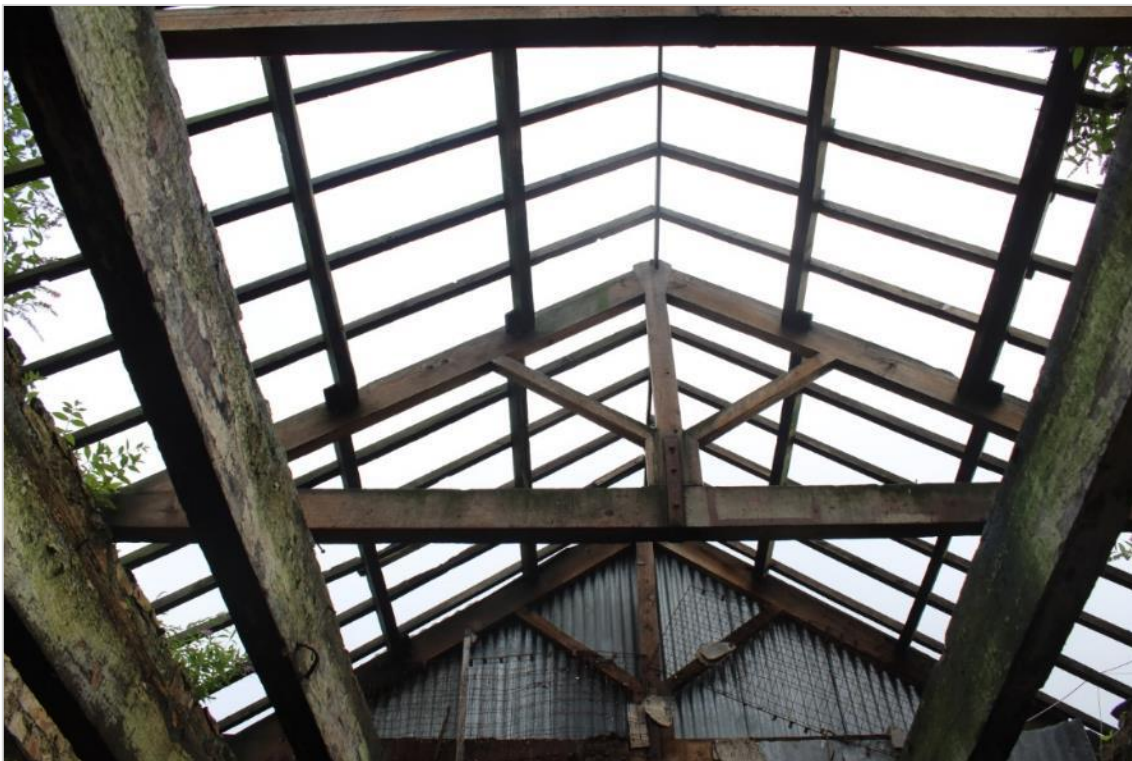
- 4.3.1 The first floor is a singular room and was not accessible when the survey was completed, so information on the upper floor and roof was collected from the ground. Earlier reports on the warehouse provide greater detail on the first floor as it was then accessible and in a better condition. The reports include Williams 'Western Quayside Redevelopment - St Mary's Foundry: Structural Condition and Approach to Repair Report 2021' and Atkins 'Haverfordwest Footbridge and Western Quayside Phase 2 - Former Cleddau Foundry Building Structural Approach 2023'.
- 4.3.2 When this survey was carried out, the first floor and ceiling was missing, revealing the roof trusses and joists which consist of softwood timber. There are six king post trusses which support a duo pitch roof (Photo 34). Where the southern wall tapers, the roof truss has been cut short and built into the wall (Photo 35).

**Photo 34:** King post trusses supporting a duo pitch roof.

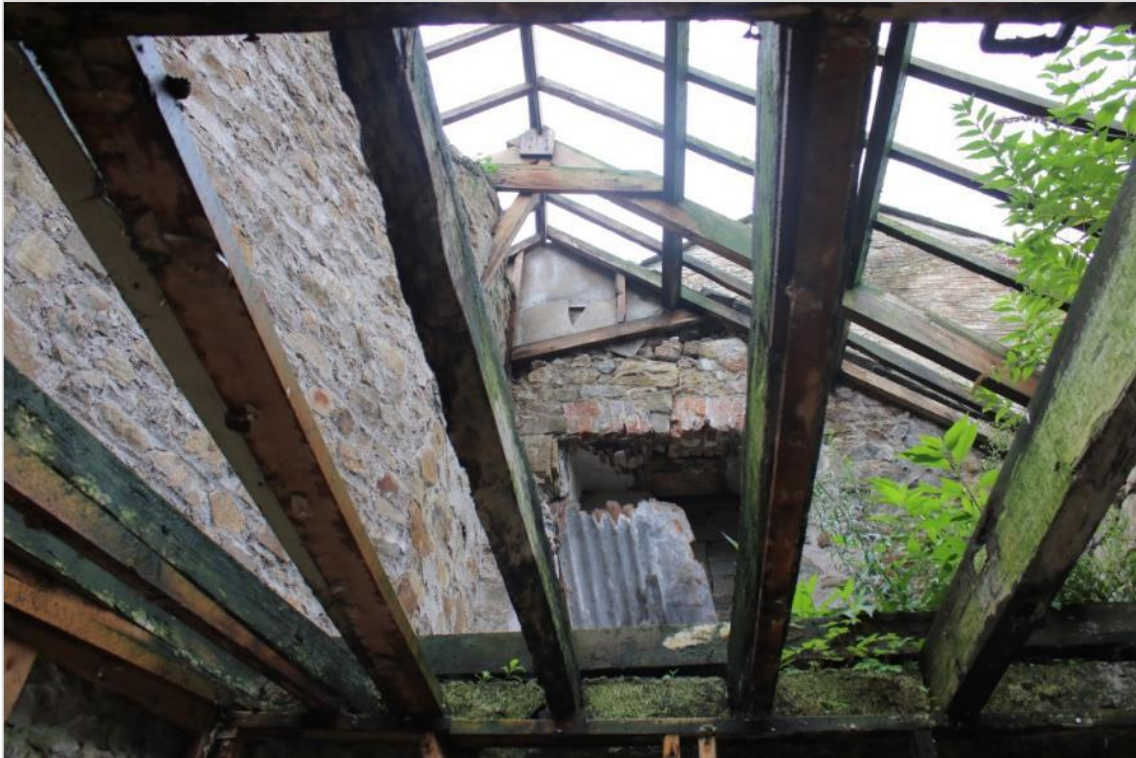
**Photo 35:** Tapered southern wall. Truss has been cut and built into stone wall.

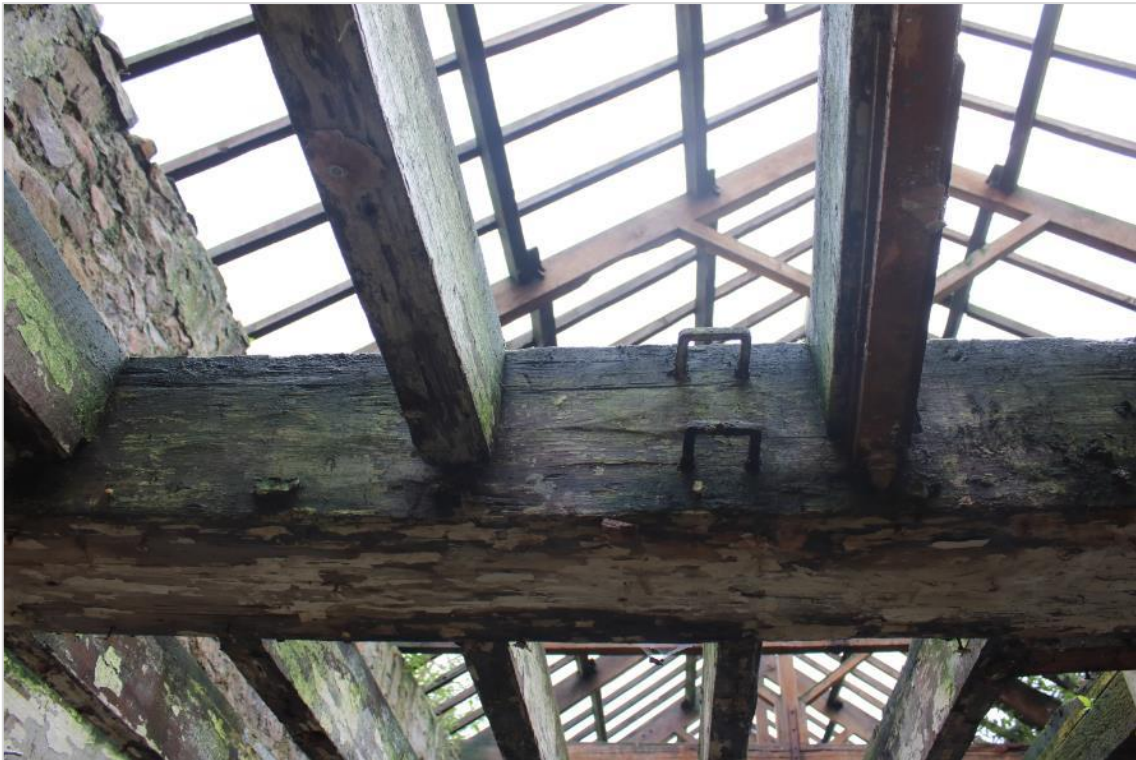
- 4.3.3 Along the building, there are metal objects attached to the roof trusses and joists, possibly linked to the building's use as a foundry (Photo 36). At the centre of the building running perpendicular to the joists are wooden herringbone struts (Photo 37). On the northwest and southeast walls, pockets in the masonry can be seen above the first floor (Photo 38). This suggests there was an earlier floor which was higher than the current level and the joists ran in the opposite direction to the present ones.

**Photo 36:** Example of metal work in the timber for the roof and floors, possibly relating to the foundry.

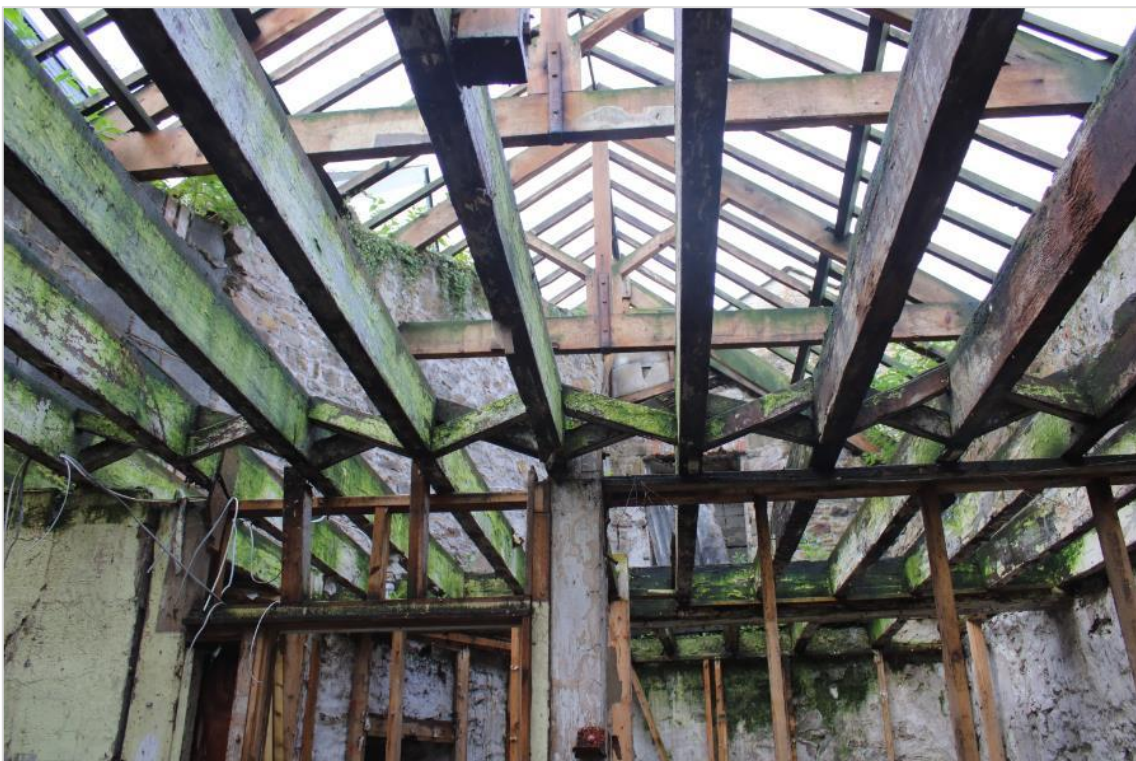
**Photo 37:** Herringbone struts.

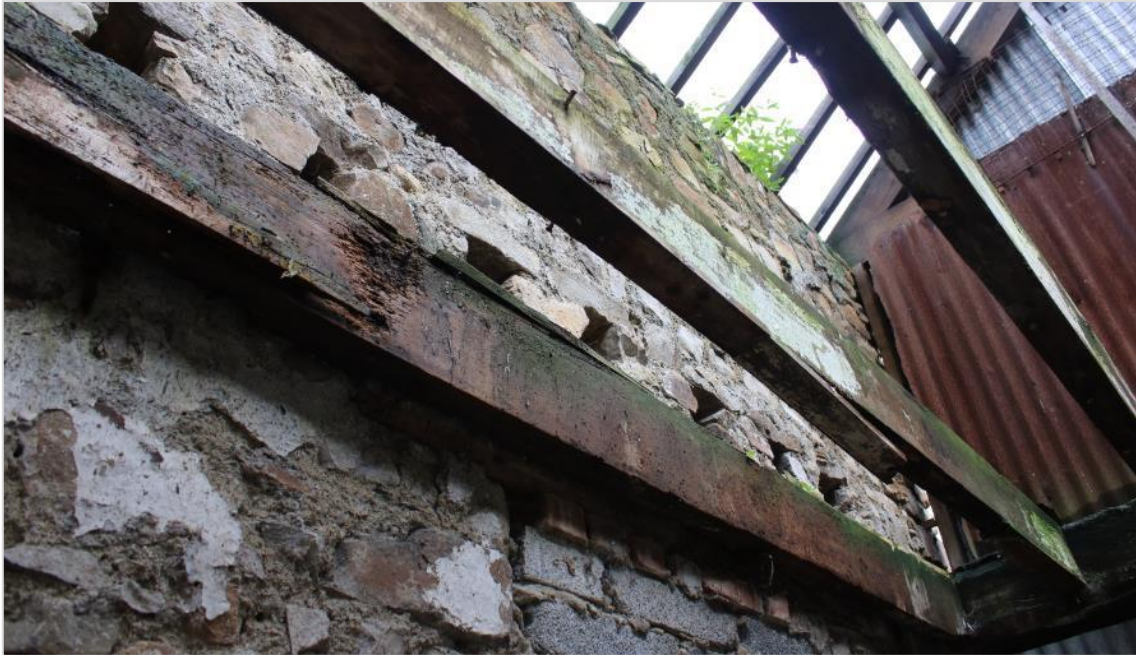
**Photo 38:** Sockets on the southeast and northwest walls. Evidence for an earlier floor level and different joist direction.

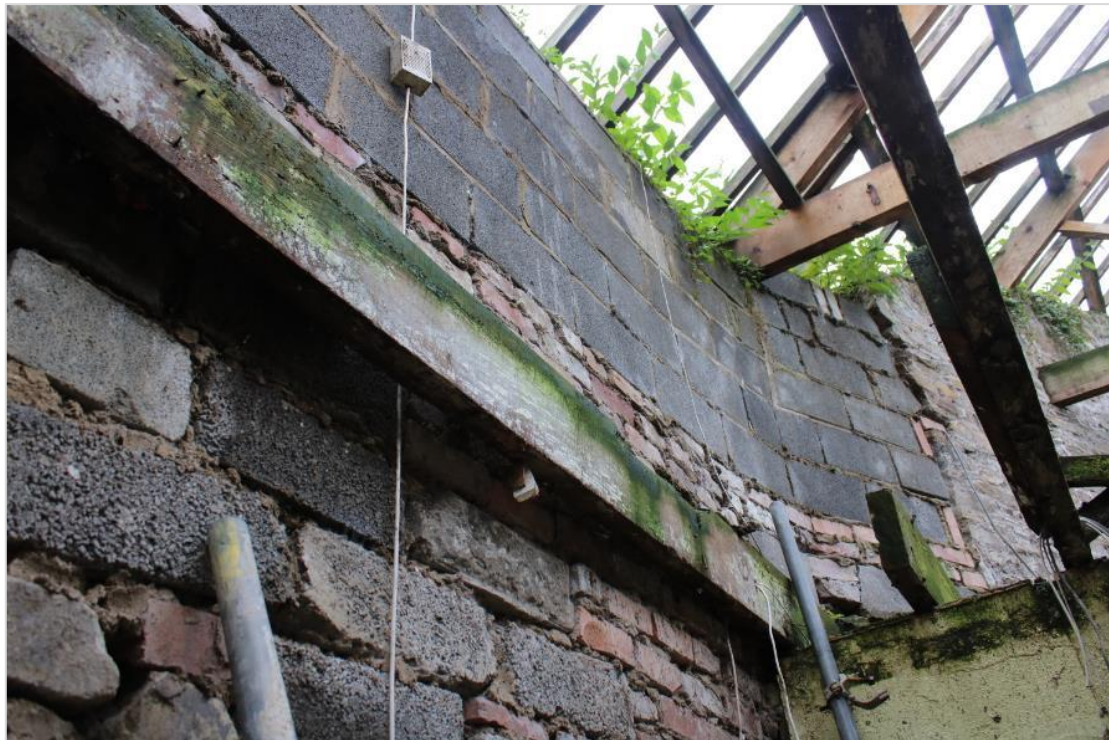
- 4.3.4 All the walls consist of stone and show evidence for plastering and alterations. As with the lower ground, breeze block, brick and stone were used for these later repairs and modifications. The southern section of the southeast wall is, in particular, a heavily remodelled area. As discussed in Section 4.2.4, Photo 20 the area covered the wall from the ground to the first floor. At first floor level, the material used for remodelling was breeze block and brick (Photo 39). The external aspects of the remodelling are described in Section 4.1.3, Photo 3.

**Photo 39:** Southern section of southeast wall and part of the southern wall. At first floor level, breeze block and brick were used.

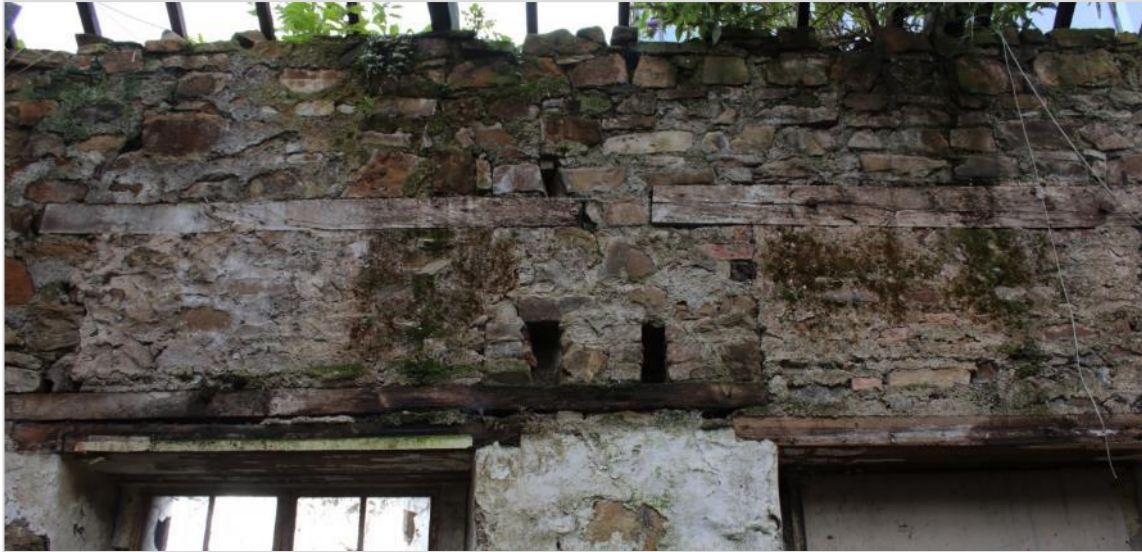
- 4.3.5 The southeast wall shows the most changes. Directly above the two current windows (one boarded) are two infilled windows, both with timber lintels and infilled with stone. Between them are pockets, possibly for beams for an earlier floor. (Photo 40). Above the open window is a piece of timber spanning beyond the window to the edge of the boarded window. It is unclear what this was for. Whilst it may have been a large lintel, it is not mirrored on the window to the south. Both of these windows can be seen externally and are discussed in Section 4.1.6, Photo 6. Notably, the window above the boarded window has a brick infill on the external side, whereas stone has been used on the interior. The reason for this is unclear.

**Photo 40:** Southeast wall infilled with stone. Pockets for timbers present and a long timber sits above the open window.

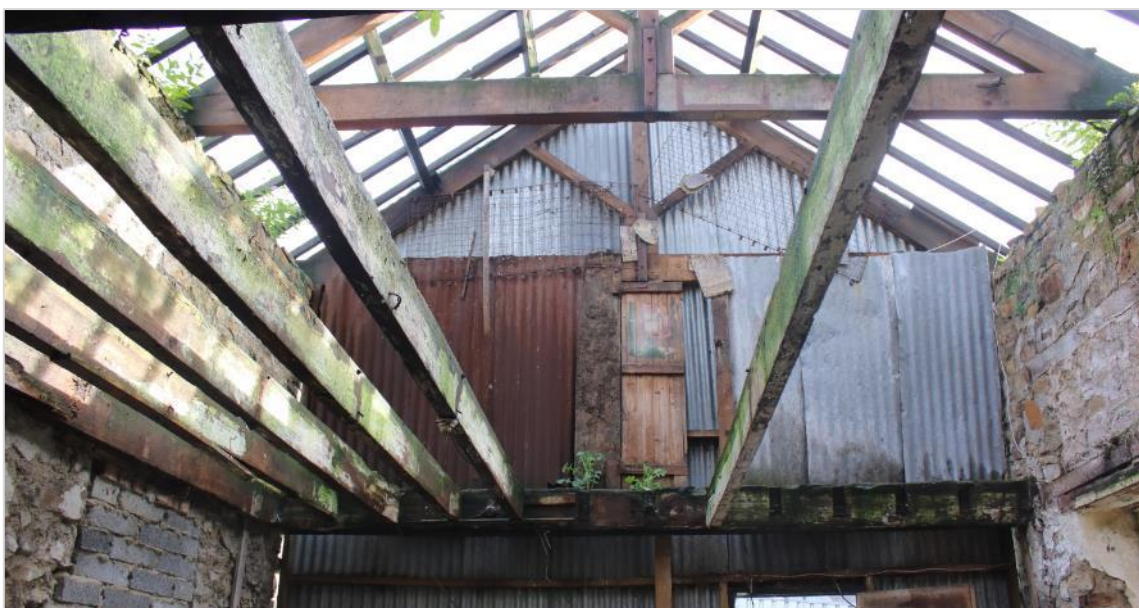
- 4.3.6 The northeast wall of the first floor is timber studwork covered in corrugated iron sheeting with evidence for an earlier, timber framed door in the centre of the wall (Photo 41).

**Photo 41:** First floor of northeast wall with earlier central door with a timber frame.

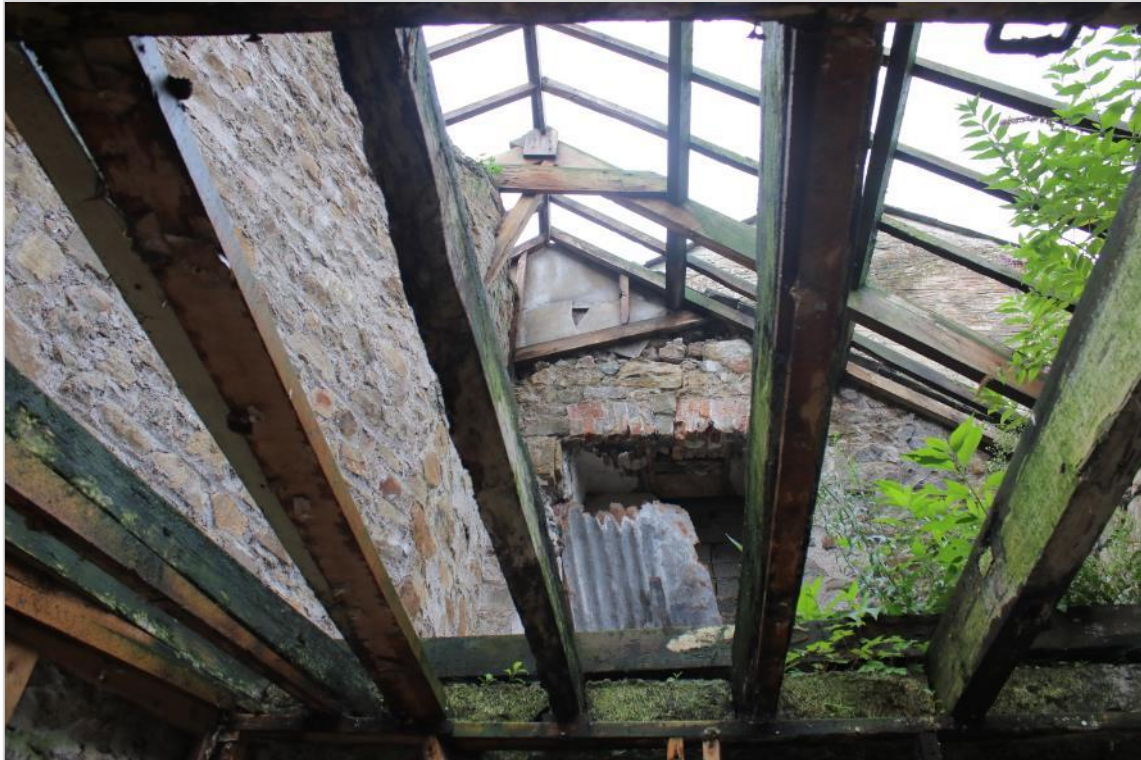
- 4.3.7 The southwest wall has a single stone doorway (Photo 42). There is a brick arch which on the underside has wooden slats which have been plastered over. The sides of the doorway have also been plastered. There are large stones above the brick arch and there is a stone design around the door frame. The door has been blocked with breeze block which can only be seen on the interior and a piece of corrugated iron sheet placed against the door.

**Photo 42:** Door in southwest wall. Brick arch with wooden slats underneath. Plaster around the door frame.
