**DYFED COASTAL PROMONTORY FORT  
ASSESSMENT 1993-1994  
D.A.T. P.R.N. 14798**

**March 1994**

**P. Crane BA (Hons)  
Dyfed Archaeological Trust Ltd.  
The Old Palace, Abergwili, Carmarthen,  
Dyfed SA31 2JR. Tel 0267 231667**

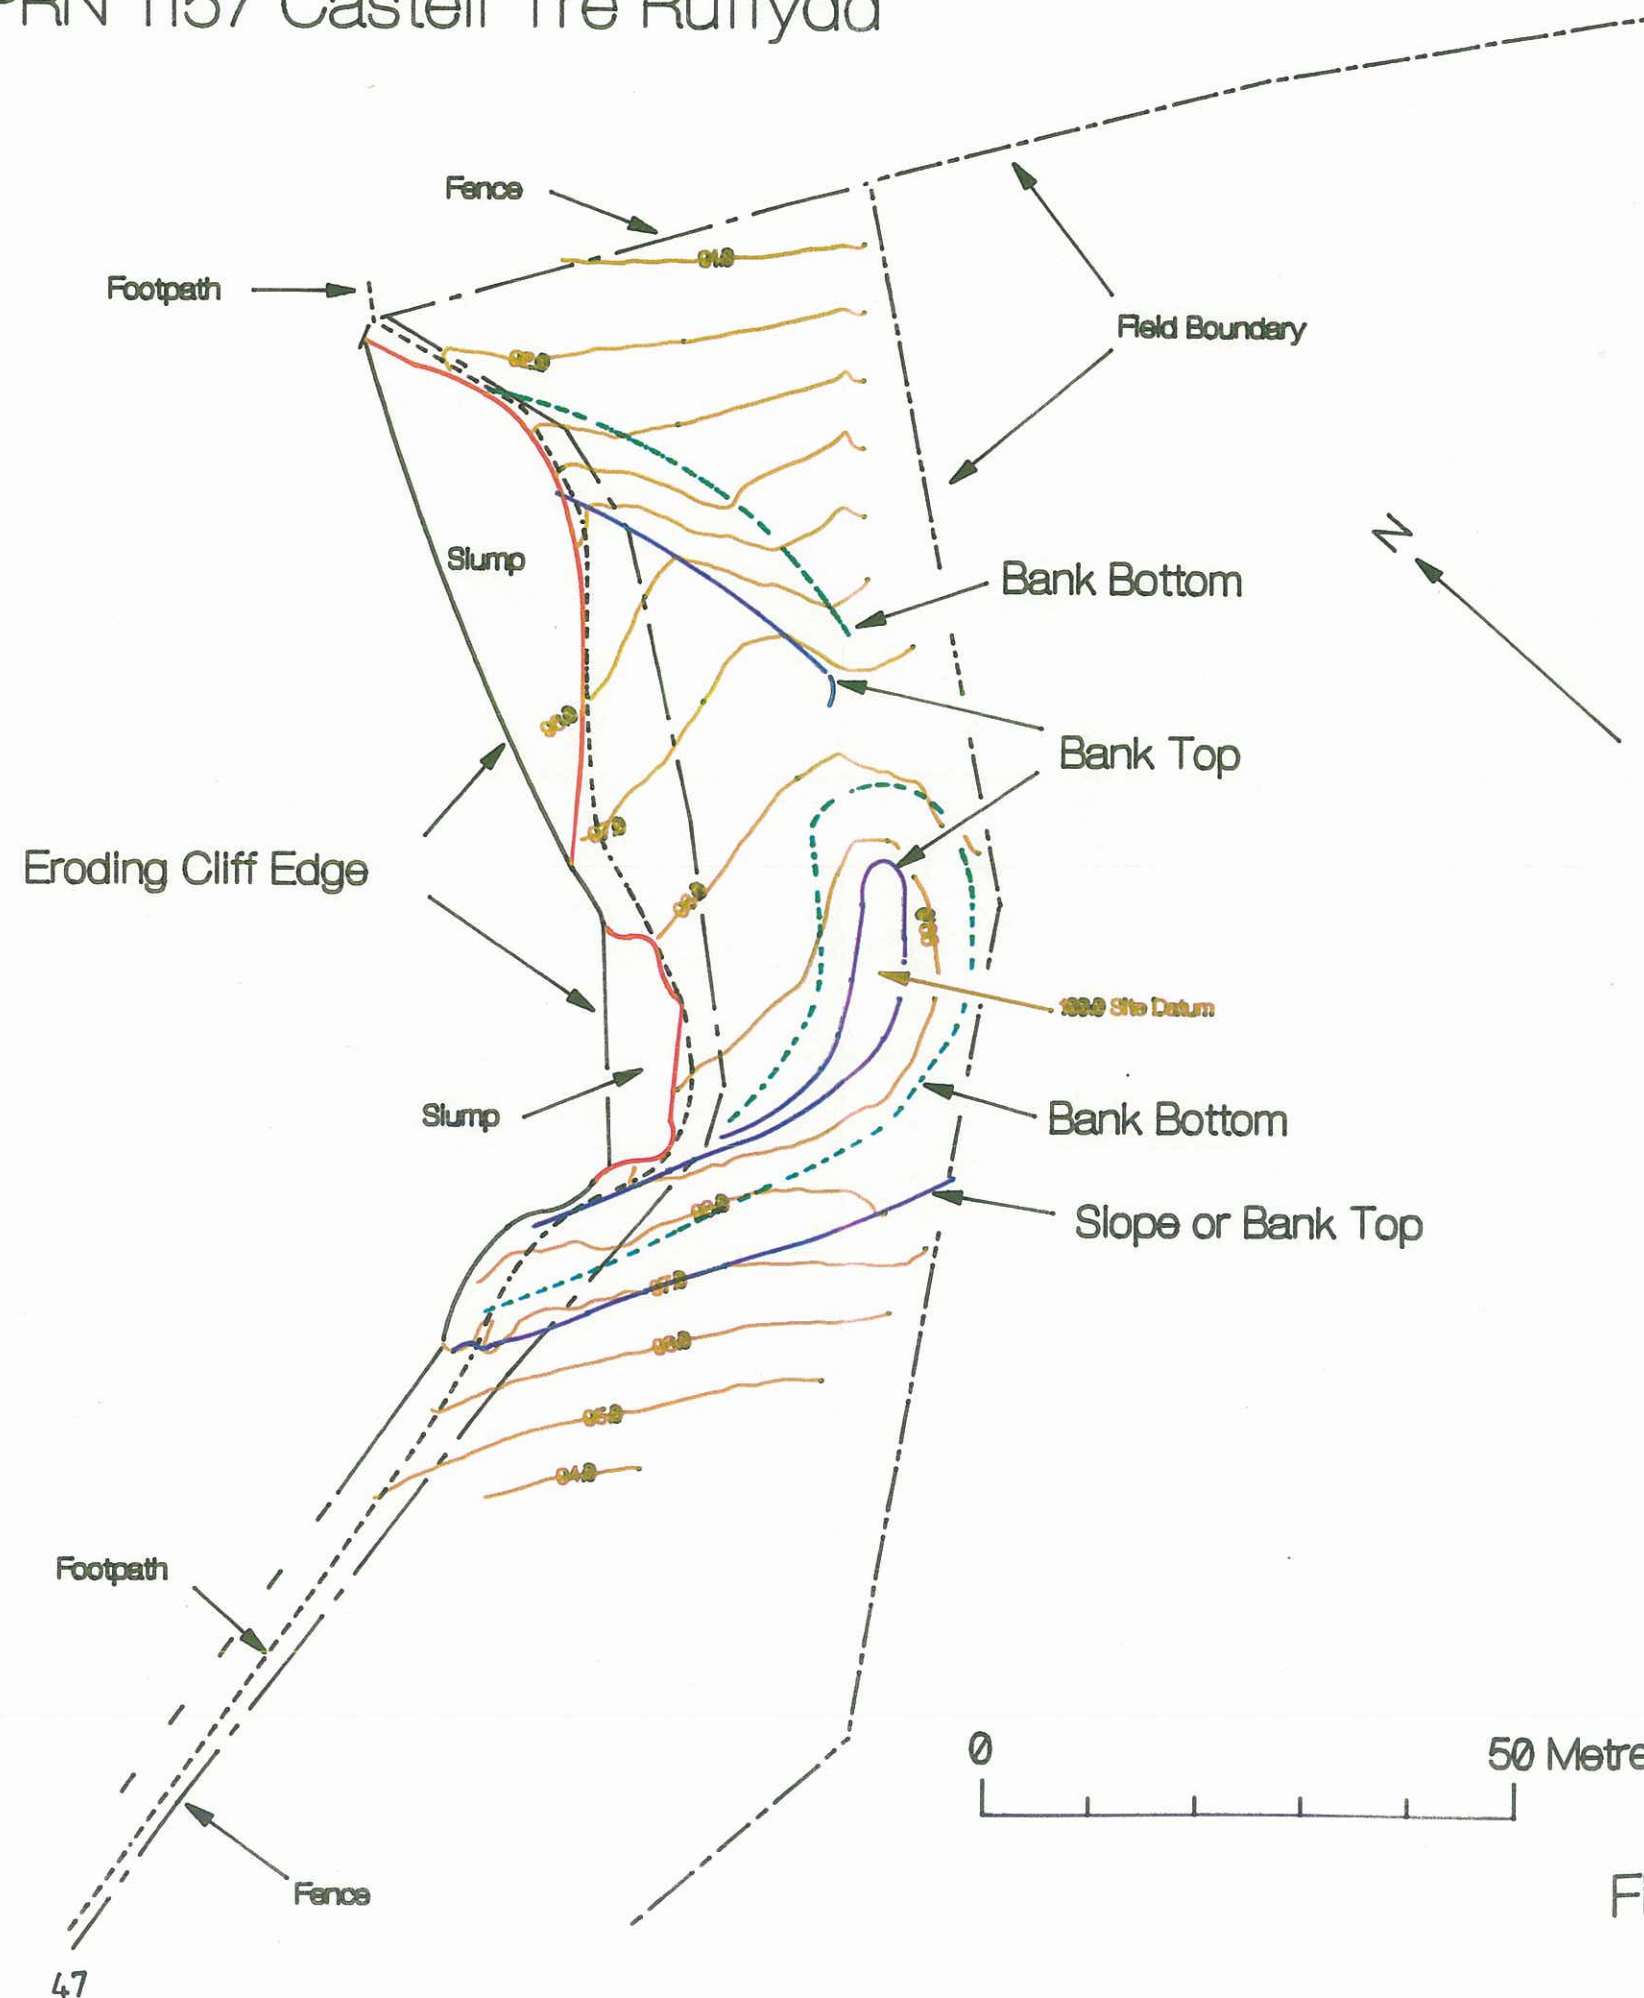
Figure 2

PRN 1157 Castell Tre Ruffydd (Map 2 and Figure 2), is probably in the most desperate condition of any of the promontory forts on the coast. Most of the promontory is no longer safely accessible. The defences and the area just inside is being rapidly eroded away, and this part is likely to disappear or become unsafe in the very near future.

Notes: Semi-circular defence. It was only practical to survey the defences and the area immediately inside them as access to the interior of this site was judged to be too perilous, so was not attempted. The most urgent of the sites seen, the whole of the interior of the site shows severe landslipping and mass wasting on the inside of the defences. The further part of the promontory was easily accessible into the 1960's, but there have been major landslides in the last 10 years. It is probable that the coast path is encouraging the cliff erosion, and as it will need to be moved inland in the future, it would be better to do so soon and route it inland of the defences.

One of the most urgent sites for action identified is PRN 1157 Castell Tre Ruffydd (Map 2 and Figure 2). The footpath needs re-routing. There needs to be an archaeological assessment up to a full scale excavation of the defences of the site and the area just inside them while it is still safe to undertake this.

Action on Erosion: Recommend re-route coast path and archaeo-

logically excavate defences and area just inside while it is still safe to do so! See notes below.

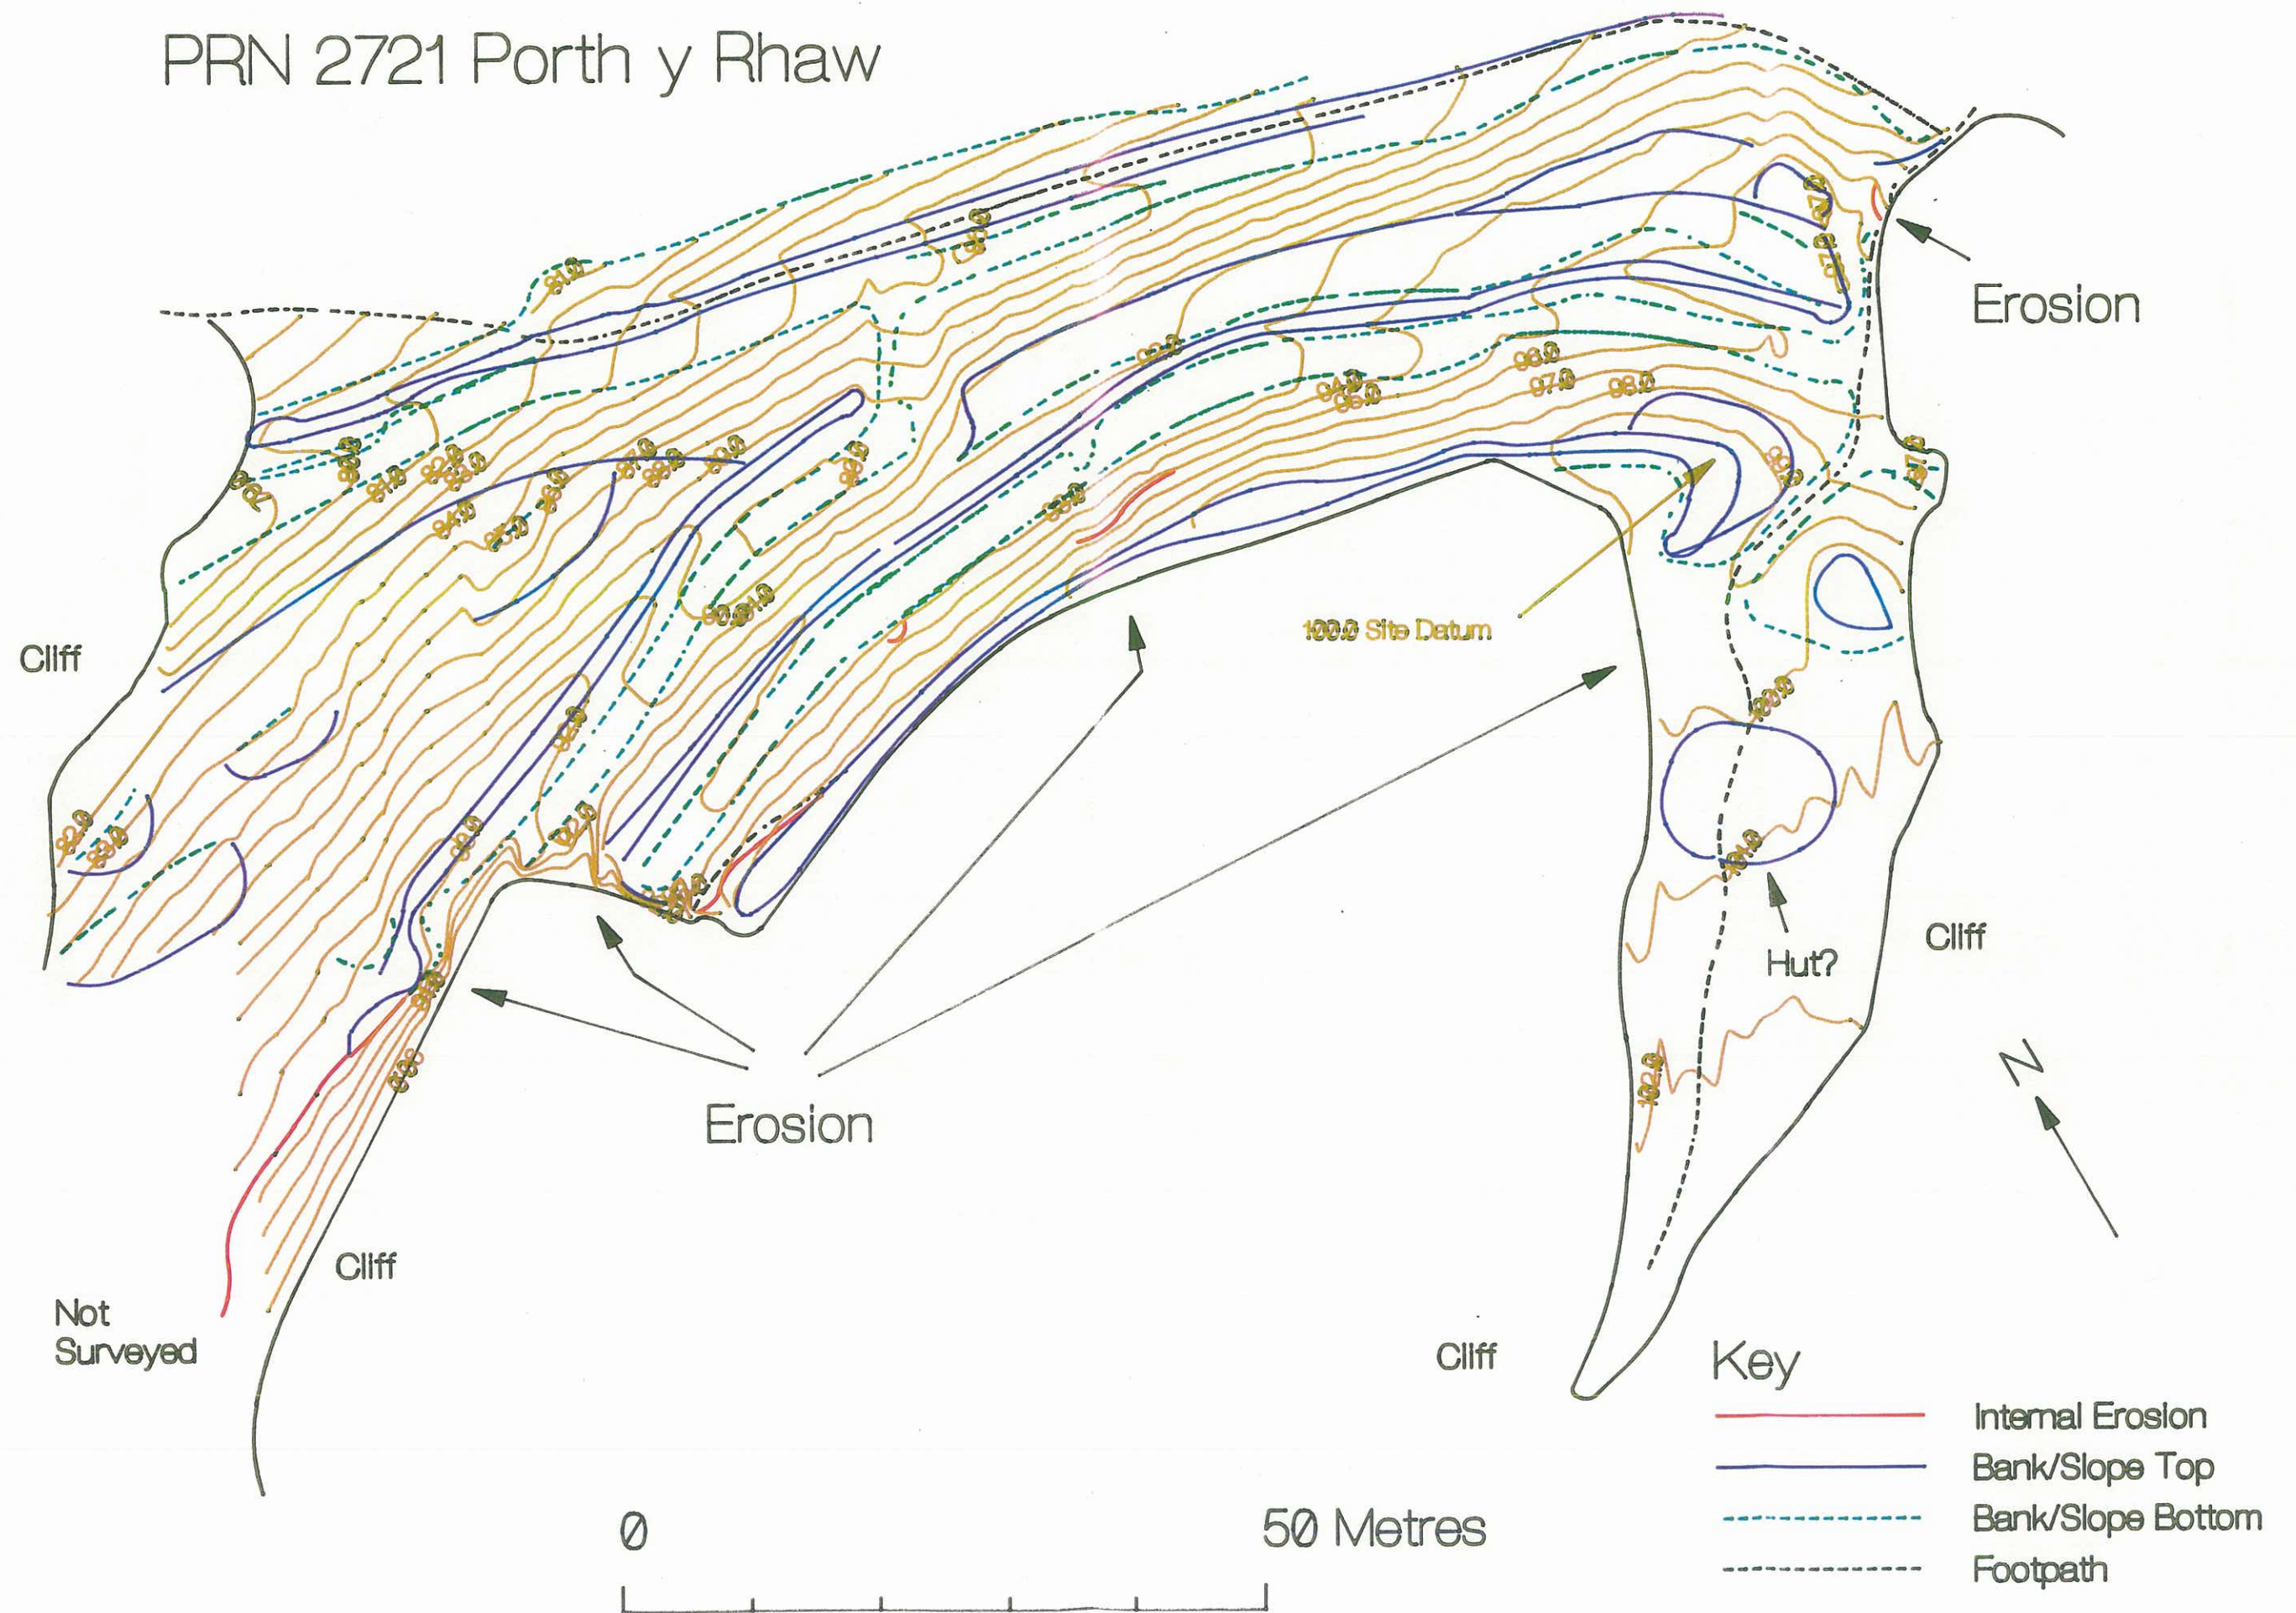
Figure 3

PRN 2721 Porth y Rhaw (Map 7 Figure 3), has been eroding steadily and there is now probably only a small part of the interior remaining. The area to the west of and the western side of the probable hut (Figure 3) on the promontory are showing signs of fissures. A long length on the inner bank, which was observed to have possible structural details within it, is now right on the eroding cliff edge.

Notes: No grazing, good grass cover on interior. Signs of rabbits in banks. Probable hut site visible (Figure 3). There may have been animal or, more probably, manmade damage to the top of both inner banks on either side of the entrance. Natural slip on small part of the north side of the top bank midway along. There has been extensive erosion at the west end of the inner defence (archive photo: 103), revealing the end of the inner ditch. The western part of the inner bank and the interior to the west of the possible hut are going to be eroded away in the near future; this is a candidate for excavation. The footpath into the promontory fort, at the east end of the site, is very close to the cliff edge and is causing damage to the end of the outer bank (Figure 3 and archive photo: 102); the footpath needs to be re-routed and the damage repaired. Coastal erosion of this fort is bad.

PRN 2721 Porth y Rhaw (Map 7 and Figure 3) needs an assessment or rescue excavation on the promontory area adjacent to the probable hut and the inner bank, before it becomes too dangerous. Conservation is also required on some of the internal erosion areas. The footpaths into the monument on the east side and the west side near the cliff need remedial action, and/or re-routing.

Action on Erosion: Recommend re-route footpath and excavate part or all of the areas that are going to go over the cliff edge in the near future.

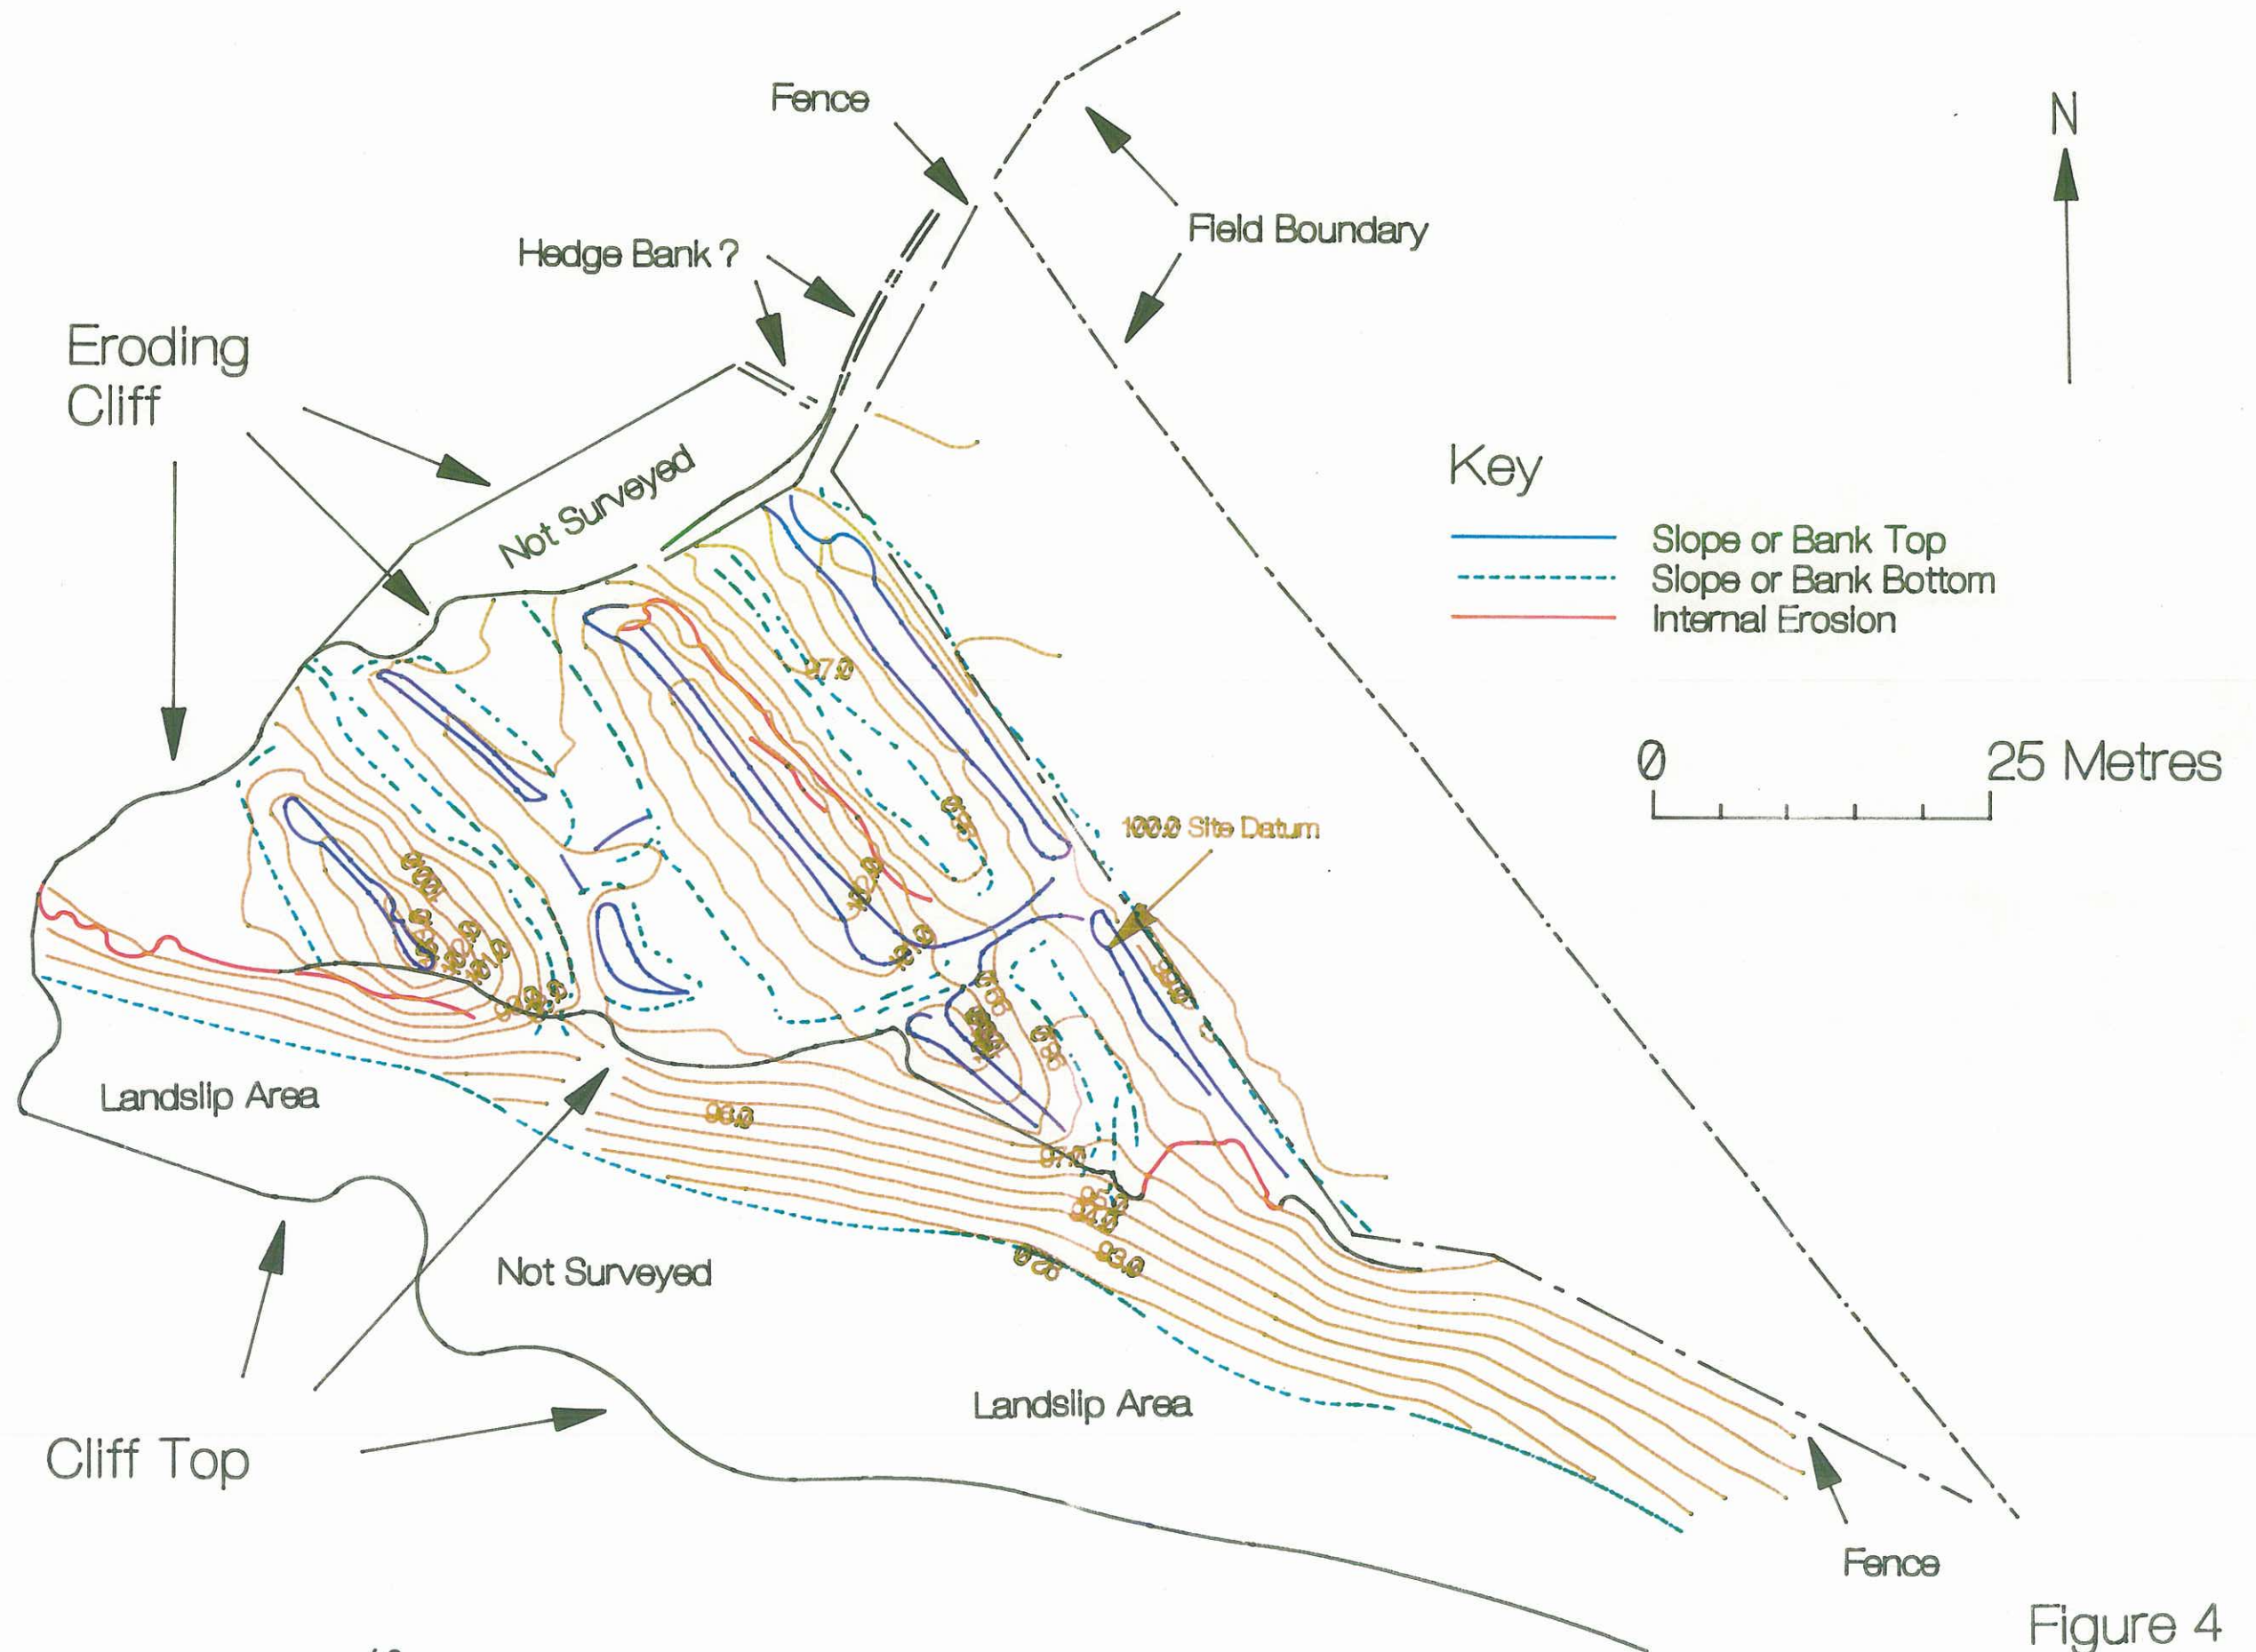
Figure 4

PRN 2960 Great Castle Head (Map 8 and Figure 4), probably only retains a very small part of the original enclosed area. The southern part of the site has suffered a severe landslip (Figure 4), and there are now signs that the north side of the promontory is going to have some land loss soon. The banks of this site are very steep and have slippage or ground creep. They are also being damaged by animal burrows; these may be due to badgers but this should be confirmed, or otherwise, by a specialist (possibly Dyfed Wildlife Trust). This problem may be difficult or impossible to cure. The wind was gusting up to gale force at the time of the survey and the area of landslip to the south had to be abandoned. It would be advisable to have this area completed in the near future.

PRN 2960 Great Castle Head (Map 8 and Figure 4) should have a survey of the areas that have slipped. There is a section of the inner bank that could be cleaned and recorded and there are areas of this site that could be excavated. However, because of the possible wild animals on this site work may be limited.
