DINEFWR CASTLE

ARCHAEOLOGICAL WATCHING BRIEF

Project Record No. 31034

REPORT OF A WATCH-BRIEF CARRIED OUT DURING CLEARANCE OF A BLOCKED CHIMNEY, WINDOW OR DOOR ON THE WEST SIDE OF THE HALL, DINEFWR CAS- TLE, CARMARTHENSHIRE

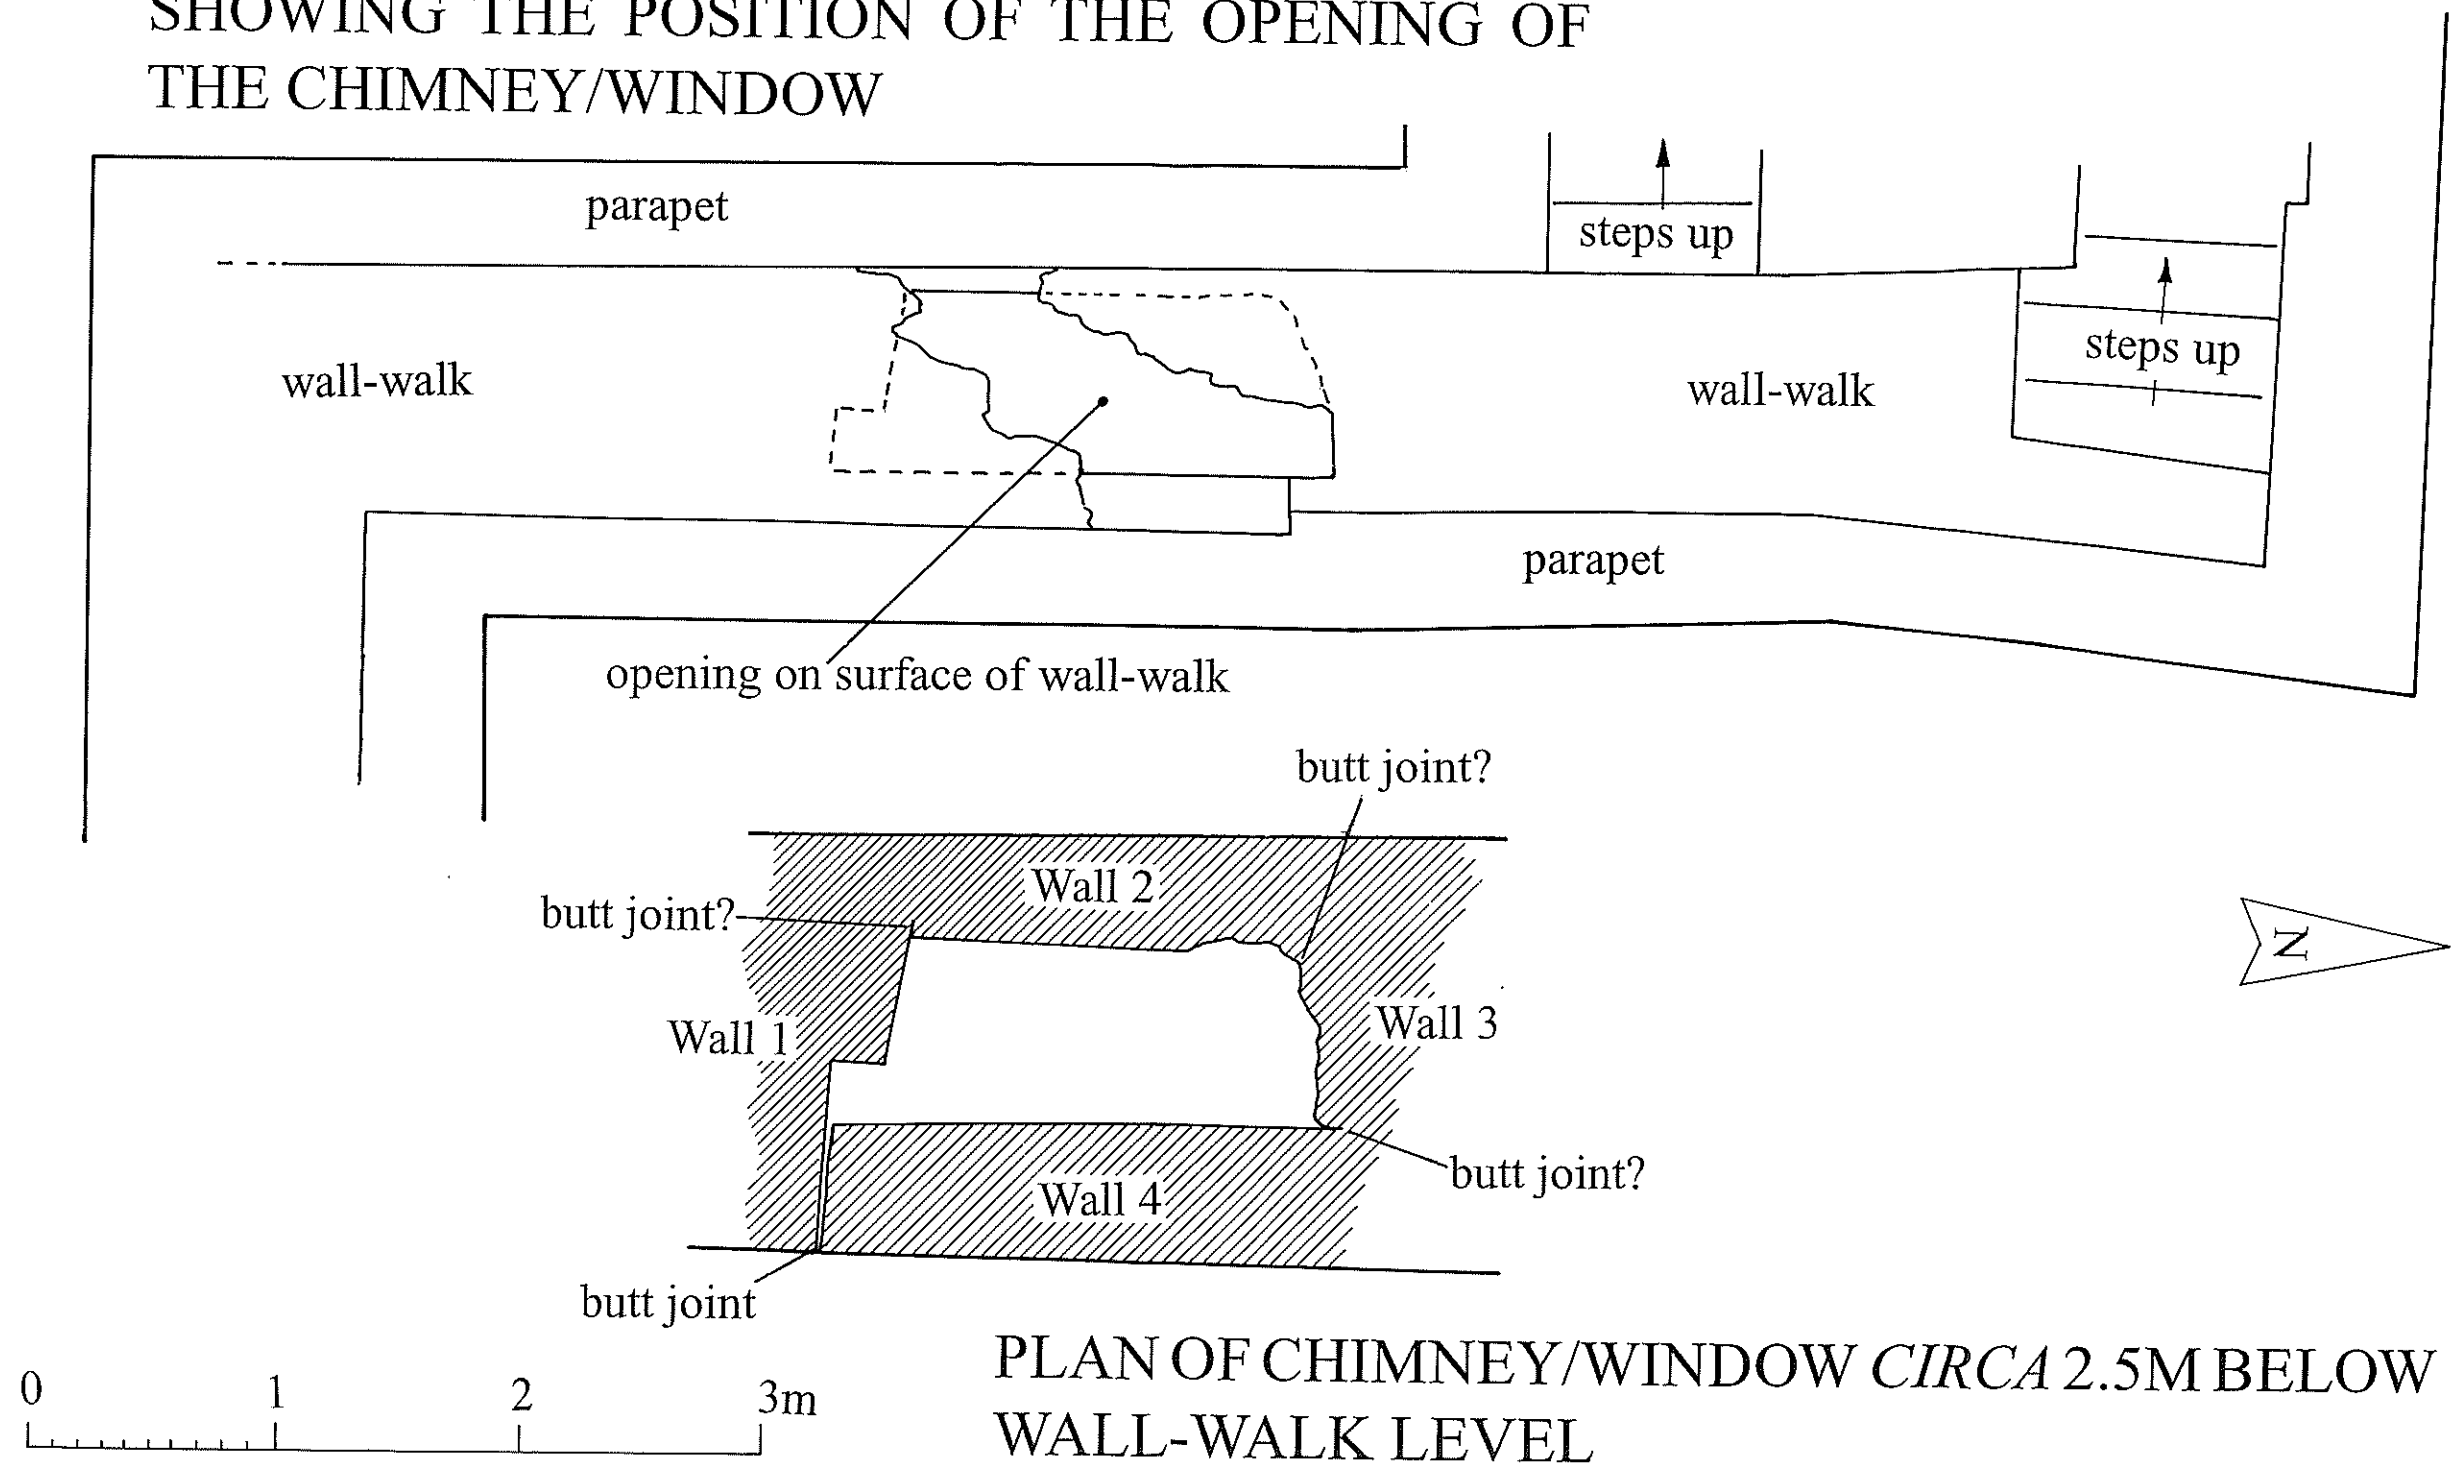
Several phases of masonry were revealed within the opening after it was emptied of its fill. It was not possible to obtain clear relationships between all these walls in the very confined and dark opening. Useful information was however gained:

Wall 2. The outer, west wall to the opening. A well-built wall bonded with white mortar. It appears that this wall may butt against Wall 1, and that at its northern end it may have been cut away to allow for the insertion of Wall 3, though neither of these relationships is certain. There is no evidence of butt joints on the outer wall-face of the hall, though it is suspected that the whole of this outer wall-face has been re-skinned in recent centuries.

Wall 3. This is a roughly built wall, bonded with white mortar and earth, and has the appearance of an exposed wall-core, certainly there are no facing stones present. It seems to butt up against Wall 2 and possibly against Wall 4.

Wall 4. The inner, east wall to the opening. Well built, mortar bonded. It is of one build with the parapet wall above. This is clearly a blocking wall. Within the opening, it is founded on soil and rubble similar the removed fill. It butts up against Wall 1 and possibly against Wall 3. The joint between Wall 4 and Wall 1 can clearly be seen in the inner wall-face on the west side of the hall, as can the base of Wall 4. The base of the wall was approximately level with the corbel stones which supported the first floor of the hall. No joint to indicate the northern extent of this blocking wall can be seen in the wall-face on the west side of the hall; this suggests that a large portion of this wall-face has been rebuilt, probably at the same time that the blocking took place and the outer wall-face was re-skinned.

Wall 5. A small portion of wall-face exposed within the opening on the west side. This had been conserved prior to the watching-brief, but nevertheless seems to form part of Wall 1. if this is correct, then a wall-face in such a position could only have been part of an inner face of a chimney.

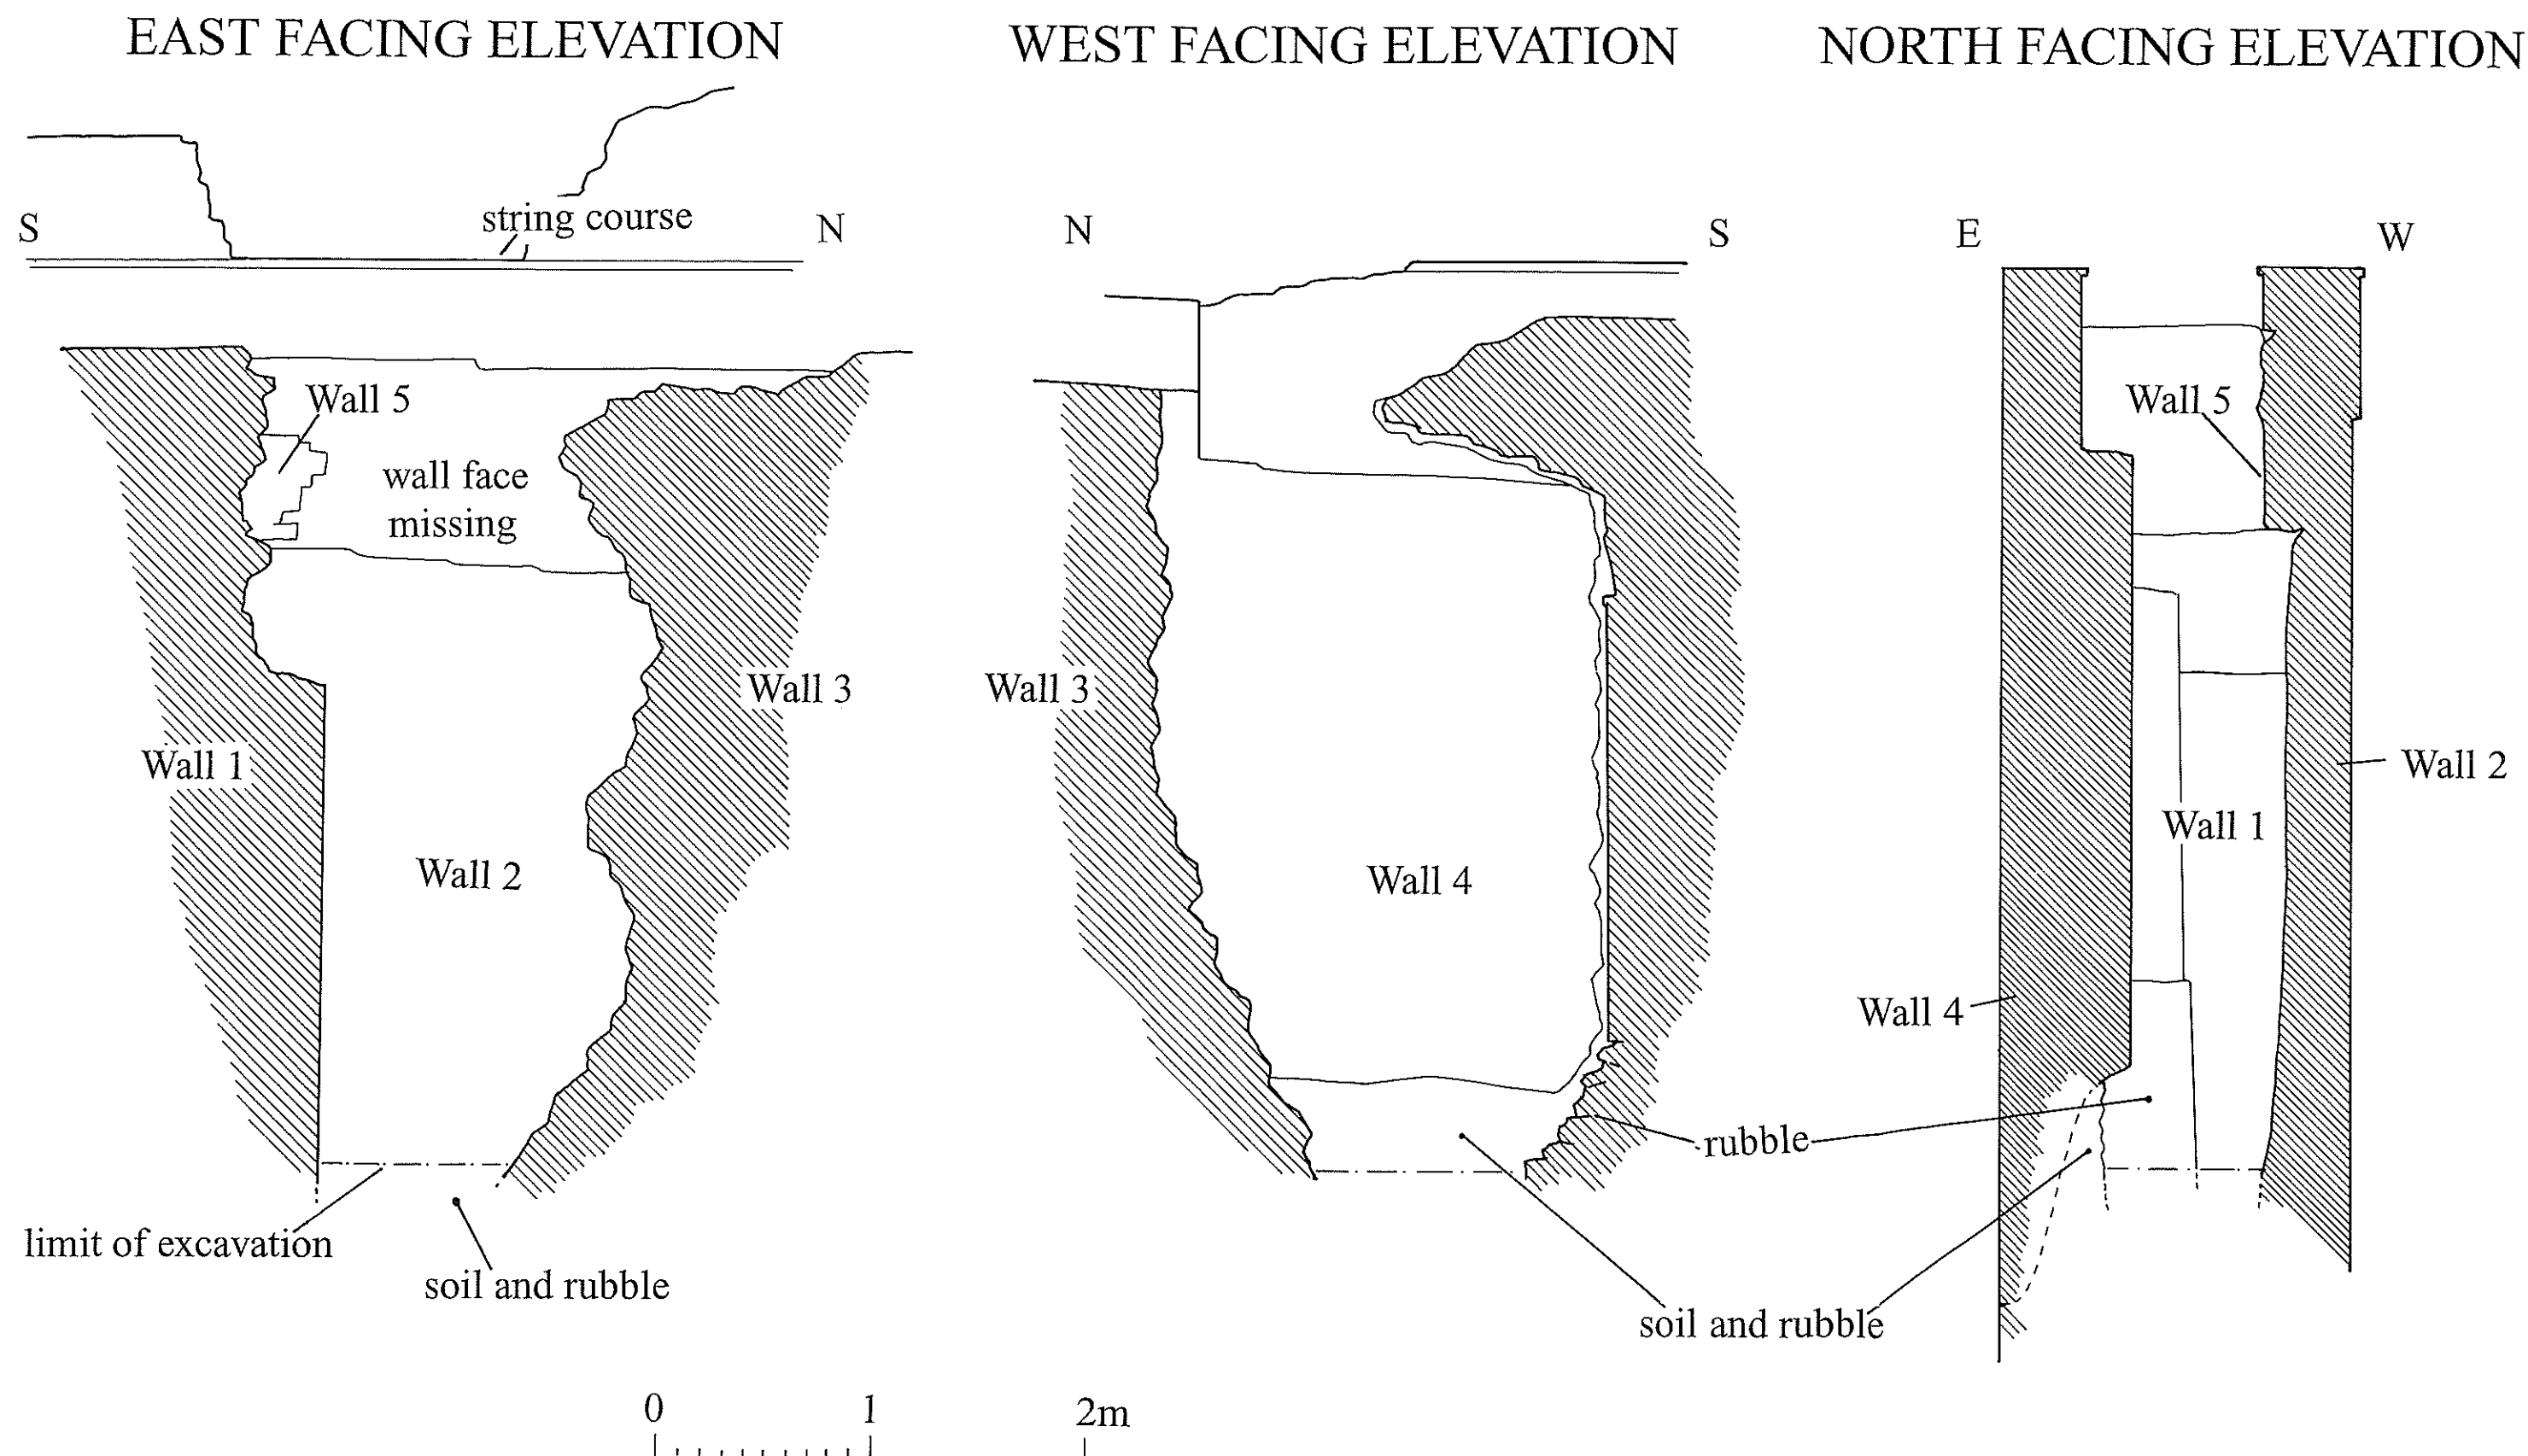
Fig. 3

Wall 1. On the south side of the opening. A well-built wall, bonded with white mortar and covered with white plaster with a corner and a reveal. As can be seen of Figure 3, West-Facing elevation, Wall 1 arches approximately halfway over the opening. It is butted by Wall 4, a joint that is clearly visible in the wall-face inside the hall. The lower portion of Wall 1 has been partly robbed, possible to remove dressed stone, and replaced with loose rubble.

The height of the blocking, Wall 4, level with the corbel stones of the first floor level in the hall and substantially lower than the sill heights of surviving windows indicates that the opening was not a window. The absence of obvious butt joints on the outer face of the west wall of the hall cannot preclude the opening from ever being a door or window as the whole of this face has been re-skinned. The most likely interpretation is that it was a fireplace, albeit much modified. Wall 3 and Wall 4 together suggest that a large portion of the west wall of the hall to the north of the fireplace has been rebuilt. The occasion of this rebuilding together with the in-filling of the opening and the re-skinning of the outer face is unknown, but is most likely to have occurred during renovation of the castle by the Dynevor Estate in the 18th and 19th centuries.
