# DYFED ARCHAEOLOGICAL TRUST LTD

## RUSTIC ALCOVE **HAFOD** CEREDIGION

ARCHAEOLOGICAL EVALUATION  
Project Record No. 32476  
MAY 1996

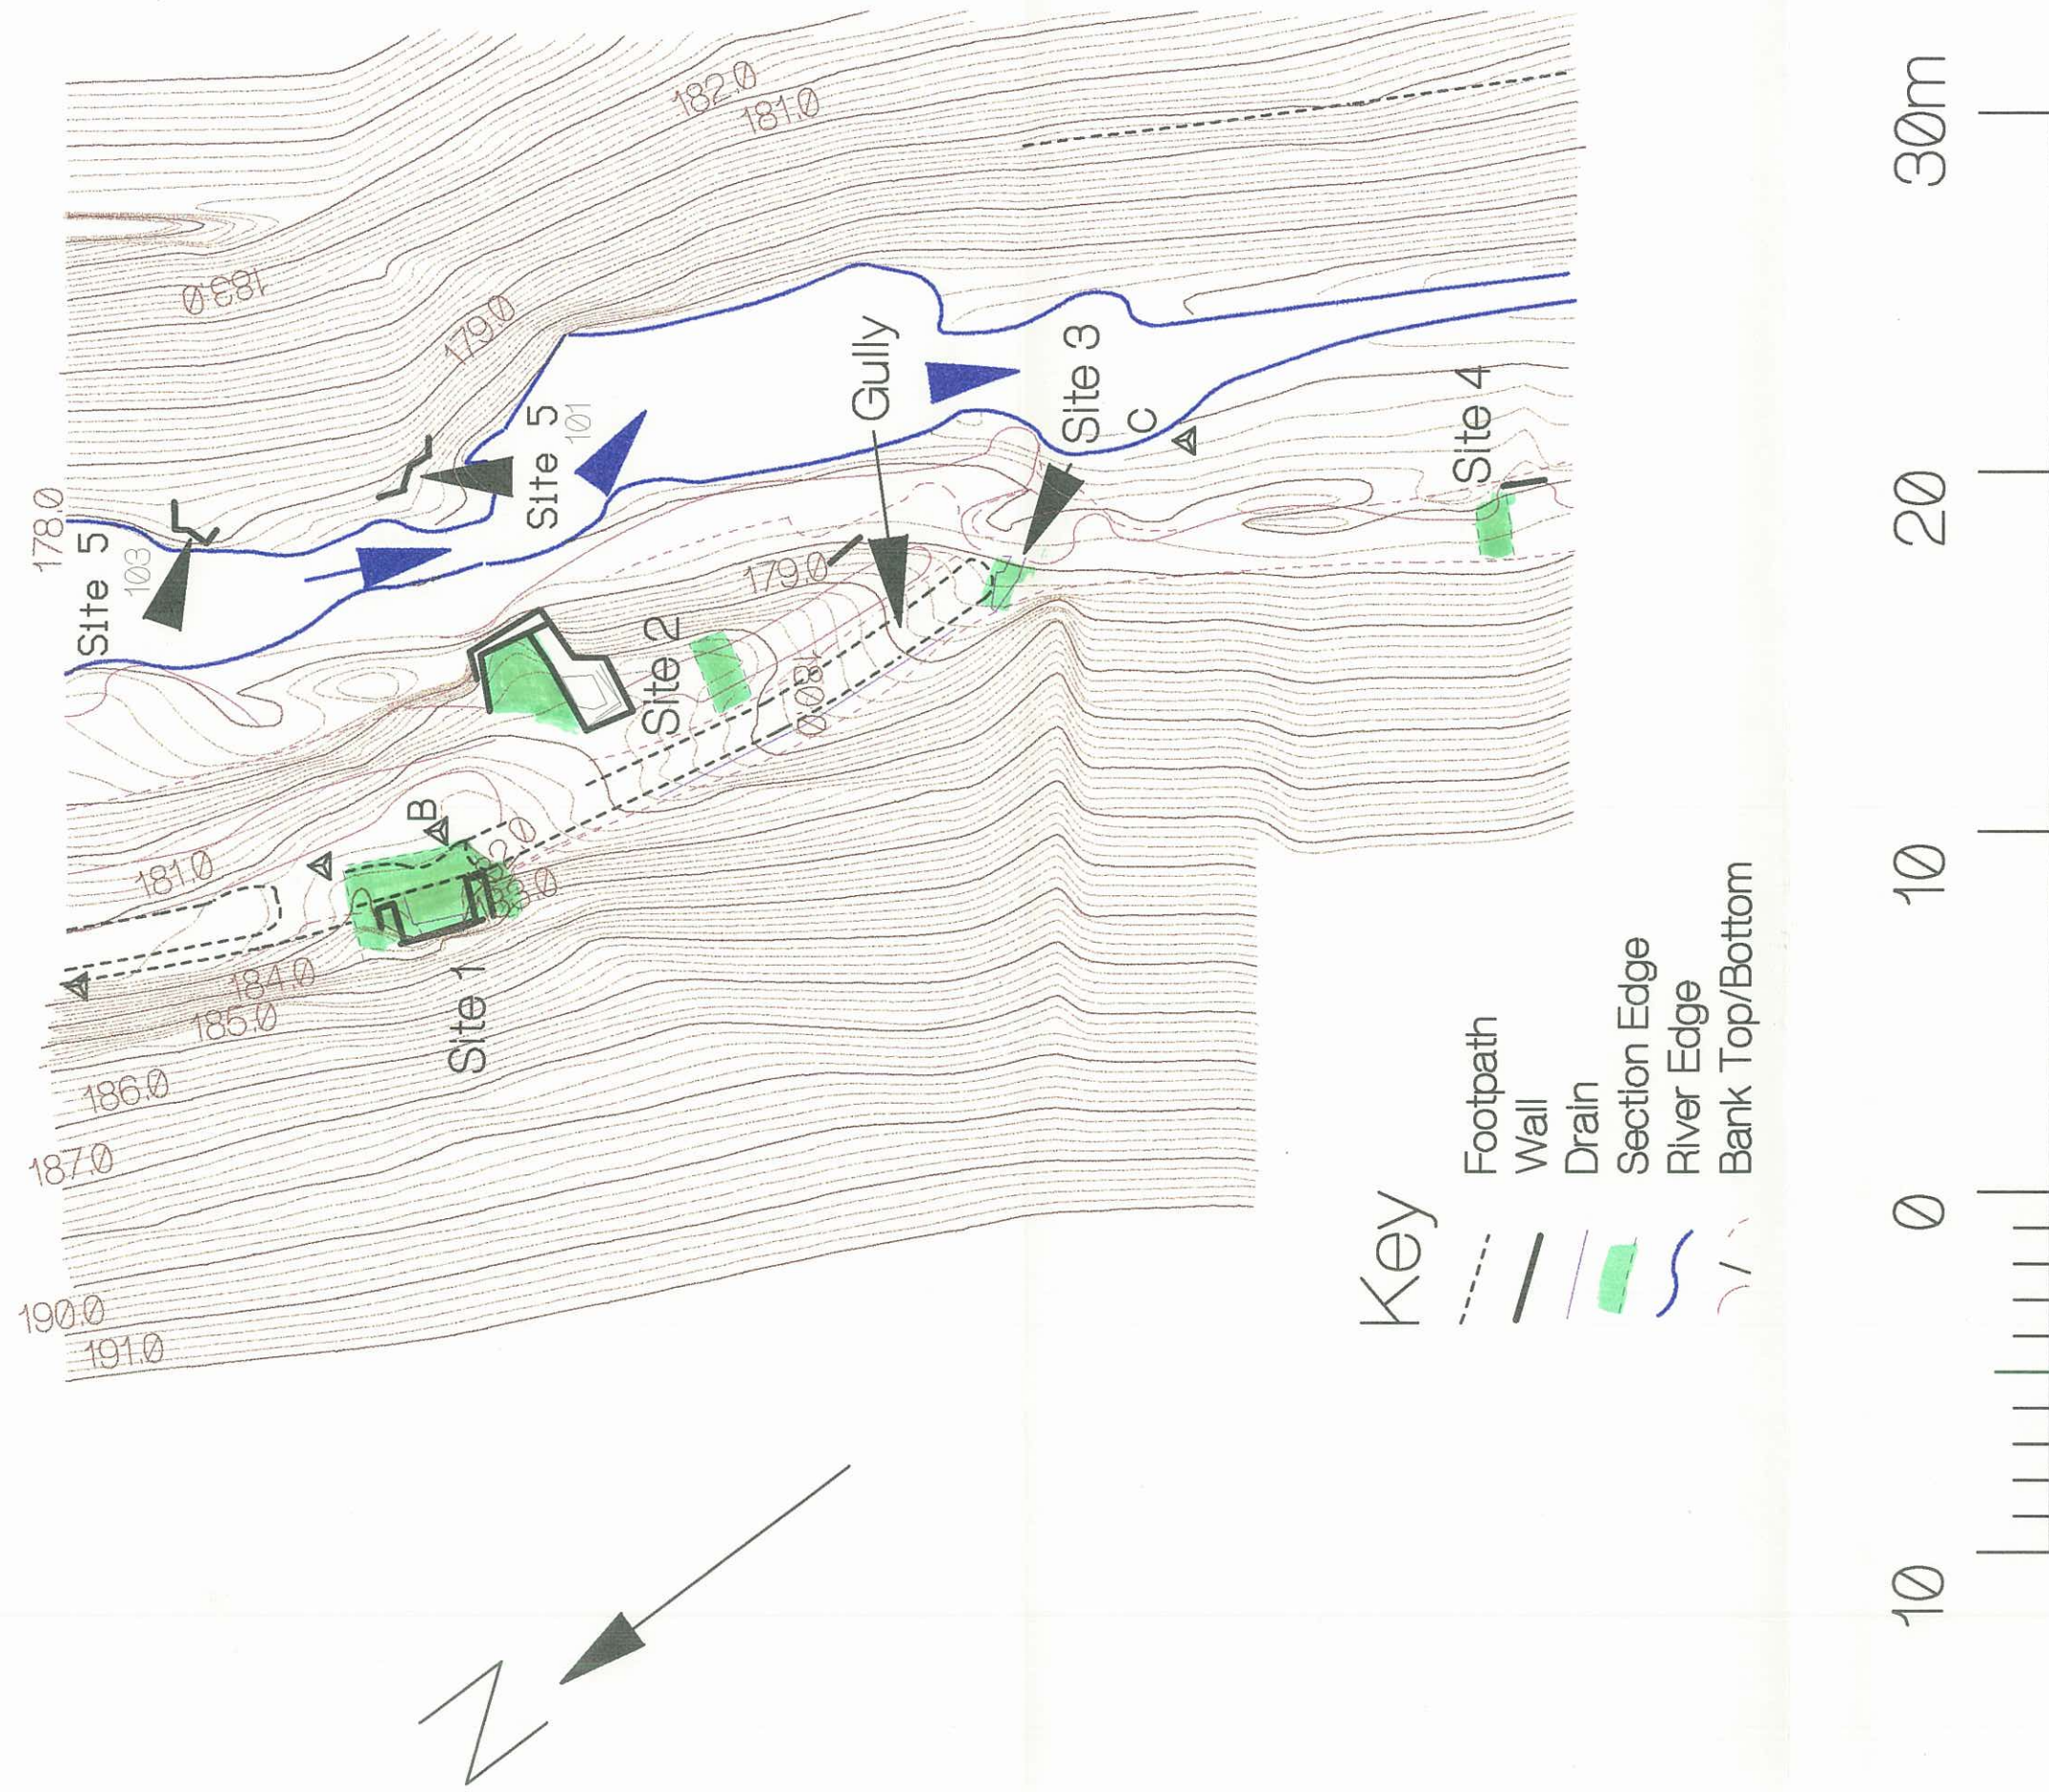
Figure 3

side walls (6 and 11) and the rear 'revetment' wall (7) which was visible prior to the excavation (figure 3).

indistinguishable from the topsoil (1 and 3) above the slump/hill wash. Within this topsoil in the area of the rock-cut platform, and partly on the line of the footpath (16), there were a number of individual stones and patches of stones (14) (figure 3). These stones were found to be within or have topsoil below them.

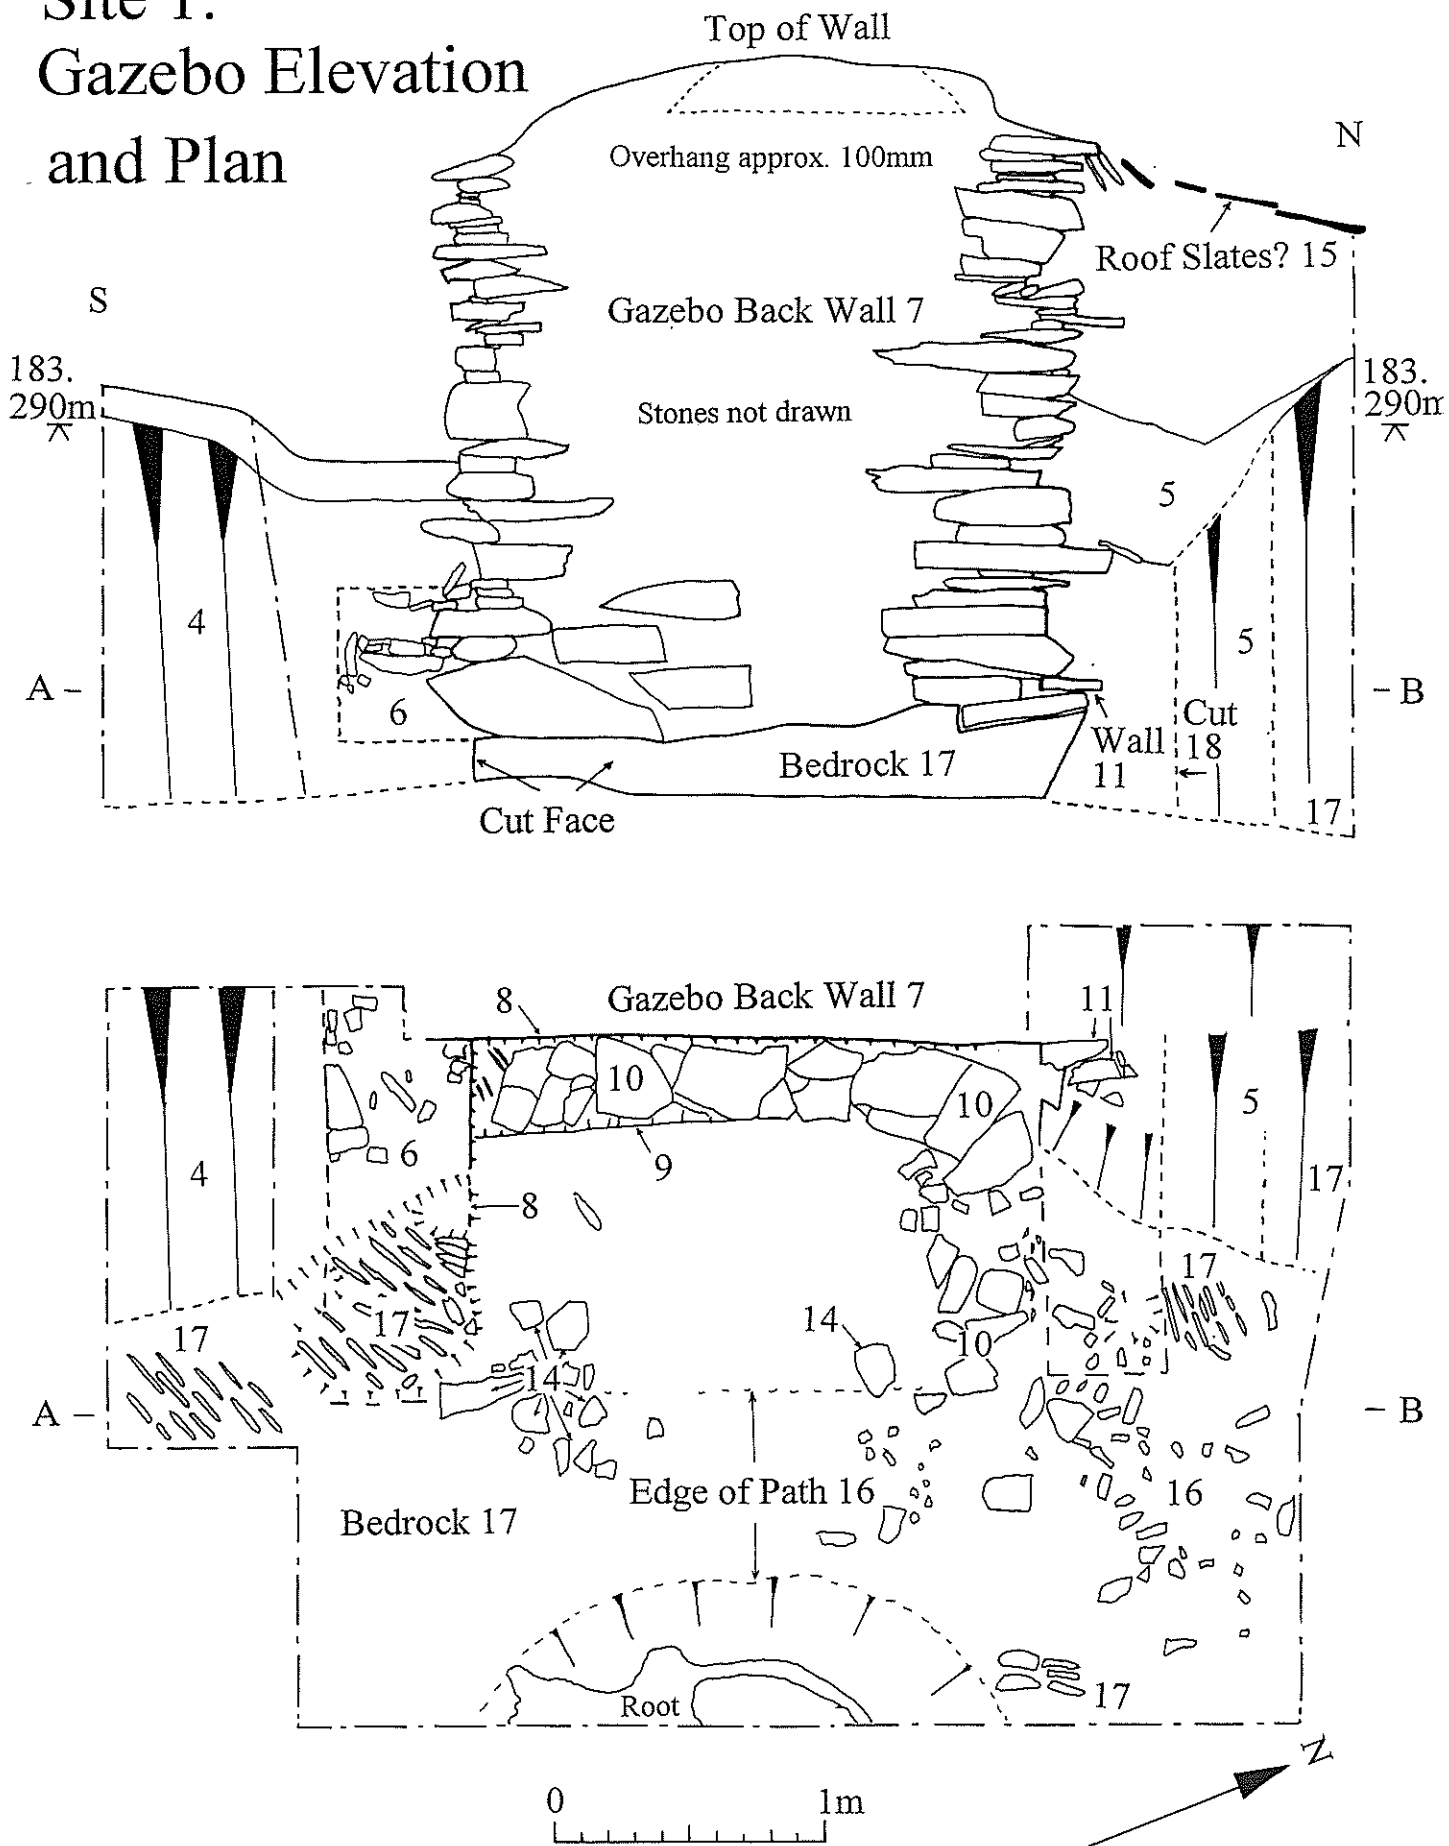
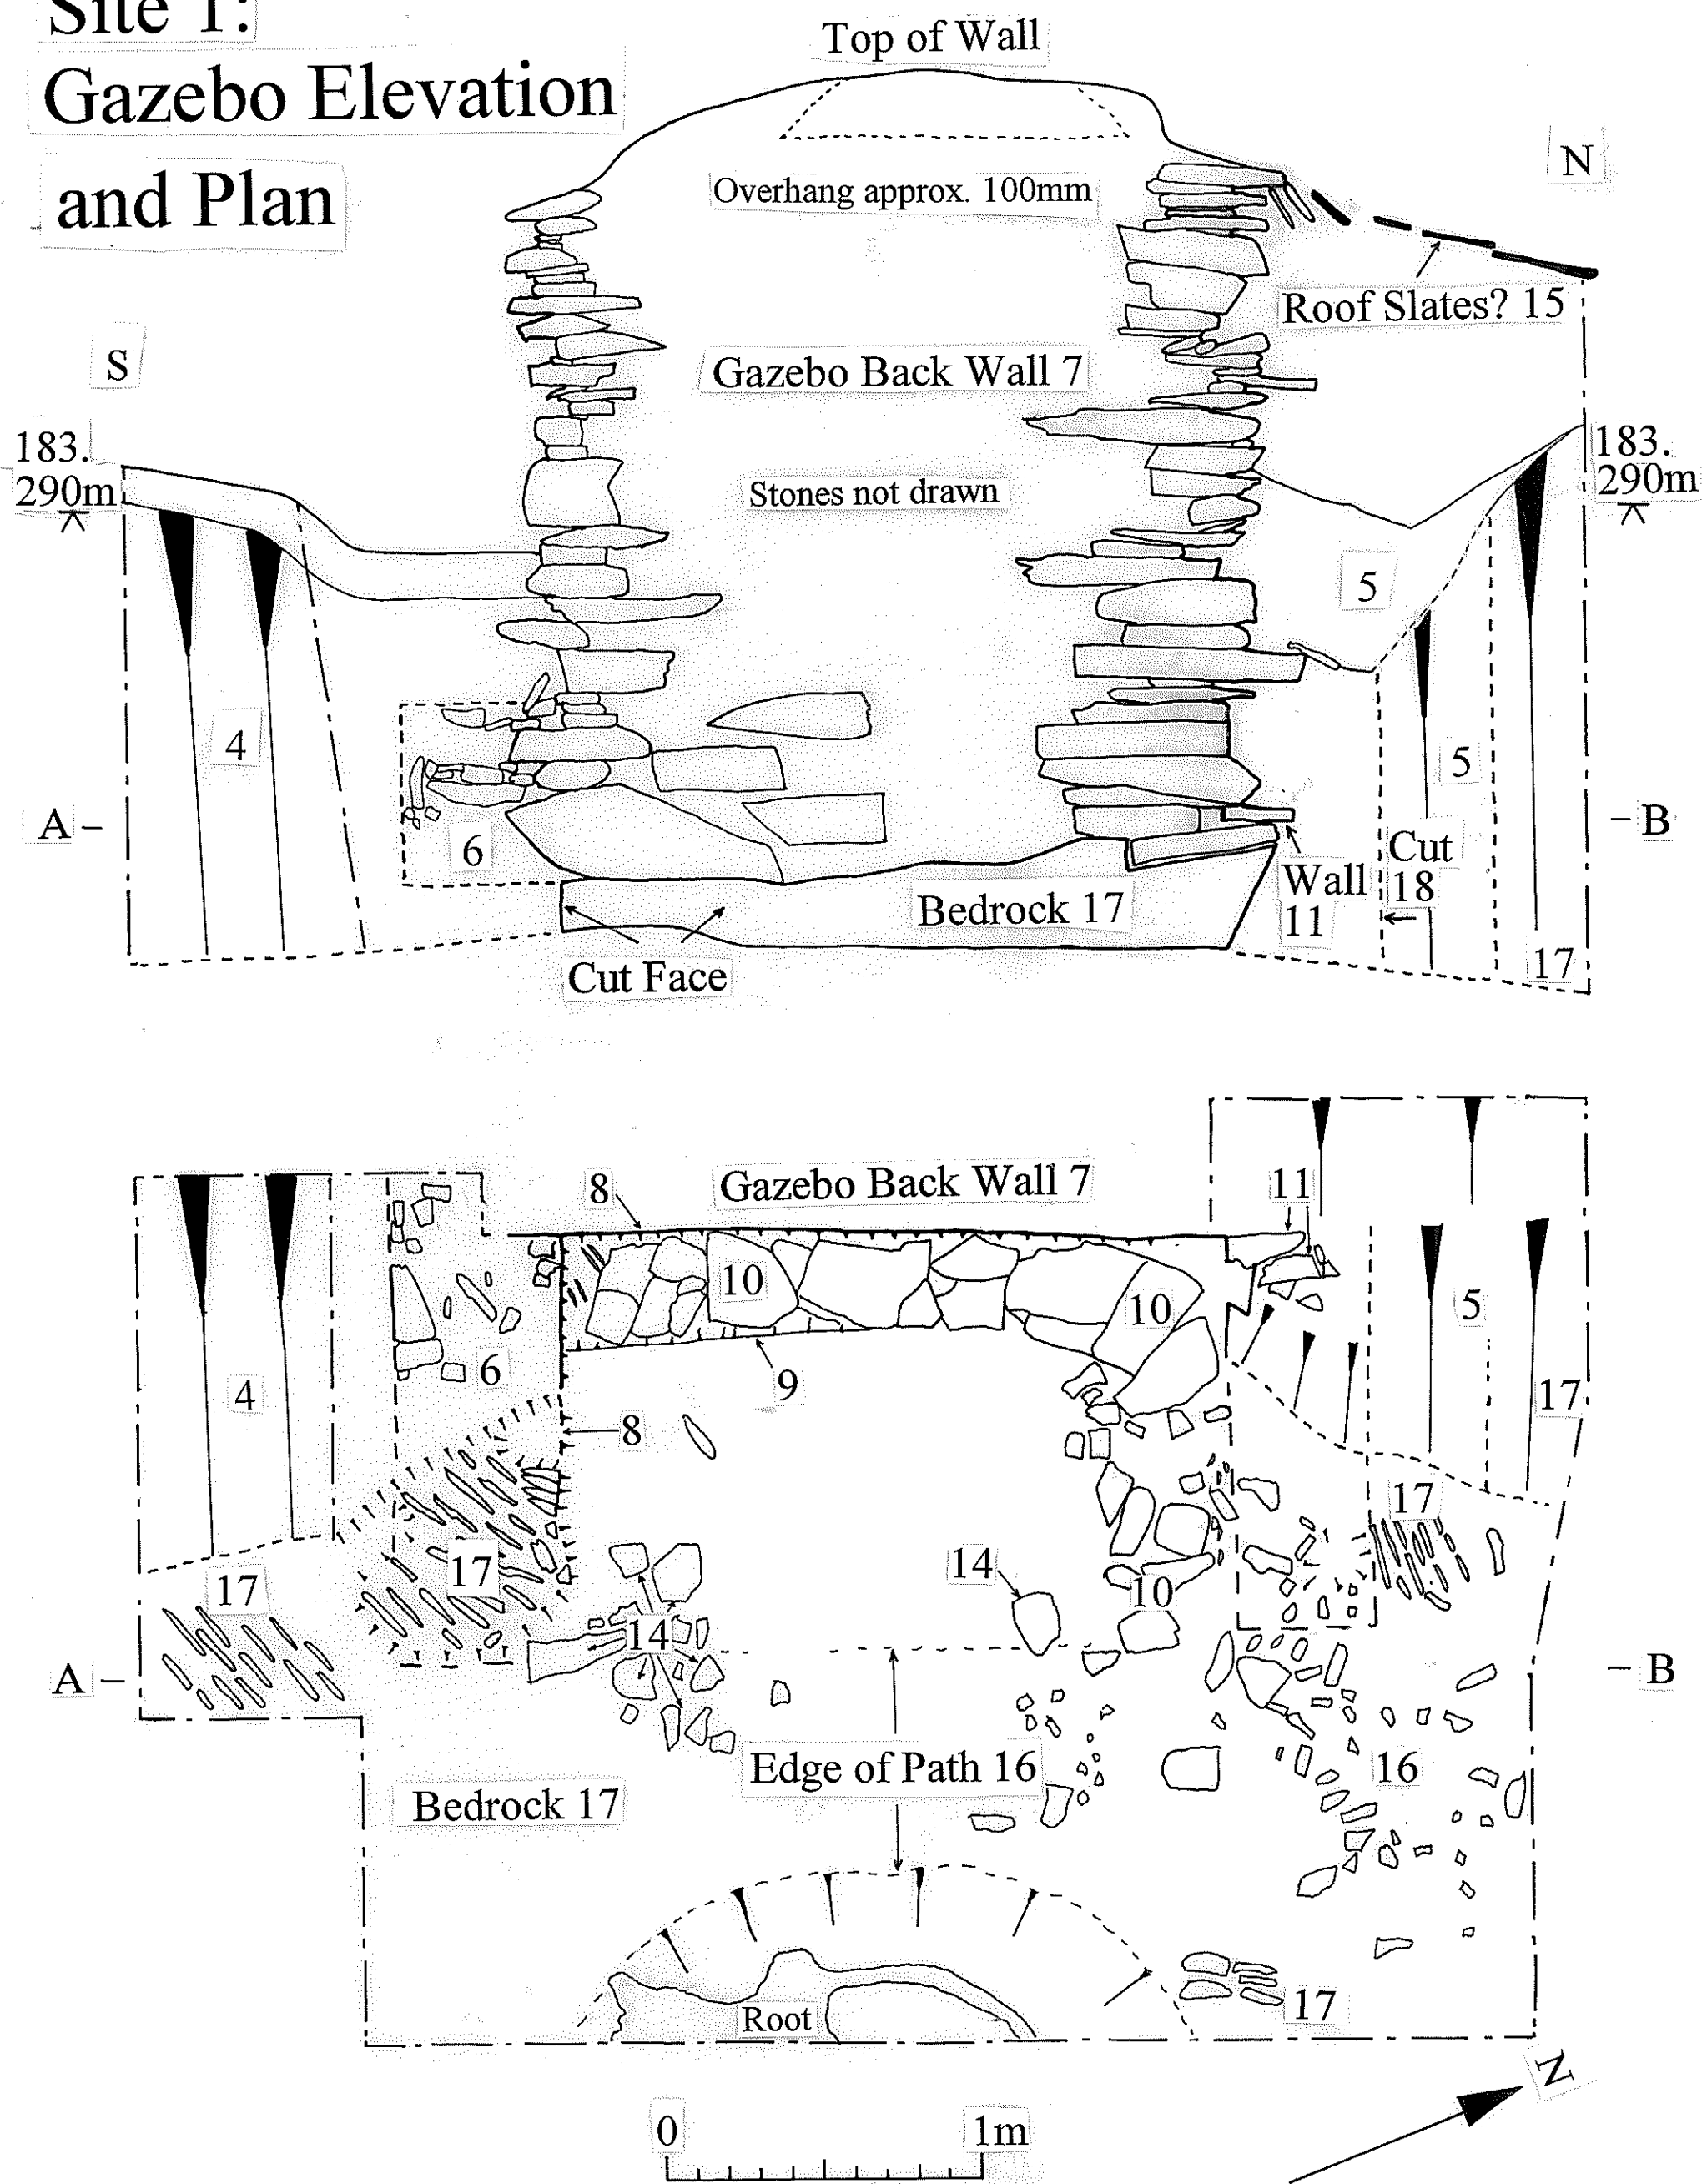
Figure 4

The earliest feature appeared to be the cutting of the bedrock (17) (figure 4) to form a level platform (8) into the base of the hill slope, on a level with the path. This platform was cut so that three sides formed the bottom edge and base for two short

The footpath metalling (16) only remained to any extent at the north eastern end of the excavation area (figures 4 and 8). This consisted of small shale slabs and fragments set on a greyish brown silty clay, lying directly on bedrock (17) and probably over part of the drain capping (10).

The roofing material for the gazebo is uncertain. A sketch which may or may not be of this gazebo appears to indicate a thatched roof (pers. comm. A Sclater). The single roof slate found and the slates (11) seen in the hillside (figure 4) may not be indicators of either the original or the final roof covering. The apparent curve of the upper part of the rear gazebo wall (7) could be a false impression; there are no indications of any roof timbers in the top of this wall and these should be sought and their existence, or lack, be recorded in any future consolidation programme.

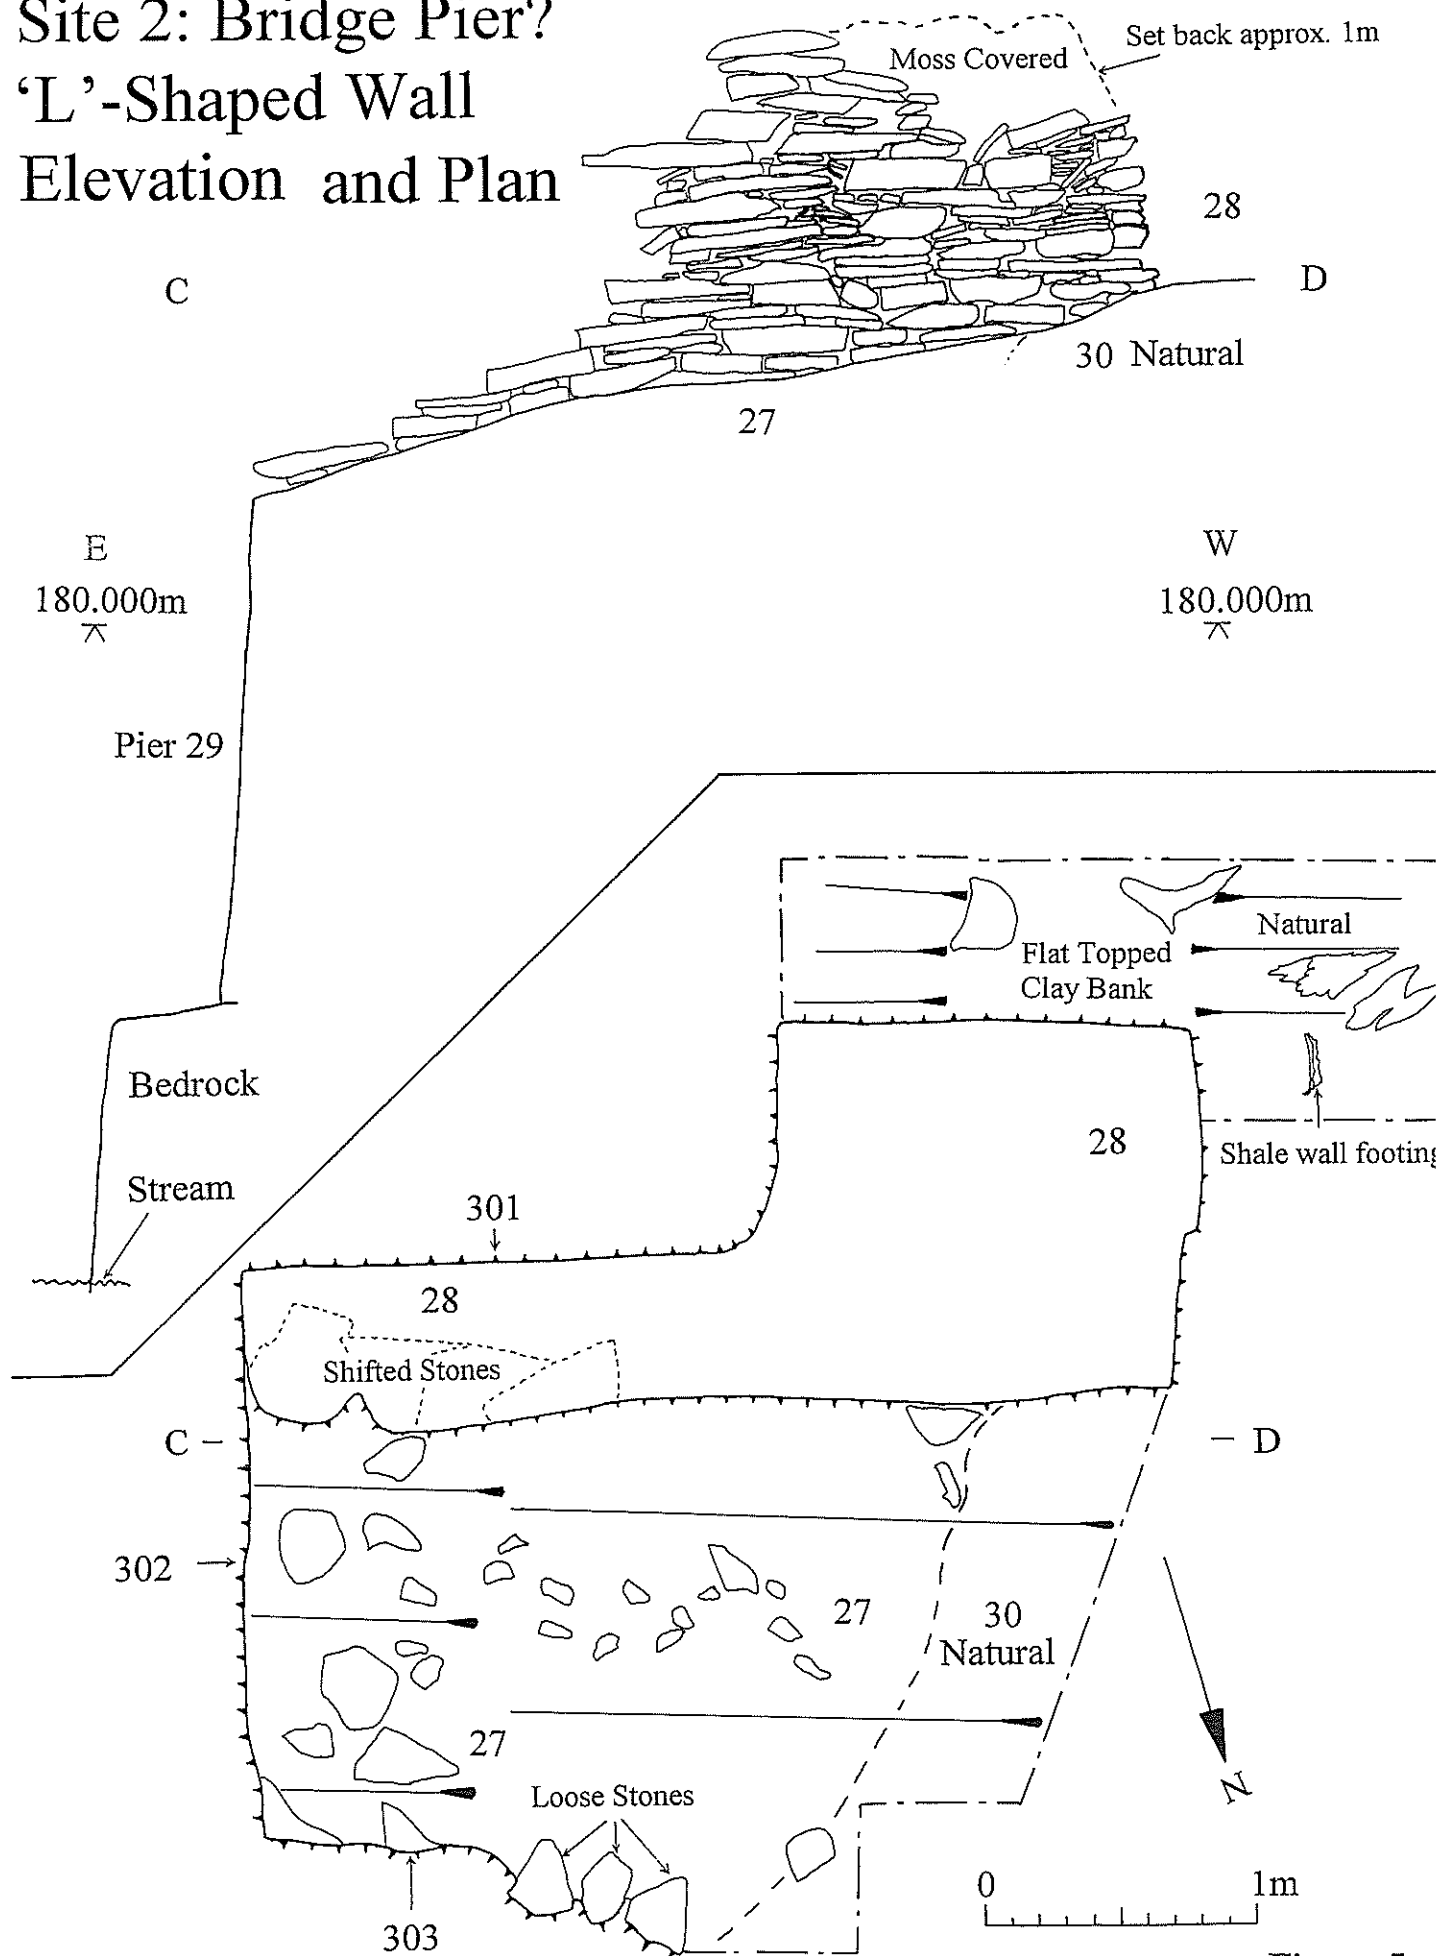
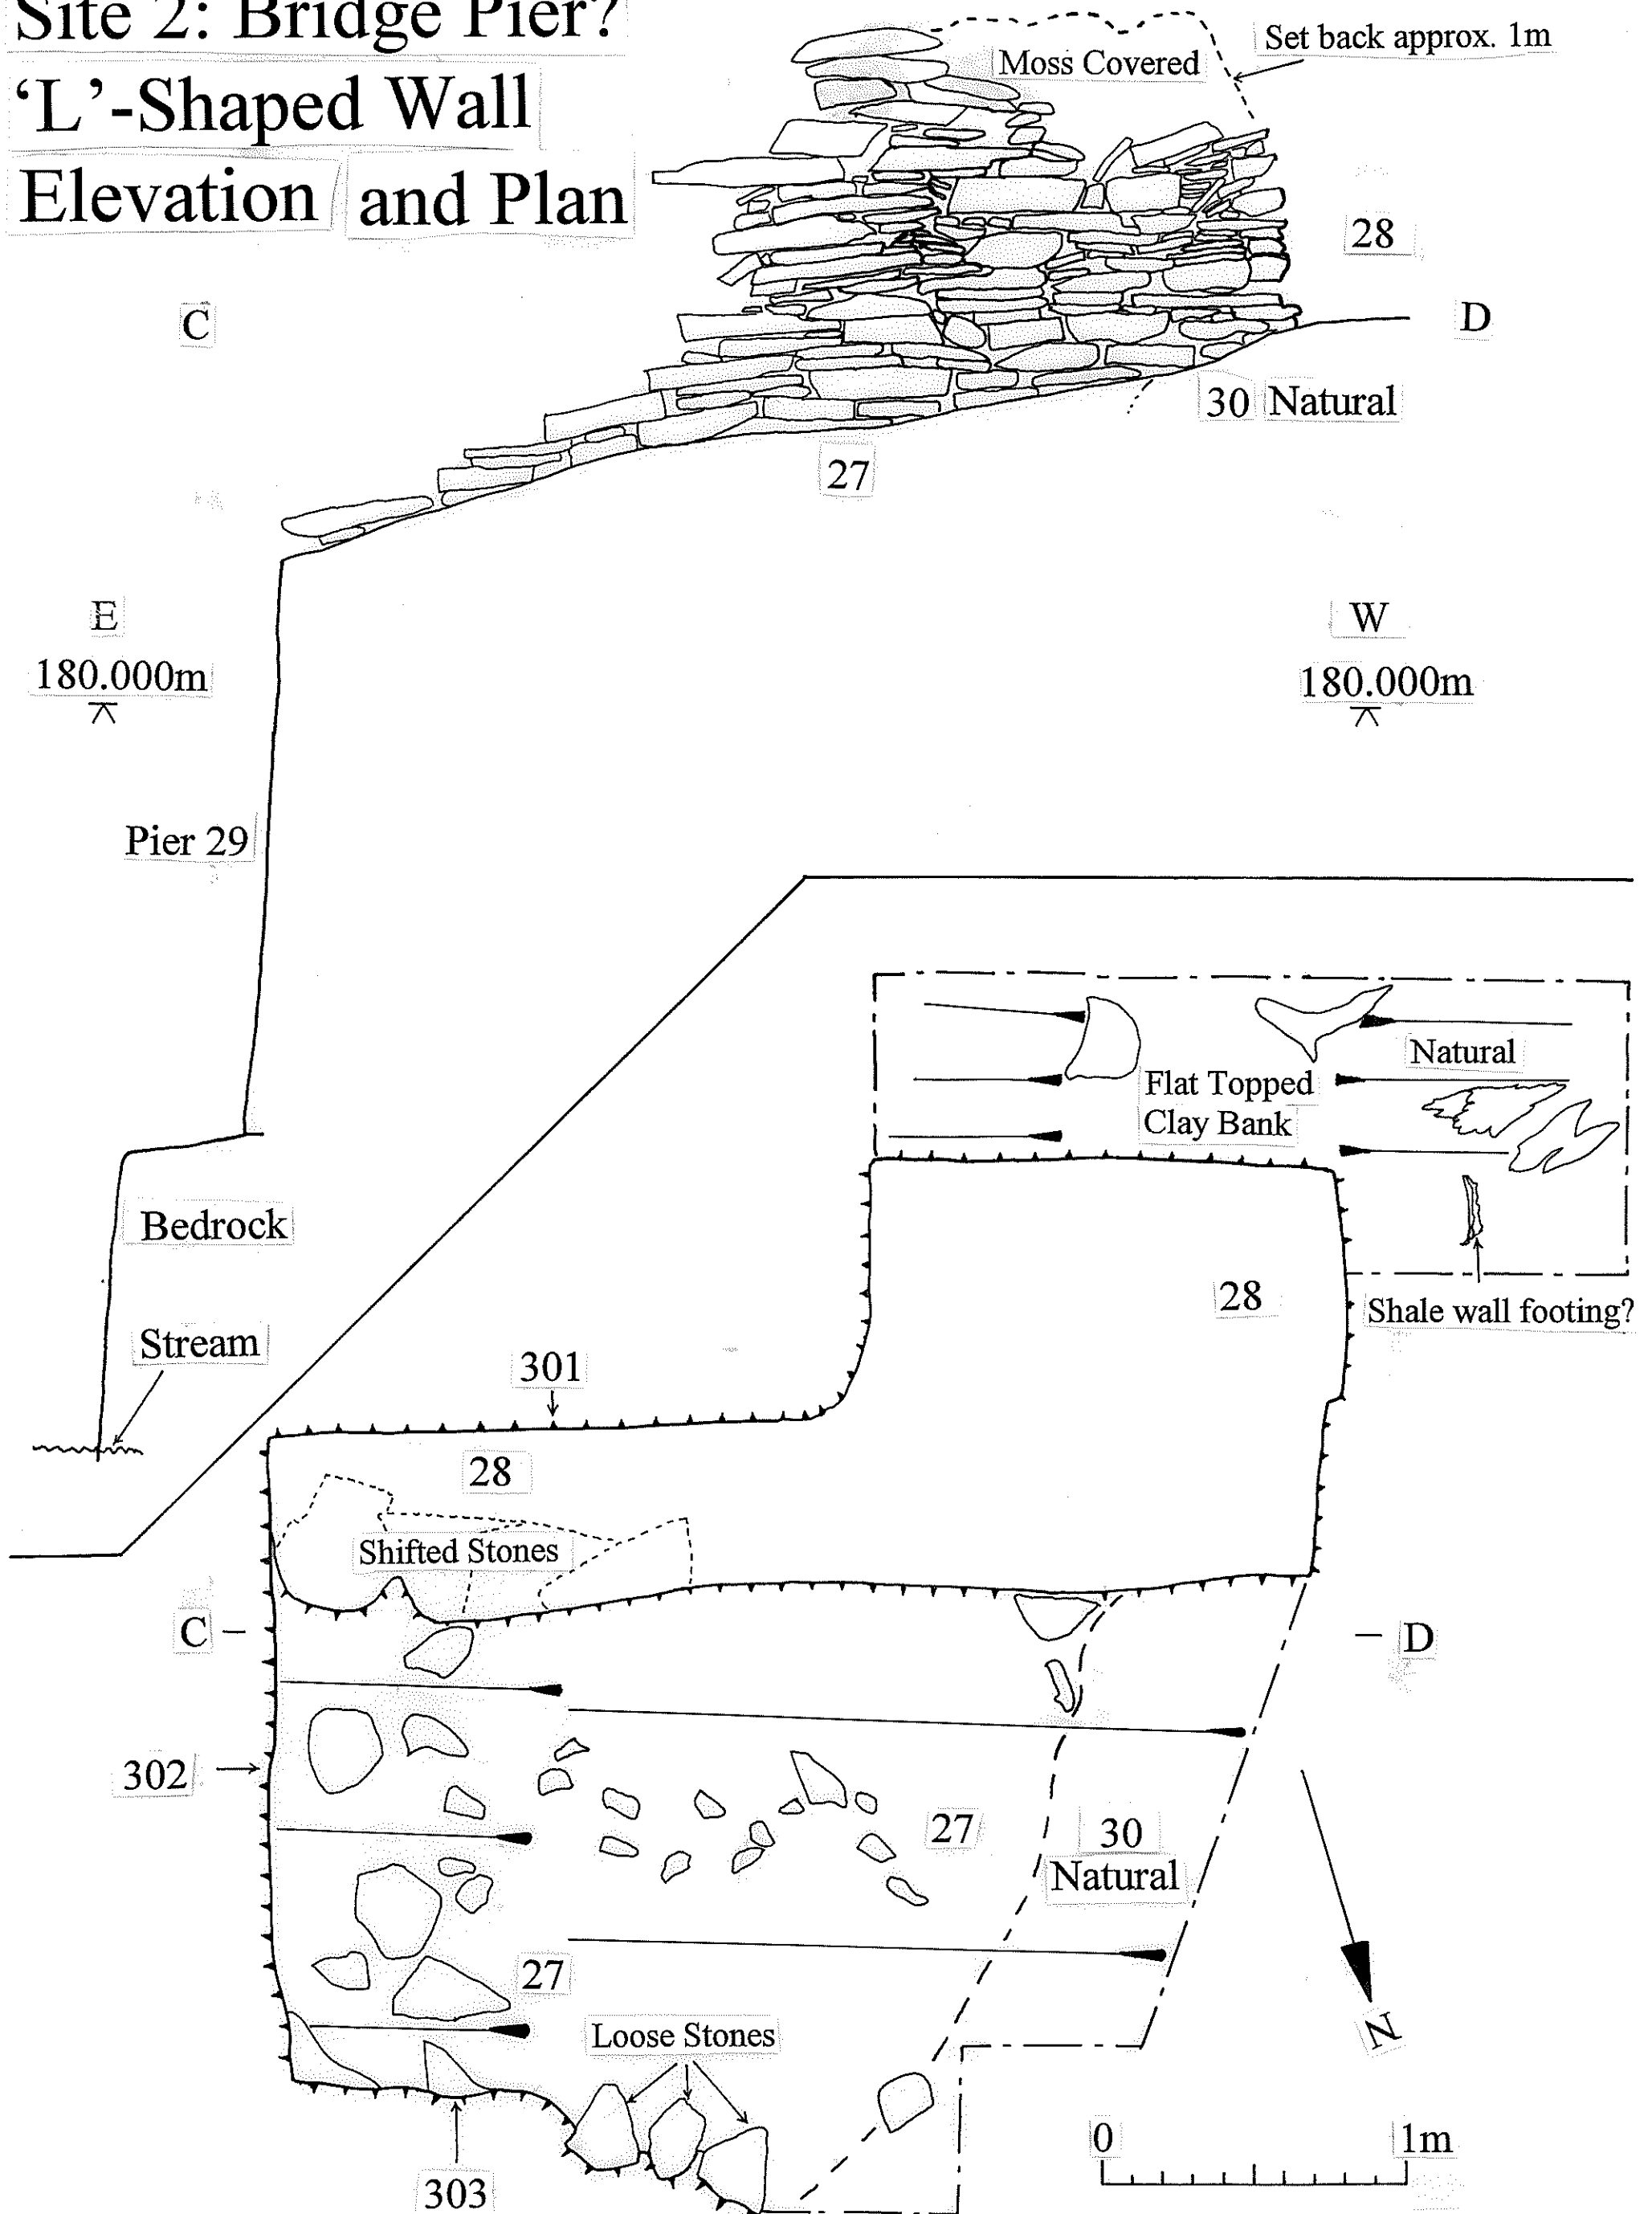
**Figure 5**

A wall (28) projected above the southern side of this platform and also further to the south on the top of the bank, making a thickened 'L'-shape (figure 5). This again appeared to be all of drystone construction (figure 11). The wall top was thickly covered in moss and almost certainly had been damaged (Phillips 1994). The eastern side of the thickened part had collapsed and this face had been lost. The long arm projecting to the east was evidently much lower than its original height and three stones had been displaced, giving it a false curved appearance. On the higher and thickened part of this wall the southern and western faces had been stepped back by approximately 150mm at 500mm height and the remaining upper part of these faces were slightly battered. The battering of this higher part of the wall could have formed a pillar, possibly to support an arch; however, there was no discernible physical evidence for any structure on the opposite side of the path, and the apparent drystone construction of this pillar is unlikely to have taken any great amount of thrust. It is possible that it was simply decorative or supported a timber structure.

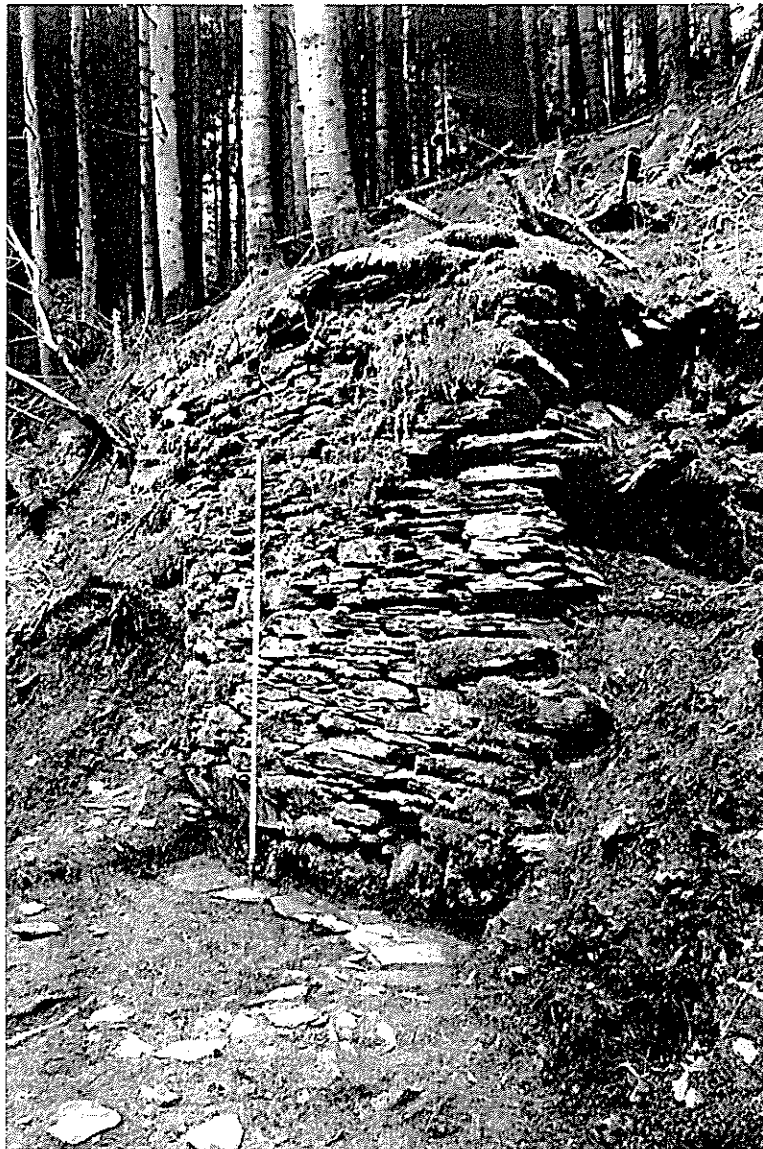
**Figure 7**

There was an 'L'-shaped rock cut drain (9) at the rear and north eastern side of the gazebo (figure 7). One of the capstones (10) at the rear of the gazebo was lifted and here the drain cut was quite shallow, 100mm. The drain fill below the capping was not excavated but appeared very humic, root disturbed and very like the topsoil (1) above. This drain must have flowed from the south west corner of the gazebo and probably out under the path (16); although the drain could be seen running towards the path (figure 8), their relationship could not be established as the remains of the path were not excavated. It could not be confirmed whether the drain cut was contemporaneous with the platform cut or was later; however, as this drain cut was right at the rear and, as elsewhere in some parts of the path, construction of a rear drain seems to be part of the original plan, it may also be the case here.

The gazebo rear wall is in a poor state of repair (figure 7) and is in dire need of consolidation. This wall appears to have been lime mortar bonded or pointed; similar material should be used in the consolidation (Cadw: *Notes on repair and preservation of masonry* revised 1994). It will be necessary to have the upper part of this wall archaeologically recorded immediately prior to this work.

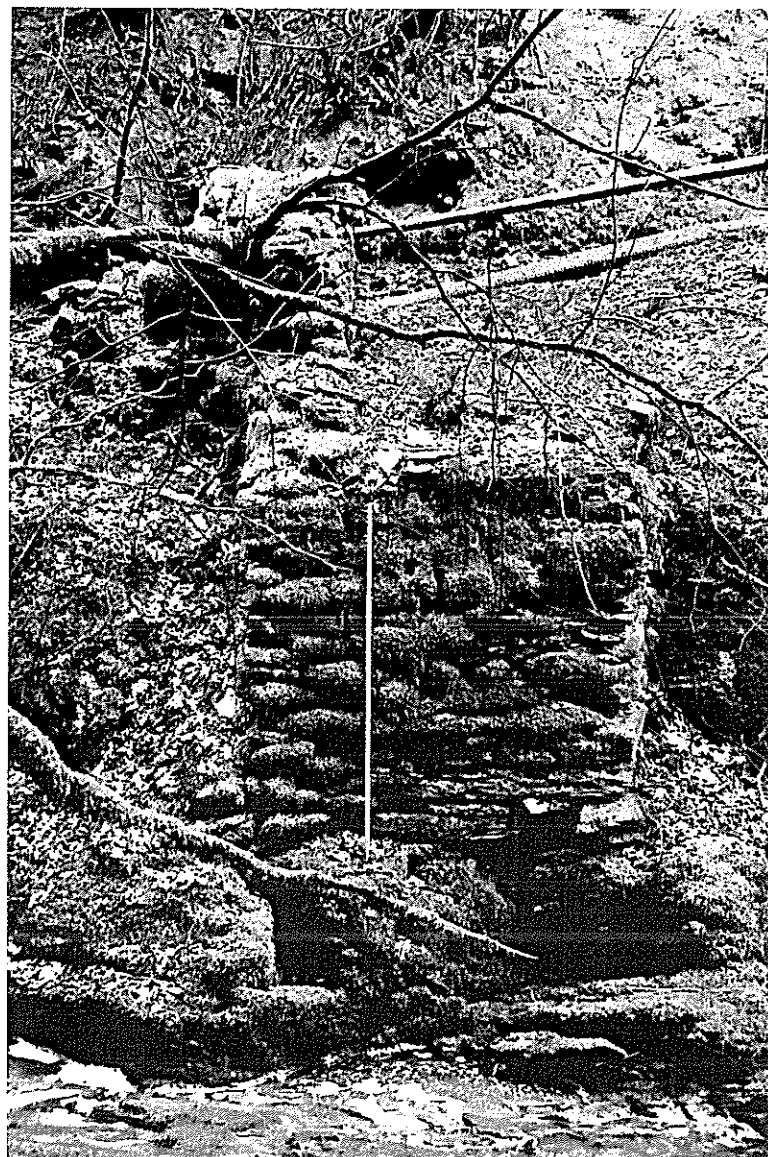
Figure 10

The earliest structure was that of a drystone pier 2.2m wide, 1.8m above the bedrock and projecting at least 1.6m out from the top of the stream bank (figure 10). It was constructed on bedrock which, in the area above the stream, appeared to have been cut to form part of the footings, and also into or on the natural clay bank/hillside material. There was no evidence for timber features in or on the surviving structure (figures 5 and 11). Stone by stone drawings (301-303, figure 6) were made of the elevations; moss cover was left intact where present.

This pier structure, other than a few stones on the northern side, appears to be in reasonable repair. The surface edge stones, however, would be vulnerable to foot damage and some thought should be given to either capping and re-surfacing of the platform of the pier or excluding visitors from this area. Consideration should be given

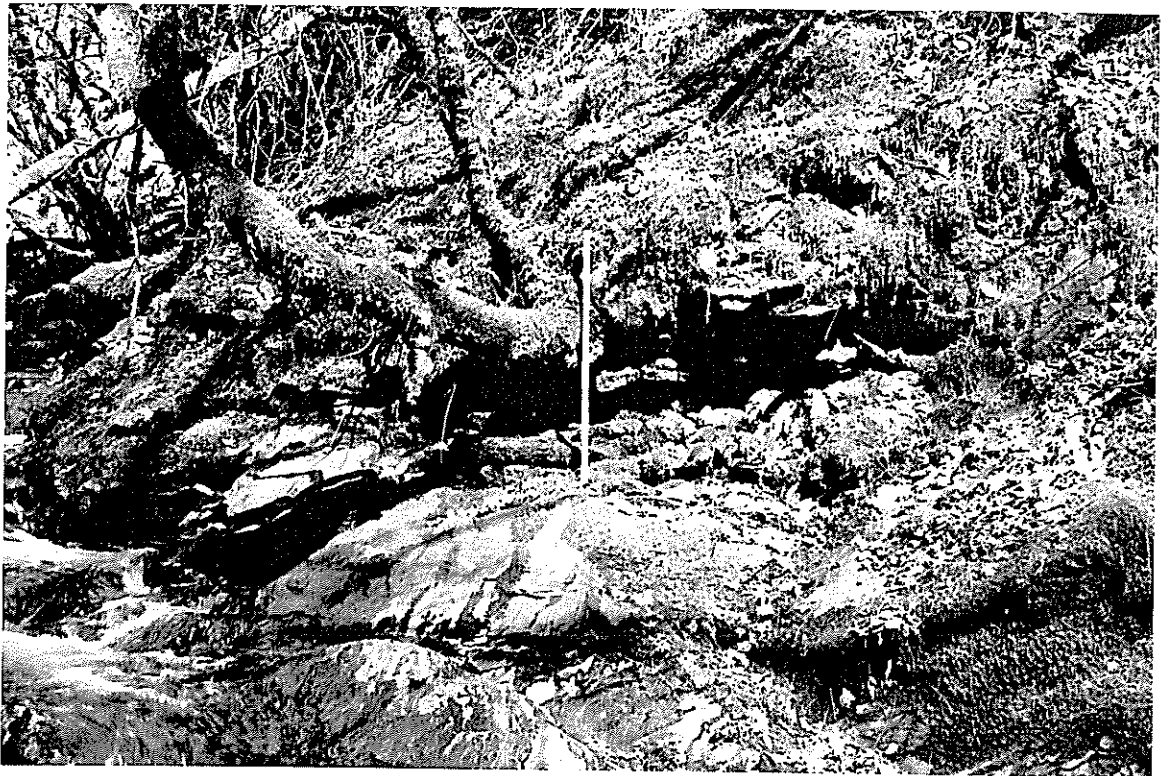
**Figure 13**

**Wall 101:** The remains of what was probably a corresponding bridge pier could be seen opposite that of Site 2 (101, figures 1 and 2). However access was poor and it was in a very ruinous condition (figure 13).

This structure was built on bedrock which slopes towards the stream. In the area where the south western corner and southern face of the pier were probably located the slope was approximately 45°, which may have been a factor in its collapse. However, part of the face remained, adjacent to the stream. Here, partly below the fallen remains of a dead tree, there was a face three courses wide by 5 courses high (approximately 0.5m). There was also a considerable amount of core work and some of the southern face may have survived further up the slope. The core work was at least 1.7m wide. It appeared that these remains possibly ran up the hillside to join the remnants of a footpath, and seemed to have been of similar height to those of the pier on Site 2.

On wall 101 the three dead trees and the one conifer at the top area should be cut down with care and the stumps left to rot in place.
