A PRELIMINARY SURVEY  
OF  
**HAFOD ICEHOUSE**  
RECORD NO. 26535

**REPORT NO. 35948**

Commissioned by: Hafod Trust

## **HAFOD ICEHOUSE (Hafod Archaeological Database No. 26535) A PRELIMINARY SURVEY**

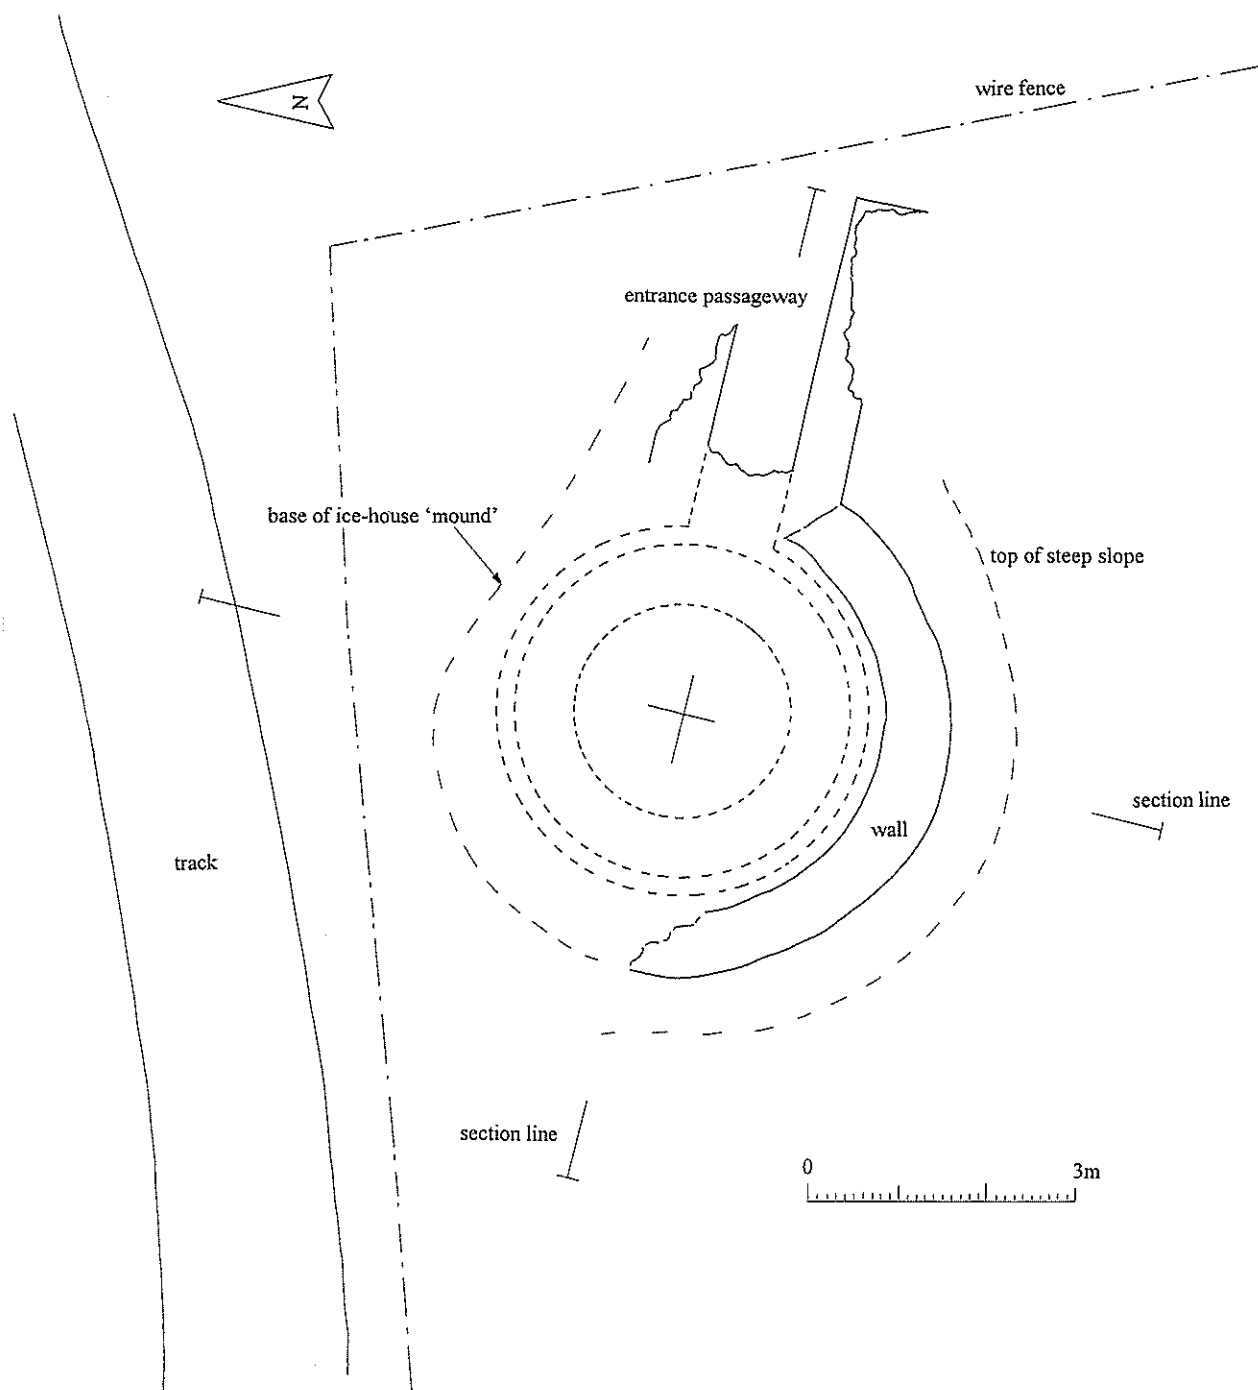
*Figure 1. Plan of Hafod icehouse.*

The icehouse entrance passageway is in a very poor state of repair: the stone vaulting has collapsed apart from a c. 1m section adjoining the icehouse's dome, much dilapidation has occurred to the stone-built side walls (the north wall in particular) and rubble has accumulated in the passageway. Nevertheless, it is possible to detect the original plan. The passageway was 3.9m long, 1.1m wide, 1.9m high and built of coursed rubble. A mortar scar of a removed door jamb is visible adjoining the chamber. The walls of the passageway are butt-joined onto the masonry of the chamber, but this is probably a reflection of the building technique employed rather than of chronological significance.

The interior of the chamber and dome of the icehouse is in very good condition. There is no evidence of root penetration from the shrubs growing above. It is built of coursed rubble. The chamber is cone-shaped, 3.35m diameter at the top narrowing down to c. 2.15m at the lowest visible point. Its depth down to rubble which fills its lower levels is 3.3m. This rubble is of unknown depth and presumably fills a sump and drain. The dome is 3.7m across at its base and is estimated to be semi-hemispherical in shape (it was not possible to conduct detailed measurements). Despite the step at the junction of the chamber and dome, there is no reason to suspect that they were not of one build.

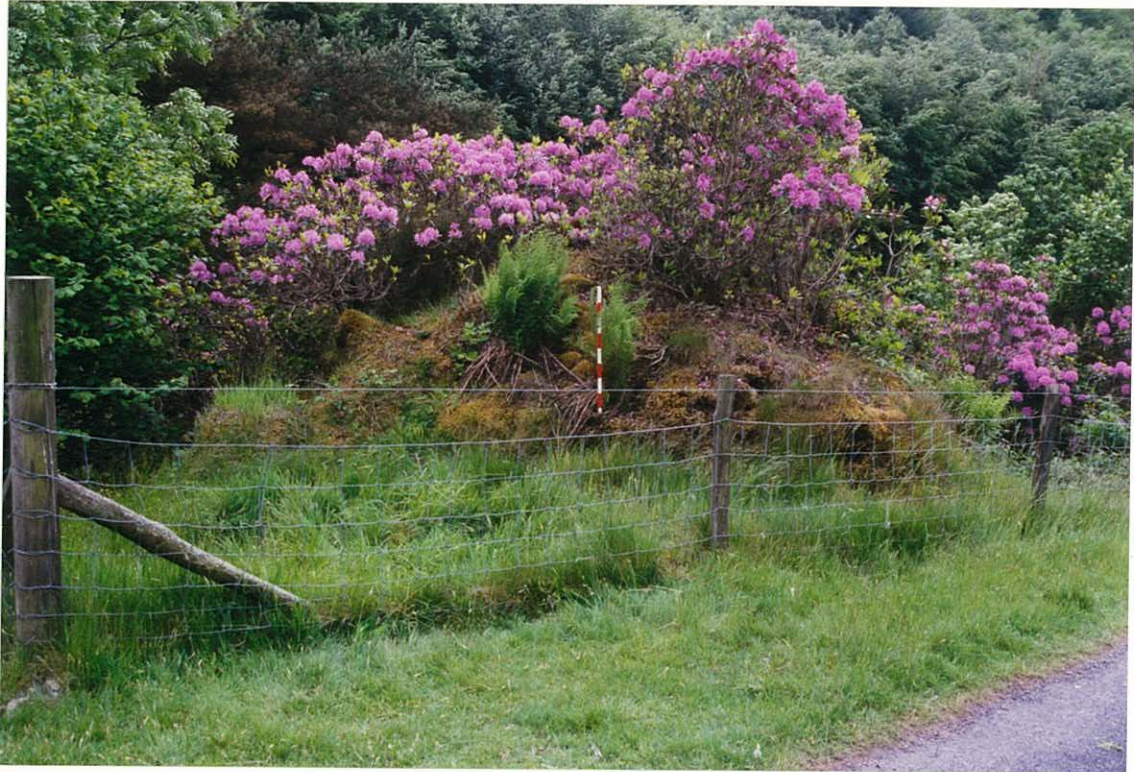
*Photo 1. Icehouse from the north-east.*

**Immediate action:** the rhododendron and hazel scrub growing on and near the dome of the icehouse should be removed and killed to prevent future growth. Also a band of ground stretching c. 5m either side of the icehouse should be cleared of rhododendrons and the ash tree down to the river, as roots may eventually begin to penetrate through to the icehouse chamber in the made-up ground. This ground should be returned to grazing land.

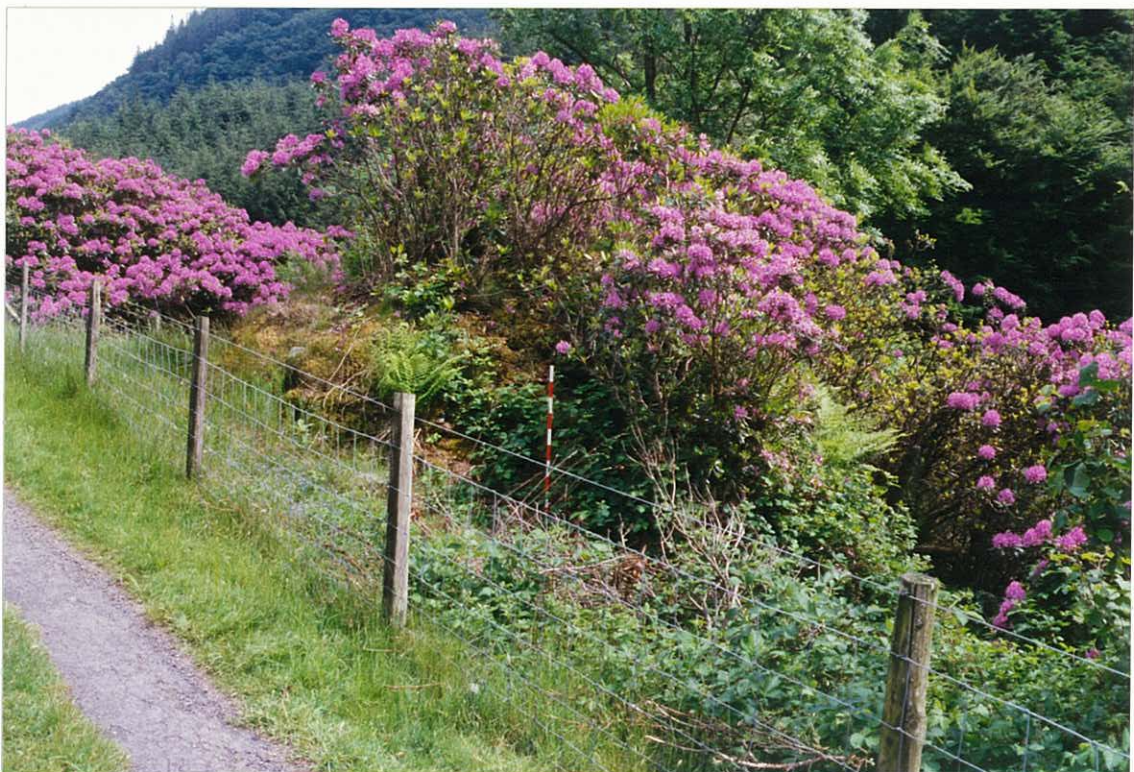
*Photo 2. Icehouse from the north-west.*

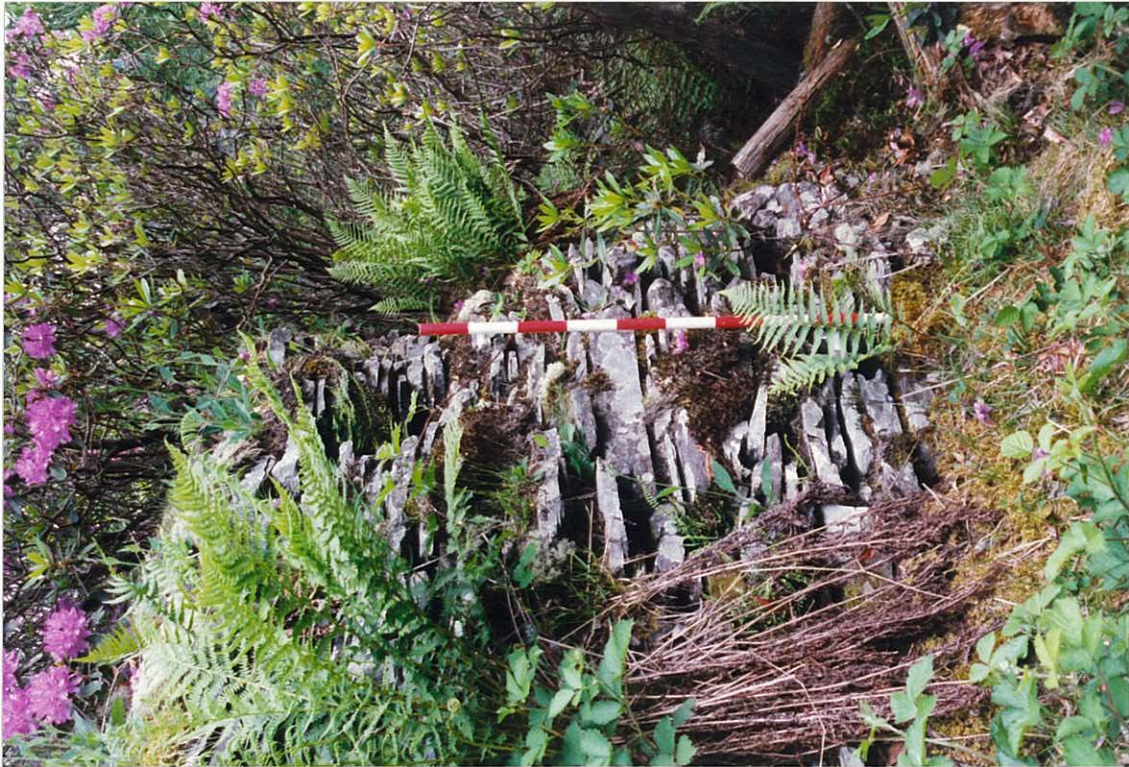
*Photo 3. External wall on south-west side.*

**Medium term:** Although the interior of the icehouse appears in good condition, the state of most of the external masonry is not known due to vegetation cover. An area of vegetation and accumulated soil should be removed using archaeological techniques from part of the icehouse mound to examine the condition of the masonry. The amount of any restoration work would depend on the condition of the uncovered masonry.

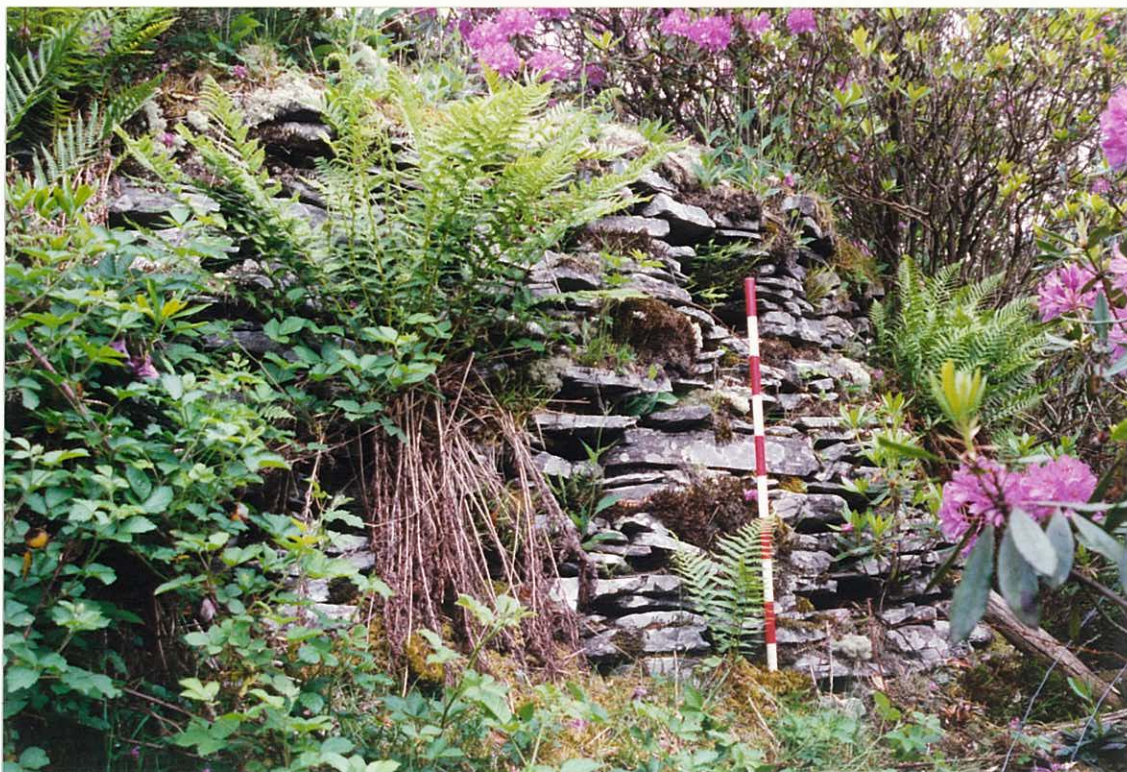
*Photo 4. External wall on south side.*

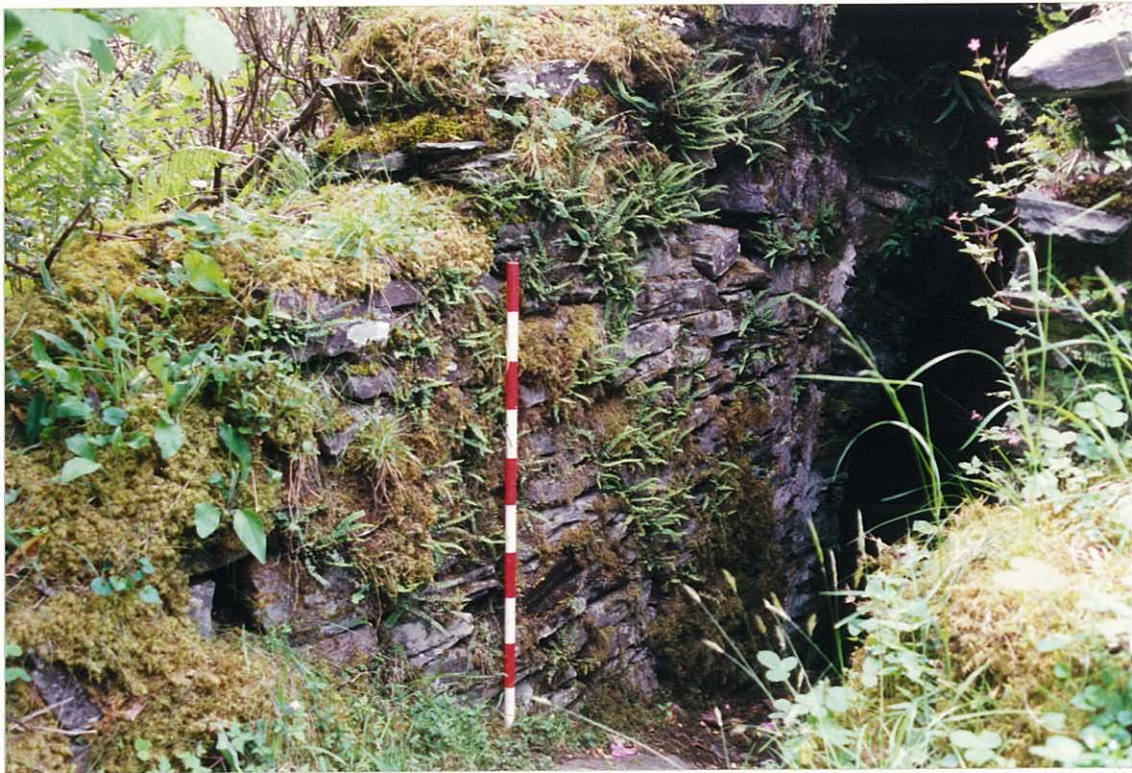
*Photo 5. South passageway wall.*

**Short term:** to prevent further decay to the passageway, repointing of the side walls is required.

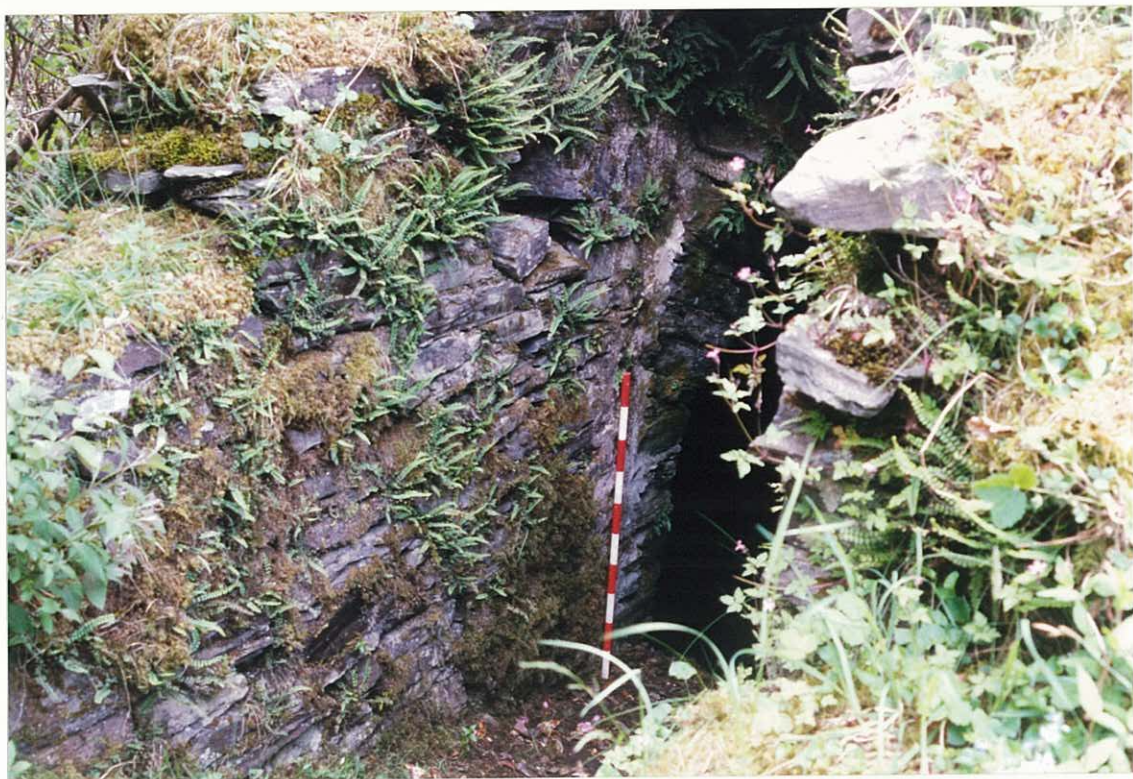
*Photo 6. South passageway wall.*

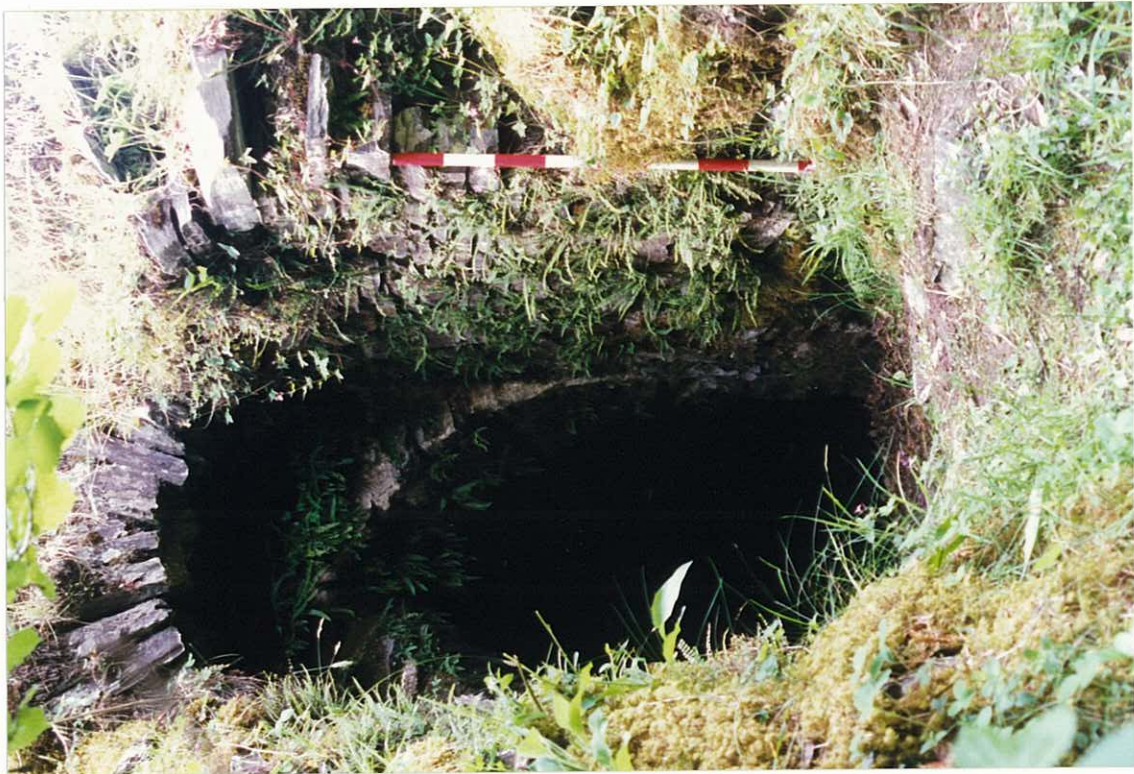
*Photo 7. Entrance.*

**Replacement of icehouse door:** two designs have been suggested: a solid door with 'letter box' for bat access and an open grill. Archaeologically there is little to choose between the two. However, a solid door will not allow visitors to view the icehouse's interior and will impede ventilation. The latter may lead to the build-up of toxic gases, particularly if there is vegetation matter mixed with the rubble in the base of the chamber.

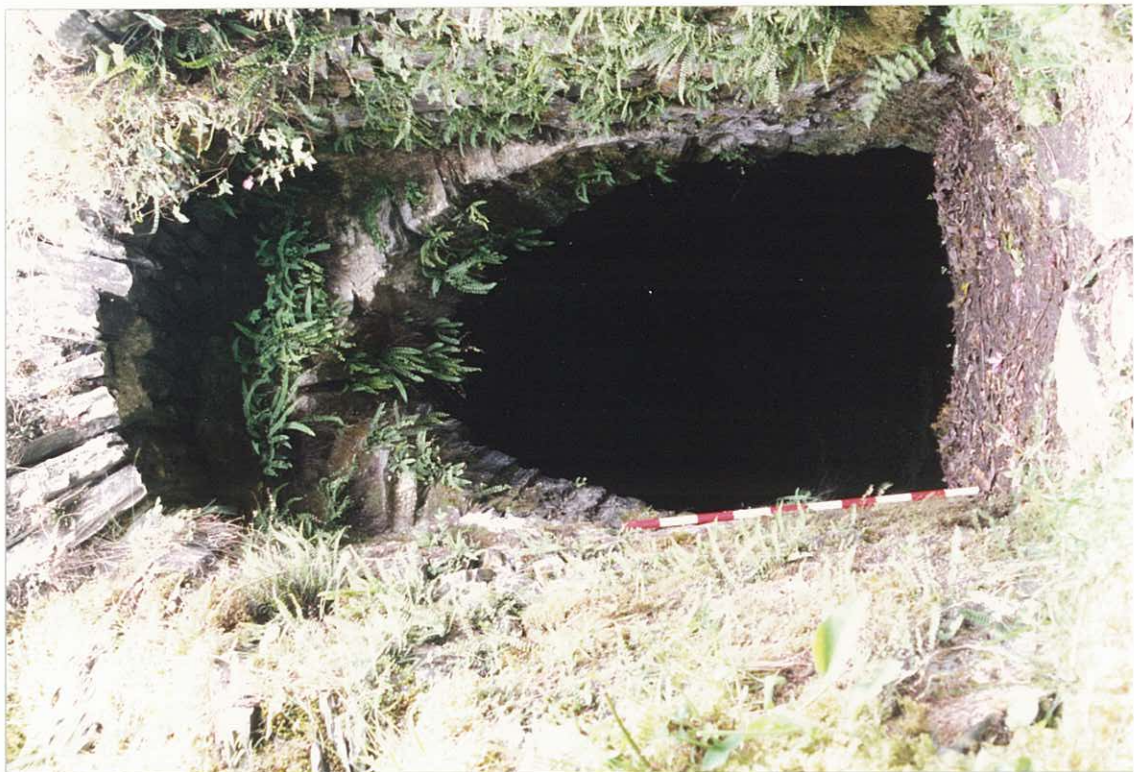
*Photo 8. Entrance.*

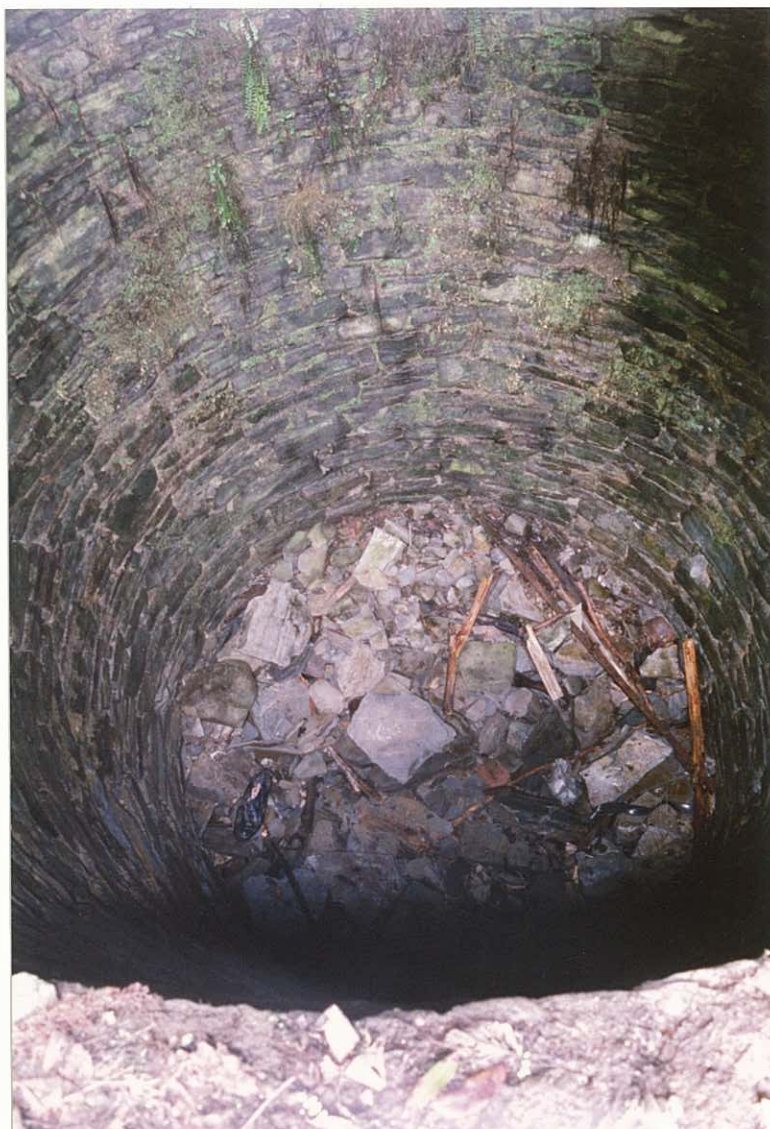
*Photo 9. Interior of the icehouse*
