WHITLAND ABBEY

Carmarthenshire

**STANDING BUILDING, GEOPHYSICAL AND TOPOGRAPHICAL SURVEYS
FEBRUARY 1999**

Project Record No. 37011

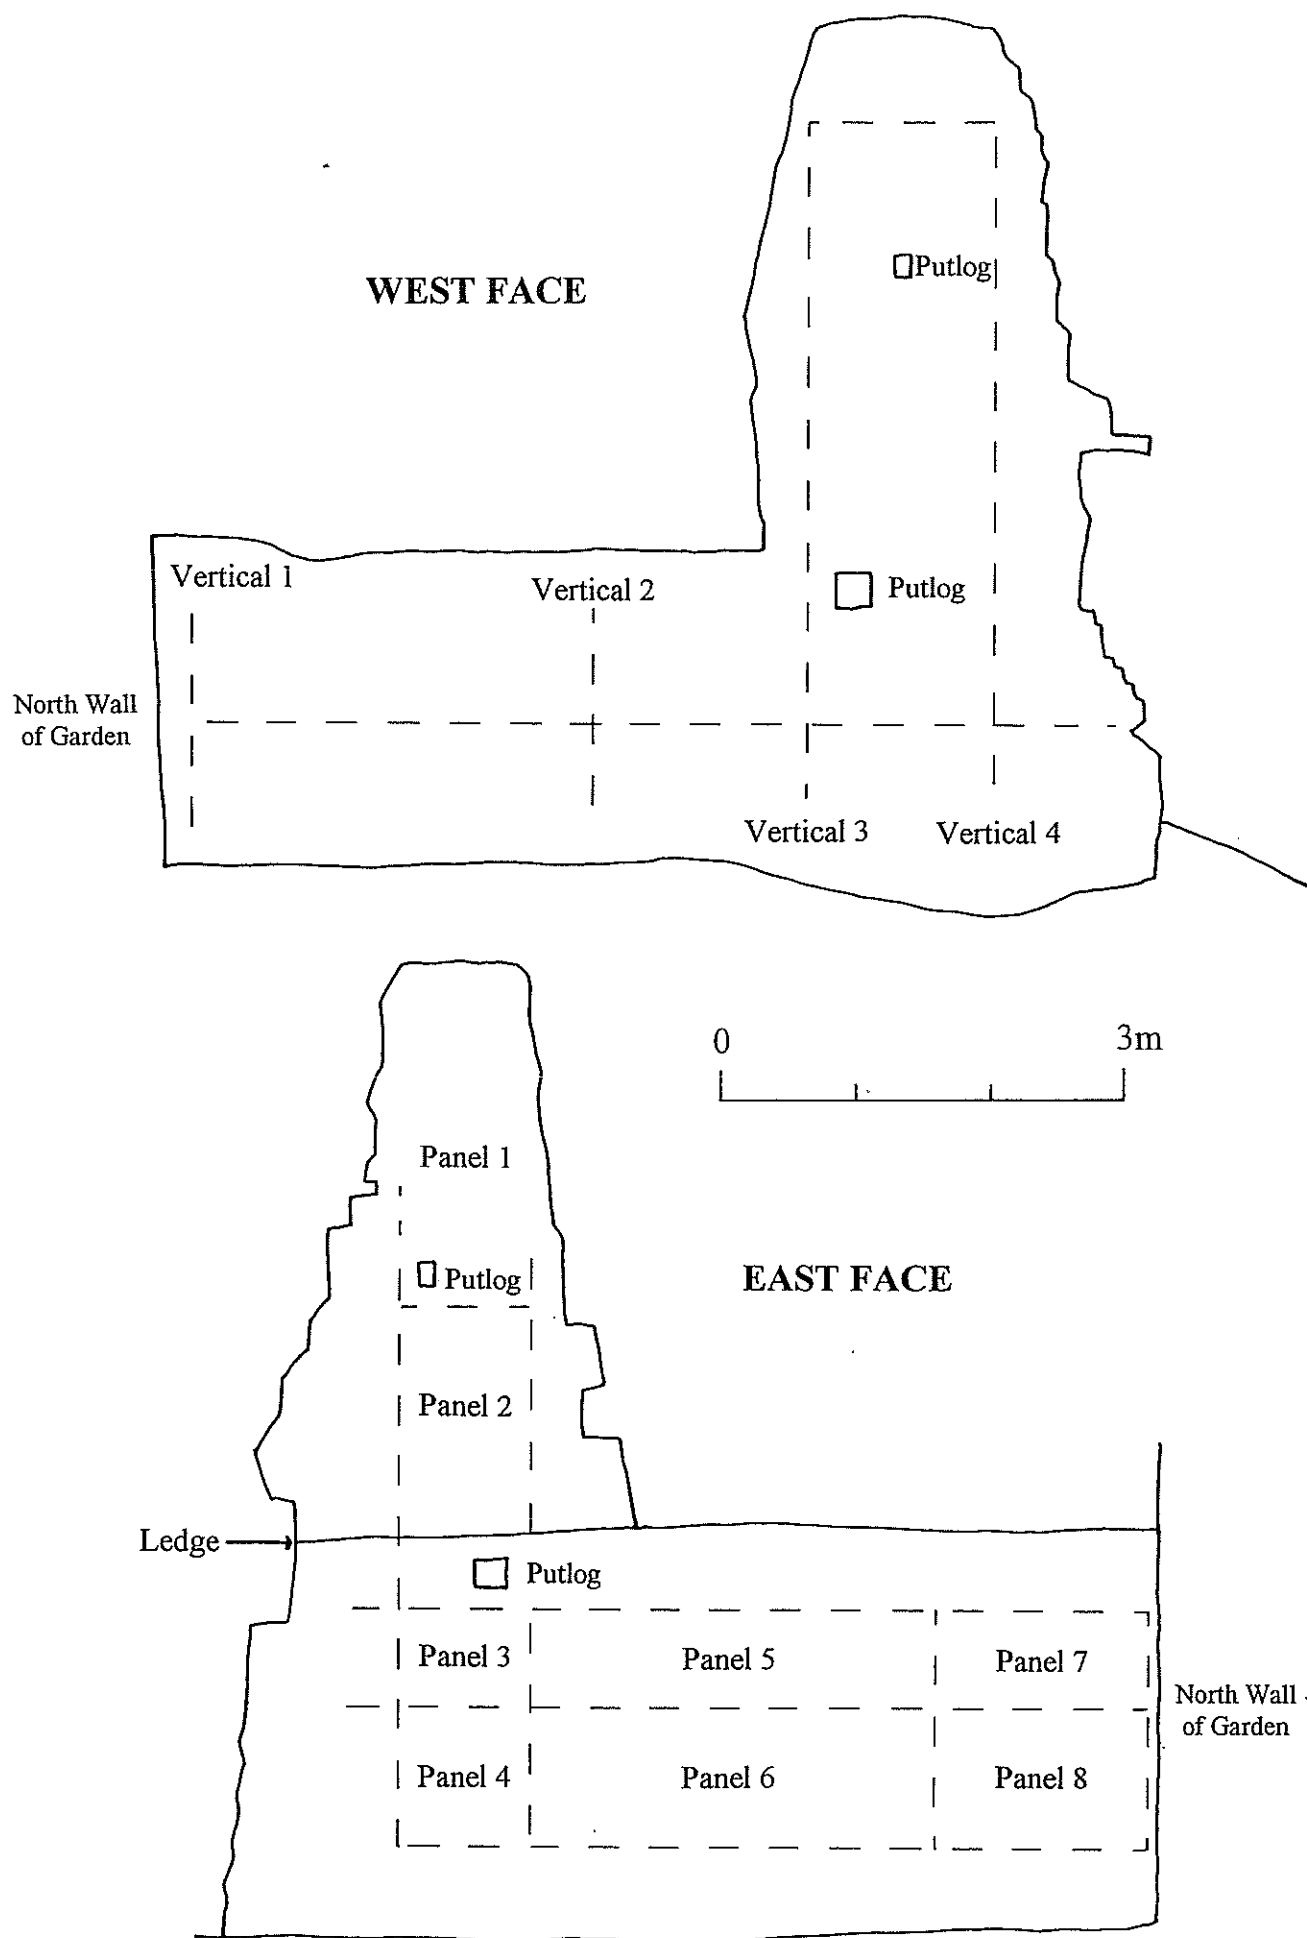
Figure 3: Elevations of Remnant of Cloister Wall (showing location of photogrammetric grid).

A 5m stretch of what is believed to be the west wall of the cloister, runs south from the north wall of the garden (see figure 3). The line of the wall appears to continue southwards as a low pile of rubble (which may have resembled a wall more formally in the past), until it reaches the late greenhouse foundations (apparently coinciding with the line of the southern cloister wall). The cloister wall appears to abut the north wall of the garden. The tallest surviving portion of upstanding wall is in a very fragile condition, and cannot be expected to survive much longer in its present state.

Apart from two putlog holes, there are no architectural features in this face of the wall. It is not clear whether this was an external or internal wall face.

In addition to two putlog holes, the east face of the cloister wall exhibits a ledge 0.18m wide, apparently running the surviving length of the wall. It is presumed that this was to support a roof around the cloister. It is possible that this portion of wall has survived through being incorporated into a later building, greenhouse, or as a 'romantic' feature.

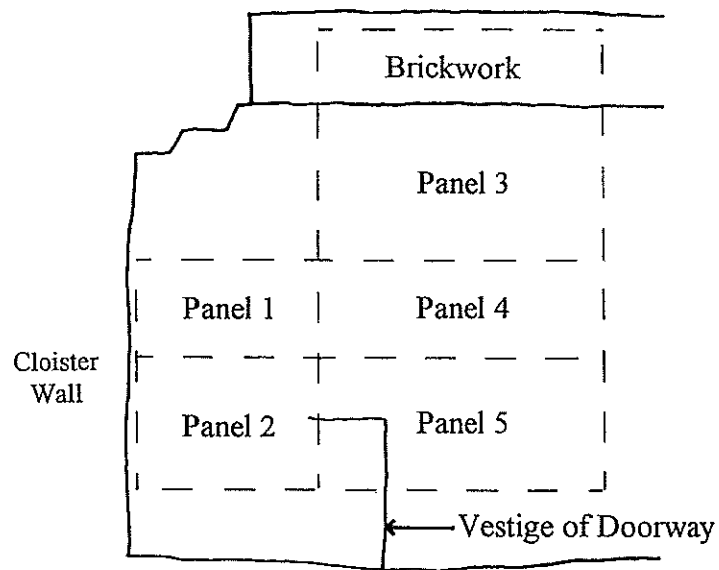
Figure 4: Elevation of Part of Northern Garden Wall (showing location of photogrammetric grid).

Immediately to the east of the west wall of the cloister, the remnants of one side of a possible doorway are visible in the south face of the northern garden wall (see figure 4). It is, however not certain that this remnant is medieval in date, and could relate to post medieval re-use of some of the site. The stone used in this section of wall differs considerably from that used elsewhere, and the doorway remnant is not constructed from dressed Oolitic Limestone (as might be expected).

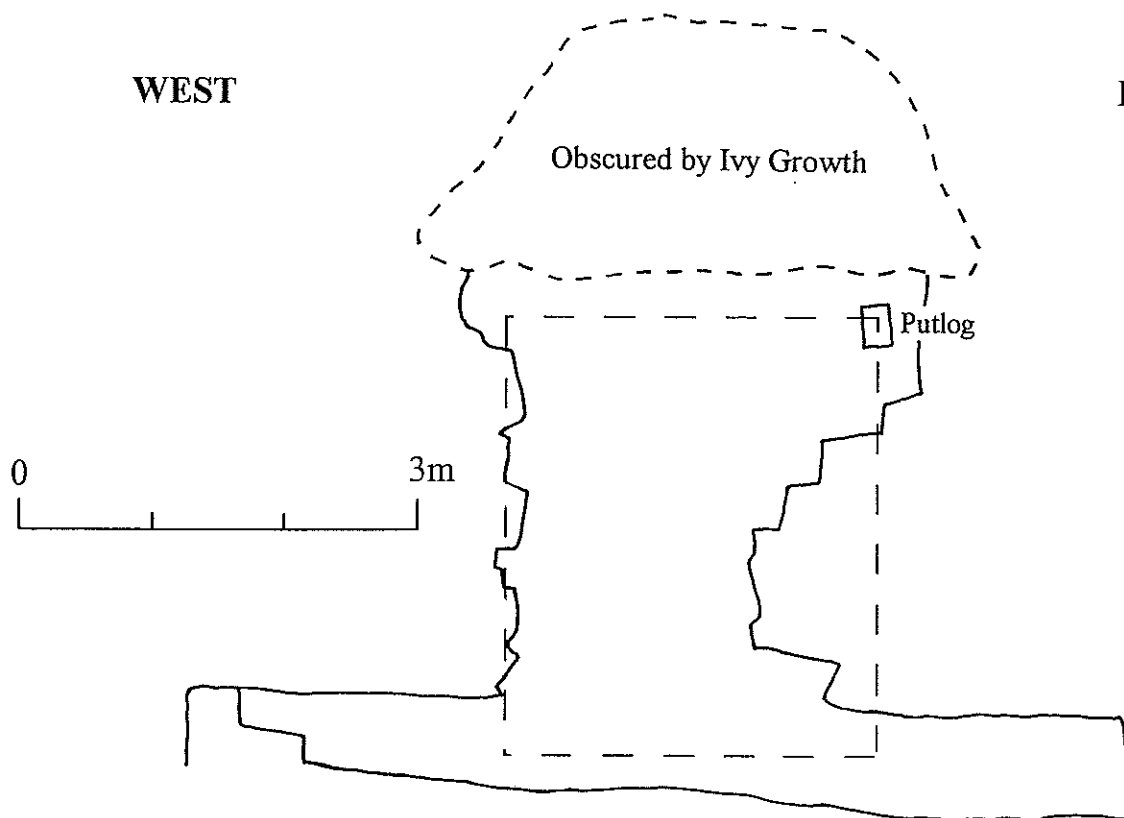
Figure 5: Elevation of South Face of Remnant of Possible Gatehouse Wall (showing location of photogrammetric grid).

In the field immediately to the west of the walled garden is a remnant of upstanding stonework running east-west. This is believed to be part of the abbey gate house. The wall is in a very overgrown and fragile state. Only limited removal of ivy was undertaken so only a small amount of stonework was clearly visible (see figure 5). One putlog hole was visible on the south face of the wall, but other architectural features may have been obscured by ivy growth. The fact that this wall sits on higher ground than its surroundings may suggest that the area has been robbed of stone.

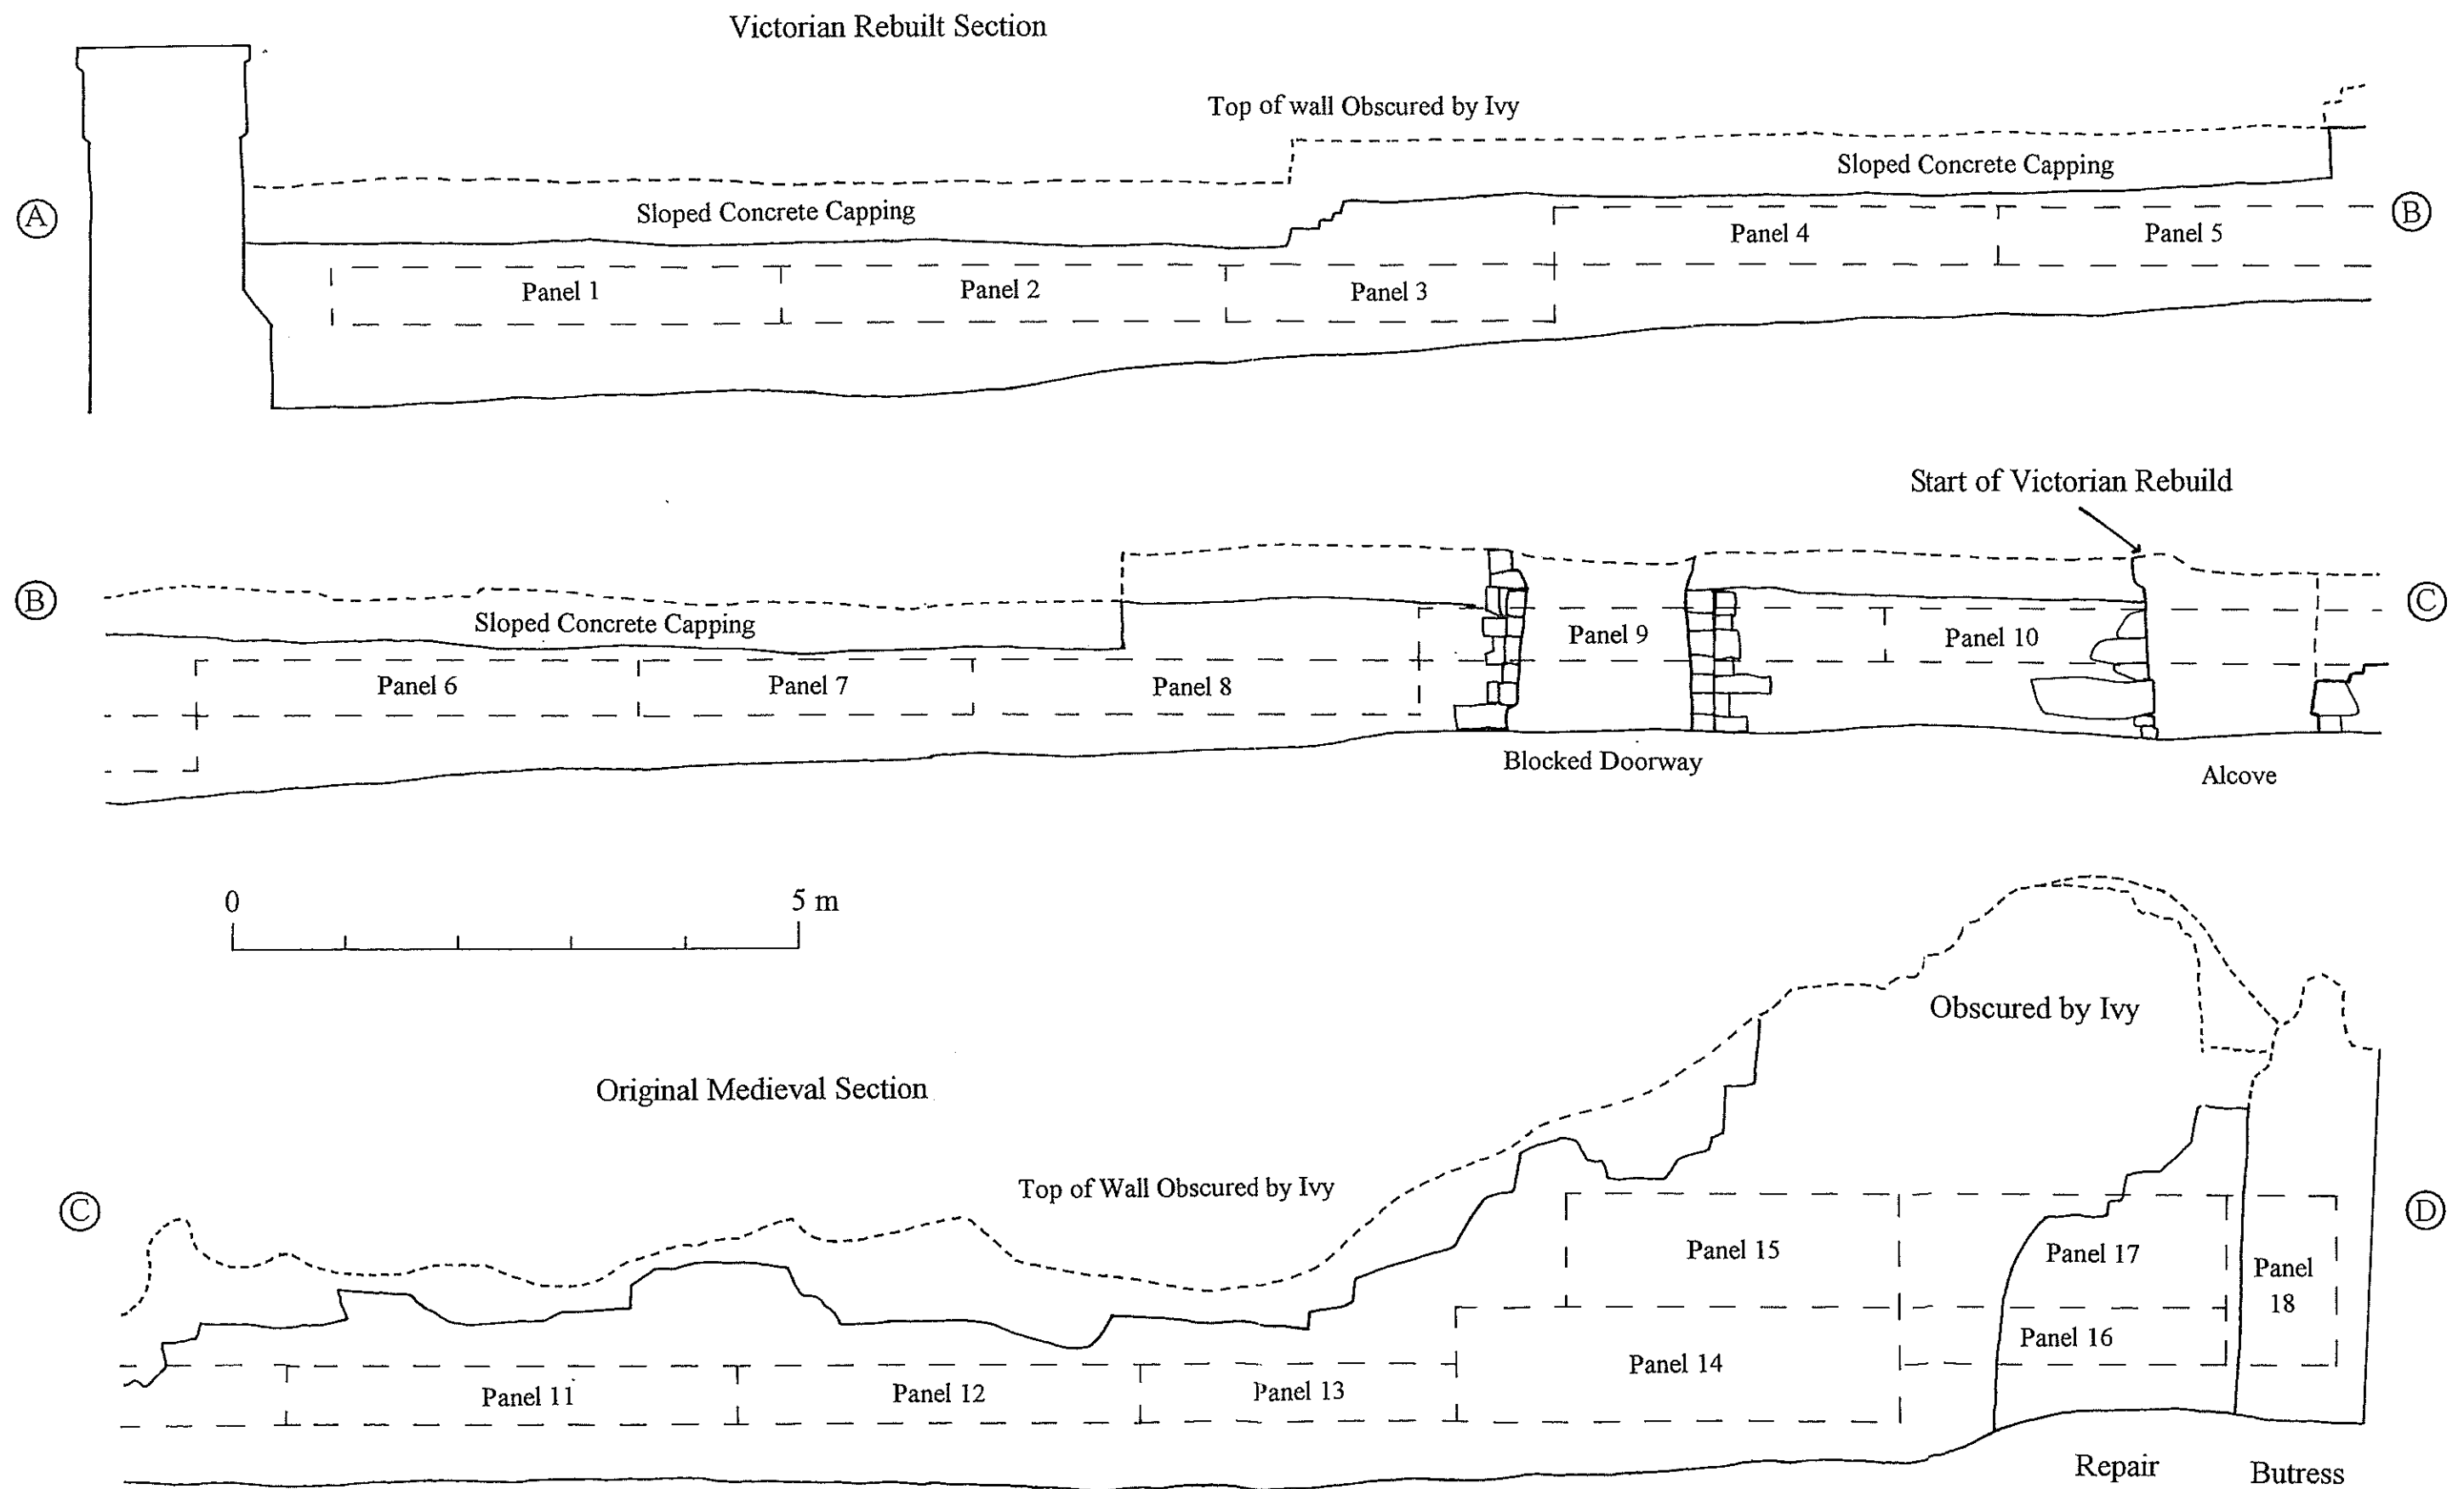
Figure 1: East Facing Elevation of Western Garden Wall (with location of photogrammetric grid).

The East face of the rebuilt section of the garden wall differs slightly from the west face. (see figure 1) Firstly, there is more extensive ivy growth. This is most pervasive along the top of the wall and has caused considerable damage to the sloping concrete wall capping. In addition, possibly due to its aspect and the degree of weathering and ivy growth, there is much poorer survival of mortar/pointing. The distinctions between the stonework of the later rebuild and the original section that were visible on the western face are much less distinct on the east. The size of stones and the mode of construction are harder to differentiate. This may suggest that only the west face of the wall has been rebuilt and repointed.

As with the western face of the wall, the only architectural feature in the rebuilt section is the blocked doorway (Panel 9). On this side of the wall the blocked doorway forms an alcove, which may mirror the alcove in Panel 10 (see below). The doorway is severely damaged by ivy and a tree sapling.

A few meters to the north of the blocked doorway is another alcove, of which there is no trace on the west face. It does, however, correspond exactly to the point on the western face, where the interface between the original and later builds is apparent, suggesting that this alcove is an original medieval feature (possibly a fireplace?). Its exact character is obscured by fallen stones, ivy and tree saplings, but it may have been utilized as a garden feature in the Victorian period, forming a pair with the alcove formed by the blocked doorway.

As noted previously, the top of original medieval stretch of wall (from Panel 11 northwards), is irregular and not capped with concrete. The stones are generally larger and although there are no strict courses visible in the stonework, the use of thin flat stones to level up between courses of larger stones is clearer than was the case on the western face. Ivy growth obscures any architectural features that may survive along the top of the wall, becoming especially problematic north of Panel 13.

Where the wall survives to its greatest height it is largely obscured by ivy growth. This is currently helping to consolidate the tops of the wall which are in a very precarious state. In its present condition it was not possible to locate any putlog holes or other architectural features in this face of the wall.

At the northern end of the wall (Panels 16 and 17) there appears to be a repair or rebuild to the wall (see figure 1). Its southern edge is obscured by ivy growth, and its north edge appears to be obscured by a buttress extending 0.35m out from the wall face (Panel 18). The stone used in the repair and the buttress is markedly different from the rest of the wall, consisting of blocks of worked Oolitic Limestone. It is unclear whether this represents a monastic period repair, or a repair and strengthening to the wall when the north wall of the garden was built. The change in stonework is not visible in the west face of the wall.

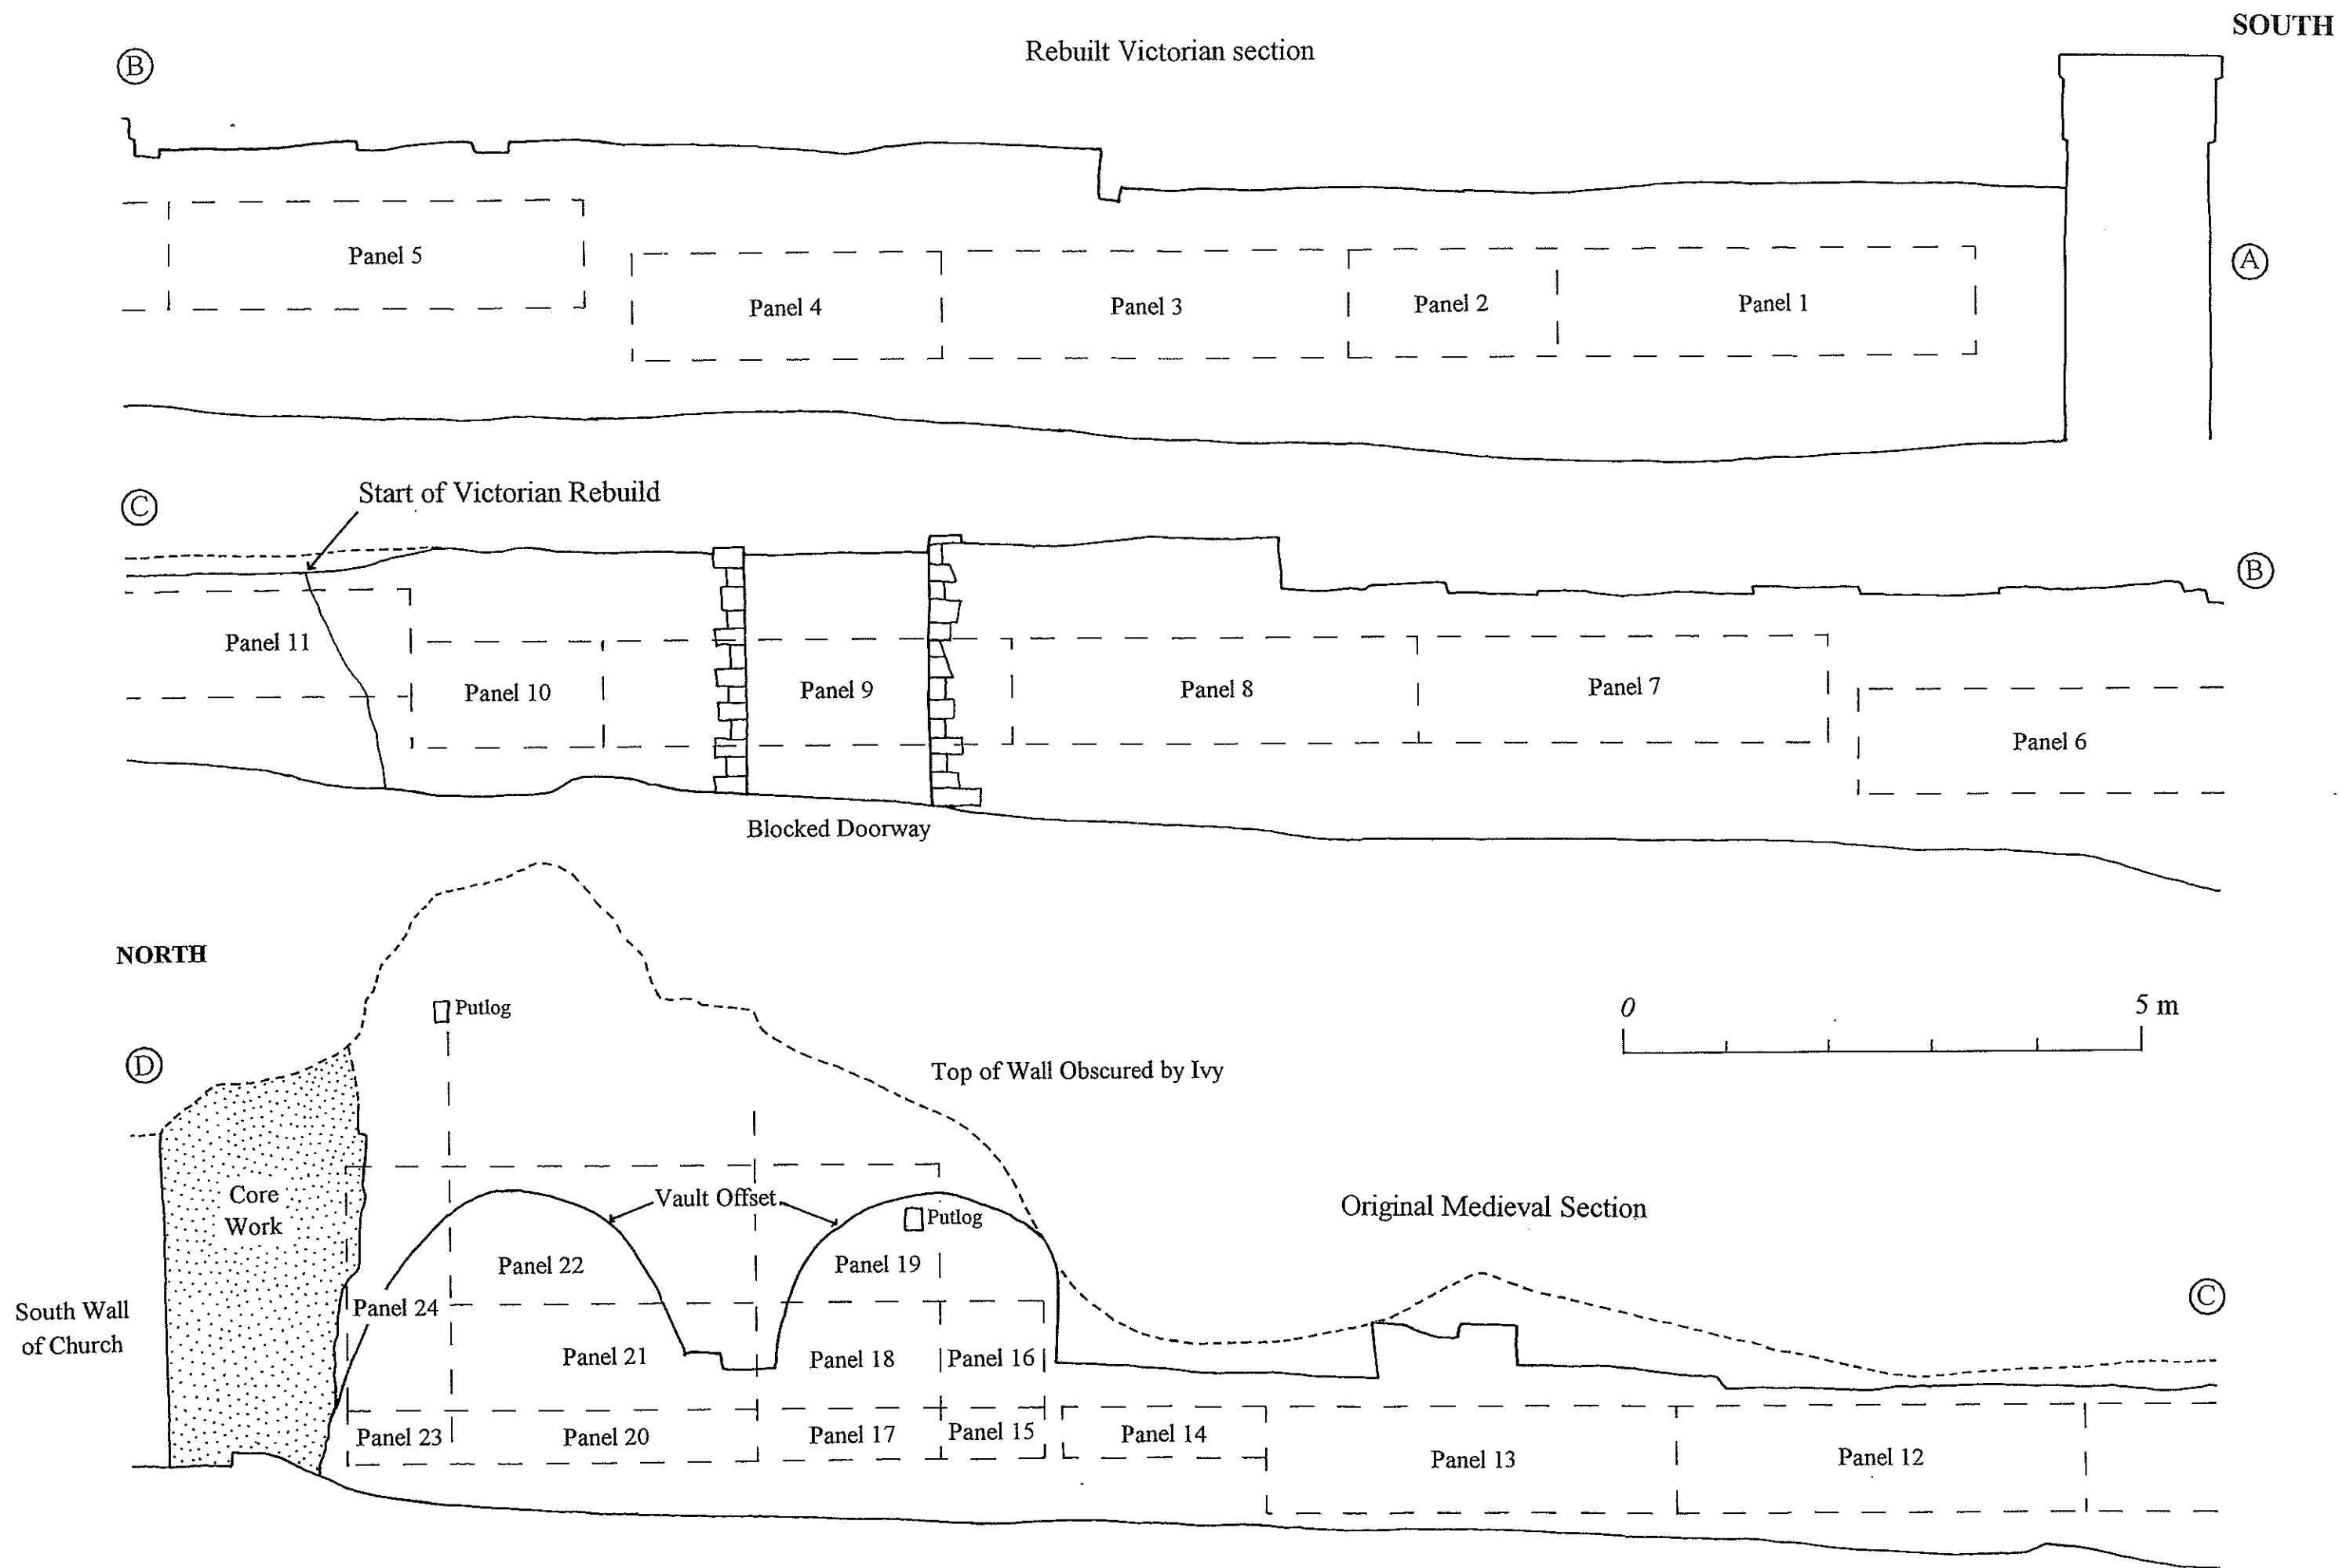
Figure 2: West Facing Elevation of Western Garden Wall (showing location of photogrammetric grid).

The west face of the garden wall seems generally better preserved than the east face, with ivy growth being less established. As a result architectural details are clearer. There appears to be a distinct change in the size of stones and character of construction at the southern end of Panel 10 (see figure 2). South of this point is considered to be a 19th Century rebuild of the wall. Stones are generally smaller and more carefully dressed, with better preserved mortar/pointing. There is no clear coursing in the construction of this section of wall, but the overall effect is neater in comparison to the Medieval wall. It is also from this point that the sloped concrete capping (visible on the east face of the wall) begins.

The fact that this section of wall is rebuilt has implications for the interpretation of the blocked doorway (in Panel 9). The alignment of this doorway with both the gate house and the gap in the north-south cloister wall (where it joins the greenhouse) may suggest that its position represents a doorway present in the original medieval building plan. It would presumably have been included as an architectural curiosity when the wall was rebuilt. Alternatively, the doorway may have been a 19th Century embellishment re-using medieval dressed stone to create a doorway into the garden that was aligned with later garden features.

From Panel 11 northwards, the wall is thought to be the original medieval build. There is little or no surviving mortar or pointing and the stonework seems to be less carefully

The top of the wall does not appear to be capped with concrete as it is in the rebuilt section. As a result there has been more extensive growth of vegetation which may be obscuring architectural features, especially above panels 13 and 14.

The northern end of the wall is considerably overgrown with ivy, which while it is to some extent holding the stonework together, is also causing it to collapse. The upper parts of the wall are distinctly unstable and bow out to an alarming degree. Many of the voids visible in the wall face are thought to be where stones have fallen, rather than putlog holes.

The clearest features in the wall are two 'vault offsets', protruding from the face of the wall from 0.10m to 0.25m, which would have supported vaults running east - west. The southernmost vault appears to have been repaired (above Panel 16) with blocks of Bath stone. There is no clear evidence that further vaults continued to the south.

The northern limit of the wall has collapsed, exposing core work. It appears to have abutted the wall that forms the north wall of the garden. Although it is on a similar alignment, it is uncertain whether this wall is the original south wall of the church. (see discussion of the east face of this wall).
