# **PILL PRIORY, LOWER PRIORY, MILFORD HAVEN**

**STANDING BUILDING, GEOPHYSICAL AND TOPOGRAPHICAL SURVEYS  
FEBRUARY 1999**

**Project Record No. 37115**

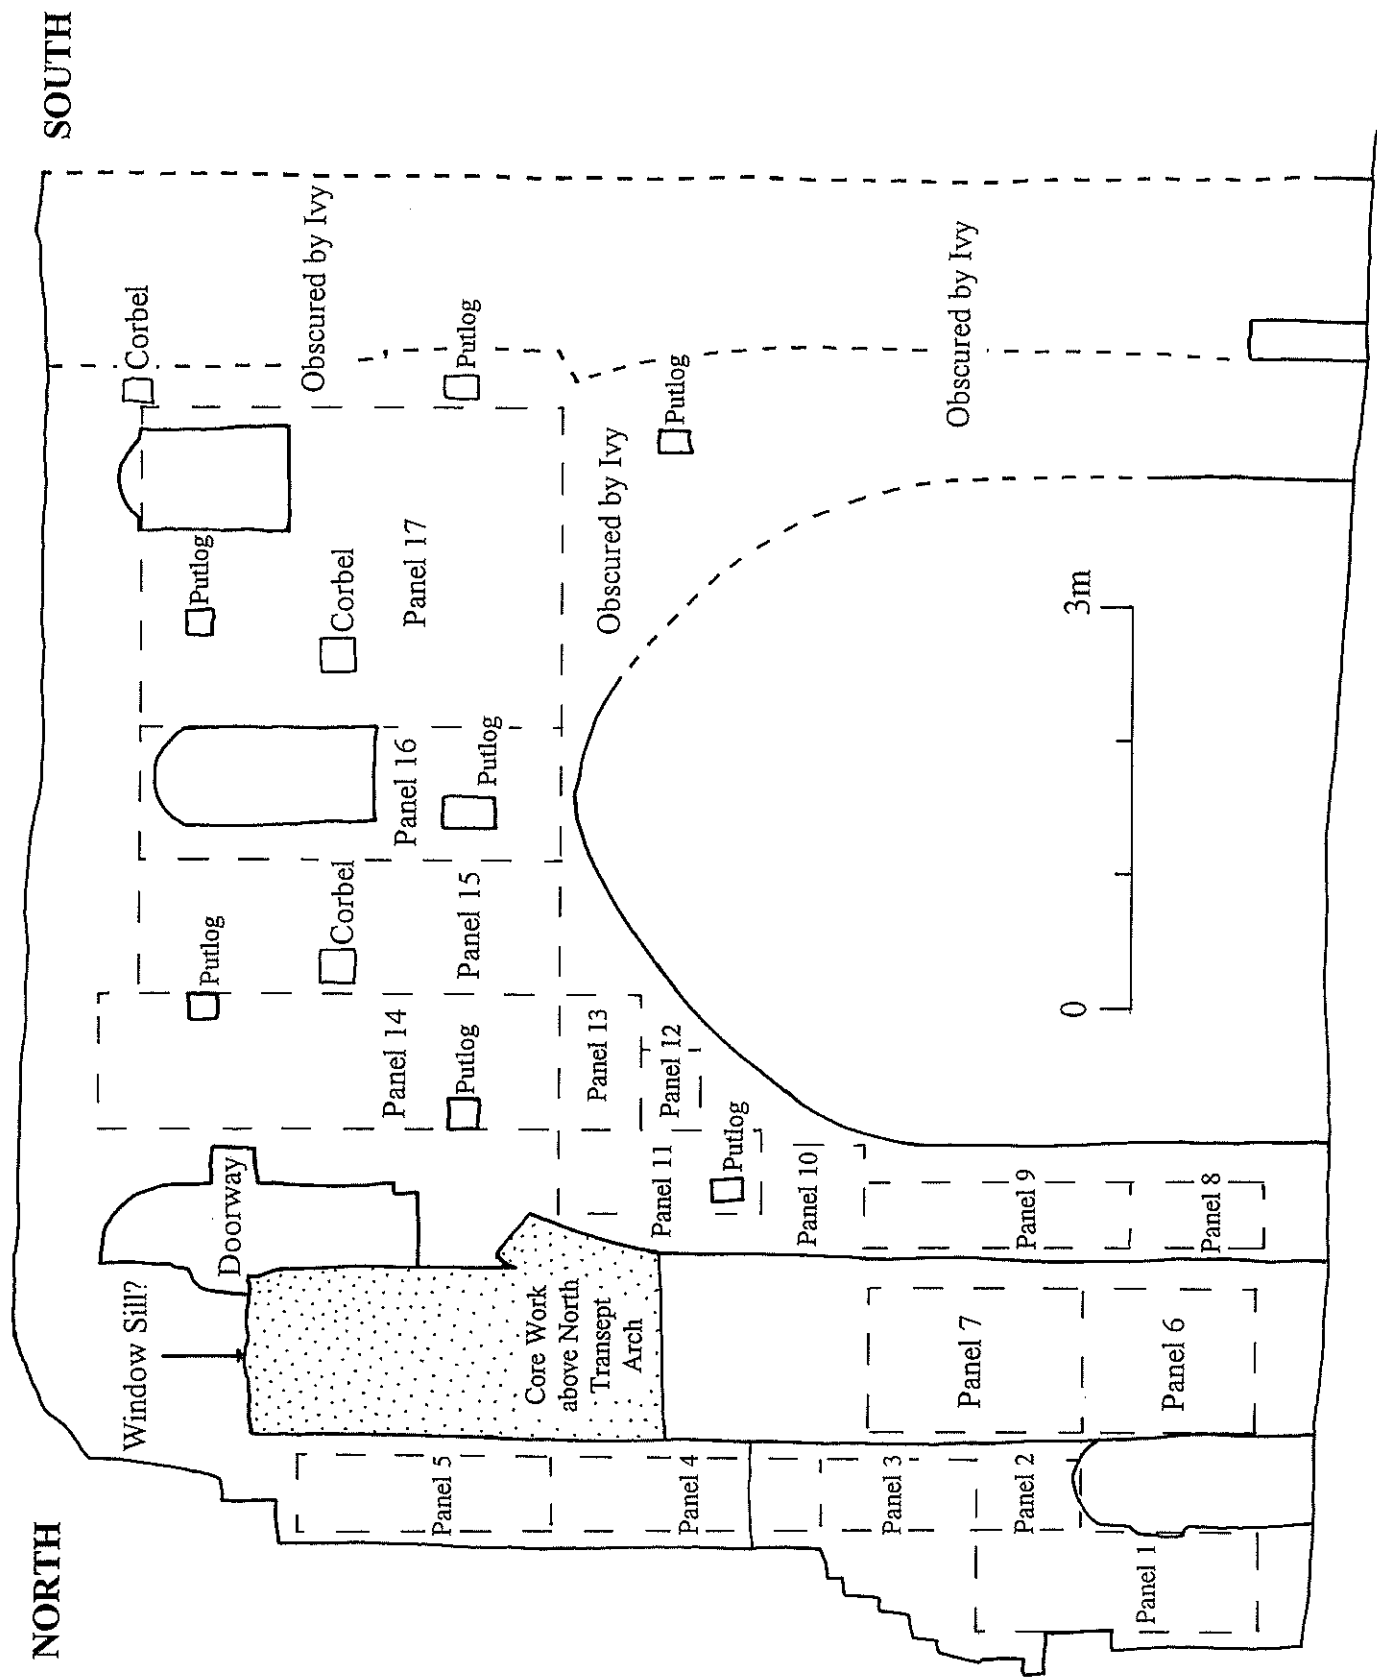
**Figure 1:** West face of Chancel Arch  
(showing location of photogrammetric grid).

The west facing elevation of the chancel arch (Figure 1) presents features of the interior crossing and tower chamber. In addition, the elevation presents the remains of the arch springers for the north and south transept arches and a small remnant of the west wall of the north transept including the doorway to the tower stairs.

Directly above the chancel arch (panel 16) is a doorway with a two centered arched head. This appears to lead from the first floor tower chamber to the roof space of the chancel

(see Section 3.1.2). On either side of this doorway are two corbels. Since these corbels appear to be positioned above the likely floor level of the first floor, it is assumed that they supported the floor of the second storey. It is not clear how both the corbels and the doorway relate to the projected line of the presumed vaulted ceiling of the crossing (indicated by the vestiges of ceiling vault remaining on the stubs of the north and south transept arches - see Figure 1). A third corbel is situated in the top right hand corner of panel 17. It is assumed that this supported the second floor of the tower. It is possible that the three putlog holes at the bases of panels 14, 16, and 17 (below the level of the corbels and the two doorways) may have supported the beams for the first floor.

To the south of the central doorway (panel 17) is an arched window which appears only as a slit window in the east facing (external) elevation. This window would have lit the first floor tower chamber. To the north of the doorway is a second doorway which leads from the tower stair into the first floor tower chamber. A slit window on the east facing elevation lit this doorway.

Seven sockets (putlog holes?) are evident above the chancel arch. It is possible there are one or two others obscured beneath dense ivy growth on the south side of the arch.

At ground level in the south east corner of the north transept is a doorway (Figure 1, below panel 2) with a two-centered arched head, leading to the base of the spiral stair of the tower. The bottom portion of the spiral stair has been removed. Little more of the east wall of the north transept survives. It is suggested, in A. J. Parkinson's RCAHMW notes on the standing remains of Pill Priory, that the north transept was in fact never completed. The presence of a scar for the roof of the north transept between panels 4 and 5 in Figure 3) and in panel 4 of the west facing elevation (Figure 1), coupled with archaeological evidence for the north wall of the north transept (Ramsey, 1998), suggests that this is not the case and that the transept was completed.

Part of the east side of the north transept arch survives. In the west facing elevation, the inside face of the arch is visible (Figure 1, panels 6 and 7) as well as the core of the arch itself. There are traces of the base of a ceiling vault on the south face of the transept arch. Although it would have spanned the crossing, it is difficult to project the likely line of this vault, especially in relation to the corbels and the centrally positioned two-centered arched doorway above the chancel arch.

The remnant of the south transept arch is essentially entirely obscured by thick ivy growth (Figure 1). Without being cleared, it can only be assumed to be similar to the north transept arch.

The base of the south transept arch retains traces of plaster and lime wash. While some of this may be original (traces of original plaster survive elsewhere), the southern part of the chancel arch has in the past formed part of a cottage that occupied the area of the south transept (demolished some time after 1922) and the plaster/lime wash may date from this period.

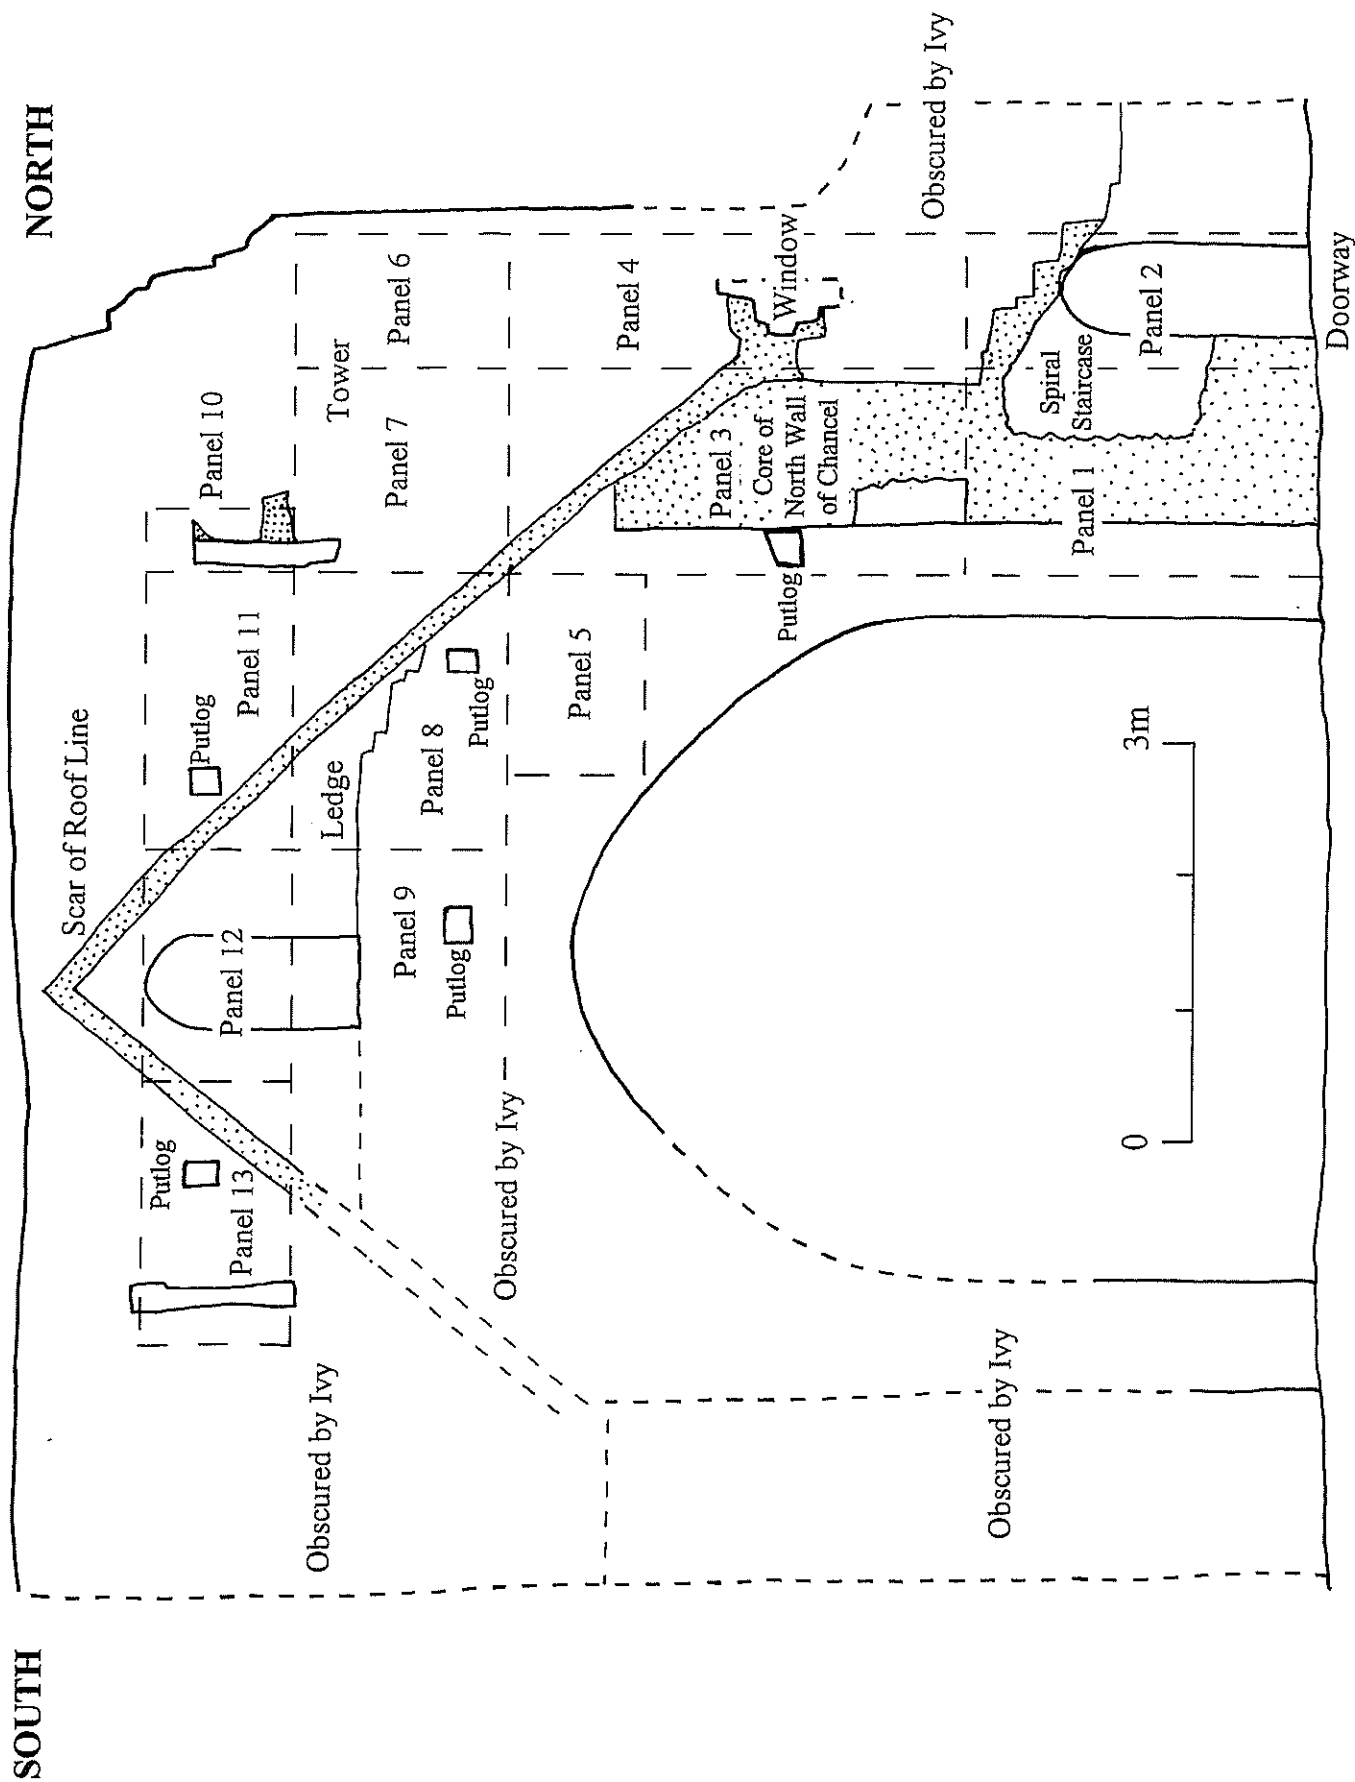
**Figure 2:** East Face of Chancel Arch  
(showing location of photogrammetric grid).

As with the west face, the southern half of the east facing elevation is largely obscured by ivy growth which may mask one or two sockets. Clearly visible is the pitched roof scar of the chancel. Immediately below the apex of the roof scar (panel 12) is the doorway described in Section 3.1.1. At the level of the sill is a ledge running the width of the roof at this point. This is presumed to have supported the ceiling of the chancel. The doorway would therefore appear to give access from the tower chamber to the roof space above the chancel.

On the exterior portion of the elevation are two slit windows positioned either side of the chancel roof. The southern window lights the first floor of the tower chamber, while the northern window lights the tower stair. A third slit window, also lighting the tower stair, is located to the north at the base of the chancel roof scar.

Although it appears there is access to the tower stair from the eastern face of the chancel arch elevation, this would not have been the case originally. The collapse or removal of the north wall of the chancel, however, has resulted in the destruction of the base of the spiral stair and tower wall, allowing access through to the doorway in the south east corner of the north transept (Figure 2, panels 1 and 2). Due to its width, the tower stair protrudes (smoothly) from the face of the east facing elevation.

The core-work of the stubs of both the north and south walls of the chancel protrude eastwards from the east facing elevation (Figure 2).

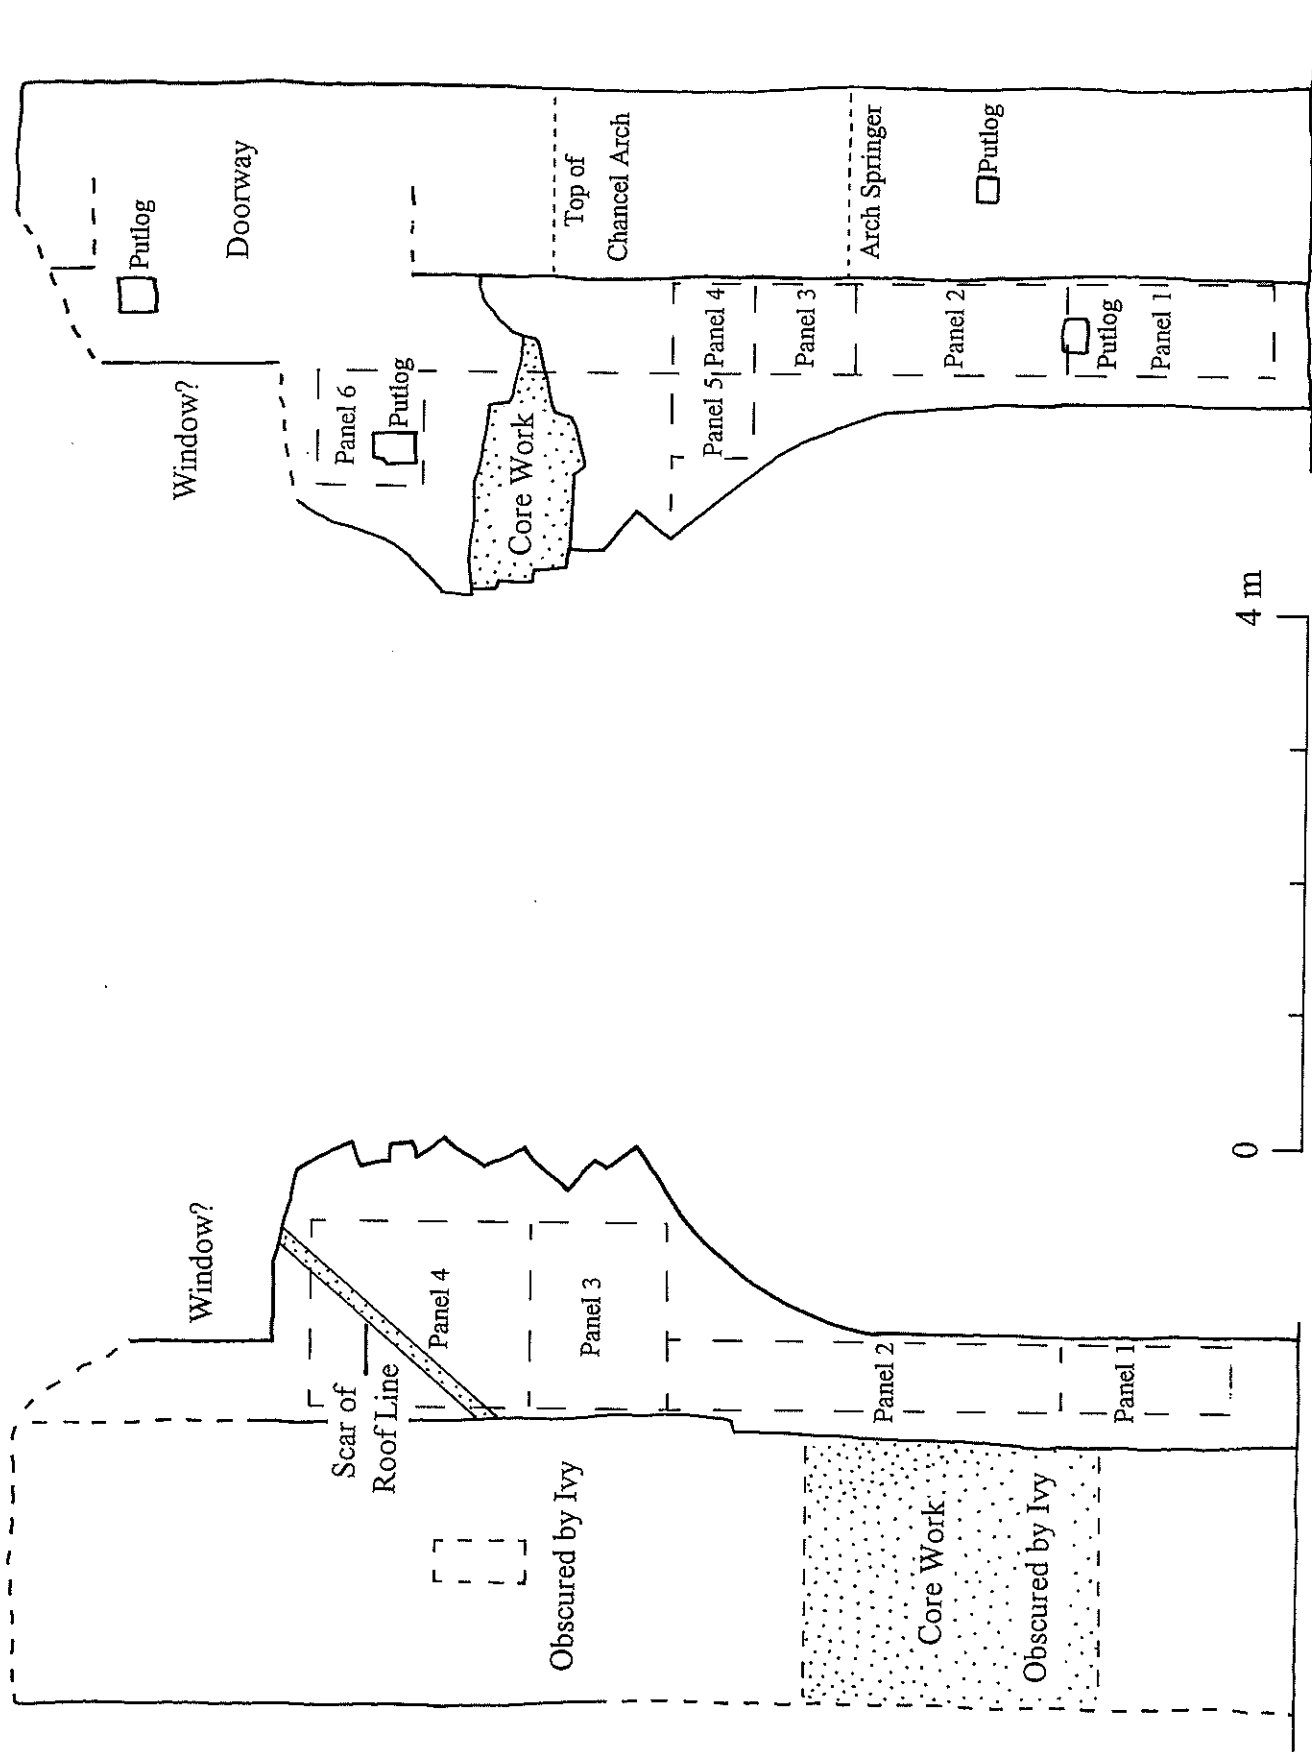
Figure 3: North and South Faces of the North Transept Arch Remnant (showing location of photogrammetric grid).

This elevation (Figure 3) shows the scar of the pitched roof of the north transept (panel 4). Immediately above panel 4 is the possible remains of a window that would have lit the first floor of the tower above the crossing. Confirmation of the existence of this window will require removal of obscuring vegetation.

The exposed core-work of the east wall of the north transept (below the extended line of the roof scar) is obscured by ivy growth, but there is possible evidence for an arch springer or sill in the east wall which may have been an alcove, window or doorway. Early drawings of the ruins do not, however, suggest this. Assuming the south wall of the north transept was at one time complete, it would appear from the illustrations that at some time the exposed core-work was capped (possibly for aesthetic purposes). The obscuring ivy will have to be removed to confirm this possibility.

Above the extended line of the roof scar is the northern external face of the tower stair (also obscured by ivy) this contains a slit window, lighting the stairway (see Figure 3).

In addition to two putlog holes, and the probable remains of a window (Figure 3, south face, above panel 6), this elevation shows the core work of the ceiling vault of the crossing. Plaster still adheres to the remains of this vault (above panels 4 and 5, south face, Figure 3), but the whole feature is in a fragile state.

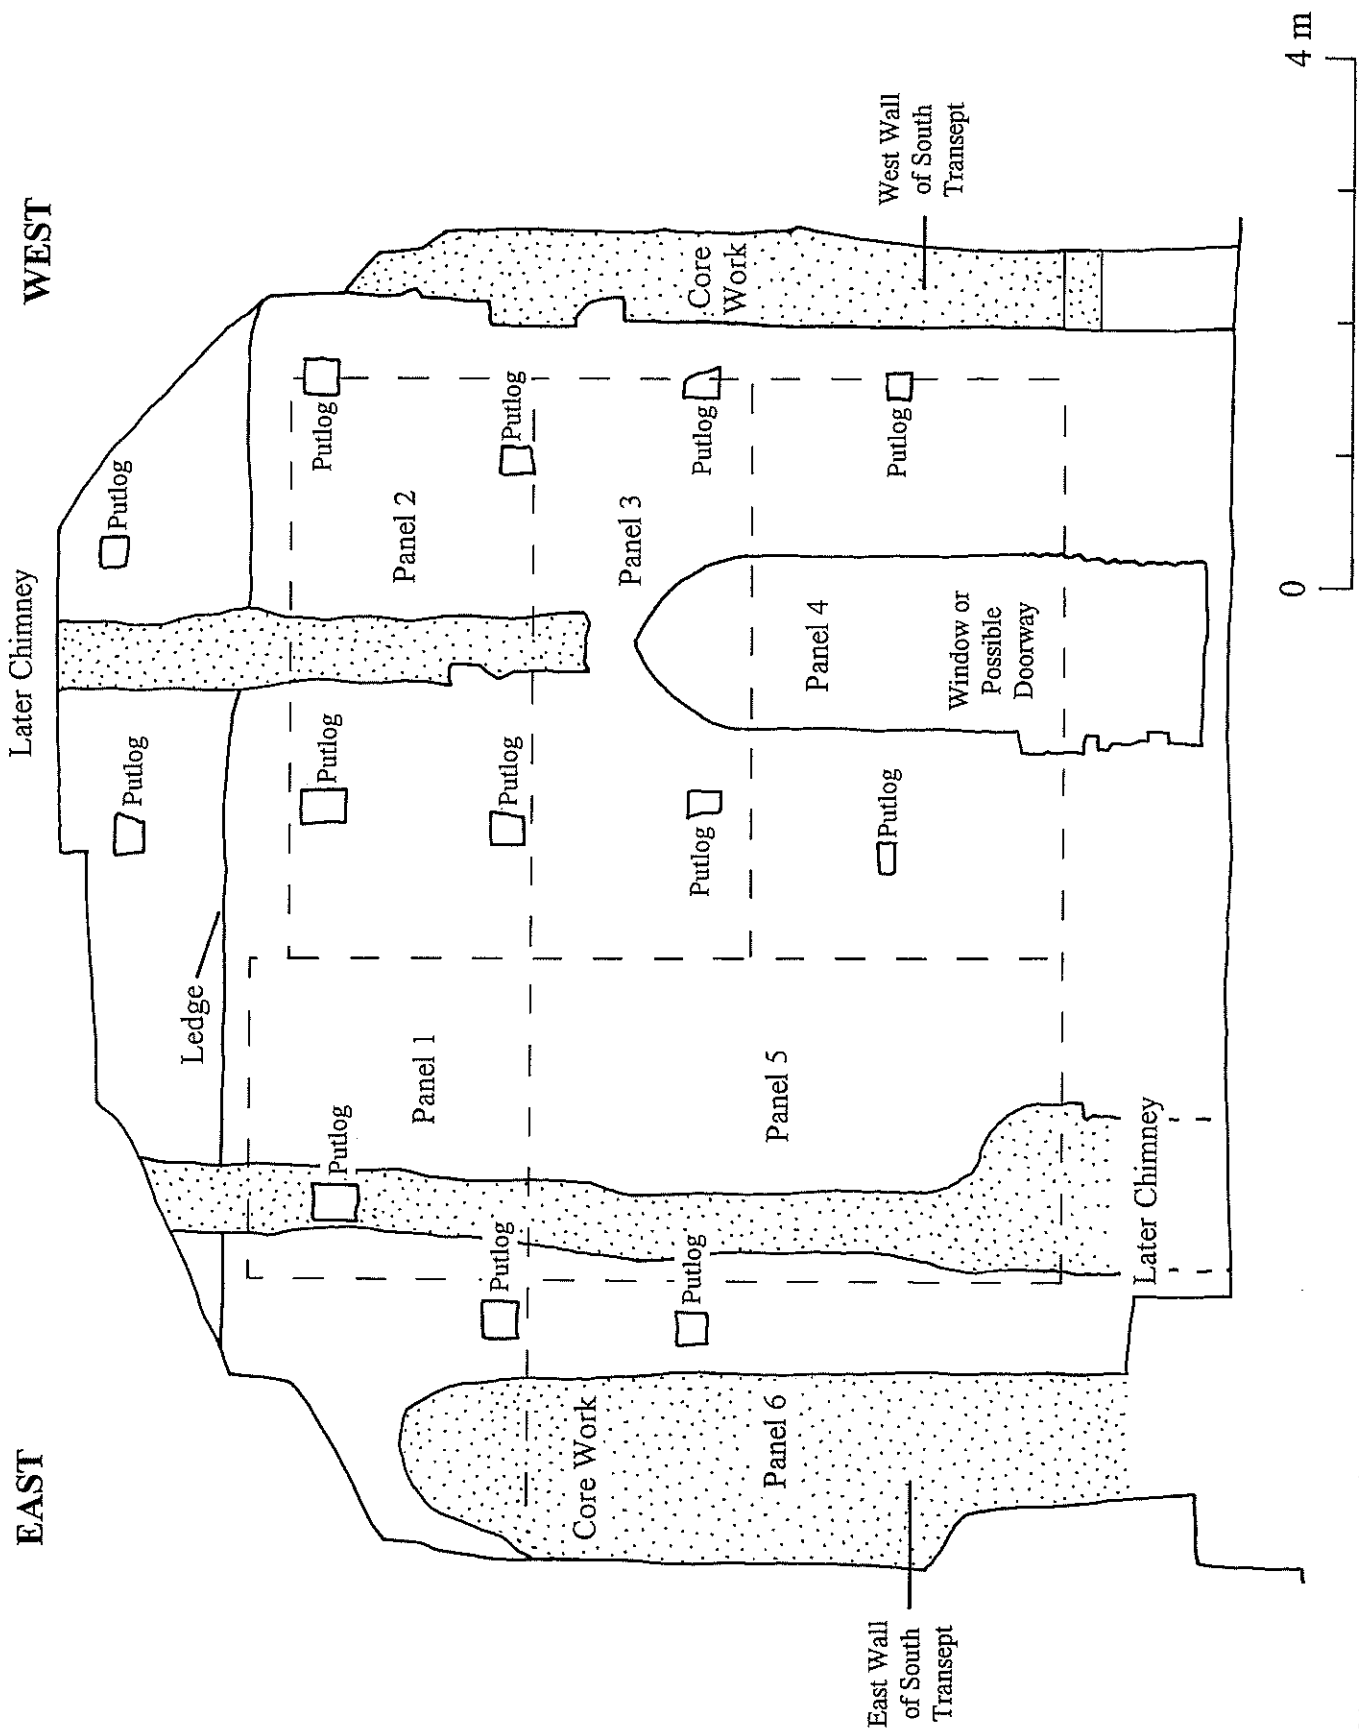
**Figure 4:** North Face of the South Transept Southern Wall (showing location of photogrammetric grid).

The north facing elevation exhibits the scars of its later use. Two chimneys have been cut into the face of the wall. The eastern chimney runs up from the ground floor; the westernmost appears to start from higher up the wall, but according to RCAHMW notes, it continued down to ground level as a brick structure.

A ledge, running east - west above panels 1 and 2, would have supported the first floor of the tower. Thirteen sockets are evident, most appear to run through the thickness of the wall.

The core-work scars of the east and west walls of the south transept are still evident.

Directly below the western chimney is the presumed south window, or door (Panels 3 and 4). This contained the brick fireplace structure and flue. In the north facing elevation the head of this window appears to have been altered relatively recently (from the presence of

fresh looking mortar) to form a point. In the south facing elevation, which appears to be of original construction, the head of the arch is rounded. The feature may always have been a doorway, but there is some suggestion that stonework below the sill of the window may have been secondarily removed to form a doorway. This has recently been blocked again from the south side, but the scars of the original stonework are visible. For further discussion of this feature see Sections 3.3.3 and 3.4.

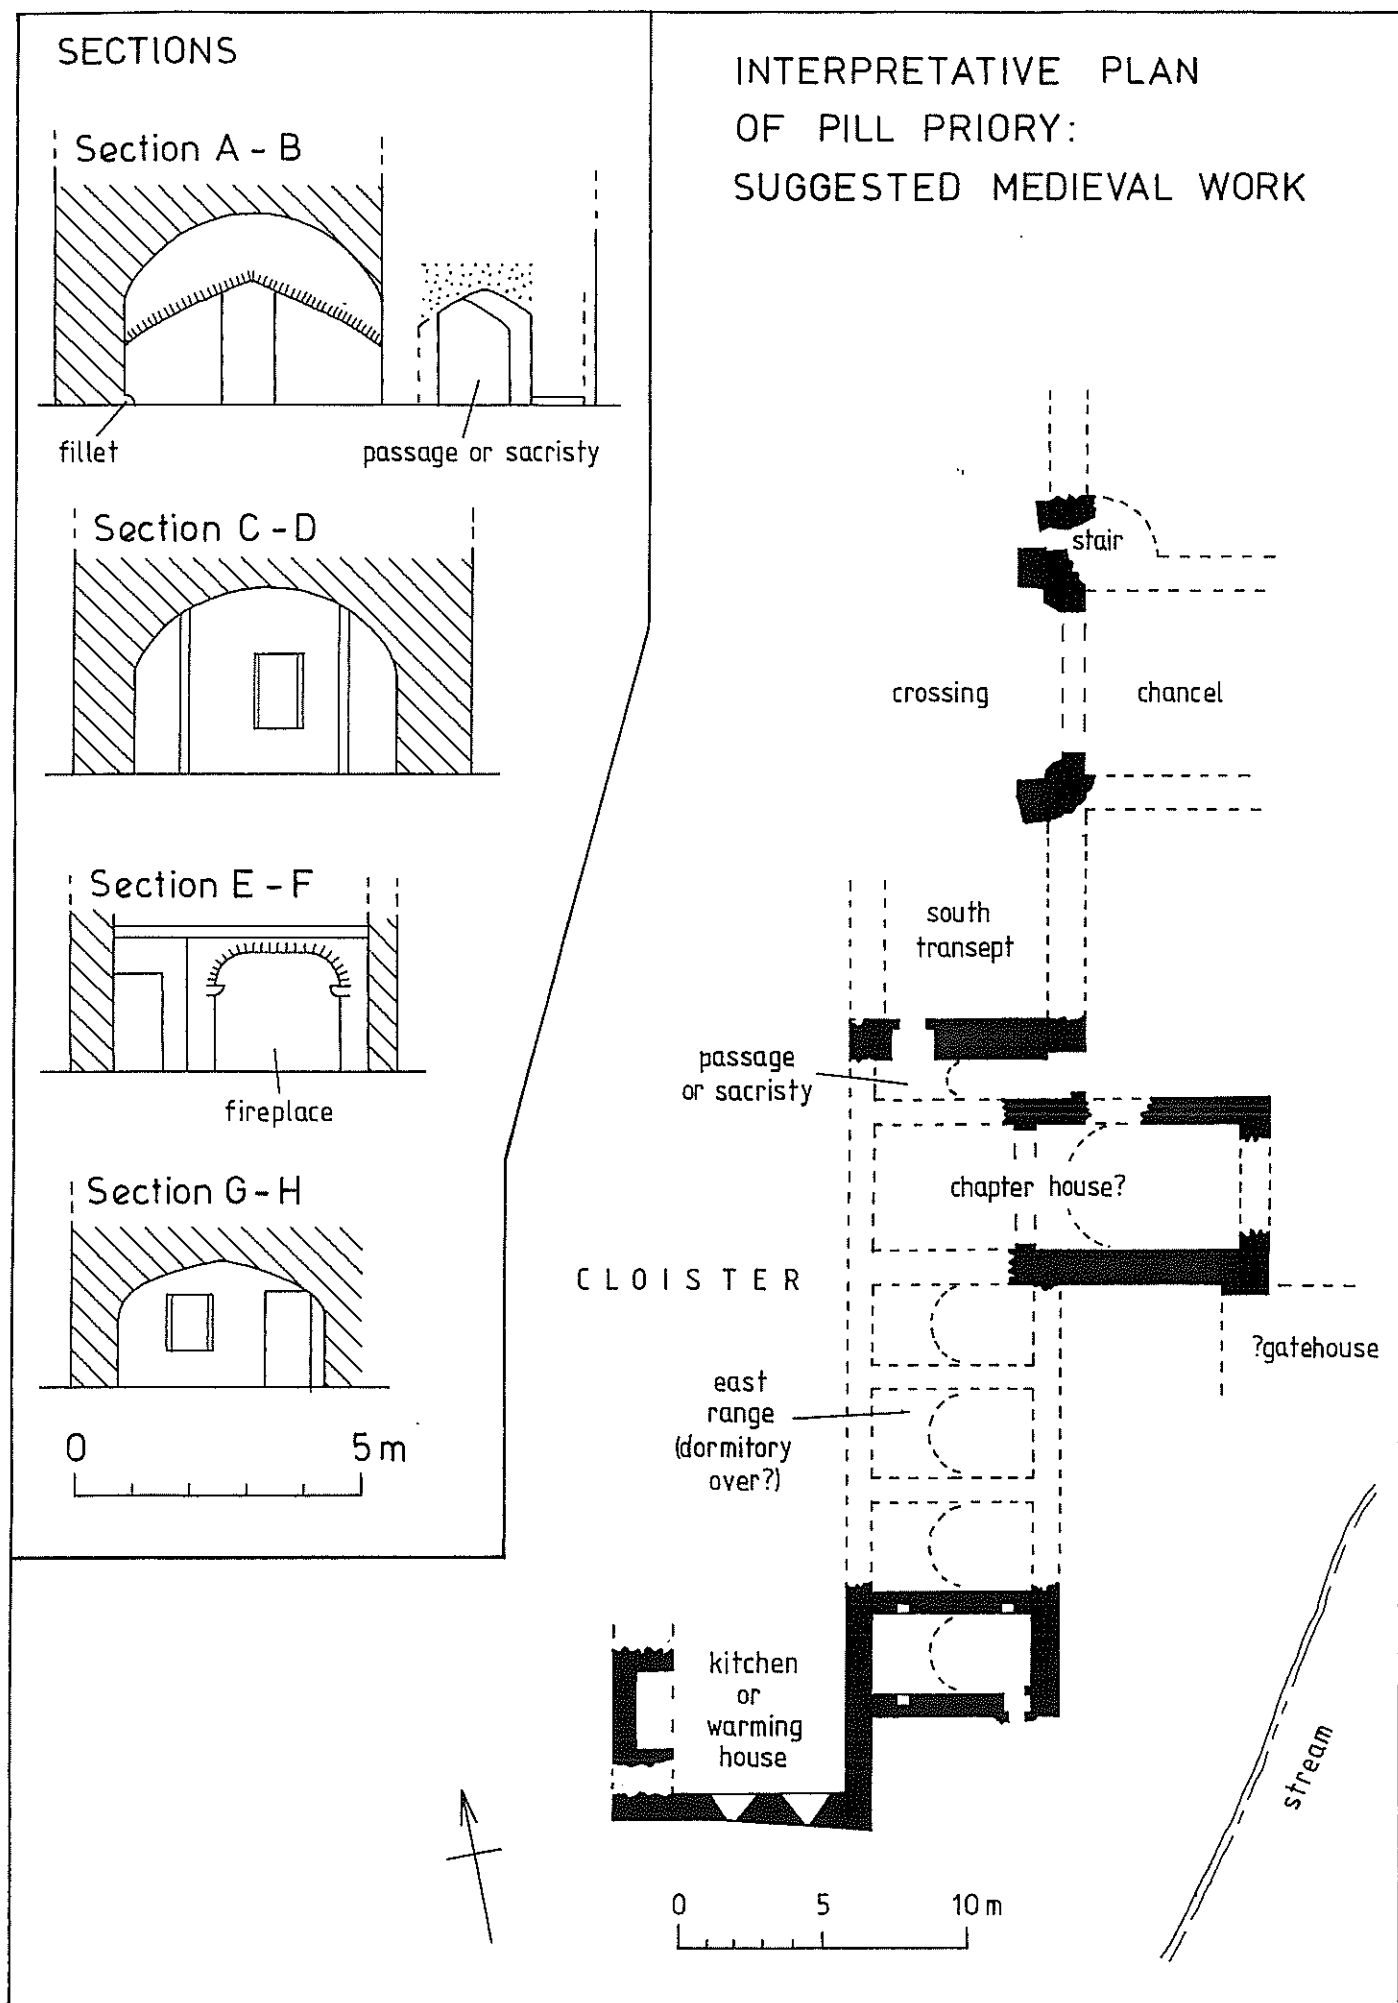
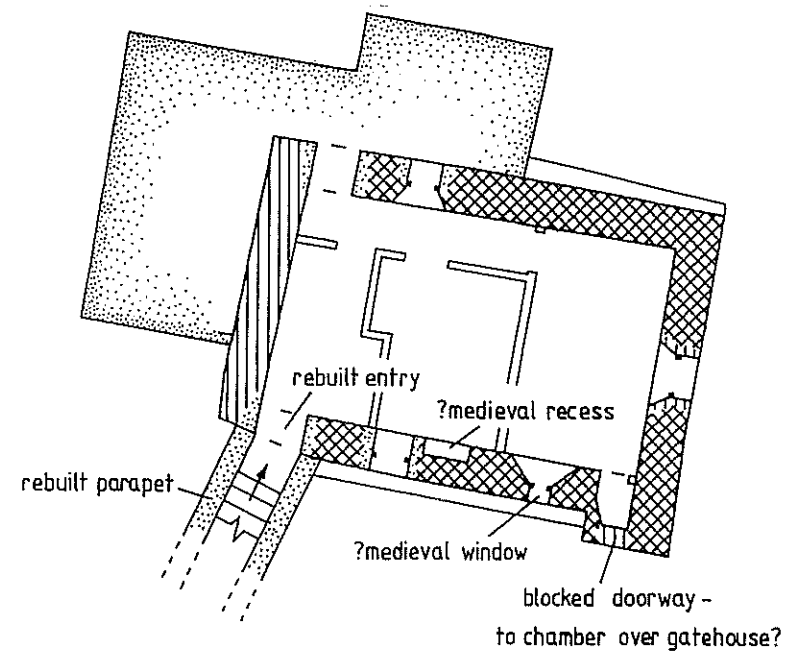
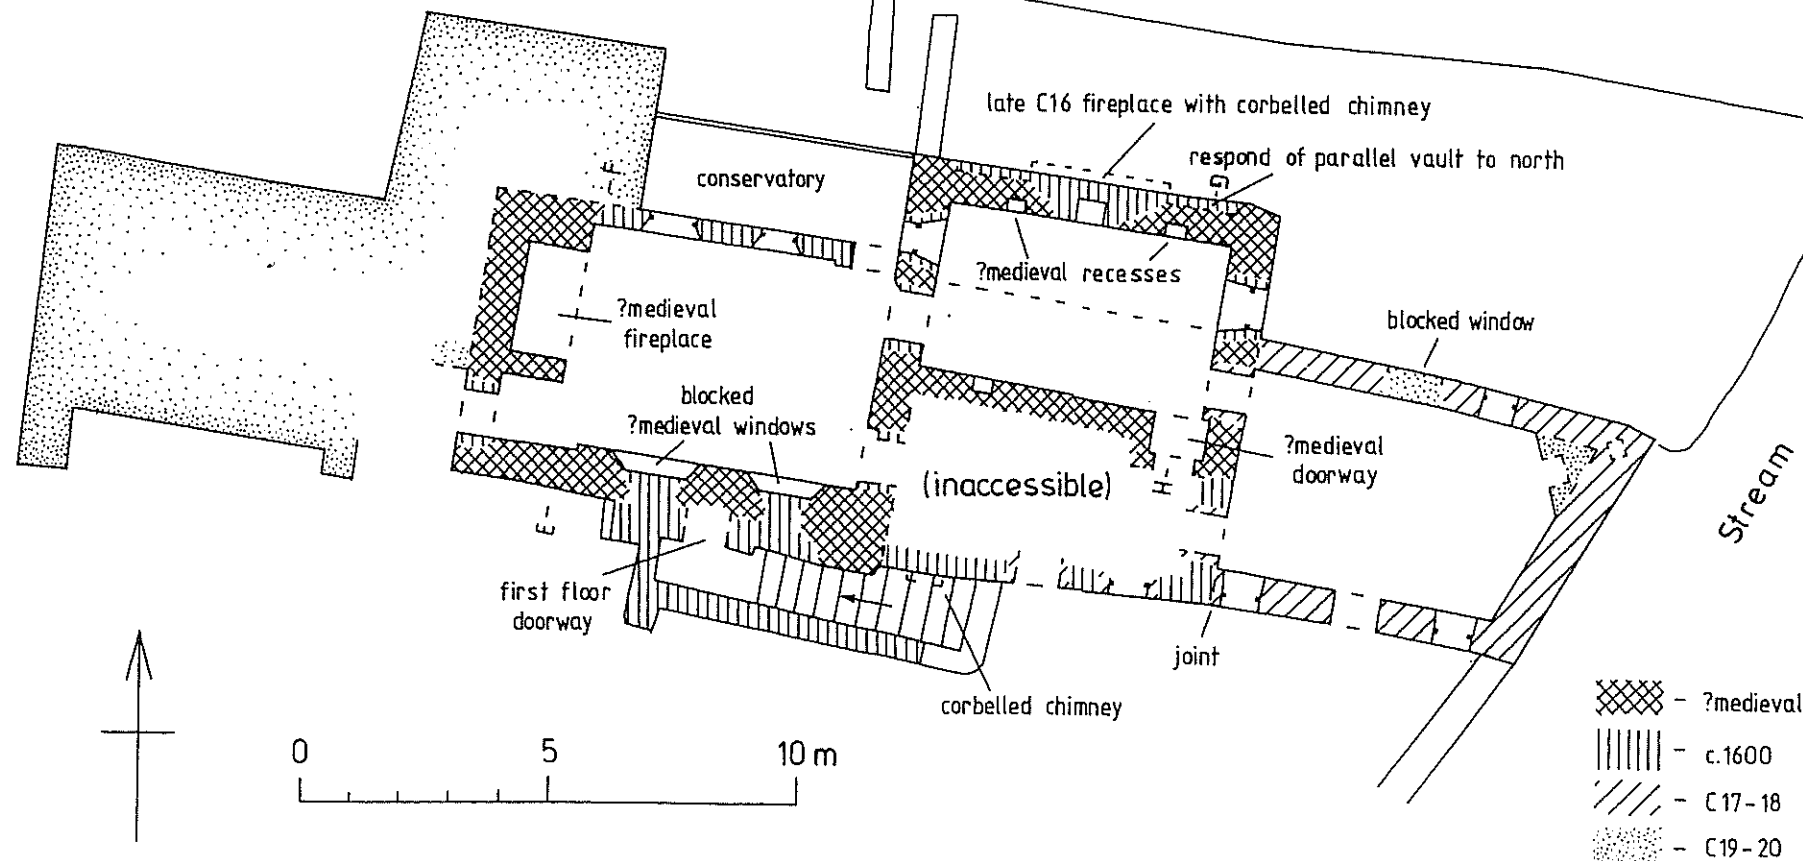
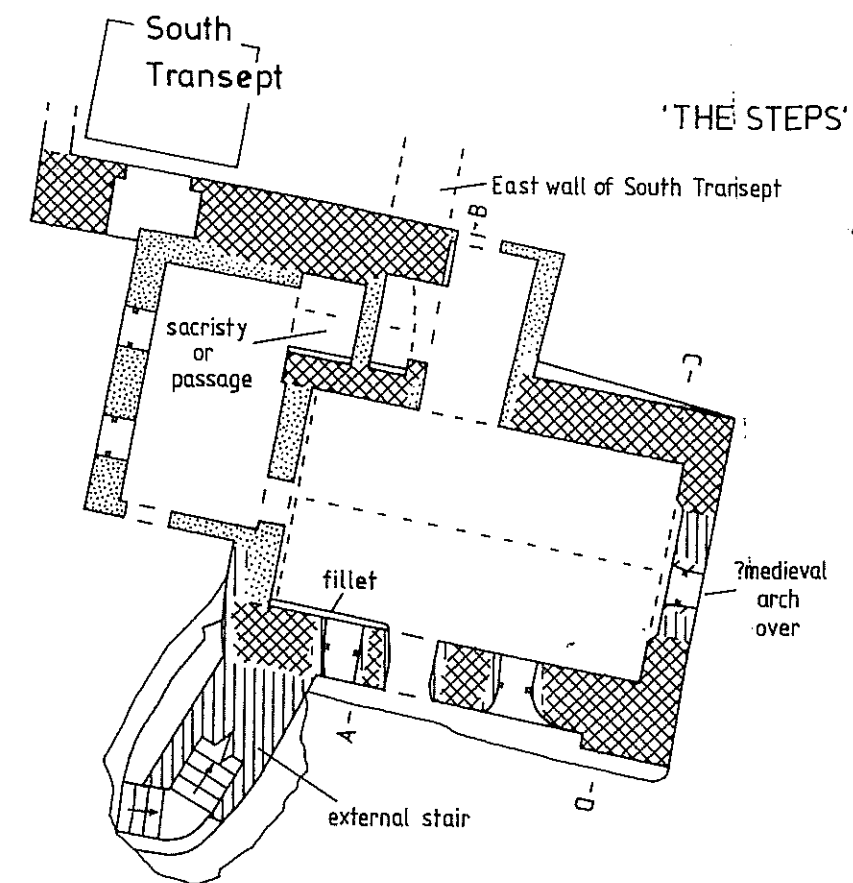
**Figure 6:** Ground plans of 'The Steps' and the Priory Inn

'The Steps' is a two-storeyed building, the ground floor of which has an irregular, semicircular barrel-vault. Parallel to 'The Steps', lying between it and the South Transept to the north and sharing their walls, is a narrower, single-storeyed area with a two-centred barrel vault, open to both east and west and possibly truncated at both ends; this area is divided into a narrower western half and a wider eastern half by a dog-leg in the north

The ground floor of 'The Steps' is now entered via an inserted entry through the north wall, and a doorway through the west wall. The latter wall is a late insertion into what was formerly a low, full-width opening into the ground floor chamber, with a rounded, depressed two-centred arch at a slightly lower level than the vault. The east wall is also inserted but the responds of the earlier wall are visible either side of the infill; the wall may originally have featured a large window opening that was, of necessity, rebuilt during the post-medieval period and the external face features a two-centred relieving arch above the level of the infill which may be medieval and probably relates to an opening rather than the vault beyond. The windows and doorway in the south wall are also post-medieval, but the windows may occupy the site of earlier openings; the north wall may originally have been blind. The west half of the south wall features an internal fillet at ground level; this may be finish over exposed footings as appears to be the case within the narrow vaulted area to the north.

The west wall of the first floor lies over the secondary ground floor west wall. This level is entered via a plain, square-headed inserted doorway in the south wall reached by an external masonry stair lying skew to the north-south axis of the priory and of post-medieval date; the stair parapets have been subsequently rebuilt. There is also a modern entry, from a modern stair, in the north wall. A buttress at the east end of the south wall appears to incorporate a medieval first floor doorway which may have led into a chamber over a former gatehouse here, which was depicted by Gastineau. Immediately to the west is a small, square-headed window, with wide splays, that appears to be entirely (late) medieval. The remainder of the windows are later insertions/alterations, but there is a segmental-headed internal recess, also in the south wall, that may be medieval.

The Priory Inn comprises four cells forming an east-west row; all are of two storeys. The westernmost cell is 19th century, while the easternmost possesses no characters that can be given a date any earlier than the 18th century.

The east-central cell is double-piled. The northern component possesses a rounded, depressed two-centred ground floor barrel-vault with a similar profile to the western arch of 'The Steps'. The exterior of the north wall, moreover, exhibits a horizontal 'chase' which represents the soffit, and ultimately the respond, of a parallel vault, of the same dimensions, that lay to the north; the finished ends of the truncated east and west side walls of this former building can also be seen. The 'chase' is interrupted by a secondary corbelled chimney inserted after this parallel vault had been demolished, probably in c.1600. The northern cell, though aligned east-west, has a north-south gabled roof over the first floor, which rises above the roof-line of the southern component and now exhibits a window with an uncusped, double-rebated semicircular-headed window from c.1600. All

other openings lack dateable detail or have been rebuilt, but the ground floor features two small, square internal recesses in the north wall and one in the south, which may be of medieval date, while at the east end of the south wall is an altered doorway also possibly medieval.

The southern component of this cell was inaccessible and its interior was not seen. It butts against the south wall of the west-central cell, but is butted in turn by the easternmost cell. Its windows, and external doorway in the south wall, are all later insertions/alterations of the 18th century, but there is a corbelled first floor chimney on the south wall, alongside a blocked window with evidence of a square surround of possible early 17th century date. It is therefore suggested that this southern component has its origins c.1600 when the northern component was altered from its original, medieval state.

The west-central component lies east-west and, as has been noted, is butted by the southern, east-central component which it then predates. It is unvaulted, and is entered at ground floor level through three doorways, all of which appear to be inserted. In addition, the north wall appears to have been rebuilt. The east wall is very thick and features a large, deep fireplace which occupies almost the entire width of the cell. This has a depressed semicircular arch, with corbelled imposts, of pronounced late medieval appearance. One of the ground-floor entries lies in the wall immediately south of the fireplace, in characteristic sub-medieval 'chimney-backing-on-entry' fashion, but this may be misleading as the door is probably inserted. There are two blocked windows with wide splays in the south wall. This cell is now entered through a much-altered doorway in the south wall, at first-floor level, reached by an external staircase against both this and the east-central cell, probably originally from c.1600. However, at the west end of the south wall is what appears to be a blocked slit-light.

'The Steps' appears to represent part of an east range (see Figure 6) that may have comprised a north-south row of undercrofts, probably all with east-west vaults and represented at the south end by the east-central component of the Priory Inn and the former, adjoining vault to the north. The ground floor of 'The Steps' appears to be a medieval vaulted chamber, with a vaulted area between it and the south transept that may have been a passage or 'slype'; however, the division of the latter into two areas suggests

There is room for three vaults of similar widths in between The Steps and the Priory Inn, with which they may have formed the undercroft of an east, dormitory range. If so, then 'The Steps' may represent a Chapter House, either added to an existing east range or originally extending further west and divided by the wide arch that forms its west wall; the evidence for a former large window in the east wall has been discussed above. However, the vault is very crude and the Chapter House may have occupied the first floor (which, though, would raise the problem of the location for the medieval night stair).

The east-central cell of the Priory Inn may be the southern bay of this projected east range. The west-central cell of this building, however, is offset to the south. The west wall of this cell, which is also aligned east-west, contains a fireplace of markedly medieval appearance, and very deep, suggesting that the cell may represent the conventual warming-house or kitchen (in this position, and according to conventional plans, it may be either - a warming-house at Fountains, a kitchen at Tintern; in both houses, the refectory lay to the west). However, the absence of a vault must be remarked upon, particularly in a room where the fire would have been the centerpiece. A first floor would also be unusual but its south wall does appear to feature a blocked first floor slit-light which is probably earlier than c.1600. The south wall is thicker towards its east end which may suggest infill around a buttress, or possibly a 'turret' - the original stairway arrangements are not known
