# Blaenblodau W/12/2320

## Tir Gofal Farm Visit Historic Environment Report

Report No. 2002/35

REPORT NO. 2002/35  
PROJECT RECORD NO. 37703

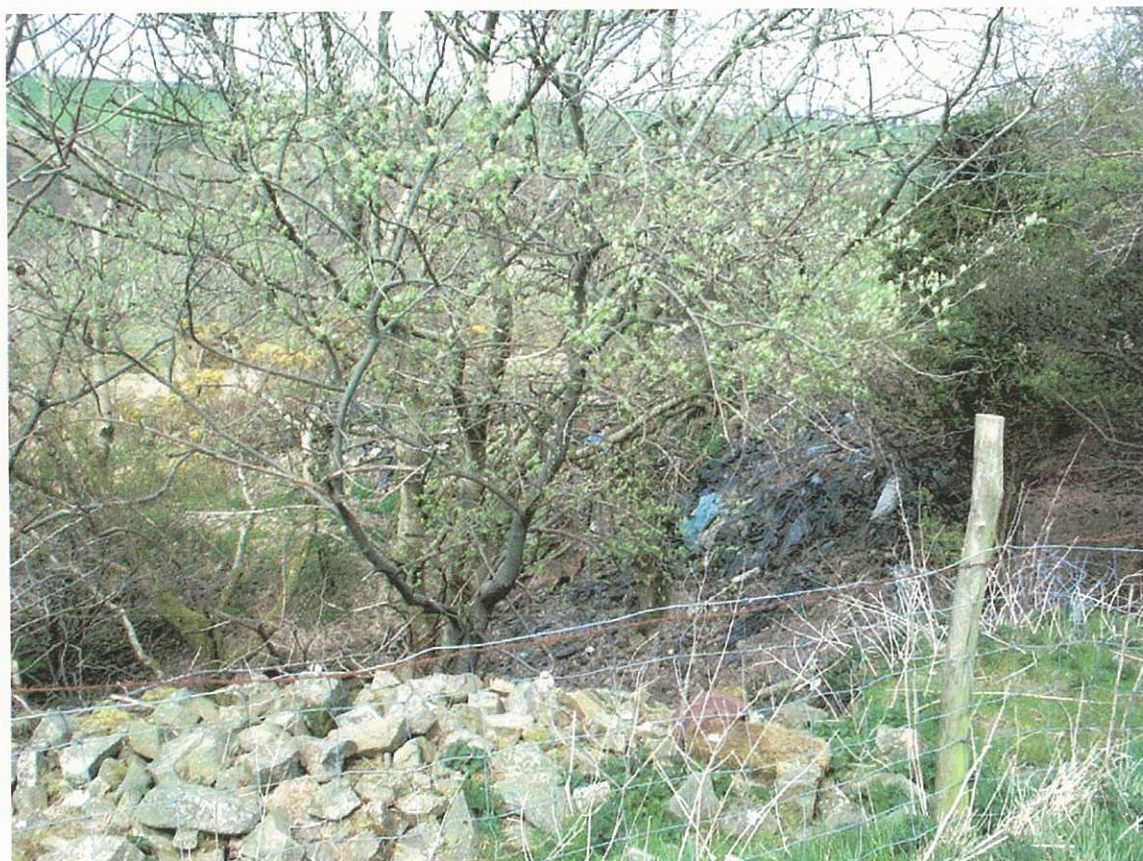
The quarry is in poor condition and has been used for the dumping of agricultural refuse. Ideally it should be cleaned out and maintained as a visible historic landscape feature, with vegetation control.

Small limestone quarry, probably post-medieval and disused by the early 19<sup>th</sup> century; marked and labelled 'Old Quarry' on the 1891 Ordnance Survey 6" map. Circular quarry, approx. 30m in diameter and 10m deep, excavated into north facing slope with narrow entry to north. The outcrop appears to have been entirely worked out. The quarry is in poor condition. The earth sides are actively weathering and overgrown with saplings and other vegetation. It has been used for the dumping of agricultural refuse including black plastic sheeting, corrugated metal sheeting, containers and tyres.

Plate 1 – Quarry (PRN 16614) from the south

Ideally the quarry should be cleaned out and maintained as a visible historic landscape feature, with vegetation control.

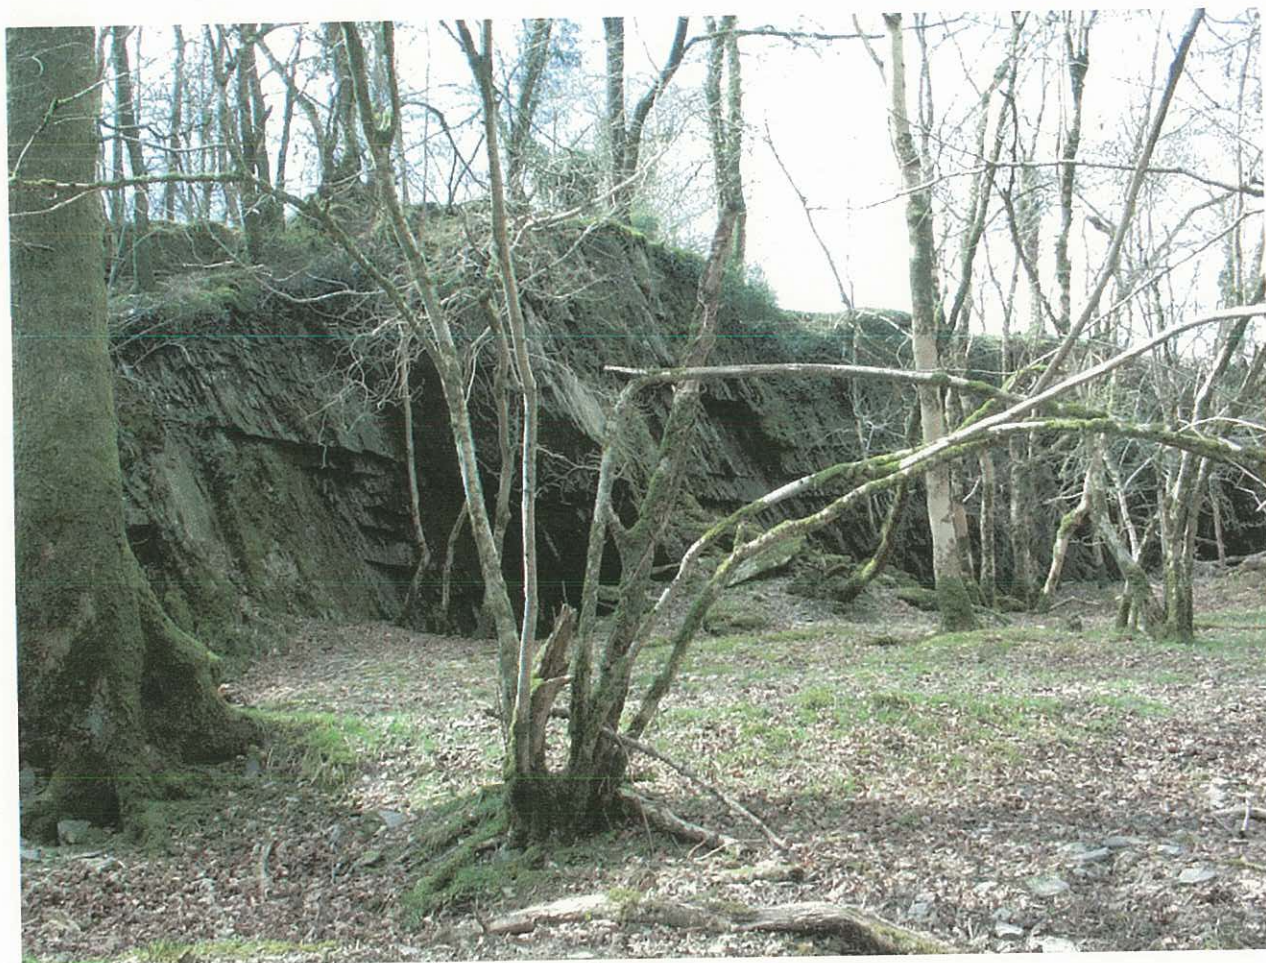
Small limestone quarry, probably post-medieval and disused by the early 19<sup>th</sup> century; marked but not labelled on the 1891 Ordnance Survey 6" map. Irregular outlined, approx. 50m north-south and 20m east-west, excavated into east facing slope from the banks of the Afon Talog. The quarry is in good condition, with limestone still outcropping throughout, supporting some saplings but with little other vegetation.

Plate 2 – Quarry (PRN 16616) from the southeast

Maintain as existing.

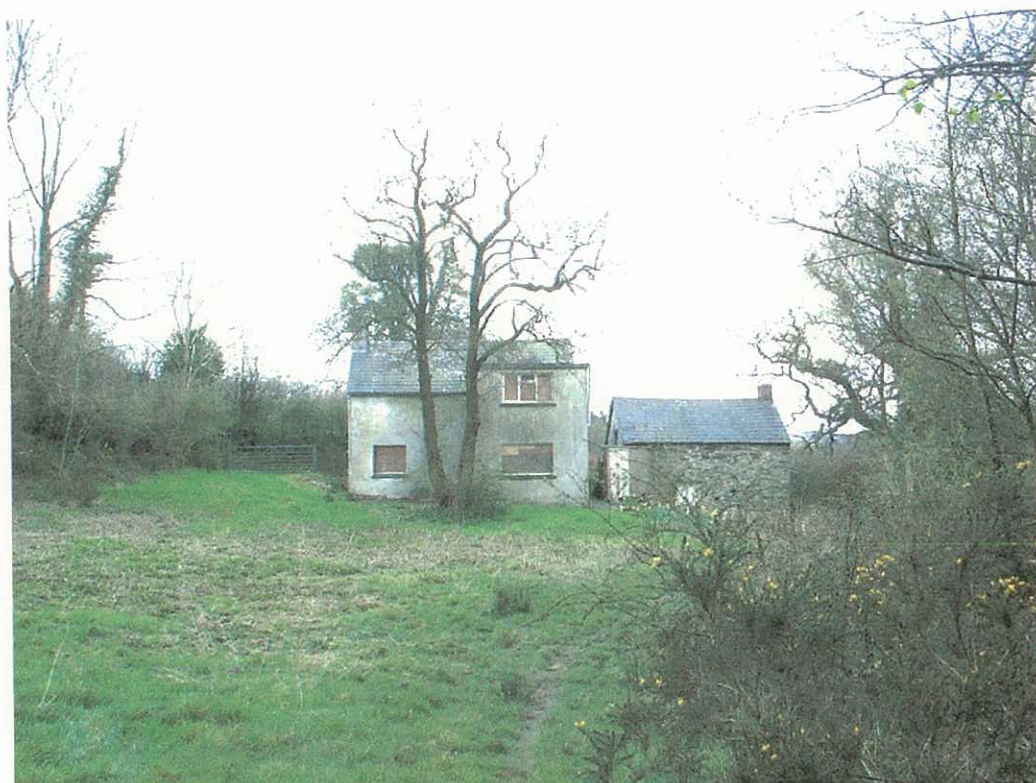
Site of post-medieval woollen mill, marked and labelled on the Ordnance Survey 6" map of 1891. A dwelling now occupies the site, of apparent late 19<sup>th</sup> century construction but possibly altered from the mill structure, which was still operational in 1904 (Ordnance Survey 6" map). Not apparently marked on the tithe map of 1842. It is a typical two-storeyed, three-bayed dwelling with a slate gabled roof and end chimneys, rendered throughout, with a later extension to the rear (east). There is little evidence of its former function. The headrace leat ran parallel with Afon Talog for 300m northeast of the mill, but is only slightly discernible as a very faint depression on the ground. There is no evidence for the wheelpit. A masonry building, comprising one storey over a basement, lies immediately north of the dwelling; it also appears to be late 19<sup>th</sup> century and of a domestic character.

Plate 3 – Talog Mill and leat (PRN 16617) from the east

Talog Mill lies outside the Tir Gofal management agreement scheme. However, the headrace leat lies within the scheme and should be maintained as existing.

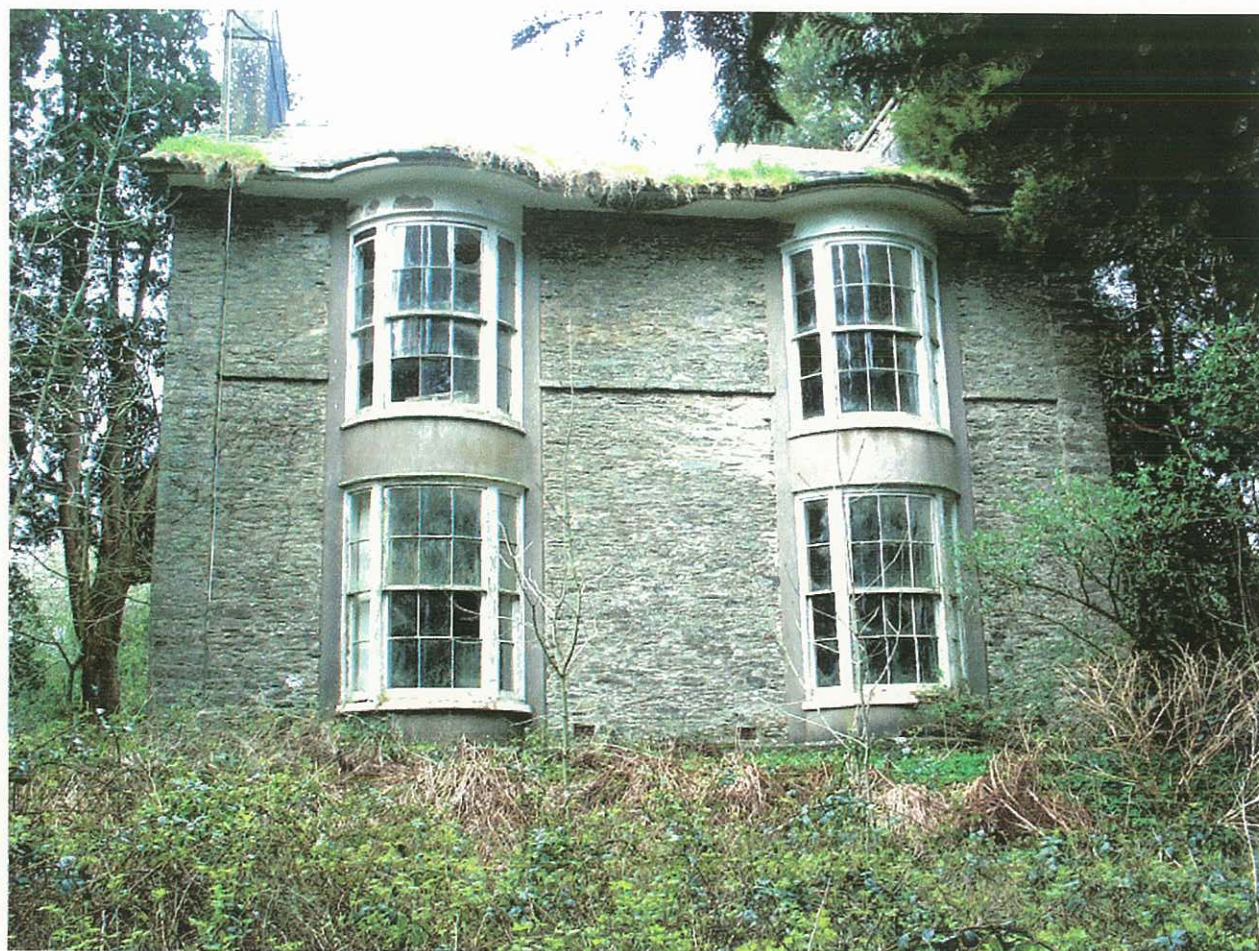
The house has been empty for over 10 years and is derelict, and becoming ruinous. It is a two-storey and basement structure, in rubble, with a slate roof on wide boarded eaves. The main, west front is three-bayed has a first floor sill band, broad end pilaster strips and 16-pane sash windows with rubble voussoirs. This elevation was originally symmetrical around a central, semicircular-headed entrance within a bowed projection, with a 6-panel door and traceried fanlight. To this was later added a two-storeyed, pebbledashed, gabled porch, open to the ground floor. To the west is a railed area containing steps down to the basement doorway, and a 20<sup>th</sup> century kitchen extension. The gable ends have 12-pane sash windows and cement-rendered chimney stacks. The rear, east elevation is two-bayed and symmetrical with two matching, full-height bowed projections with similar glazing; sill band and pilasters similar to west elevation. The interior retains many original features including the late-Georgian staircase, 6-panel doors, panelled shutters and moulded cornices. The rear (east) half of both floors is occupied by a full-width room with original sliding partitions, a simple applied 'Adamesque' detail being applied to the ground floor ceiling.

Plate 4 – Blaenblodau Hall (PRN 24910) from the east

Blaenblodau Hall lies outside the Tir Gofal management agreement scheme. However, work on any structures abutting the enclosure may fall within the listed building curtilage and will need to be discussed with the conservation officer of the Local Planning Authority.

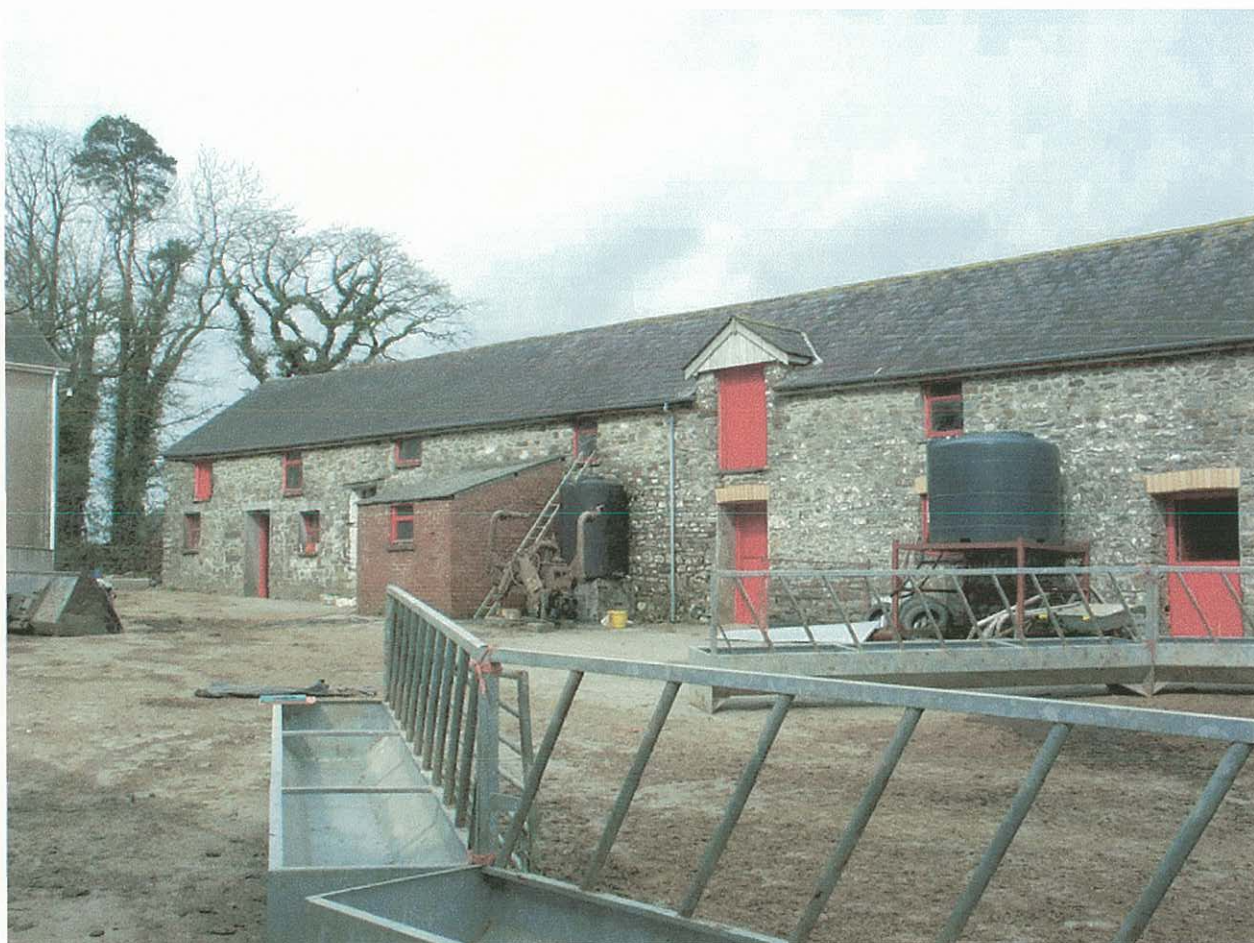
Long masonry block forming the north range of the farmyard. It is probably of locally quarried limestone rubble construction, of two storeys throughout, and gabled with a continuous slated roof. Openings are simple, many of them with segmental, yellow brick heads, and the entire building appears to be an addition, built between 1887 (Ordnance Survey 6" map, 1891) and 1904 (Ordnance Survey 6" map, 1907). It has been little altered. The eastern two-thirds of the building comprise a long chamber, with a loft over, with two wide ground floor entries from the farmyard ie. in the south wall, beneath segmental, yellow brick heads. There are two small, square windows, with similar heads but with modern, 2-pane glazing, in the same wall. The interior was not seen, but this part of the building appears to have been a cowshed. The loft over is lit by three small, square windows at eaves level in the south wall, glazed as in the ground floor, and has a gabled loft door in the same wall. The northern third of the building is defined by a transverse, masonry stair to the loft. It is also of two storeys, with similar detail to the rest but without the brickwork. The impressions of three, wide blocked arches can be seen in the south wall suggesting that it was originally a cart shed. These were subsequently blocked (in the early-mid 20<sup>th</sup> century?) and this part of the building perhaps converted into a dwelling, entered from the farmyard through a ground floor doorway in the south wall, with a concrete lintel, in the central infilled arch, and lit by a square window with a concrete lintel, and contemporary 6-pane glazing, in both the blocked flanking arches. The first floor was also a loft and has similar lights to those to the east, but one is

Plate 5 – The cowshed/cart house (PRN 44757) from the southeast

The building is currently in good order and its openings and detail have been little altered since it was constructed in 1887-1904, although the timberwork and glazing are more recent. It should be continued to be maintained in this condition. Any repairs should be carried out using traditional materials.

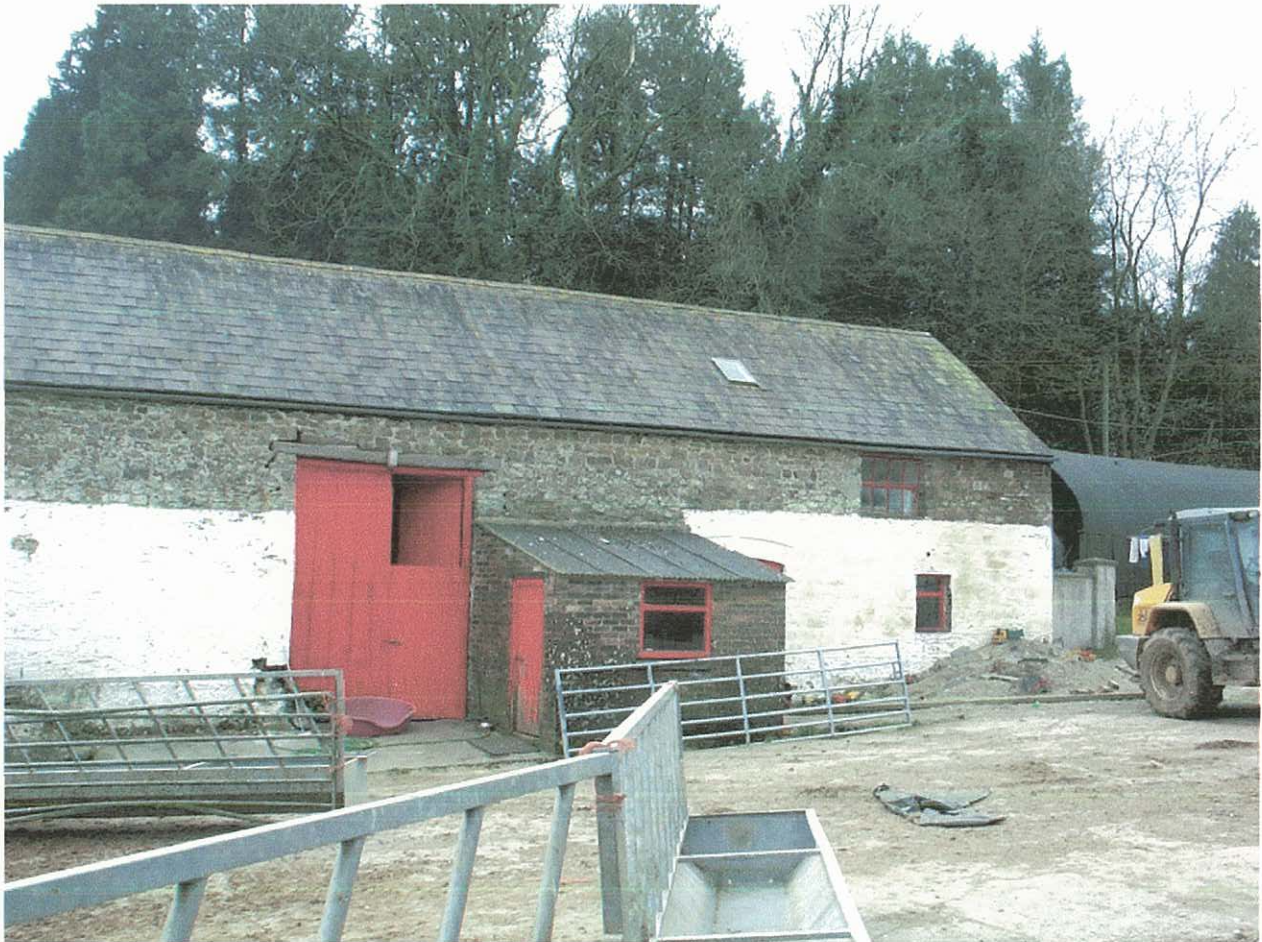
Long masonry block forming the south range side of the farmyard. It is of locally quarried limestone rubble construction, and gabled with a continuous slated roof. Openings are simple, mostly with timber lintels, and the entire building appears to be from the 1811-1842 period of re-organisation when the farm became the home farm of the Blaenblodau estate; it is suggested on the tithe map of 1842 (shown properly on the Ordnance Survey 6" map of 1891). It has been little altered. The eastern half of the building comprises a large, single storeyed chamber, entered from the farmyard through a wide, full-height opening in the north wall; there are no further external openings in this wall. The interior was not seen, but this part of the building appears to have been a barn, with a threshing-door to the yard. A single-storey brick lean-to against the north wall appears to have been an engine-house for machine-threshing, added in the early-mid 20<sup>th</sup> century. The western half is of two storeys, and is entered from the farmyard through a large opening in the north wall with a segmental head; it is lit by a simple square window in the same wall with modern 2-pane glazing. It appears to have been a stable, with a loft over, reached from an external masonry stair against the west gable wall. The loft is lit by a similar window at eaves level. A two-storeyed extension was subsequently added against the east end of the range (before 1904), apparently representing a further stable with a large entry at ground floor level, with a segmental brick head, and a loft reached from an external masonry stair against the north wall. The loft is ventilated by a slit in the east, gable wall and both floors are lit by small square windows with brick heads and modern 2-pane glazing.

Plate 6 –The barn/stable (PRN 44758) from the northeast

The building is currently in good order and its openings and detail have been little altered since it was constructed in 1811-1904, although the timberwork and glazing are more recent. It should be continued to be maintained in this condition. Any repairs should be carried out using traditional materials.

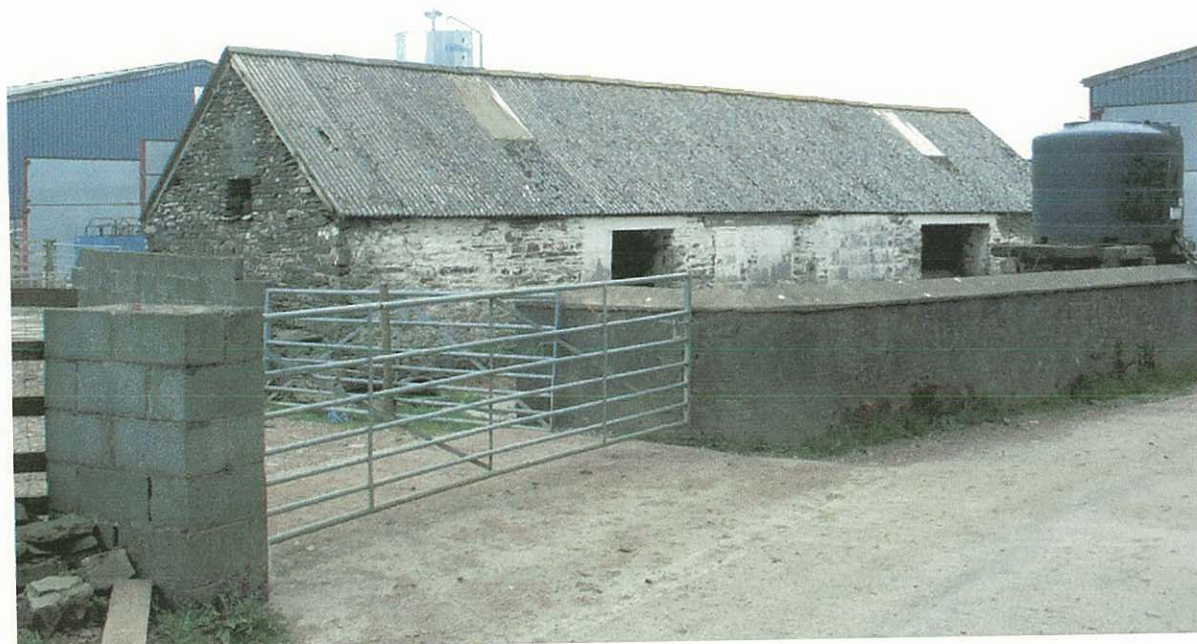
Low, single-storey detached masonry building lying to the northwest of the farmyard. It is probably of locally quarried limestone rubble construction, and gabled with a continuous slated roof. The interior was not seen, but appears to have comprised a single chamber with large entries in the south wall. These have been altered and now comprise two full-height openings with concrete lintels. However, the outlines of two similar openings can be seen between them, with later 20<sup>th</sup> century breeze-block infill. The building, which is first clearly shown on the Ordnance Survey 6" map of 1891, may have been constructed as a cowshed, and the square opening in the west gable wall, at eaves level, may originally have been the pitching hole of a loft reached from an internal stair.

Plate 7 – The possible cowshed (PRN 44760) from the southwest

The building is currently in reasonable order, and should be continued to be maintained in this condition. Any repairs should be carried out using traditional materials.

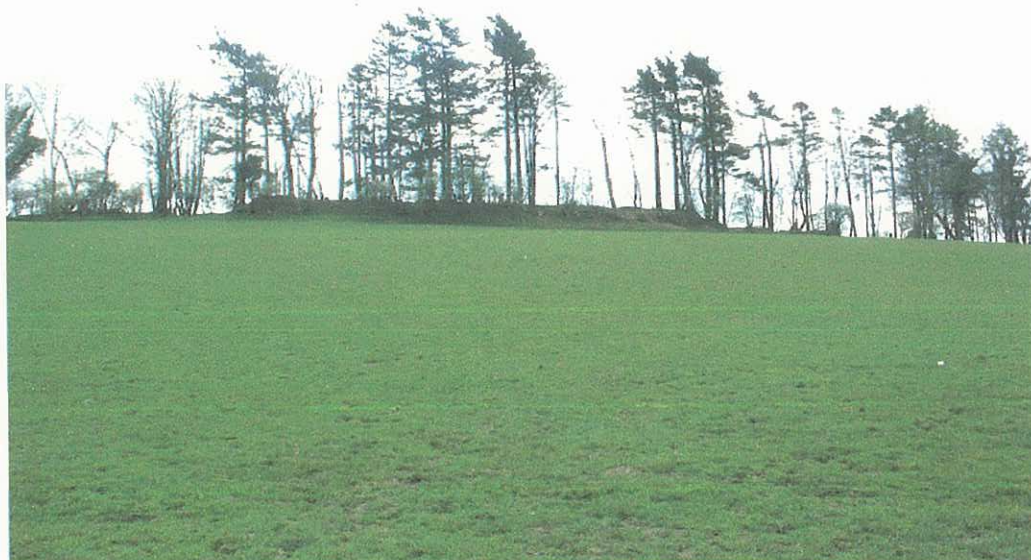
The largest of the four ponds on the holding. It now lies within a shelter belt 500m to the north of the farmstead, and consists of a regular, rectangular area, approx. 50m east-west and 20m north-south, defined by substantial banks on the (downhill) north, east and west sides to catch run-off from the field. The banks are 2m wide and 1m high, with vertical sides and with a rubble core. There does not appear to have been any masonry lining. The pond is now dry. It appears to date from the early 19<sup>th</sup> century landscape re-organisation, suggesting that the shelter belt was a later planting; however it comprises mature Scots Pines which have also been planted within the pond banks.

Plate 8 – The large pond (PRN 44763) from the north

The pond banks are in good condition and although now supporting many mature standard trees, have not been subject to livestock erosion. Nevertheless, vegetation should be monitored and controlled, and protected from livestock erosion through stock level management or, if impractical, with stockwire fencing.

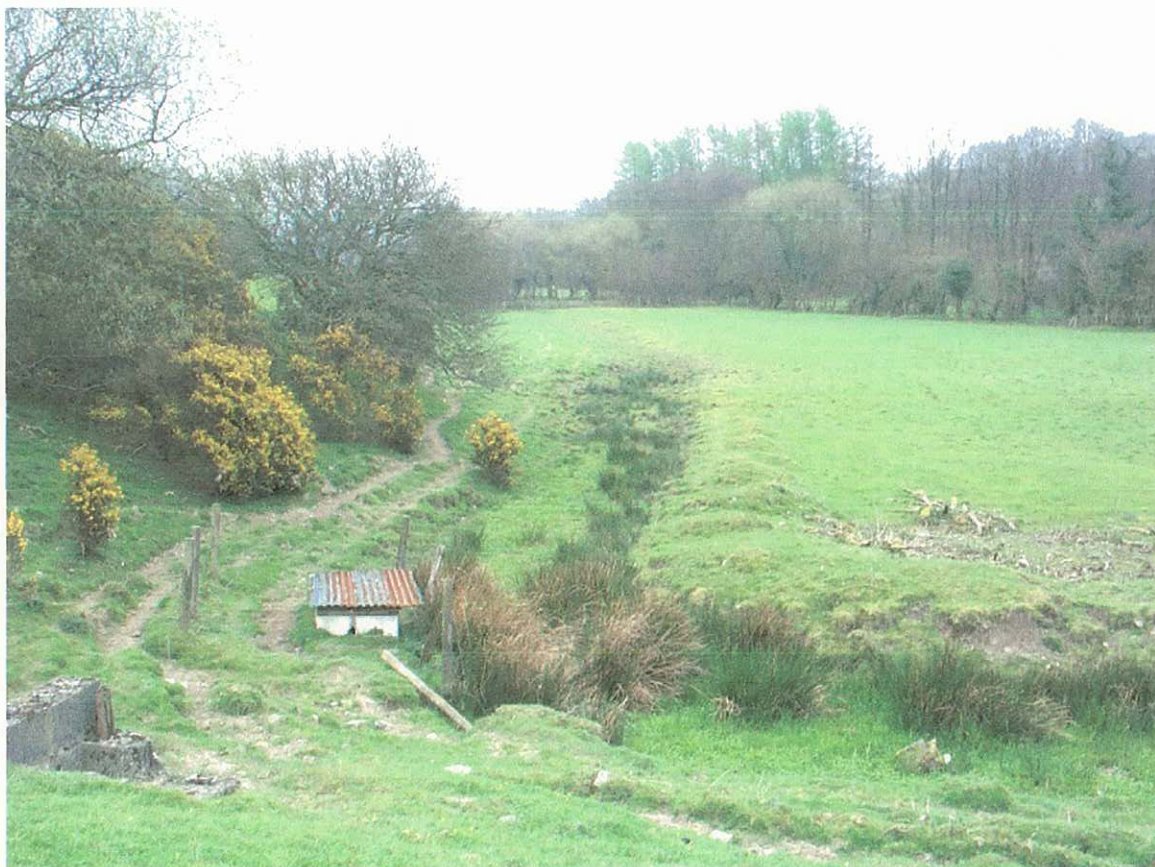
The leat should be preserved as a visible feature. Cleaning and management should be periodical, minimal and ensure the least disturbance to wildlife. It is currently suffering from some livestock erosion. Livestock level management, or selective stockwire fencing may prevent further erosion of the banks.

Silted leat running WNW-ESE from the Afon Gwyddgrug across two fields, to supply the former Sunnyhill Woollen Mill (PRN 16619), which lies outside Blaenblodau holding to the southeast. The line of the leat is clearly visible though the channel, which is approx. 1.5m wide, is now practically dry, and supports a marsh vegetation of rushes etc. The channel lies between two low banks, each approx. 2m wide, which have been eroded by livestock in areas.

Plate 9 – The mill leat (PRN 44768) from the northwest

The leat should be preserved as a visible feature. Cleaning and management should be periodical, minimal and ensure the least disturbance to wildlife. It is currently suffering from some livestock erosion. Livestock level management, or selective stockwire fencing may prevent further erosion of the banks.

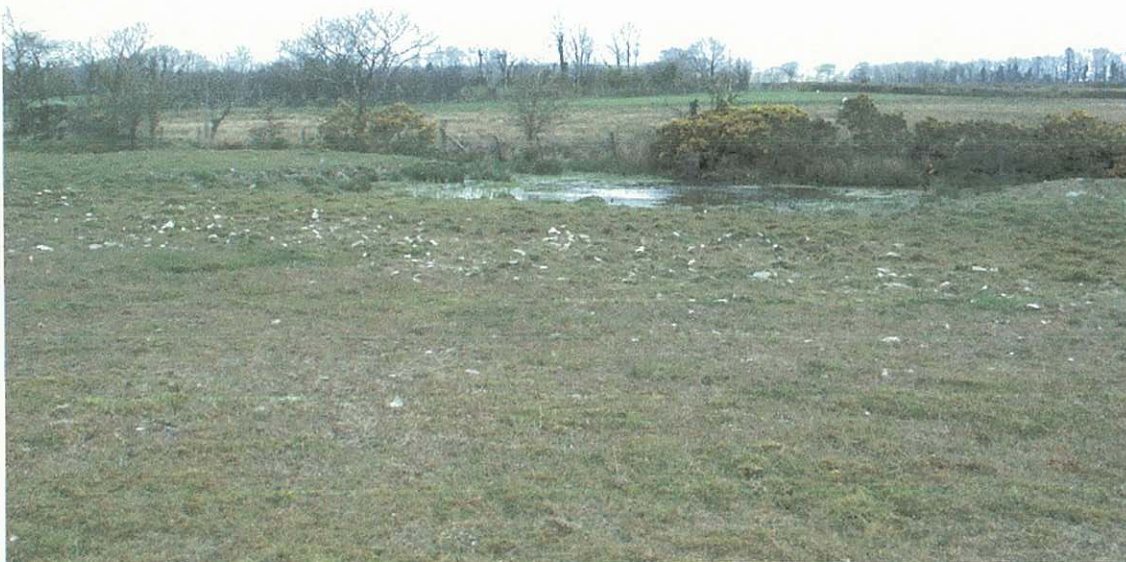
The pond should be maintained as existing, as a visual feature. Cleaning and management should be periodical, minimal and ensure the least disturbance to wildlife. It is currently suffering from some livestock erosion. Livestock level management or, if impractical, stockwire fencing may prevent further erosion of the banks.

The least well-preserved of the four ponds on the holding. It lies against a field boundary that forms its east side, to catch run-off from the downhill slope of the field to the west. It is still wet. It consists of a regular, rectangular area, approx. 20m north-south and 15m east-west, defined by low banks to the north and south. These were once higher and have been ploughed or bulldozed out, leaving them as irregular spreads, up to 5m wide, featuring much loose limestone derived from the rubble core. There does not appear to have been any masonry lining. The pond appears to date from the early 19<sup>th</sup> century landscape re-organisation.

Plate 10 – Pond (PRN 44769) from the southwest

The pond should be maintained as existing, as a visual feature. Cleaning and management should be periodical, minimal and ensure the least disturbance to wildlife. It is currently suffering from some livestock erosion. Livestock level management or, if impractical, stockwire fencing may prevent further erosion of the banks.

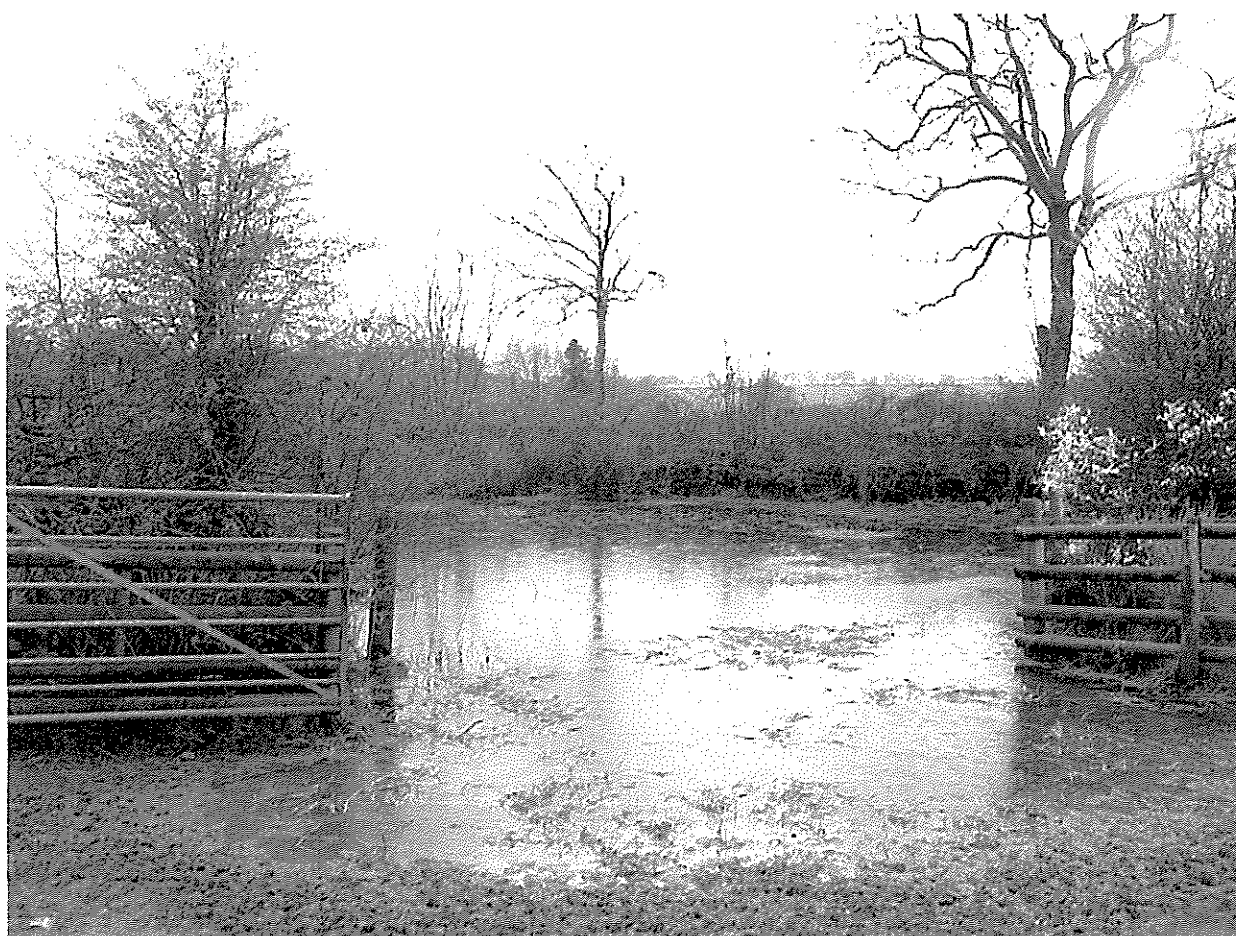
One of the four ponds on the holding. It is still wet, and lies against a field boundary that forms its east side, to catch run-off from the downhill slope of the field to the south. It is still wet. It consists of a regular, rectangular area, approx. 20m north-south and 15m east-west, defined by low banks to the north and west. These now support hedgerows and their construction cannot be seen. The pond has internal masonry lining. It appears to date from the early 19<sup>th</sup> century landscape re-organisation, and is still in active use now being entered by livestock from the southeast via a modern gate.

Plate 11 – Pond (PRN 44770) from the southeast

Maintain as existing.

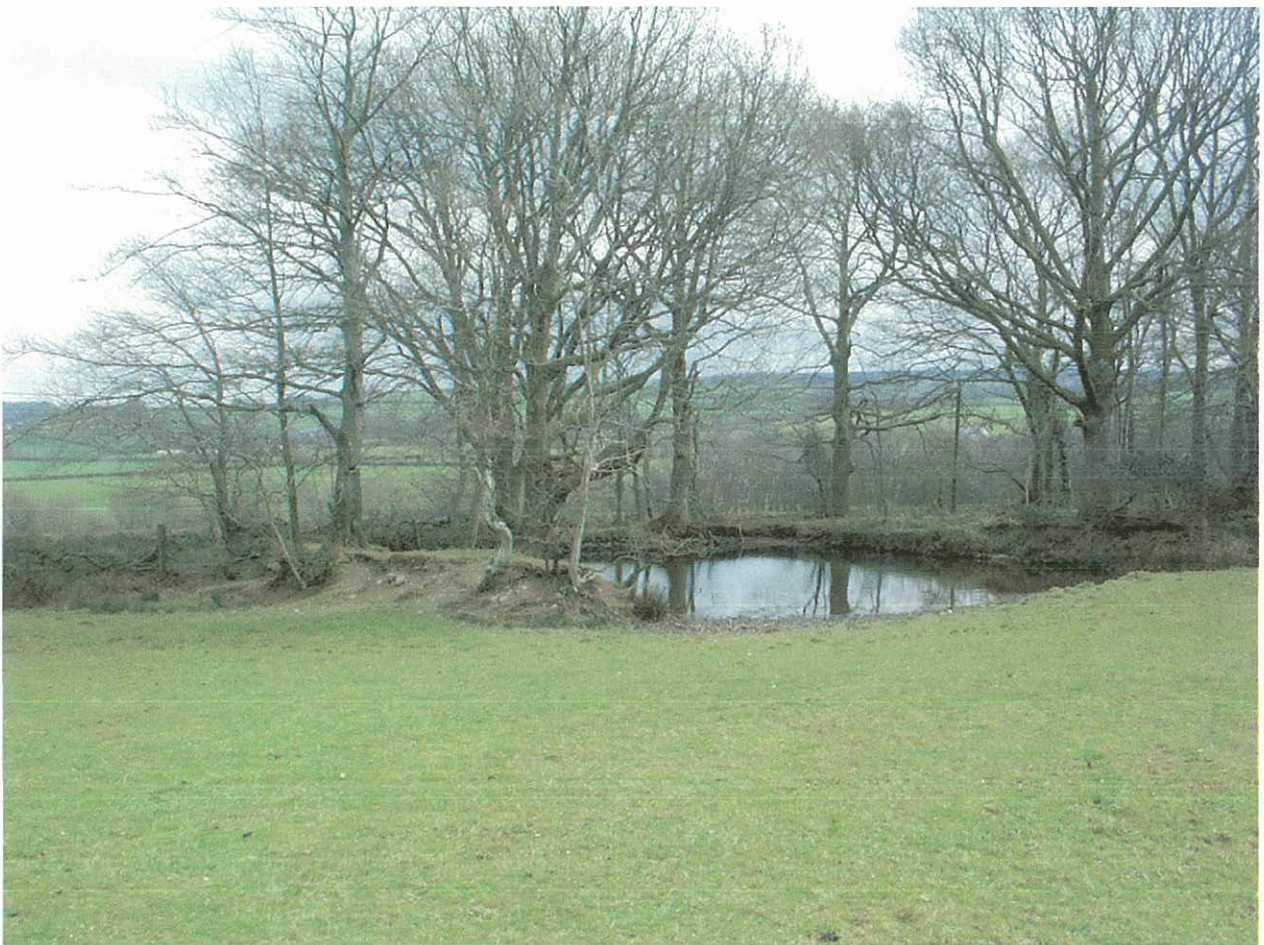
The banks on the north and east sides are field boundaries and actively managed. The bank on the west side is suffering from livestock erosion and levels of stock should be managed, or the bank protected by stockwire fencing.

The best-preserved of the four ponds on the holding. It is still wet, and lies against two field boundaries that form its north and east sides, to catch run-off from the downhill slope of the field to the south. It is still wet. It consists of a regular, square area, approx. 15m x 15m, defined by a low bank to the west. All banks now support standard trees. The pond has internal masonry lining. It appears to date from the early 19<sup>th</sup> century landscape re-organisation, and is still in use.

Plate 12 – Pond (PRN 44772) from the southwest

The banks on the north and east sides are field boundaries and actively managed. The bank on the west side is suffering from livestock erosion and levels of stock should be managed, or the bank protected by stockwire fencing.
