Tir Gofal Farm Visit Report

Llanllyr

W/11/810

ACA Project Record No 39020

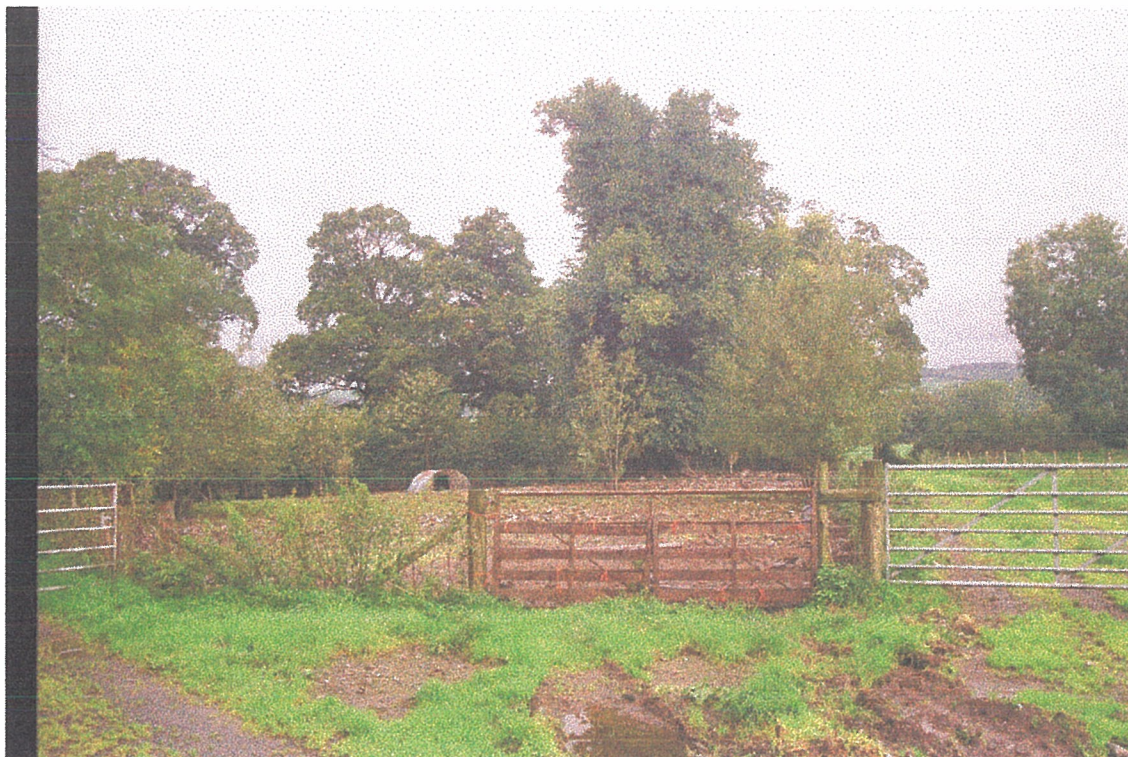
It is likely that a mansion house was built on the site of the former nunnery at Llanllyr in the late 16th century by the Lloyd family. A drawing identified by Tom Lloyd as Llanllyr shows an 'Elizabethan' mansion of several elements possibly incorporating earlier structures set in formal gardens. An estate map of 1768 indicates that the mansion faced west from which direction a tree-lined drive led. Walled gardens - possibly 39021 - lay to the east of the house. In 1696 the house was decayed but according to the present owners was not pulled down until 1830 when the present mansion was built. However the tithe map of 1843 seems to show the old mansion with no trace of the new. There is now no trace of the mansion. Its site lies partly under pasture, partly under woodland, partly under a pig foraging area and partly under modern farm buildings.

Presumed site of old mansion, 39022, looking northeast.

It is likely that remains of this mansion survive beneath fields and woodland. It is important therefore that no works that involve ground disturbance are undertaken in these two areas.

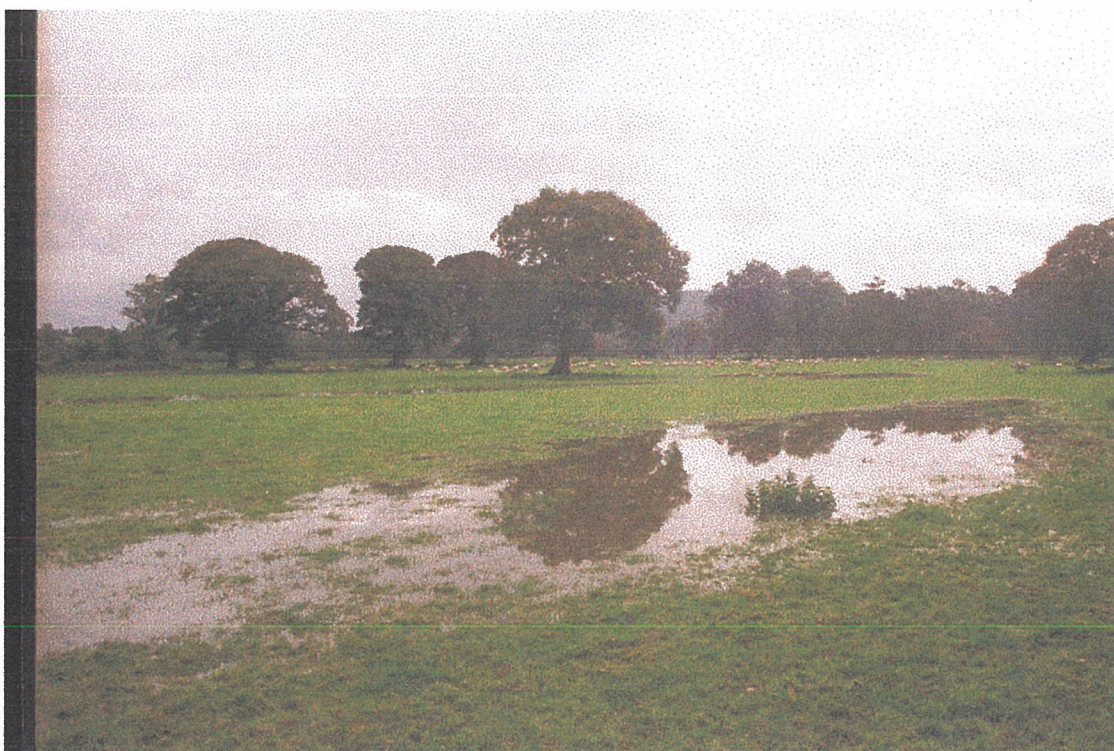
This is a most unusual field system as it has been created by a series of canalised, north-to-south flowing streams - the Afon Ty-cam, the Nant-Cleifon and the Nant Llan-Llyr. The long narrow divisions created by these streams are sub-divided by east-west boundaries, most of which consist of ditched streams. Alongside every stream/ditch is a boundary bank. Every bank was once topped by a hedge but these are now in various stages of decay; few are stock-proof and most consist of straggling bushes. However, every bank is topped with mature trees at intervals of 10 - 20m. Some scrubby woodland has developed alongside some of the boundaries but the main land-use is pasture, which is improved in some of the drier areas and unimproved and rushy elsewhere. At the time of the visit standing water was everywhere. Most of the area has been subjected to land drainage - as shown on a map supplied by the owners of Llanllyr and evidenced by drains in the side of ditches - and a pond has recently been created. In the side of most ditches, a 30cm thick peat deposit is visible 0.70m to 1.00 below the surface covered with colluvial deposits and resting on a white/grey clay. This field system has been established by 1758 but its origin is unknown. It may be of Medieval origin and associated with the Llanllyr Nunnery - 4786 - or created when the post-Medieval estate was established in the late 16th century.

Northeast portion of field system 39035

This field system is an important historic landscape element. Every effort should be made to preserve it. Some of its components - the hedges in particular - have suffered degradation and it is probably too late to save them, but it is vital that ditches are maintained and boundary banks retained. A pond has been recently excavated in this area which has destroyed an area of buried peats. Further pond digging should be avoided or carefully sited to prevent more damage to these peats.

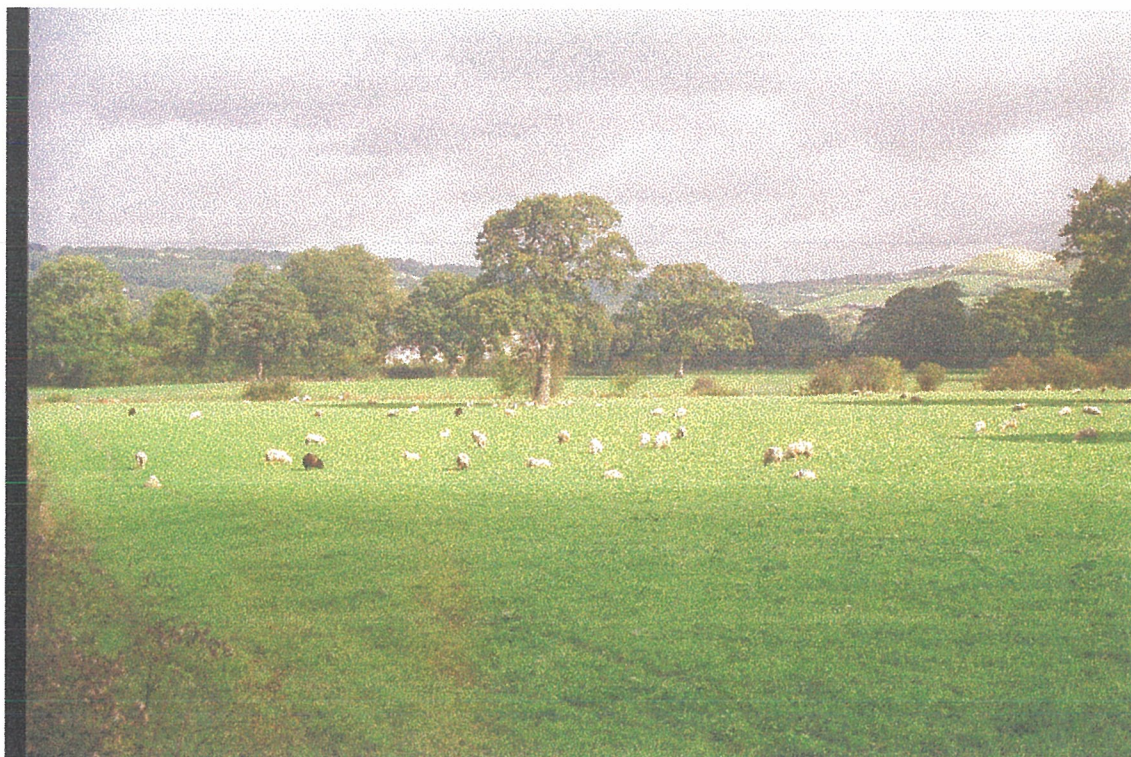
This field system lies to the east of Llanllyr House. According to a mid 18th-century estate map and the tithe map of 1843, this area was divided into a system of small irregular fields. The date of creation of this system is unknown. Considerable changes had taken place when the Ordnance Survey surveyed the area in 1887. By then the landscape had been reorganised into parkland and divided into very large enclosures with isolated standard trees. Interestingly, the standard trees were the remains of the former field system - a careful examination of the OS six inch first edition map reveals that the trees are in sinuous lines which match the boundaries shown on the tithe map. In field examination, the course of some of the old boundaries can still be detected in the lines of extant trees. The parkland was laid out following the building of the new Llanllyr Mansion - 9675 - in c. 1830 or during additions to it in the 1870s. In recent years even the regular field system of the parkland has been removed though isolated trees remain. The system now essentially consists of three large enclosures surrounded by well maintained hedges on earth banks. Of note is a band of woodland alongside the road to the north of the mansion which contains fine specimens of yew. Planting of shrubs and trees as part of garden recreation to the north of the house has also recently been undertaken.

View across field system/parkland 39038 towards the mansion looking towards the north.

There has been some degradation in recent years of what is essentially a 19th century parkland landscape. Restoration of the parkland with careful tree planting would be desirable.

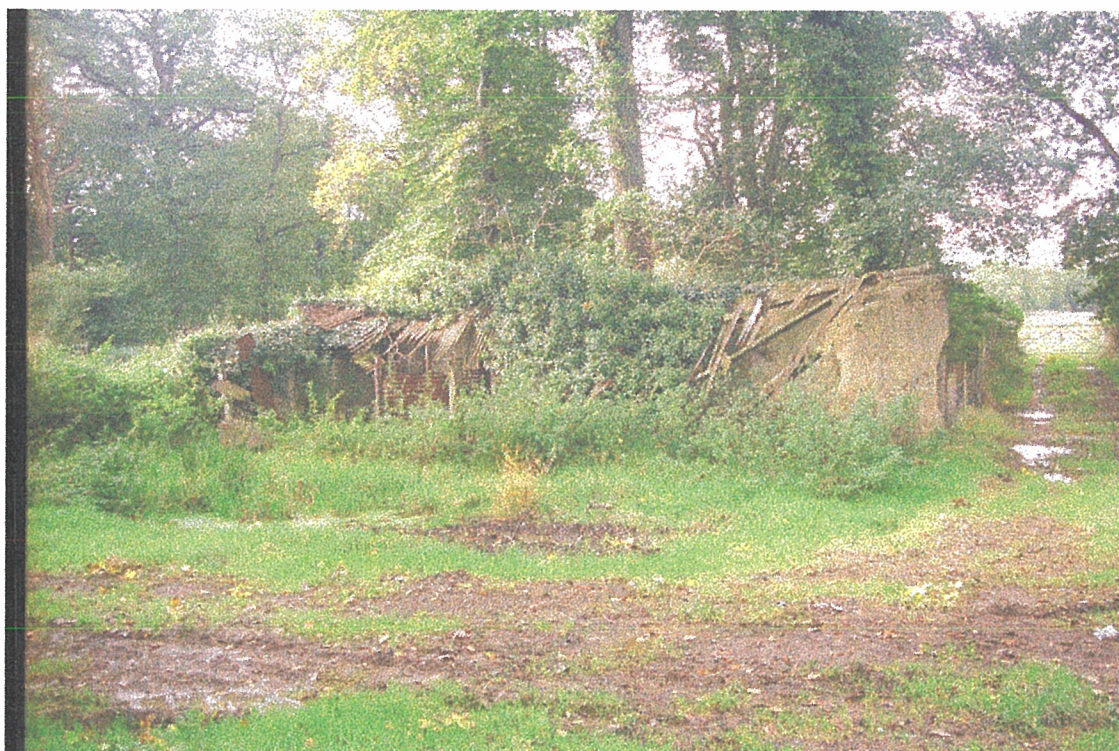
Building 39026

This building is not marked on an 18th century estate map or on the 1843 tithe map and therefore presumably dates to the later part of the 19th century. It is built of clom - earth - on a stone foundation. The latest roof was of tin but this has all but gone. It is derelict but enough survives to indicate that it was open fronted to the east and therefore seems to have been a cart house.

This small earth building is probably beyond repair. Care should be taken not to cause unnecessary damage to the surviving remains.

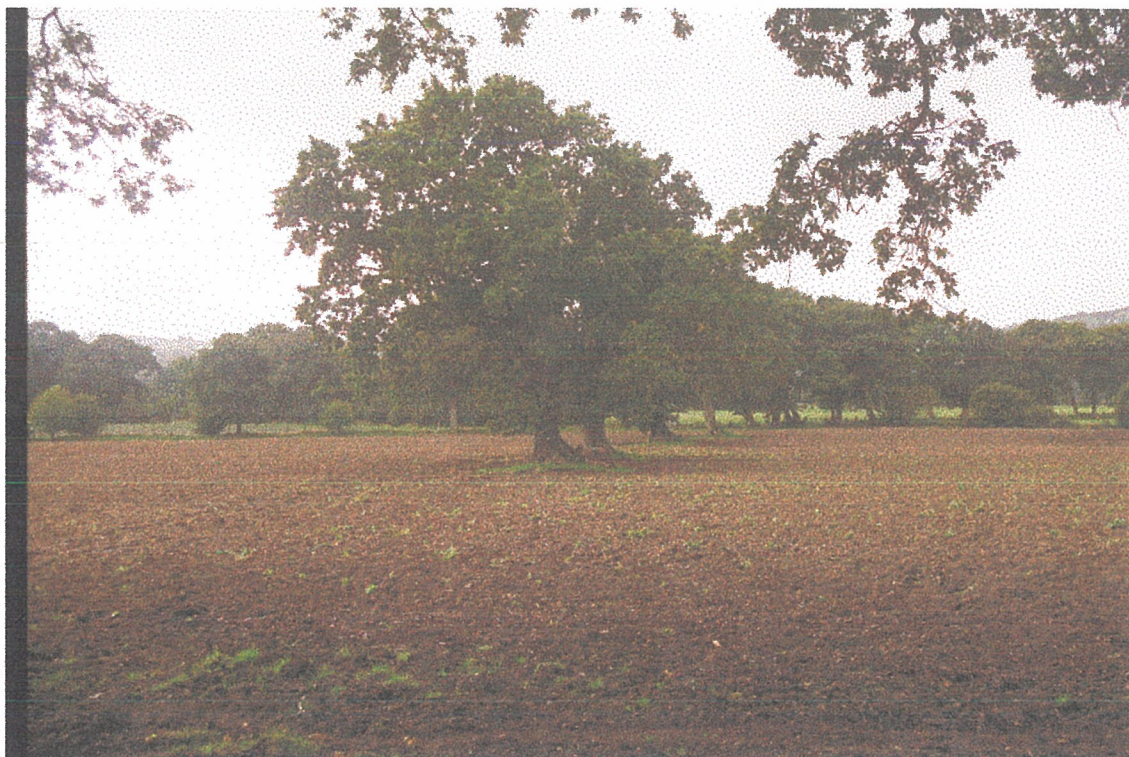
The Afon Aeron formerly meandered across a wide flood plain between Pont Talsarn and Pont Fawr 2 km down stream. The river was straightened and its course moved to its present position several hundred metres to the north in the mid 16th-century - PRN 39036. It is probable that prior to this straightening, the flood plain of the Aeron was just that and therefore the system of fairly small regular fields that were in existence up to 20-30 years ago were laid out contemporaneously with or later than the straightening. The fields were probably always wet - post World War 2 they are recorded as rushy. In the 1970s they were comprehensively drained and the former course of the Aeron which was then still visible was erased. Since the draining and the conversion of the fields into good quality pasture and arable there has been a degradation of the field boundaries. The system of small irregular fields established in the 16th century has all but gone and wire fences provide most divisors. Where historic boundaries survive they are of earth banks topped with hedges and are generally derelict but do contain distinctive trees. Where the boundaries have been removed the distinctive trees usually remain. Alongside roads the boundaries survive in good condition and are well maintained.

Field system 39037 showing a removed hedgebank.

This field system is very degraded. Therefore no recommendations are made here for its preservation/retention.

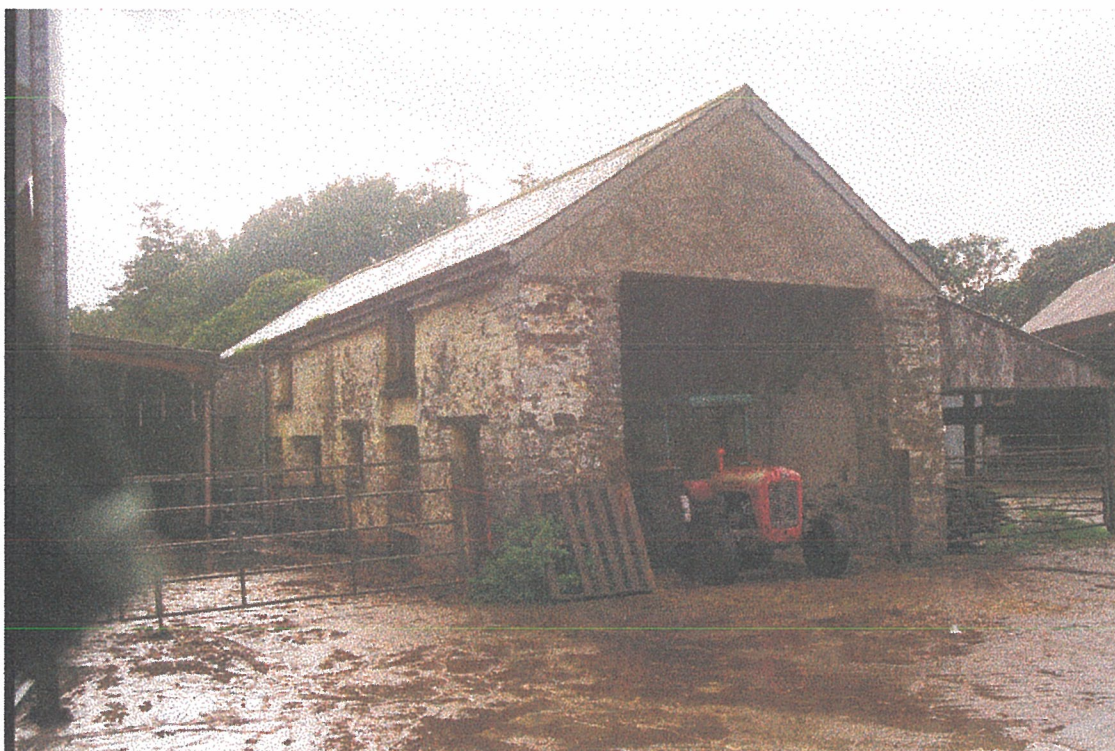
This is the only substantially intact old farm building in a farmyard of predominantly late 20th century structures. It is stone-built two-storey with a slate roof. It seems to have functioned as a stable with a possible pigeon-loft over, but all the internal fittings and first floor have been removed as has the north end wall. One of the roof trusses is dated 1845.

Agricultural building 39023.

There are no recommendations for this site.

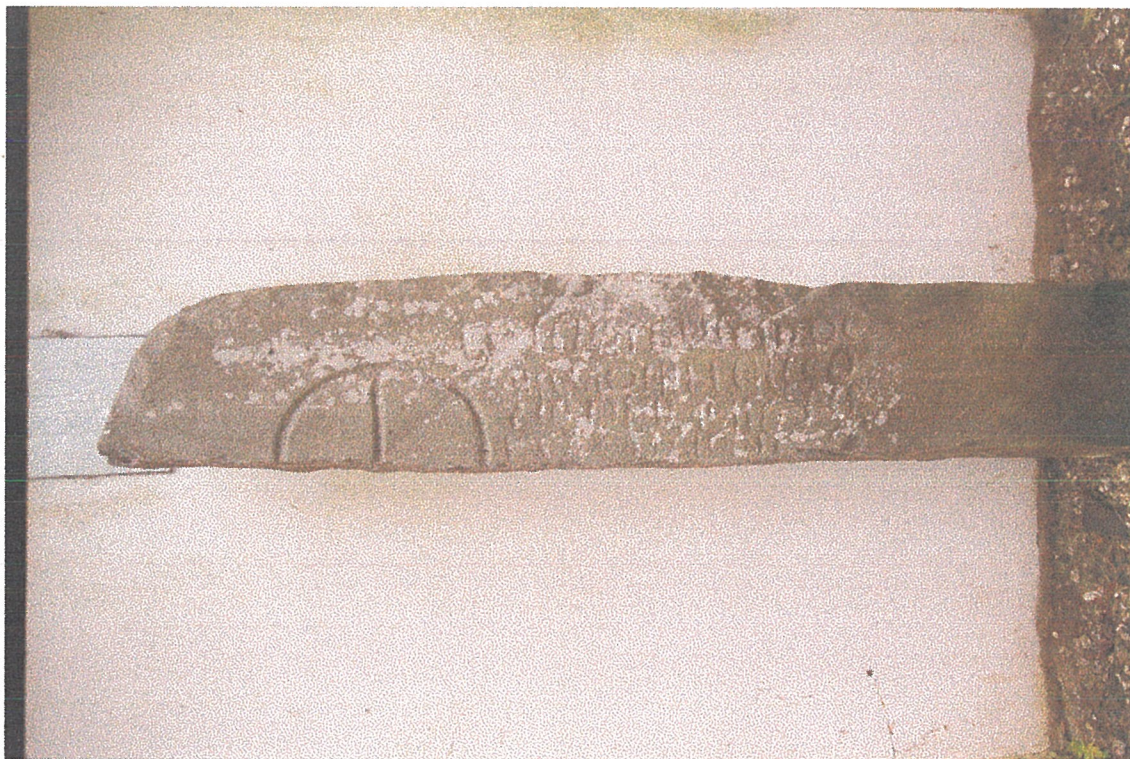
This stone has now been mounted in a niche in a wall in the restored gardens of Llanllyr. It is available for inspection by the public by appointment.

Early Christian Monument, 4781.

As this monument has been recently mounted and is made available for public inspection, no further management recommendations are suggested.
