YSTRAD EINION LEAD MINE, CEREDIGION

Report on Archaeological Recording by Dyfed Archaeological Trust during a Derelict Land Reclamation Scheme .

Report by H. J. James
& D. H. Phillips

June 1994.

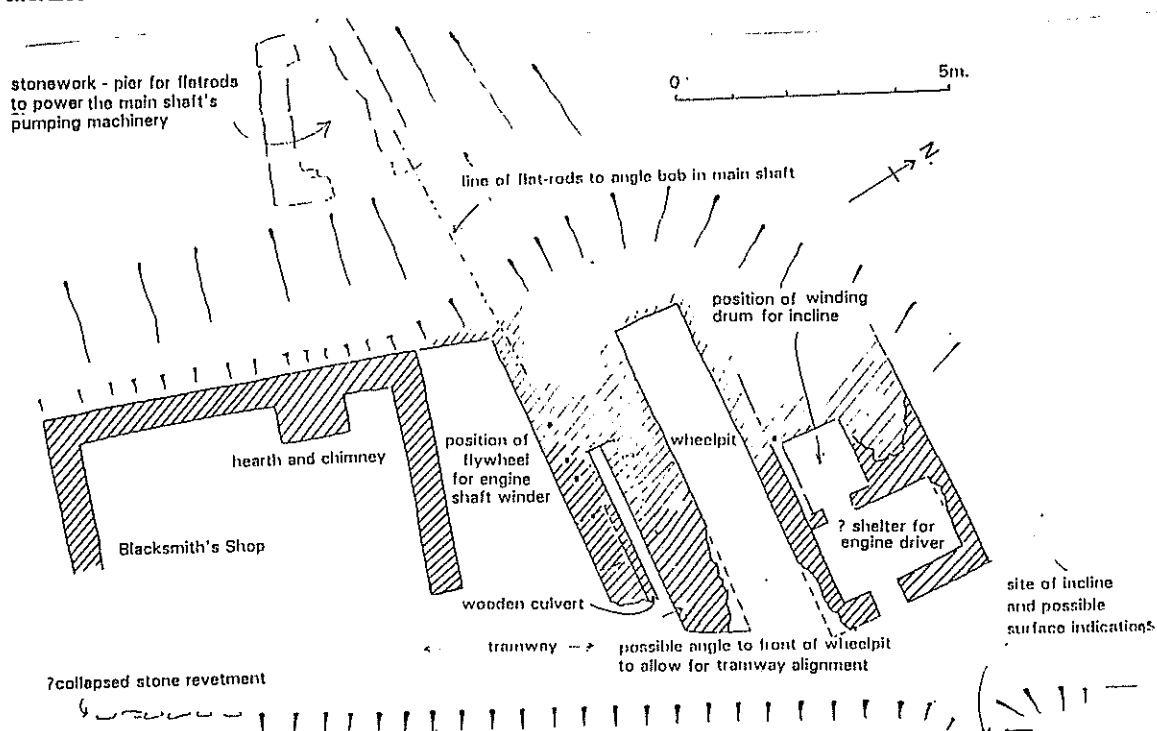
Fig. 8: Sketch Plan by DAT at 1:50, base information enlarged from DCC's 1:200 Site Plan with adjustments made following on-site recording and with interpretative captions by DAT.

3.2.1 These buildings are in a fragile condition and even clearance with hand tools of the trees and vegetation choking them could cause further instability. There are still a number of iron tie rods for machinery and fittings visible within the structures. However their clearance and consolidation did not form part of the recent phase of Dyfed County Council works on the site. It was agreed therefore that the Trust should make a measured record of the present condition of the structures in case of further collapse. (See Fig. 2, Bick's A4 and Fig. 8).

3.2.3 The wheel pit was cut back into the hill-slope and the cutting revetted with a stone face; the rear being clearly visible. There has been considerable collapse of the northern, free-standing walled edge of the pit and its southern wall is leaning inwards. at a dangerously unstable angle. Holding down rods and seating arrangements for the wheel housing are still visible. The recorded dimensions of this upper wheel are: 22 foot diameter, 3 ' 6" width. R. Protheroe-Jones suggests that the angled end of the wheelpit wall fronting the tramway, making the northern wall shorter than the southern, is deliberate in order to accomodate the alignment of the tramway in front, which in turn was constrained by the contours of the hill slope.

3.2.4. On the south side of the wheel pit and set back from the tramway is a rectangular length of stone with brick upper courses which was the seating for a flywheel to the main waterwheel. This is some 1m. wide and 5m. long. Three protruding and one truncated iron holding down rods survive within the build of this seating and there is more iron work within the collapsed material adjacent to the tramway. Originally the southern wall of the wheel pit and the flywheel seating were constructed flush against each other. Because the southern wheelpit wall is now leaning inwards the northern face of the flywheel seating is exposed. This has revealed a wooden, plank lined culvert which was constructed within and on the concealed northern face of the flywheel seating. Although conducting water, its source and purpose are not known. The flywheel, powered from the main wheel itself powered the flat-rods which operated the angle bob pumping the main shaft.

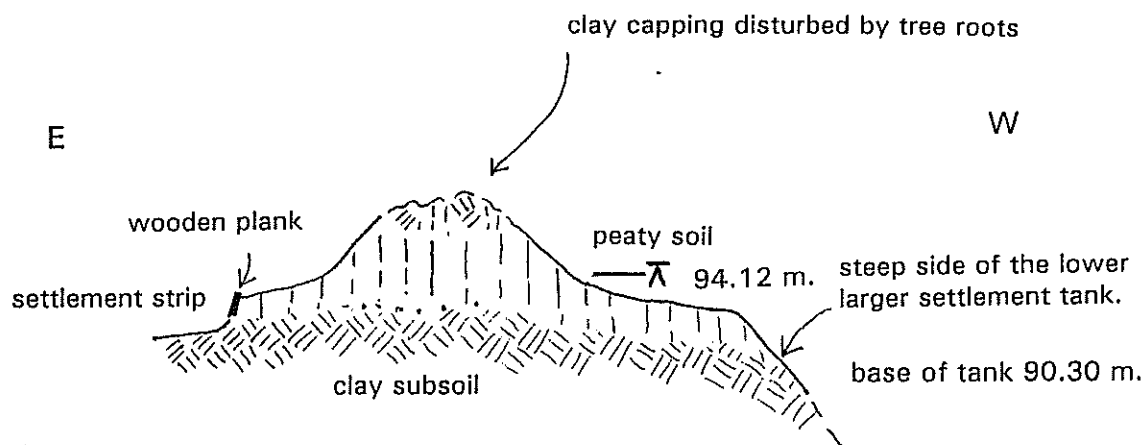
Fig. 13: Sketch Section of the bank between the lower row of settlement strips and the main deep settlement tank. Scale 1:20.

deep. A low bank or bund separated the strips from the tanks. It was simply constructed of upcast peaty turves set over the subsoil clay and held in place with a clay capping (see Fig. 13). It is likely that the initial dense afforestation of the whole area of the slime pits had destroyed most of the traces of wooden launders leading water off the settlement strips after the heavier ore particles had settled to their base and down to the tanks themselves. The clearance of the trees by the contractors and removal of stumps in 1993, work necessary to prepare the area for an impermeable membrane, further obscured the site.

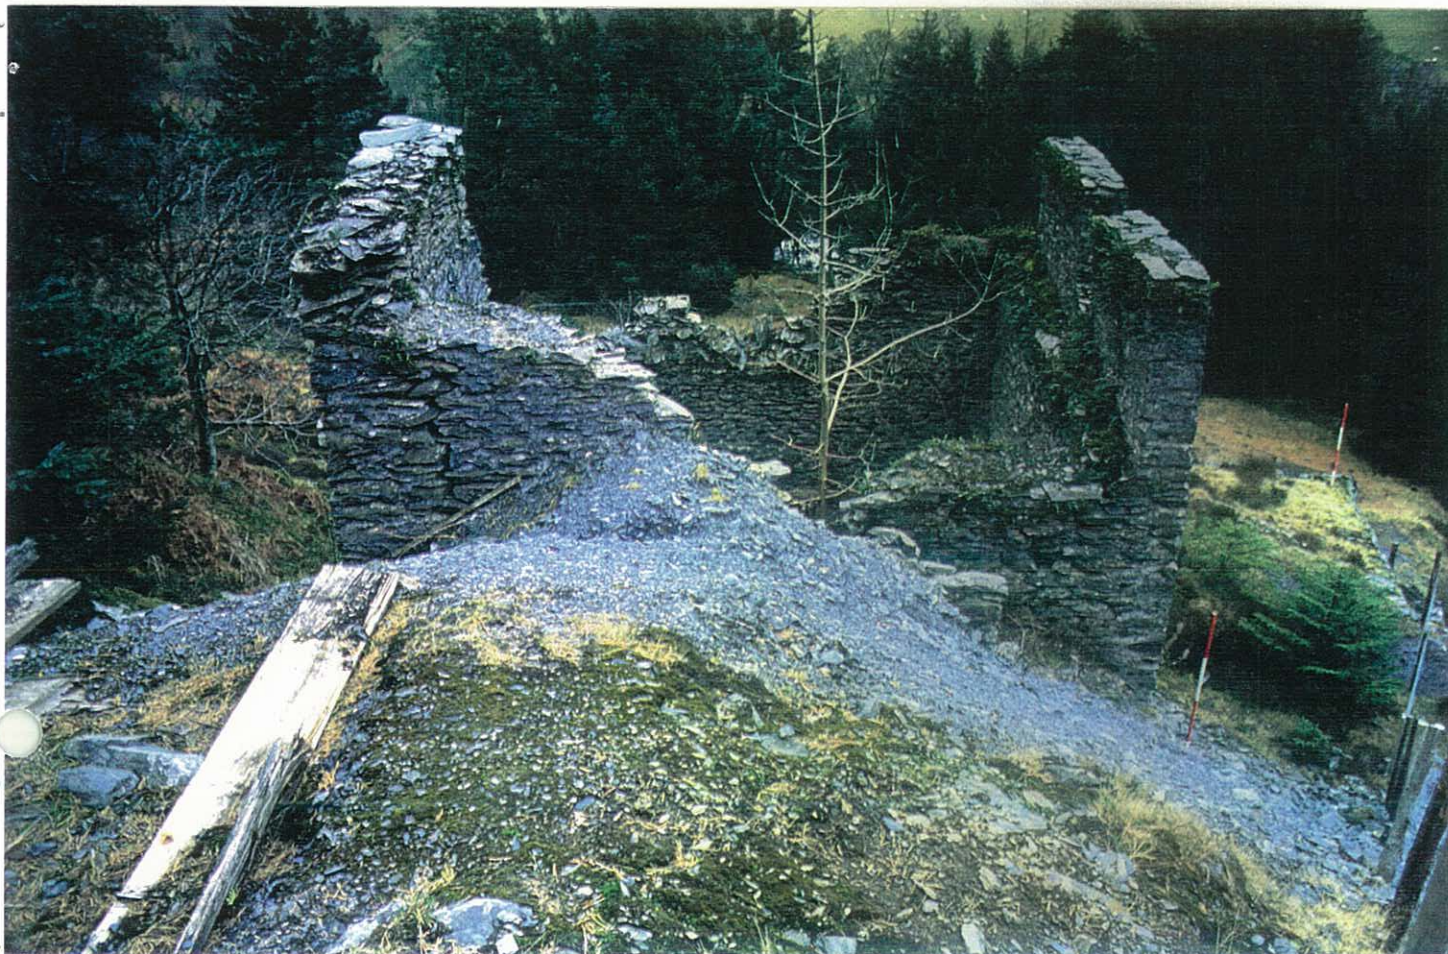
Plate 1a: View from rear of Crusher House, showing part of wooden frame still in position and height of spoil - March 1993.

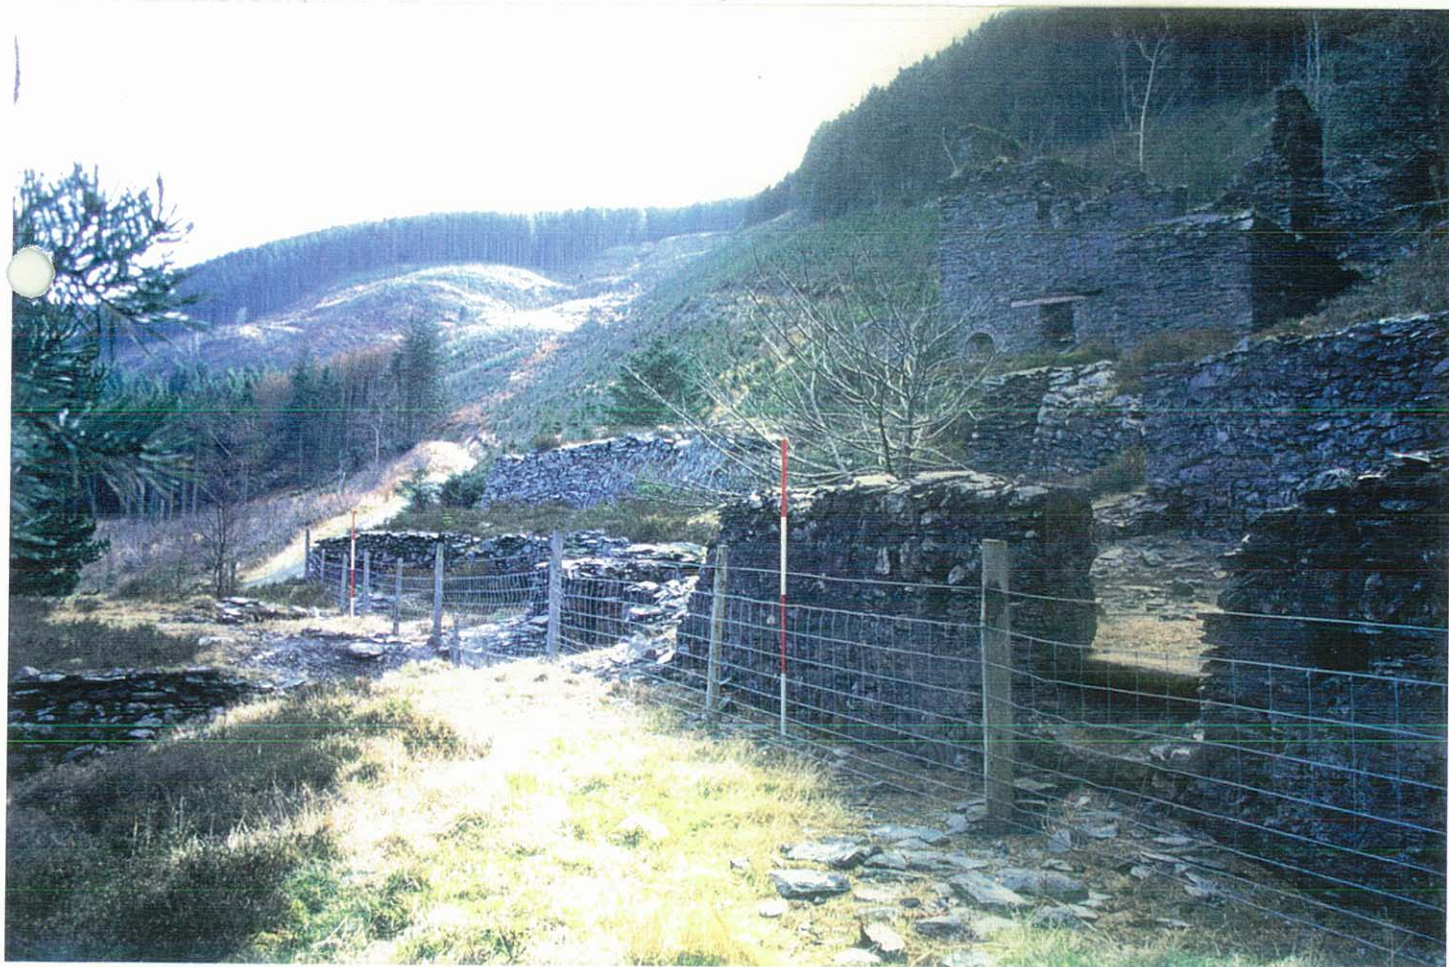
Plate 1b: View from the 'Storehouse' above the slime pits, looking up to the Crusher House, before reclamation. March 1993.

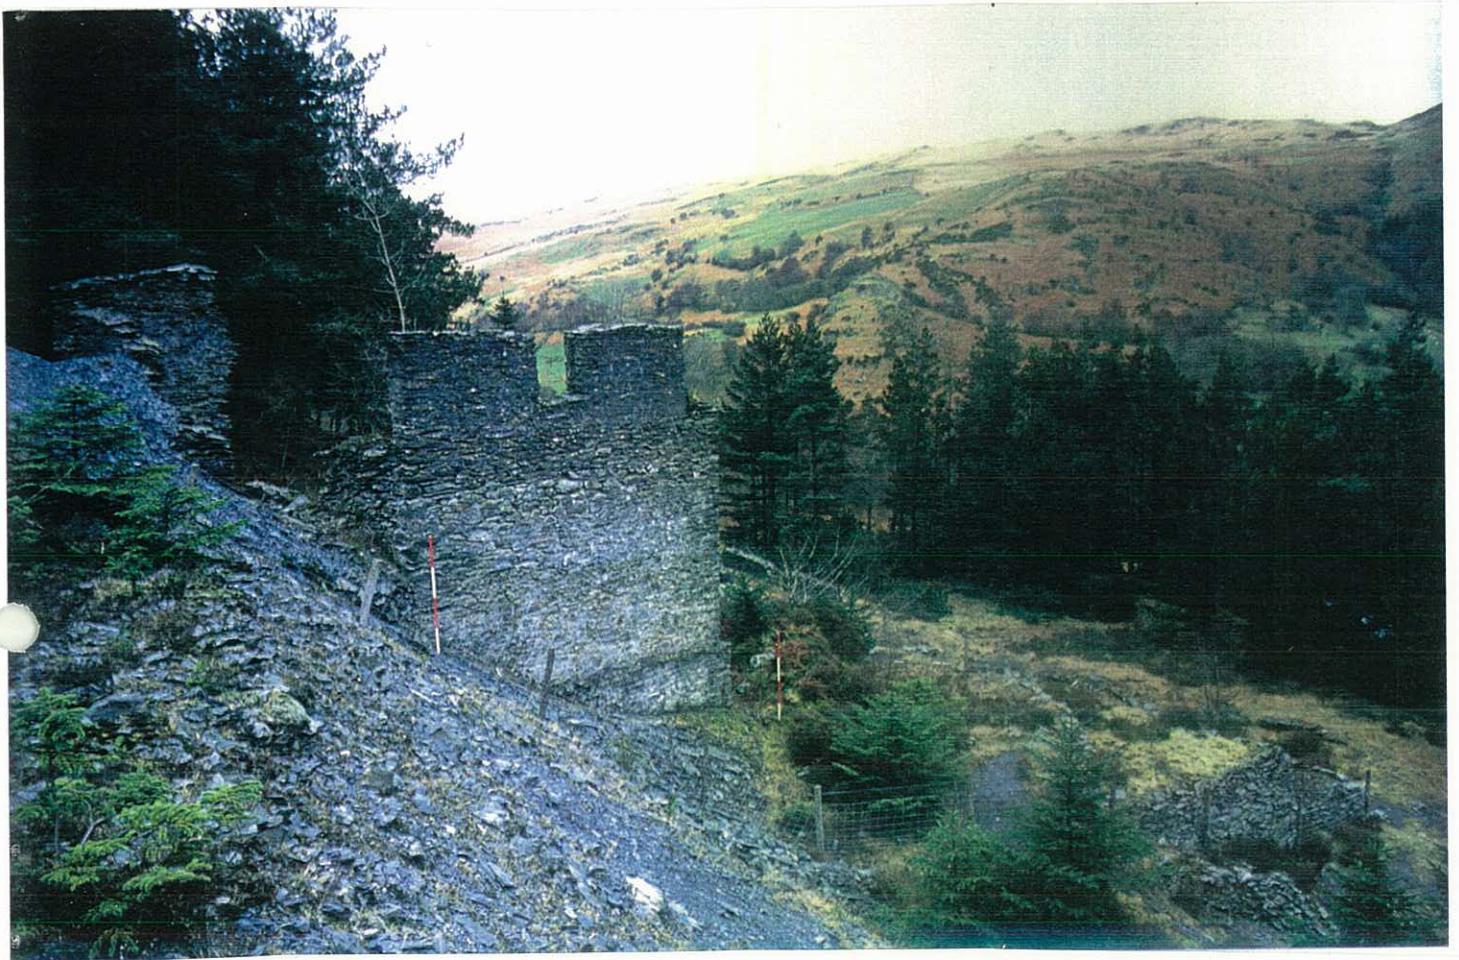
Plate 2b: View across the Buddles, up to the jigger floor and front of the Crusher House.

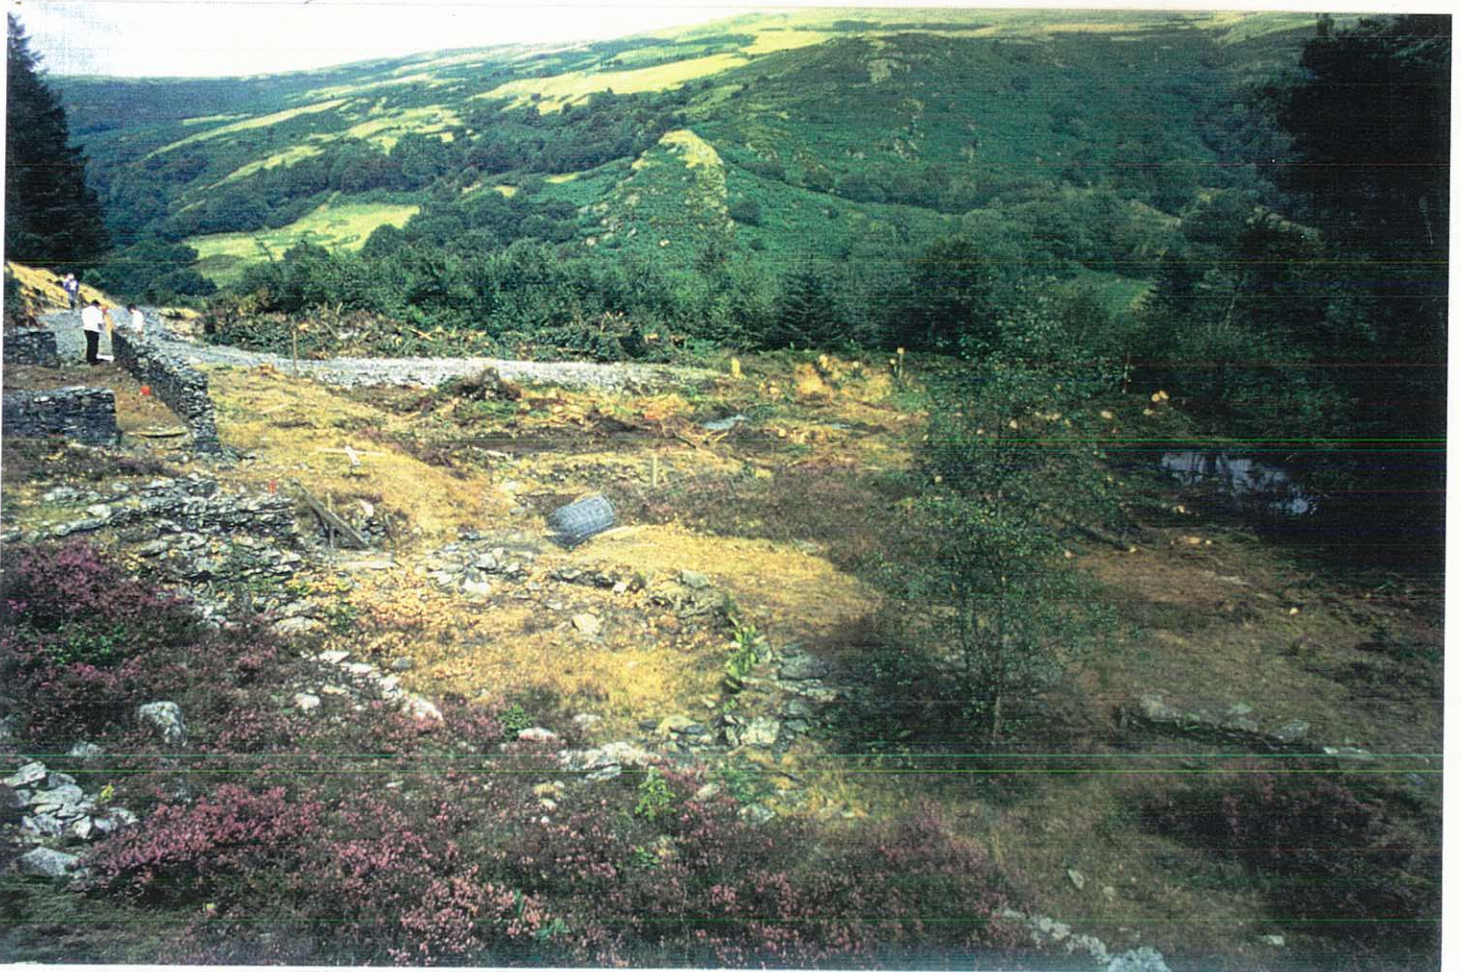
Plate 3b: View from the jigger floor of the Buddles, before clearance and consolidation, August 1993.

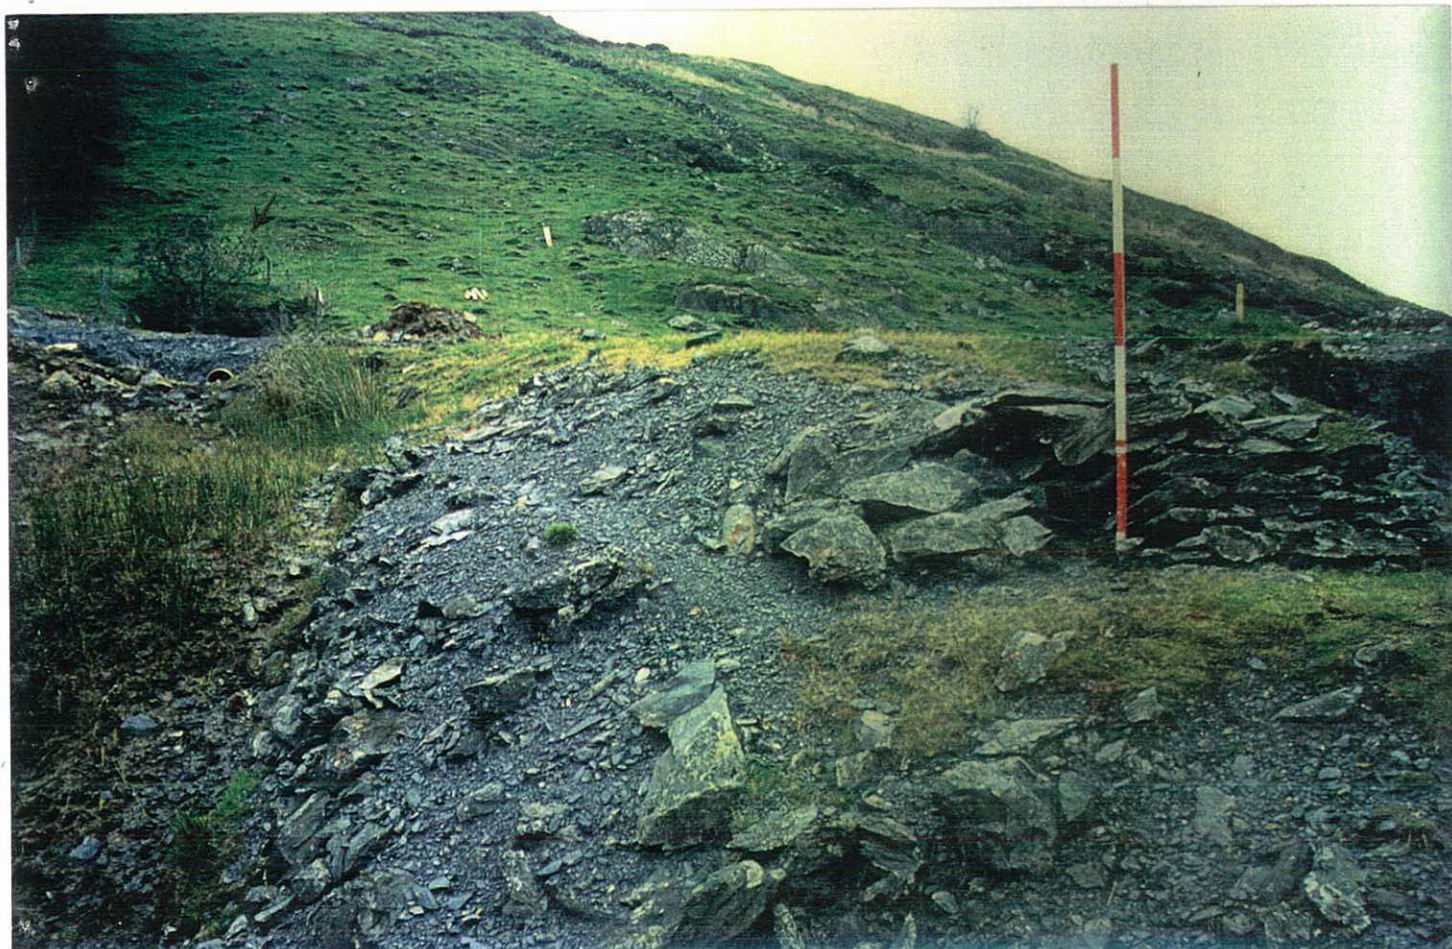
3.7.1 A large spoil tip at the mouth of the Deep Adit level was sited some 100m. north of the ore processing areas (see Fig. 14 7 Plates 4a & b). It was noted in May 1993, during R. Protheroe Jones' rapid survey of the site, that the toe of this coarse development rock tip had already been quarried away for use as hardcore. The Reclamation and Consolidation programme required the spoil from the tip for infilling the settlement tanks prior to laying down the membrane and also for surfacing the access tracks (later to be used as footpaths). The spoil tip had been revetted on its south eastern side by dry stone retaining walls and it was agreed at the preliminary site visit to undertake a day's rapid investigation, by machine, of the tip to look for and record any other structural evidence. In the event this was not done, but it was clear from watching spoil removal that the only structural elements in the tip were the side retaining walls. Due to a modification of the scheme for encapsulating the slime pits, it was not necessary to remove the whole of the tip. Sufficient therefore remains to indicate its former extent and the retaining walls and traces of a wooden launder and leat pillar have been preserved.

Plate 4a: Spoil Tip below the Old Level - Bick's level 3 (arrowed), showing leat pillar, marked by ranging pole. August 1993.

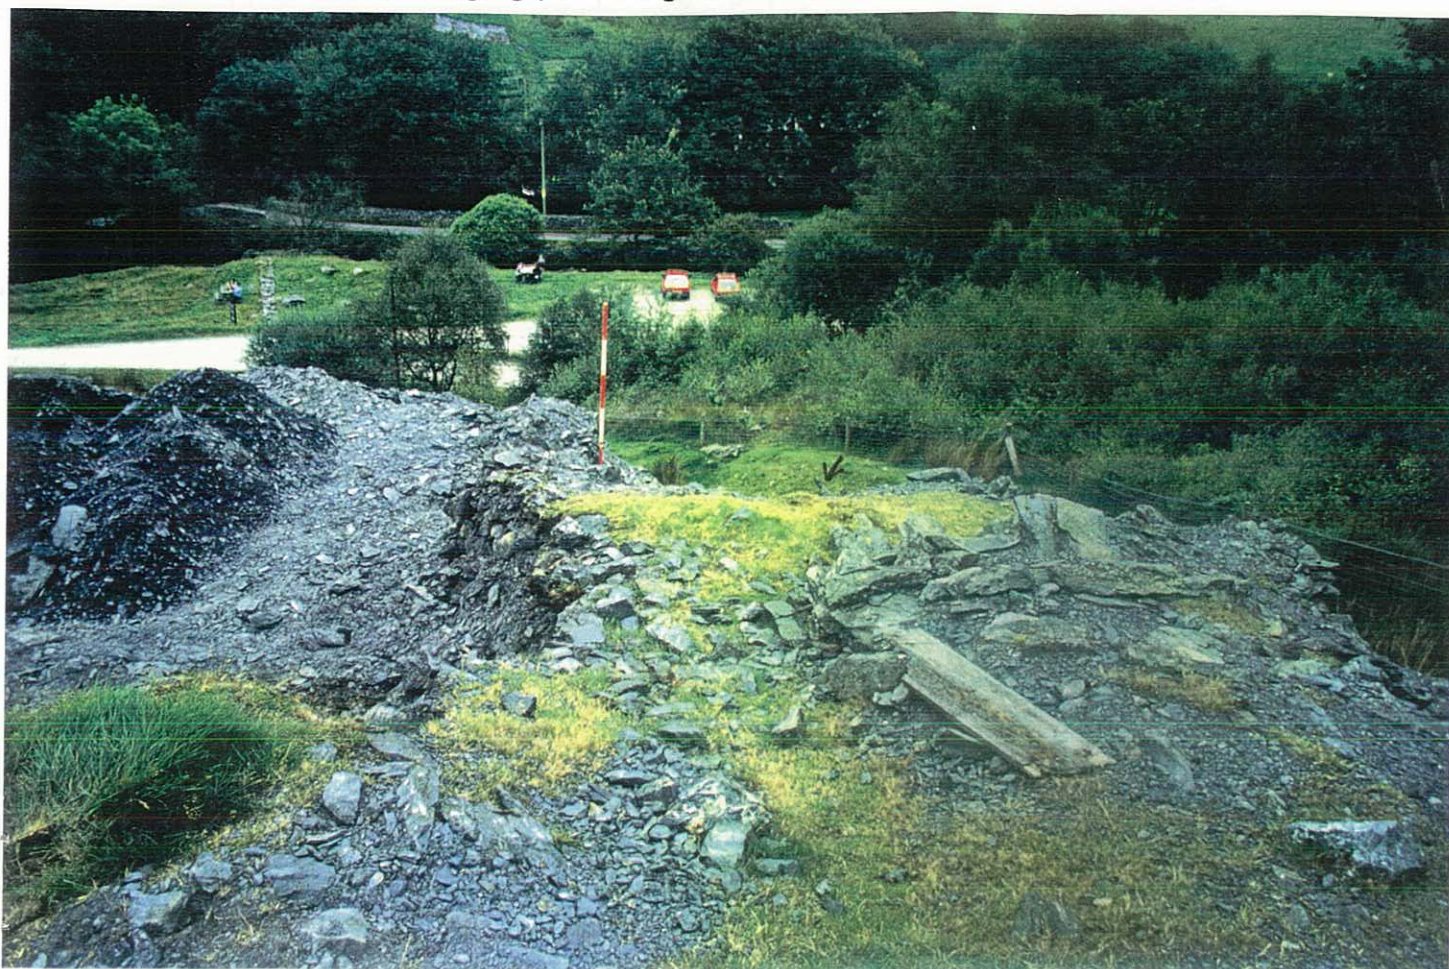
3.7.2 The water issues from the tunnel like entrance to Level 3 and was possibly culverted before being discharged down the side of the Spoil Tip and thence to enter the R. Einion. Today the water takes a ragged course down a channel alongside the remains of the spoil tip. The 1st and 2nd editions of the O.S. 1:2500 maps (see Fig. 4) both show a length of causeway abutting the Spoil Tip from the south east. This cannot at present be traced and its purpose remains uncertain. Possibly the length closest to the tip now lies below the wide, metalled modern access track but where this diverges from the original causeway line the area is covered in impenetrable tree growth. The short length of tramline issuing from Level 3 out onto the Spoil Tip shown on the first edition, allowing easier exit and disposal of development rock spoil from the level, was obviously out of use by 1905 and is not shown on the 2nd edition. A piece of tramline was recovered during clearance.

Plate 4b: Spoil Tip during clearance in August 1993, showing revetting and remains of wooden launder and pegged support (arrowed).

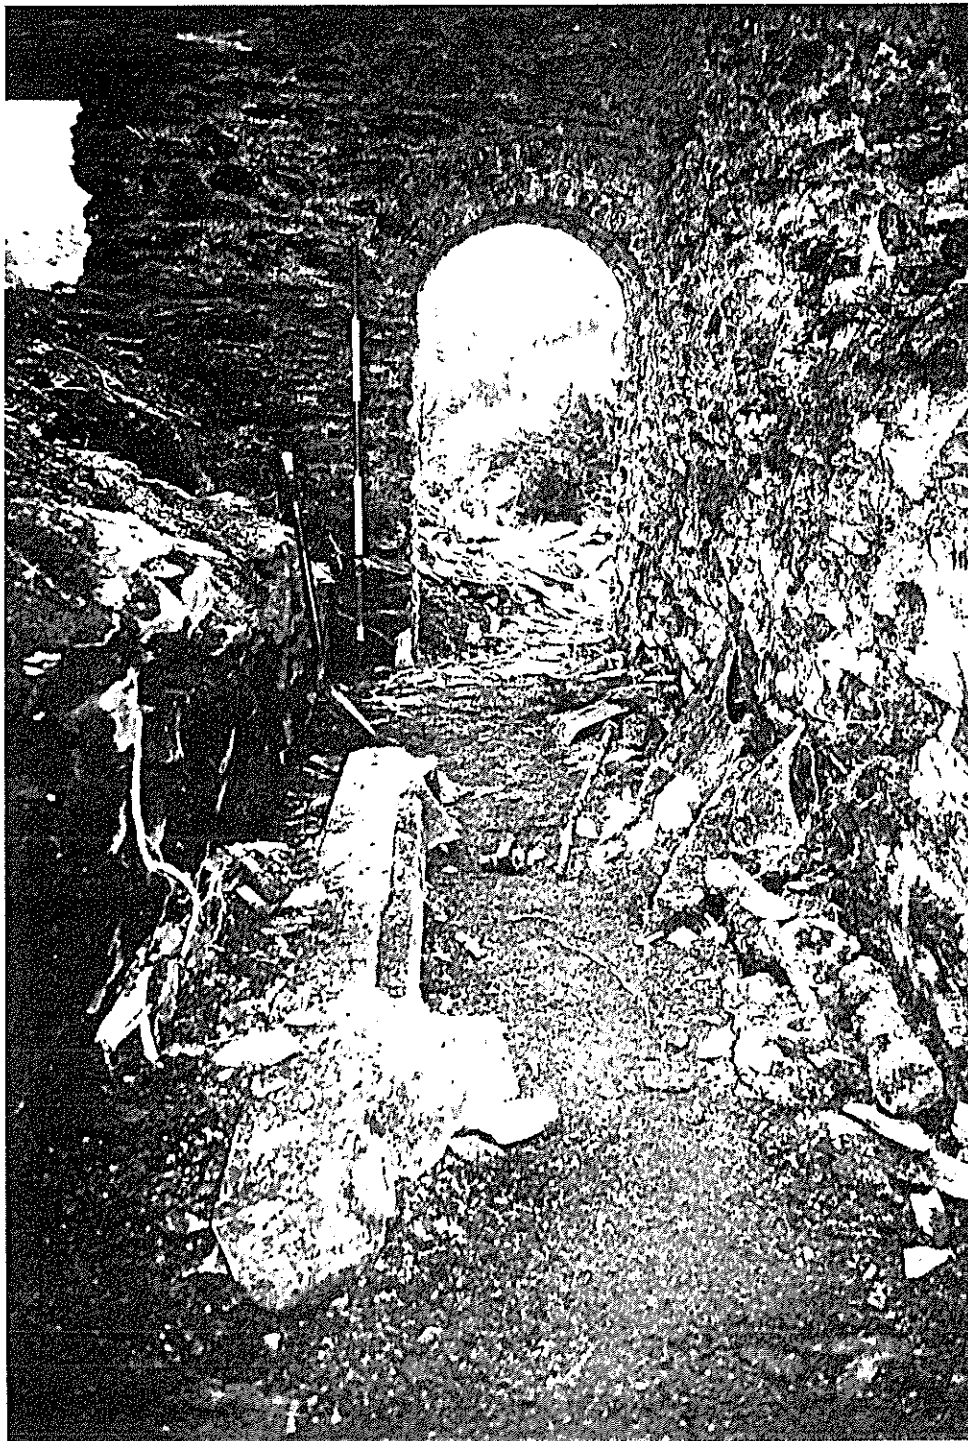
3.4.7 The most important of the fragments of machinery remaining inside and put to one side by the workmen (see list of artefacts at the end of the report and Plate 5)) was a large casting identical to that shown as the bearer for the crusher rolls themselves. This was found on the floor of the lower, entrance area, presumably left because it was too heavy to transport.

Plate 5a: Casting discovered during clearance of the interior of the Crusher House August 1993.

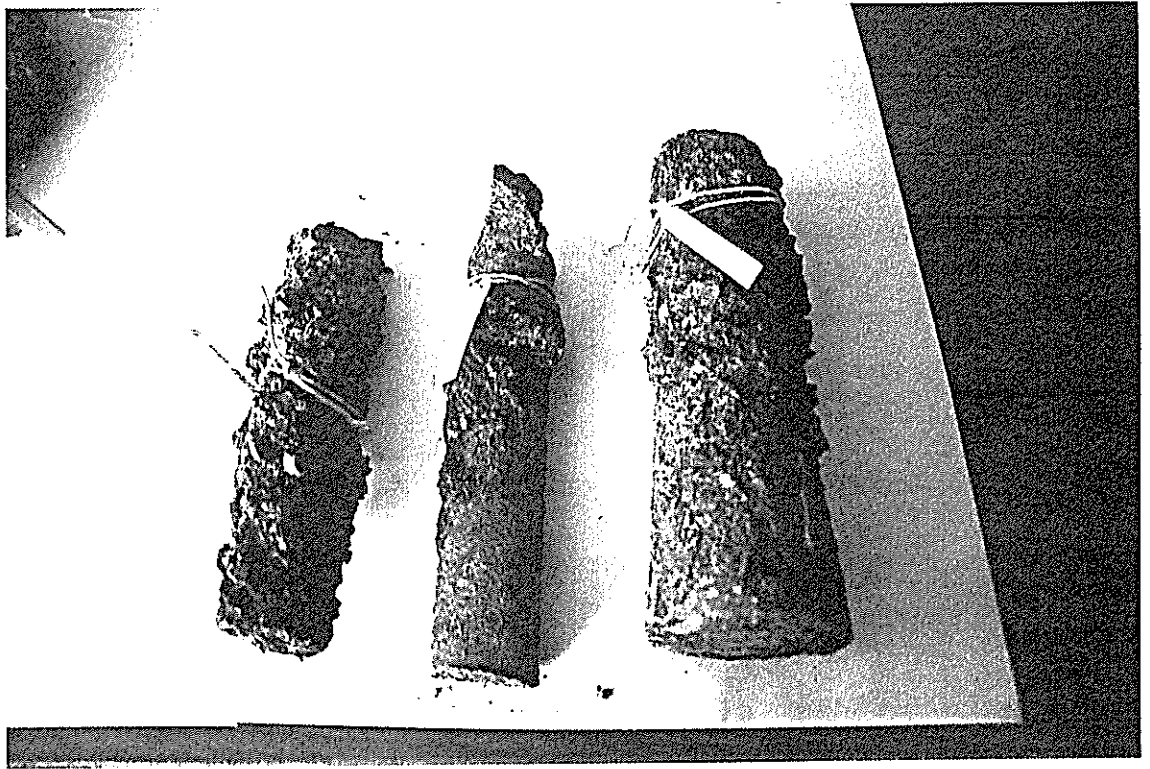
Plate 6a: Iron 'pins' from the Crusher House

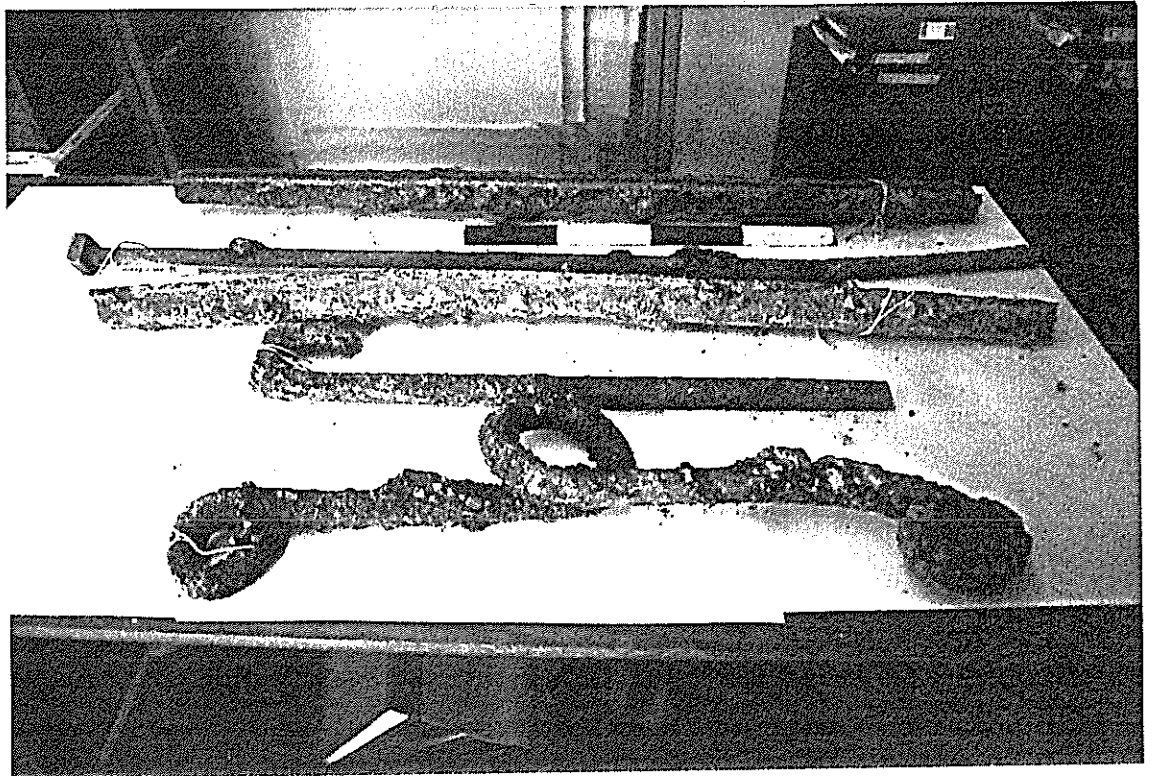
Plate 6 b: Holding-down stud, tramrail, bar and handle of a 'kibble' or ore-bucket - all except the tramrail, from the Crusher House.
