# **Tir Gofal Farm Visit Report**

## **Boulston Manor**

### **W/13/389**

ACA Project Record 39422

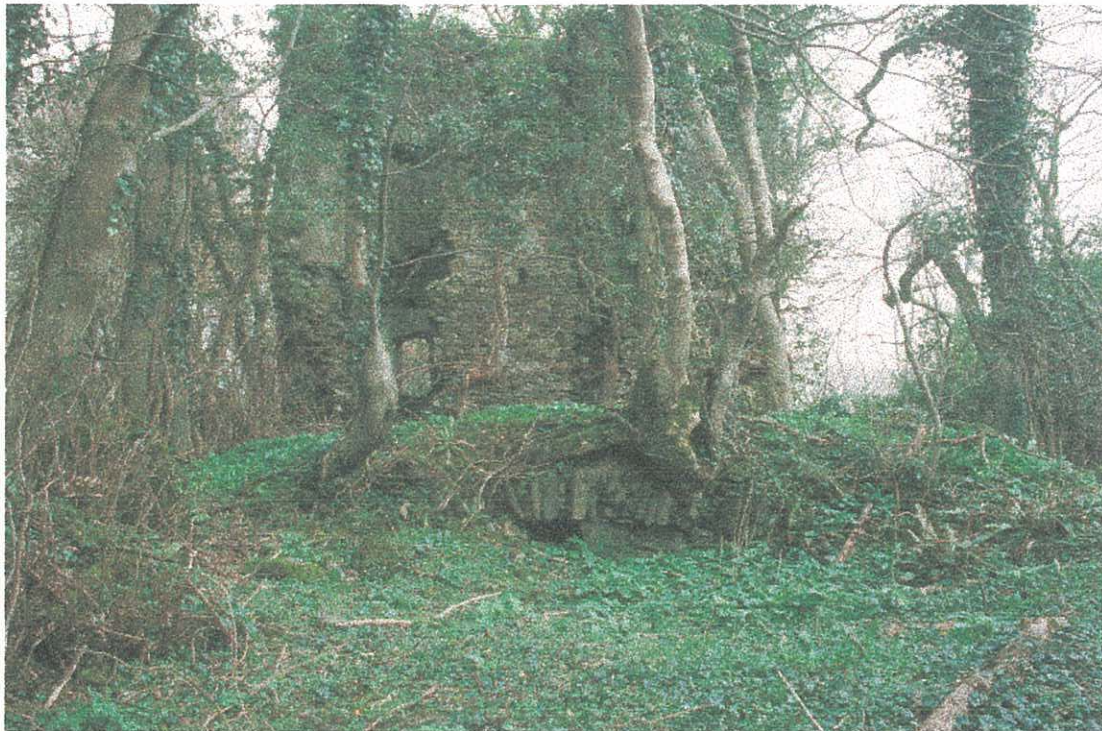
Remains of the original medieval Boulston Mansion on the north bank of Hook Reach on the Western Cleddau. The remains consist of a few ivy clad columns of masonry and several stone walls. Part of one of the vaulted cellars is visible where it has partially collapsed. A small watercourse runs beneath the northwest column of masonry at the west end of the remains and in due course will undermine it and cause it to collapse. Boulston Manor was formerly the family seat of the Wogans. The first recorded occupant of Boulston was Henry Wogan in 1450 (Jones 1996 11-12). Direct descendents of Henry Wogan lived at Boulston until 1715 when the estate passed into the hands of a branch of the Wogan family from Norfolk. By the late 18th century the mansion was in ruins and the present Boulston Manor (PRN 17786) was built to replace it.

Plate 1: PRN 3363 - Interior of the remains of medieval Boulston Manor. Note the top of the vaulted cellar in the foreground.

This site is worthy of consideration for scheduling. There are some immediate remedial works that should be carried out the watercourse has to be diverted from running under the column of masonry. During that operation it should be possible to produce a detailed topographical and structural survey of the surviving structure to be used in future management plans.

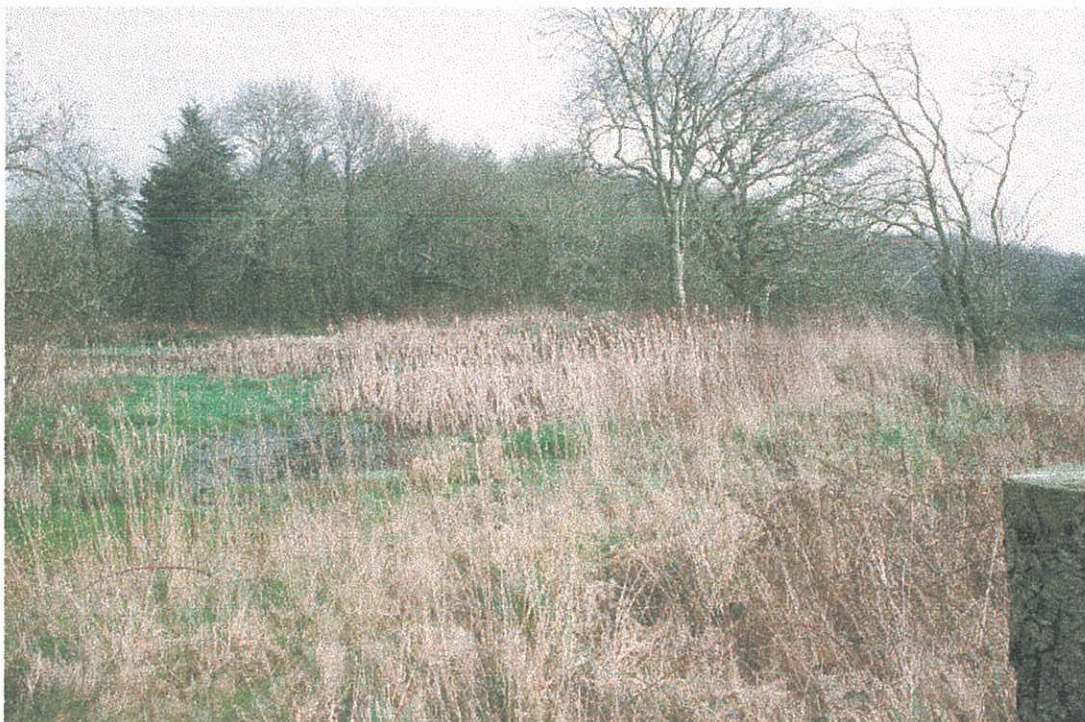
Two reed-filled ponds connected by a small watercourse. Possibly medieval fishponds, or mill ponds to feed the former mill (PRN 12500). The ponds have earth banks which survive up to 1.5m high x 4m wide. water is still running between the ponds and from the lower pond water drains into a boggy area by the medieval mansion (3363). Trees have become established on and in the ponds and they are now fairly overgrown.

Plate 2: PRN 40633 - overgrown ?medieval pond.

The ponds are probably associated with the medieval mansion or its mill and as such they are an important part of the group of medieval structures that includes the mansion (PRN 3363) and the church (PRN 3365). If there are any plans to remove trees from the pond area or to clean the ponds themselves archaeological advice should be sought.

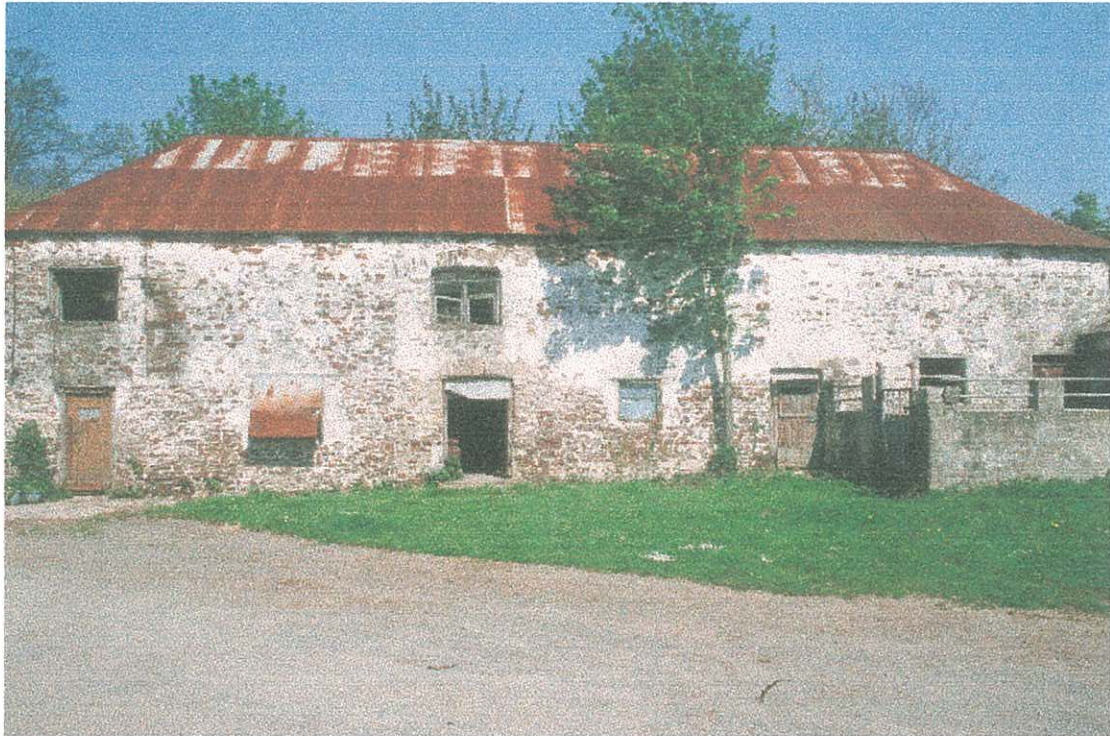
Two-storey stone built barn with a corrugated iron hipped roof. There is a half loft at either end of the barn leaving the central section full height. The early OS maps show a large extension on the north side which may be a horse engine to drive the threshing machinery. This extension has been demolished.

Plate 3: PRN 39400 - Large barn at Home Farm.

The barn is generally in good condition and it should be maintained in its current state.

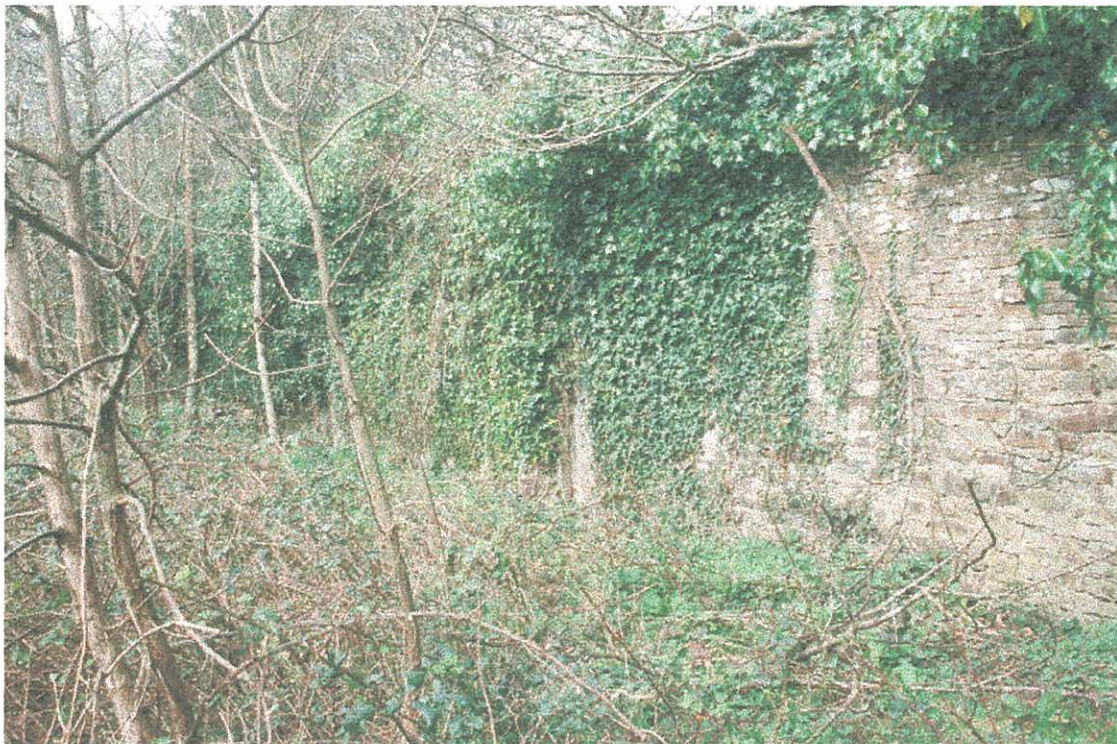
Probable early 19th century walled garden constructed from coursed rubble. The interior is very overgrown and it is not known if the original internal layout of paths and beds is still traceable. A door in the northwest wall leads to a small potting shed which survives in good condition.

Plate 4: PRN 40643 - Interior of walled garden at Boulston Manor

The garden walls appear to be in good repair and they along with the potting shed should be maintained in their current condition.

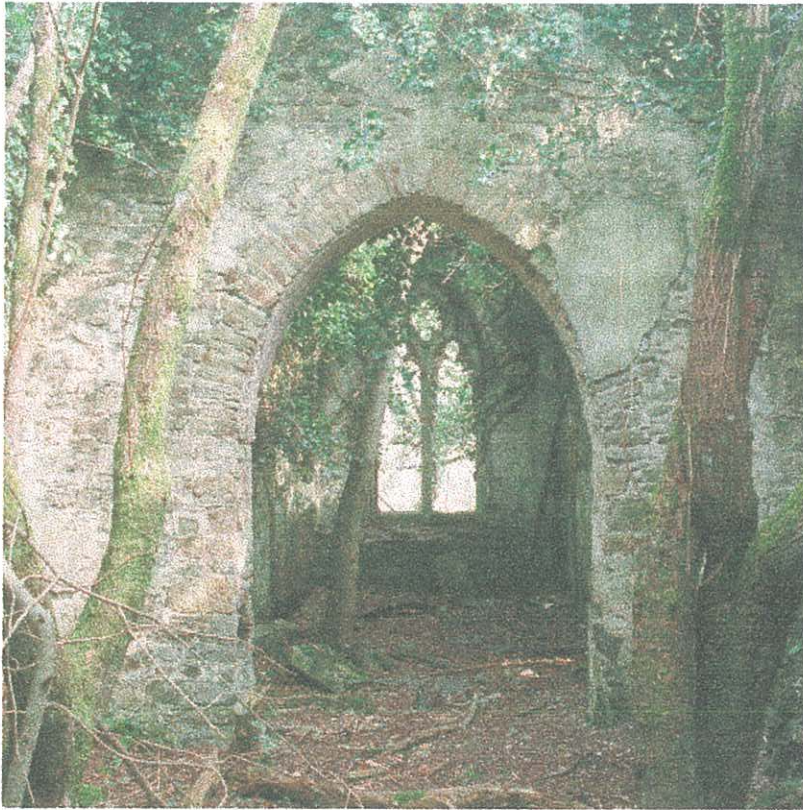
The roofless shell of Boulston Church. The medieval church was almost entirely rebuilt in 1843 but it was in ruins again by the mid 20th century. The chancel arch survives and dates from the 1843 rebuild, but the windows in the west wall of the chancel and the east wall of the nave are typical of late 19th century Victorian High Gothic architecture and indicate some refurbishment during the 1880s or 1890s. The church sits in a square graveyard which is still consecrated. A stone wall, now grass covered in places surrounds the yard.

Plate 5: PRN 3365 - Chancel arch in abandoned Boulston Church.

The graveyard is still consecrated and is therefore protected by deliberate damage, but the church itself has no statutory designation. The church and yard should be considered for scheduling or listing, particularly given its close association with the nearby medieval Boulston mansion (PRN 3633).
