# Tir Gofal Farm Visit Report

## Trefayog

## W/13/0031

ACA Report Number 2001/15

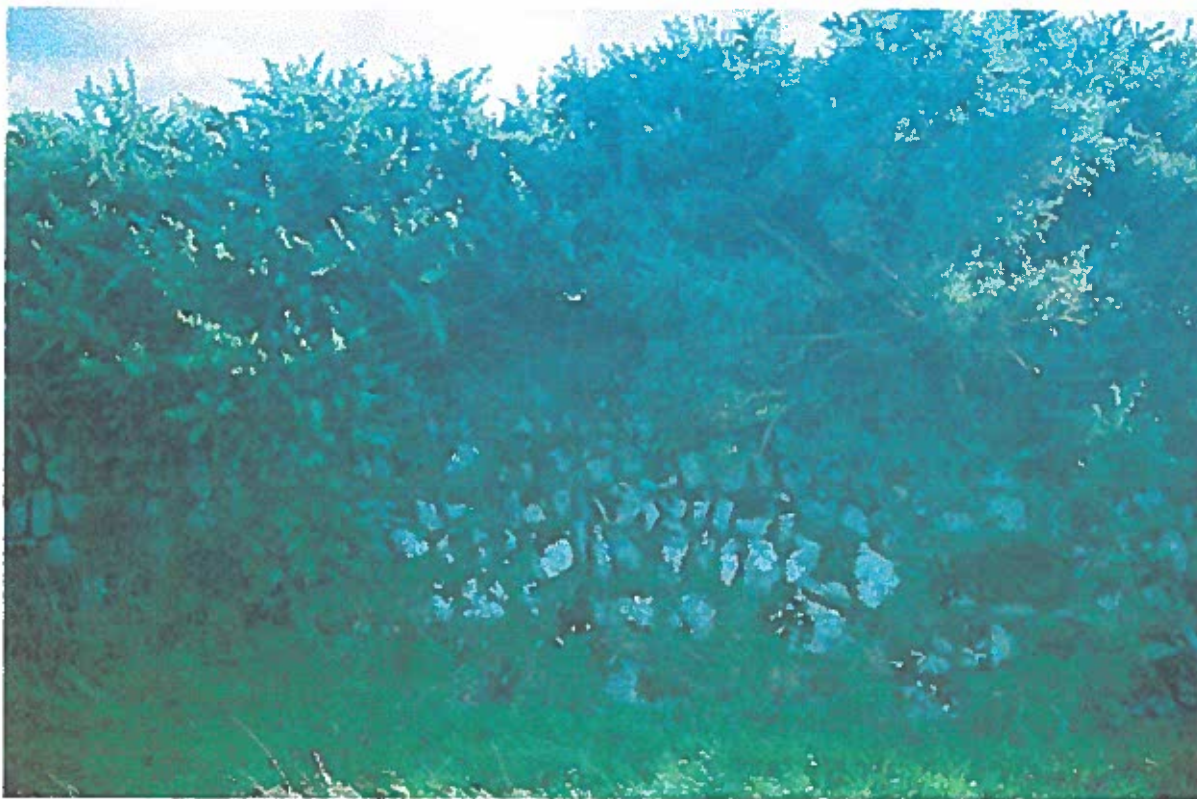
Plate 1 - typical field boundary on Trefayog Farm.

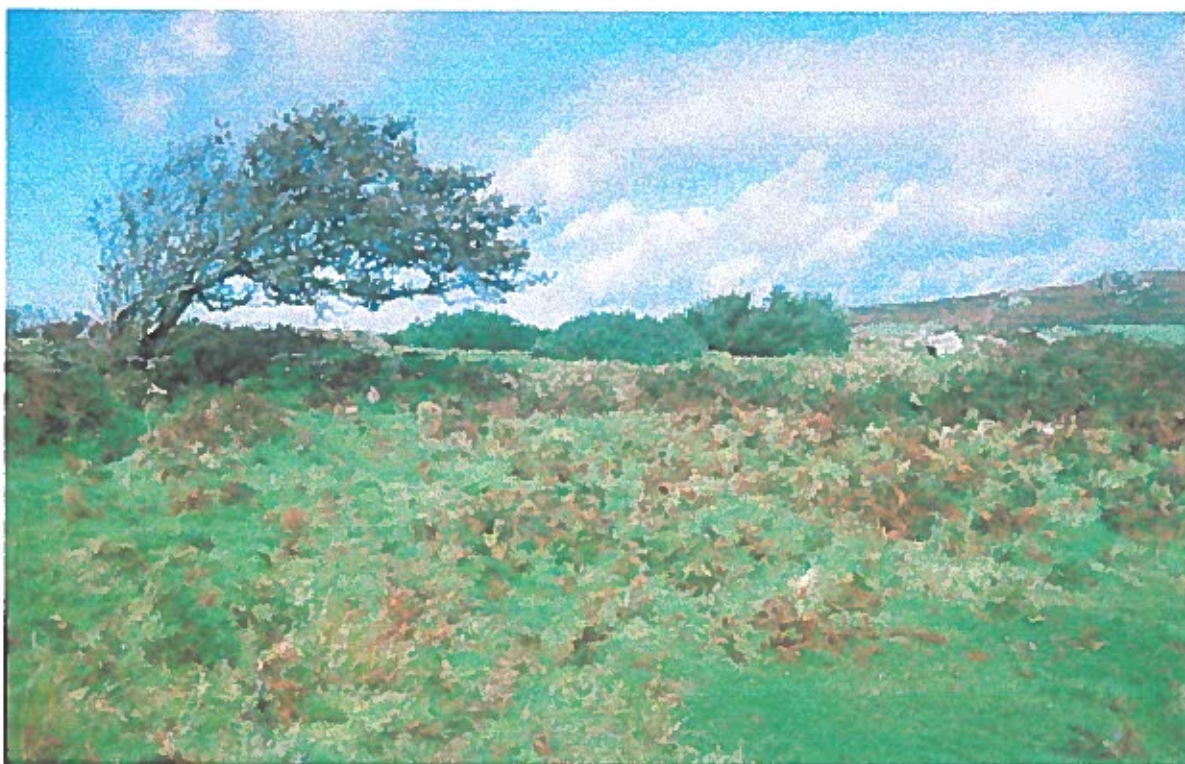
A small enclosure to the west of the farm, bounded by low c.0.5m high stone faced banks, includes several unusual earthworks on two terraced platforms which could relate to this former settlement (plate 2). However, the ground within this area has obviously been disturbed more recently and it is likely that many of the earthworks in this area relate to this more recent activity. Within the enclosure, the lower platform to the east is marked as marshland on the 1st edition OS map of 1891 and at that time contained a small pond. It is now bisected by a substantial drain. The higher platform at the western end of the enclosure contains several recent piles of stones and is overgrown. The field to the southwest of this enclosure also includes a substantial linear scarp (PRN 41895), which does not appear as a field boundary on any recent or historical maps. These earthworks do not provide unequivocal evidence for the medieval settlement of Llandedreion however, the entire area to the north and west of Llandrudion farm, including the site of the Dark Age cemetery (PRN 2513) should be treated as archaeologically sensitive.

Plate 2 - possible site of dark age settlement of Llandedreion (PRN 12318).

The area to the north and west of Llandrudion farm should not be ploughed to prevent the destruction of any subsurface remains of the Dark Age settlement. The owner would like to remove the piles of stones from the upper terraced area to the west of the enclosure and to use them to create a more gradual bank between this area and the lower, marshy area to the east. This work should be carried out under archaeological supervision. If possible, the site should be left undisturbed until the nature of the earthworks has been more thoroughly investigated. Further survey and documentary investigation would be useful to determine the nature, extent and preservation of the settlement, the survival of which would be extremely unusual.

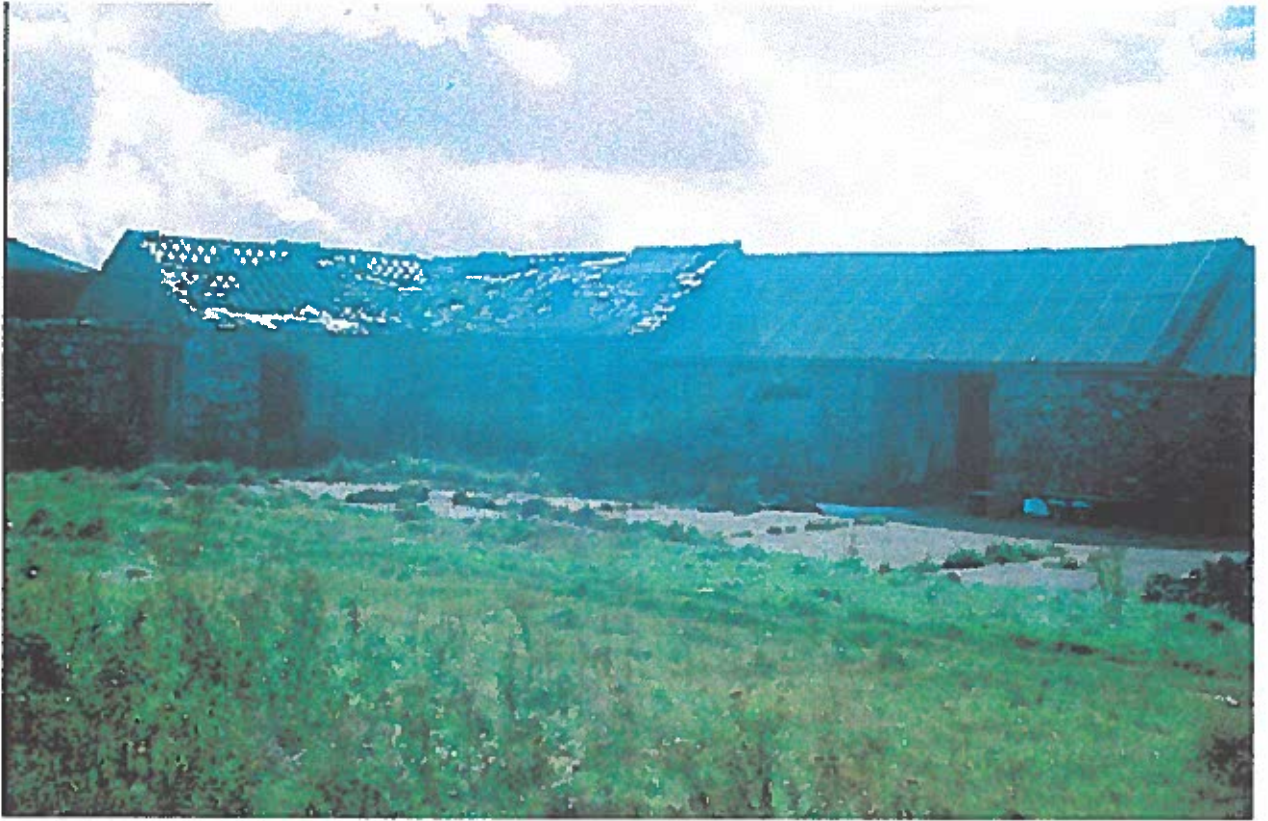
The farmstead at Llandruidion is of at least 18th century origin and is first recorded on a 1798 map of the Pencaer Peninsula by Thos Probert, at the time of the French Invasion of Fishguard. At this time, it was depicted as a substantial farmstead. It consists of a large quadrangle of farm buildings, including three cartsheds (PRN 41881, 41884, 41885), a cow house (PRN 41882), stables (PRN 41880), an animal shed (PRN 41883) and an engine house/barn (PRN 42112) which appear to have been built in several stages (plate 3). The farmhouse is now under separate ownership. See farm description at front of report for more details.

Plate 3 - the farmyard at Llandruidion (PRN 21745).

The owner would like to restore and convert the farmyard buildings for non-agricultural purposes. Any alterations and repairs should be carried out using materials and designs that are sympathetic to the character of the original structures. Where possible, the original openings and features should be retained.

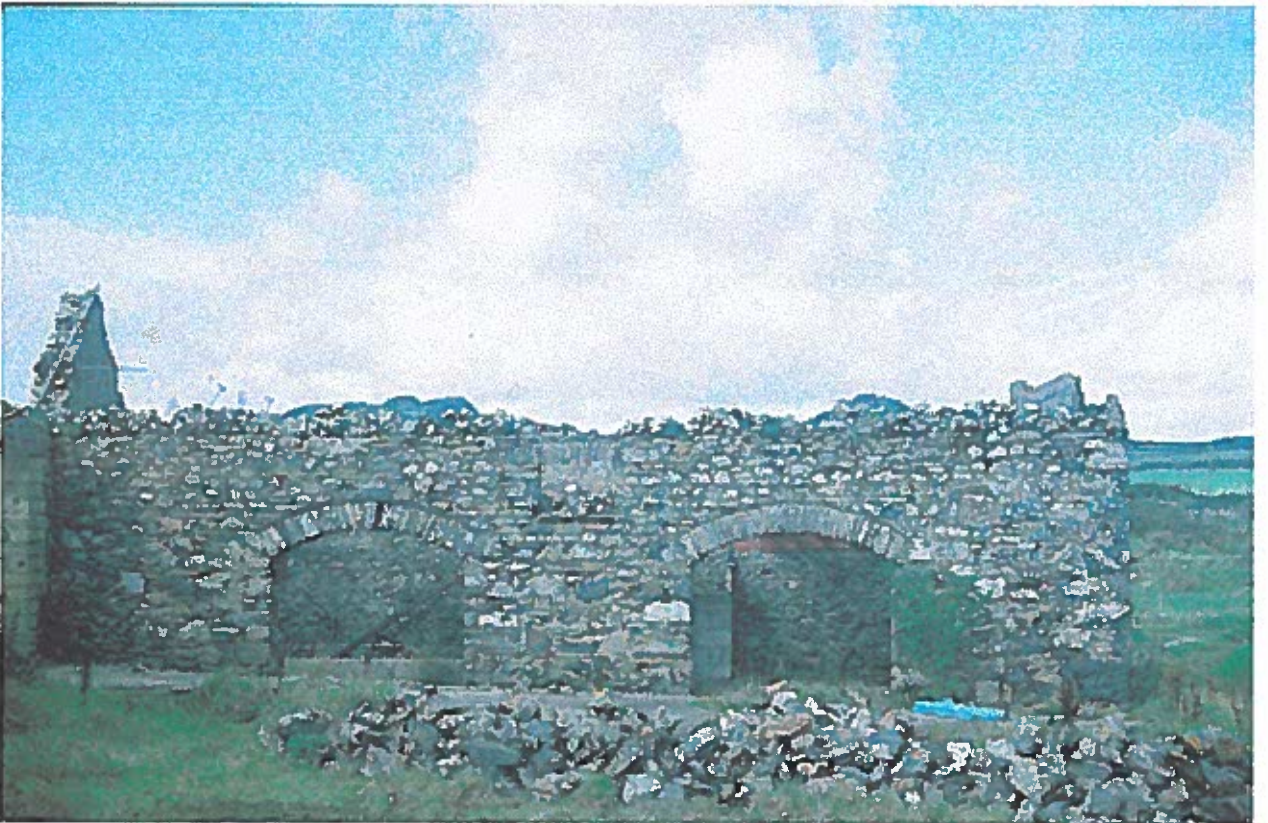
One and a half storey random rubble and slate cart house with dressed stone quoins and a gabled roof (plate 4). No roofing material survives. Orientation north-south. It forms the western side of a quadrangle of farm buildings at Llandruidion Farm. First recorded on the 1st edition OS map of 1891. It is accessed via two, double-width arched entrances in the eastern wall, headed with stone voussoirs. The windows along the western wall are also headed with stone voussoirs. Formerly whitewashed interior. A further entrance in the northern gable wall has been rebuilt with breeze blocks. The interior and northern gable wall have already been partially converted using breeze blocks to provide living accommodation.

Plate 4 - the cart shed at Llandruidion Farm (PRN 41884).

The building is in a reasonable state although it should be reroofed to prevent a rapid deterioration in its condition. Any alterations or repairs should be carried out using materials and a design that are sympathetic to the character of the original structure. Where possible, the original openings and features should be retained.

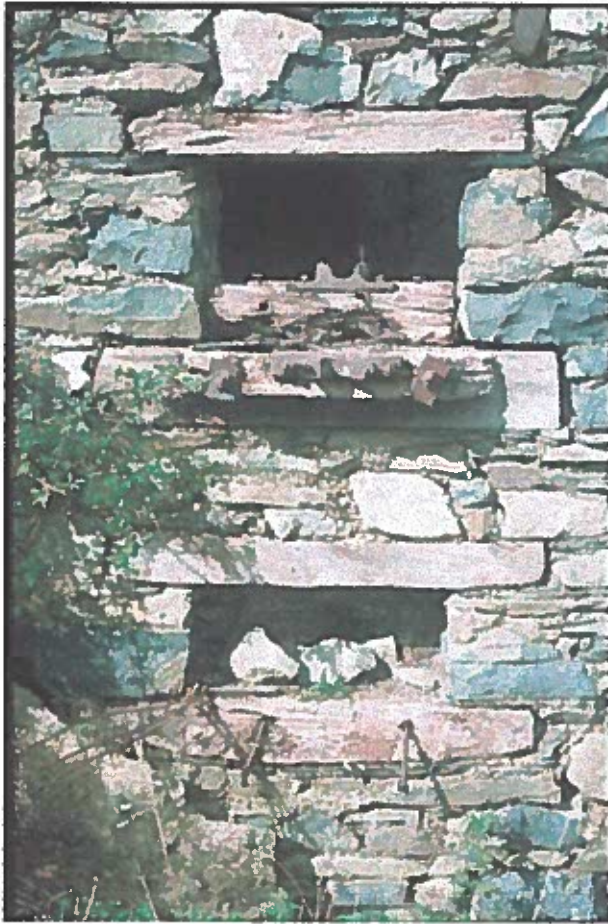
Plate 5 - fittings for the mill wheel at Llandruidion Farm (PRN 41886).

The wheel pit and fittings are in a reasonable condition and should be retained as integral features in the nineteenth century farmyard. Further documentary research may reveal the purpose of the massive wheel and an examination of the fields to the northeast of the farm may reveal the location of the former millpond.

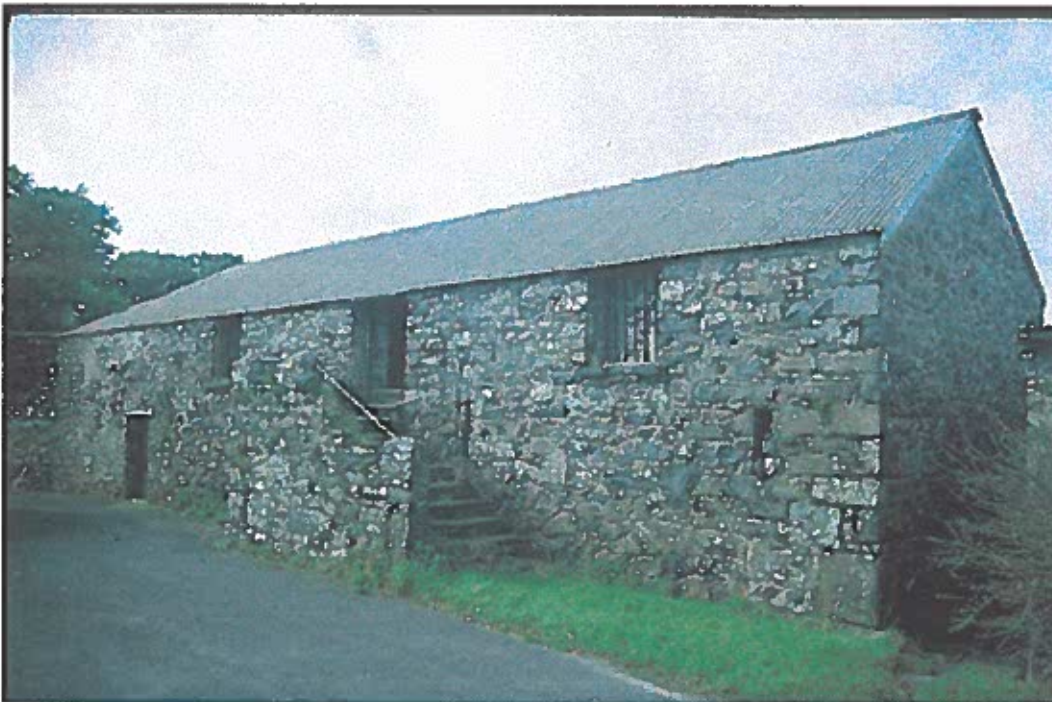
Plate 6 - farm building at Trefayog Farm (PRN 41889).

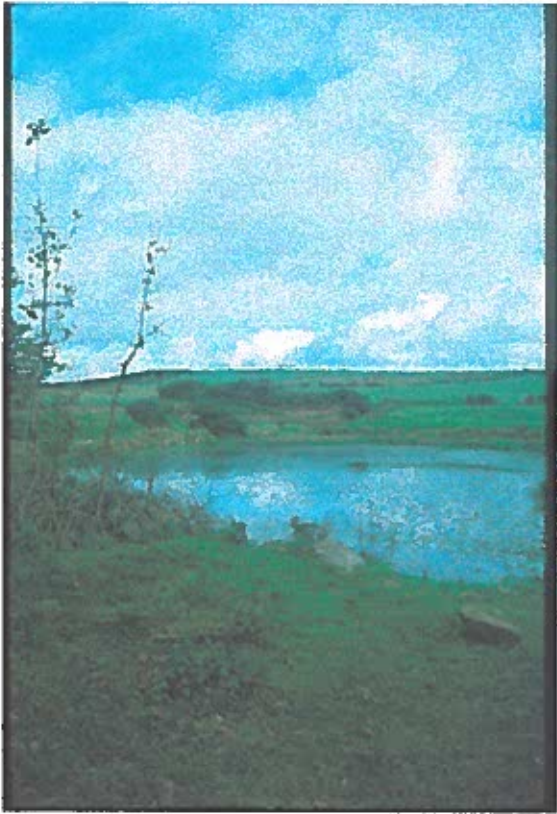
Plate 7 - the mill pond at Trefayog Farm (PRN 41891).

The pond and the wall that surrounds it are in good condition and should be retained as integral features of the farm. The walling should be maintained in its current condition. The owner would like to clear the algae from the pond which would enhance its appearance and condition.

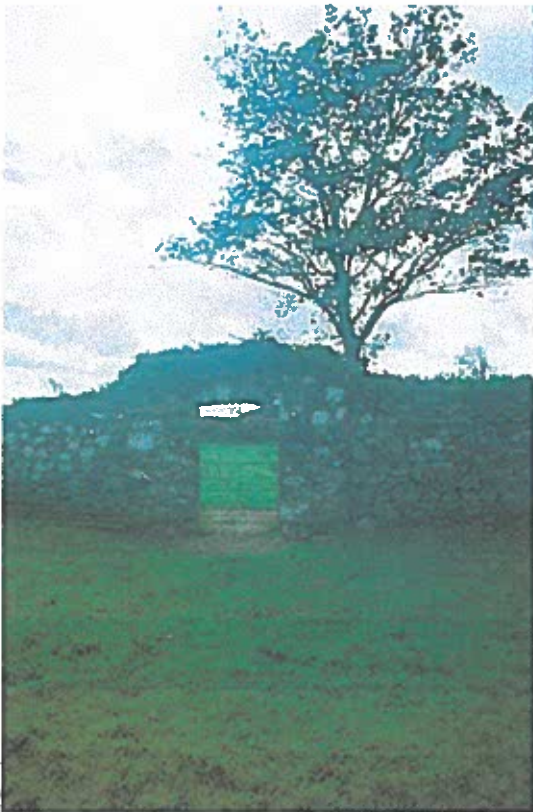
Plate 8 - the garden at Trefayog Farm (PRN 41892).

The farmhouse and garden are in an excellent condition. No specific management recommendations.
