Tir Gofal Farm Visit Report

Lecha

W/13/1100

ACA Report Number 2001/1

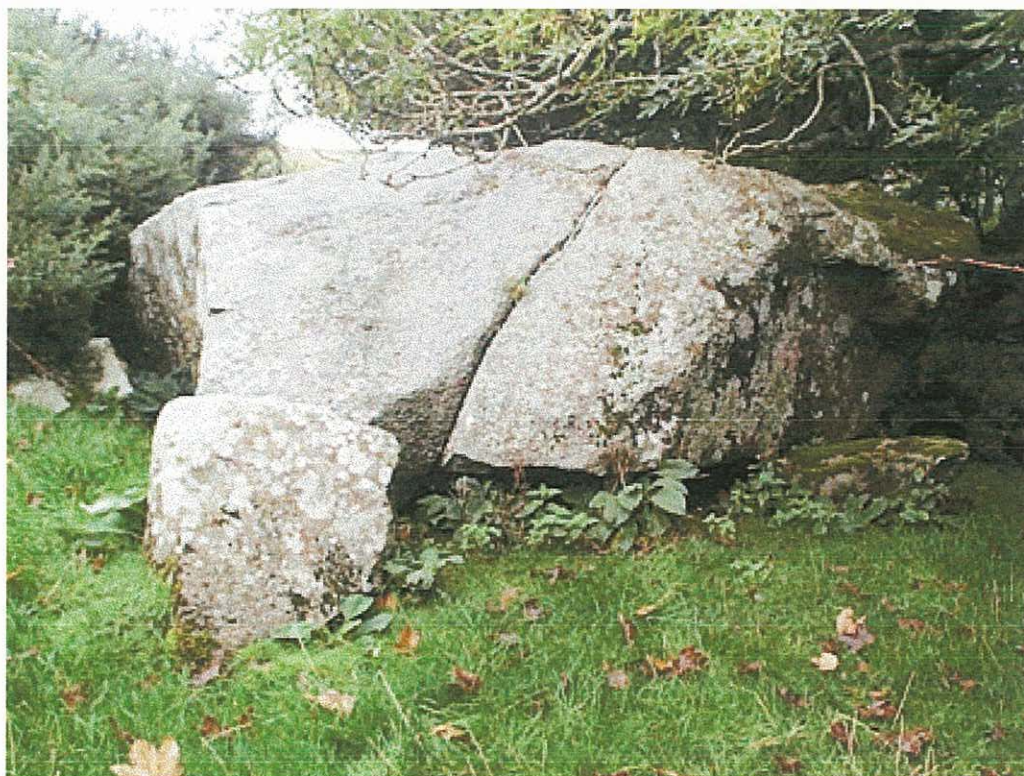
Plate 1 - Lecha Chambered Tomb (PRN 2747).

Neolithic chambered tomb, situated in a small, wooded gully beside a stream. The most visible element of the monument is a huge capstone which measures 5.3m long and 1.3m thick. This sits on two small side boulders and is abutted by another which may formerly have been a side stone. The size of the chamber is difficult to gauge and stands only 0.1m above the current ground surface. It lies beneath a prominent outcrop of rock from which the capstone probably originates (plate 1).

The site is protected from damage as a Scheduled Ancient Monument. The scheduling also extends to the area around the tomb and this should be cleared of gorse. The field in which it stands should remain under pasture and any periodic ploughing should avoid the area around the monument.

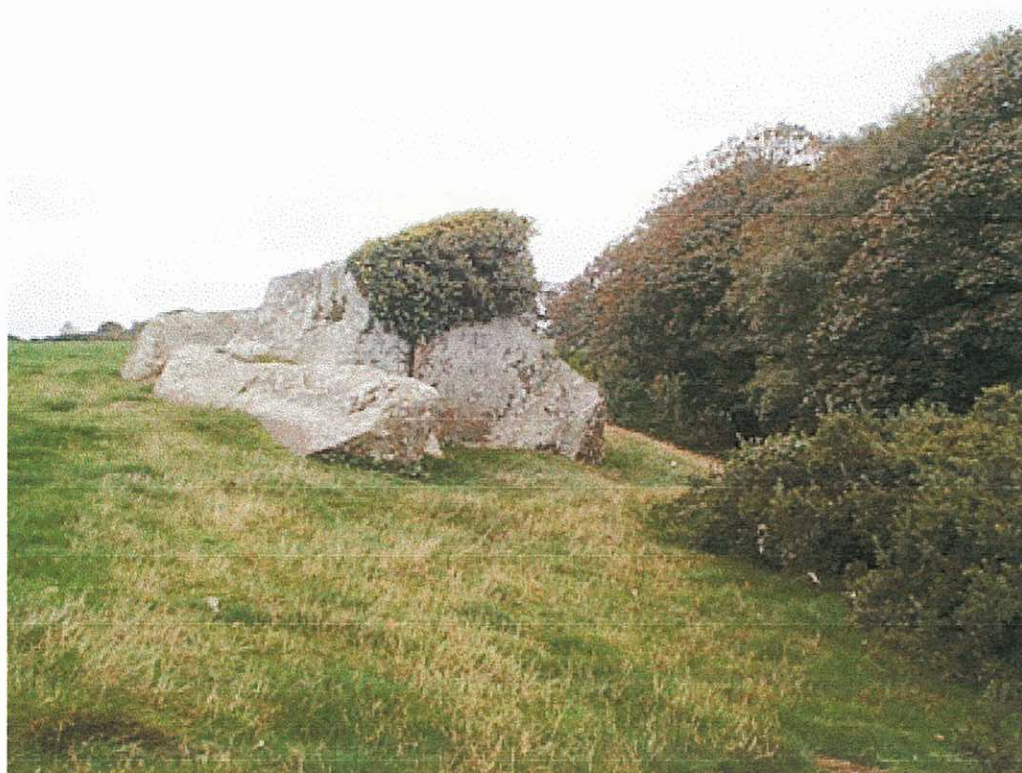
Plate 2 - Stone source for Lecha Chambered Tomb (PRN 2748).

A prominent outcrop of rock, situated on the edge of a small stream, just to the west of Lecha chambered tomb (PRN 2747). The outcrop is of a similar material to that of the capstone of the tomb and was probably the source of stone for it (plate 2).

The outcrop is overgrown with ivy in places and according to the owner, a large slab has recently fallen from its western side. The break is now grassed over and the outcrop appears to be in a stable condition. *the ivy should be cut but not removed + the outcrop*
~~It should be cleared of ivy and treated as an important associate of the tomb itself. It should be considered for inclusion in the scheduled area.~~ *Already within scheduled area*

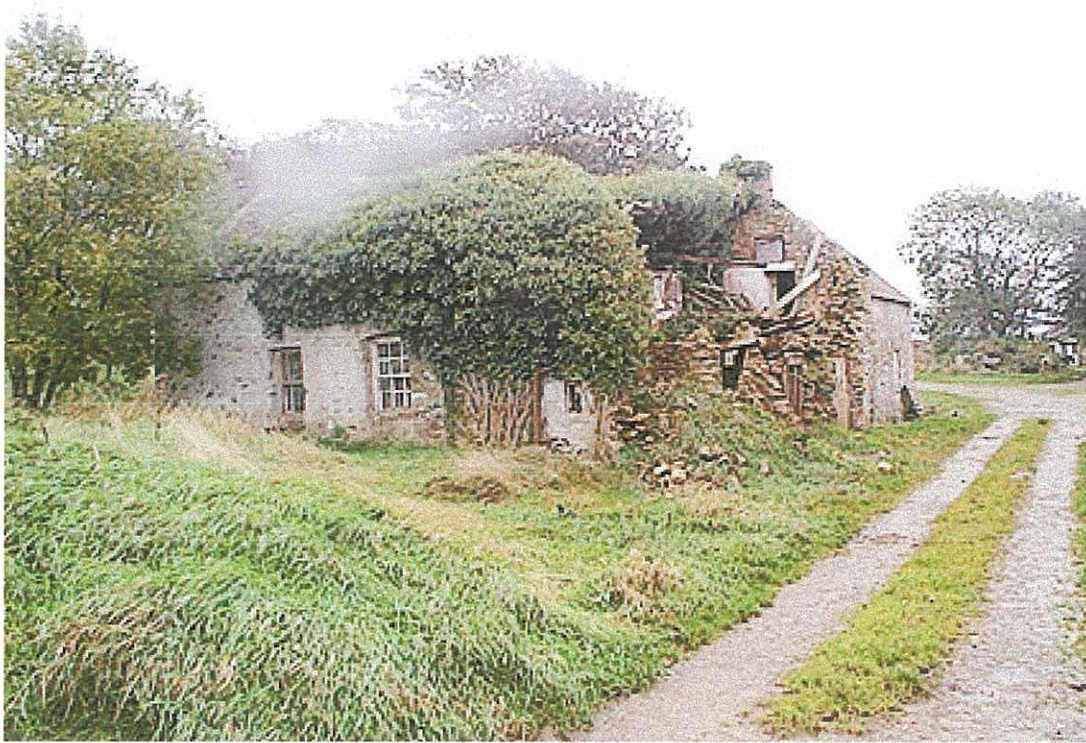
Plate 3 - Lecha Farmhouse (PRN41428).

Lecha Farmhouse was first recorded on the tithe survey of 1845. However, the farm is known to have been occupied since 1562 and it is possible that parts of the original building survive. The building has obviously been altered and extended on several occasions during its long period of occupation and use as a house and surgery. What remains of the it is of random rubble construction and formerly had a slate roof (although parts of this have been replaced with corrugated asbestos). It is now in a ruinous state and is structurally unsafe. The remains of the former surgery, outbuilding and rubbish pits survived until recently to the rear of the farmhouse but have since been flattened (plate 3).

The building is now completely derelict and unstable. The roof and walls are collapsing and the rooms are filled with rubble. The owner plans to demolish it and reuse the stone for building elsewhere if he is successful in his application to convert the farm into a leisure park. A detailed photographic record of the building should be made prior to and during any demolition work. The owner might consider installing a noticeboard here for visitors to the farm to inform them about its history of use and occupation.

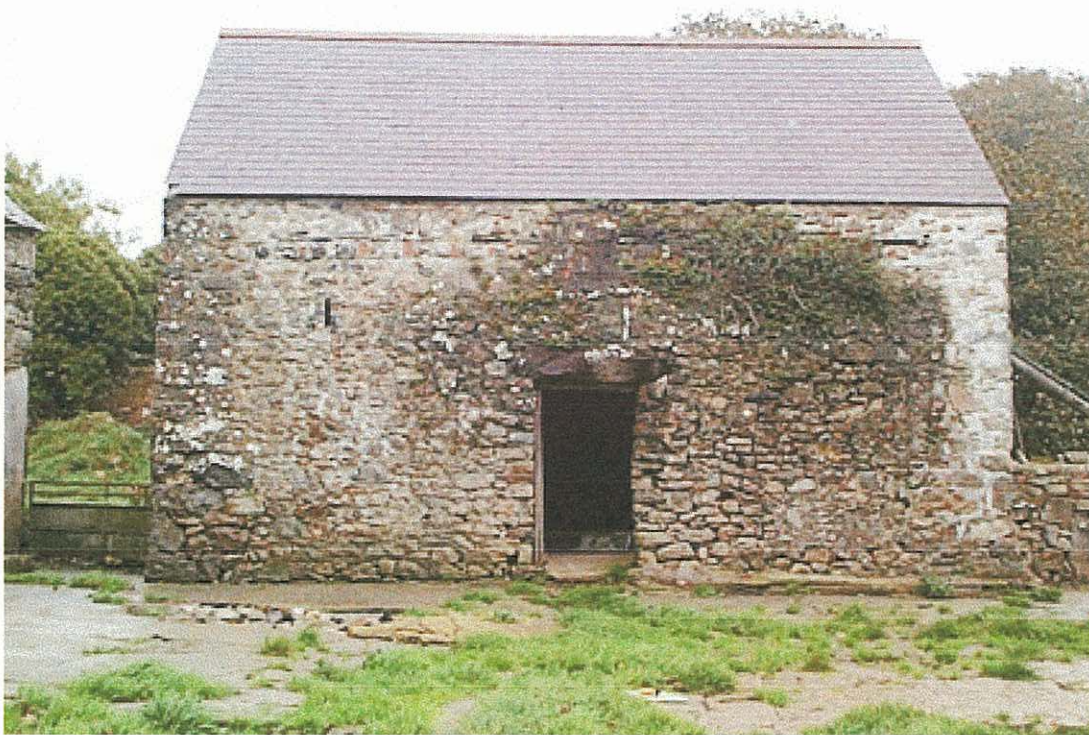
Plate 4 - the barn at Lecha Farm (PRN 41429).

Small, detached barn forming the eastern side of the farmyard at Lecha. First recorded on the 1st edition OS map of 1891. Orientation north-south. Two storey rubble construction with dressed stone quoins and a gabled slate roof. Accessed at ground floor level by opposing single width doorways to the east and west, headed with huge stone lintels. The entrance to the east has been blocked. The loft floor has been removed (although the joist holes remain) and was formerly accessed by a square headed, timber lintelled door in the southern gable wall. Ventilated by small, square headed, timber lintelled windows above the entrances and ventilation slits along the western side wall. Formerly whitewashed interior (plate 4).

The walls of the barn are in a reasonable condition. The roof is fairly recent and is in good condition. Any conversion or repairs should be carried out in a way which is sympathetic to the original function and construction of the building. Compatible materials should be used and where possible, the original openings and features should be retained.

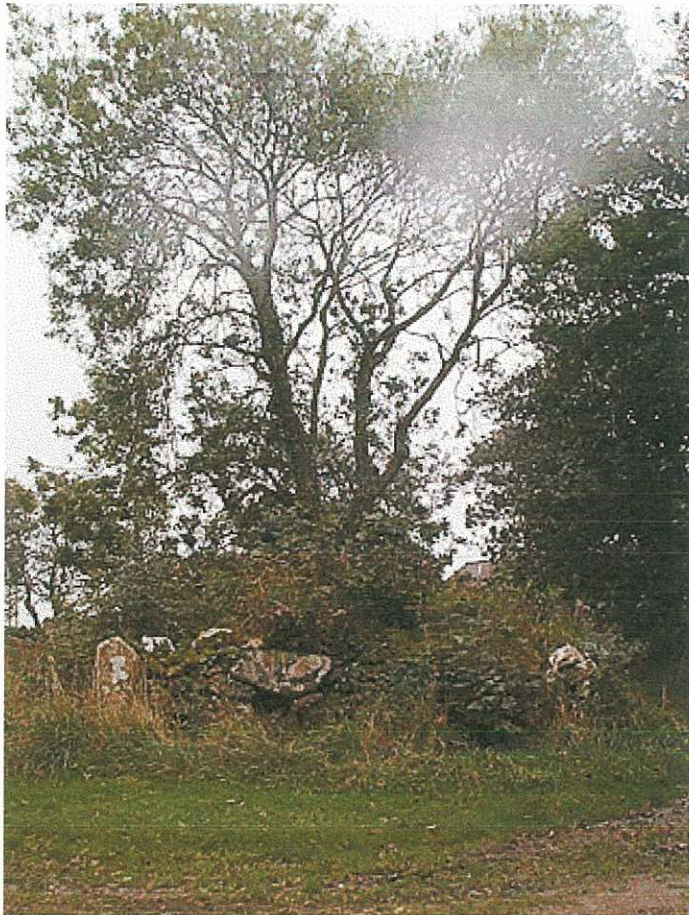
Plate 5 - the winnow mound (PRN 41430).

Large, c.5m by 10m by 1.4m high raised platform to the south of Lecha farmhouse and yard. Rubble construction with an internal recess accessed via a stone lintelled opening at the northern end. A sawing pit c.2.5m by 0.5m is built into its southern end and was reputedly used into the twentieth century. First recorded on the 1st edition OS map of 1891 (plate 5).

The stonework that surrounds the platform is loose and its upper surface is overgrown. The owner is willing to clear and consolidate the mound and should seek archaeological advice in doing so. The mound is a rare surviving example and should be considered for scheduling.

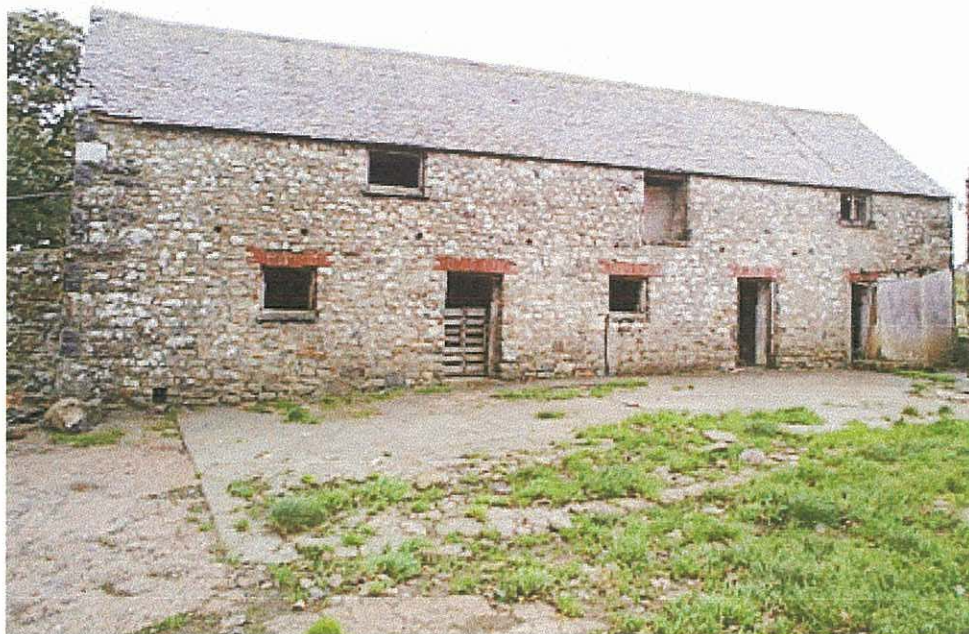
Plate 6 - early nineteenth century cowhouse (PRN 41433).

Two storey rubble cowhouse with dressed stone quoins and a gabled slate roof (plate 6). One of the three original buildings at Lecha Farm, first recorded on the tithe survey of 1845. Accessed at ground floor level by two single-span doorways on its southern side and a single doorway on its northern side. Fenestration at ground floor level is provided along the southern wall only. All ground floor openings are headed by brick voussoirs which probably replace earlier stone or timber lintels. The loft is accessed through a single width, brick voussoired doorway, via a stone and slate-built stairway against the western gable wall. The other openings at first floor level are directly under the eaves and have square headed timber lintels and slate sills with the exception of the fine gothic-style arched window in the eastern gable wall. The latter was probably a later nineteenth century addition and may have been designed to decorate the view towards this otherwise functional building from the house. The loft floor has been removed, but the joists survive in good condition. The interior was formerly whitewashed. No original fittings survive.

The roof timbers and joist survive in good condition and have been treated for woodworm. The roof slates are in a reasonable condition although some need replacing. The walls are also in a reasonable condition but need pointing in places and some of the brick work above the openings has fallen loose. Any conversion or repairs should be carried out in a way which is sympathetic to the original function and construction of the building. Compatible materials should be used and if possible, the original openings should be retained.

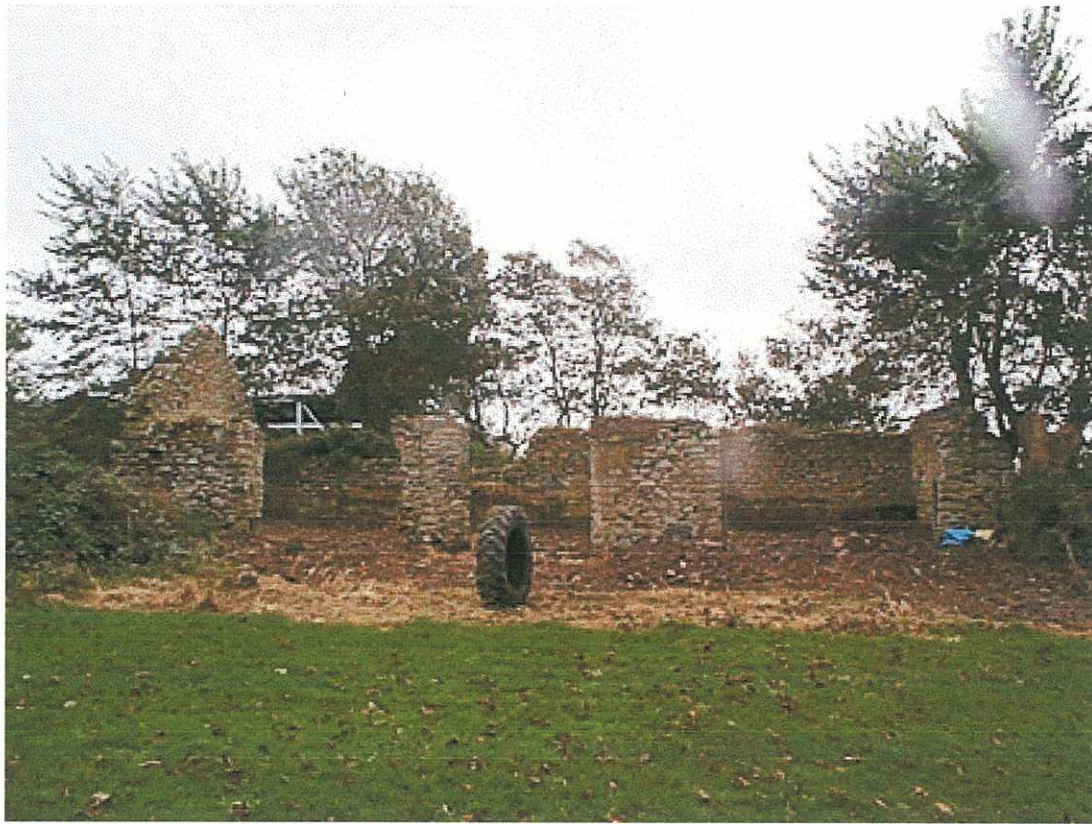
Plate 7 - the cart shed at Lecha Farm (PRN 41435).

Single storey rubble cart house situated about 100m to the south of the main cluster of farm buildings at Lecha. One of three original buildings at Lecha farm, first recorded on the tithe survey of 1845. No roof survives. The openings are crumbling and appear to have been widened. The eastern gable wall survives to gable height, the remaining walls are lower and unstable. The internal fittings are recent concrete and brick constructions (plate 7).

The cart house is essentially derelict and requires substantial repair work. The owner plans to renovate and reroof the building and would like to use it to store farm machinery. Archaeological advice should be sought before commencing this work.
