CILGELL UCHAF FARM

TIR GOFAL

SITE VISIT

Report No. 2001/23
Project Record No. 39477
TG Reference No. W/12/0076

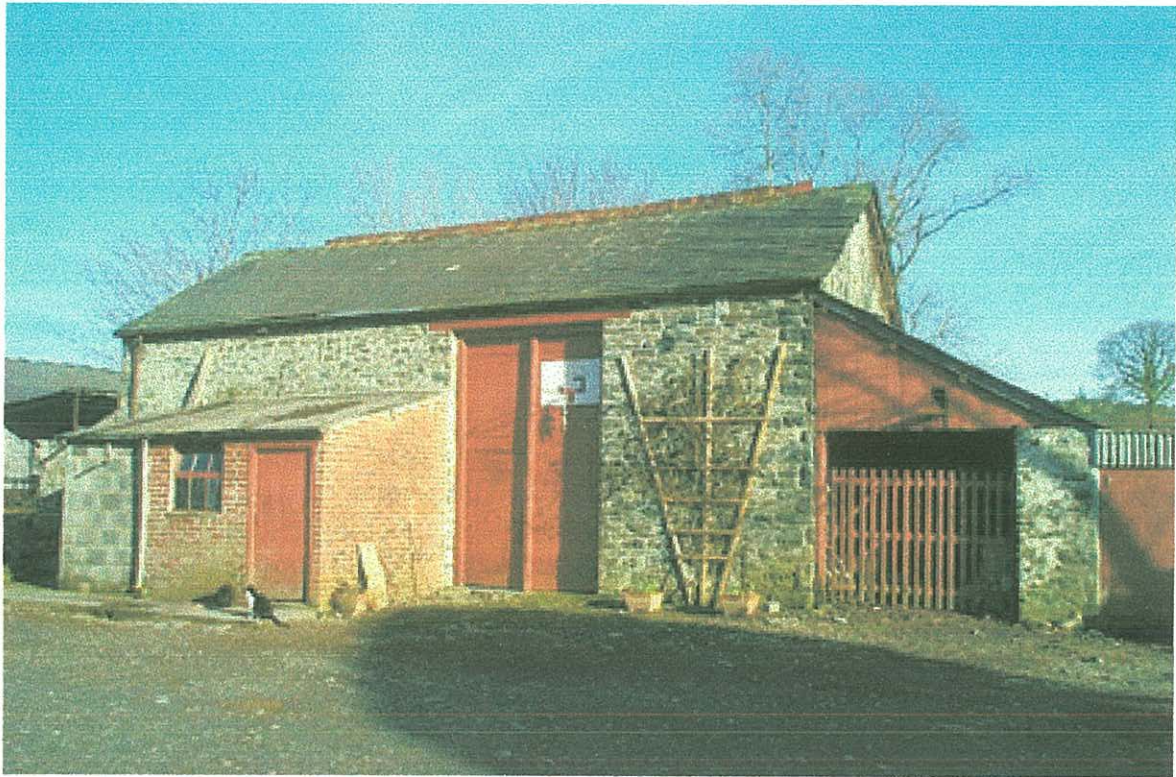
The threshing barn (plate 1) - Two storey rubble and lime mortar threshing barn with dressed stone quoins and a gabled slate roof with decorated ceramic ridge tiles. It lies to the east of the farmyard, orientation north-south. It was first recorded on the tithe survey of 1840 and is probably one of the original farm buildings. It is accessed by opposing, full height, square-headed double doors, positioned towards the southern end of the building. The entrance to the east has been blocked in with a low (c.1.2m) breeze block wall and a corrugated tin and PVC window (plate 2). The traditional wooden fittings have been retained in the entrance to the west. The barn is lit by a small, square window at the eastern end of the northern gable wall and a centrally positioned window in the east-facing wall at loft level. These openings are square headed with stone lintels and sills. Their original fittings survive but are in poor condition. The barn is ventilated by two, c.1.5m high loops in the west facing wall, a single loop in the east-facing wall and a smaller (c.1m high) loop in the northern gable wall at loft level. The interior is open to roof height at the southern end and lofted to the north of the entrances. The loft floor is in reasonable condition. There is no evidence of the original means of access to this level. The original flagged floor has been retained between the entrances at ground floor level although elsewhere the floor is concreted. Remarkably, the original threshing machine and fittings for the waterwheel to the north survive in-situ against the eastern wall of the

Plate 1 - the threshing barn from the west.

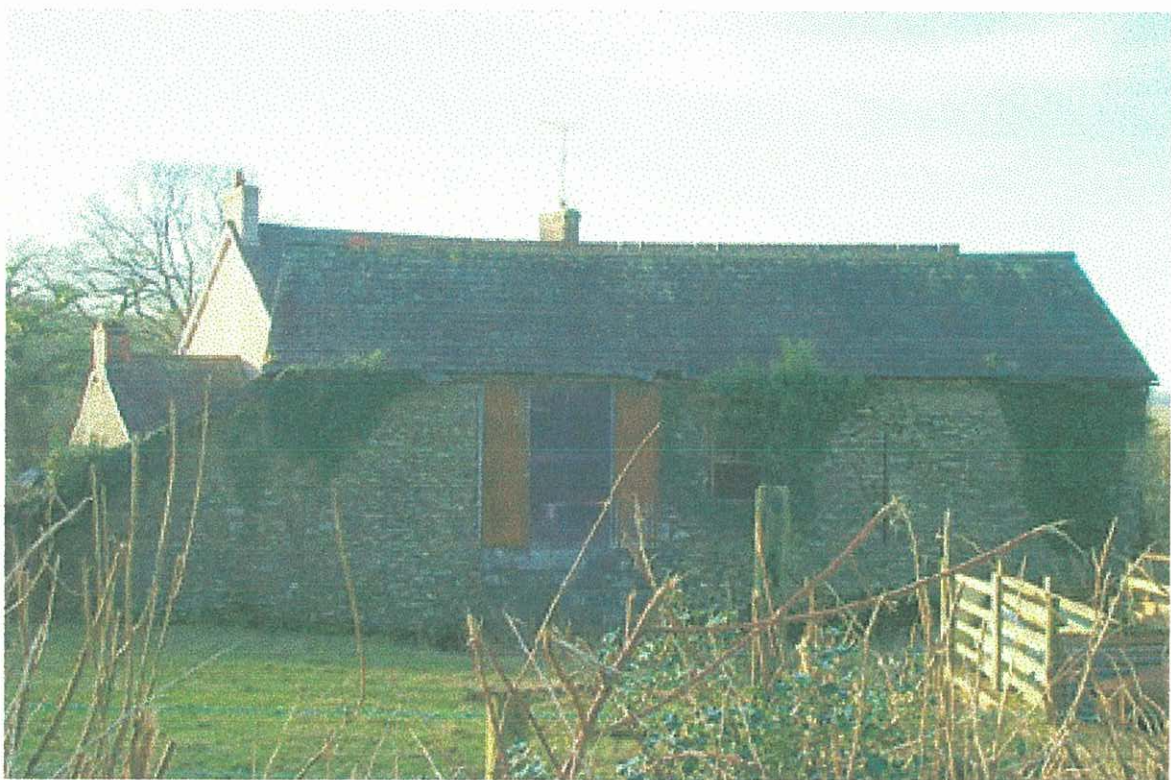
Plate 2 - the threshing barn from the east showing the blocked in entrance, ivy growth and poor roof condition.

Management recommendations - The barn is generally in very good condition. The walls have been repointed and the fittings are well maintained. The roof to the east of the building has recently deteriorated in condition and several of the slates are now missing. The owners would like to re-roof this side of the barn which would considerably improve its condition and survival. The fittings in the windows are also in poor condition and the owners would like to replace these as part of their Tir Gofal Agreement. These repairs should be carried out using appropriate traditional materials in a way that is sympathetic to the character of the original building. The owners would like to retain the breeze block and plastic fittings that now occupy the eastern entrance to the barn. The walls to the east of the building are overgrown with ivy and this should be cleared.

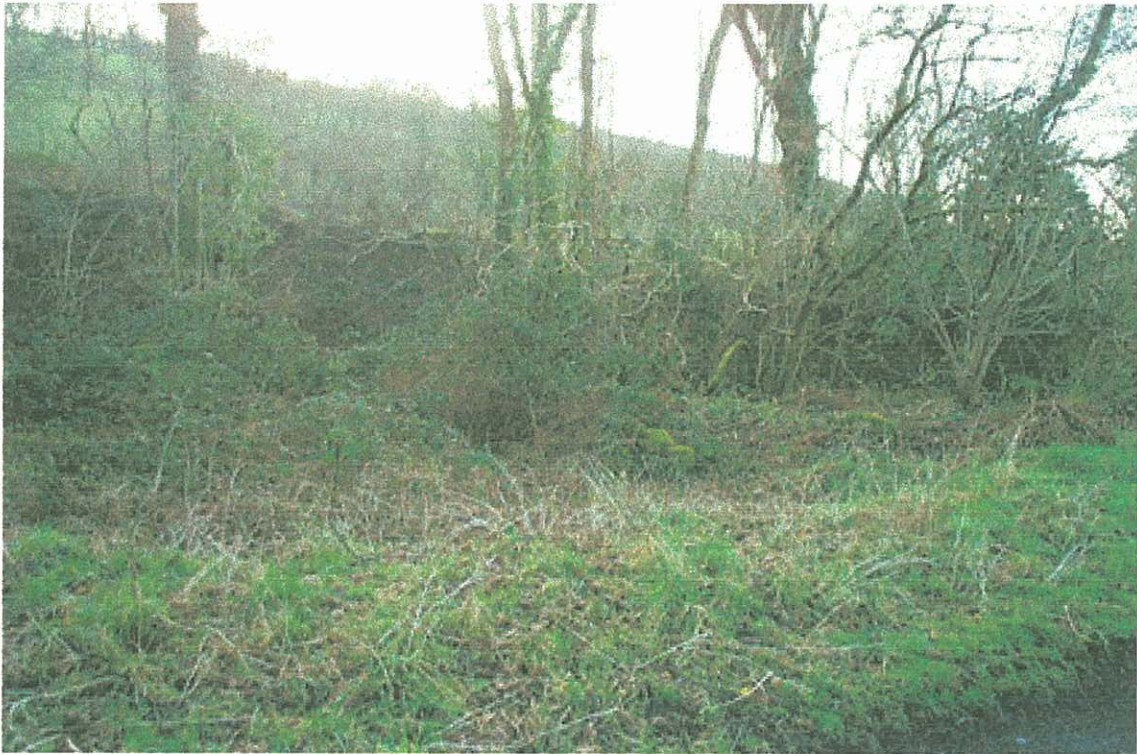
A possible millpond lies alongside the approach road to the farm about 100m to the southeast of the farmyard (plate 3). It consists of a shallow, c.10m by 10m by 0.6m deep hollow which is apparently dammed by a substantial earthen bank along its western side. The area is now overgrown and infilled with rubbish. There is no evidence of sluices. The pond is not clearly marked on any historic maps although a large rectilinear structure is marked in this position on the second edition OS map of 1906. The stream braids just to the west of the millpond and the northern branch is dammed about 30m further to the west by a small, rubble-built weir (plate 4) from which an overflow channel runs. The head race (c.1.5m wide and 0.4m deep) runs from this point, beneath the trackway to the north and across a pasture field to the east of the farmyard (plate 5). It turns sharply about 40m to the east of the mill wheel and from this point onwards runs along a substantial raised platform (c.1m high by 2m wide) (plate 6). This is faced with a drystone wall into which stone steps have been built for access (plate 7). The owners have rebuilt the wall for most of this length, but the section closest to the waterwheel is unstable and surrounded by fallen rubble. The final 10m of the head race runs along a wooden launder that raises the water to the overshot wheel (plate 8). The wooden launder is rotten and appears to have sunk from its original position above the height of the wheel. It may formerly have been supported on a series of wooden stilts. The cast iron overshot water wheel (c.2.5m in diameter) stands in-situ within a rubble-built wheel pit (c. 4m by 1m by 1.5m deep) (plate 9). The walls of the wheel pit are unstable and overgrown. The tail race runs underground from the base of the wheel pit and resurfaces in the northwestern corner of the farmyard. There are several large slabs of stone in this area which may formerly have provided a bridge over the leat between the farmyard and the field to the north. The

Plate 3- the possible millpond, now completely infilled and overgrown.

Management recommendations - The survival of the entire system of the watermill is unusual and deserves protection. The owners would like to restore the mill as part of their Tir Gofal Agreement. This would promote the survival and maintenance of this rare feature. Advice should be sought from an architectural conservationist for the programme of restoration (see list enclosed) and an archaeological record should be made of the work. Historic map evidence should be consulted further to establish the original form and layout of the pond.

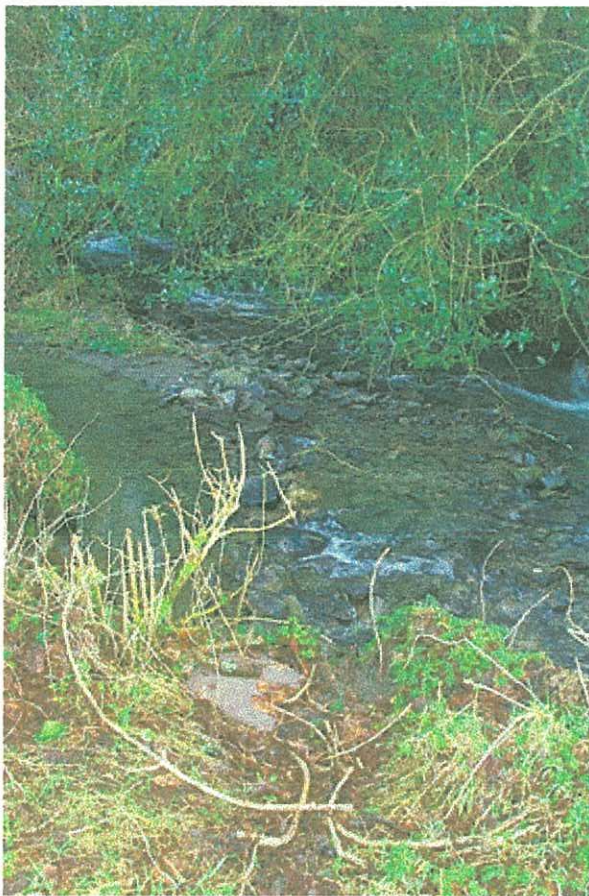
Plate 4 - the weir and start of the head race.

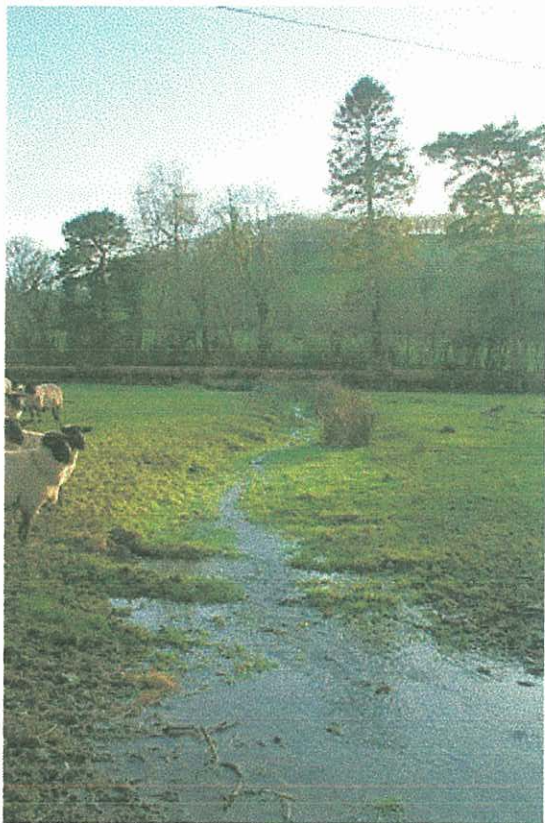
Plate 5 - the open head race where it crosses a pasture field to the east of the farmyard.

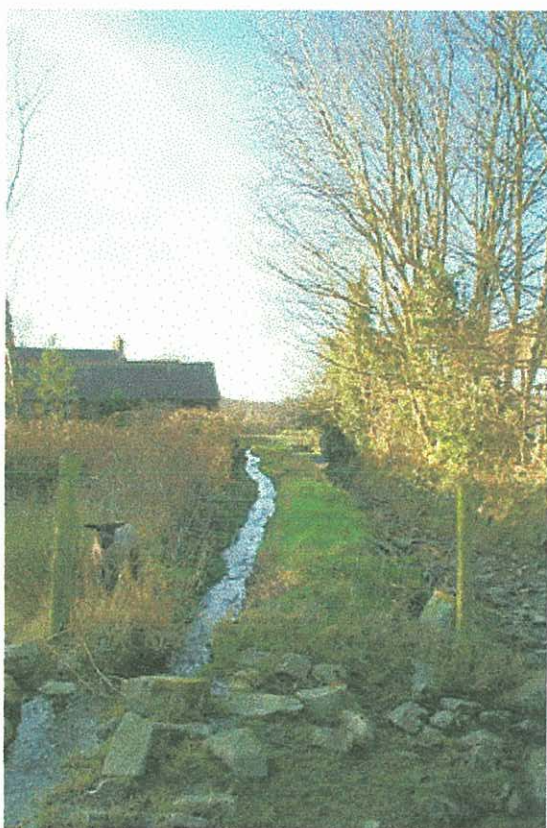
Plate 6 - the head race from the east as it runs on a raised platform towards the mill wheel.

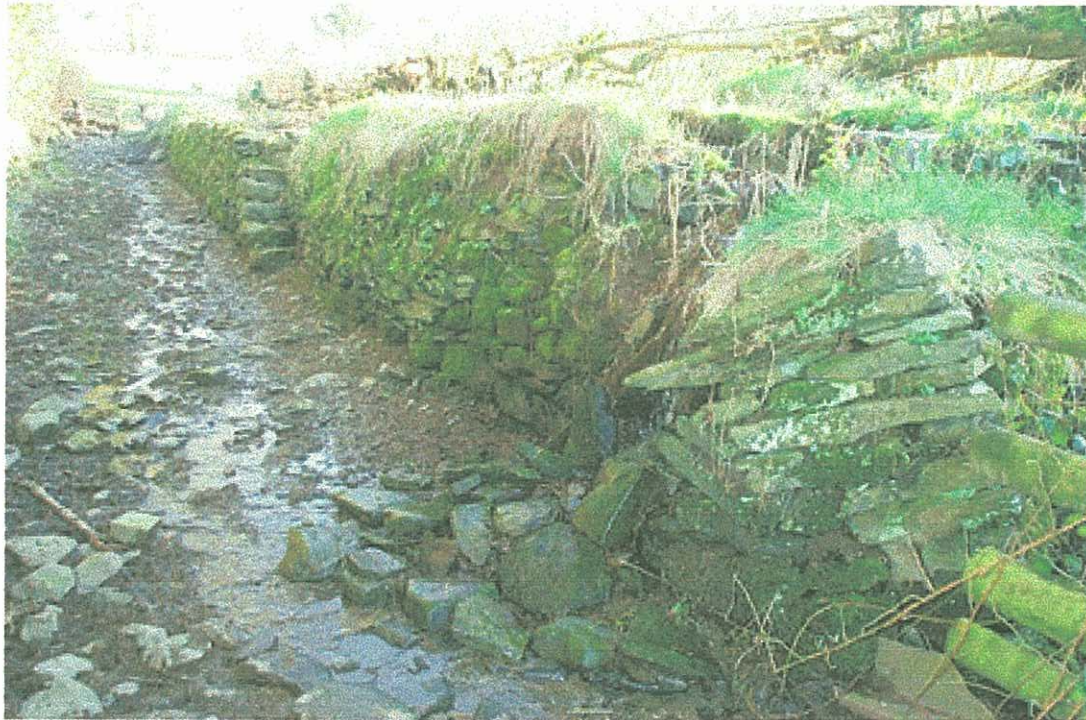
Plate 7 - the drystone wall alongside the raised head race, showing the recently repaired section to the left and the section in need of repair to the right.

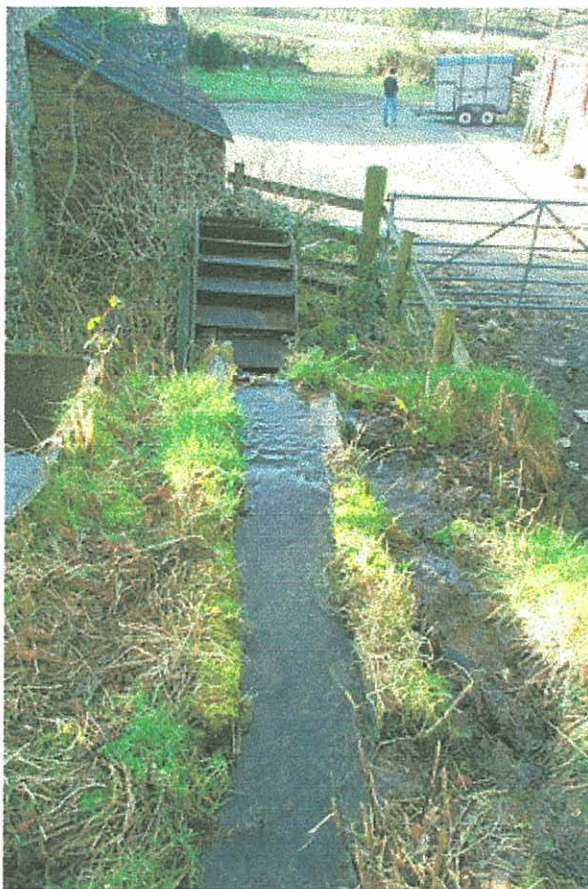
Plate 8 - the wooden launder immediately to the east of the mill wheel.

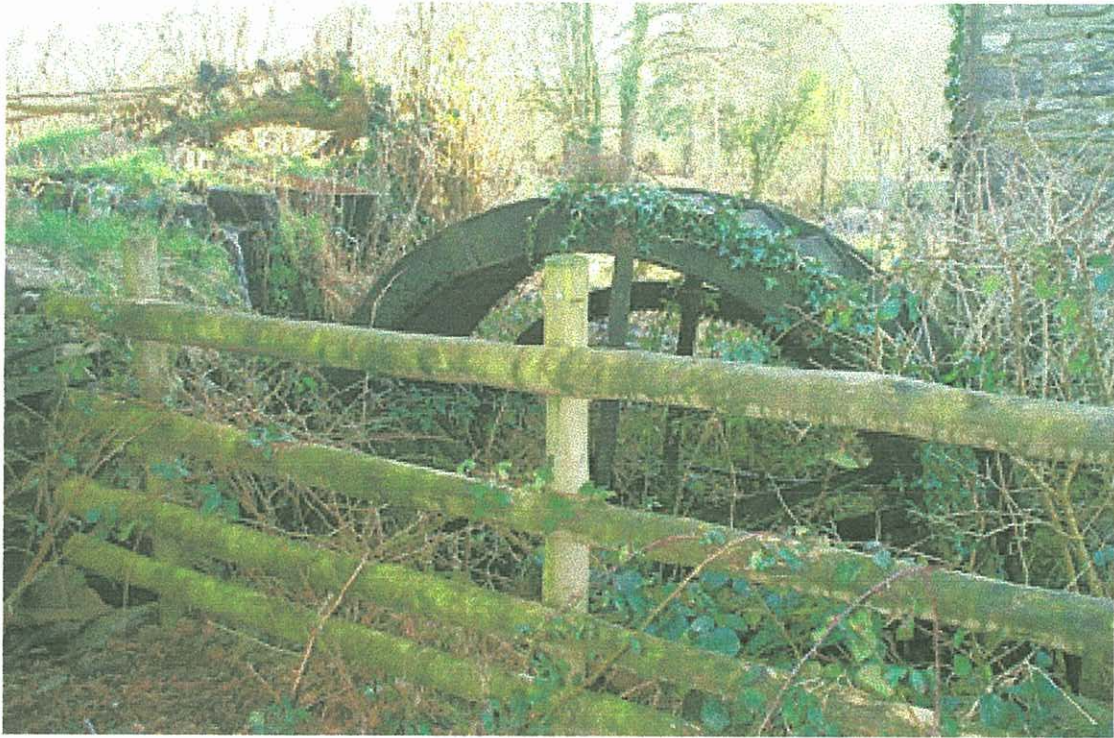
Plate 9 - the overshot water wheel and overgrown wheel pit.
