Tir Gofal Farm Visit Historic Environment Report Call Out

Report No. 2003/130

REPORT NO. 2003/130
PROJECT RECORD NO. 39841

Tir Cwrt
Tir Gofal Farm Visit Historic Environment Report
Call Out

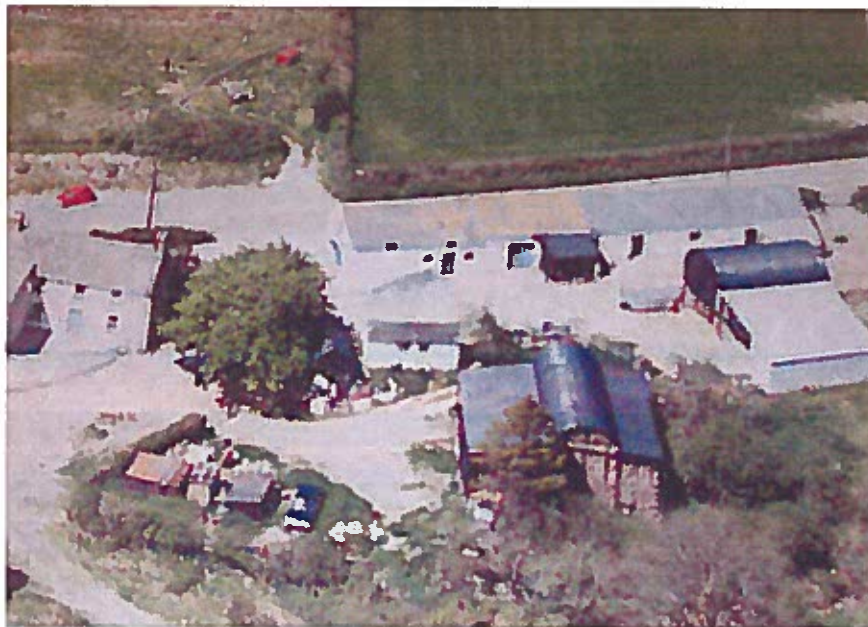
Cwrt Farm c.1970

The photograph shows the long roadside range comprising three separate buildings; a cow shed to the north, a central barn with attached engine house and a lofted stable and cart shed? to the south. This arrangement is typical of the organised farmsteads, which appeared in west Wales from the mid-nineteenth century onwards (William, E 1986, 73). The primary function of the barn was the storage of unthreshed corn, threshing it and storing the resulting straw. Siting the barn in between the cow shed and stable would have enabled some ease in the provision of straw to the livestock housed on either side. A small rectangular building opposite was apparently a dairy. All farm buildings are whitewashed at this time giving the farmstead an appearance of cleanliness and unity. Today, the cow house and an abutting lean to are the only surviving elements of the original farmstead. These buildings form the focus of the present enquiry.

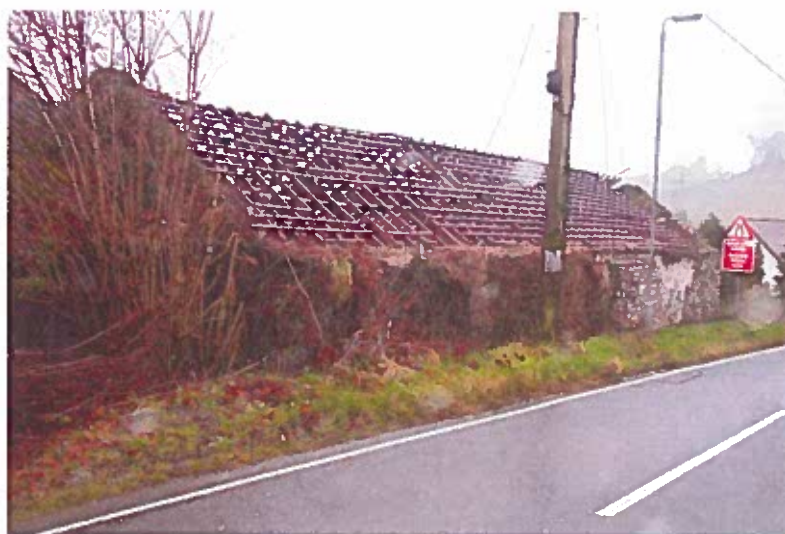
Despite the internal modifications and the rebuilding of the south gable end, the cow house remains a reasonably well preserved example of its type and the decision to re-roof it is to be welcomed. Its importance is further enhanced by its status as one of few surviving elements of the original nineteenth century farmstead at Cwrt Farm. It remains in a reasonable condition, although ivy is smothering much of the rear wall. The roof trusses are on the whole in a good condition, although some are displaying early signs of rot.

Plate 1- looking south towards the cow shed from the road to FelingwmUchaf.

The building is to be re-roofed with slate. This is to be welcomed. Care should be taken to retain the original timbers as far as is practically possible.

The ivy growth is damaging to masonry bonds and a potential source of building instability. The ivy should be cut off at the roots, allowed to die and then removed. Stumps should be spot treated in order to prevent re-growth. Where necessary, this should be followed up by a programme of re-pointing in areas, where masonry bonds have been weakened by intrusive vegetation growth. Materials and techniques used should be compatible with those of the original construction. Following restoration works, whitewashing the building could be considered to restore it to its original historic appearance.

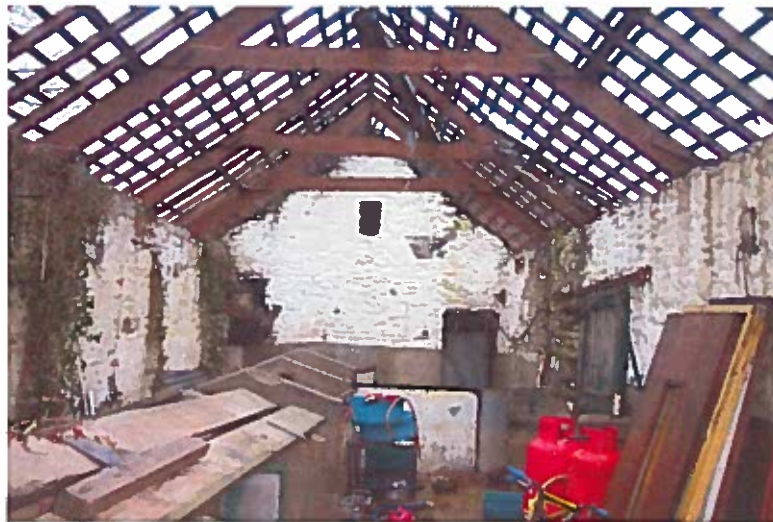
It is a one and a half storey building and measures approximately 6m E-W by 18m N-S. It is of stone rubble construction with roughly squared quoins and a pitched roof. The front (east) wall faces onto the farmyard. It is pierced by three evenly spaced narrow doors. The rear elevation faces onto the road and is blind. A narrow splayed window pierces the north gable end at loft level. The original appearance of the south gable end, which formerly abutted a barn, is not known and it has been rebuilt recently. All faces of the building, both inside and out, were originally whitewashed. Doorways are characterised by stone lintels, which have been painted giving the appearance of red brick. None of the original doors survive, and the central doorway has been partially blocked to form a window. The historic internal arrangements have been lost, although sawn off joist slots indicate that the building was originally lofted. Cow houses of this type typically saw cattle tethered in a single row facing across the building, often with a feeding passage flanking one of the lateral walls. Modern cattle stalls currently occupy the interior and may replicate something of the original arrangement. The building is currently roofless, although the original trusses and purlins survive.

Plate 2- interior of the cow shed looking north

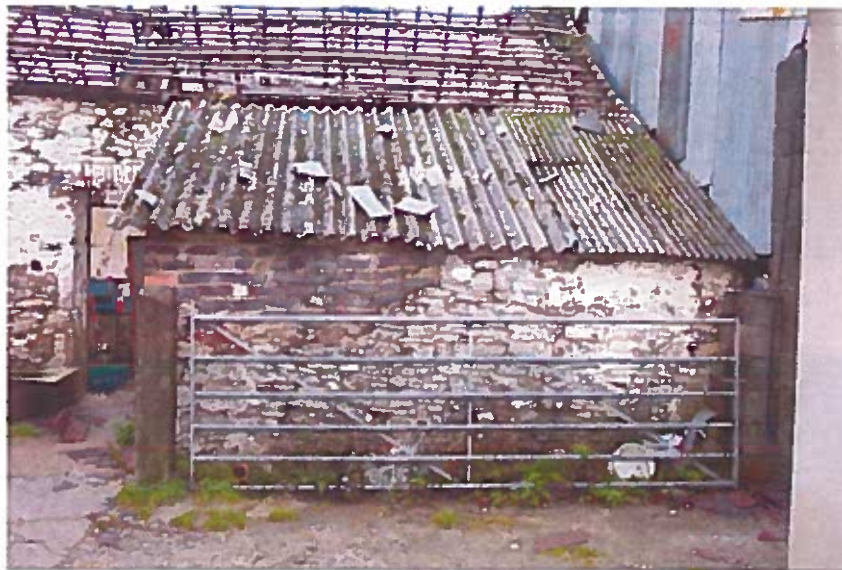
Some areas have been re-built following the partial collapse of the east and south walls. Engineering bricks now complete the walls, and have altered the historic appearance of the building. The original doorway has also been modified. A concrete lintel and red brick dressings have been added during the rebuild. None of the historic internal arrangements survive and the original function of the building is not known. None of the original roofing materials or timbers

Despite some modifications to its original appearance, the lean to retains good historic character. It is currently in a stable condition, although lime mortar bonds are washed out of the walls in places.

Plate 3- east elevation of the lean to

The landowner who is keen to enhance the historic appearance of the farmstead is unsure whether to retain the lean to or remove it altogether. There is a presumption in favour of retaining traditional agricultural buildings within the Tir Gofal scheme. Despite some modifications, the lean to retains much of its historic fabric and continues to make an important contribution to the historic appearance of the farmstead. It remains in a usable condition and should be retained in its present condition. Unstable areas of masonry should be re-pointed using a traditional lime mortar mix. Whitewashing the lean to would enhance its historic appearance and should also be considered.

Any future restoration works should be undertaken using materials and techniques, which are faithful to those of its original construction.
