Tir Gofal Farm Visit Report

Norton Farm

Report Number 2001/38

NORTON FARM
TIR GOFAL FARM VISIT REPORT

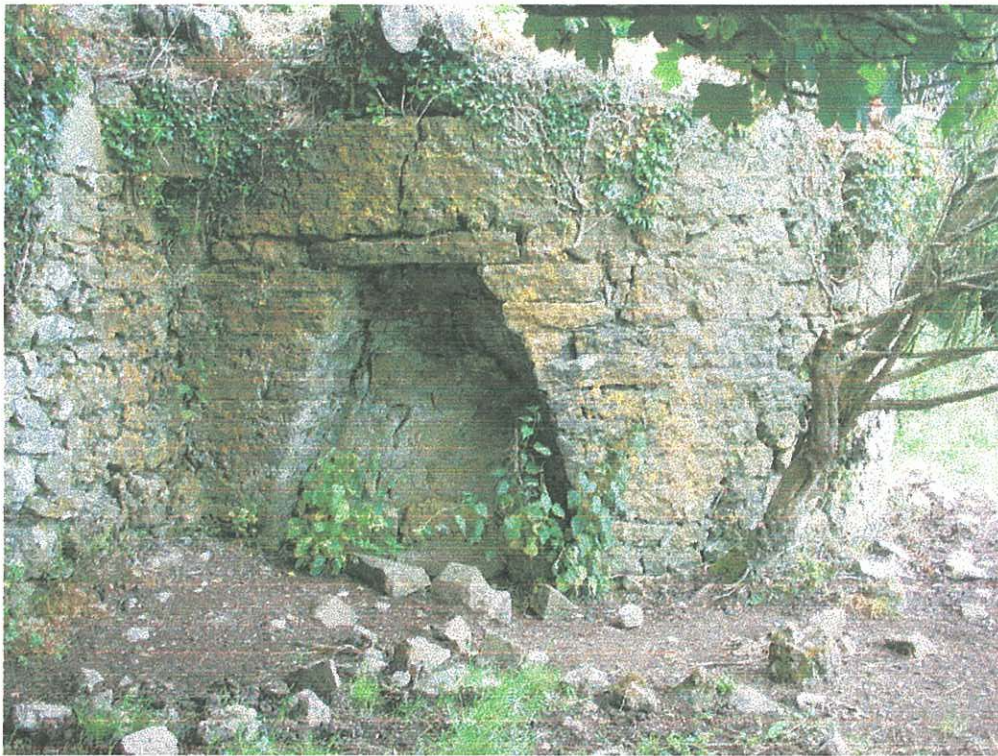
Plate 1 – the lime kiln (17340) showing the drawing arch and overgrown superstructure.

The limekiln is well preserved but its superstructure has been considerably damaged by tree and ivy growth. Although the owner has made every effort to prevent further damage there are two substantial cracks in the sides and the walls are still overgrown with ivy. The owner would like to repair the kiln as part of his Tir Gofal Agreement. A structural assessment should be made of the wall so that positive steps can be taken to consolidate it as a stable ruin. Any loose stones should be left in situ or used to repair the existing structure. In the meantime, the ivy growth should be cut but not removed. The area that surrounds the kiln should not be ploughed to protect any surviving buried remains.

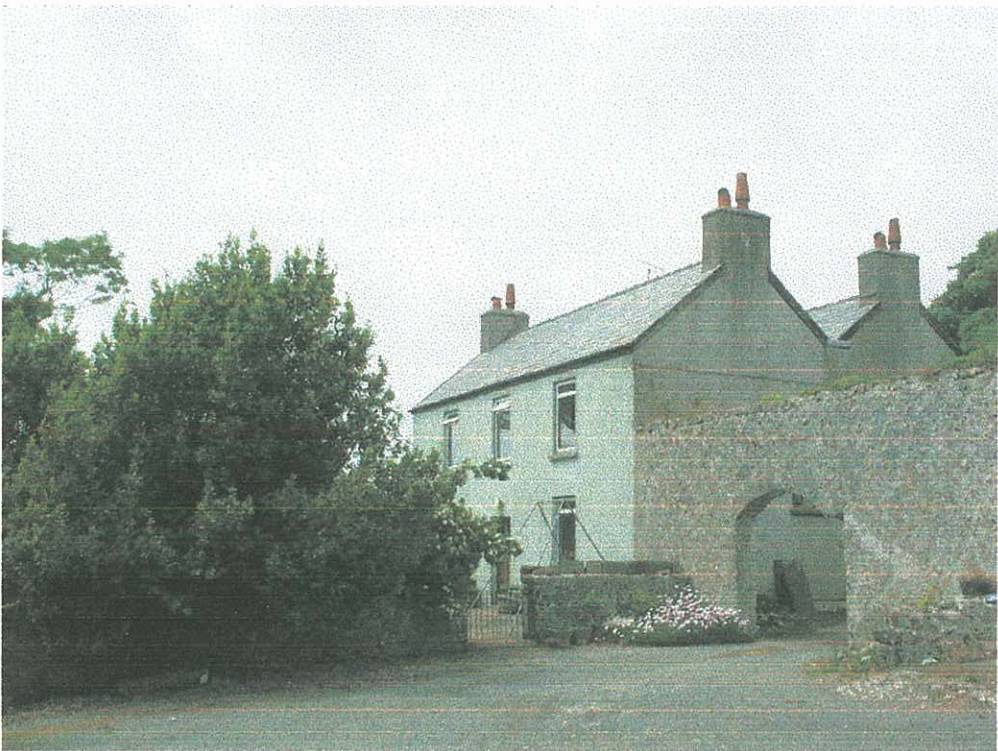
Plate 2 – the farmhouse (42859) and arched entrance to the farmyard.

Two storey, south-facing farmhouse at Norton Farm with a gabled slate roof and modern stacks at either gable end (plate 2). It consists of an earlier house to the north which was later extended to the south, orientation east-west. The original part was recorded on OS Surveyor's Drawings in 1809-10. The extension was probably built in the late nineteenth century most of the other farm buildings were added to the farmyard. The exterior has been completely rendered and all of the fittings have been modernised. The owners discovered a stone arch in an internal wall that divides the northern and southern sections of the house. This suggests that the original part may have been used earlier as a farm building.

The owners of the farm now live in the farmhouse. No specific management recommendations.

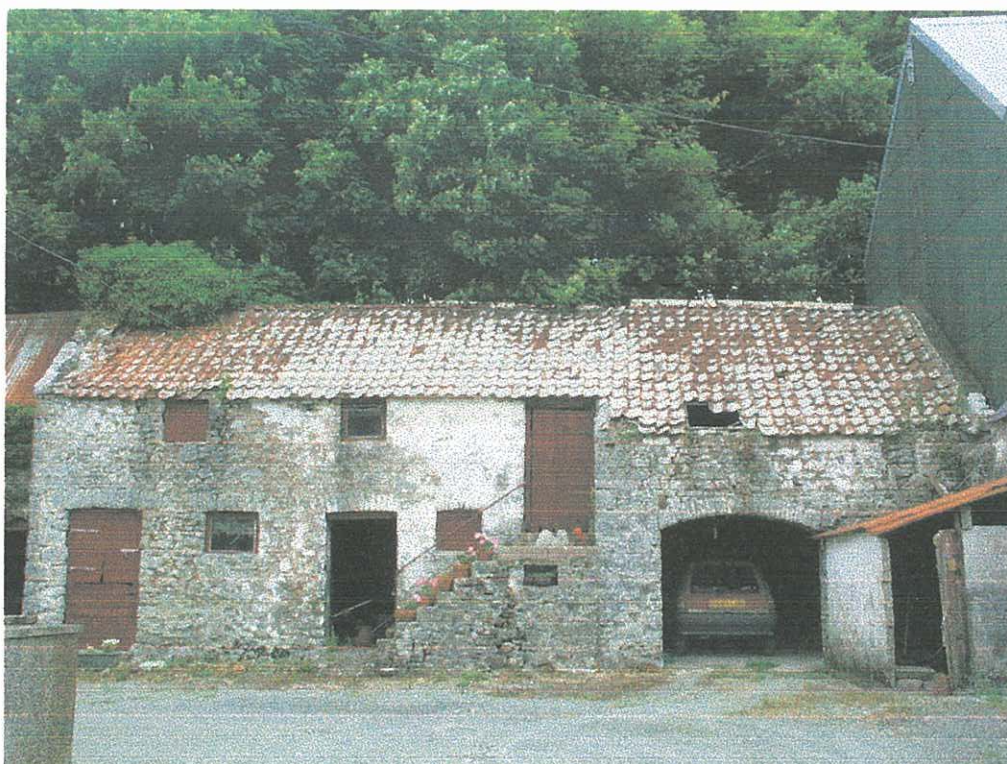
Plate 3 – the stable block (42861) and cart shed (42862) showing the decorative openings and overgrown roof.

Two storey stable and hayloft at the centre of the northern side of the farmyard at Norton Farm, orientation east-west (plate 3). It is terraced into the hillside and built of dressed stone and lime mortar with dressed stone quoins, whitewashed walls and a gabled tile roof. It was first recorded on the 1st edition OS map of 1887. The stable at ground floor level was accessed via two single-width doors in the southern wall which are headed with stone voussoirs. It was lit by two small, square, fairly recent windows positioned to the east of these doors and also headed with stone voussoirs. The interior has an earthen floor and no original features survive. The hay loft at first floor level is accessed via a set of stone steps that run up the eastern end of the southern wall and through a single-width door which is directly under the eaves. It is lit by two evenly spaced windows in the southern wall both of which have modern fittings. There is a small recess with a stone lintel built into the steps. The interior at first floor level was not examined and the loft floor is unstable.

The stable and hay loft are in reasonable condition but in need of repair. They are now used for storage. The northern wall is very damp. The roof is overgrown and some of the tiles need replacing. The roof timbers were not examined. The loft floor timbers are in very poor condition and in danger of collapsing. The exterior has been re-pointed with concrete in places. The fittings for the doors and windows are also in poor condition. Ideally, the walls should be consolidated, the loft floor replaced, the roof repaired and the doors and windows replaced. Any alterations and repairs should be carried out using traditional materials in a way that is sympathetic to the character of the original building.

The cart shed is in reasonable condition but is in need of repair. It is now used for storage. The loft floor is in very poor condition and the northern wall is very damp and has several large cracks in it. The roof is overgrown, several of the tiles are missing. The roof timbers were not examined. Ideally, the loft floor should be replaced, the northern wall consolidated and the roof repaired. Any alterations and repairs should be carried out using traditional materials in a way that is sympathetic to the character of the original building.

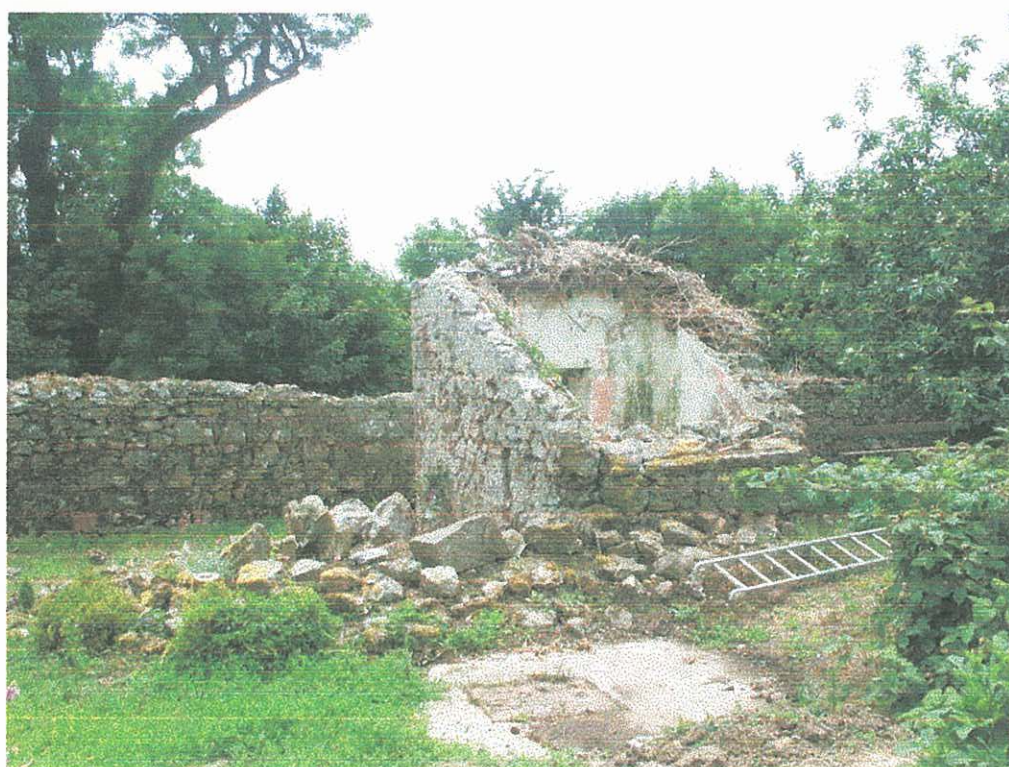
Plate 4 – the privy (42865) and walled garden (42864) to the west of the farmhouse.

The walled garden has fallen into disrepair but the current owners have cleared much of the interior and cut and burnt the ivy along large sections of the wall. Any remaining intrusive vegetation should be cut but not removed. Any loose stonework should be consolidated and the collapsed sections of wall should ideally be rebuilt. This work should be carried out using traditional materials in a way that is sympathetic to the character of the original structure.

Substantial, single storey rubble and lime mortar privy (plate 4) with whitewashed walls and dressed stone quoins. The roof is missing but originally sloped from south to north. It is square in plan and situated within the walled garden on its southern side. It was first recorded on the 1st edition OS map of 1887. It was accessed from the south by a door headed with stone voussoirs and ventilated by small loops at the northern end of the eastern and western walls. The original two-seater privy was rotting and has been removed. The structure has been severely damaged by ivy grown which the owner has tried to control.

The privy is in reasonable condition but the huge ivy stems on its southern wall have created large cracks in the walls which are now unstable. The owner has cut the ivy to prevent further damage and would like to rebuild the unstable section of wall once the stems have rotted. This should be carried out using traditional materials. The roof should be replaced to ensure that the building remains as an upstanding structure.

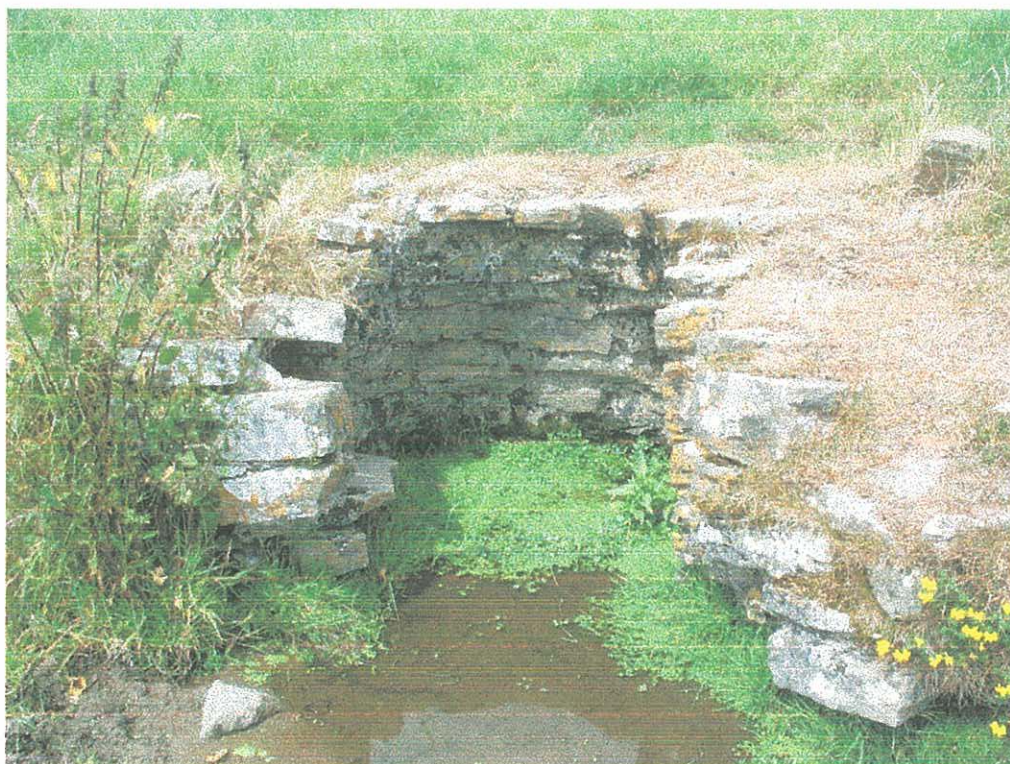
Plate 5 – the well to the northwest of Norton Farm (42868) showing the domed structure, silted up shaft and stone recess (to the left of picture).

A fine rubble and lime mortar built well lies alongside a pathway (42876) in a field to the northwest of Norton Farm (plate 5). It was first recorded on the 1st edition OS map of 1887 and according to the owner was probably built to supply water to the occupants of Norton Farm and Slough Farm which lies to the north of the holding. It is built into the south-facing slope and stands to a height of c.0.6m above the ground surface. It is semi-circular in plan (c.1.5m wide) with a slightly domed central superstructure and a stone recess in its western side. The frontage to the south is faced with dressed stone. The central domed area may originally have been roofed although it is now open and the upper surface of the walls is grassed over. The well shaft is completely silted up but is still wet and the line of the spring can be seen running southwards down the field.

The well is well preserved and now lies in a pasture field. The owner would like to restore it as part of his Tir Gofal Agreement and should seek specialist advice before doing so. A full recorded of the existing structure should be carried out before any work is carried out.

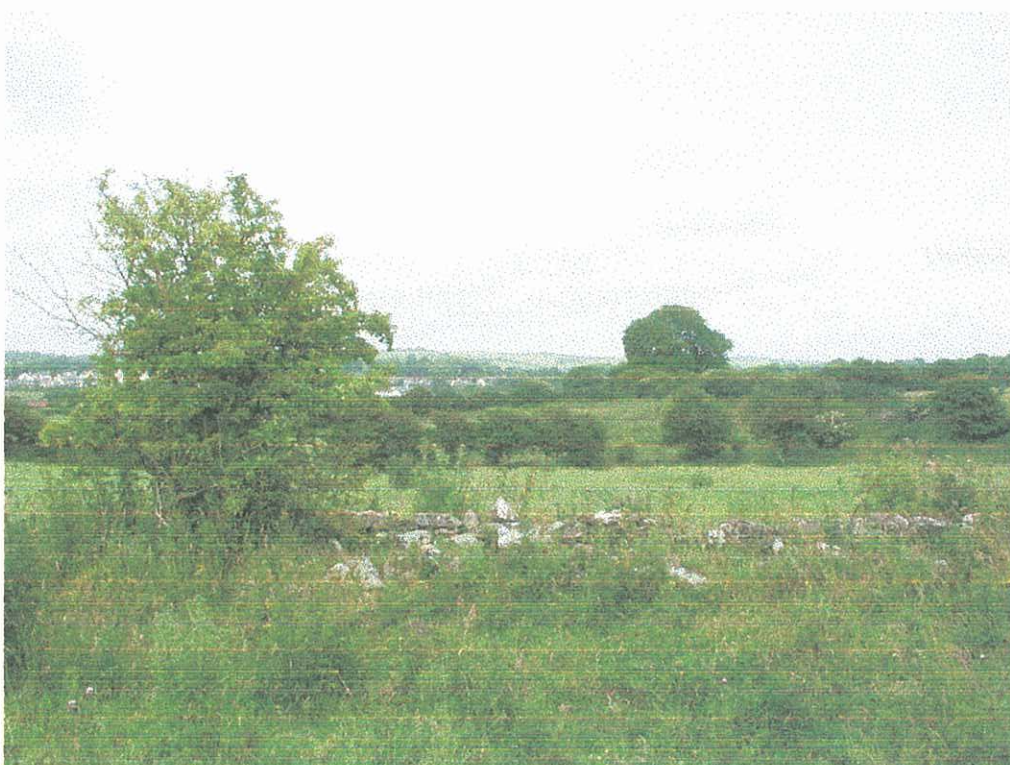
Plate 6 – a typical field bank and drystone wall defining the system of strip fields at St Florence (42878).

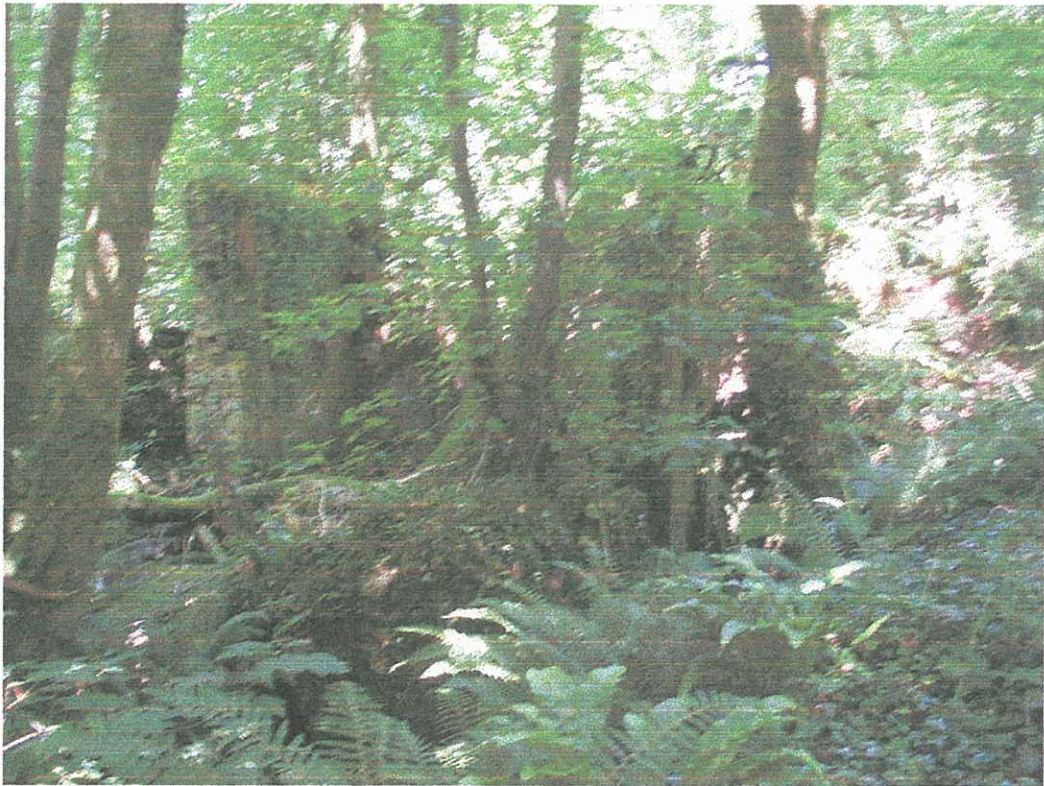
Plate 7 – the corn grist mill at Knightson Farm (42885).

The mill is fairly well preserved but in a deteriorating condition. The area around the building is littered with fallen rubble and the walls are overgrown with ivy and are unstable. The millpond, dam and tailrace are also overgrown. Ideally, the walls should be consolidated and maintained in a stable condition. Any ivy should be cut but not removed and intrusive vegetation should be cut and left in-situ until the roots have rotted. The pond and leats should not be infilled or disturbed and the vegetation around them should be controlled. The mill is of considerable archaeological interest and it is recommended that a more detailed survey is carried out to record the surviving remains.
