Glynhenllan Uchaf

Tir Gofal Farm Visit Historic Environment Report Call Out

Report No. 2004/41

REPORT NO. 2004/41
PROJECT RECORD NO. 40400

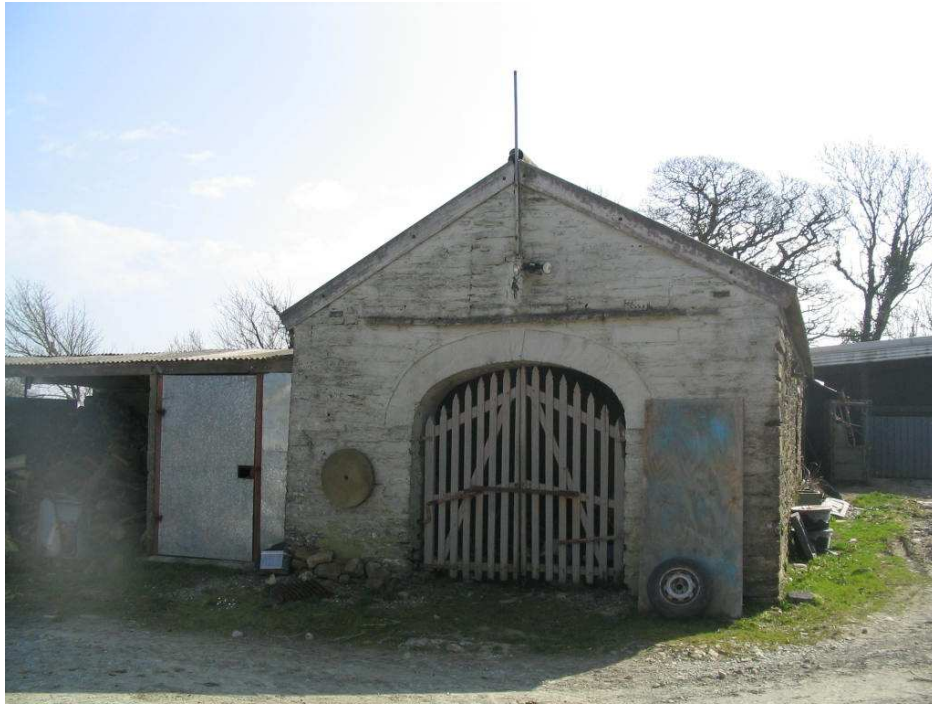
Plate 1 (above) *The cart entrance in the northwest gable. Note the dressed stone archway and the projecting slate course above it. These appear to be a kind of architectural 'signature' of Glynhenllan Uchaf.*

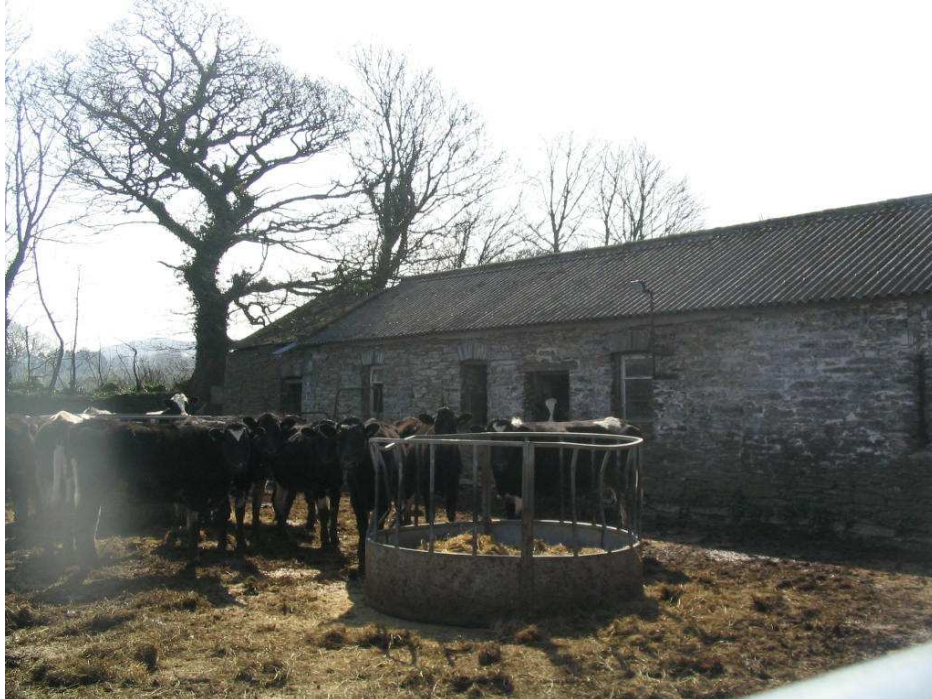
The cowhouse is generally in good to fair condition. Some of the stonework has been lost from parts of the rear wall, and one of the internal walls is also in need of repair. The landowner intends to re-build these sections of the cowhouse in stone, using stone from the derelict single storey building near the house.

Plate 2 (below) *The cowshed is generally in good condition and is still in use.*

Repairs to this building are to be welcomed, and the replacement of modern breeze-block with stone will have a positive impact on the integrity of the whole farmyard. The works should be carried out using a lime mortar which matches as closely as possible the one used in the original construction of the building.

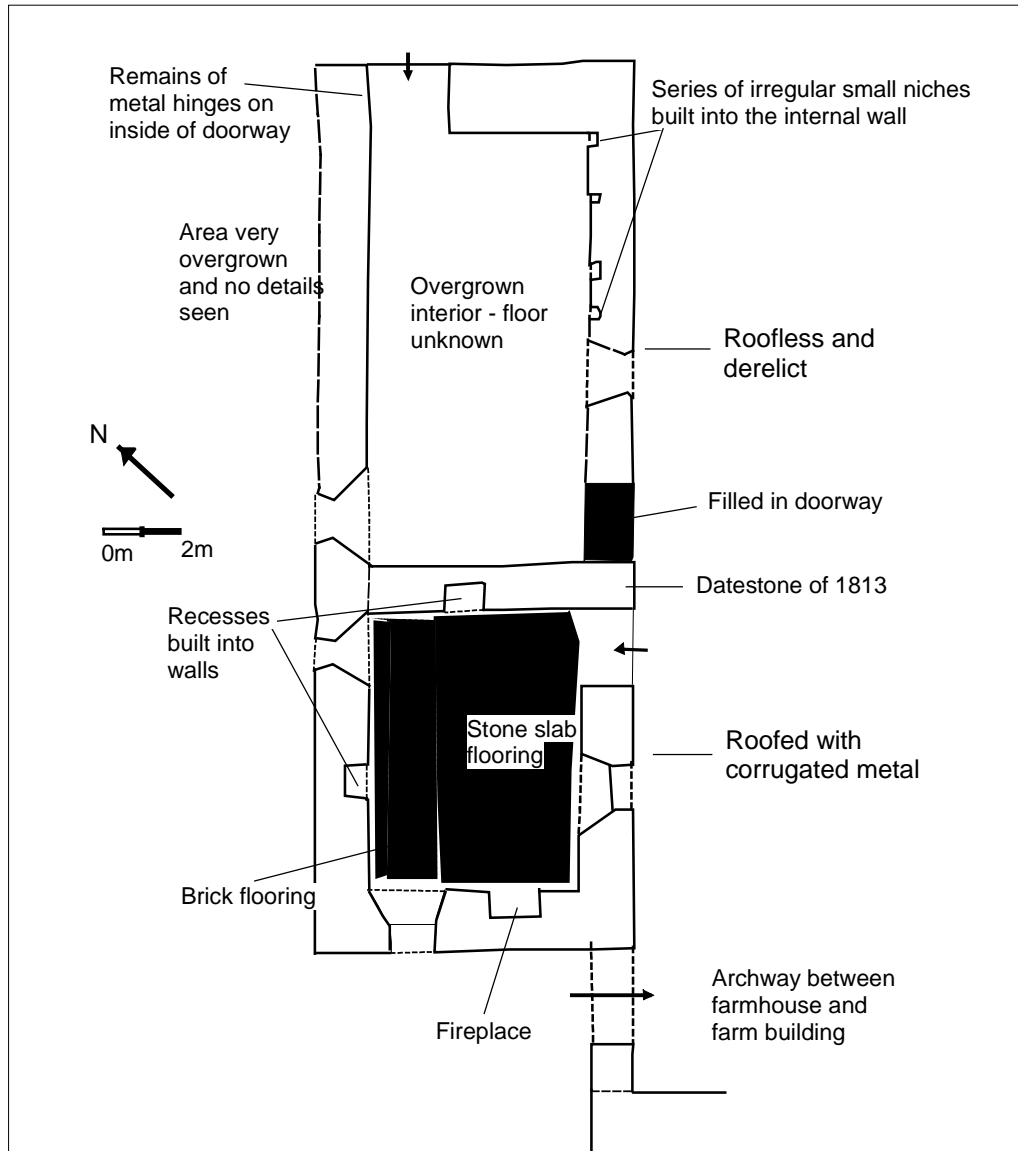
Plate 3 Plan of the service building showing the main features. Photographs of the building are included in the appendix.

The building is currently in poor condition. The north end is roofless and derelict, and appears to be structurally unsound. Parts of the stonework have collapsed, and the rear wall is heavily overgrown. The south end is in a better state, roofed in corrugated metal and appearing to be relatively sound and weatherproof. Through Tir Gofal the landowner has agreed that the north end will be partially taken down to provide stone for restoration works on the cowshed and the well-house. The south end is to be retained.

Under most circumstances the practise of taking stone from one building to repair another is not one which would be encouraged. However, the north end of the service range is in poor condition and it seems that there is now no viable way to save it. The preferred option is always to retain and repair buildings; especially where they are of an early date, of architectural interest, or have substantial group value. In this case, the loss of part of the building will ‘unbalance’ the overall appearance both of this building and of the house.

The south end of the building is to be retained. No material should be removed from this area.

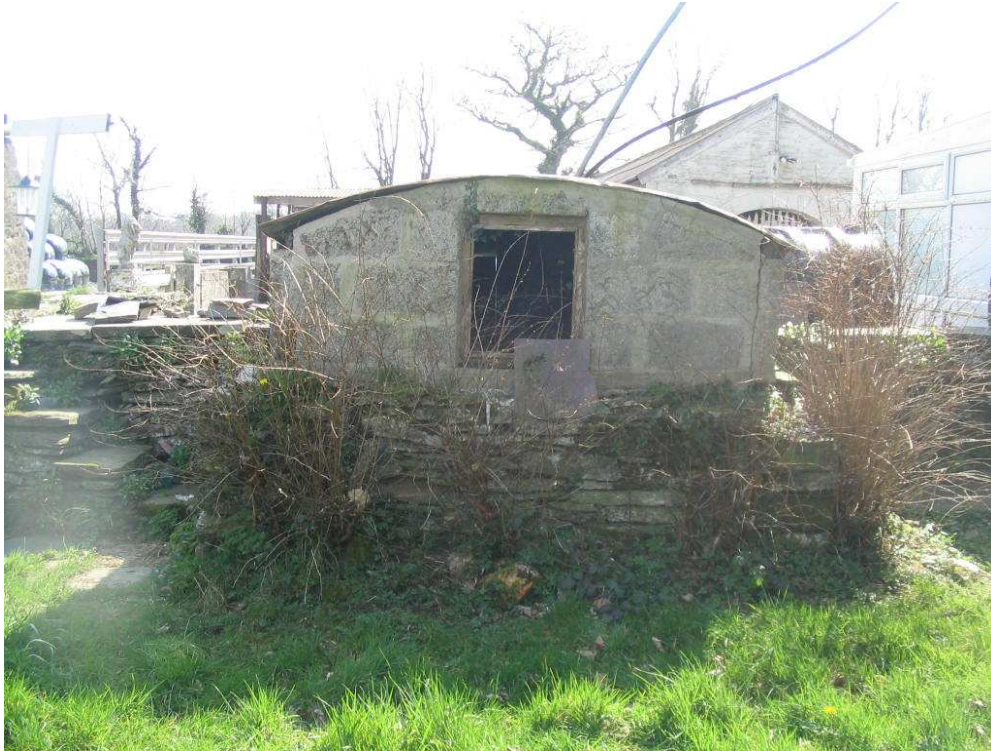
A small, modern well-house made of breeze-block set on stone footings. A pump or well is shown on historic maps, and the well is still the source of water for the farmhouse. The landowner intends to rebuild the well-house through Tir Gofal, using stone from the service building and finishing it with a slate roof.

Plate 4 *The well-house, viewed from the northeast.*

Although historic maps show that there has long been a well or pump in this location, there is no real evidence to suggest what any building or structure may have looked like. Consequently, it is suggested that any new building should be low-key and of unobtrusive appearance. The use of stone from the service building, and of a suitable lime mortar will ensure that the new well-house ‘blends in’ with the farmyard.

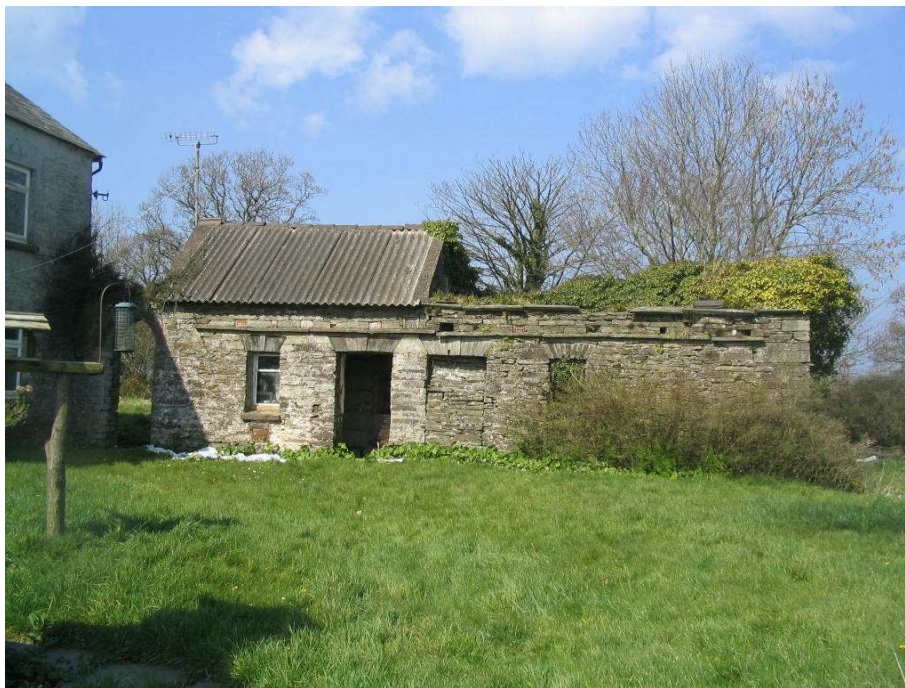
DAT 2004-22.1 (above) General view of the building from the southwest

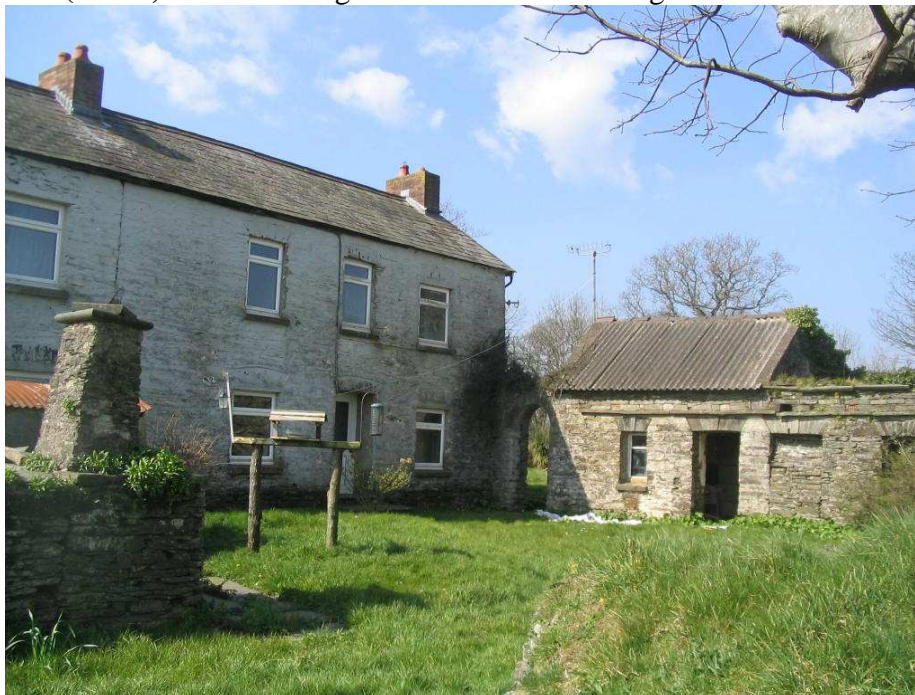
DAT 2004-22.2 (below) View showing how the service building relates to the main house

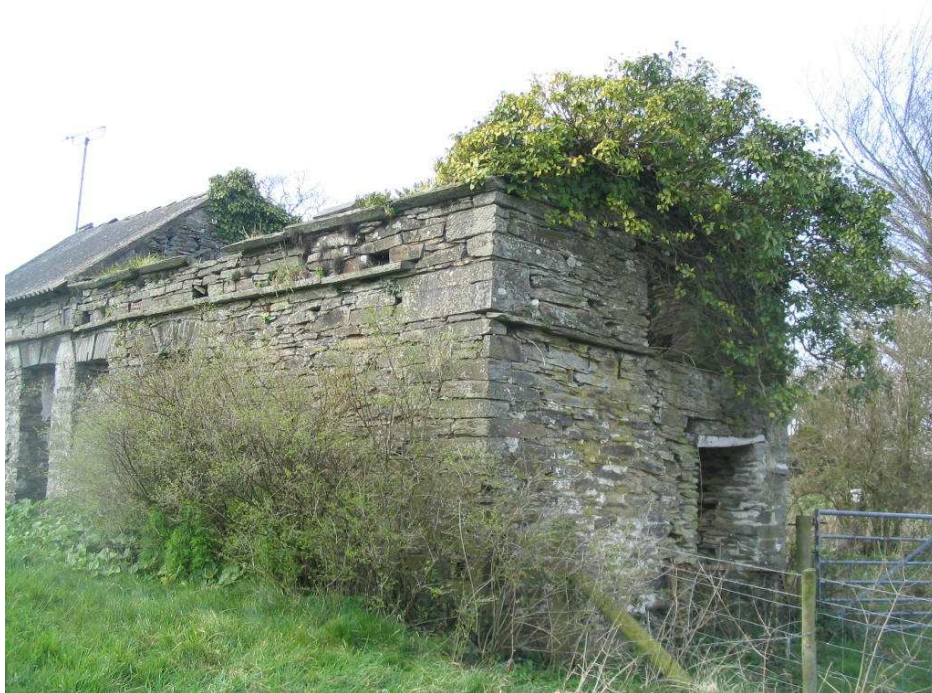
DAT 2004-22.3 (above) Northwest corner of the building

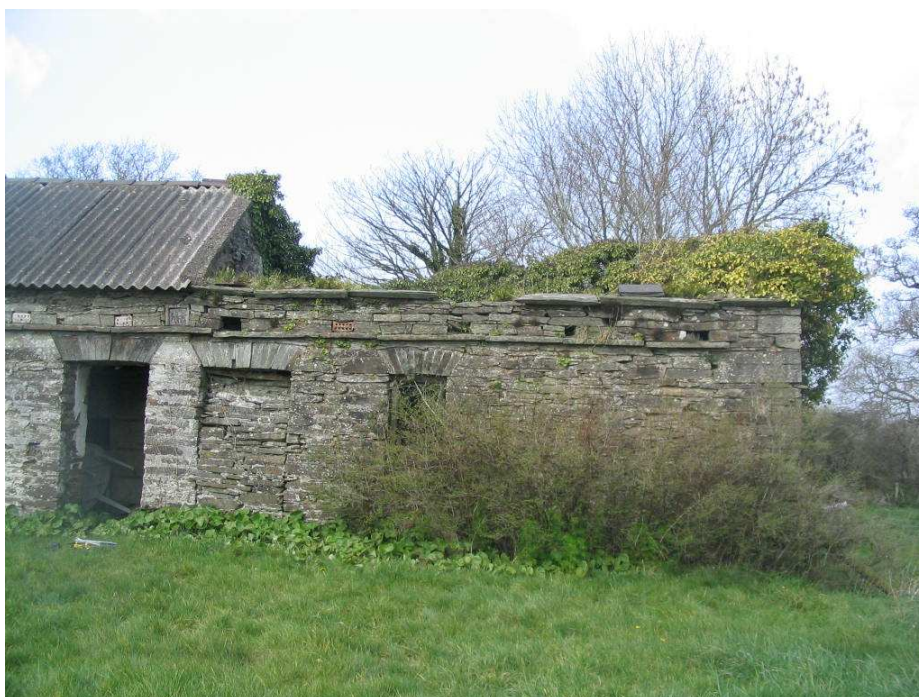
DAT 2004-22.4 (below) Main (southeast) elevation, north end

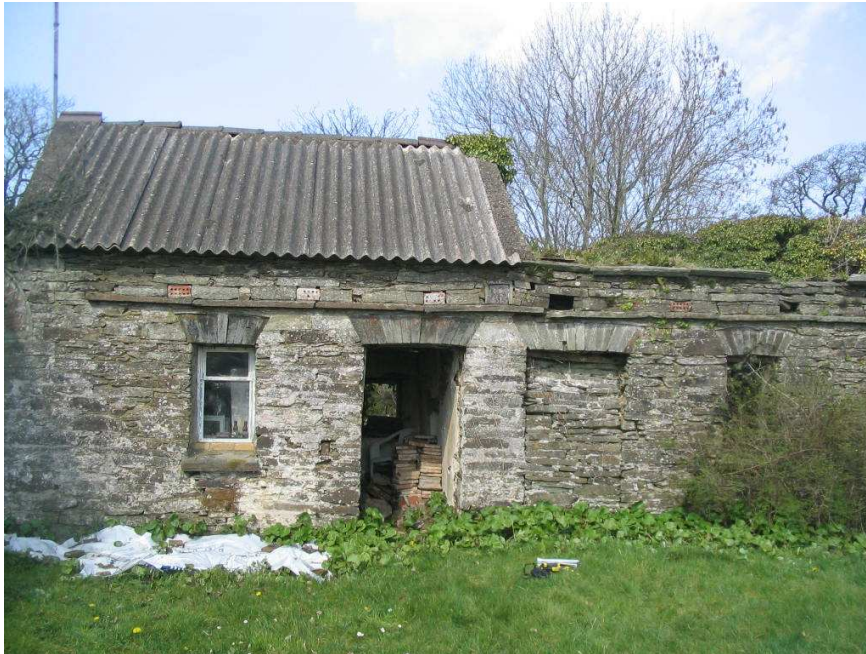
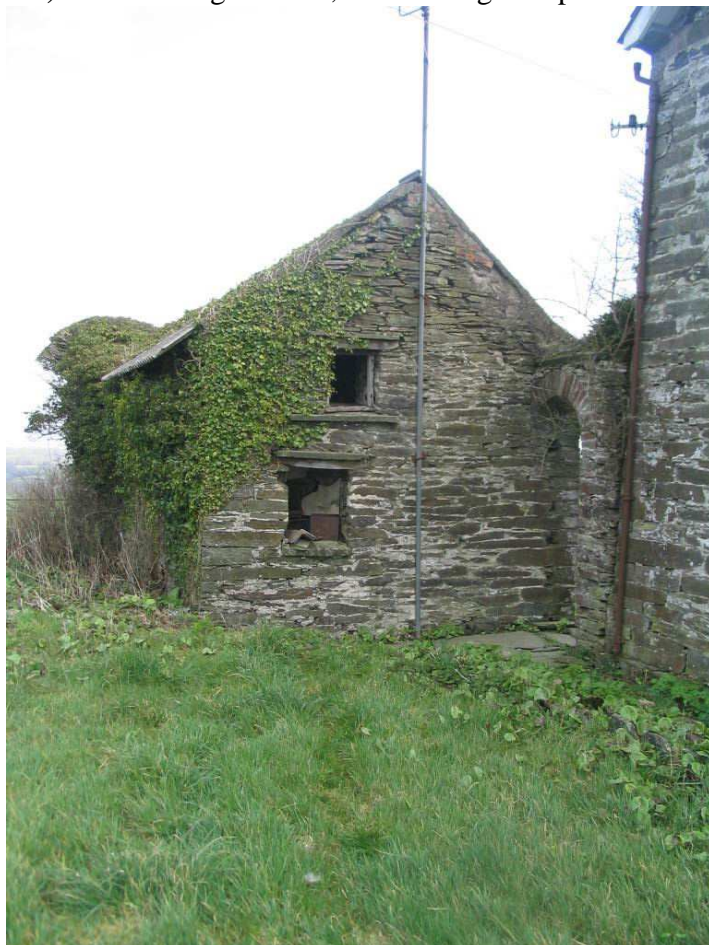
DAT 2004-22.5 (above) Main (southeast) elevation of the building, south end.
DAT 2004-22.6 (below) Southwest gable end, house to right of picture.

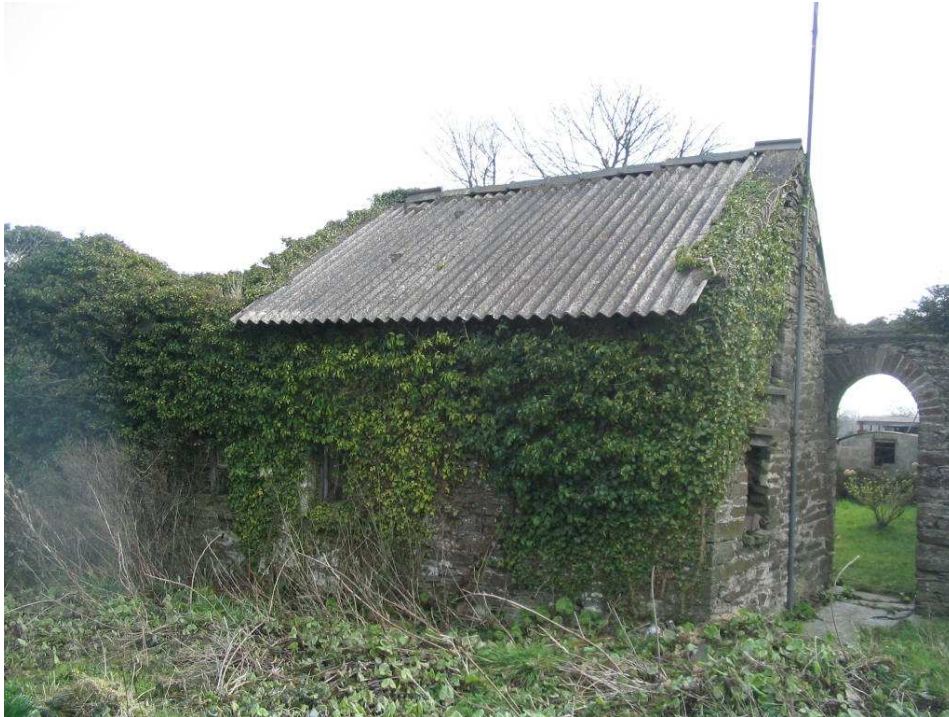
DAT 2004-22.7 (above) Rear (northwest) elevation, south end.

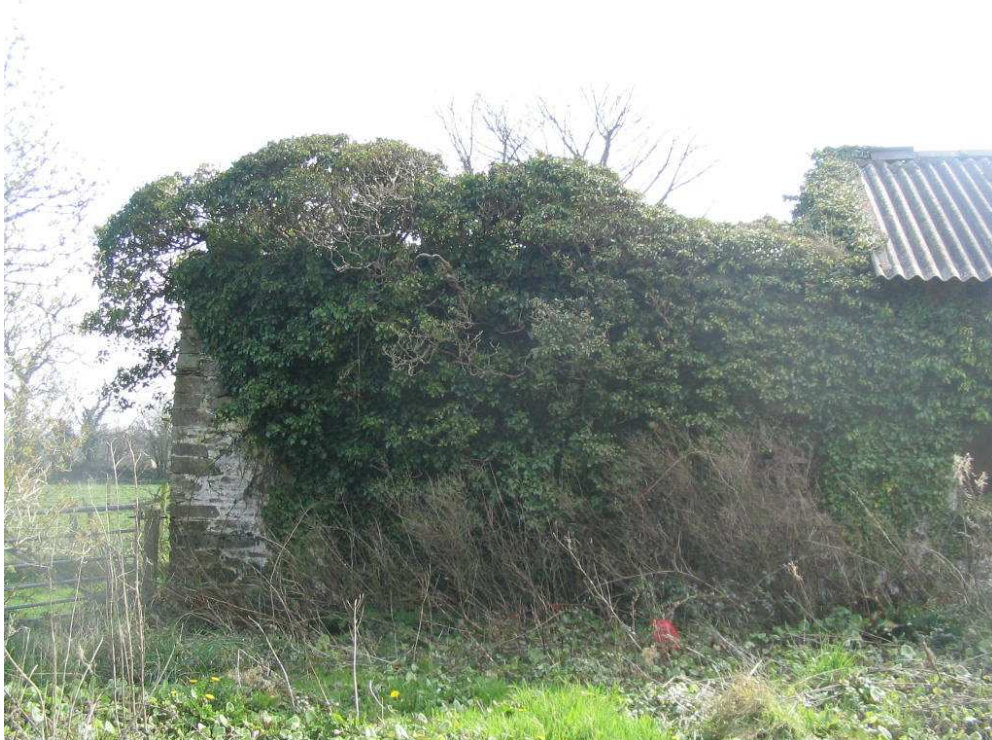
DAT 2004-22.8 (below) Rear (northwest) elevation, north end.

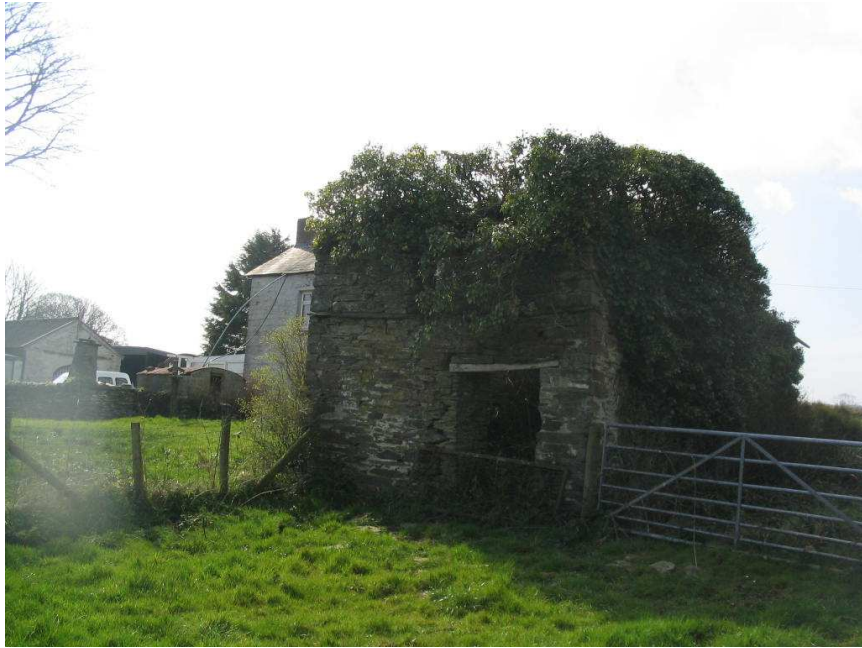
DAT 2004-22.9 (above) Northeast gable end.

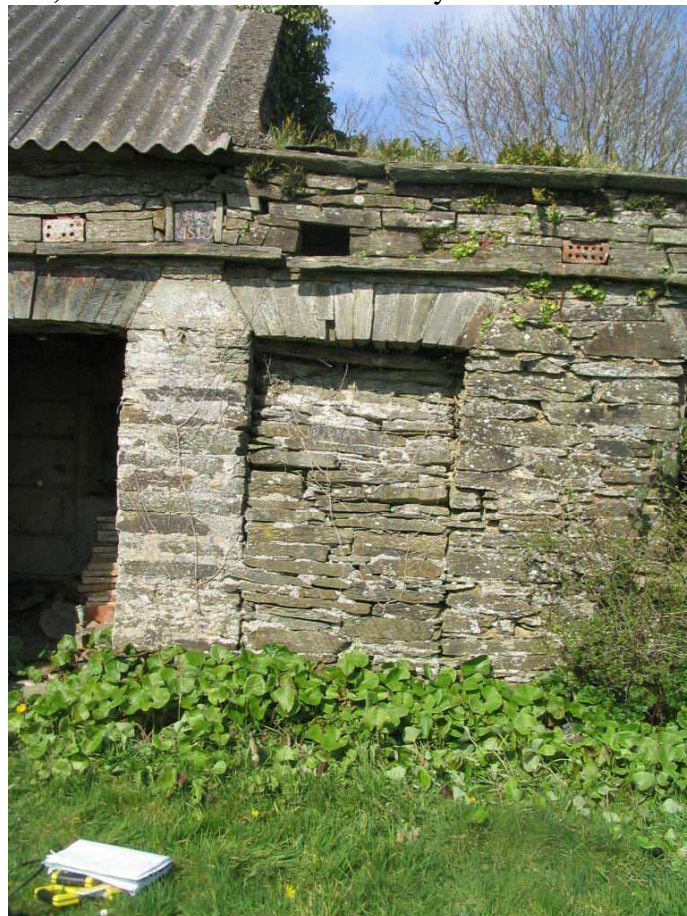
DAT 2004-22.10 (below) Detail of the filled in doorway and decorative coursing above.

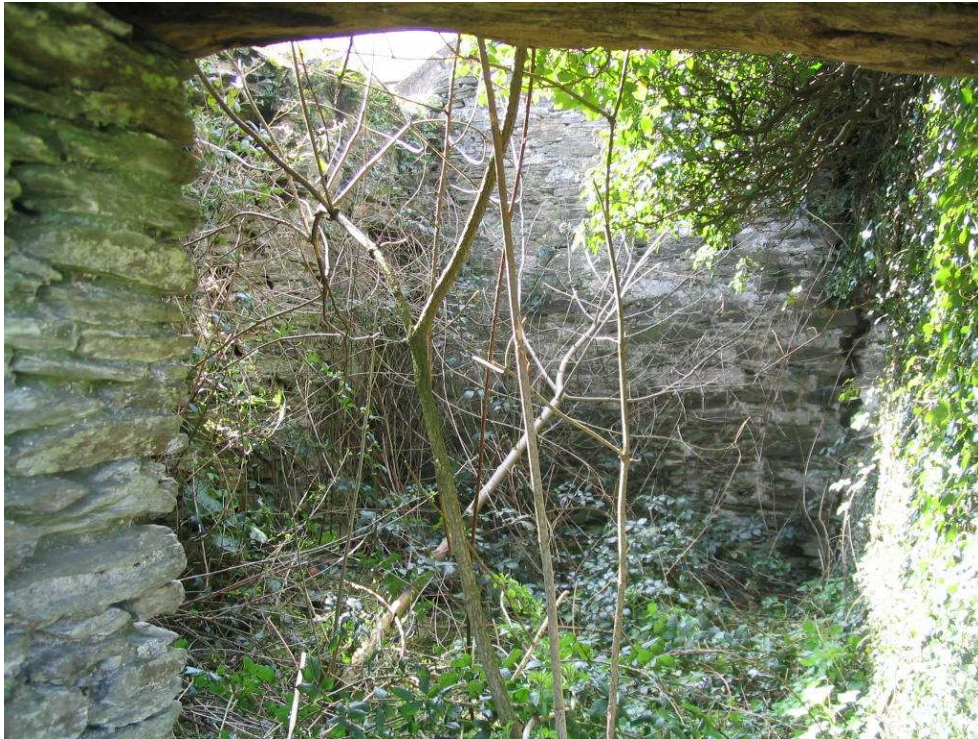
DAT 2004-22.11 Interior of the north room of the building.

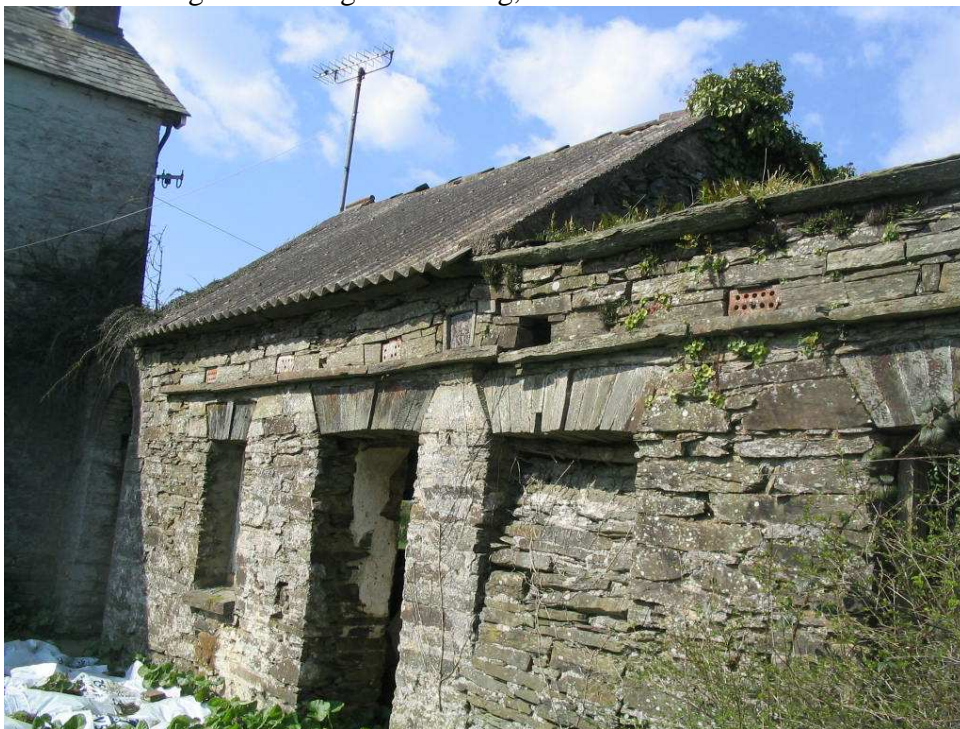
DAT 2004-22.12 Looking south along the building, towards the house.
