# Tir Gofal Farm Visit Report

## Moelgolomen

ACA Report Number 2000/55

January, 2001

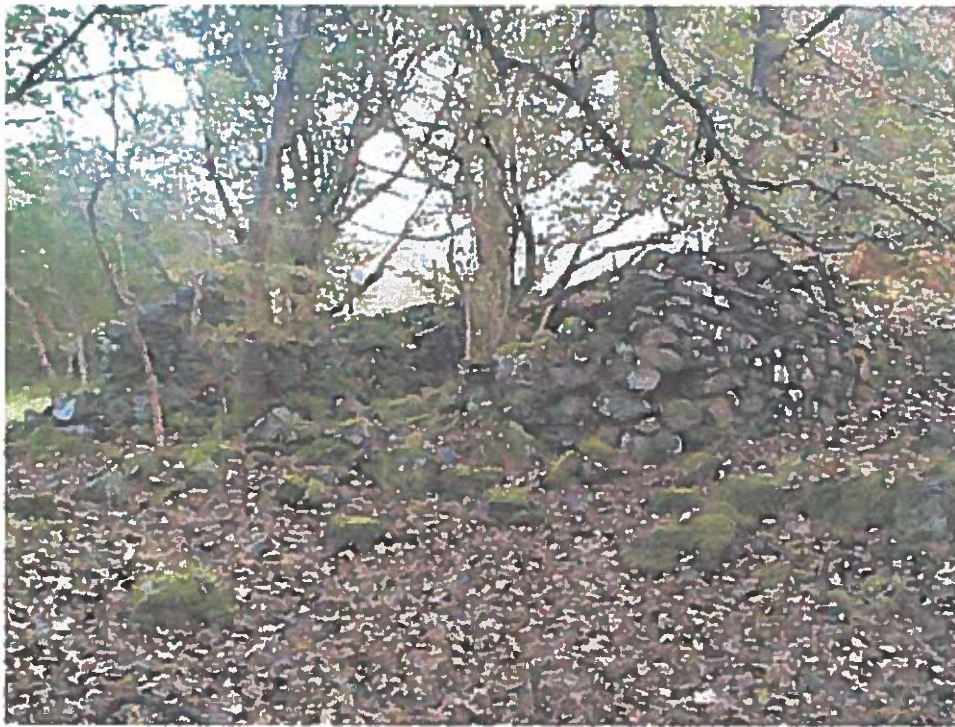
Plate 1 - PRN 41898, Llwyn Bedw Farm.

Ruined footings of a single-storey house and outbuilding, set within a triangular, stone-banked enclosure on the western side of Moelgolomen farm. Drystone, random rubble construction. The footings of the house (c.5m by 8m) stand to a maximum height of c. 2m. None of the original openings or fittings survive and the interior is infilled with rubble. The footings of the outbuilding to the north of it (c.5m by 5m) stand to a height of 0.5m. A raised garden area lies to the west of the buildings. The house was approached from the west by a short drive which led from the road that ran to the south of it (see plate1).

The ruins should be left undisturbed. No stone should be removed from the area and any intrusive vegetation should be cleared.

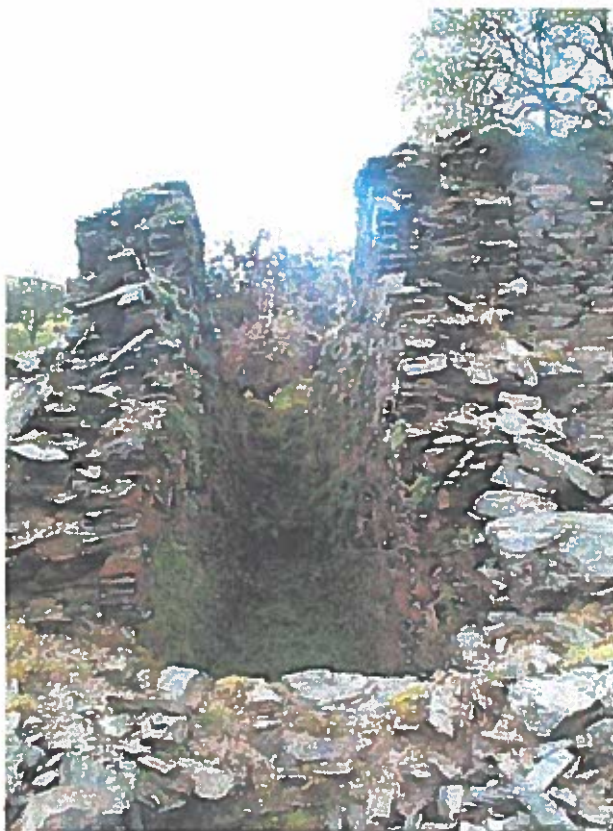
Plate 2 - PRN 41899, Ty Newedd Mine, Wheelpit.

Wheel pit, attached to a crushing house (PRN 41902), forming part of an extensive area of lead mining (PRN 9131) to the east of Moelgolomen Farm. Rubble and lime construction, c. 2m by 10m by 5m deep, tapering slightly to the south west. The walls are in a highly unstable condition and are overgrown with vegetation. The interior is infilled with rubble. The outline of a small, 1.5m square bob-pit lies to the southwest and is in a stable condition (see plate 2).

The walls of the wheel pit are overgrown and in an unstable and dangerous condition. They require consolidation to prevent their immanent collapse. In view of the owners plans to promote public access to this area, a scheme of fencing should be devised to create an exclusion zone in the area immediately around it.

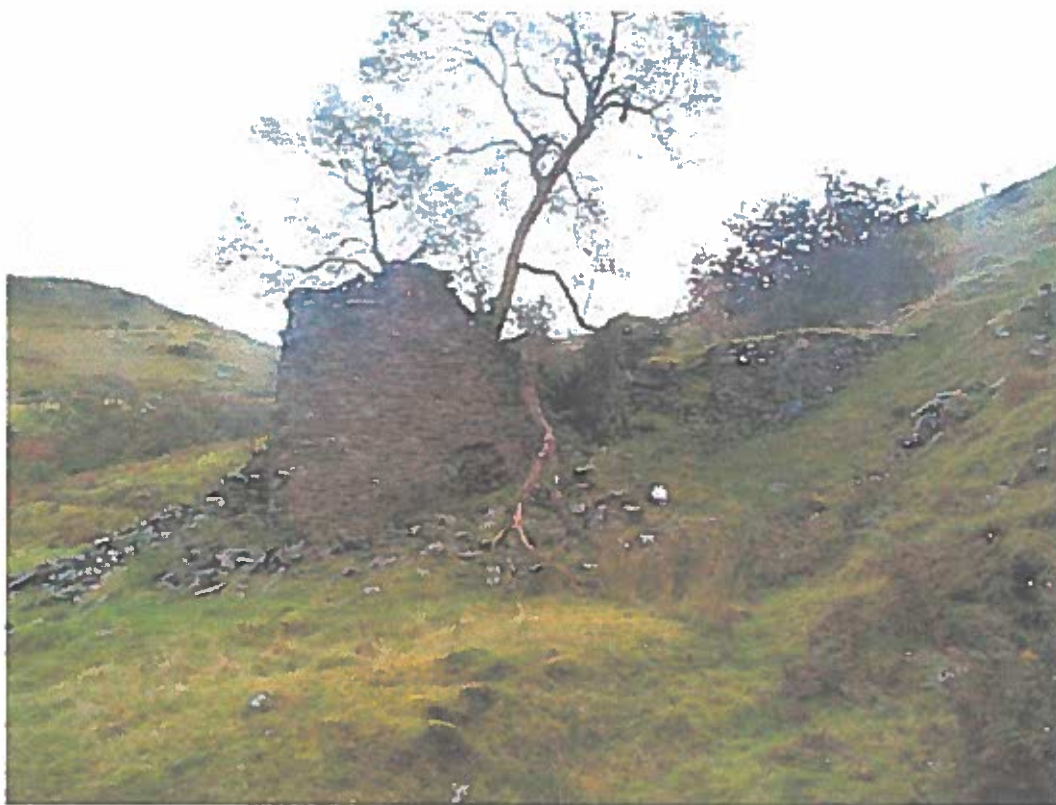
Plate 3 - PRN 41900, Ty Newedd Mine, Crusher House.

Ruined crusher house, associated with wheelpit and bob-pit (PRN 41899), forming part of an extensive area of lead mining (PRN 9131) to the east of Moelgolomen Farm. Rubble and lime construction the stone quoins have been robbed. Walls stand to a height of c. 5m but are unstable. A fine arched opening in the north western wall survives, but the original entrance has somewhat collapsed. The walls are overgrown and the interior is infilled with rubble and overgrown with nettles and young trees. A quarried platform, c. 5m by 3m by 0.5m high lies to the north west and is in a stable condition (see plate 3).

The walls of the engine house are now overgrown and unstable and are in a dangerous condition. They require consolidation to prevent their immanent collapse. The condition of the building has obviously deteriorated since a survey by R. Protheroe-Jones in 1993. In view of the owners plans to promote public access to this area, a scheme of fencing should be devised to create an exclusion zone in the area immediately around the it.

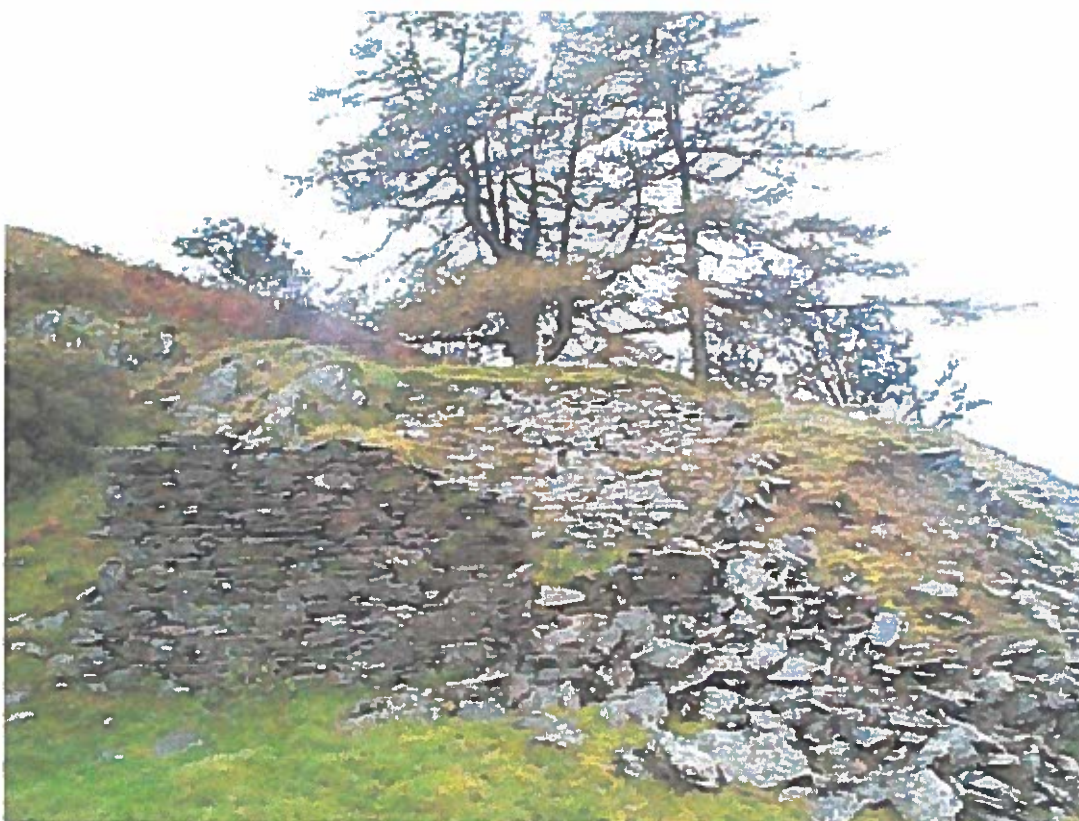
Plate 4 - PRN 41901, Ty Newedd Mine, Ore slide.

Semi-hexagonal oreslide of rubble and lime construction, forming part of an extensive area of lead mining (PRN 9131) to the east of Moelgolomen Farm. It was apparently unused during the lifetime of the mine. The stonework to the south and west is in excellent condition and stands to a height of 2m. The area around the entrance to the north east is slightly unstable (see plate 4).

The ore slide is in a reasonable condition and should be maintained in its current state. Its north eastern wall is slightly unstable and should be consolidated to prevent further deterioration.

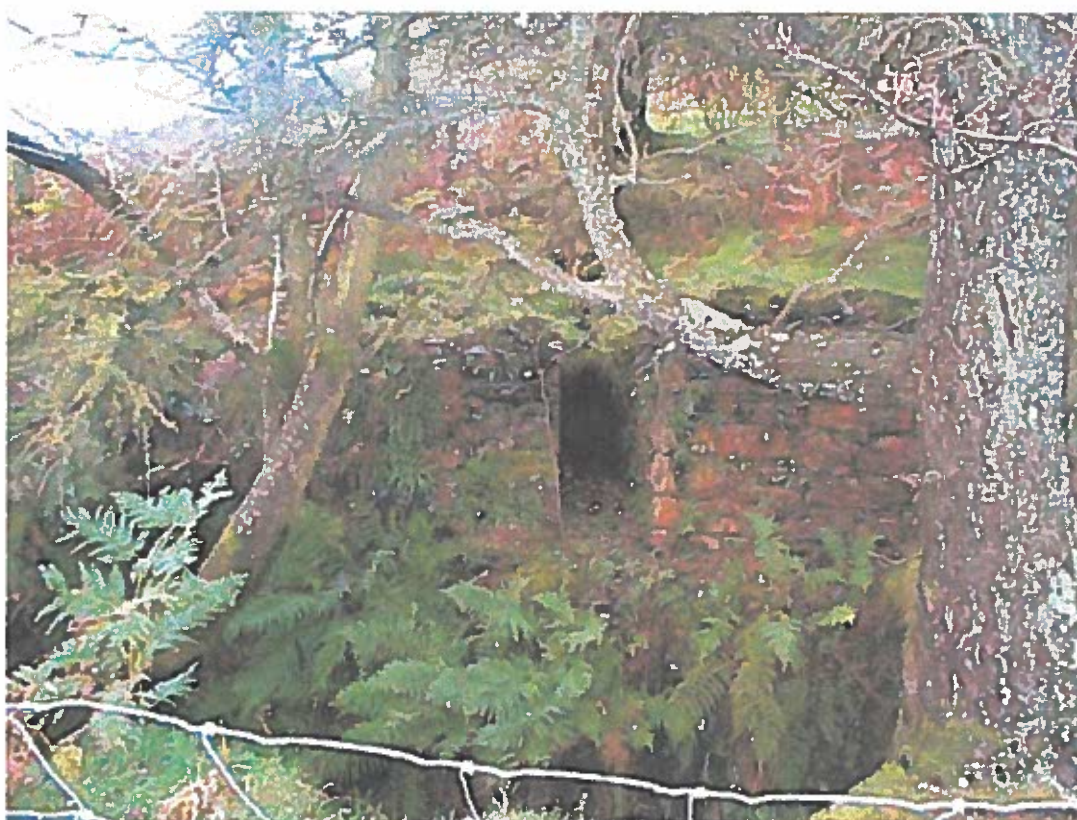
Plate 5 - PRN 41902, Ty Newedd Mine, Mine shaft.

Three, open rockcut mineshafts with associated tips, forming part of an extensive area of lead mining (PRN 9131) to the east of Moelgolomen Farm. The southernmost of these is associated with a rubble and lime constructed platform, with a narrow channel running through it, possibly related to some sort of lift for hauling material from the shaft. The interiors were not examined, although they are thought to have been cut to a depth of c.40m (see plate 5).

The rims of the mine shafts are overgrown with trees. The fences that surround them are in poor repair and should be replaced. The trees around them should be cleared. In view of the owners plans to promote public access to this area, a warning notice should be installed to highlight the dangers of these shafts.

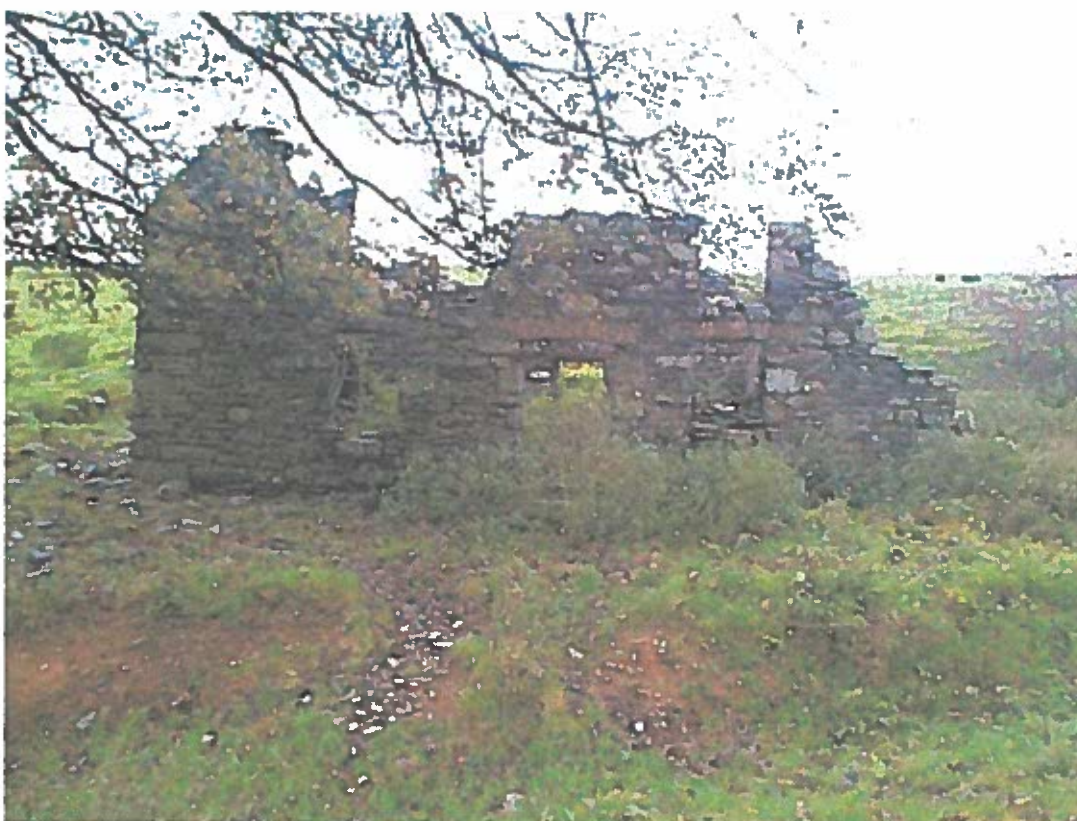
Plate 6 - PRN 41908, Newydd Pant Glas Farm.

Ruinous, two-storey dwelling and adjoining outbuilding to the east of Moelgolomen Farm. Orientation east-west. Dressed rubble construction with a gabled slate roof. Openings are headed with brick voussoirs and have stone sills. The original brick-built oven in the north western corner and stacks on both gable walls survive. The walls stand to roof height except at the eastern end which has recently collapsed and all are becoming unstable. The footings of the outbuilding to the east stand to a height of 0.6m. The buildings stand in a low, earthen banked enclosure which is bisected by a trackway that lies to the south of the dwelling. A squareish garden area lies to the north east of the house. The building was reputedly originally occupied by a blacksmith who brutally murdered his wife and daughter. It was later an inn alongside a known drovers route, and more recently still became the farmhouse for Newydd Pant Glas Farm (PRN 42108). It was first recorded on the tithe survey of 1845, on which it was depicted as an L-shaped arrangement of buildings (see plate 6).

The interesting history of this building and its survival to roof height make it of regional importance. Its management should be prioritised over that of the other deserted buildings on the holding. The upstanding walls of the building are in a reasonable condition but due to the fairly recent collapse of the roof, their survival is threatened. The upper part of the eastern wall has fallen fairly recently and its condition is rapidly deteriorating. The interior is rubble filled and overgrown with nettles. The owner would like to reroof the building and consolidate the walls. This would secure the survival of the building for the immediate future until sufficient funds are available to restore it more fully. The history of its occupation and its location immediately adjacent to a public footpath would make an ideal site for the installation of an interpretation board. The adjoining building to the east is in a more ruinous condition. It should be maintained as a stable ruin and any loose stones should be left in-situ.

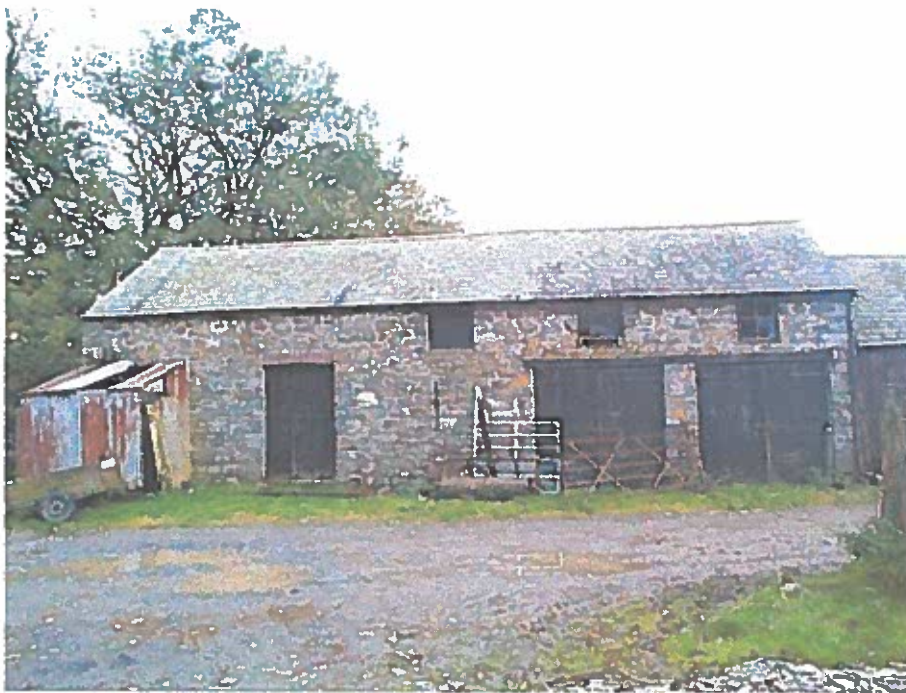
Plate 7 - PRN 41912, Moelgolomen Farm, Barn.

The barn is in a reasonable condition although the owner is worried about recent cracks which have appeared in the stonework at the southern end of the western wall. It is now used for storage purposes. The building should be maintained in its current state and any unstable sections of wall should be consolidated. The owner would like to replace the doors and windows. This should be carried out using fittings of a design that is sympathetic to the original character of the building.
