Tir Gofal Farm Visit Report

Plas-y-Bryniau

ACA Report Number 2001/13

January, 2001

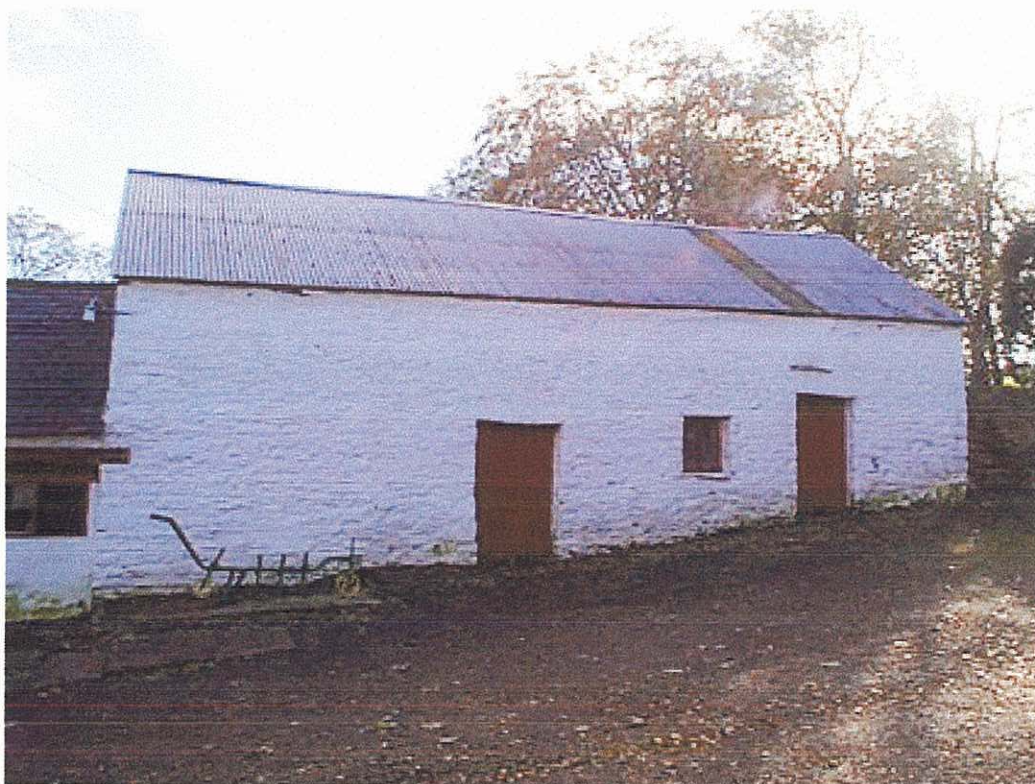
Two-storey, whitewashed rubble farm building (plate 1) with dressed stone quoins and a gabled roof consisting of a cowshed (PRN 42032), cartshed (PRN 42033) and barn (PRN 42034). Orientation north-south. It forms the eastern range of the farmyard at Croes Winter Farm (PRN 42029). First recorded on the tithe survey of 1839. See individual site descriptions for more details.

Plate 1 - the barn and stables at Croes Winter Farm (PRN 42033 and 42034).

The farm building is in very good working order and the owner has taken particular care to retain the original internal features. The owner has no immediate plans for the building. It should be maintained in its current condition and repairs and alterations should be carried out in a way that is sympathetic to the original structure of the building. (See individual site recommendations for more details).

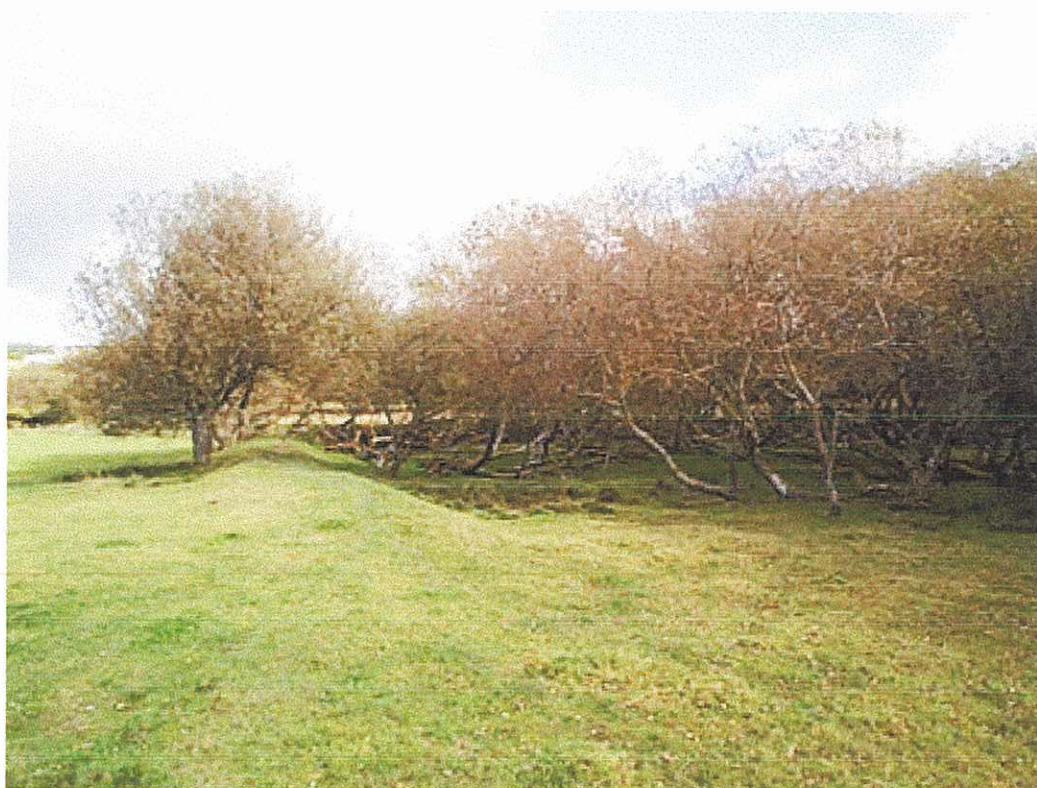
Sub-circular millpond, c.15m in diameter at the northeastern corner of Plas-y-Bryniau Farm. Defined to the north by a substantial earthen bank c.1m wide and 1.8m high. It still holds water, but is silted up and overgrown with young trees (plate 2).

The millpond is now completely silted up and overgrown with young trees. The bank that defines its northern edge is in good condition. The owner would like to clear the pond to restore its original character. Clearance of the pond, retaining the original profile, would enhance the feature.

Plate 2 - the millpond at Croes Winter Farm (PRN 42037).

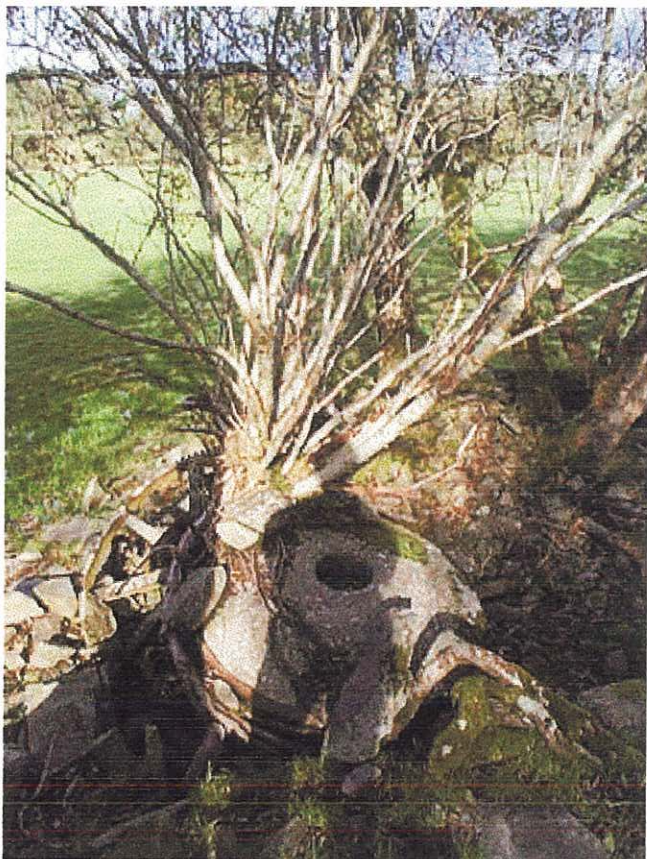
Ruined mill building, c.3m wide by 8m long, at the north eastern corner of Plas-y-Bryniau Farm. Drystone rubble construction, no roofing material survives. The wall footings survive to a height of c.0.6m. A large grinding stone and iron cogs and fittings still lie within the walls of the building (plate 3) although some have apparently been robbed for scrap metal. The wheel pit has been infilled and the run-off leat to the northwest has silted up. The building is overgrown with young trees. It was first recorded on the 1st edition OS map of 1891.

Plate 3 - the mill building and fittings at Croes Winter Farm (PRN 42038).

The complex of the surviving mill building, millpond and an upstanding lime kiln (which stands just beyond the boundary of the farm) is unusual and deserves protection. The footings of the mill building are covered with vegetation but in a fairly stable condition. Any intrusive vegetation should be cleared. The wheelpit alongside the building has been infilled. The grinding stone is now encompassed within a small tree but is also in a stable condition. The iron fittings from within the mill building are loose and the owner is concerned that they may be removed by passers-by for use as scrap metal. Given the proximity of the site to the public road these fittings may be best preserved by removing them from the site for safe-keeping on the farm. Archaeological advice should be sought to ensure that these items are fully recorded prior to their removal. Any loose stone should be left in situ. The field to the north of the mill should not be ploughed to preserve the remains of a run-off leat which ran across it.

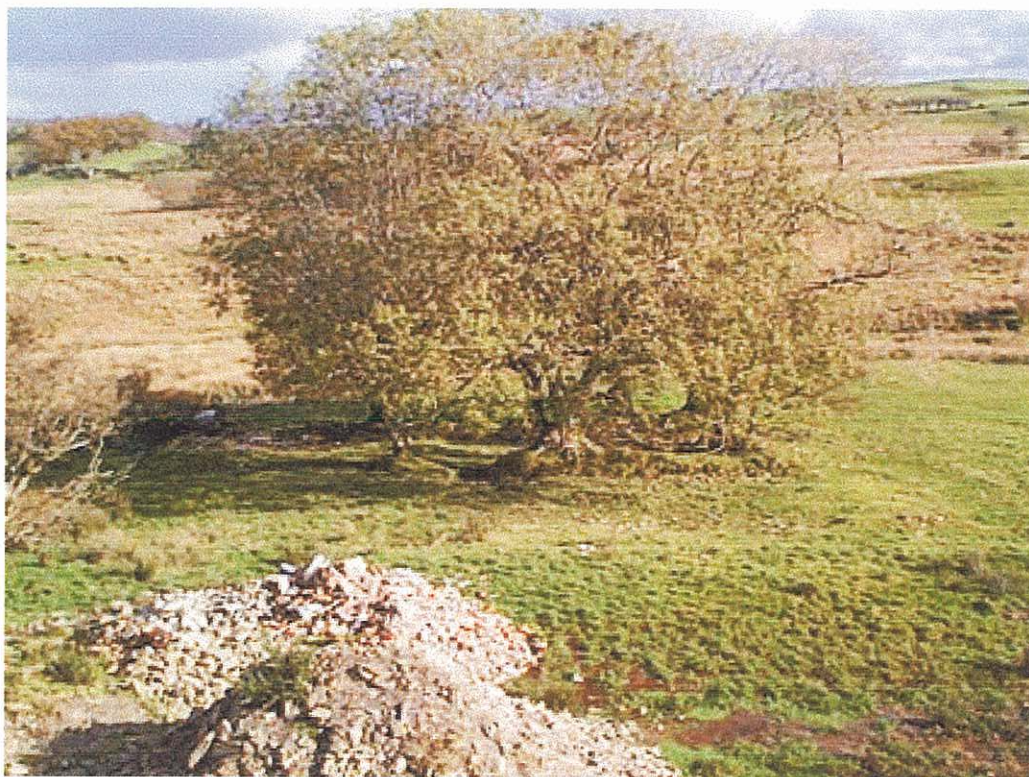
Plate 4 - the deserted farmstead of Cwm (PRN 42043).

The piles of rubbish and rubble from the adjacent quarry should be removed to restore the character of the area. The footings of the former buildings are grassed over and in a stable condition. Any loose stones from these should be left in-situ and the bank that defines the garden should be maintained as an upstanding earthwork. The sheep dip and pond should be retained.

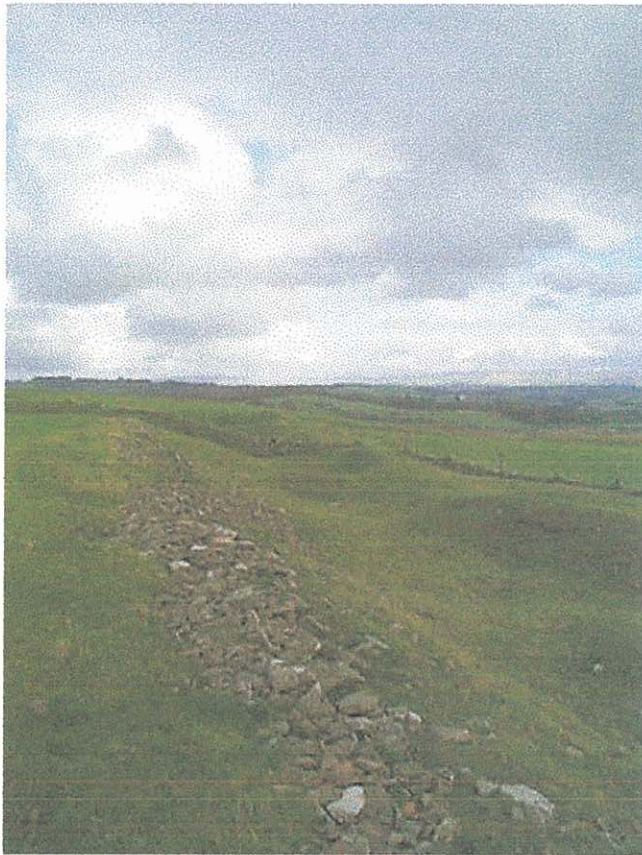
Linear sequence of distinct hollows (c.2m deep) and spoil heaps (c.1.5m high) on the western edge of Plas-y-Bryniau Farm. The hollows and spoil heaps are almost completely grassed over although there are areas of small, loose stones along the western side of the scar (plate 5). Probably the remains of mineral extraction, with the excavations clearly following a seam. The mining clearly predates the late nineteenth century field boundary which crosses it.

Plate 5 - mineral extraction (PRN 42044).

The extraction hollows and spoil heaps are grassed over and in a stable condition. Any loose stones should be left in situ. The spoil heaps should not be levelled and the extraction hollows should not be infilled. Further survey in the area to the east of the farm may reveal other evidence of mineral extraction to provide a context for this site.

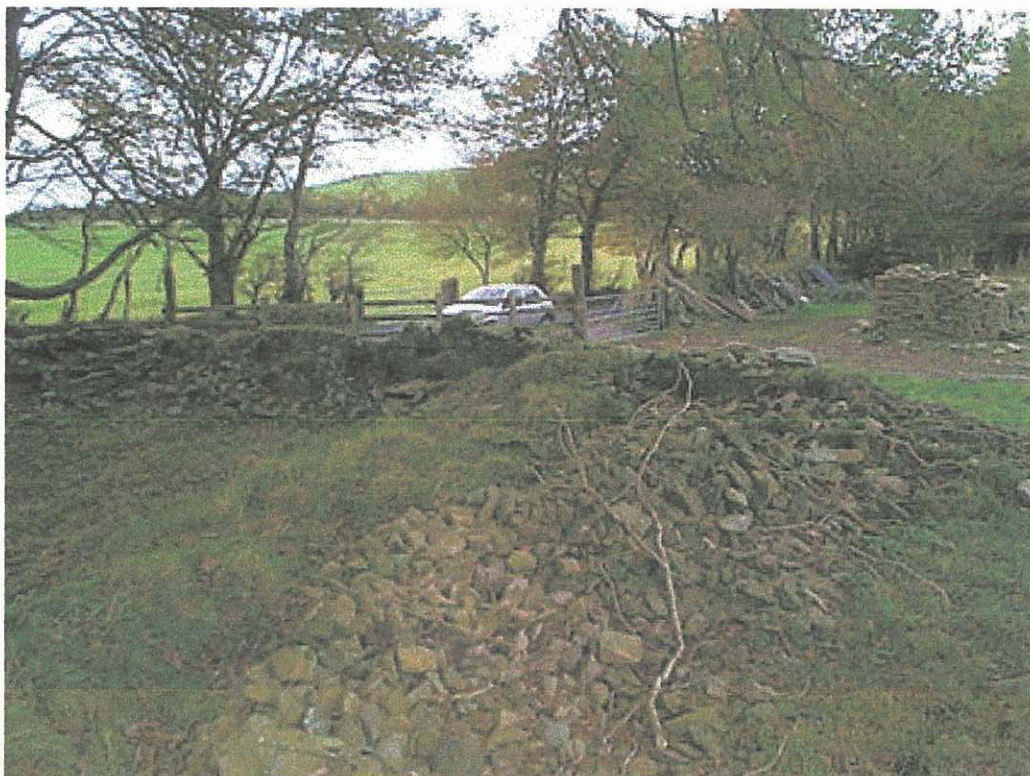
Plate 6 - rubble remains at Common-fynnedd-fawr ruined farmstead (PRN 42050).

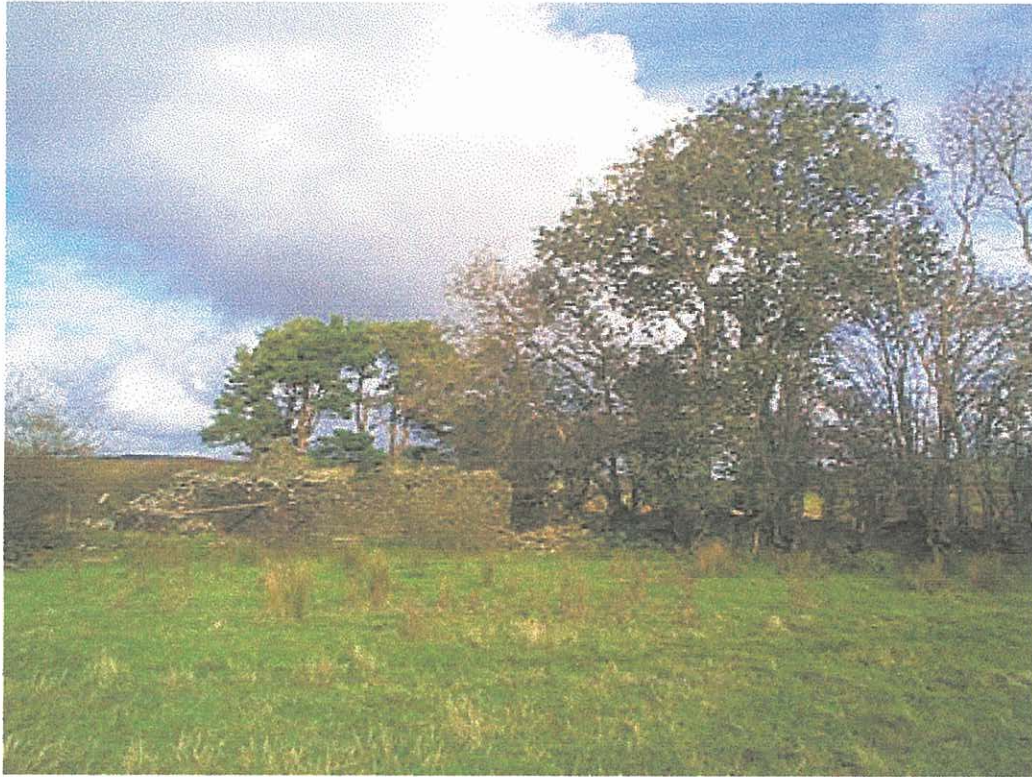
Plate 7 - ruined farmstead of Pen-banc (PRN 42052).

This ruined farmstead is the best preserved of all those on the holding and its conservation should be prioritised. The ruined buildings are now unstable and infilled with rubble and overgrown with nettles. They should be consolidated and maintained as stable ruins. The enclosure in which they stand is in good condition and should be maintained in its current state. See individual site recommendations for more details.

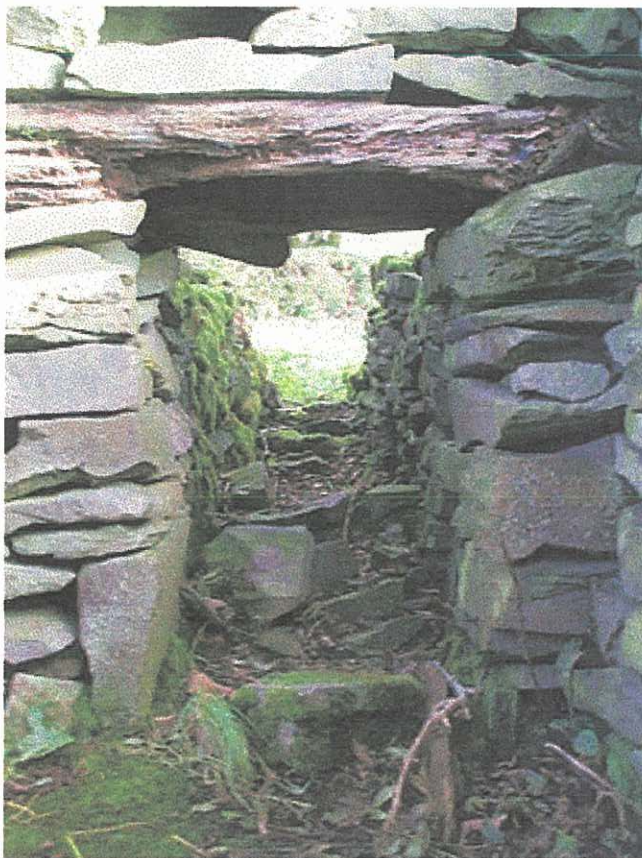
Plate 8 - sheep crawl at Pen-banc Farm (PRN 42052).
