**TIR GOFAL MANAGEMENT PLAN:
HERITAGE MANAGEMENT INFORMATION
(Call Out)**

**Prepared for:
Llystyn**

**Tir Gofal Reference No:
W/12/0719**

**Report Number: 2006/121
Project Record Number: 40442**

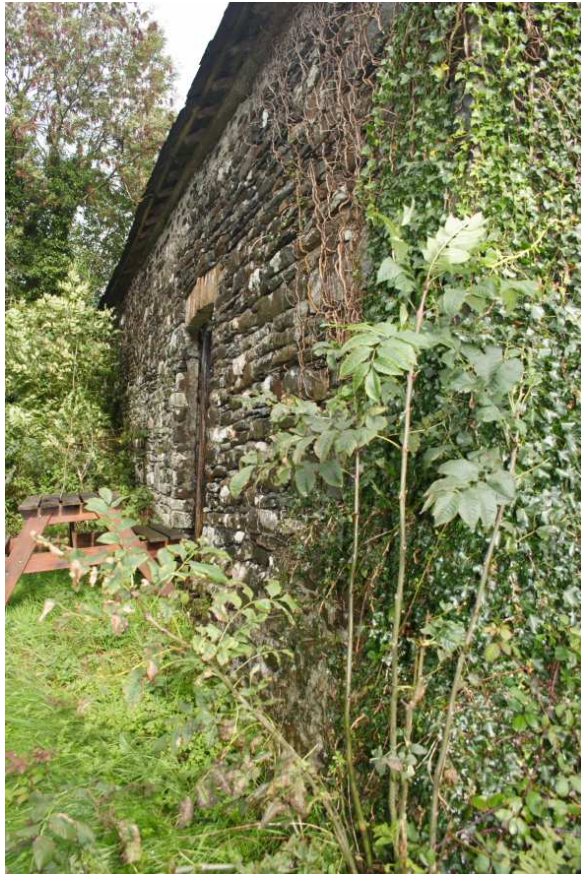
- Ivy covers much of the south gable wall of the barn. Vegetation root growth can potentially threaten stability by expanding masonry joints. Monitor ivy growth. Consider cutting ivy off at ground level, allowing it to die followed by removal then repointing and masonry consolidation.

Ivy covers much of the southern end of the building.

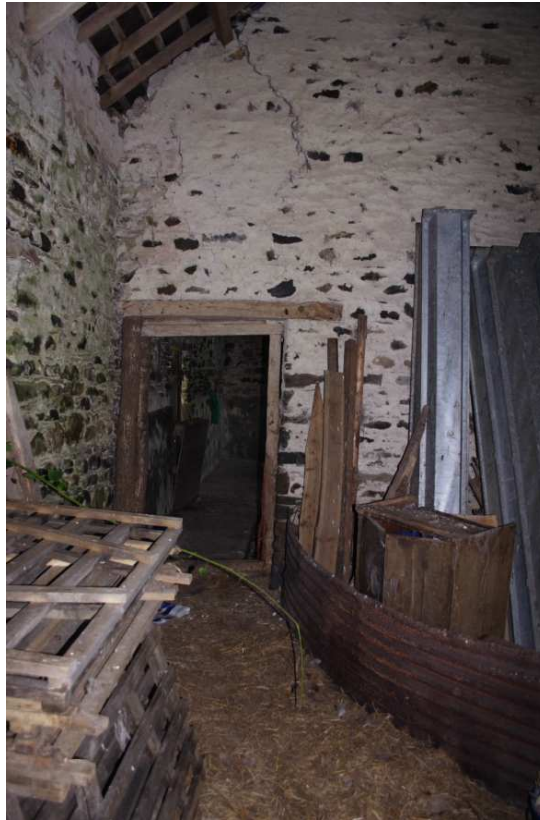
2. Structural concerns. Structural concerns were highlighted above the internal doorway between the former threshing floors where the lintel is rotted through and there are movement cracks in the wall above. Stout wooden posts now provide additional support.
- Any replacement materials used should be on a like for like basis.
 - If in doubt about structural integrity seek specialist advice (eg. from a suitably qualified builder or a structural engineer).

Facing north towards the internal doorway.

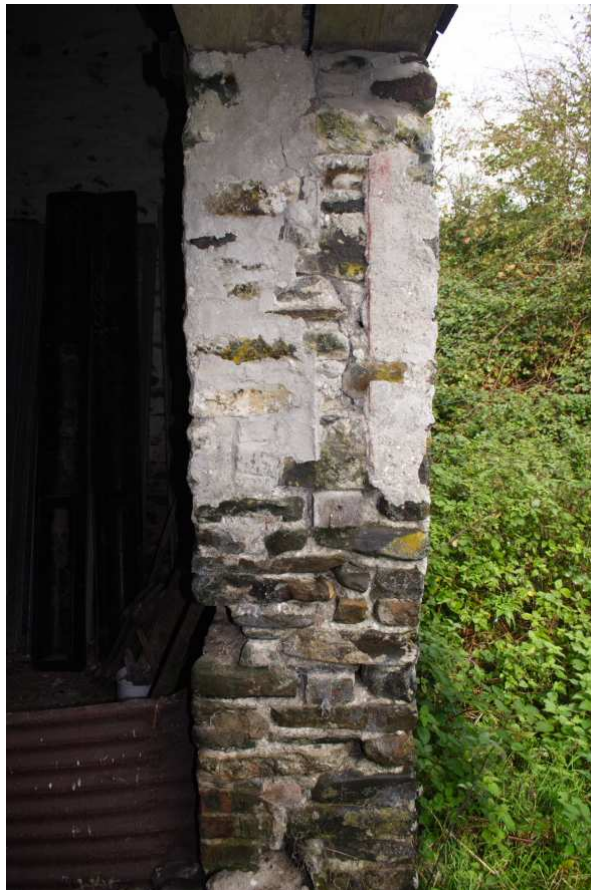
- If in doubt seek specialist structural advice (eg. from a suitably qualified builder or structural engineer).
4. Door replacement. Threshing barns typically had large doors to enable carts to enter. None of the large doors or their frames survive at Llystyn although an imprint from one of the frames is embedded in the mortar in the south east threshing doorway. Standard sized doors opposite remain but are decaying or damaged.

An imprint of the threshing door frame remains embedded in mortar.

- Replacing the doors is not considered essential but if done sympathetically it would be a welcome enhancement to the barn.
 - Where possible replacement features should be modelled on the originals using the same materials and methods of construction. Where possible old door furniture such as hinges and latches should be retained.

- As the appearance of the original threshing doors is not known it may be necessary to seek replacements based on comparison with other threshing barn doors. Photographs of some examples are included.

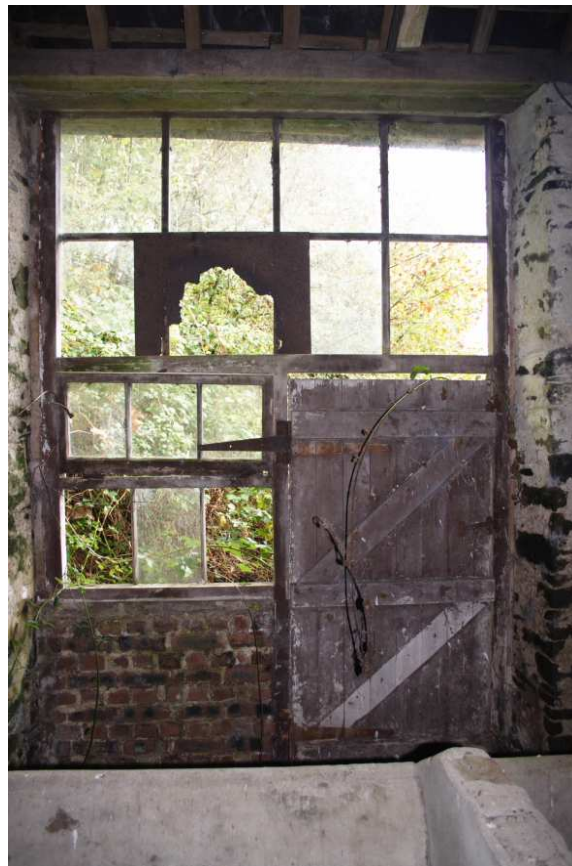
a. removing mid-20th century concrete cattle stalls, feed passage and mainly glazed opening within the northern threshing floor to reinstate a level, more usable surface with good access.

The glazed frame in the north east threshing doorway with contemporary cattle stalling in the foreground.

- As a general rule characteristics and features which reflect the history and function of traditional buildings must not be removed during the lifetime of the Tir Gofal agreement.
- The scheme also promotes the sympathetic use of traditional buildings within sustainable farming practice.
- The concrete cattle stalls, feed passage and mainly glazed opening to the former east threshing door are all contemporary, inserted during the mid-20th century. They are non-traditional features and as such are of lesser historical significance.
- Standard conservation guidelines recommend that a record is made in the event that historic features are to be removed. The sketch plan, field notes and digital photographs taken during the visit are considered adequate if these features are to be removed.
