NANTYFEN FARM

TIR GOFAL

SITE VISIT

Report No. 2001/19
Project Record No. 40446
TG Reference No. W/12/1382

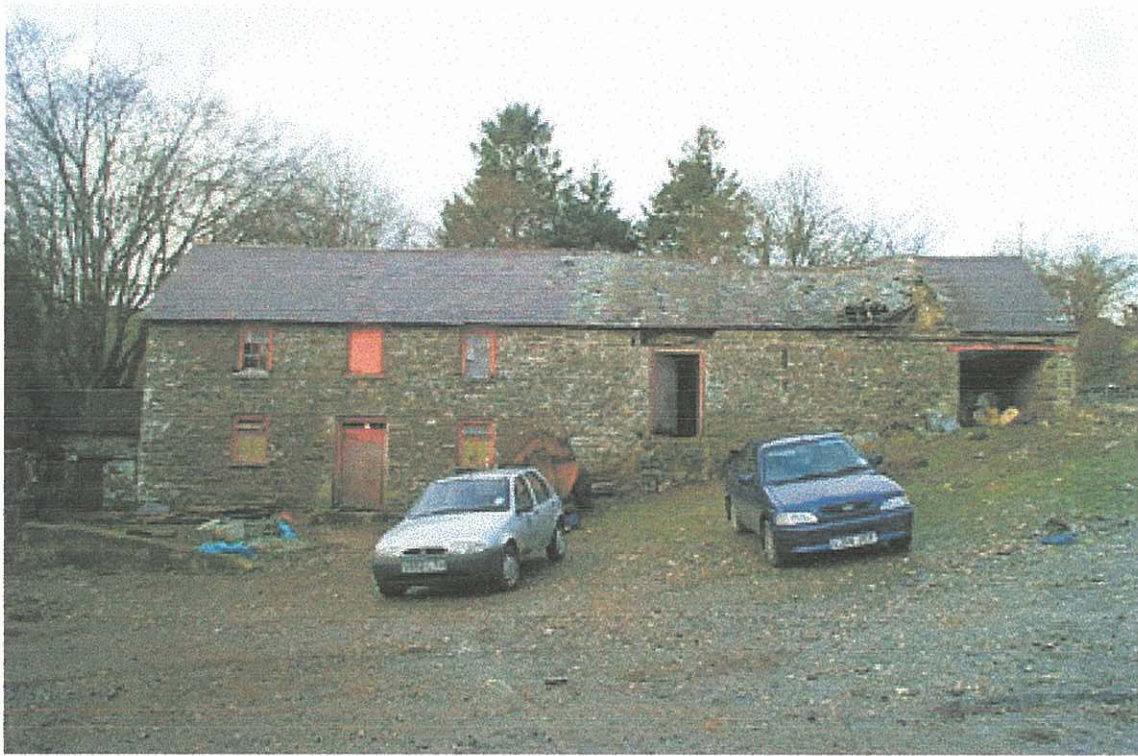
The farm now consists of detached farm buildings on three sides of a central farmyard, with a pigsty, stable, threshing barn and cart shed to the north (plate 1), a farmhouse and cottage to the east (plate 9) and a cow house to the south (plate 10). Most of the buildings are in good working condition and have been sensitively managed.

Plate 1 - the northern range of farm buildings at Nantufen Farm including the pigsty, stable, threshing barn and cart shed.

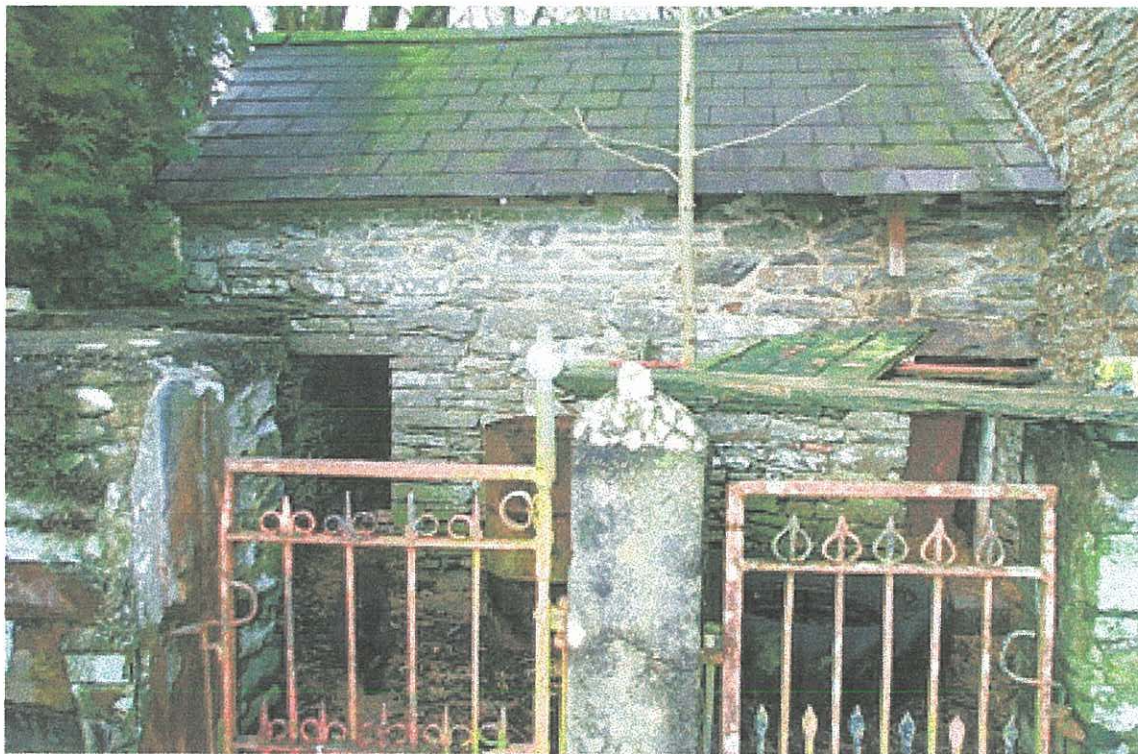
Pigsty - Single storey rubble and lime mortar pigsty with a gabled slate roof at the western end of the building that makes up the northern side of the farmyard at Nantfen Farm (plate 2). It is not recorded on any historic maps and is probably of twentieth century date. It consists of two small covered pens to the north and open runs to the south. The wall that defines them to the south has been capped with concrete. The openings are headed with slate lintels. The openings to the pens and the wall that divides them are defined by large slate slabs. The pens are accessed via wrought iron gates.

Plate 2 - the pigsty from the south.

The pigsty is in very good condition and is now used as a kennel. The walls have recently been pointed and the roof is in good condition. It should be maintained in its current state. Any alterations and repairs should be made using appropriate traditional materials in a way that is sympathetic to the character of the original building.

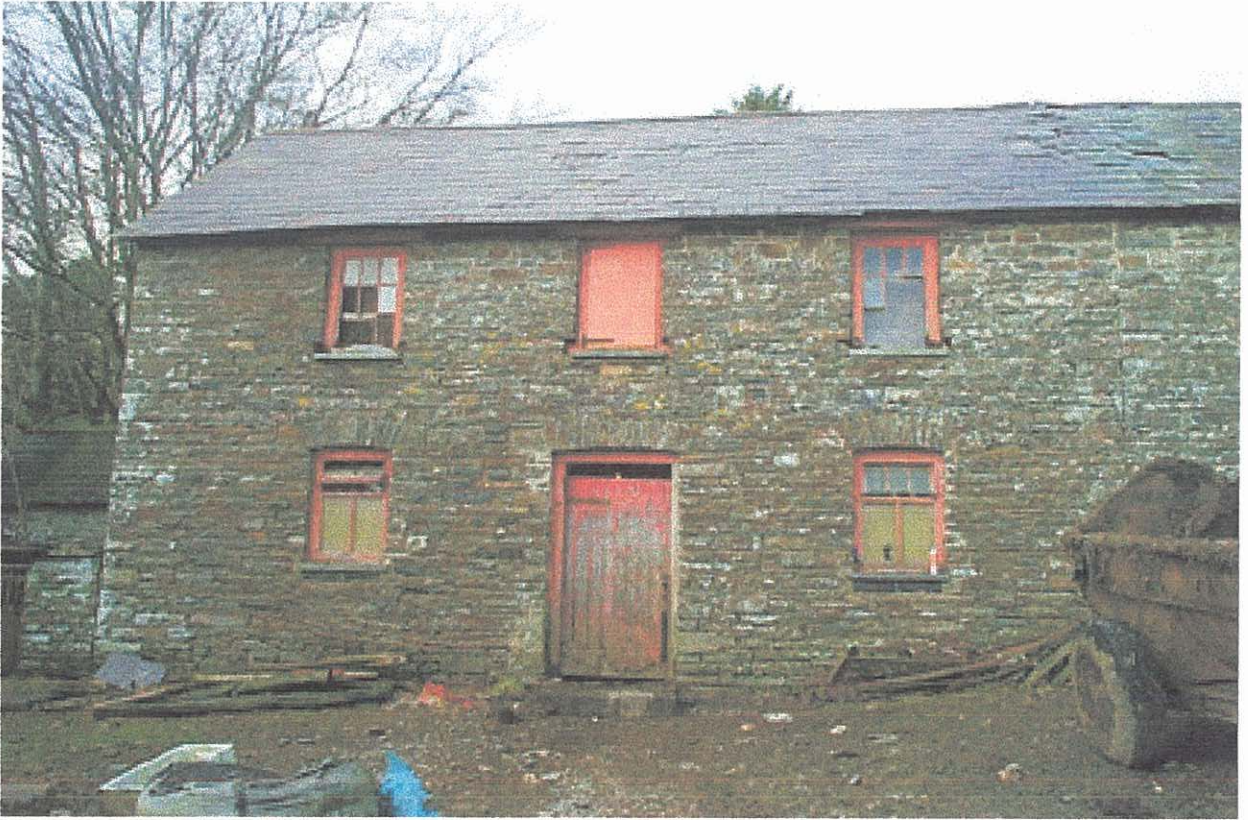
Stable - Two-storey rubble and lime mortar stable with dressed stone quoins and a gabled slate and tin roof to the western side of the range of buildings that make up the northern side of the farmyard at Nantfen Farm (plates 3, 4 and 5). It was first recorded on the 2nd edition OS map of 1906 and is probably of late nineteenth century date. The openings are headed with stone voussoirs at ground floor level, are directly under the eaves at first floor level and all have slate sills. The fittings for these survive in poor condition. It is fenestrated to the south by four symmetrically positioned windows with fairly elaborate fittings, placed to either side of the doorways at ground and first floor levels. This gives the building the appearance of a domestic dwelling (plate 3).

Plate 3 - the stable from the south showing the original wooden fittings to be replaced.

The building is in good working condition. Some of the roof-slates are missing and the northern side of the roof has been replaced with tin (plate 4). The owner would like to reroof this section with slate and replace the windows and doors as part of her Tir Gofal Agreement. This work and any further repairs and alterations should be carried out using appropriate traditional materials. The original internal fittings should be retained and the current use of railway sleepers should be continued to protect the floor and help with its management.

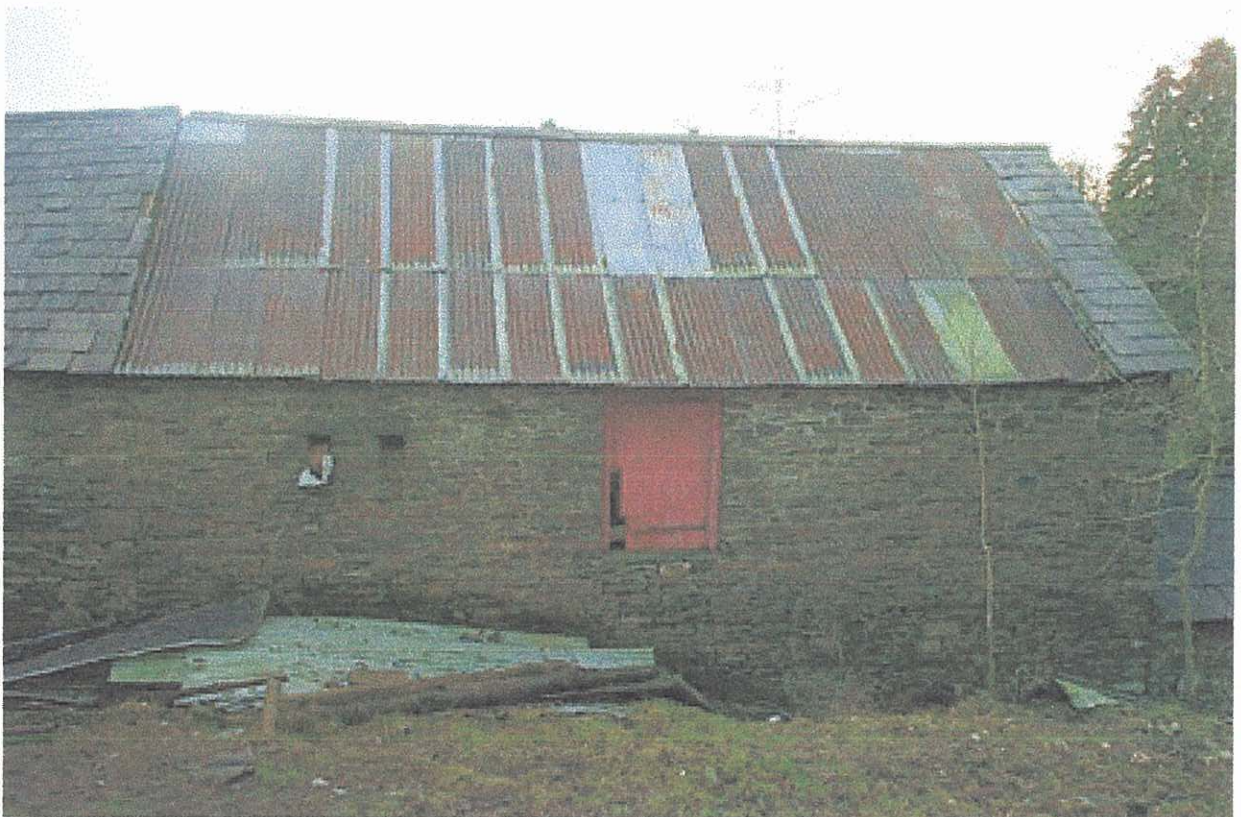
Plate 4 - the stable from the north showing the roof due for replacement.

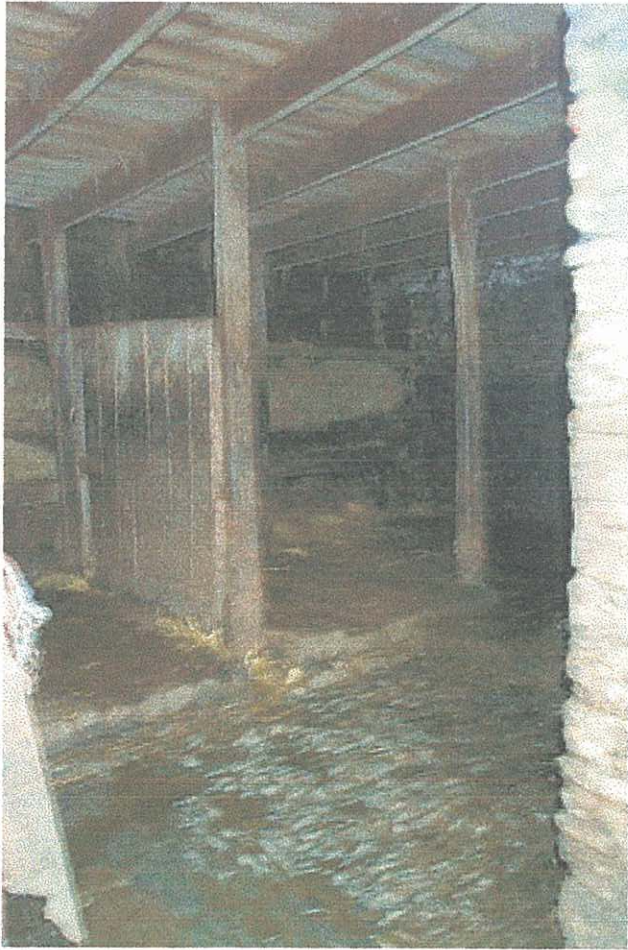
It is accessed at ground floor level by a single-width, centrally positioned doorway in the southern wall. The interior at ground floor level is in excellent condition and many of the original fittings have been retained, including the pitched stone floor, horse stalls, hooks for tack and the stone supports for a trough which ran along the northern wall (plate 5). The building is still used for farm purposes and the owners have modified it sensitively in order to retain these original features. Railway sleepers have been laid over the pitched stone floor. These have both protected the original floor and make it easier to manage. The stone stands for the trough are used to support a more recent wooden hay stall.

Plate 5 - the barn interior showing the original pitched stone floor and stalls.

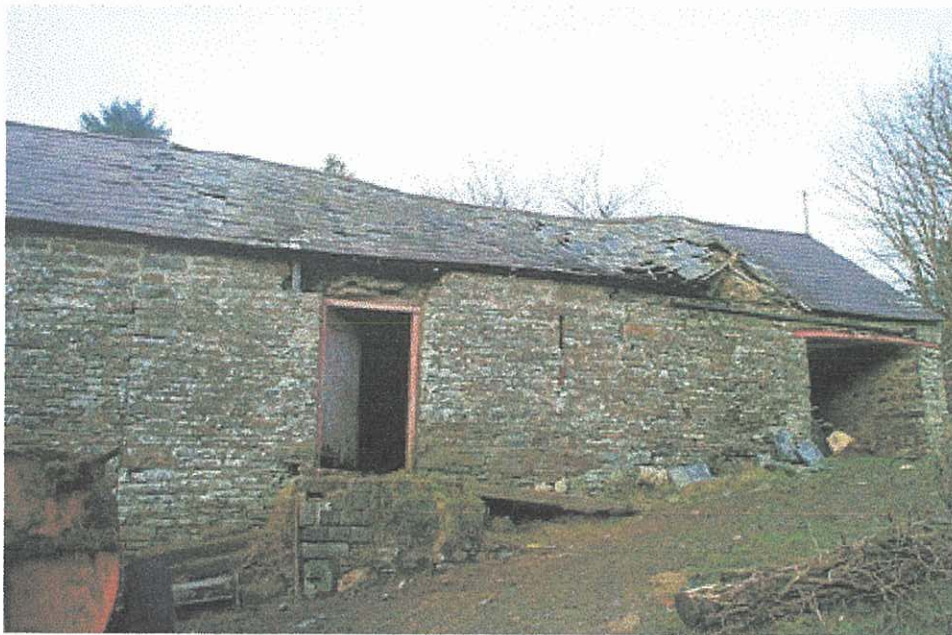
Threshing barn - The threshing barn forms the western end of the building at the eastern end of the northern range of farm buildings at Nantfen Farm (plates 6 and 7). It is ventilated by a single, centrally positioned loop in the southern wall and accessed via opposing single-width doorways at the western end of the northern and southern walls. The door to the north is headed with stone voussoirs, that to the south is square headed with a timber lintel. The door to the south is raised above ground level and approached via a rubble-built stairway which has partly collapsed. The doorway is now accessed by a ramp constructed of wooden railway sleepers and the stairway has been repaired with breeze blocks. The interior is open to roof height. It was formerly whitewashed and now has a concrete floor. Some of the original internal fittings survive, including two disfunctional threshing machines. The roof and southern wall are in very poor condition.

Cart shed - The cart shed forms the eastern end of the building at the eastern end of the northern range of farm buildings at Nantfen Farm (plates 6 and 7). It is accessed at ground floor level by opposing double-width arched entrances, headed with curved timber lintels to the north and south. The loft level was accessed by a half-height single-width loft door in the eastern gable wall. The interior is filled with rubbish and the loft floor has collapsed. The roof and walls are in reasonable condition in this part of the building.

Plate 6 - the threshing barn and cart shed from the south showing the wall to be rebuilt and the roof to be replaced.

The building is now in poor condition. The roof has partly collapsed, the roofing timbers are rotten and many of the slates are missing. The southern wall is structurally unstable and the remaining walls need consolidating. The owners would like to reconstruct the southern wall of the barn and cart shed, reroof it and replace the doors and windows as part of their Tir Gofal Agreement. This would considerably improve the appearance of the farmyard and would promote the survival and maintenance of the oldest building on the farm. The engine house should be retained and restored as part of this renovation work and the stone stairway to the south should be rebuilt with rubble. The owner would like to erect some form of barrier at the top of this stairway to make it less hazardous for animals. This would improve the practicality of the building for working purposes. Advice should be sought from an architectural conservationist for the restoration of the building (see list enclosed). The work should be carried out using appropriate traditional materials and in a way that is sympathetic to the design of the original building. The original internal fittings should be retained.

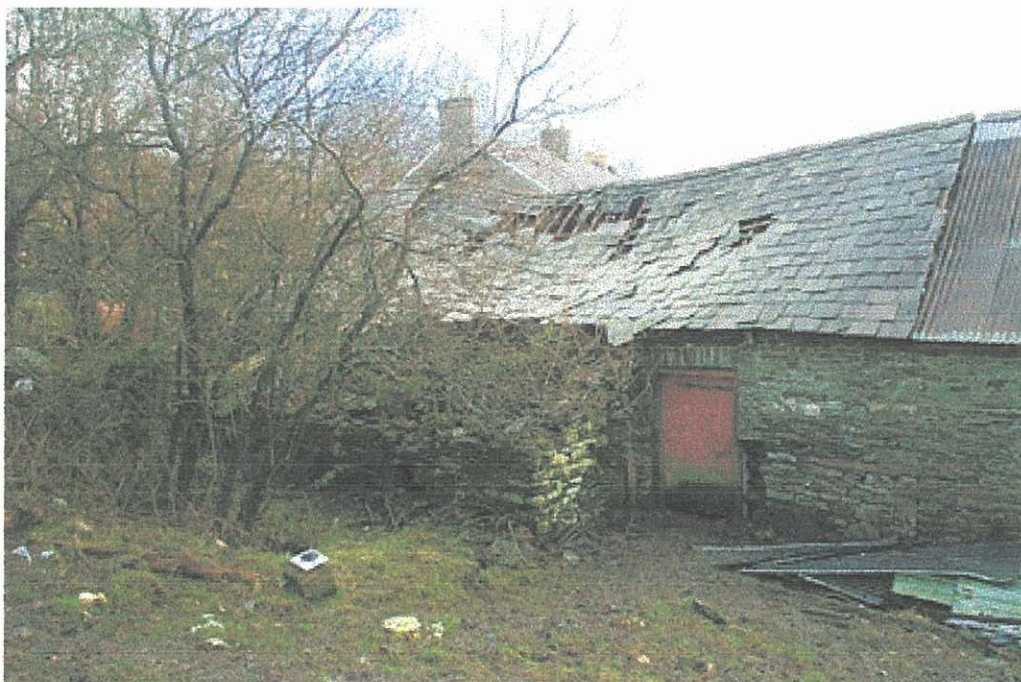
Engine house - Narrow, 1/2 storey rubble and lime mortar extension to the north of the building at the eastern end of the northern range of farm buildings at Nantfen Farm.(plate 7). It appears to have been a later addition to this building although its date of construction is hard to determine. It is accessed by a low, single-width doorway in the western gable wall and through a double-width, arched opening from the cart shed. The openings through to the waterwheel survive in the northern wall. The walls stand to roof height but are unstable, particularly at the western end around the door. The roof has collapsed and the roof timbers and slates are missing. No internal fittings survive and the interior has been used for dumping rubbish.

Plate 7 - the threshing barn and engine house from the north.

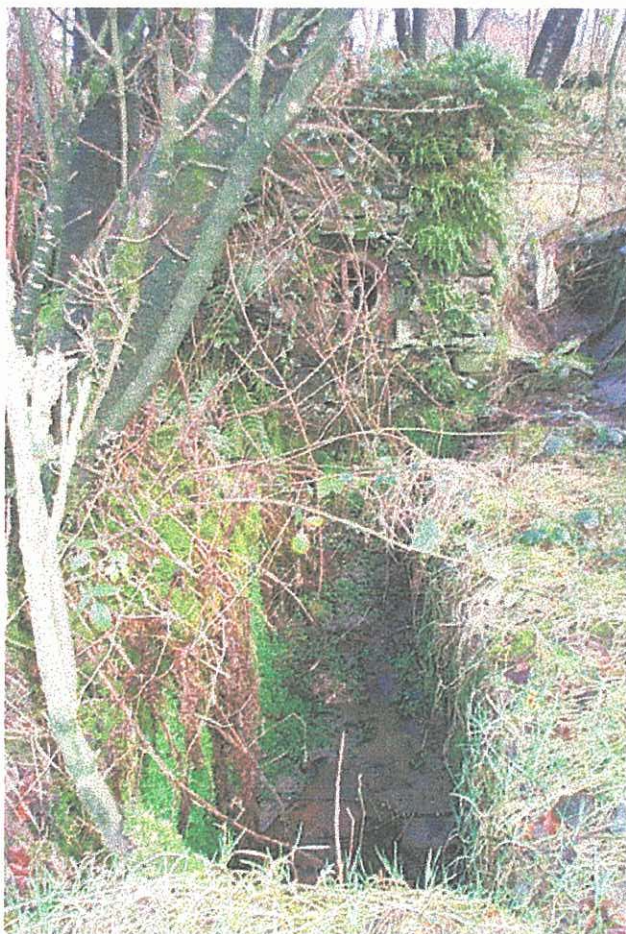
Waterwheel - A wheelpit (c.3m by 1m by 1.5m deep) and iron inlet pipe for a waterwheel lie to the north of the engine house at Nantufen Farm. The wheelpit is slightly overgrown with young trees and ferns and has been partly infilled with rubbish (plate 8). The millpond and head race that once fed the waterwheel have been infilled.

Plate 8 - the overgrown wheelpit to the north of the threshing barn.

The wheel pit should be cleared of rubbish and intrusive vegetation. The rubble walls that surround it should be consolidated and maintained.

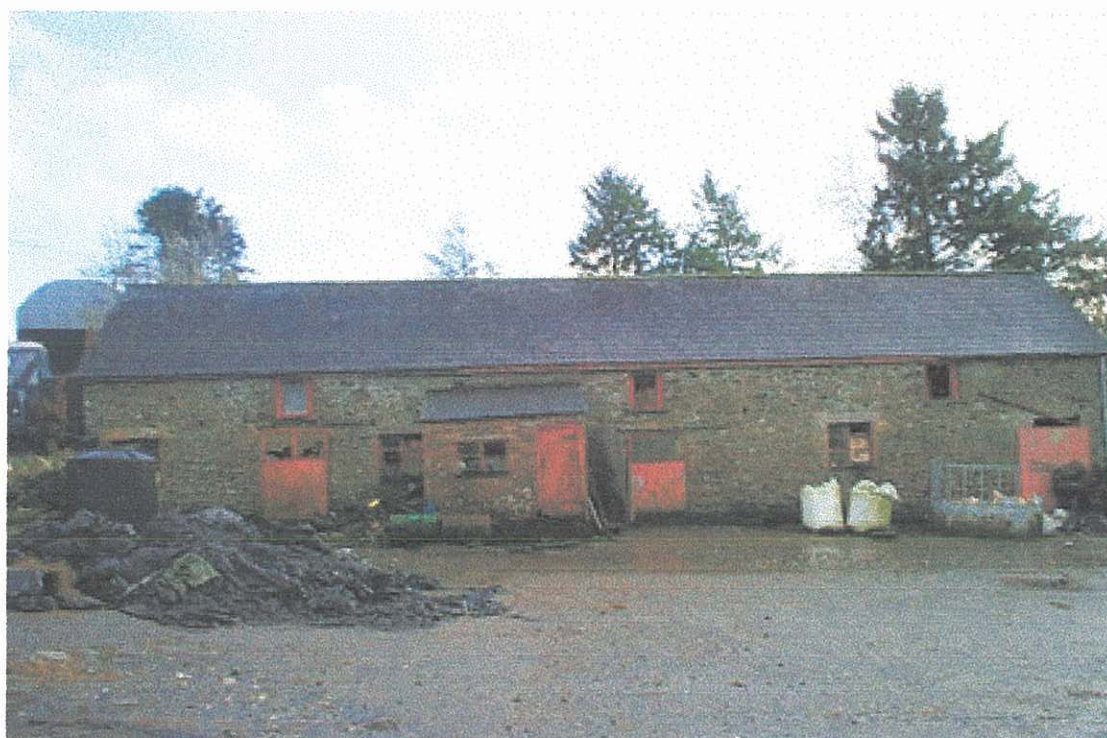
Cow house - Double-breasted rubble and lime mortar cow house with a gabled slate roof and dressed stone quoins, forming the southern side of the farmyard at Nantufen Farm (orientation east-west), (plate 10). It consists of a two-storey cow house to the north and a later(?) single storey structure to the south. A building is first recorded in this position on the tithe survey of 1840. It is accessed at ground floor level by four single-width doorways in the north-facing wall, a single doorway in the southern wall and a single-width doorway in the southern part of the western gable wall. First floor level is accessed by two half-height loft doors in the eastern gable wall. A modern brick dairy has been constructed midway along the northern wall. The openings at ground floor level vary. Most have been modified but all have original slate sills. The original fittings for these have been replaced and are in poor condition. The openings at first floor level are directly under the eaves. The original fittings for these do survive but are in poor condition. The interior has been modified to accommodate modern farming practices. The walls have been concreted to head height, the floor has also been concreted and the original wooden stalls have been replaced with steel. The loft floor survives in good condition. The roof is also in good condition.

Plate 10 - the cow house to the south of the farmyard at Nantufen Farm.

The cow house is in good working condition and should be maintained in its current state. Any alterations and repairs should be carried out using appropriate traditional materials in a way that is sympathetic to the character of the original building. The owner would like to replace the windows and doors with traditional wooden fittings as part of her Tir Gofal Agreement. This would considerably improve the appearance and condition of the building.
