## TRECADWGAN FARM

TIR GOFAL

SITE VISIT

Report No. 2001/20  
Project Record No. 40456  
TG Reference No. W/12/0590

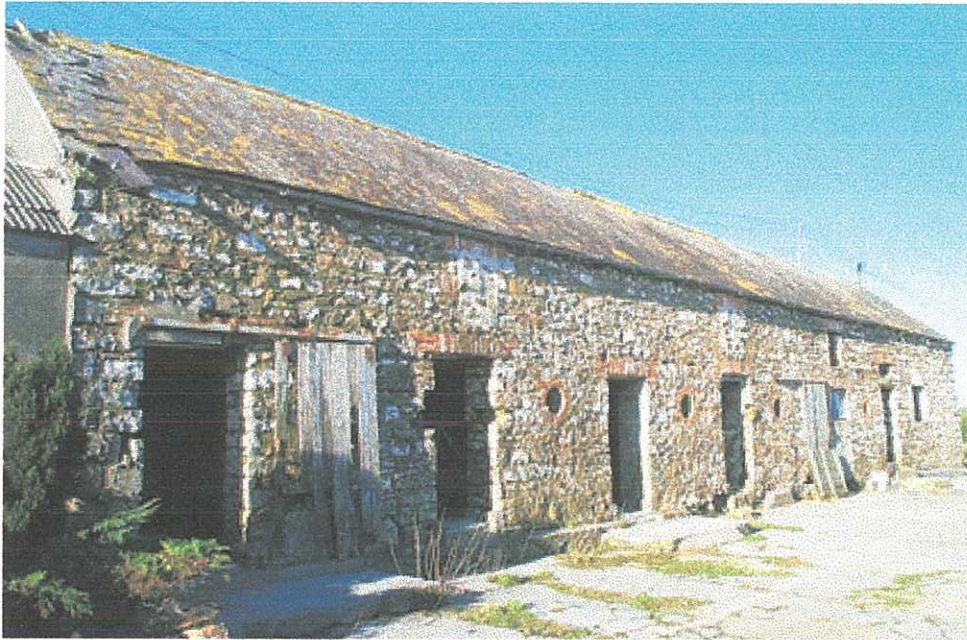
Two-storey, rubble and lime mortar farm building with dressed stone quoins and a gabled slate roof, forming the northwestern side of the farmyard at Trecadwgan Farm (orientation northeast-southwest). The exterior was formerly whitewashed. It includes a stable block to the southwest and a cart shed to the northeast. A building was first recorded in this position on the tithe survey of 1841. The entire building was converted into a milking parlour during the twentieth century.

Plate 1 - farm building to the northwest of the farmyard including a stable block and cart shed.

The owner would like to restore the exterior of this building as part of his Tir Gofal Agreement. The building was obviously designed with some care and deserves to be protected. The walls are in reasonable condition although the stonework requires repointing and is loose around some of the modified openings. Any loose stonework should be consolidated. The roof is also in reasonable condition but some of the slates are loose or missing (particularly at the southeastern end) and these should be replaced. If possible the render should be removed from the northwestern facing wall. The original openings should be retained and ideally restored in a way that is sympathetic to the character of the original building. The fittings for the openings should be replaced using traditional materials.

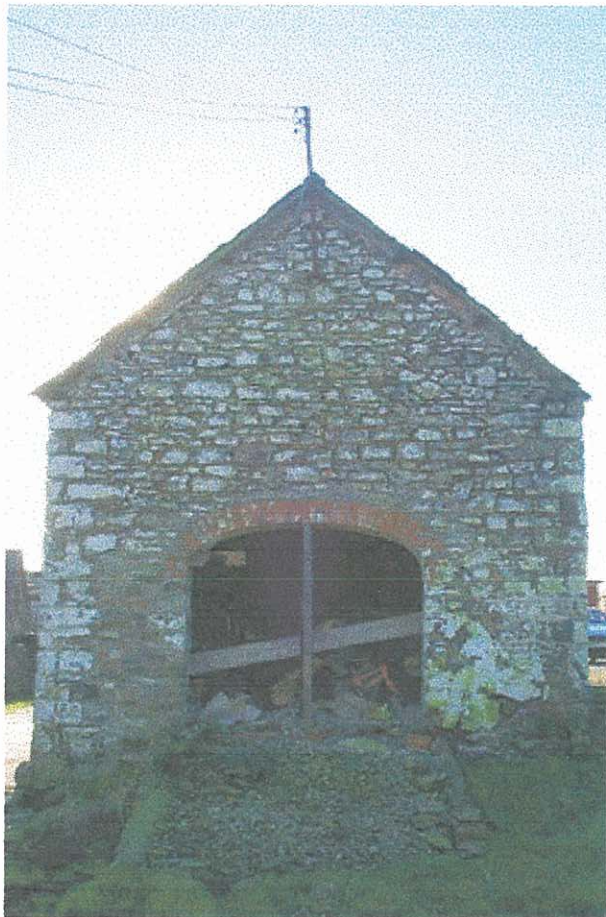
Plate 2 - the cart entrance at the northeastern end of the stable block.

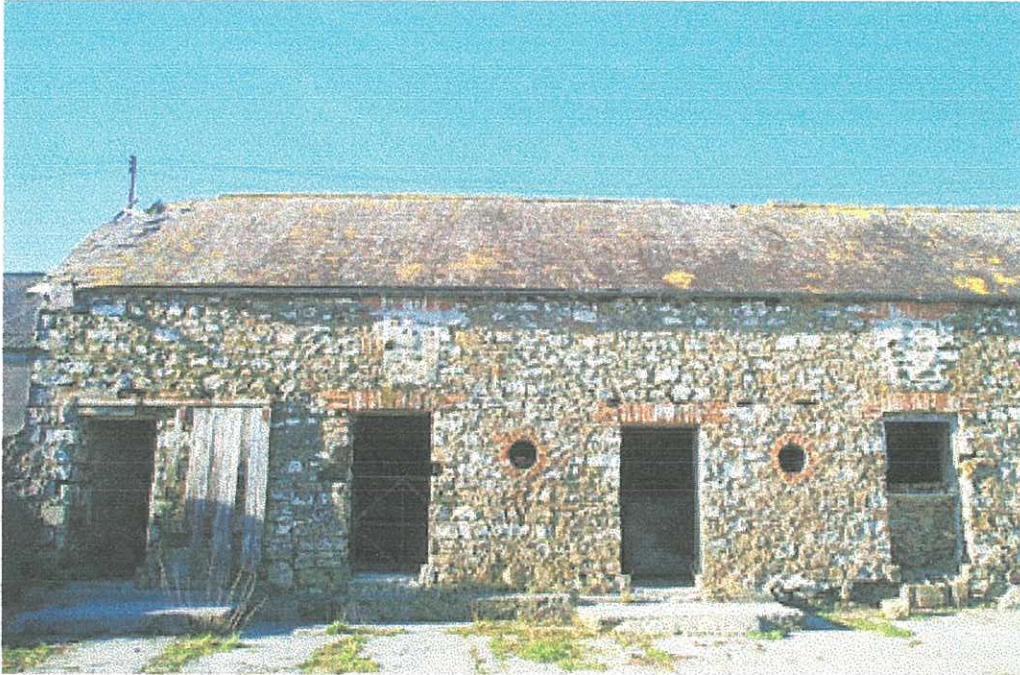
Plate 3 - symmetrically arranged doorways to the stable block.

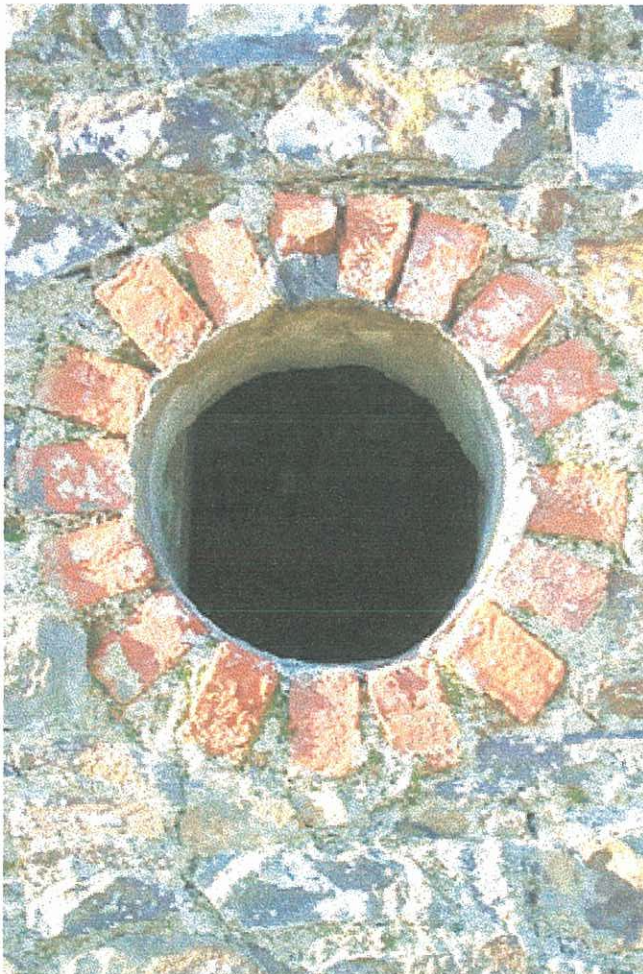
Plate 4 - ventilation oculus with brick surround on the stable block.

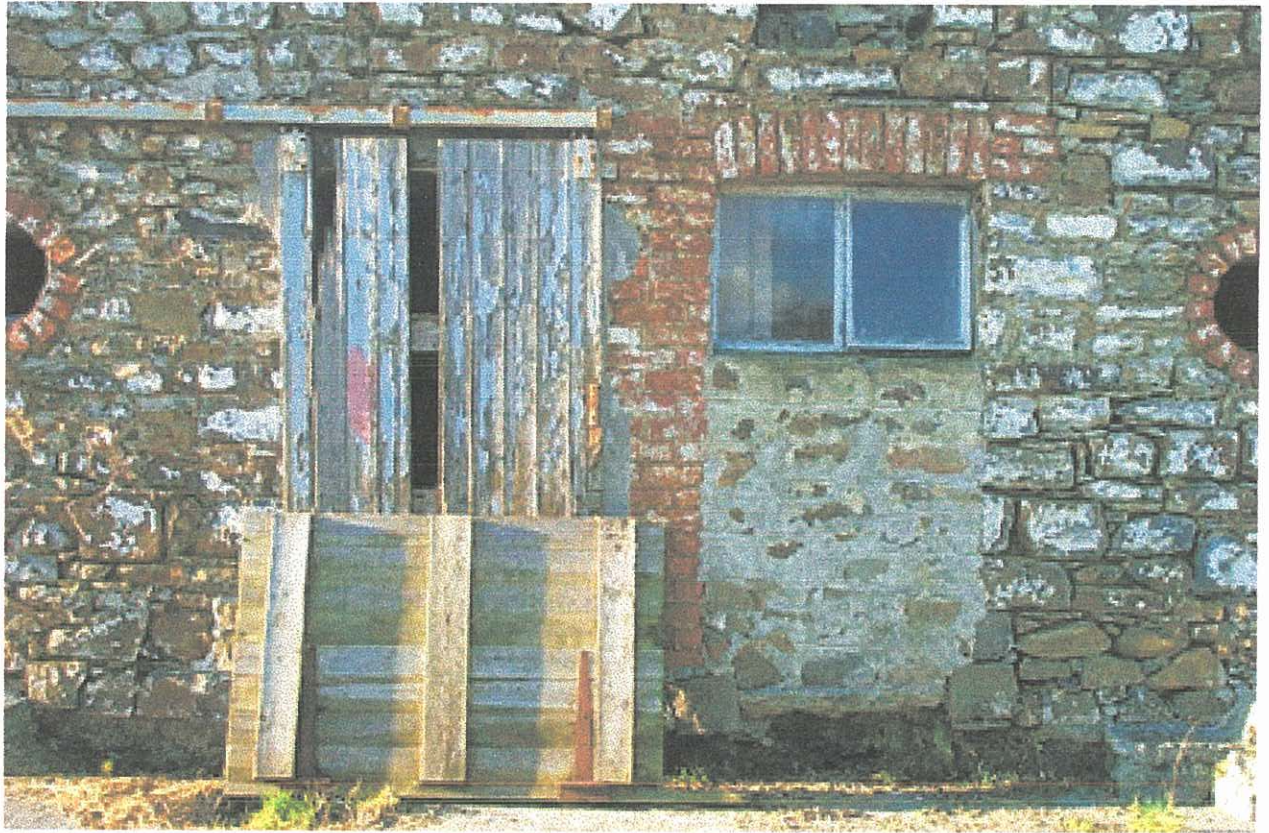
ornate, oculi with brick surrounds (plate 4). The first floor was fenestrated by four openings in the southeast facing wall and at least two openings in the northwest facing wall. The northwest facing wall has been rendered in places and the location of the original openings is hard to determine. There is no evidence of the original access at first floor level suggesting that the loft level was reached via an internal stairway. All of the openings at first floor level have been blocked in. Several of those at ground floor level have also been blocked in or modified and the fittings in all of the remainder are either missing or modern (plate 5).

Plate 5 - modified entrances to the stable block.

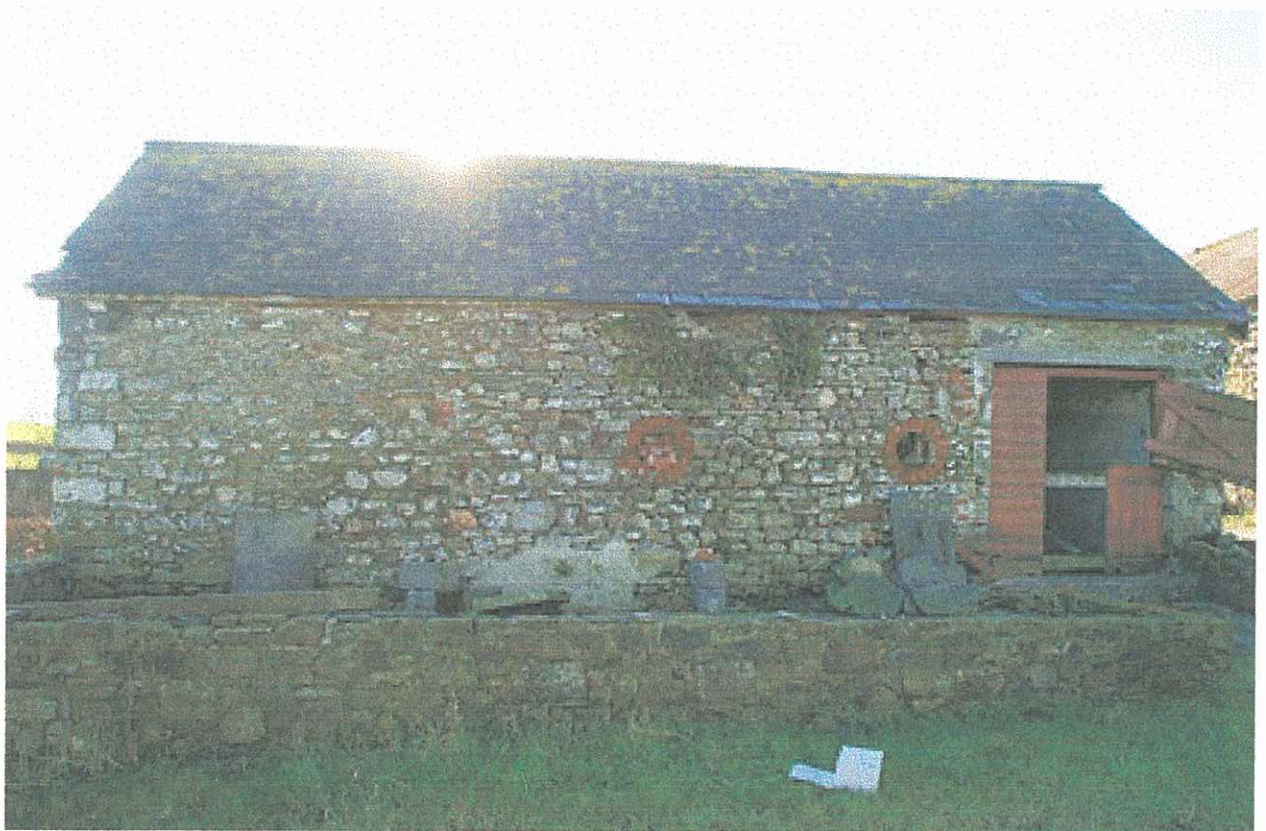
Single-storey rubble and lime mortar farm building with dressed stone quoins and a gabled slate roof forming the northeastern side of the farmyard at Trecadwgan (orientation northwest-southeast). The exterior was formerly whitewashed. It includes a stable to the northwest and an animal pen to the southeast. The building is less elaborate than the stable block and cart shed to the northwest of the farmyard and appears to have been an earlier construction (see below for an explanation). A building was first recorded here on the tithe survey of 1841.

Plate 6 - farm building including the animal shed and stable.

The building is in reasonable condition and the owner would like to restore it as part of his Tir Gofal Agreement. The walls are generally well maintained although they are overgrown in places and some of the stonework along the northeastern wall is loose. Any loose stonework should be consolidated and the vegetation should be removed. The roof is generally in reasonable repair. The timbers are in good condition but some of the slates are loose and need replacing. Ideally, the fittings should be replaced using traditional materials. A breeze-block structure has been constructed along the southwestern wall and detracts from the appearance of the building itself and the farmyard as a whole. This is no longer in use and if possible should be demolished.

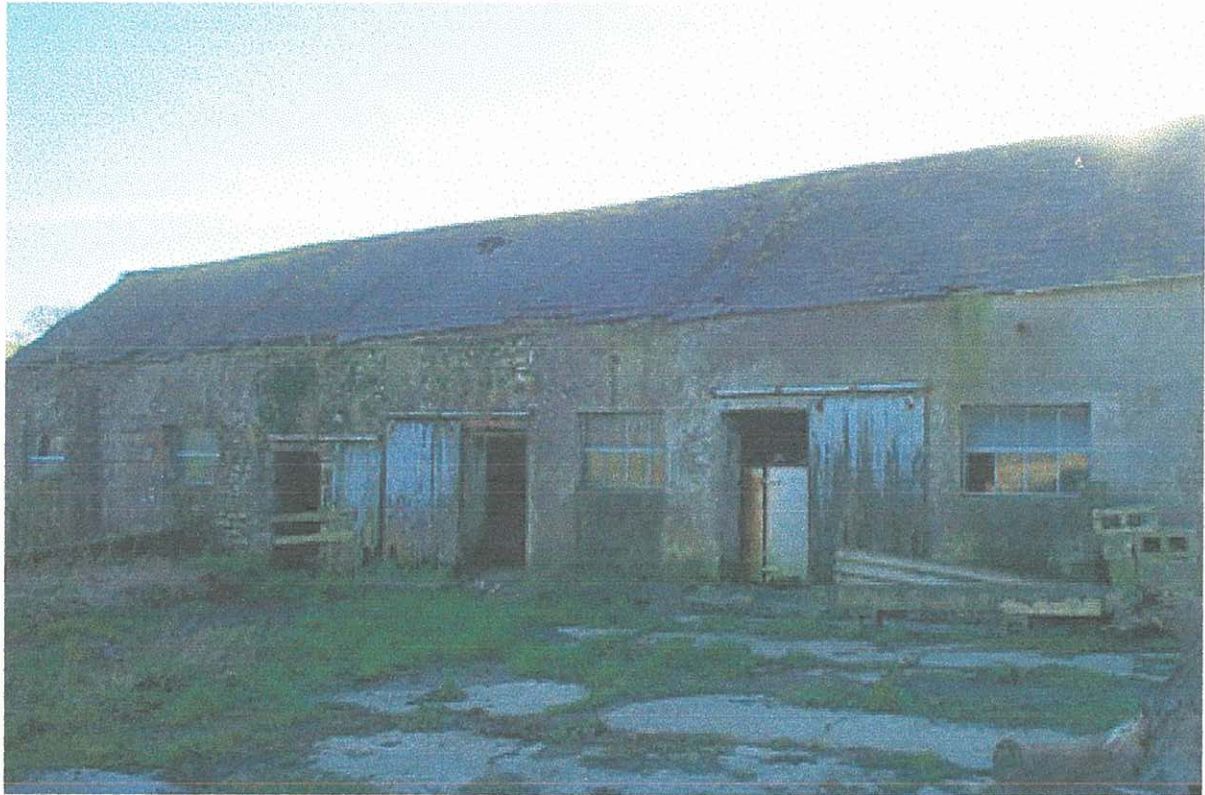
Two storey rubble and lime mortar cow house with dressed stone quoins and a gabled slate roof to the southwest of the farmyard at Tregadwgan (orientation northwest-southeast). The exterior was formerly whitewashed. A building was first recorded in this position on the tithe survey of 1841. The cow house has been extensively modified to accommodate a milking parlour and is now in a poor state of repair.

Plate 7 - the cow house from the northeast, showing the poor roof repair and modified exterior and openings.

The cow house is in poor condition. The walls are overgrown with ivy and young shrubs. They are structurally unstable and have been rebuilt with breeze blocks in places. The roof is also in poor repair. The roof timbers are in reasonable condition but many of the slates are missing. The renovation of this building would require considerable financial investment and the owner would like to demolish it. He has offered to donate the stone from it for historic building purposes. Alternative funding sources to assist with its renovation should be investigated. Further archaeological advice should be sought prior to demolition.

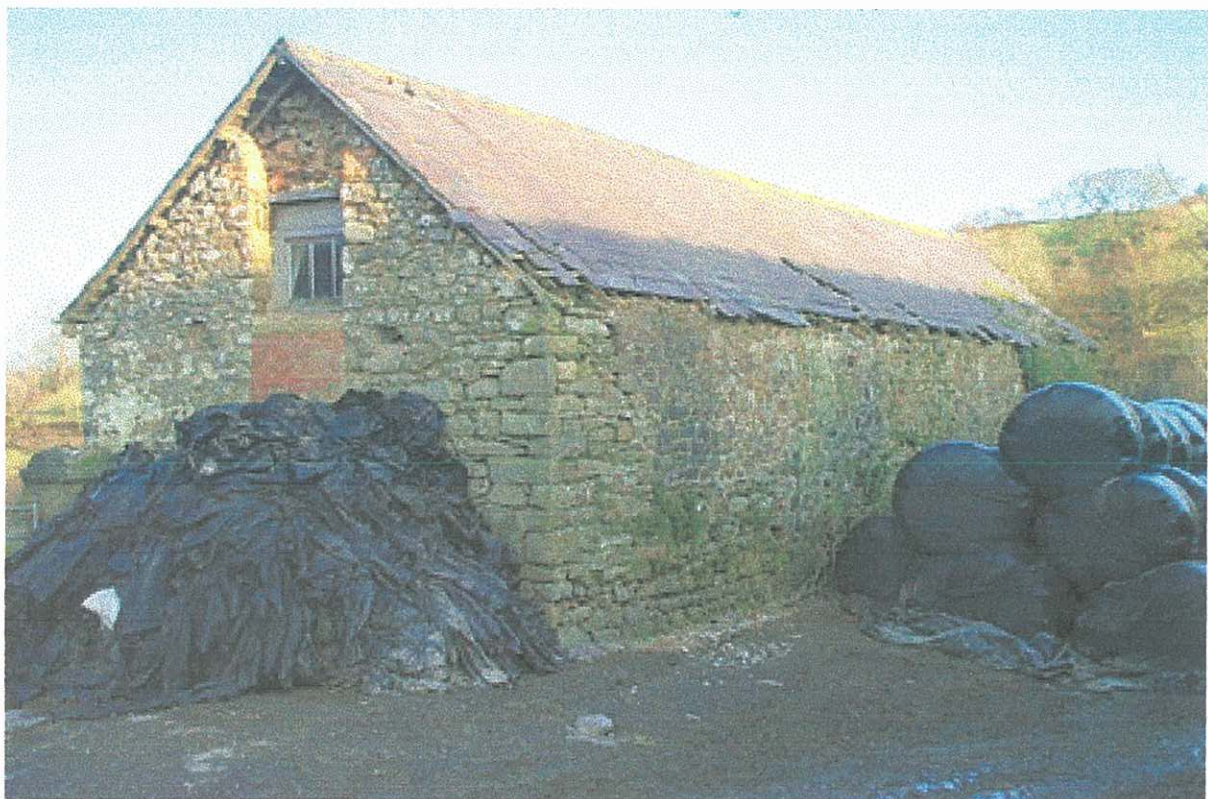
Plate 8 - cowhouse from the southeast showing poor roof repair, overgrown walls and modified openings.
