# Parce W/11/2045

## Tir Gofal Farm Visit Historic Environment Report Call Out

Report No. 2003/96

REPORT NO. 2003/96  
PROJECT RECORD NO. 41413

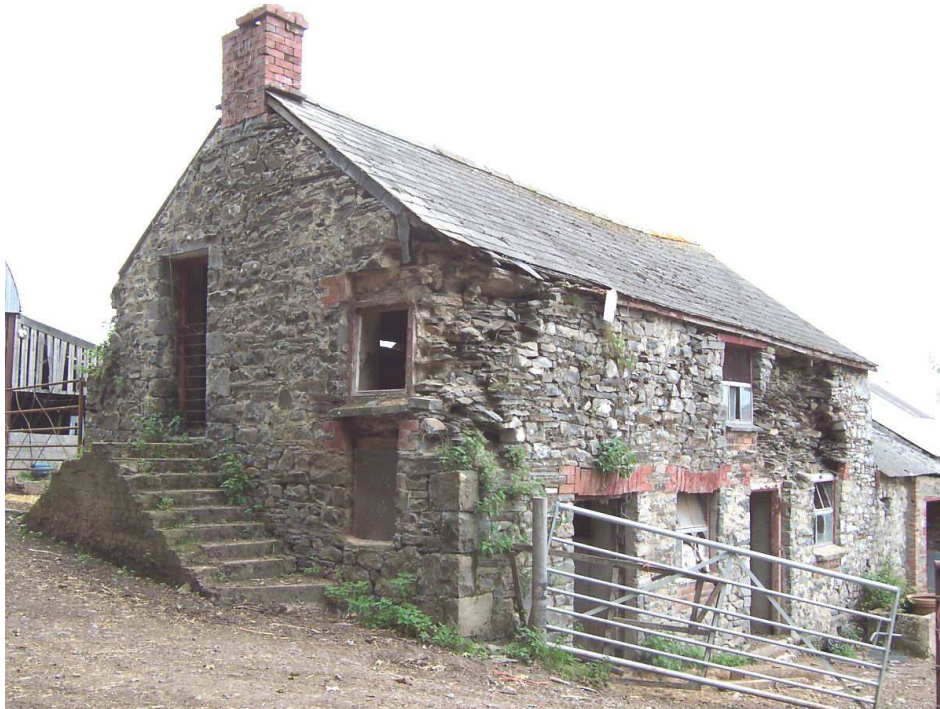
Plate 1 – the south elevation and west gable

The southwest corner of the building has lost its facing stonework and all the quoins, or corner stones, above the ground floor are missing. The red brick arch over the first floor window in the gable end has collapsed. It is unknown what may have caused the loss of stonework here, but it is possible at this location by the side of a gateway, that the quoins may have been dislodged by passing machinery.

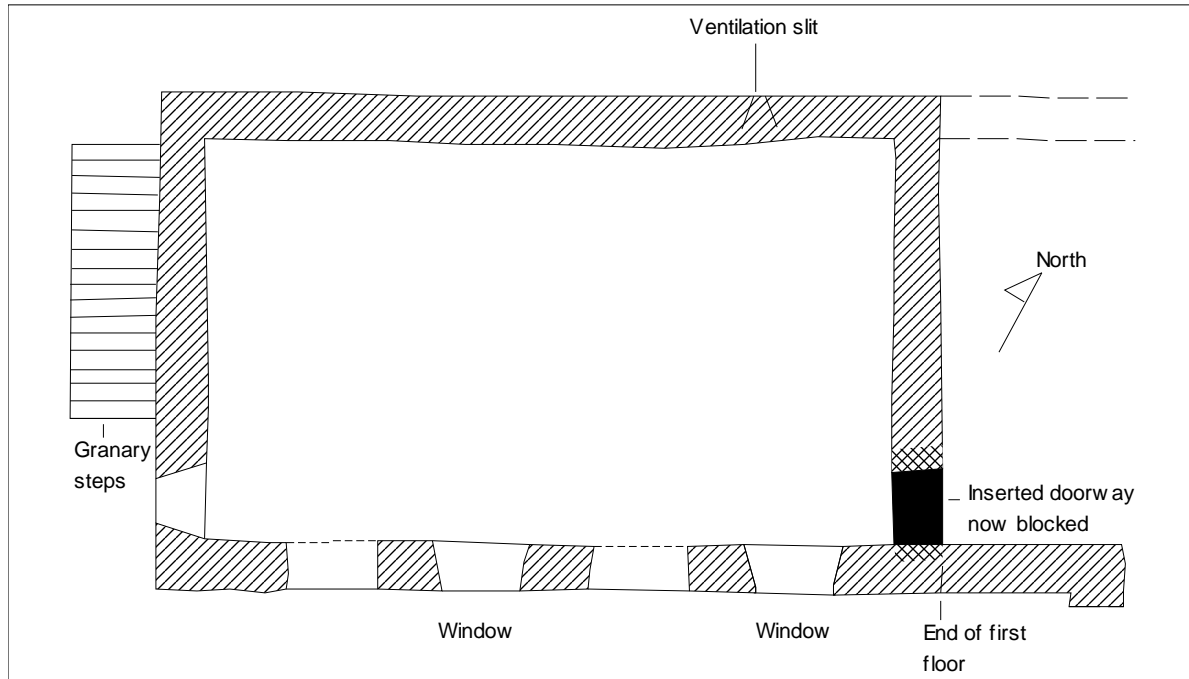
Figure 1 – Ground plan (not to scale)

In plan the building is approximately 9.4 metres long by 5.85 wide. At the west gable end, constructed in brick, are external steps to access the first floor. The front (south) wall extends to the east 2 more metres and has been heavily modified in its incorporation with the adjoining one storey building (figure 1).

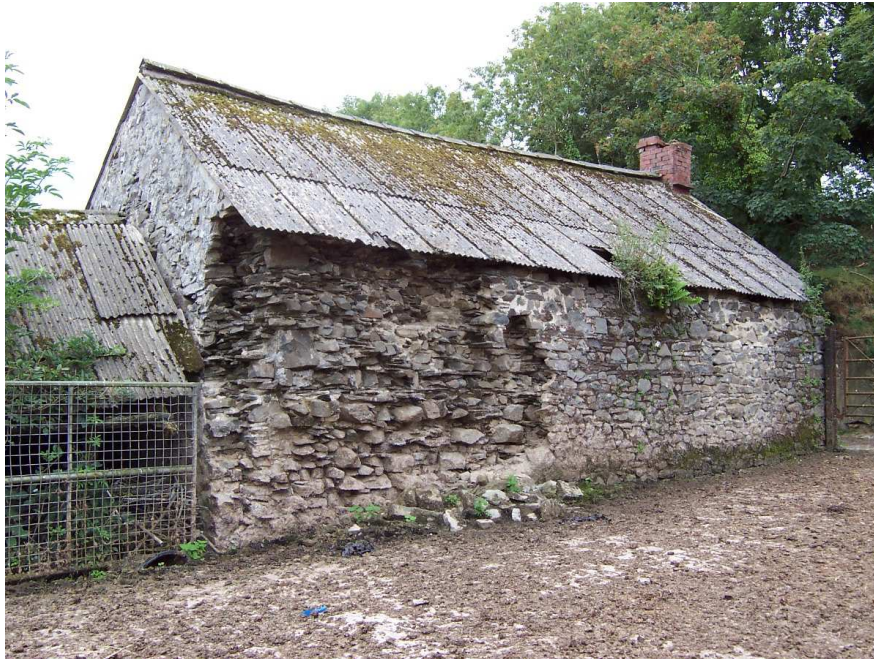
Plate 2 – the north elevation, showing loss of facing stone at the eastern end.

To the rear of the building a further large area of collapsed stonework is visible. The exterior of the northeast corner and the wall from ground level to eaves at the eastern end of the building has lost all facing stonework. It appears that the core has also gone and the internal face is all that survives, and it is possible that this remains only because of the cement render on the interior. It is unclear what may have caused this collapse and it is likely that it was due to a number of failings.

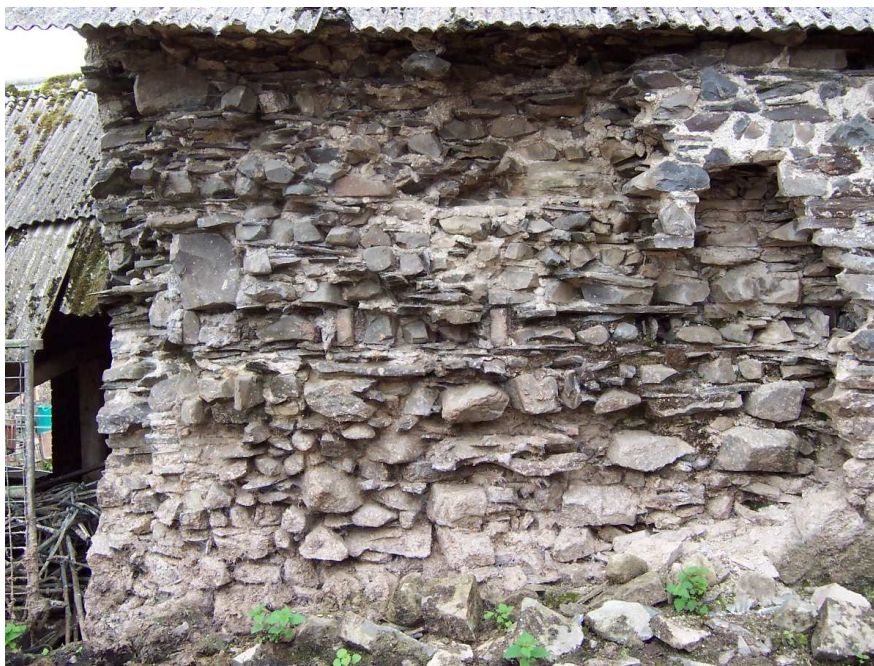
Plate 3 – the exposed wall core on the north elevation, showing blocked ventilation slit (right of centre at base of the wall), also sockets for the first floor joists.

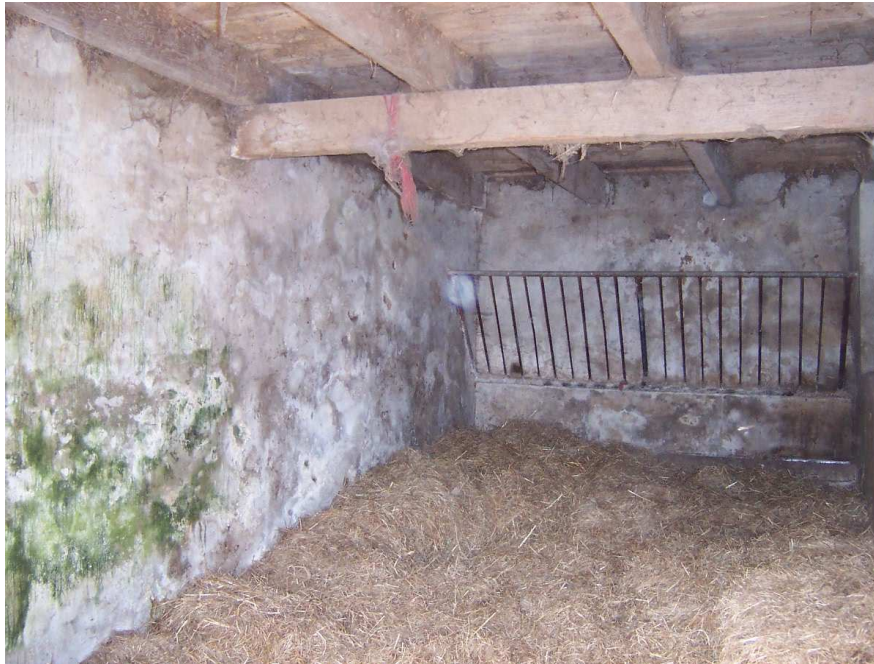
The interior walls are covered over by cement render which obscures any further features and the floor is concreted (Plate 4). The ground floor has modern partitions subdividing the space into pens.

Plate 4 – the interior of the ground floor (west end).

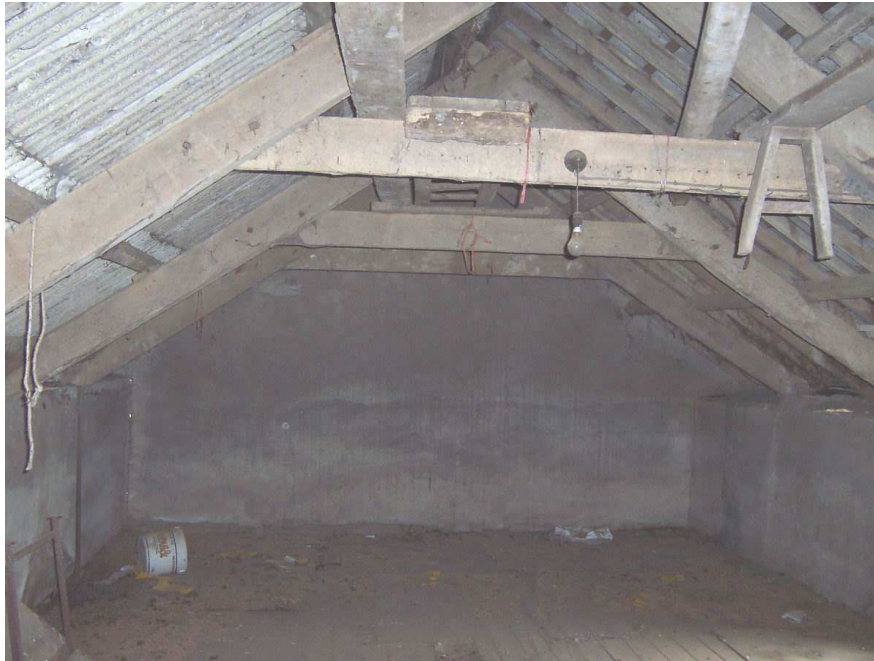
The roof is constructed with four A frame trusses jointed with iron pins and two sets of continuous purlins on either side (Plate 5). The south side of the roof also has rafters and battens to support the asbestos tiles

Plate 5 – the interior of the first floor showing the roof trusses
