# Tir Gofal Farm Visit Report Bryndias W/12/1697

# **REPORT NO. 2002/3** PROJECT RECORD NO. 41482

# **BRYNDIAS** TIR GOFAL FARM VISIT REPORT

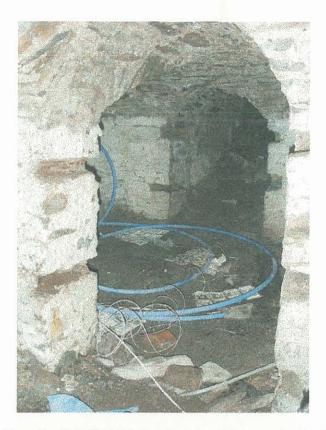
The cellar beneath Bryndias farmhouse is accessed via a stone staircase in the floor to the left of the rear entrance into the house (in the south facing lateral wall). It comprised 2 vaulted rooms, off which an arched tunnel (PRN 43804) apparently ran southwards from the house. The rooms are c.1.5m high, but a build up of debris and floor earth has probably left them slightly lower that they would have originally been. It is assumed that the cellar is mid-19th century in date and dates to the period that the present farmhouse was built.

The cellar (PRN 43803) uncovered beneath Bryndias farmhouse, leads to an arched tunnel running southwards from the house. This tunnel had collapsed within a few metres of the cellar and is blocked. However, groundwork on the farmyard, near the western gable end of the old milking parlour (PRN 43800) and some 20m from the cellar, broke into the top of an underground passage which has been presumed to be a continuation of the same tunnel. No explanation can be offered as to the significance of this feature.

Plate 1: The cellar (PRN43803) below Bryndias farmhouse, looking towards the collapsed tunnel that appears to cross beneath the farmyard.

Maintain in present condition.

Further examination is needed to fully understand these underground features. Care must be take not to break into the passage from above. It is already proposed by the owners to seal and make safe the breach near the house and that near the old milking parlour has been sealed and buried.

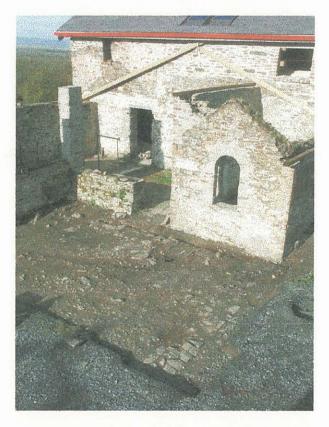
Builders have excavated the foundations of two sides of what appears to be a rectilinear building immediately south of the present Bryndias farmhouse. The alignment and position of these foundations suggest they may mark the site of one of the buildings (the northernmost) shown on the tithe map. The second (southernmost) of the buildings shown on the tithe map may be the present ruined stable building or another lost and unidentified building.

Plate 2: The rear of the Bryndias farmhouse (PRN43795) showing the foundations of what may be a demolished building (PRN43805).

The present owner intends to preserve the visible foundations as features of interest. It is important that the stone foundations and any archaeological layers associated with them are sealed and protected from erosion by human activity or natural erosion.

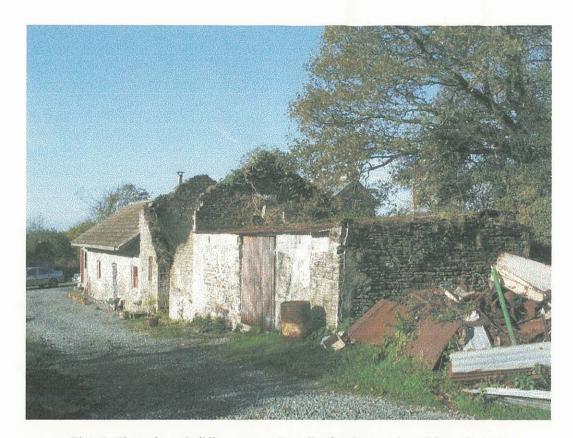
The main outbuilding range at Bryndias comprises of three abutting buildings stand in a linear arrangement on an east-west axis. The easternmost of the three is a stone built shed or byre which is now used as a workshop. This building is not in pristine condition, but remains intact and usable.

The central building of the main outbuilding range at Bryndias is a stone and brick built cottage which is roofless and ruined. The red-brick voussoirs around the door and window spaces suggest that this is a late 19th century building and comparison of the 1891 and 1905 6" OS maps suggests that it was built during this period.

Plate 3: The main outbuilding range at Bryndias farmhouse, viewed from the east. Components from right to left: Outbuilding PRN43796; Cottage PRN43797; Outbuilding PRN43798

Maintain and sympathetically renovate in conjunction with the cottage and former milking parlour which form the rest of this building range. This is the long term intention of the present owner.

The owner has a long term intention to rebuild or replace this building. The degree of ruination is such that reconstruction is not possible, but it would be appropriate to suggest that the blend of local stone and red-brick used in the original facade be replicated if any rebuilding is undertaken.

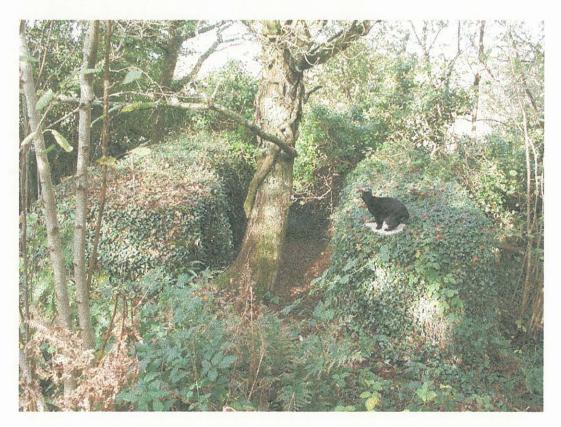
Plate 4: The possible loading stage (PRN43808) associated with the Bryndias colliery site.

This is one of very standing structures associated with the Bryndias coalworkings and must be protected. It is recommended that consideration be given to removing or managing the thick ivy which covers parts of the stonework, although care will have to be taken not to damage the stonework. The structure should be kept free of ivy and other vegetation in future. A tree is also growing between the two walls at the southern end of the structure. This tree should be removed carefully.
