# Tir Gofal Farm Visit Report Penback W/13/1892

Report Number 2001/63

# **REPORT NO. 2001/63** PROJECT RECORD NO. 41585

# PENBACK TIR GOFAL FARM VISIT REPORT

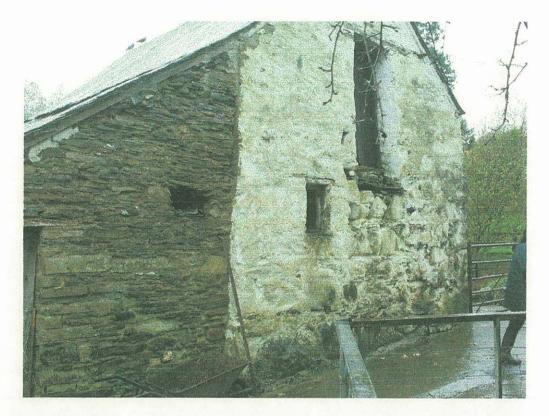
Stable with loft over, constructed from random rubble, including some very large boulders, with a gabled slate roof. There is a later, full-length extension along the east wall. The extension is constructed from rubble and thin shale slabs, built to courses, with a single pitched slate roof. Both roofs are currently cement washed, and the exterior of the original stable is whitewashed. Access to the loft is via a door at loft height in the north gable wall. There are no external steps, suggesting that access was probably gained by removable ladder. The original stable building is probably of 18th century date, and associated with a cartshed (PRN 43770) to the west, with the extension added during the 19th century. The roof structure was not accessible during the site visit, but the roofline suggests that it is suffering severe movement. The cement wash on both roofs has made them temporarily watertight, but long-term problems with gaps between the tiles will eventually lead to significant deterioration. The walls of the original stable are in poor condition, especially the south gable, which is showing signs of movement.

Plate 1: PRN 43769 – stable showing the differences in construction between the original ?18<sup>th</sup> century whitewashed stable and the 19<sup>th</sup> century extension.

This building is potentially of national importance, particularly as part of a group with the cartshed (PRN 43770) and the cowshed (PRN 43771). It should be subject to further, more detailed survey to try to establish its construction date, to record any surviving original fittings and to fully assess its current condition. Urgent remedial works are required to make the roof watertight and to consolidate the walls.

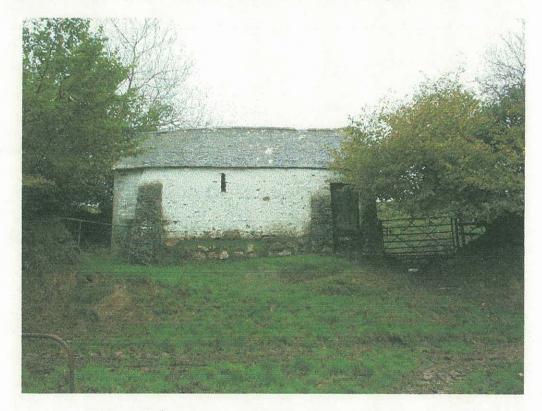
A small rectangular, 18th? century, end-entry single cartshed of random rubble construction with a gabled slate roof. The east wall was constructed on a foundation of large boulders. The cart entry in the front (south) wall has been rebuilt in modern blocks and cement. A single door in the north end of the east wall, gives access via a set of external steps from the yard area, which is lower than the cart entry on the south side. The roof is an A-frame structure with sawn tree trunk collars, which may be a fairly modern and cost-effective repair. The walls have an external and internal whitewash finish. The cartshed is terraced into the hillslope on its west side. It is associated with the stable (PRN 43769) to the east. The roof is showing signs of significant movement and there is some water ingress between the slates. The west wall is suffering from severe damp problems, which are having a significant effect on the structural stability of the building. Creeping vegetation is becoming established on the west wall, through gaps in the roof and along the top of the wall.

Plate 2: PRN  $43770 - ?18^{th}$  century cartshed. The uneven roofline is caused by severe movement within the roof structure.

The cartshed could potentially be of national importance, particularly as part of a group with the stable PRN 43769) and the cowshed PRN 43771) It should be subject to further, more detailed survey to try to establish its construction date, to record any surviving original fittings and to fully assess its current condition. Urgent remedial works are required to make the roof watertight and to ensure the walls are stabilised and consolidated. The modern rebuild could be removed and the cart entry rebuilt in stone using materials to match the existing. Vegetation should be controlled. The removal of vegetation such as ivy or trees from buildings and other structures should not be undertaken where there is any danger that such action may result in damage to the structure. In such cases the vegetation should be cut and allowed to die before removal. It may be necessary to undertake consolidation works at the same time because in extreme cases the vegetation may be supporting structurally unsound masonry.

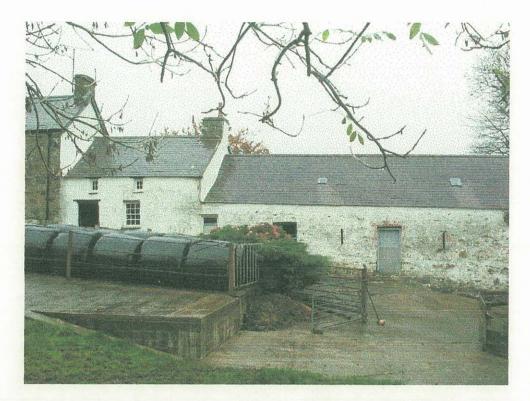
Single storey cowshed attached to the east end of the original Penback farmhouse. The cowshed is of rubble construction with a gabled slate roof. Lights have been inserted into the roof. Like the stable (PRN 43769) and the cartshed (PRN 43770), large boulders have been incorporated into the walls of the cowshed. The exterior is whitewashed. Internally there are six double stalls arranged longitudinally, with a feeding passage on the east side. There is a drive shaft fixed to the east gable wall of the interior of the cowshed, which was driven originally by a horse engine on the north side of the building, and later by a steam engine positioned on the south side. The shaft drove chaff cutting machinery, which was housed in a small extension on the east end of the cowshed. The extension was constructed from rubble and thin shale slabs, in the same style as the extension to the stable, and it probably dates from the 19th century. The cut chaff was fed through a square hatch into the cowshed for feeding the stalled cattle. The cowshed appears to be contemporary with the original house, which may be of 17th century date. The cowshed has been re-roofed and the chaff shed has been partially been rebuilt following movement of the cowshed. Two buttresses have been built in the chaff shed to support the east gable wall of the cowshed in an effort to halt the movement of the structure. The rebuilding works have ensured that the building is in a good condition.

Plate 3: PRN 43771 –The house and cowshed may date from the 17<sup>th</sup> century.

The cowshed and the original house could be of National importance, particularly as part of a group with the stable (PRN 43769) and the cartshed (PRN 43771). It should be subject to further, more detailed survey to try to establish its construction date, to record any surviving original fittings and to fully assess its current condition.

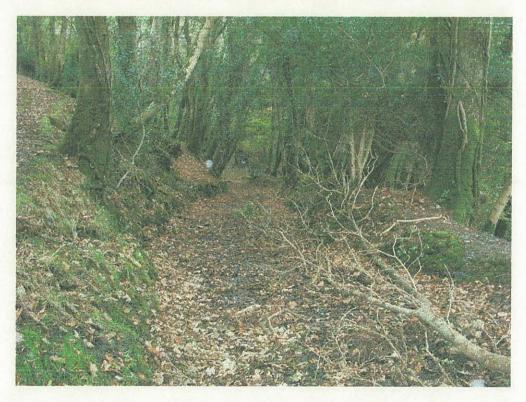
A series of terraced tracks through the woodland east of the yard. The tracks are rock-cut into the steep sides of the small stream valley that marks the east boundary of the farm. The tracks are a mixture of cart-width tracks, which lead from the yard and from the quarry (PRN 43777) down towards the valley bottom, and a narrower, single-width, footpath, which follows the contour around the hillside. Although not closely dateable the tracks appear to be part of complex network of tracks that connected the various farmsteads and cottages that once stood in the area. There are remnants of stonework facing the banks alongside the tracks immediately east of the yard. Some of the facing is in a herringbone pattern, which is also present in the banks of the original farm access track (PRN 43776) to the west of the yard. The tracks are still clearly visible and it is possible to follow them for some distance. They are generally clear of vegetation. Silting, caused by hill-wash, is occurring along some of the single-width footpath.

Plate 4: PRN 43772 – one of a series of rock-cut pathways along the sides of the stream valley to the east of the farm. This shot shows a well-defined single-width footpath.

The tracks should be kept clear of vegetation. It may be possible to open some of the paths for public access and to link them with any existing footpaths in the area.

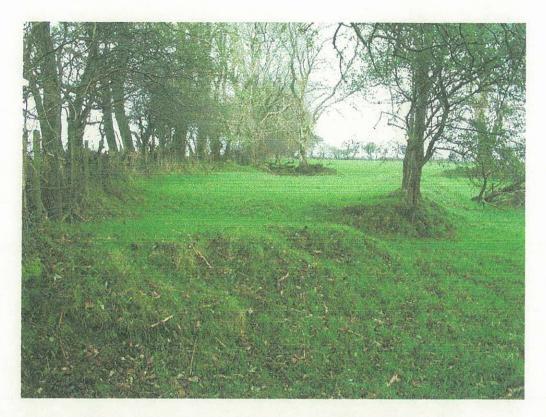
Blaenwaun is the site of a now demolished cottage in a small ovoid garden enclosure. The construction date is unknown, but an 18th century date seems reasonable. Blaenwaun appears on the Llandissilio parish tithe map of 1839. By 1851 it was occupied by the James family. Daniel James was a clog maker, probably using wood taken from the woodland on the sides of the stream valley that bounds part of Penback. The cottage was abandoned sometime around the turn of the 20th century. There is no stone, or other construction materials from the cottage visible on the site, suggesting that perhaps it was constructed from clay on a low stone foundation. There are no standing remains of the cottage, although the low earth bank around the enclosure survives in places. A few grass-covered mounds inside the enclosure may be traces of the cottage walls. The enclosure is clear of vegetation and has a good grass cover.

Plate 5: PRN 43774 – The remains of the enclosure of Blaenwaun cottage.

Regular, but controlled grazing would prevent vegetation growth and maintain the site in its present condition.

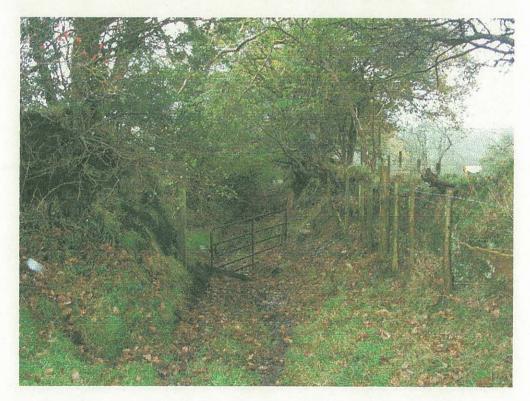
A track leading west from the yard that was formerly the main access track to the farm. The track survives as a hollow-way, c.3m wide, flanked by earth and shale banks up to 2.3m high. A number of inverted V-shaped slate drains through the south bank indicate the original level of the track, some 1.5m higher than today. There are remnants of herringbone pattern stone facings alongside the track. The condition of the track varies, the section nearest the yard is becoming overgrown and water is flowing along its base. The westernmost section survives at its original depth, with low earth banks on either side.

Plate 6: PRN 43776 – the overgrown line of the original farm entrance track.

The vegetation could be controlled and cut back in the section close to the yard.
