Llangwathen W/13/2021

Tir Gofal Farm Visit Historic Environment Report

Report No. 2002/34

REPORT NO. 2002/34
PROJECT RECORD NO. 41594

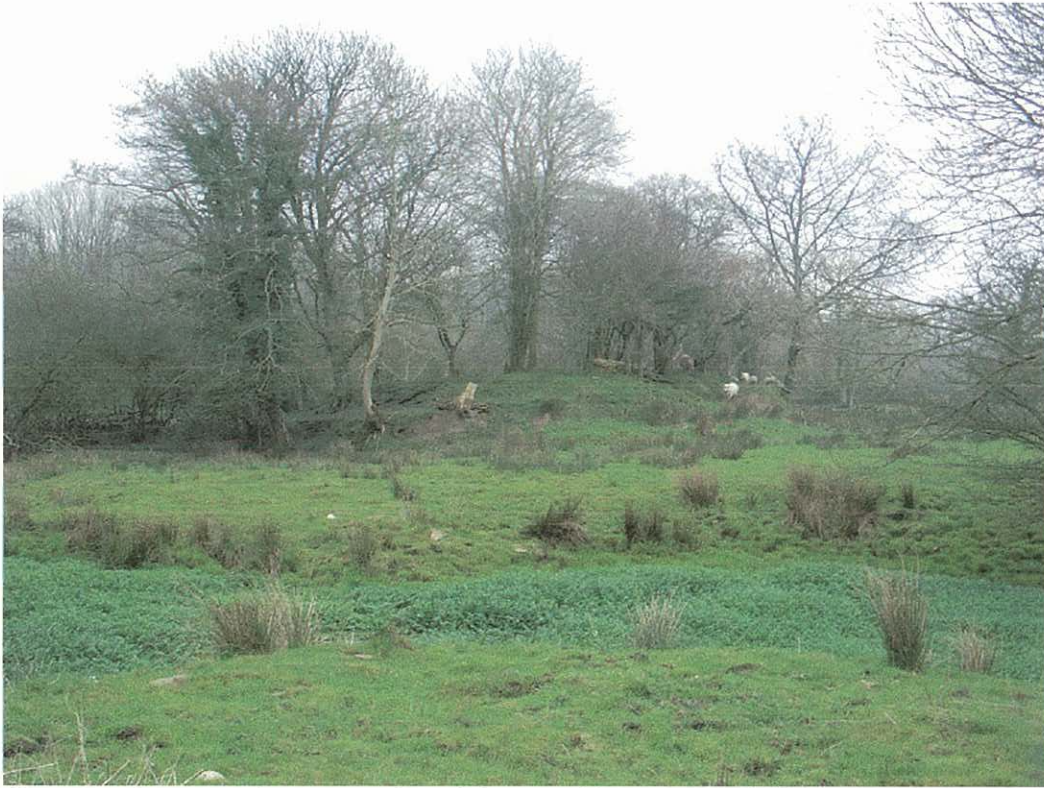
The castle mound is roughly circular in shape and approximately 20 metres in diameter and between 1.5 to 2 metres high with steeply sloping sides (plate 1). To the north the remains of a ditch around 3 metres wide and 0.25 metres deep surround the motte. A low bank to the north west of the mound and another bank to the north east would appear to suggest that the bailey may have extended to the north of the mound. The bank to the north east is rather irregular and has some stonework outcropping in places.

Currently the mound and the adjoining area to the north are partly wooded and the mound has an under storey of thorn bushes. Some patches of erosion caused by sheep were observed on the south side of the motte.

Plate 1 – the motte (PRN 9918) and the pond (PRN 44539) in the foreground.

To the south west of the motte is the remains of an irregularly shaped pond approximately 20 metres long and 10 metres wide (plate 1). At the south east end is a spring which the owners believe may be the holy well of St. Deilo.

The pond no longer has standing water but is now a waterlogged area.

It is important that this feature has a scheme of active woodland management put in place which will prevent tree fall from damaging the structure. This includes not only the motte itself but also the surrounding area which most likely contains sensitive archaeological deposits. Clearance of scrub growth on the motte will also enhance the visibility of the structure.

The patches of erosion to the south side should be covered with netting or chicken wire to keep the stock off and allow the turf to regenerate. It may also be necessary to reduce stock numbers to help prevent this kind of damage.

The owners hope to reinstate the pond and raise the water level. Archaeological advice should be sought if a sluice structure is to be inserted to raise the level of the pond, likewise if the pond is to be dredged. The proximity of the pond to the motte makes this area archaeologically very sensitive. If this structure is to be placed within the scheduled area it will also require scheduled monument consent.

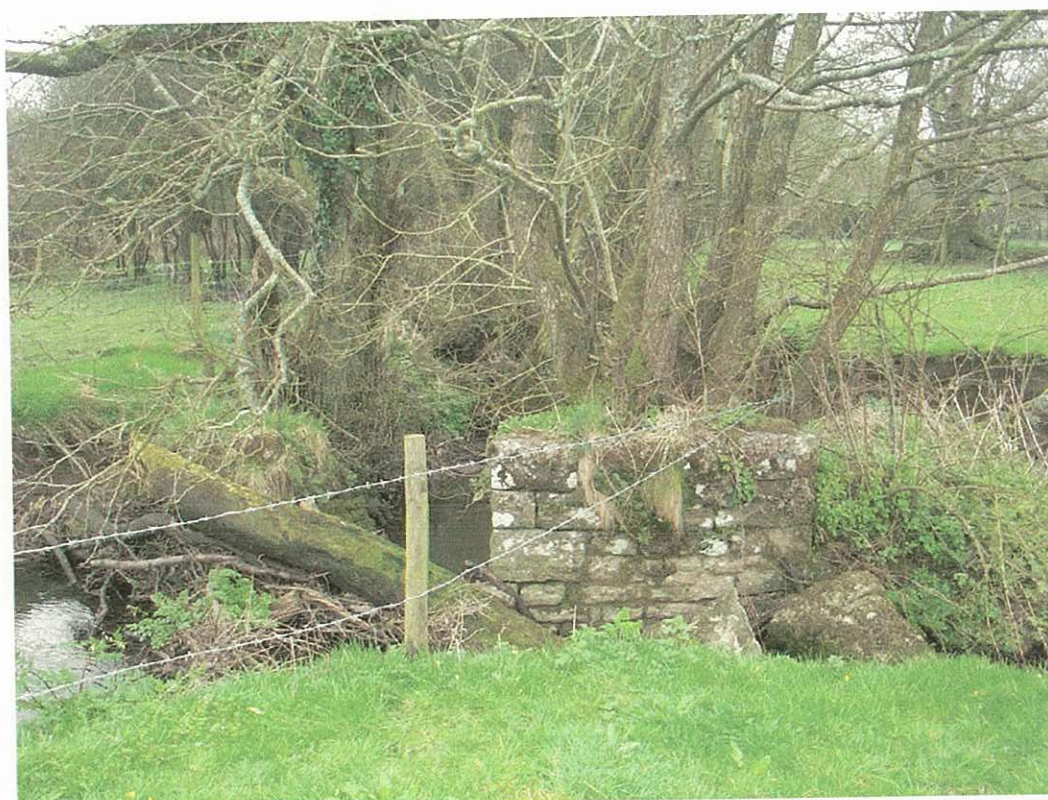
Within the stream to the north west of the motte is a large stone sluice composed of two large masonry piers to either side of a central channel (plate 2). It is well constructed out of roughly squared stone, built to courses with substantial stone jambs. The face of the stone piers are convex in shape with the stream now running around the sides. The rebates for the sluice gate are visible however there do not appear to be any remains of the gate or paddle itself.

There is a large amount of wood and debris which has built up against the central sluice way. This is of concern to the owners since it is redirecting the force of the stream to the south, around the structure and undermining the stream banks. There is also a considerable amount of vegetation growing out of the structure. This structure is locally known as a sheep wash; however the owners believe it may relate to a scheme of redirecting the water towards the motte.

Plate 2 – the sluice (PRN 44538) showing the accumulated debris against the sluice channel.

The accumulated debris, which has built up against the face of the sluice, should be removed to allow a free flow of water through the structure. The vegetation in the structure should be carefully removed and the masonry consolidated. Mrs Lewis mentioned that the structure is gradually deteriorating with each winter. It would therefore be beneficial that an archaeological record is made of the structure.

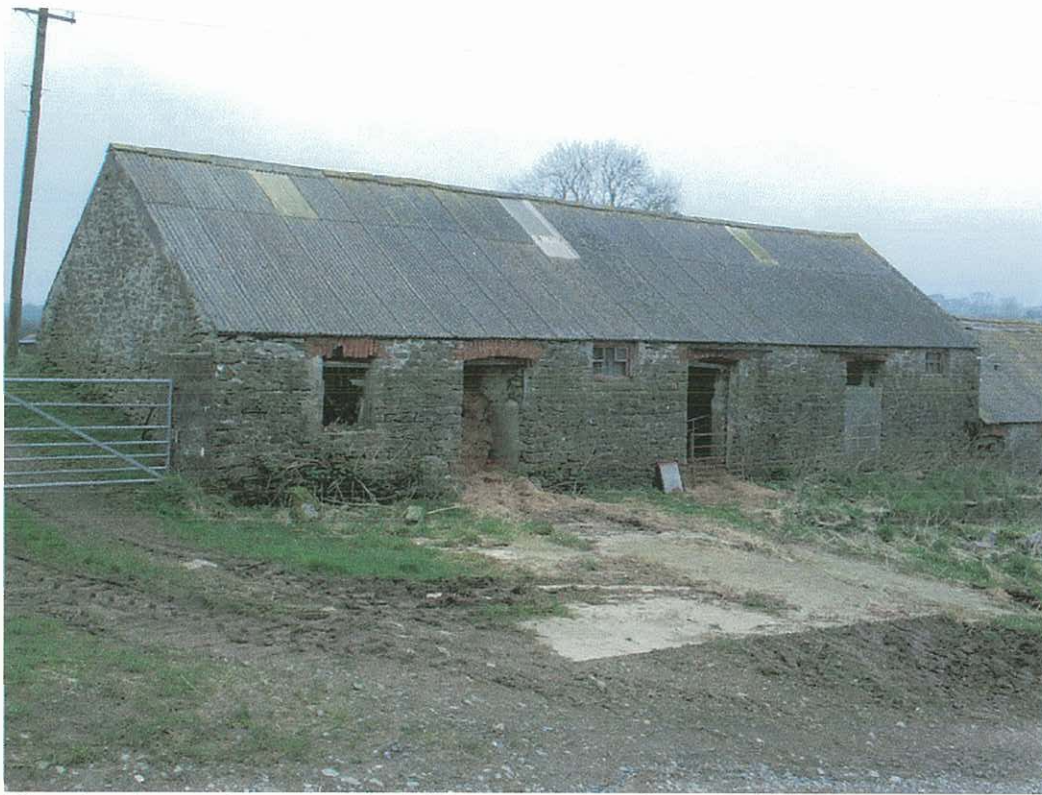
To the west side of the farmyard is a long row of cow sheds, divided into two sections. The range of buildings are built across the slope so the southern building is considerably higher than that to the north. Both buildings are constructed out of rubble stone walling with low brick arches over the openings and corrugated asbestos roofs. The southern cow shed has three doorways in the east elevation, at the south end is a large inserted window (plate 3). Two further windows are placed high into this elevation. The southern third of the cow shed has three bays of cow stalls across the transverse wall. The northern two thirds has a feed passage running along the west lateral wall.

The roofs to the cow sheds have begun to deteriorate, the north cow shed has a very uneven roof line which may indicate some of the roof structure is rotten (the trusses themselves appeared to be intact). There is also substantial ivy growth penetrating the structure from the west elevation.

Plate 3 – the southern cow shed (PRN 44540) to the west of the farm yard.

Mr and Mrs Lewis hope to repair the farm buildings. It is recommended that the roof repairs are undertaken as soon as possible before water ingress damages the masonry structures. Some consolidation of the masonry will need to be carried out in conjunction with the careful removal of ivy. If possible the wooden doors and windows should be retained and repaired.

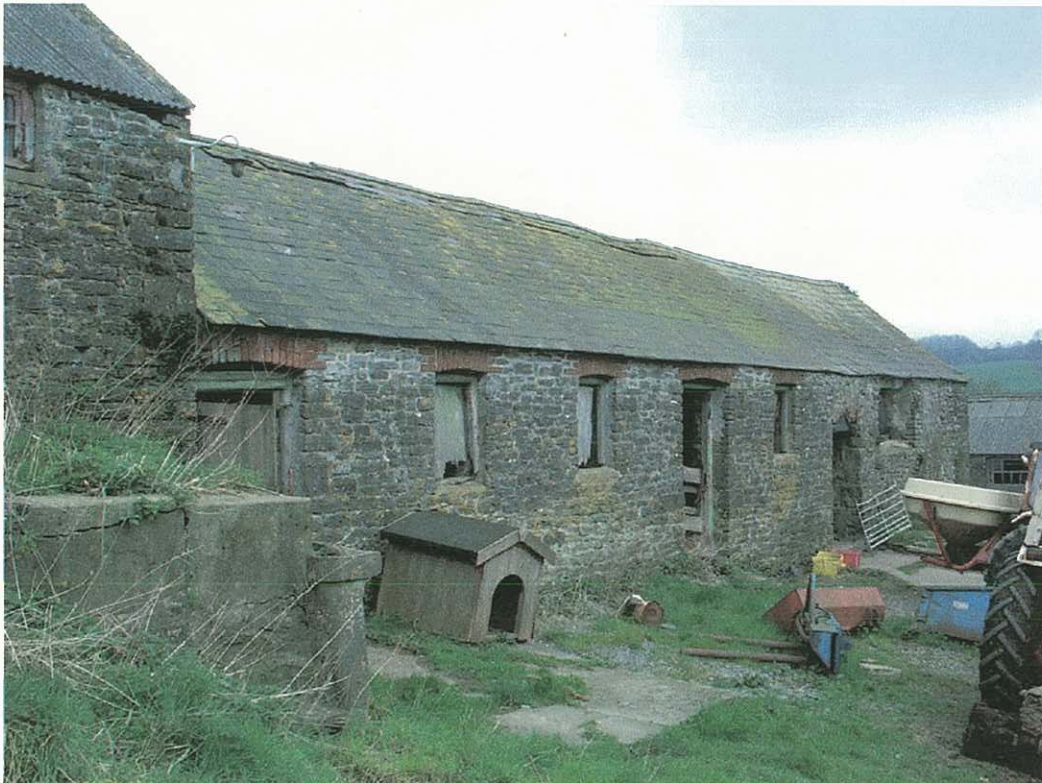
The north cow shed butts up to the south cow shed (plate 4). It is subdivided at the north end which is used as a grain store. To the south end of the cow shed is a feed passage running along the west lateral wall. There are two doorways in the east elevation and three windows opening into the cow shed. The grain store at the north end is accessed by one wide doorway. To the north of this doorway is a scar of an adjacent building, which has since been demolished.

Plate 4 – the northern cow shed (PRN 44540)

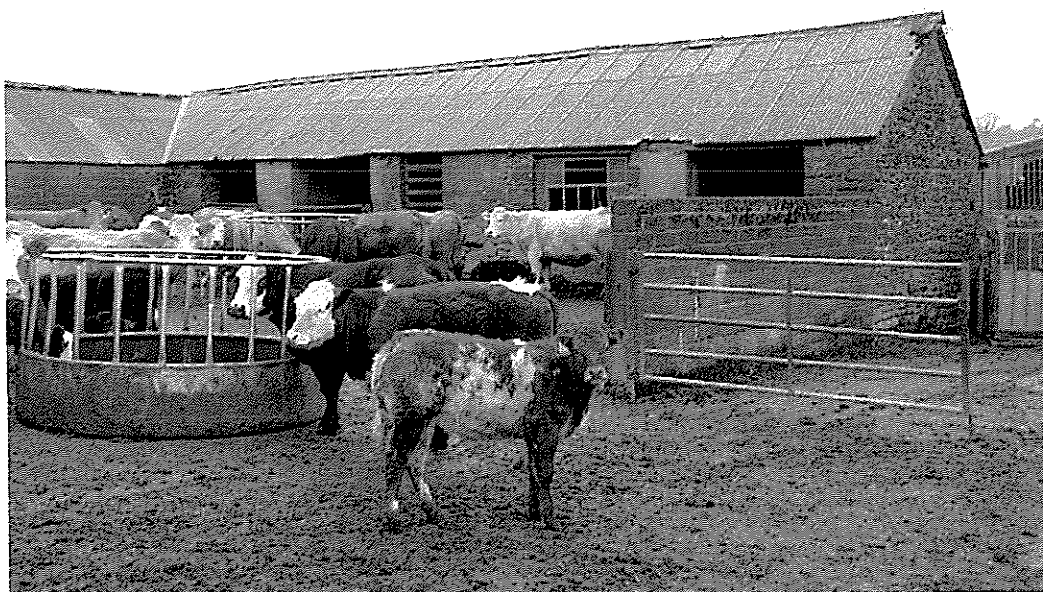
An L-shaped range of cow sheds are situated to the north west of the farmstead. These are arranged around the north and west sides of a modern concrete fold yard. These buildings were inaccessible but appear to be of similar construction to the other farm buildings. There is a hole in the roof at the east end of the cow shed which is allowing water to penetrate the gable wall (plate 5).

Plate 5 – the L-shaped cow shed (PRN 44541) in the north west corner of the farm yard.

The roof of the cow shed should be repaired and the structure made watertight.

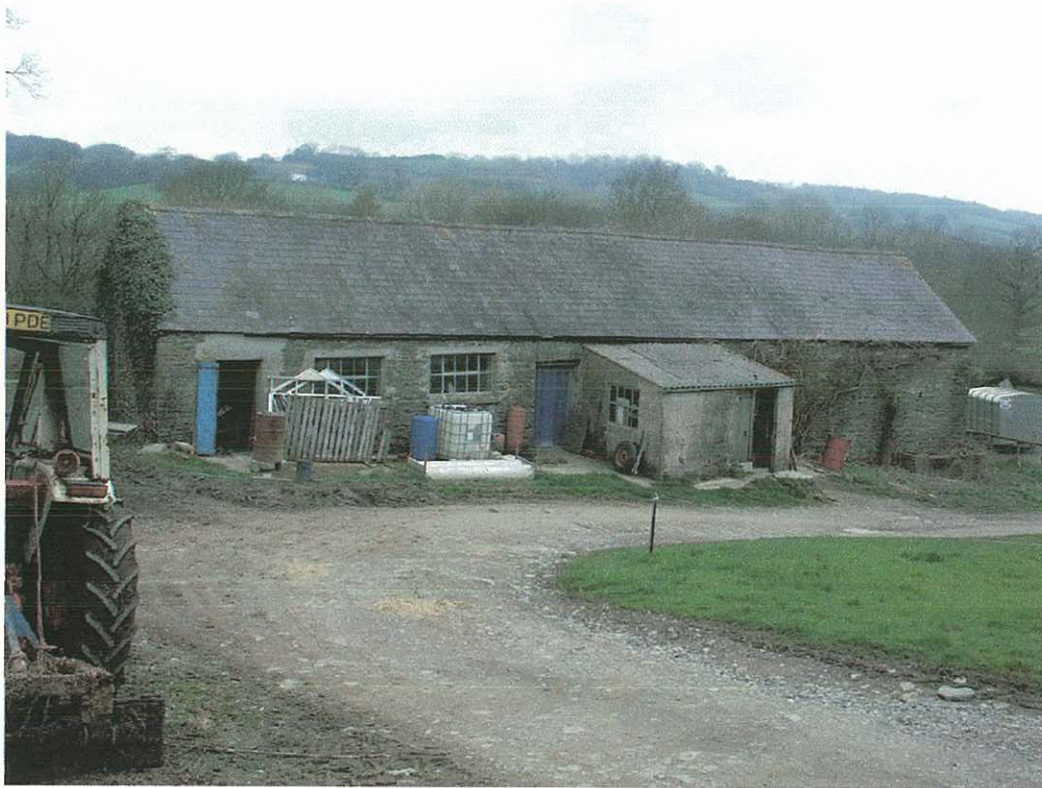
A cow shed with a cart shed and granary at the east end are positioned on an east west orientation to the east of the farmyard (plate 6). The roof is largely covered with slate except an area to the north which has been replaced with square sectioned corrugated sheeting. The west end has been heavily modified with concrete windows and doorway and a breeze block outshoot has been attached to the south elevation. A doorway to the west of this outshoot is constructed with a low stone arch and jambs. To the east is a wide cart entrance also constructed with stone voussoirs and jambs. The east end of this range is two storeys with wooden steps leading to the upper storey from the cart shed. The east gable wall has a stable doorway and window in the ground floor and a central window above.

The cart shed and granary has a considerable amount of ivy growing over the west gable end, and some roof slates have been lost on the east end.

Plate 6 – the combined cow shed, cart shed and granary (PRN 44532).

The roof to this cow/cart shed and granary should be repaired and made watertight and the masonry consolidated.

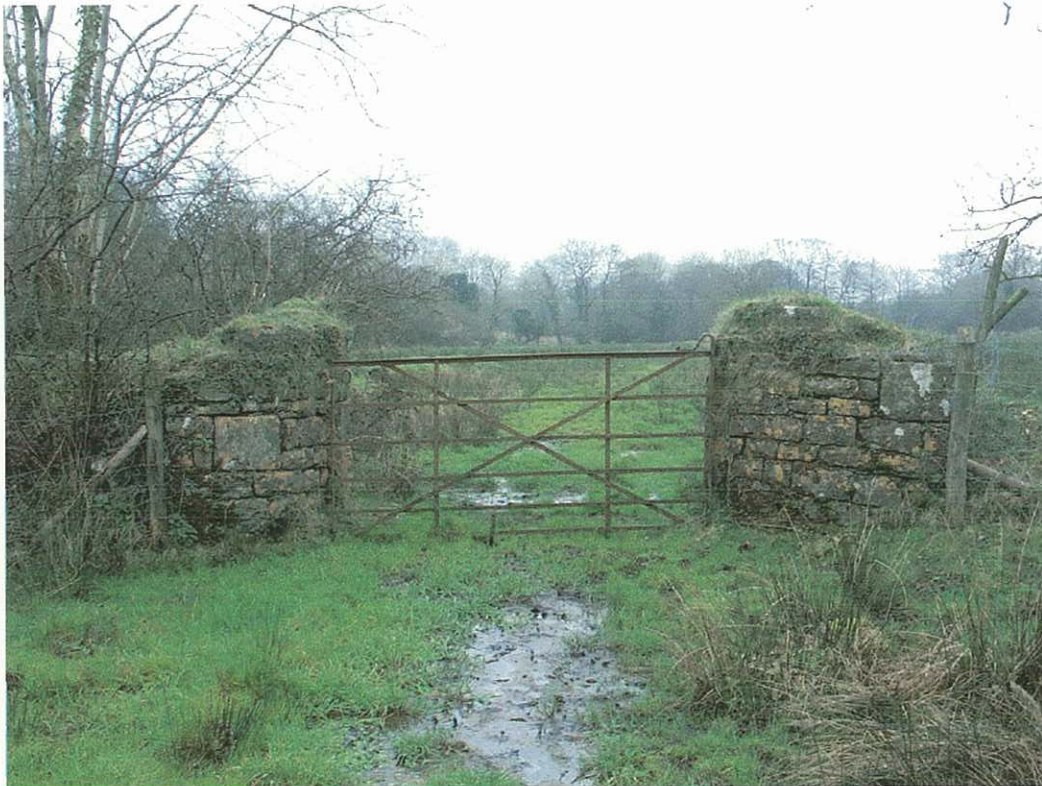
To the east of the motte is an impressive stone gateway, situated across the line of the trackway (PRN 44544). The gateway is constructed with large stone piers approximately 1.6 metres high built to courses with large rough stone blocks (plate 7). The piers are rounded with stone rebates to hold the iron gate. The gate piers are becoming overgrown with ivy and some woody growth is beginning to get established in the masonry.

Plate 7 – the stone gateway (PRN 44535) and the line of trackway beyond (PRN 44534).

The vegetation should be carefully cleared from the gate piers and the masonry consolidated using traditional materials.

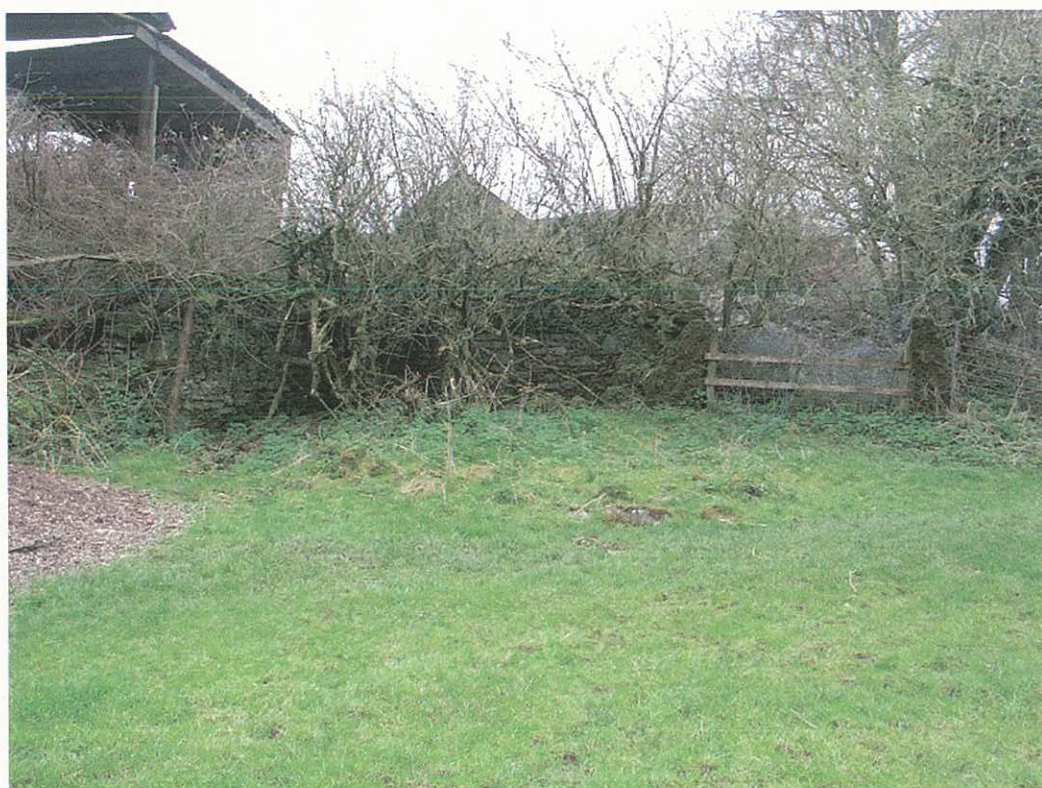
The remains of a building can be seen to the north of the farmstead. Only the south and west walls remain to a height of approximately 1.8 metres. The building is constructed out of rubble stone walling and appears to be c. 7 metres long by 4 metres wide. The ruins of this building are becoming engulfed by vegetation.

Plate 8 – the remains of a building to the north of the farmstead (PRN 44537).

The vegetation should be cut back and treated to prevent regrowth. Ideally the stonework should be consolidated.
