# Tir Gofal Farm Visit Report Upper Cowsland Farm W/13/2013

Report Number 2002/20

# **UPPER COWSLAND FARM** TIR GOFAL FARM VISIT REPORT

CA Tir Gofal Archaeologist Alice Pyper Visit Date 15/01/02

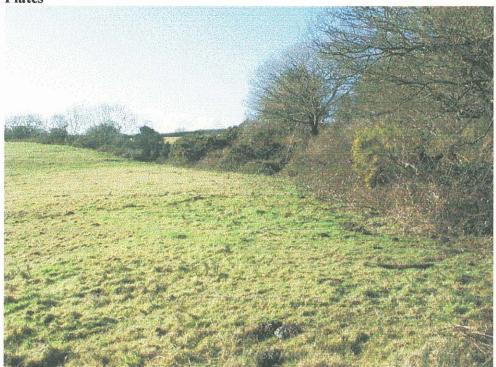
The Reynalton railway extension was built during 1914-15 when the pit at Reynalton was developed. It is documented that the route of the extension followed the line of the contours to reduce costs. The route of the Reynalton extension can be traced in the fields to the south east of Upper Cowsland farm (plate 1). A cutting in the hillside extends in a north east direction for a distance of c. 110 metres from the Reynalton direction and gradually arcs to the south east in a large embankment over the stream. The cutting with battered sides is c 2-3 metres in depth and is overgrown and largely impenetrable.

Plate 1 – the remains of the Reynalton railway (PRN 44359) looking towards the cutting.

The railway is a significant feature relating to the mining industry which is an important element in the history of this area. The vegetation should be cleared or thinned to a manageable and stable state to expose the remaining earthworks as a visible landscape feature.

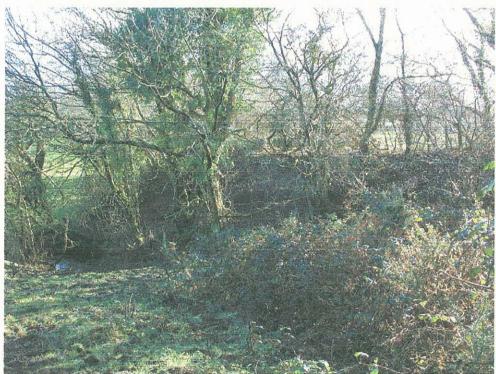
The embankment is a very impressive feature, with high battered sides reaching approximately 8 metres in height. It appears to survive to its original height and although overgrown the route of the railway could be followed. There do not appear to be any remains of the railway other than this monumental earthwork, and the sale of the rails after the railway closed has already been mentioned. The stream has been culverted through the embankment in two iron riveted pipes c. 0.5m in diameter. Above the iron pipes is a smaller ceramic pipe c. 0.25. in diameter which is a later insertion. The embankment is currently quite overgrown with scrub and young trees and the south side is also quite heavily poached.

Plate 2 – the north side of the embankment (PRN 44360) of the Reynalton railway line.

The vegetation on the embankment should be thinned or cleared and a management scheme introduced which will keep the vegetation in control. The levels of stock should be managed to minimize poaching which is currently a problem.

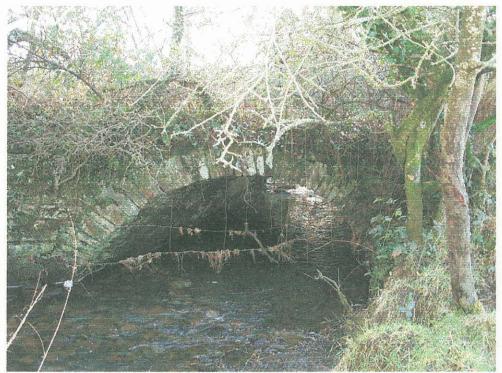
A finely constructed stone bridge connects the land on either side of the stream to the east of the farm holding. It has a low arch constructed with roughly dressed stone voussoirs c 1.10m high and 3.5m wide (plate 3). The bridge is angled across the stream in a north east - south west direction. It appears on the 1st edition Ordnance Survey map of 1888/9 (1:2500) with a footpath which runs to Upper Cowsland Farm to the north west and to the old road to the east (now abandoned) which ran up to the New Hayes pit from the crossroads to the south. The 1st edition map also shows a field boundary to the east side of the stream which extended in a north east direction to the site of the old New Hayes colliery. This may indicate the route of a trackway which connected the New Hayes and Hacket collieries. It would seem that the bridge is a relic of the Hacket and New Hayes mining complex. The bridge although currently in a reasonable condition is becoming quite overgrown.

Plate 3 – the north side of the bridge (PRN 44361) which may have linked the Hacket and New Hayes collieries.

The boundary of the farm falls short of the bridge. However a stone retaining wall is situated to the north of the structure on the west bank and this requires clearance of the intrusive vegetation and some consolidation of the masonry.

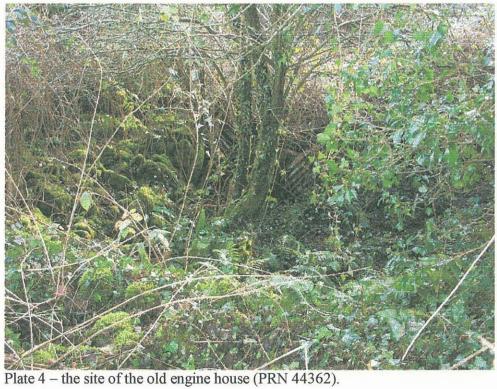
The remains of a building can be seen just within the southern boundary of the farm. It is labelled on the 1st edition Ordnance Survey map of 1888/9 as the "Old Engine House". From the mapping evidence the building is rectangular and orientated on a north east - south west axis. The site of the building is now engulfed in vegetation and has been at least partially fenced off. The extensive vegetation makes this site difficult to assess, however a large quantity of stone within a depression c. 4-5m in diameter and some upstanding masonry survive. This building is almost certainly associated with the Hacket colliery which was in operation in the 1850's.

The remains of this building should be carefully cleared of intrusive vegetation by cutting back, and allowing vegetation to die back before removal. Any upstanding remains should be consolidated. Archaeological advice should be sought prior to works being undertaken.

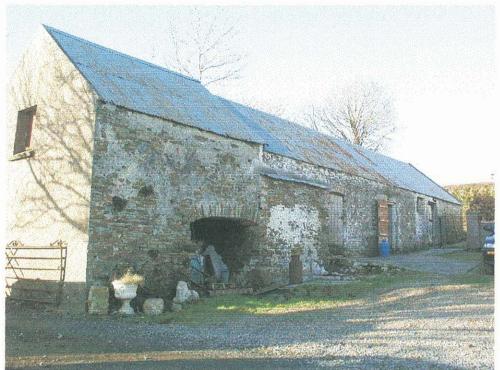
The south end of the building (the cart shed) is suffering from structural damage. The west wall has a large bulge and in the gable end is a crack which runs from the 2nd storey to the ground. This may be caused by, and is undoubtedly exacerbated by the eroded corrugated iron roof on the west side. This is allowing water to permeate the masonry and wash out the mortar.

Plate 5 – the cart shed and cow shed beyond (PRN 44364).

The cart shed requires attention to the severe structural faults in the south east corner as soon as possible. The roof, which is at least partly the cause of the problem, should be renewed and made fully watertight with enough overhang at the eaves to prevent rainwater washing down into the wall tops. These repairs should be undertaken using traditional materials and techniques. The historic internal floor surface and fittings should be retained and repaired using traditional materials.

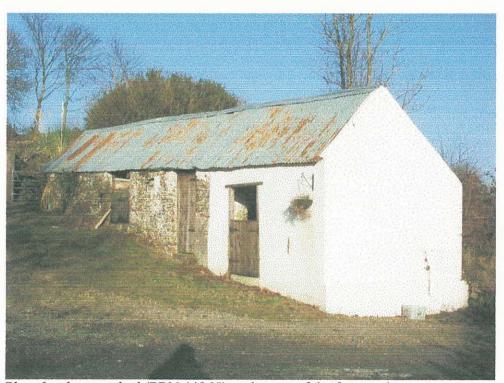
To the east of the farmyard is a long narrow cow shed, orientated on a north south axis. This is constructed out of roughly coursed rubble with a pitched corrugated iron roof (plate 6). The southern end of the building has been rebuilt on the south and west walls with breeze block.

Plate 6 – the cow shed (PRN 44365) to the east of the farmyard.

This cow shed is in fair condition. Most of the structure is stable, however in some areas the masonry needs consolidating particularly the quoins at the north west corner and the stone jambs around the doorway. The roof has corroded in places and needs repairing or renewing in the near future. All repairs and maintenance should be carried out using traditional materials.
