**Tir Gofal Farm Visit Report**  
**Cleggars Farm**  
**W/13/1680**

**Report Number 2001/55**

REPORT NO. 2001/55  
PROJECT RECORD NO. 41636

CLEGGARS FARM  
TIR GOFAL FARM VISIT REPORT

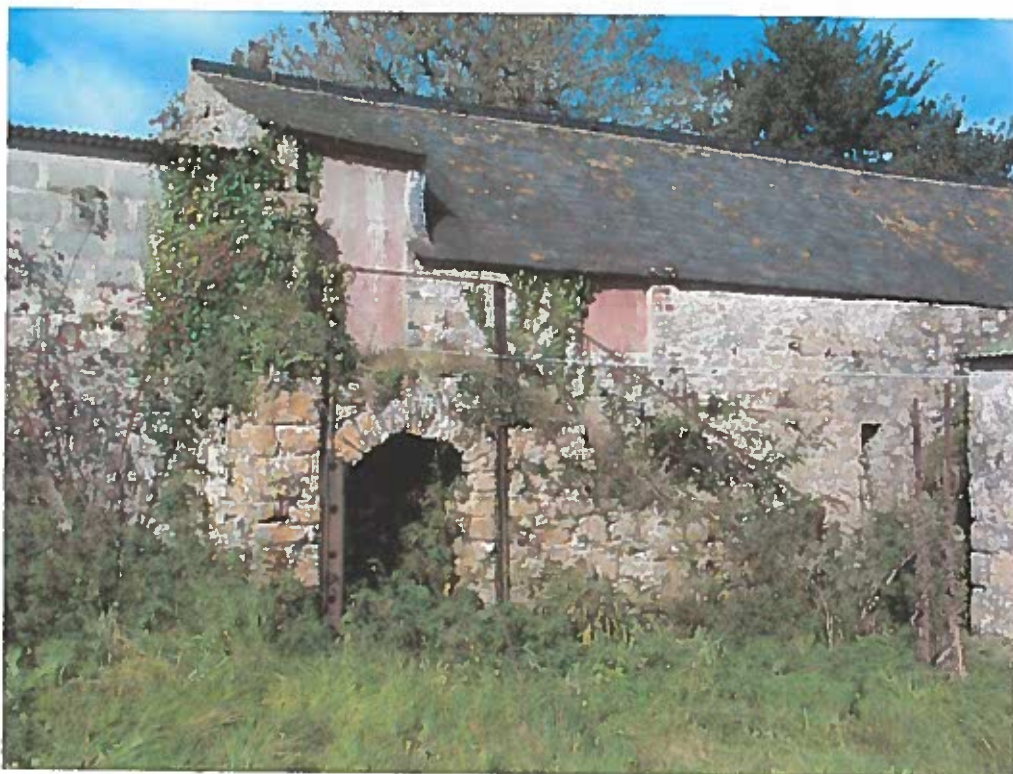
An 18th or early 19th century two-storey field barn and cow shed, of random rubble construction with a slate gabled roof, which incorporates some elements of an earlier building. The lower floor is entered via two square headed openings from the field to the east of the yard. The openings are of different sizes, the larger probably being for carts. The loft, now removed, was entered via external steps on the east wall. There are two sets of opposing pitching eyes at eaves height. The southern end of the building has been substantially rebuilt in breeze block. The steps to the loft are of dressed stone and appear to belong to an earlier, sub-medieval, building. There is an asymmetrical, four-centred arch below the steps, which may have led to a door to the ground floor of the original buildings. The Lamphey parish tithe map of 1841 shows a building in roughly the same position, albeit on a different alignment. Using this map evidence, with the usual caution of not relying on the accuracy of buildings shown on the tithe map, it seems that the external steps may have been on the east gable wall of the earlier, sub-medieval, building, and that the present building was constructed on its current alignment during the mid 19th century rebuilding programme. There are some gaps in the slates, and the external steps are becoming overgrown with moss, ivy and other vegetation. The walls are generally in good condition, but there is some cracking around the wall tops.

Plate 1: PRN 43578 – Steps from an earlier sub-medieval building reused on the exterior of the 19<sup>th</sup> century field barn.

The gaps in the roof should be repaired using slates to match existing, the steps should be cleared of vegetation and the stonework should be repaired where necessary using local materials and, as far as is possible matching the mortar.

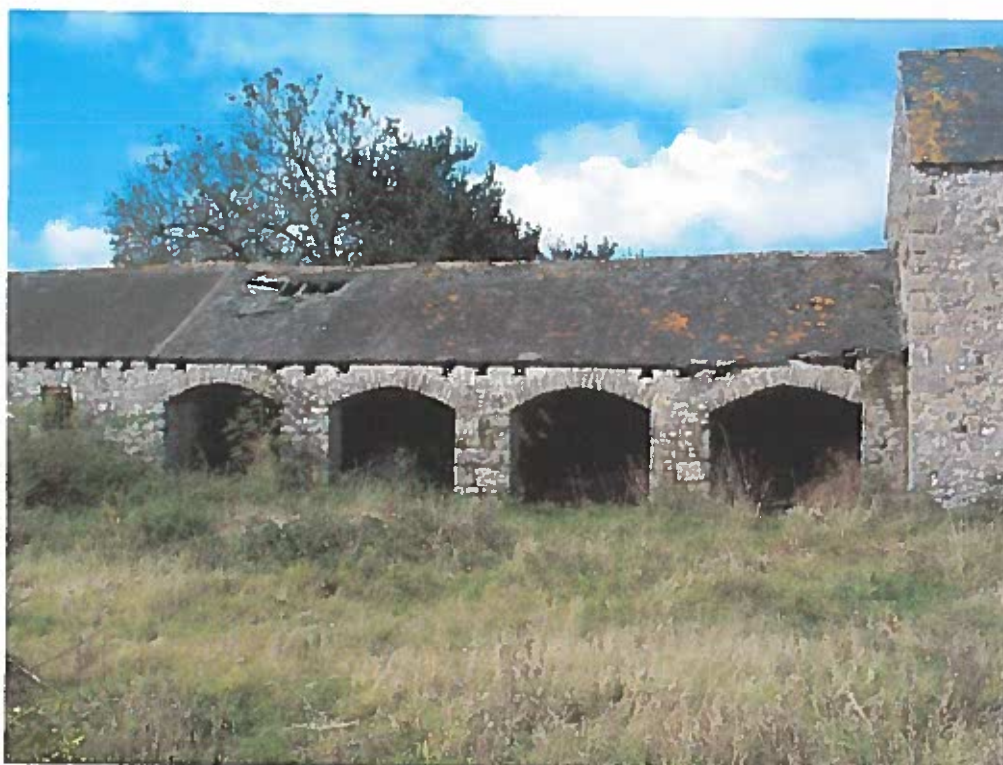
The cart has flattened two-centre stone arches supported on dressed stone pillars. There is a row of pigeon or dove roost boxes under the eaves, which extends across some of the front of cow shed PRN 43579. The roof is gabled and constructed using pegged slates resting on batons. There are traces of a lime mortar over the undersides of the slates. It seems that the cart shed and the cow shed (PRN 43579) were added to the south side of threshing barn PRN 43614 to form the west range of the yard during the 19th century. There is a large hole in the roof where slates have fallen which is allowing severe water ingress, which is having an effect on the roof timbers around the damaged area. Plant roots have invaded the roof space through gaps between the tiles. There are clear signs of damp on the interior walls, which may be the result of water ingress from the roof, or damp penetrating the walls.

Plate 2: PRN 43581 – 19<sup>th</sup> century cart shed, showing the damage to roof structure.

The damage to the roof should be repaired using pegged slates to match existing. The vegetation creeping through the slates into the roof space should be removed and the extent of the damp in the roof timbers and walls should be properly assessed.

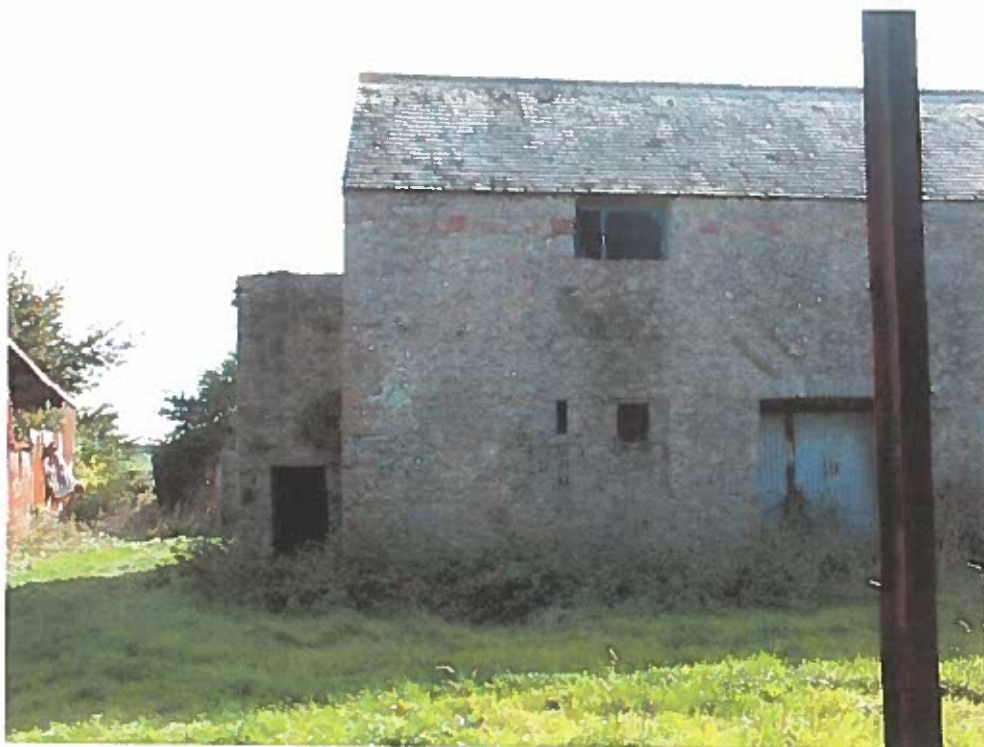
A large two-storey threshing barn of probable 18th century date. The barn is of random rubble construction with a slate gabled roof. There are large central opposing doors to the threshing floor and pitching eyes below the eaves. The loft is reached via a flight of external steps on the north wall. The beams for the loft are massive in comparison to the structural timbers used in the other buildings and they may be a later addition. Roof scars on the exterior of the west wall suggest that an extension had been added at some time, probably to house a horse engine to drive a threshing machine. There are two square openings in the west wall, which were for the driving gear from an overhead engine. There are gaps between the slates on the roof, but in general the building is in good condition. A plastic oil tank has been installed on the external steps, which are also becoming overgrown with moss and ivy.

Plate 3: PRN 43614 – 18<sup>th</sup> century threshing barn, showing roof scars and rectangular hole for gear from a former horse engine.

The gaps between the slates should be repaired using slates to match the existing. The external steps should be carefully cleared of the vegetation and the oil tank should be removed.

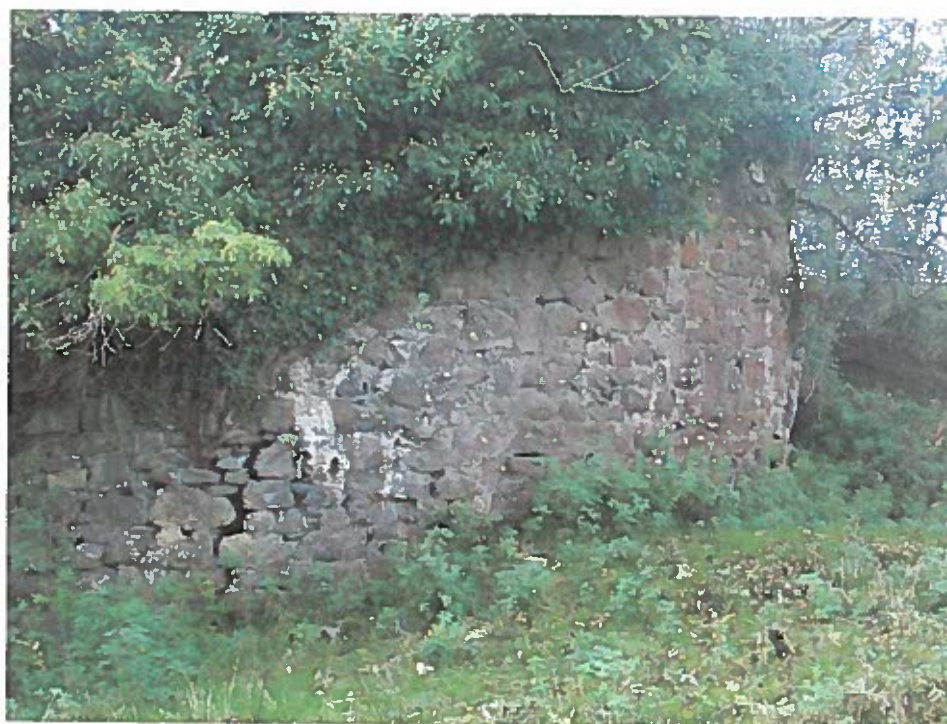
The kiln is a three quarter circle kiln, constructed against the north-facing wall of a quarry to the east of Cleggars farm. It has opposing drawing arches in the east and west walls and is constructed from stone and rubble slabs bonded with lime-based mortar. The structure survives to full height and is in reasonable condition, although there is severe structural movement of the exterior of the north wall, the roots of trees growing on the structure have caused cracking and bulging. The partial collapse of the crucible has damaged the east drawing arch. The quarry, which contains the kiln, is large, c.100m x 30m, and split into two by a wide baulk of unquarried stone. This may have been deliberately left to provide access between the two sides of the quarry. The kiln is located in the smaller, west side. The quarry is overgrown and there are substantial trees rowing in its interior. A late 18th century map book for the Lamphey Estate records the field in which the kiln is situated as Kiln Field, a name that survived throughout the 19th century, clearly indicating that a kiln has stood in this area since at least the mid - late 18th century.

Plate 4: PRN 15967 – Cracking and movement in the north wall of the limekiln. The kiln is a Listed Building Grade II, so Listed Building Consent would be required for any remedial works.

Vegetation could be removed from the limekiln (PRN 15976) and the damage caused by tree roots, particularly on the north side should be repaired to stabilise the structure.

The kiln requires remedial works to remove some of the most damaging vegetation, including the trees that are growing on the structure and the ivy on the external walls. Vegetation should be cut back and the roots left in place and treated to prevent new growth. Listed Building Consent would be required for any works on the structure. Once the worst of the vegetation has been removed the walls, particularly the north wall should be consolidated to stabilise the masonry. The quarry should be kept clear of modern rubbish and maintained in its present condition.
